Item Numbers: 05-1057.00, 05-1058.00, 05-1059.00 Franklin County US 421 Bridge Replacements

Appendix H – Structure Inventory and Appraisal Sheets

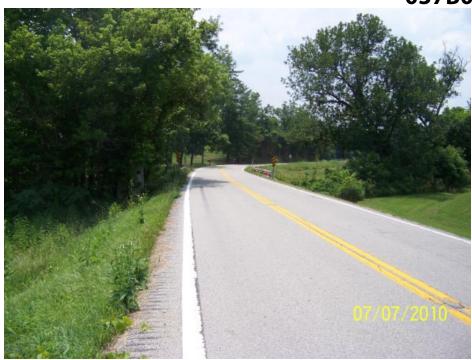
037B00023N

Looking south along US 421.

Looking north.

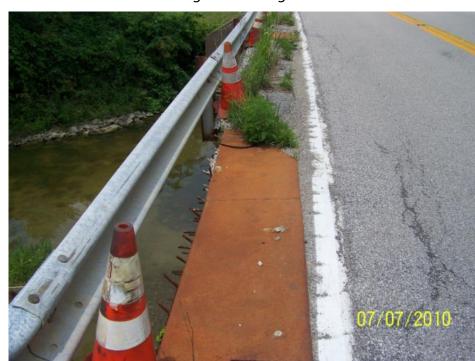
West edge supported by steel plates.

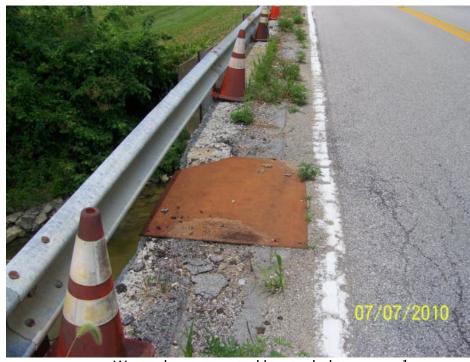
West edge supported by steel plates.

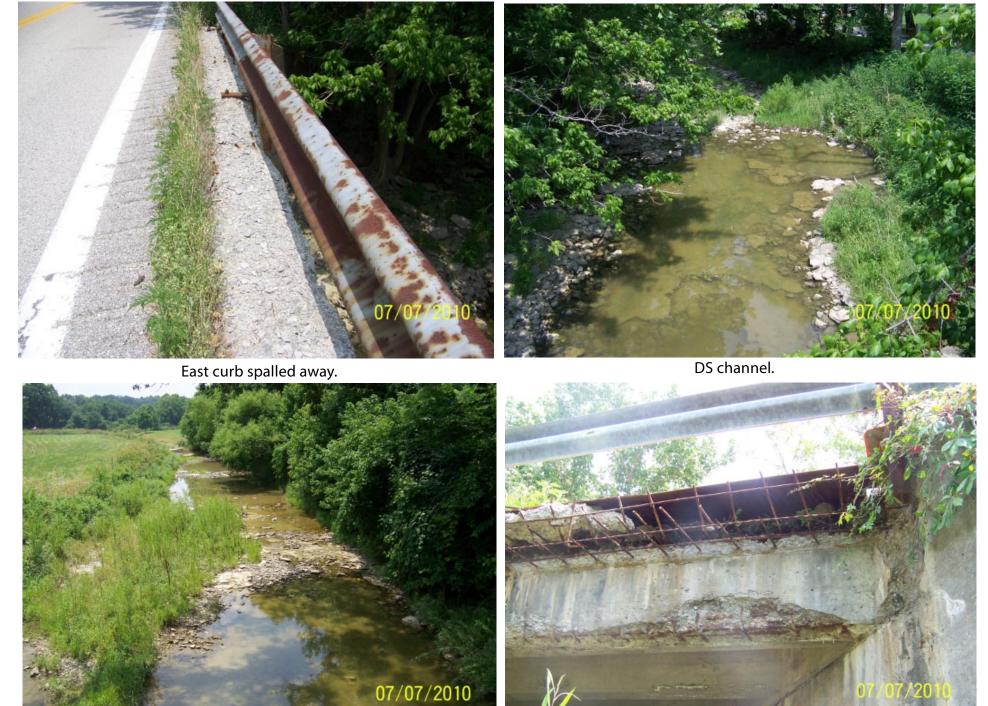
037B00023N

US channel.

Span 1 west edge; Girder 1 spalled.

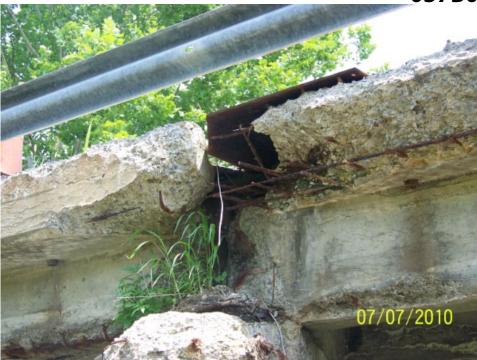
037B00023N

West edge at P2: pier column & cap spalled, G1 spalled.

Span 1 G5 spalled.

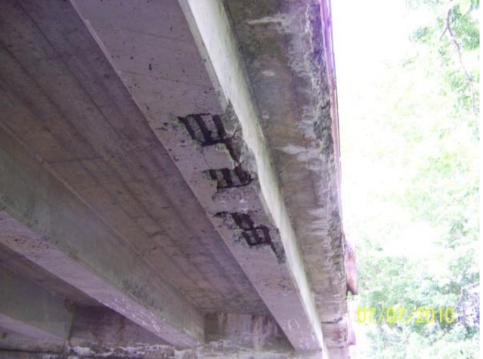
East edge at P2: pier column & cap spalled.

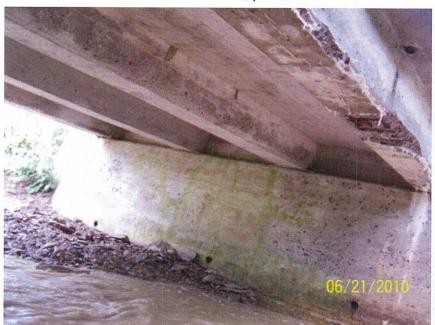
Underside of bridge and south abutment

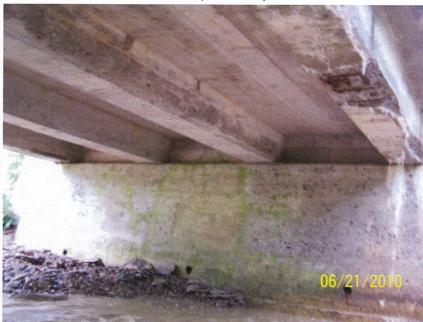
Underside of bridge and south abutment

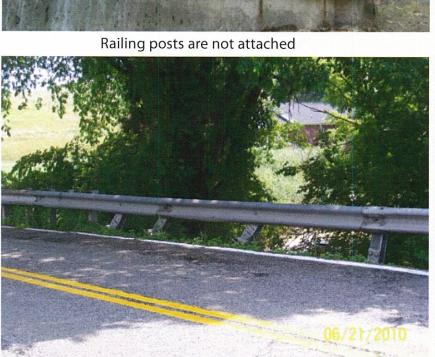
Railing posts are mis-aligned

1	334/1	Metal Bridge Railing - Coated	The guardrail posts are not anchored at all due to the condition of the concrete the anchors were in.
1	359/1	Soffit of Concrete Deck or Slab	Bottom of deck has minor cracks, some with efflorescence and moderate amounts of possible full depth deterioration. Overhangs and edges of deck are severely spalled and deteriorated with resteel exposed that has advanced section loss.
1	503/1	Reinforced Concrete Curb	Curbs are severely spalled and crumbling.

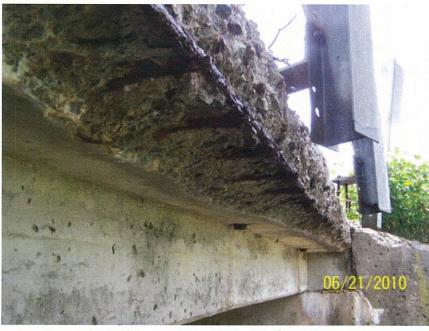
Railing posts are hanging from the rails

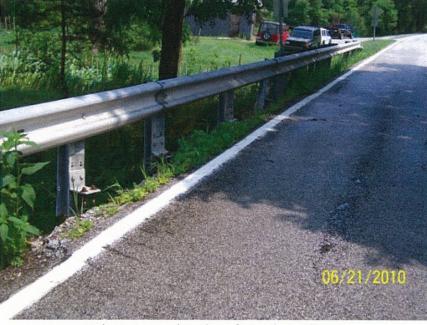
Rail posts are dangling from the railing

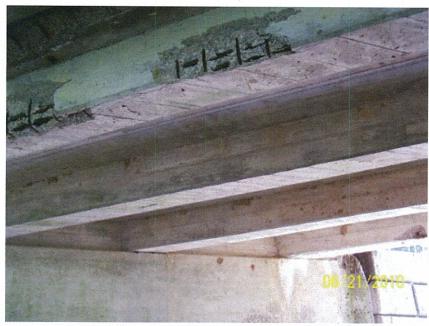
Underside of bridge from east side

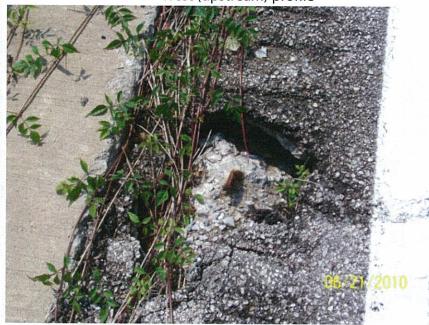
Approximatel 20" X 16" hole in deck at west edge

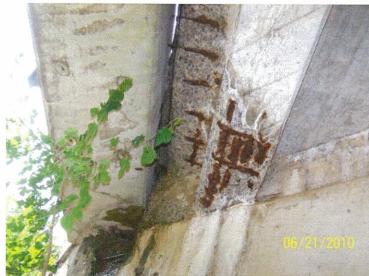
037B00025N

< Steel exposed in west beam (and deck)

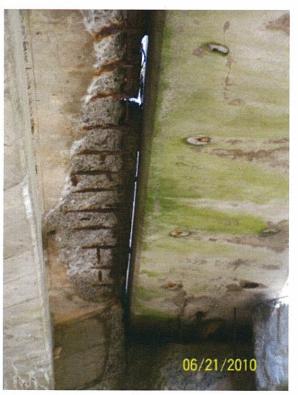
< Smaller (8" X 24") spall and hole in deck at west side

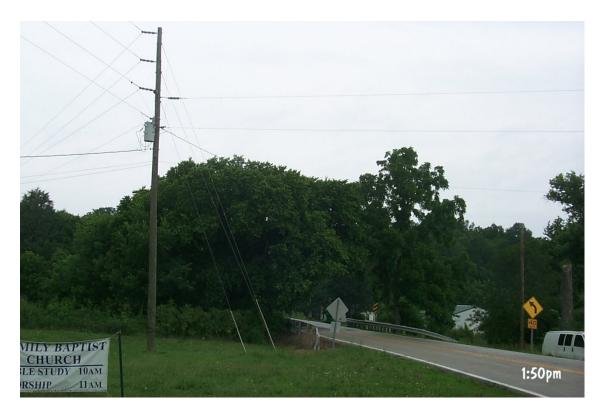
Figure 12: Overhead Utilities at Structure

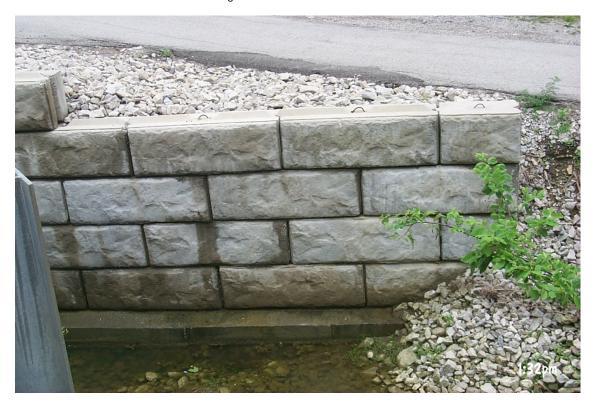
Figure 16: Southwest Wingwall
