June, 2020

Western Kentucky
Parkway Upgrade Study
Final Report

Hopkins, Muhlenberg, and
Ohio Counties, KY

HMB Professional Engineers, Inc.

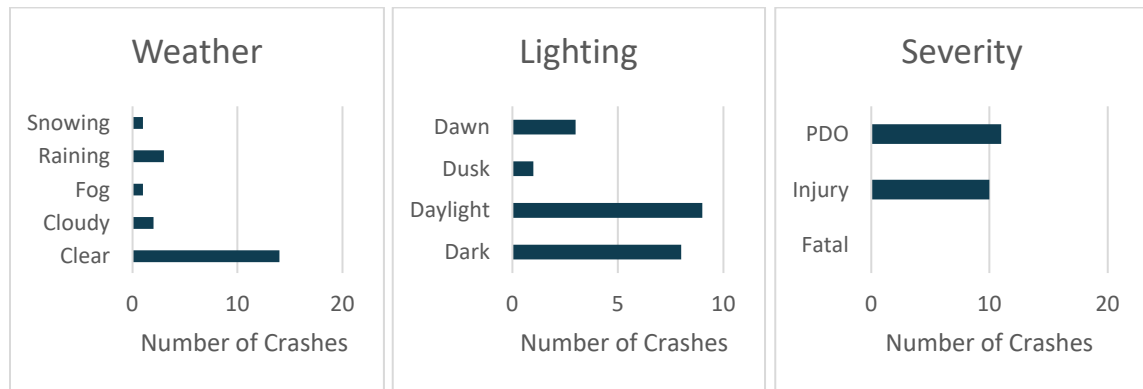
Figure 17. Additional Crash Information - Huck's

Twenty-one (21) crashes were identified as occurring in the area associated with Huck's. **Figure 17** provides details regarding weather, lighting, and severity.

The data presented in **Figure 17** shows that the majority occurred during clear weather conditions. A review of the severity of the crashes (i.e. fatality, injury, or property damage only) showed there were almost as many injury crashes as there were property damage only.

Three out of twenty-one crashes involved vehicles exiting / entering the WKP from Huck's. One was a result of water pooling on the exit ramp. A second one involved a merging issue from Huck's to the WKP. The third one noted driver expectation, and it further detailed that the driver thought the exit would be on the right and then swerved left to get off the exit and hit another vehicle.

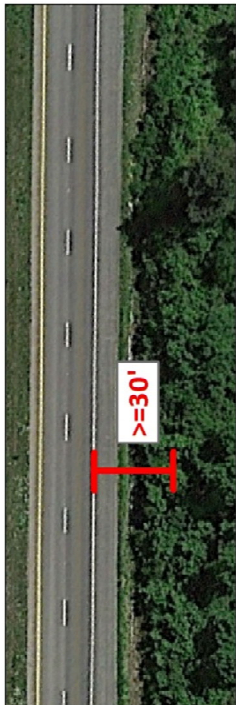
Pavement Cross Slope Example

As discussed in previous sections, there was a limited field review conducted that revealed several areas in which the traveled lane cross slope was less than 1.5%. A cost could not be associated with this work item because there was not enough information gathered to determine the extent of this deficiency. This will need to be further investigated through a detailed field survey, therefore, the planning-level cost estimate for this work item could not be determined. This work item is illustrated in **Figure 21**.

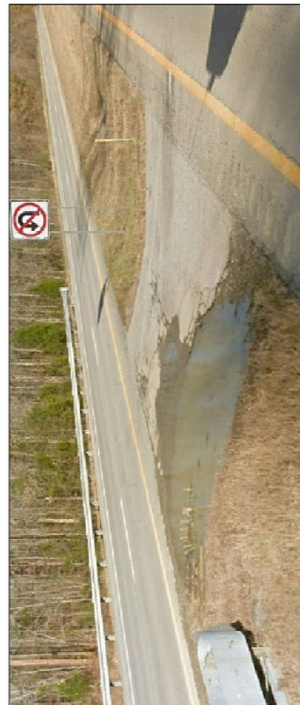
Median Turn Around Example

Upgrade Deficient Cross Slopes		
Description	No. of Locations	Cost (2019 Dollars)
Cross Slopes (Flatter than 1.5%)	N/A	N/A
Work Item Description: Re-work pavement to upgrade cross-slopes to meet interstate standards.		
Upgrade Deficient Clear Zones		
Description	No. of Locations	Cost (2019 dollars)
Clear Zones (Less than 30')	18 miles (113 locations)	\$ 8,922,100
Regrading (Option 1) Guardrail (Option 2)		\$ 2,766,700
Work Item Description: Regrade sideslopes or add guardrail at locations with deficient clear zones to meet interstate standards.		
Upgrade Deficient Median Widths		
Description	Milepoints	Cost (2019 dollars)
Median Width Compliance Upgrades		
Cable Barrier	38.326 - 77.143	\$ 5,621,800
Double Face Guardrail		\$ 5,661,400
Work Item Description: Add cable barrier or double face guardrail in areas in which the median width is less than interstate standards.		
Upgrade Median Turn Arounds		
Description	No.	Cost (2019 dollars)

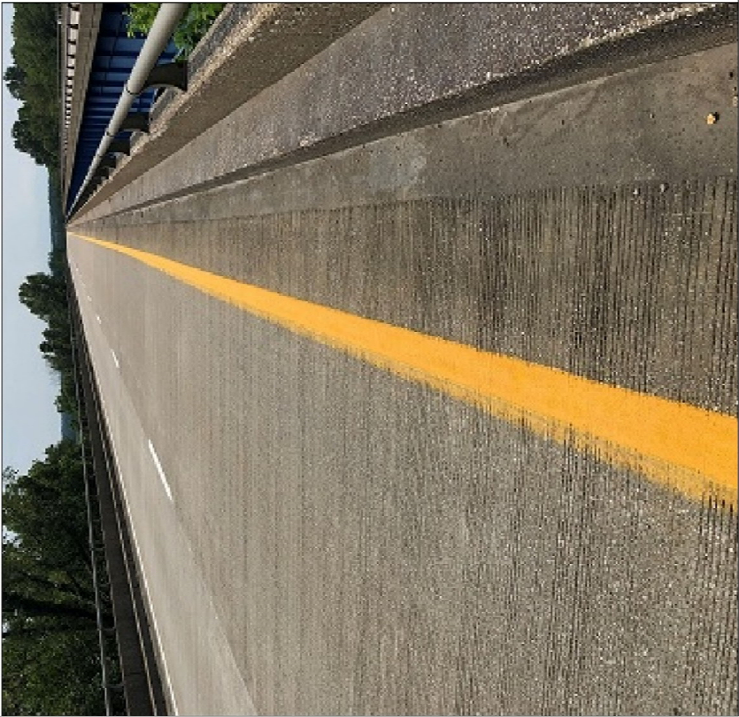
Figure 23. Bridge Barrier / Width Work Items

Based on recent parkway to interstate conversion projects, existing bridges which do not meet minimum width would remain in place as long as the bridge barriers meet or are upgraded to current interstate standards. There are four bridges on the WKP with barriers that will need to be modified if the bridge widening alternatives are not considered. Recent construction costs were evaluated for retrofitting bridge barriers, and per linear foot unit costs were used to estimate the cost for upgrading the barriers on the Green River and Lewis Creek bridges. The planning-level cost estimate range for this work item is \$483,000 to \$10,984,100. These work items are illustrated in **Figure 23**.
