MEMORANDUM

SUBJECT: Boone County
I-275 Slide #8 Beginning @ MP 8.62
Item # 6-2002.00
Stations 334+00 to 340+00
Geotechnical Engineering Report
for Landslide Correction

PLAN VIEW
I-275 SLIDE 8

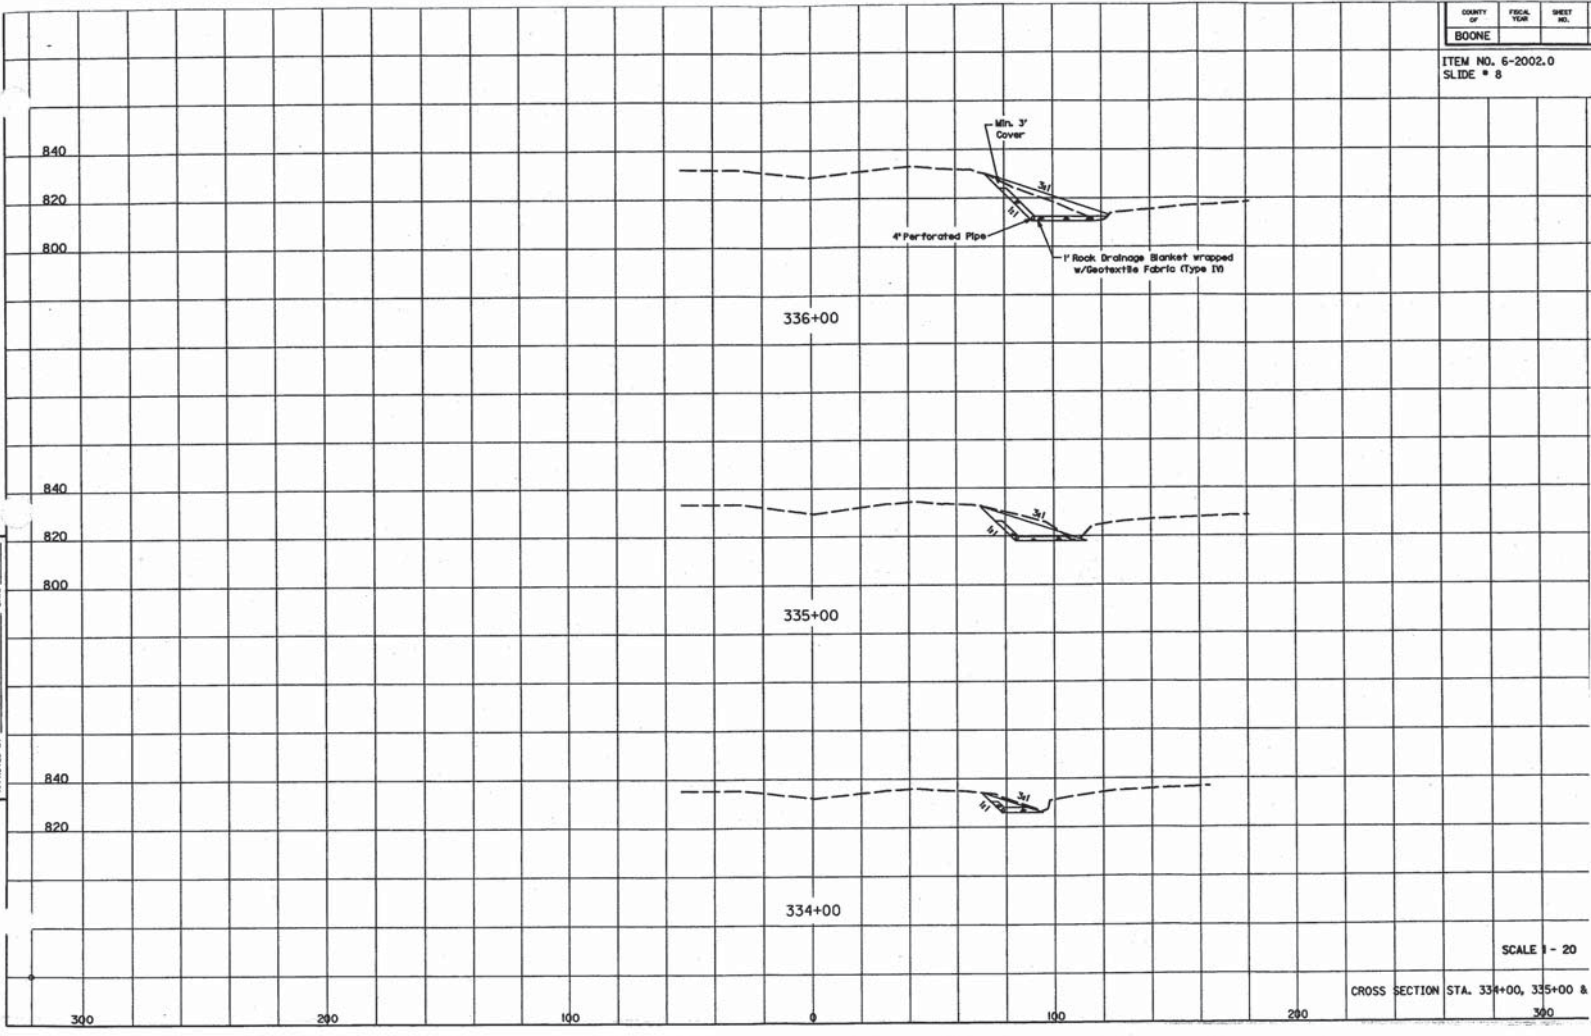
QUANTITY	FISCAL	SHEET
OF	YEAR	NO.
BOONE		
ITEM NO. 6-2002.0		
SLIDE # 8

Exist. 2' Concrete Flat Bottomed Ditch (Remove & Replace with 2' F.B. Class II Channel Lined Ditch Underlain by Type I Geotextile Fabric.)

Replace Existing RC Headwall
