Site Investigative Report

GEOPHYSICAL SURVEY RESULTS AND FIGURES

Sympson Lake Dam Evaluation

For the Kentucky Transportation Cabinet (KYTC)

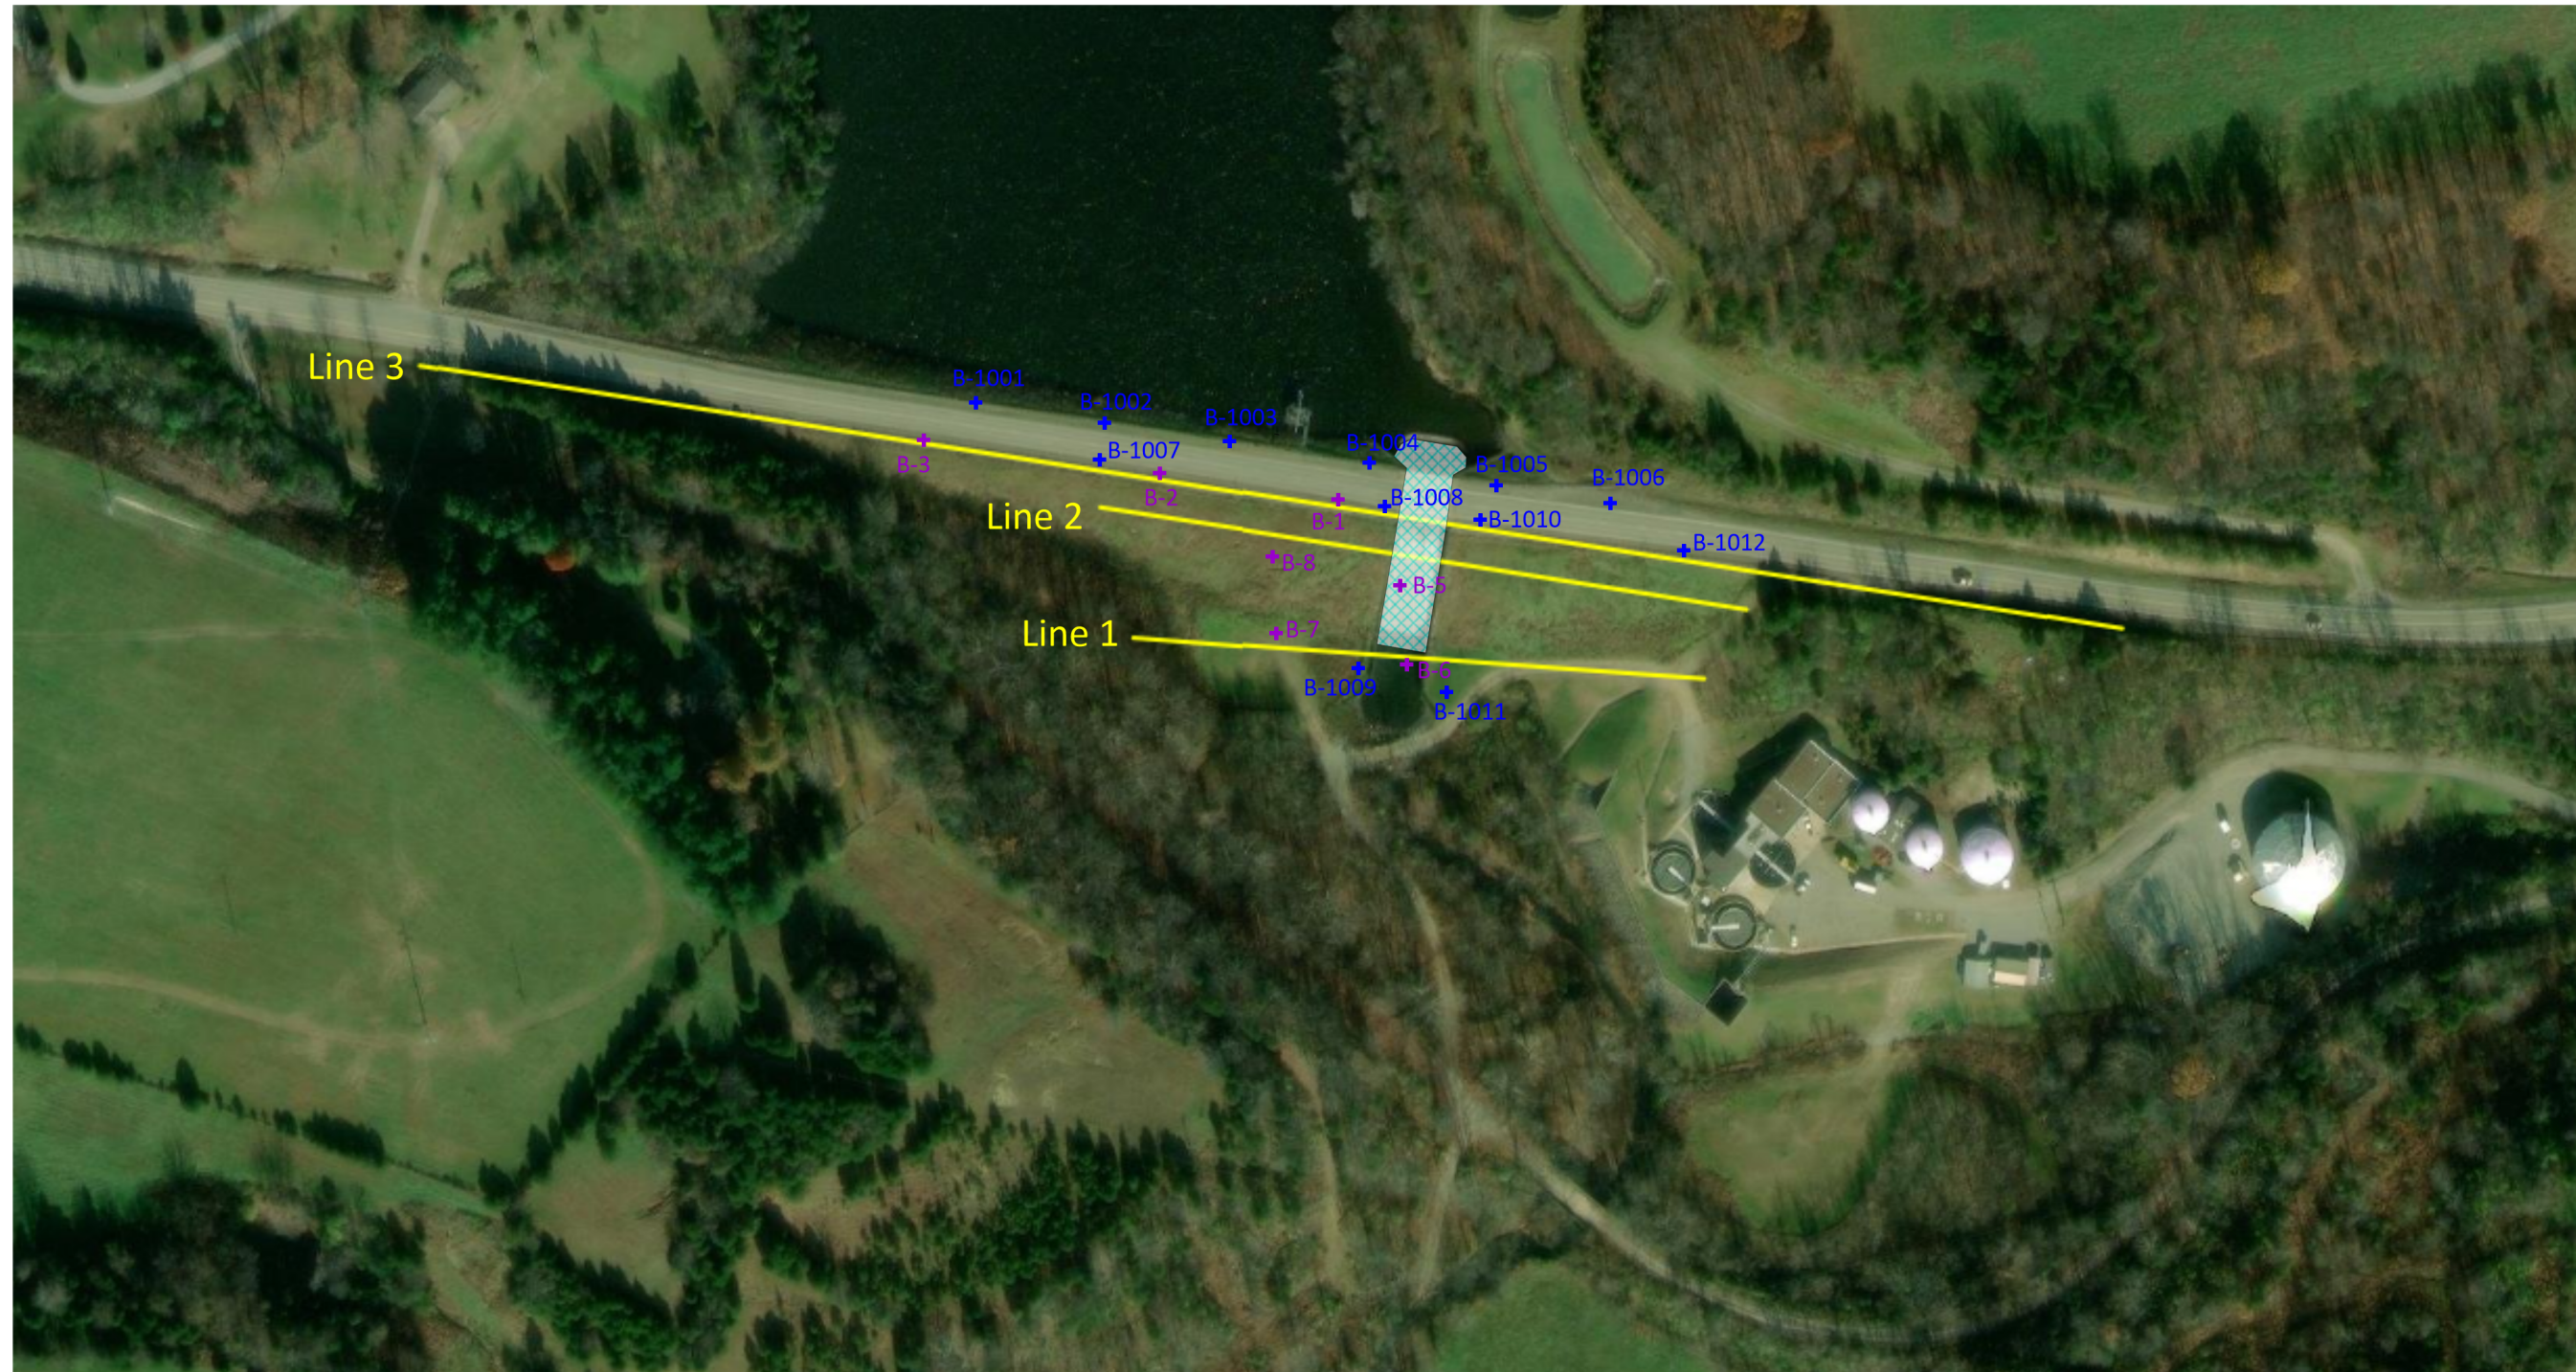
The seismic surveys were conducted along 3 designated lines, shown in Figure 1. The compressional wave (P-wave) velocity profile data were collected both along the shoulder of Highway 62 and the downstream side and toe of the dam. During data collection, VRS (corrected GPS) locations and elevations were collected along each line with a Trimble DA2 GPS unit. GPS location data was processed using a digital elevation model (DEM) from previous site surveys to extract elevations along the seismic lines. The seismic profiles are plotted as distance in feet along the lines and were processed using the elevations from the DEM. Subsequent geotechnical borings were conducted by the client and those locations are also shown in Figure 1 based on provided coordinates for each borehole.

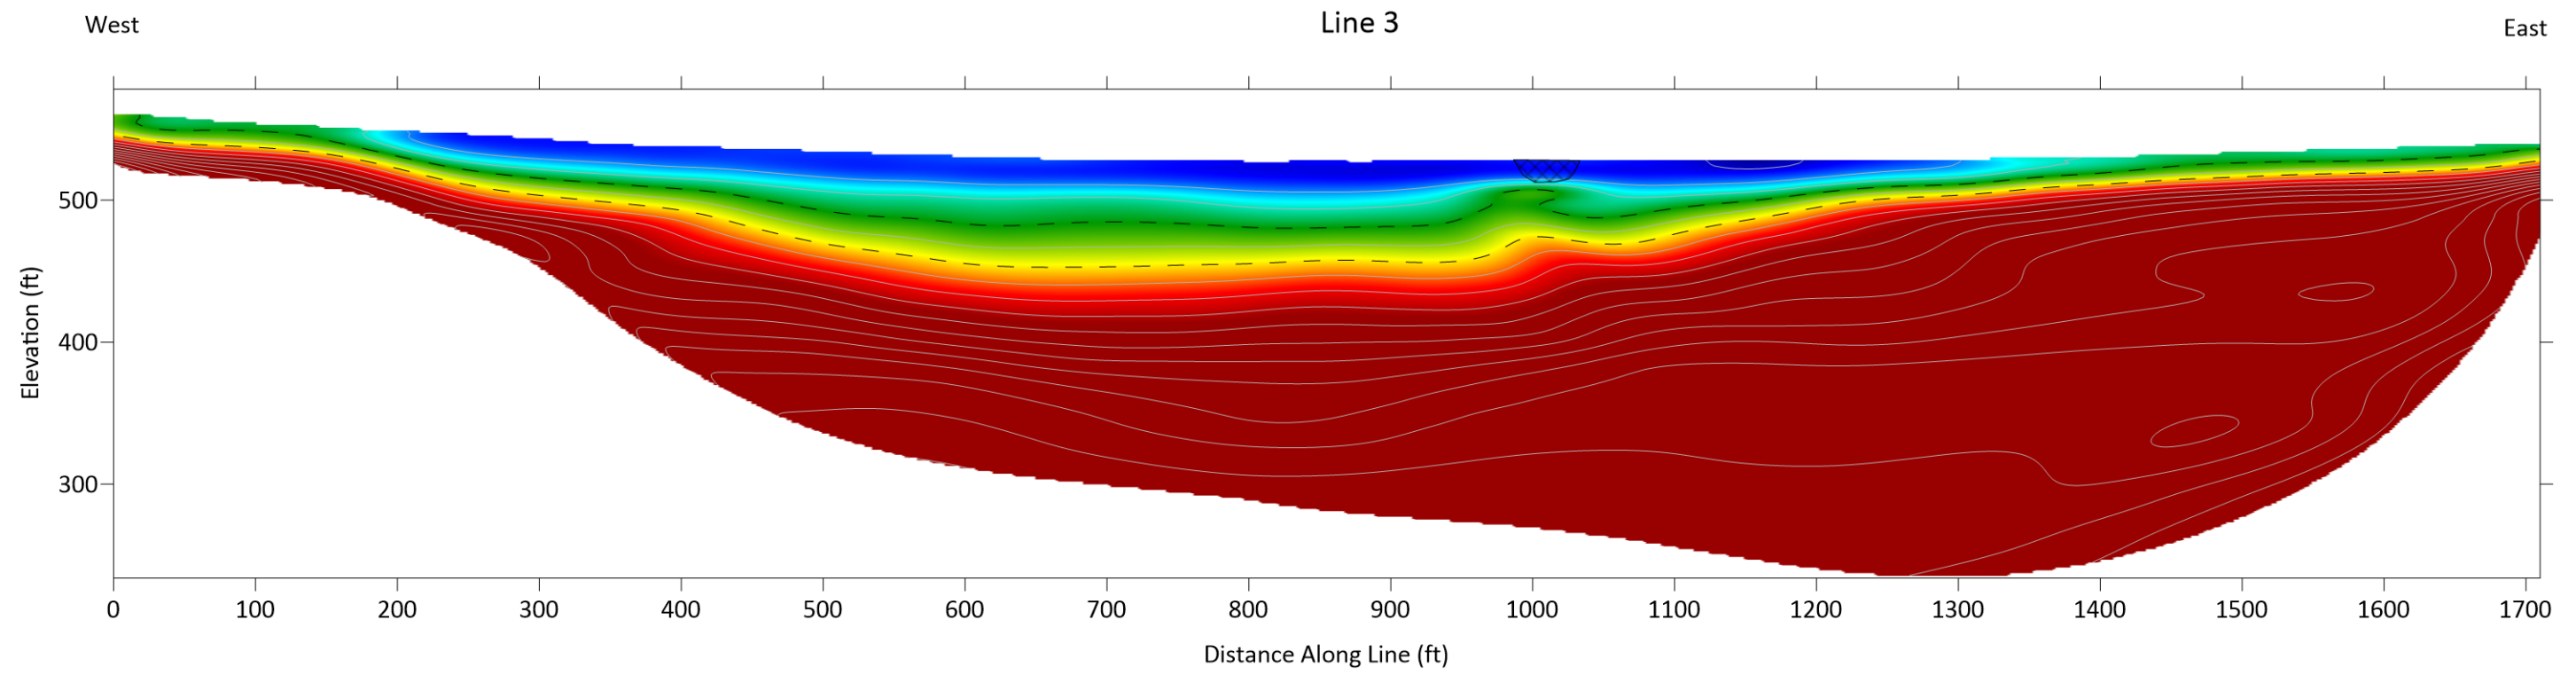
data for the three seismic lines. These lines crossed the spillway; however, this area was not accessible to install geophones. Therefore, small data gaps were observed and are represented based on ray-path mapping as diagonal checked/hatched areas on the data plots. These areas of lower data coverage are shown on the figures to aid in the data interpretations. Although the anomalies are outside the lower data coverage areas, it is not certain that these could be at least partially influenced by the data gaps. All three lines have a slight velocity increase near/under the spillway, and Line 2 has a slight velocity inversion as well. Another notable item in this same area is that the original outlet pipe/duct structure crosses the seismic lines within the vicinity of the spill way structure. Historic records show the buried water intake conduit and duct structure connects from the intake tower (west of the spillway) to a small ditch east of the spillway pool near the toe of the dam. However, these historic records show the conduit/pipe intake structure to be near the base of the dam and aligned towards the current treatment plant at about elevation 459-ft. The Dames and Moore 1976 report boring logs/locations were also overlaid on Line 3. B-1, B-2 and B-3 from this report were spaced along the shoulder of highway along the dam crest. The boring locations are shown on Figure 1 and the simplified logs were added to the seismic Line 3 on Figure 4. The depth to the top of the limestone is similar to the current studies borings, and no anomalous zones were noted within the dam cross-section/fill.

Low coverage zone below spillway
