August 31, 2019

**Re: Broadway Bridge (KY 3506) over Kentucky River
 Bridge No. 037B00066N
 Frankfort, Kentucky
 In-Depth Bridge Inspection Report**

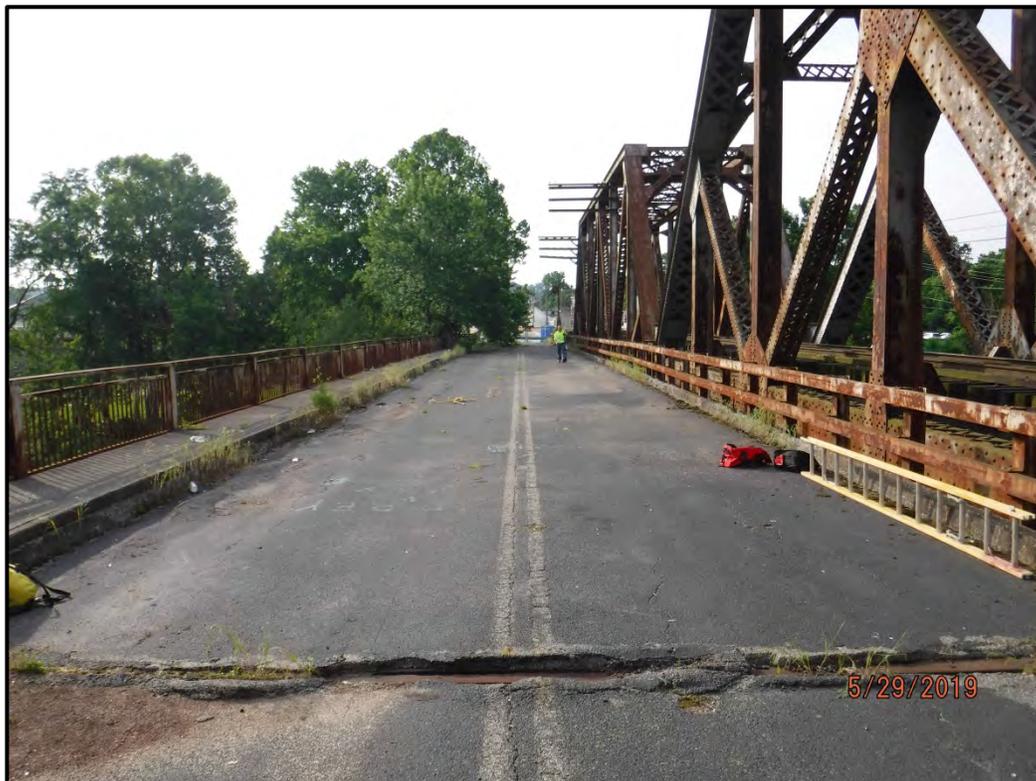
- Asphalt is bulging at deck expansion joints and has failed above deck expansion joints creating a 6" long x 3" vertical x full width transition between spans. (See Photo 12-2)

Photo 12-2: 6' long x 3' vertical x full width transition between Spans 4 and 5.

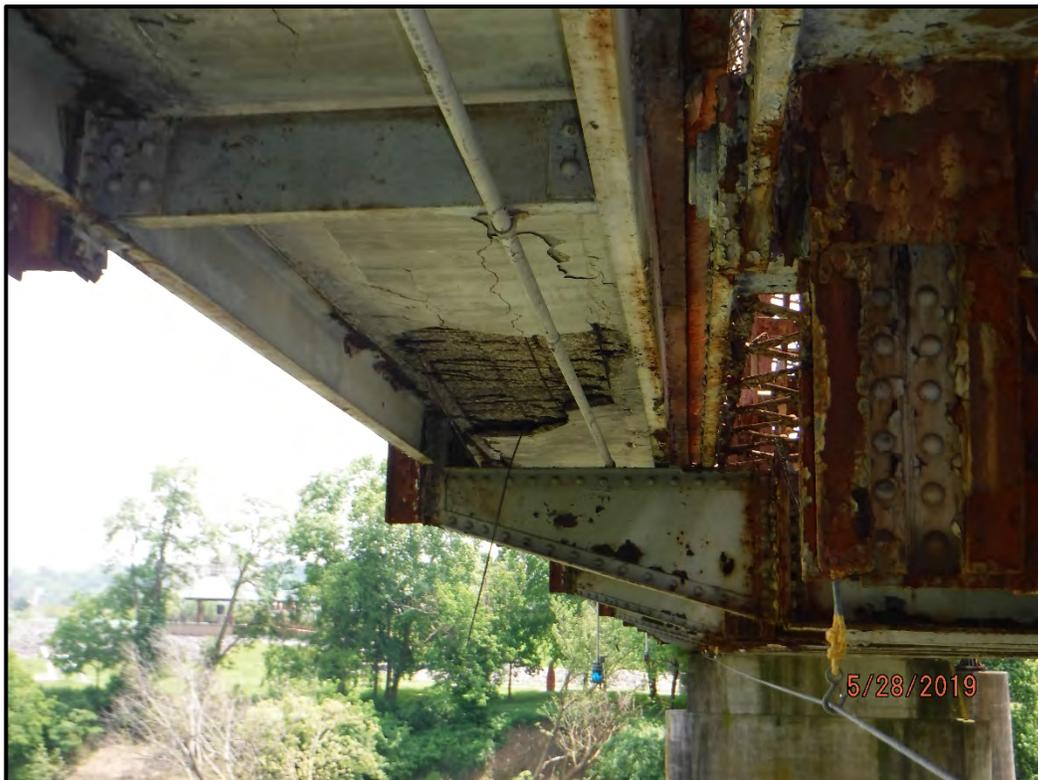
- The sidewalk is in similar, but slightly worse condition than the deck. In addition to the aforementioned deck deficiencies, the sidewalk has large areas of spalling with exposed reinforcement. (See Photo 12-6)

Photo 12-6: Heavy spalling with exposed reinforcement on the underside of the sidewalk in Span 5. The poor condition of the sidewalk concrete is a risk to the public beneath the bridge due to falling of spalled concrete.

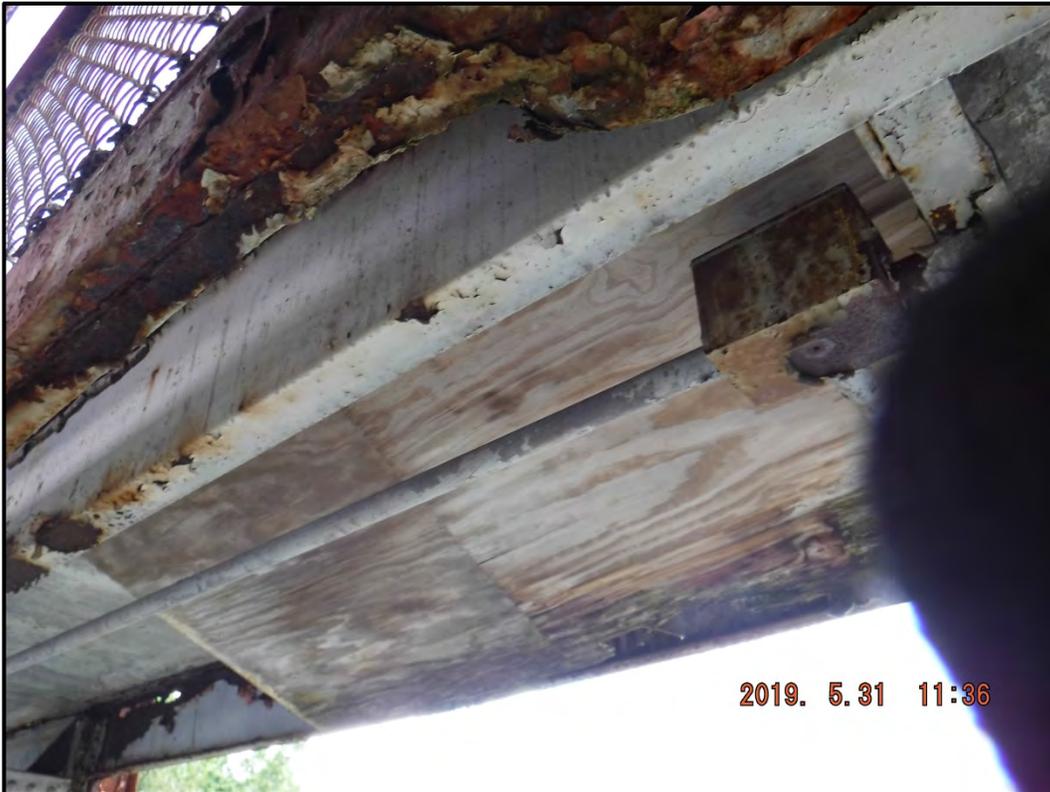
- There is a wood stay-in-place form under the downstream sidewalk the near mid-span of Span 5. The plywood is not solidly attached to the underside of the sidewalk and is a falling hazard for boat traffic under the bridge. (See Photo 12-7)

Photo 12-7: Plywood protection for spalling concrete under the sidewalk that has become a hazard to boat traffic underneath; the location is around mid-span of span 5 near the blue navigation light.

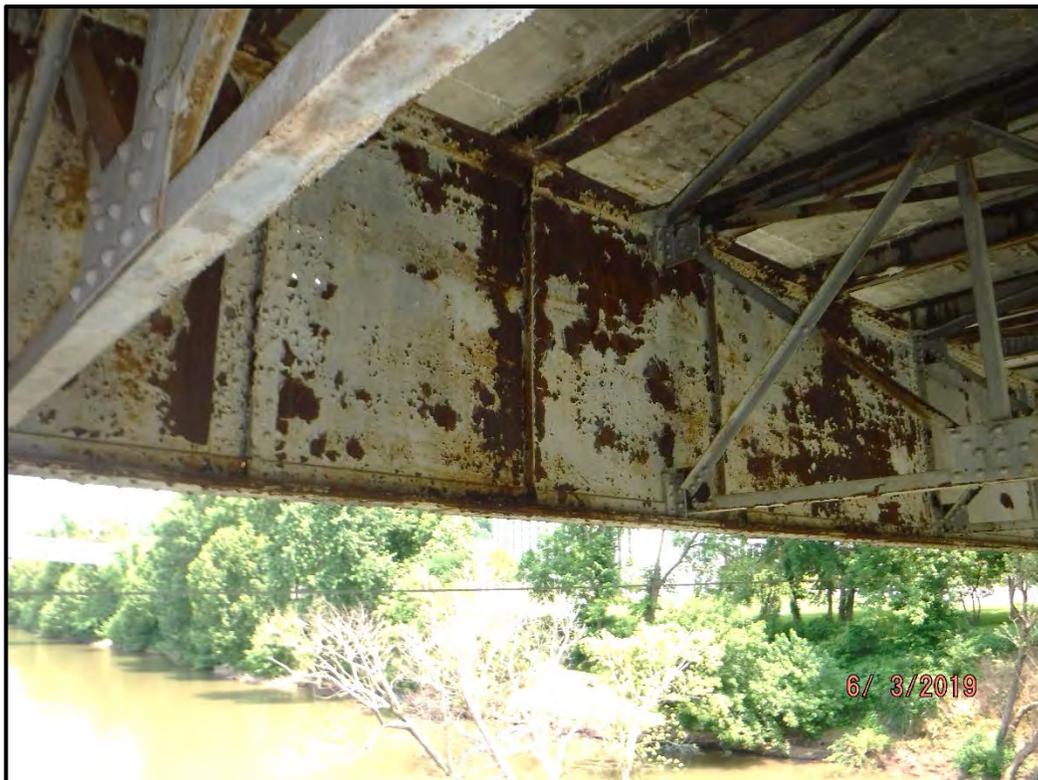
- The steel girders are in poor condition (NBI Rating is 4 out of 9).
- The steel protective coating is partially effective and in poor condition. Large areas of the girders have exposed steel with no protective coating. (See Photo 107-1)

Photo 107-1: Typical condition of the protective coating on the steel girders. The inside face of Girder 2 in Span 3 is shown.

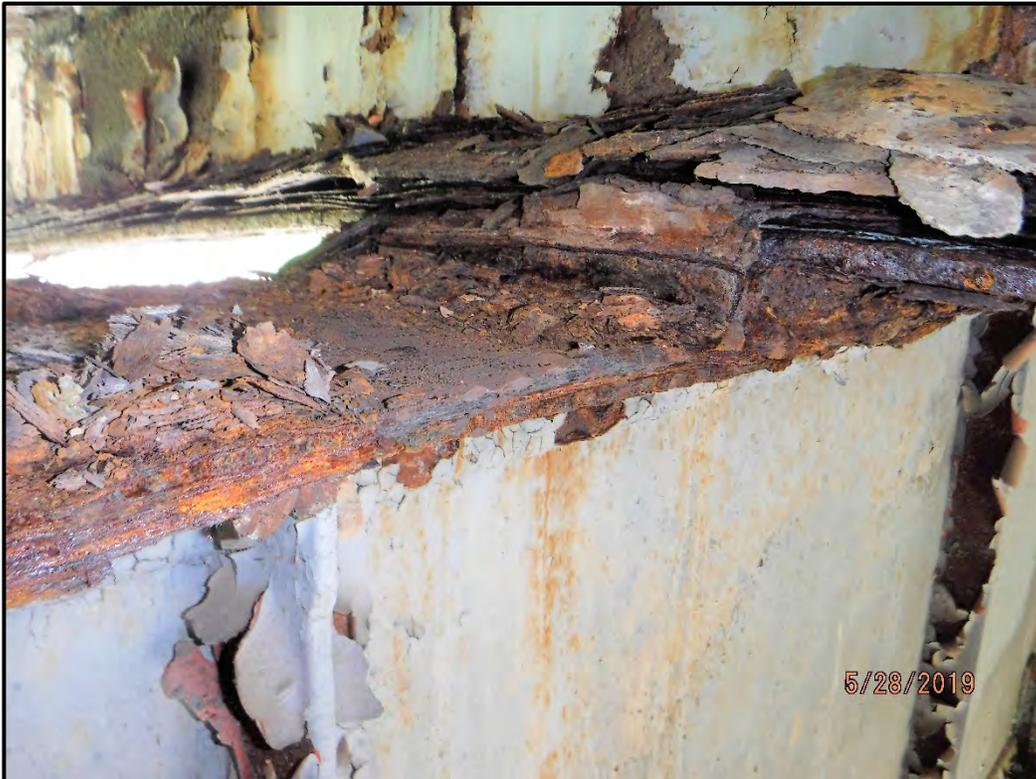
- There is pack rust and section loss of the girder top flange and top flange cover plates throughout all girder spans. This is more prevalent adjacent the floorbeam connection plates (See Photos 107-2 and 107-3)

Photo 107-2: Top flange section loss on the Girder 2 at FB 5 in Span 1. 0.32" thickness out of 3/8" remains of the cover plate.

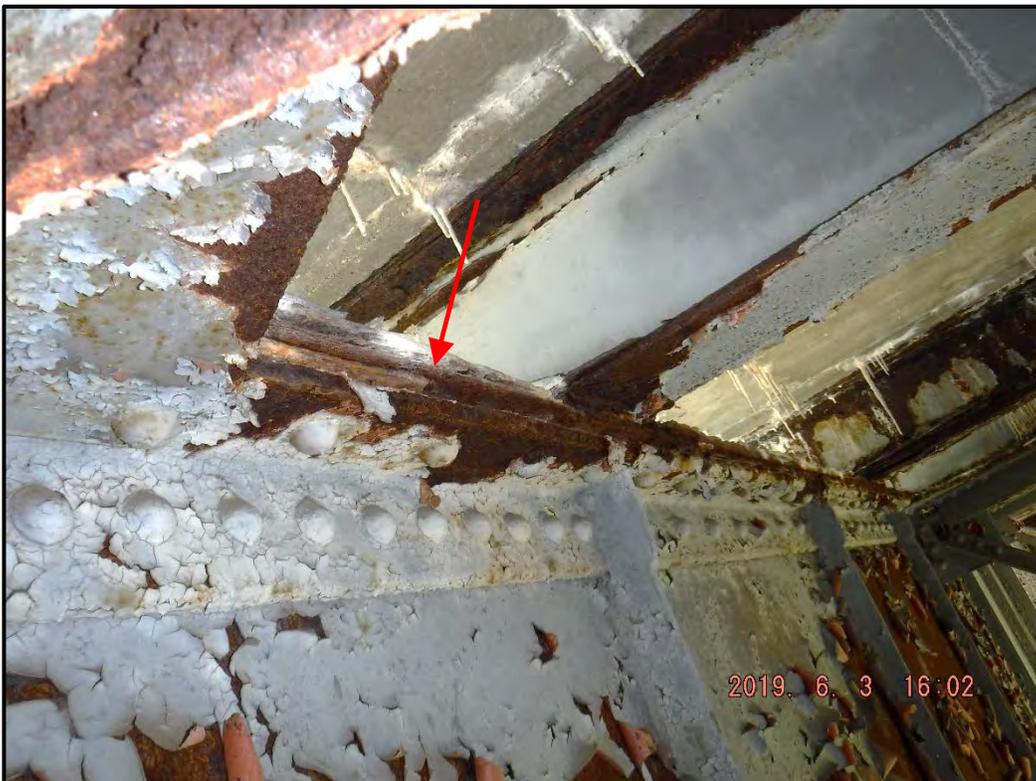
Photo 107-3: Typical pack rust causing deformation of the top flange cover plate. Girder 2 in Span 3 is shown.

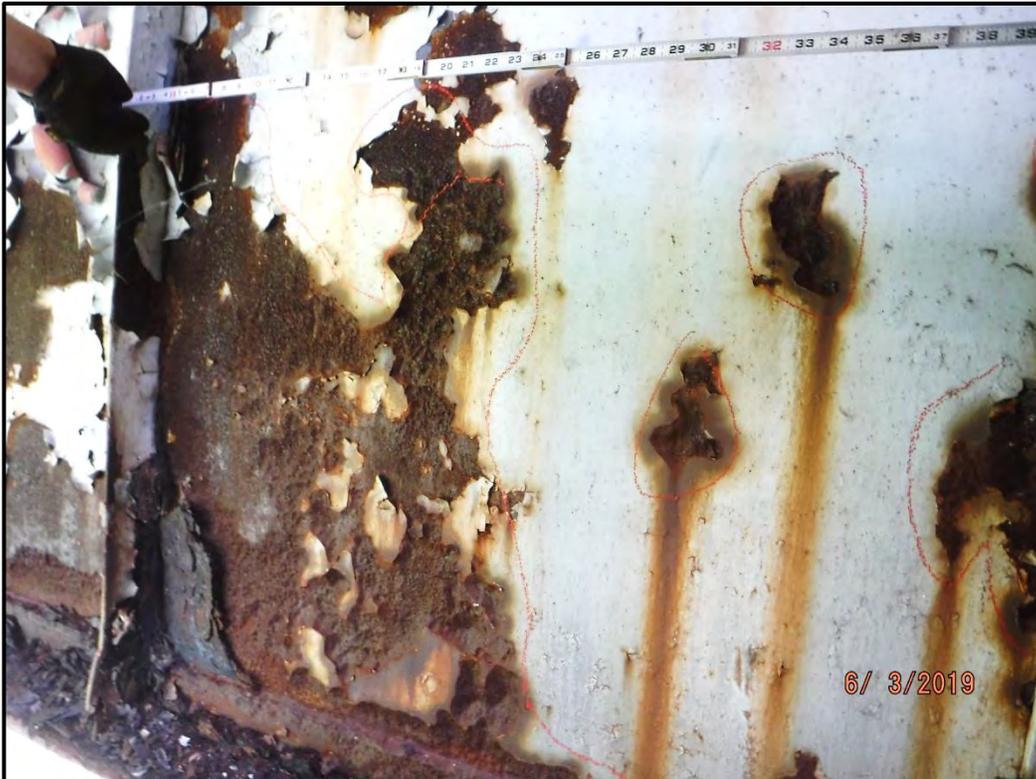
- Active corrosion is widespread on the girder webs. There are isolated areas where there is pitting and section loss (See Photos 107-4 through 107-6)
- Pack rust between the bottom flange angles, cover plates, and splice plates is common throughout all spans. There are isolated locations of section loss of the bottom flange cover plates. (See Photos 107-7 through 107-9)

Photo 107-4: Section loss in the Span 4 Girder 1 web at Pier 3. Minimum thickness remaining is 0.185" out of 0.5".

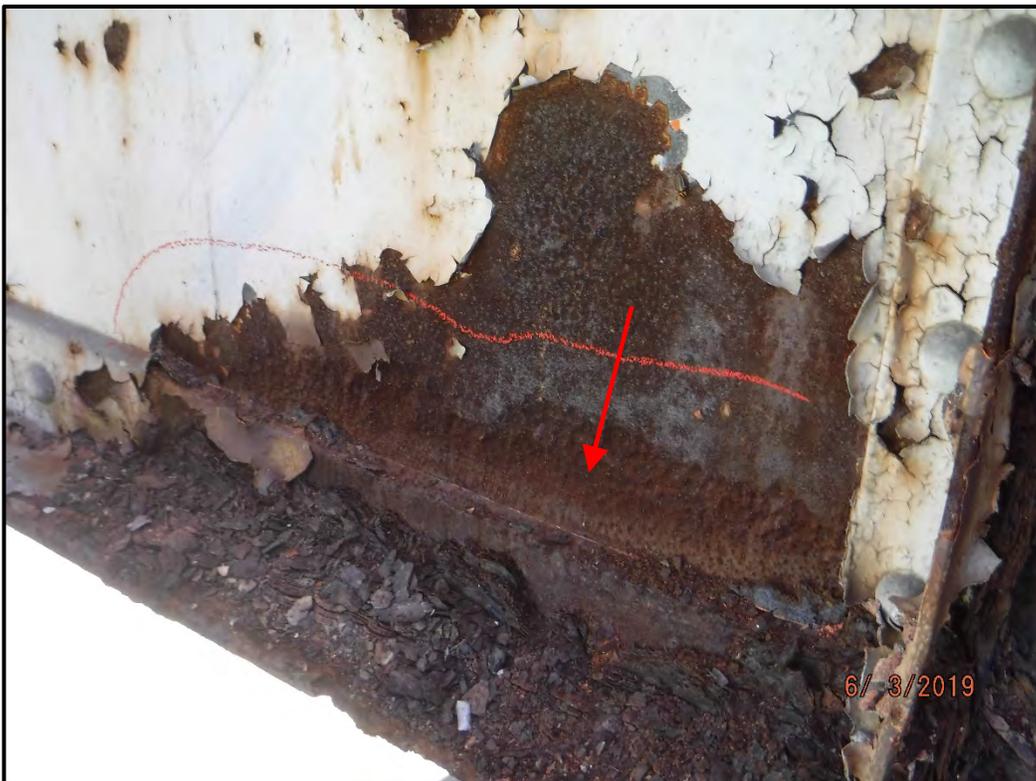
Photo 107-5: Section loss of the Span 4 Girder 1 web just above the bottom flange adjacent Pier 3. Minimum thickness remaining is 0.22" out of 0.5".

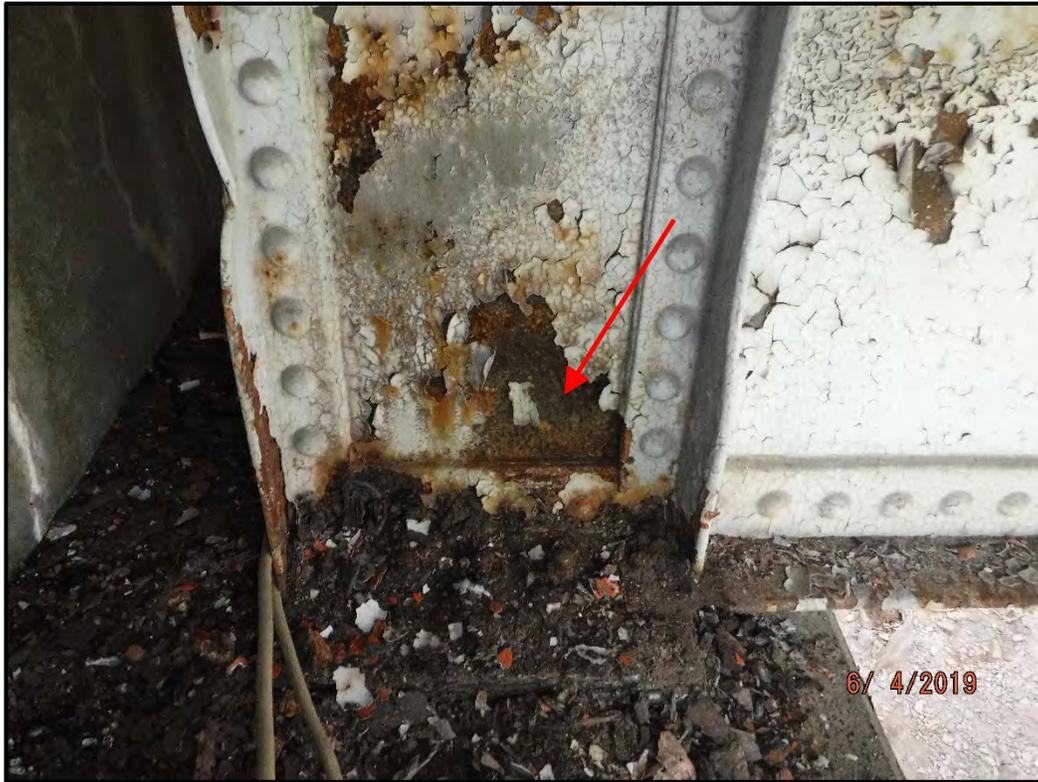
Photo 107-6: 0.11" deep pitting of the Span 6 Girder 1 web at Pier 6.

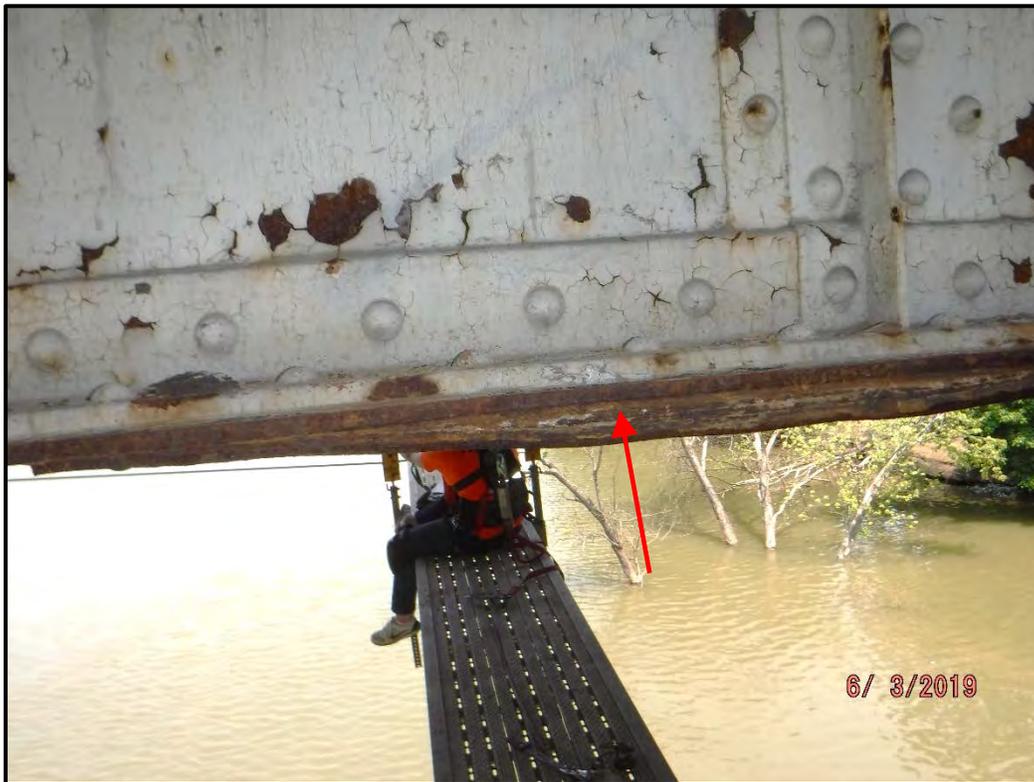
Photo 107-7: 1 1/8" of pack rust between the Girder 1 bottom flange cover plate and splice plate in Span 4.

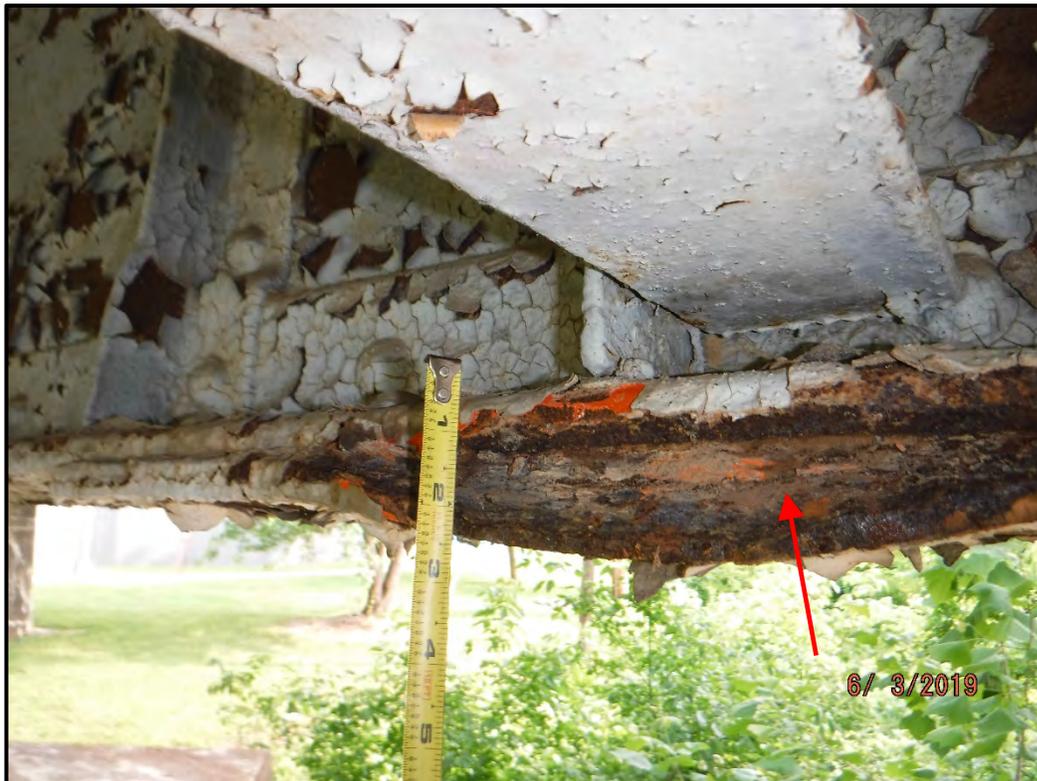
Photo 107-8: 1 ½” pack rust between the Girder 1 bottom flange angles and cover plate in Span 3.

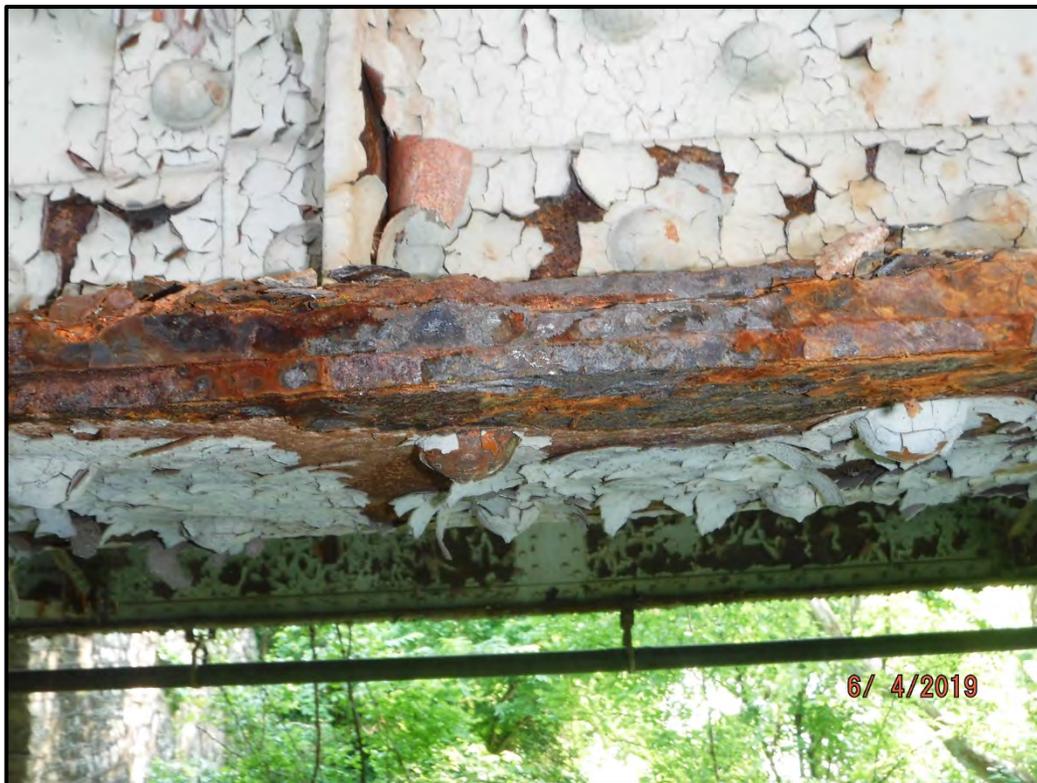
Photo 107-9: Section loss of the Girder 1 bottom flange in Span 6. 0.35” out of 3/8” splice plate thickness remains, 0.46” out of 9/16” cover plate thickness remains, and 0.47” out of 5/8” double angle thickness remains. (Girder 2 is similar)

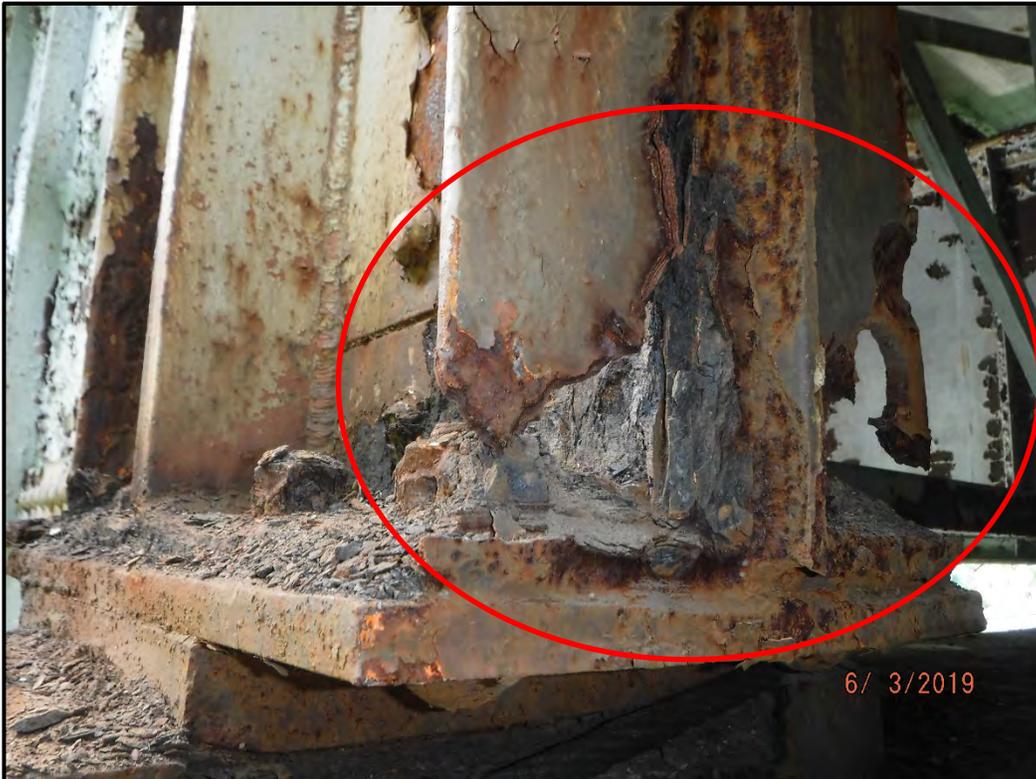
- Active corrosion with up to 100% section loss is common on the bearing stiffeners. (See Photo 107-10)

Photo 107-10: Active corrosion with 100% section loss of the bottom 6" of the Girder 1 end bearing stiffeners over Pier 3.

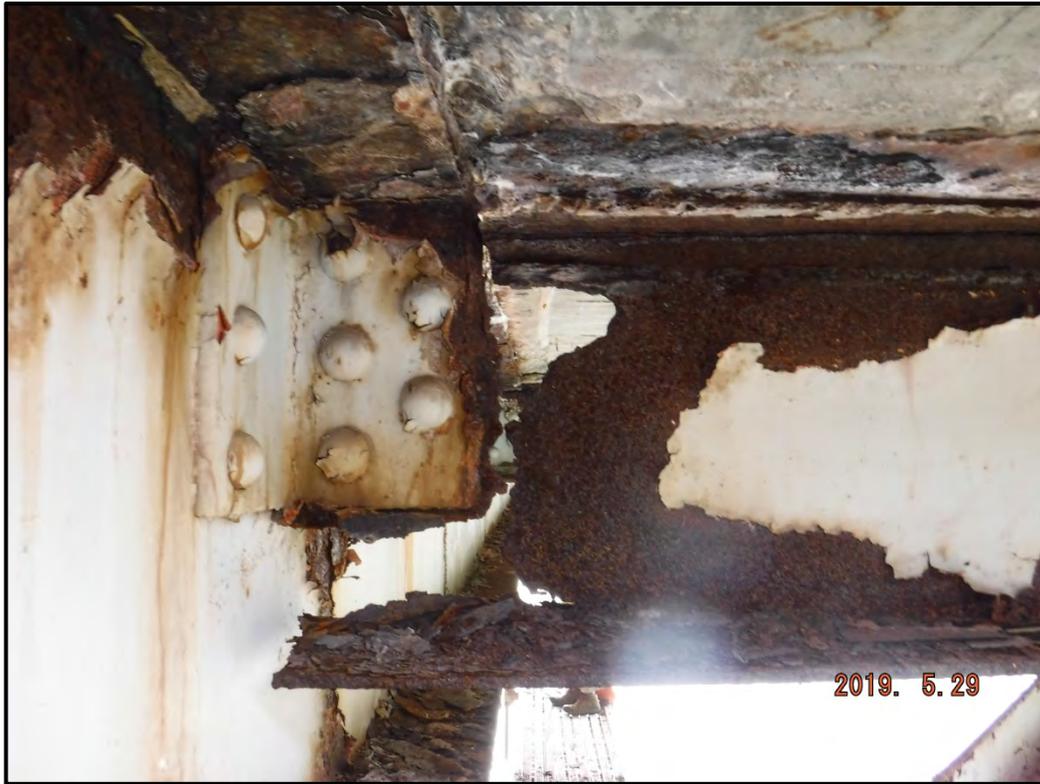
- Stringer 1 has failed at its connection to the east face of Floorbeam (FB) 12. The stringer has separated from the bridge deck and is only being supported as a cantilever by its connection to the west face of FB 11. (See Photos 113-2 and 113-3)

Photo 113-2: Stringer 1 has failed at its connection to the east face of FB 12.

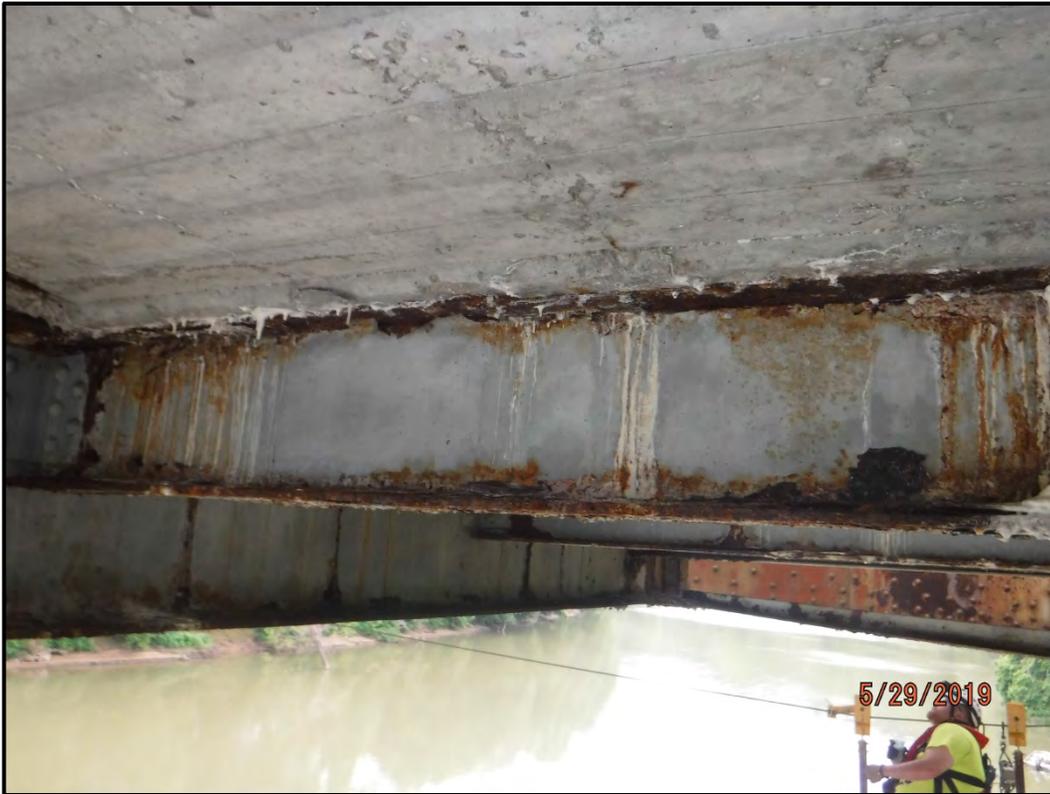
- There are locations of heavy laminar corrosion on the stringer bottom flanges and webs. This laminar corrosion is more prevalent on the fascia stringers, but the two interior stringers have isolated areas as well. (See Photos 113-4 through 113-6)

Photo 113-6: Minor corrosion of the Stringer 3 web and section loss of the bottom flange (0.45" thickness remains out of 0.54") between FB 12 and FB 13.

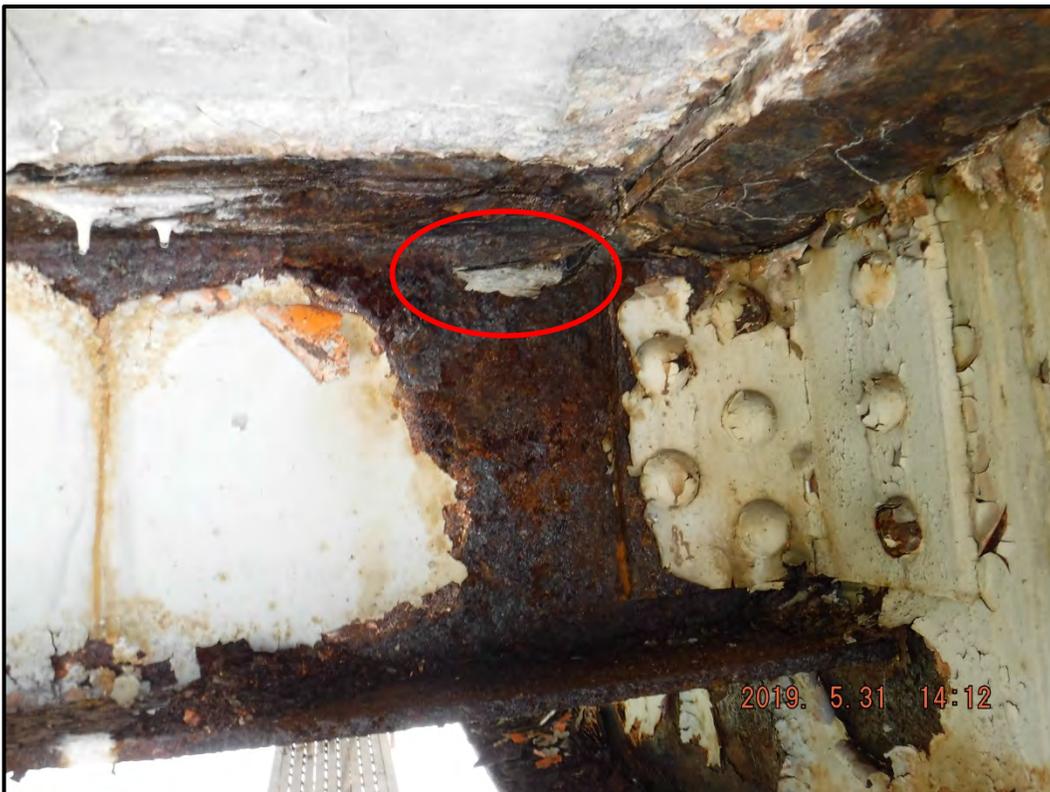
- There are corrosion holes in the fascia stringer webs adjacent to the floorbeam connections. (See Photo 113-7)
- The sidewalk stringers have 100% section loss of the web and flanges throughout. (See Photo 113-8)

Photo 113-7: 6" x 4" hole in the Stringer 4 web at the west face of FB 4. A similar condition also exists on Stringer 4 west of FB 6.

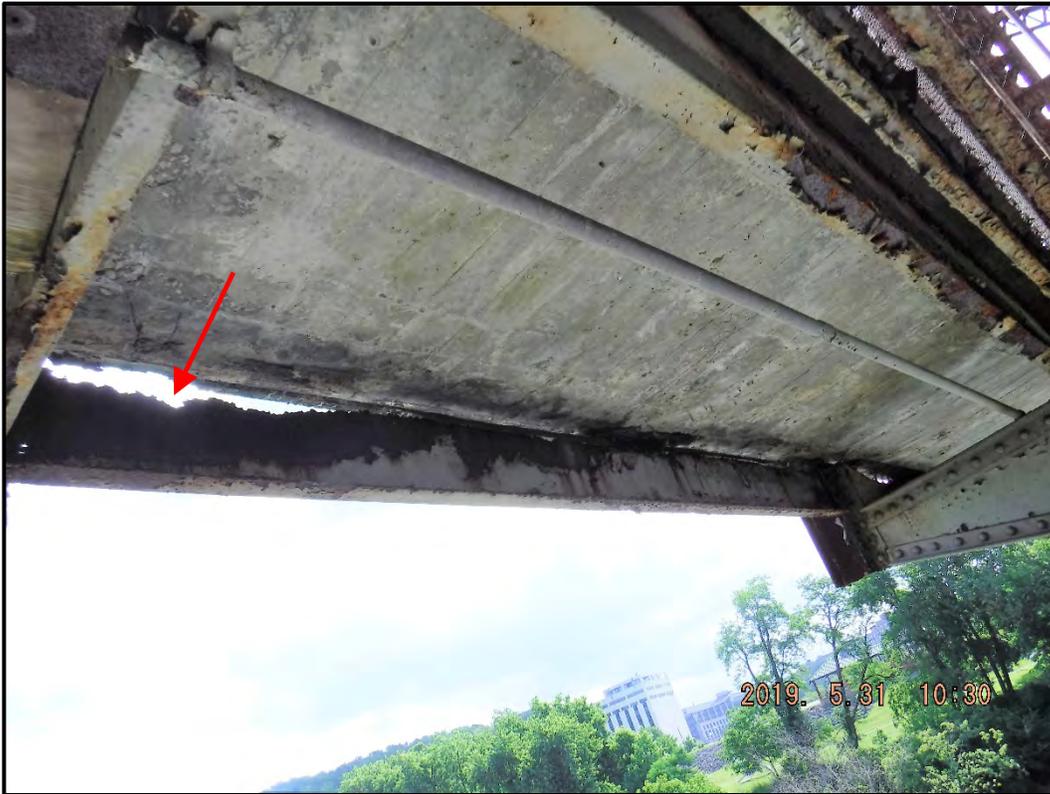
Photo 113-8: The sidewalk stringers exhibit 100% section loss in the web and flanges throughout. Many of the stringers are no longer in contact with the concrete sidewalk above.

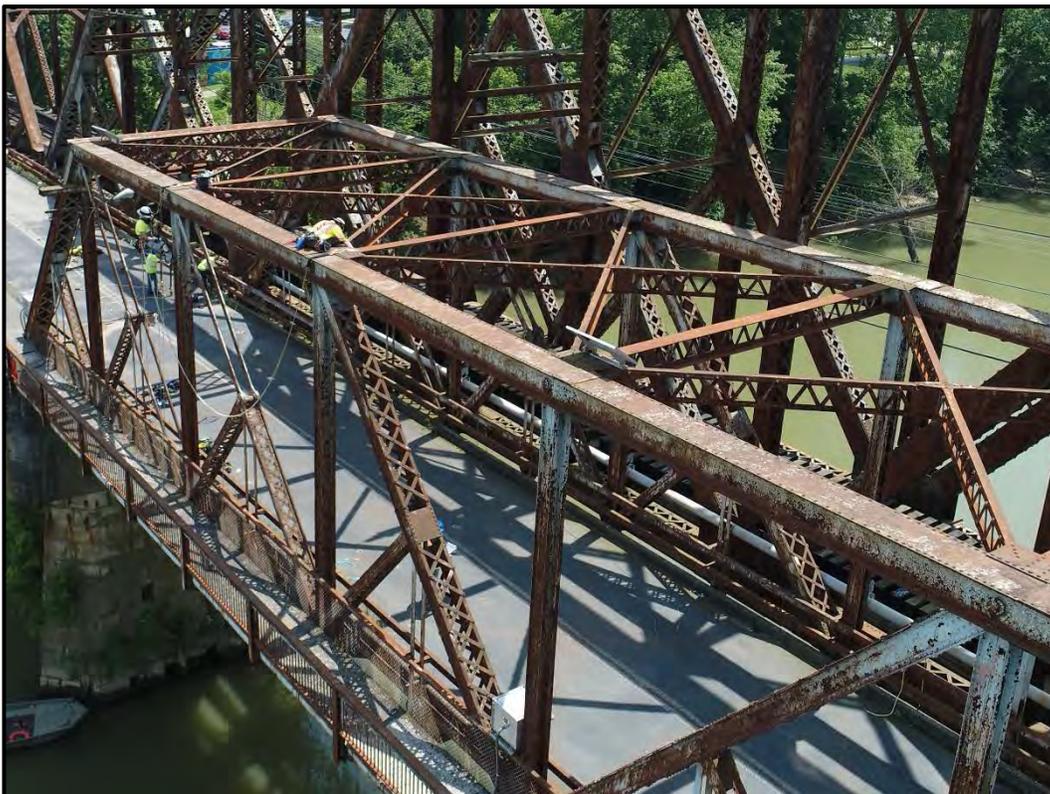
- Span 5 is a pin-connected Baltimore Petit Truss. The steel truss is in “imminent” failure condition (NBI Rating is 1 out of 9).
- The protective coating is peeling off the truss members throughout, leaving bare metal exposed. (See Photo 120-1).

Photo 120-1: Overall condition of the truss with peeling paint and exposed metal throughout.

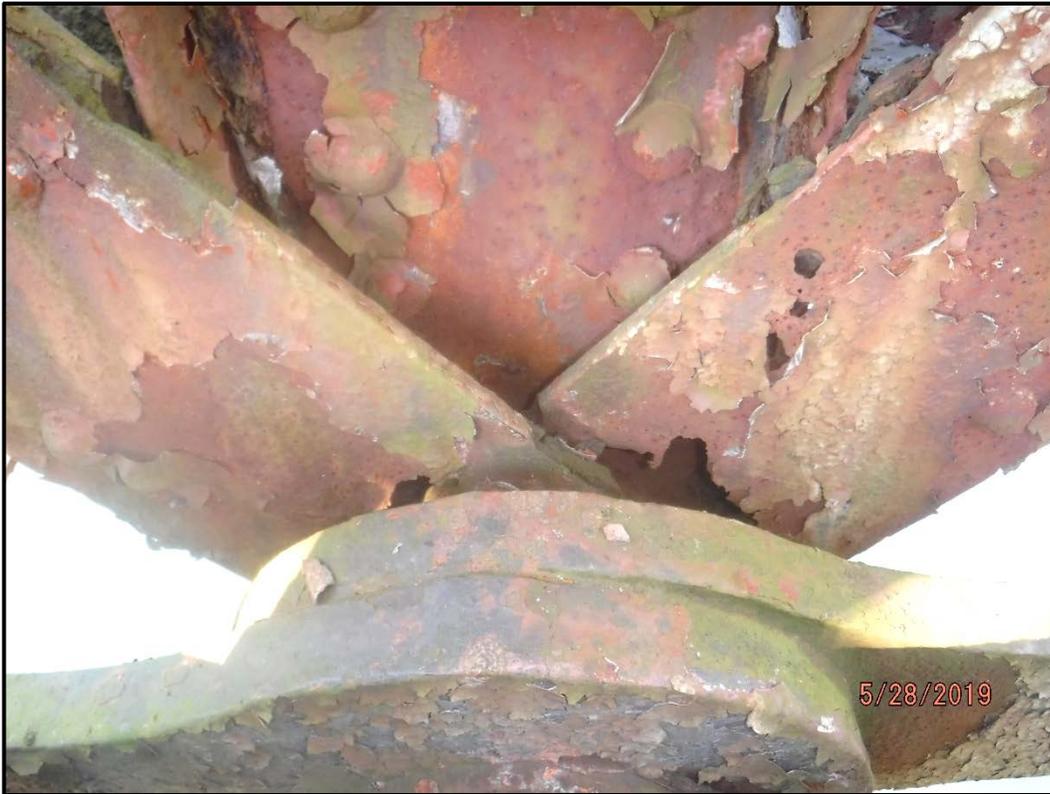
- There is active corrosion with up to 100% section loss on the counter-diagonal pin connection plates at deck level. Although these counter-diagonals are not primary tension and compression load path members, they are critical to the overall stability of the Baltimore Petit Truss design. This is the impetus for the “imminent” failure condition of the steel truss. (See Photos 120-2 through 120-8)

Photo 120-2: 100% section loss of the counter-diagonal pin connection plates at panel point L2 on the downstream truss.

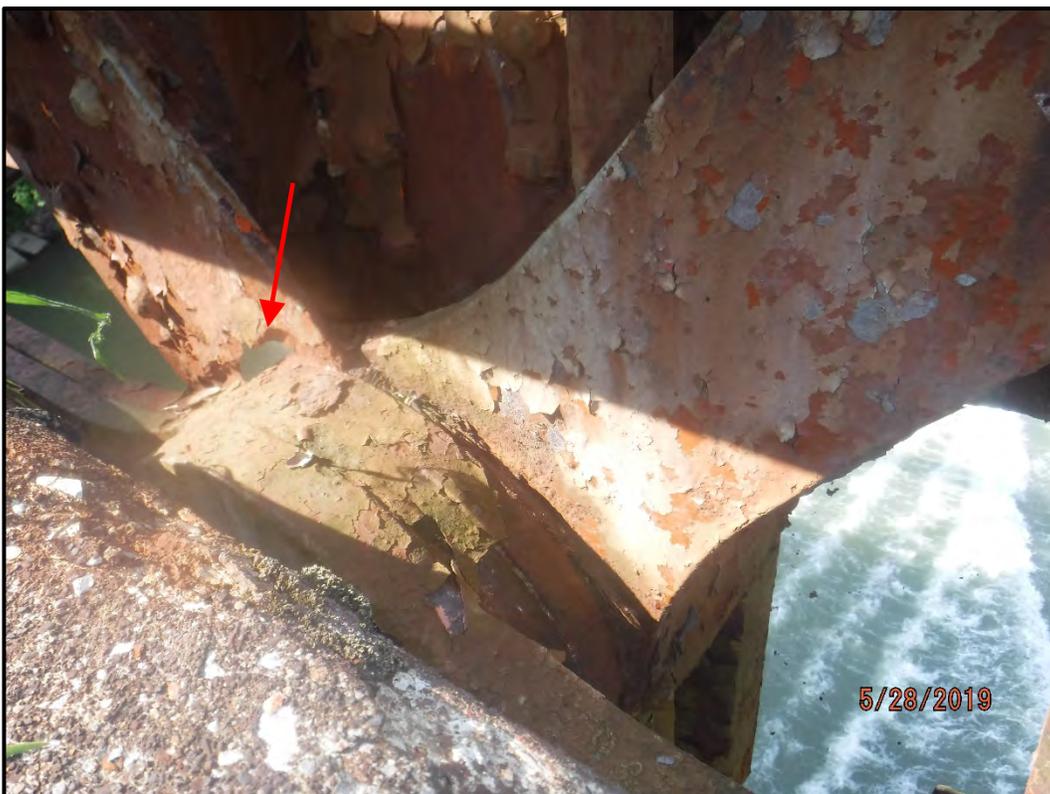
Photo 120-3: 100% section loss of the counter-diagonal pin connection plate at panel point L4 on the downstream truss.

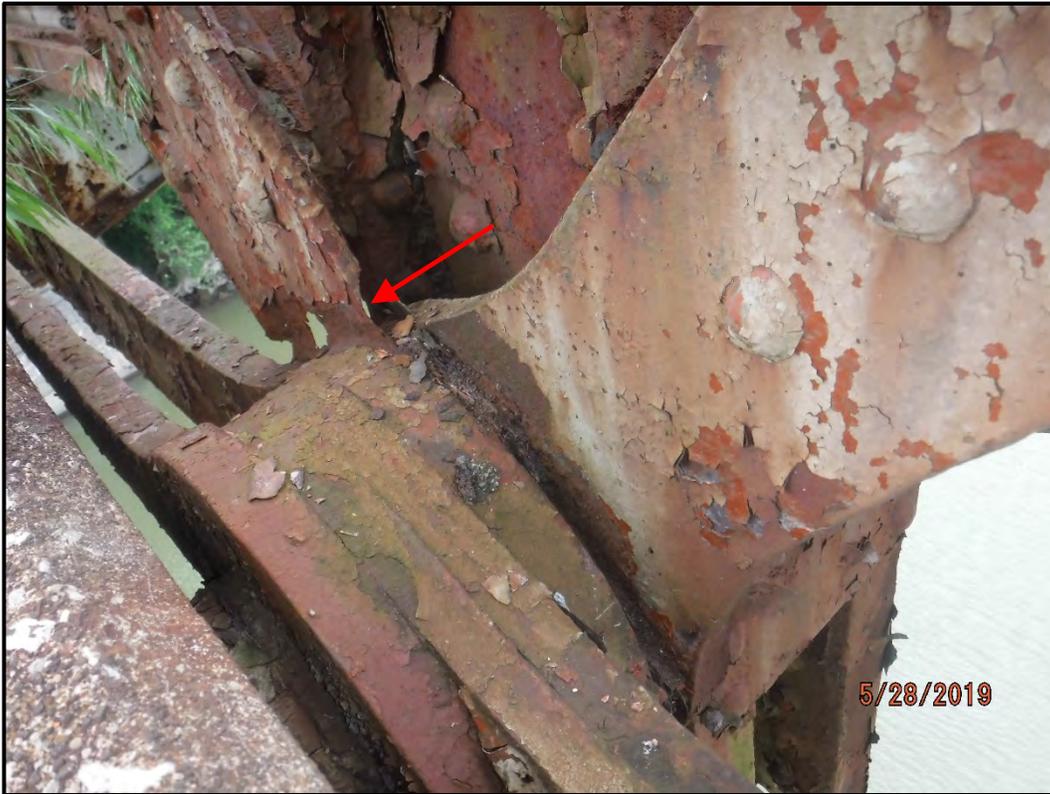
Photo 120-4: 100% section loss of the counter-diagonal pin connection plate at panel point L6 on the downstream truss.

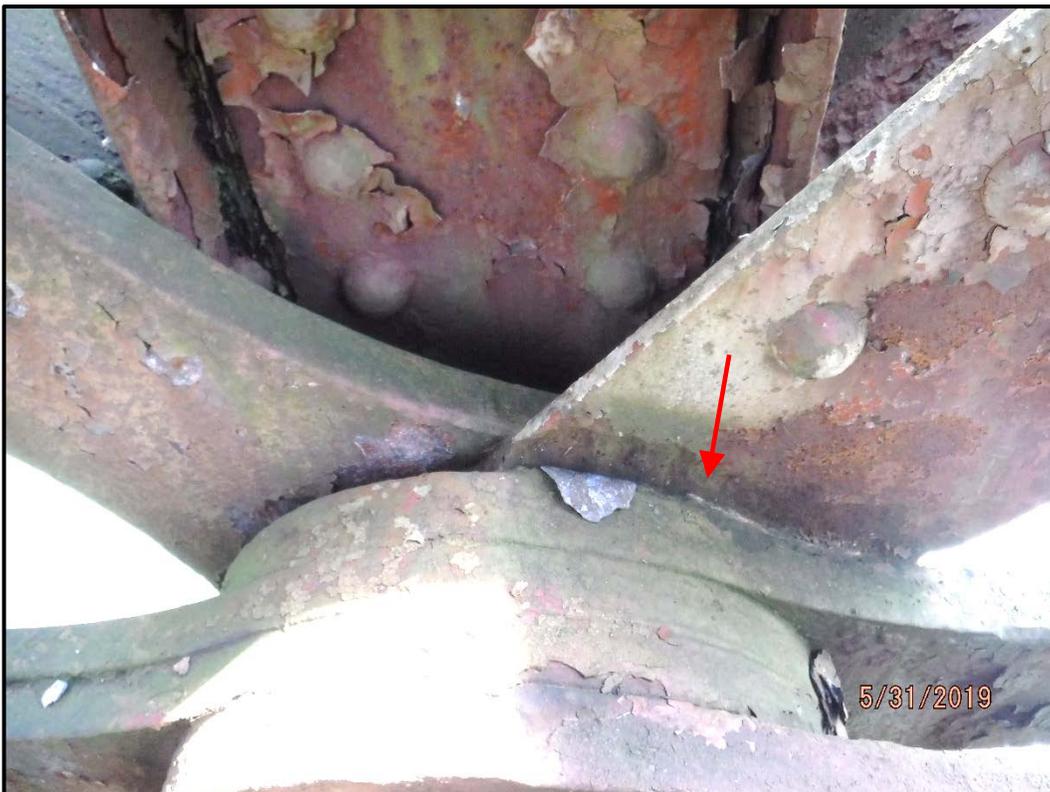
Photo 120-6: 1/16" out of 1/2" thickness remains on the counter-diagonal pin connection plate at panel point L10 on the downstream truss.

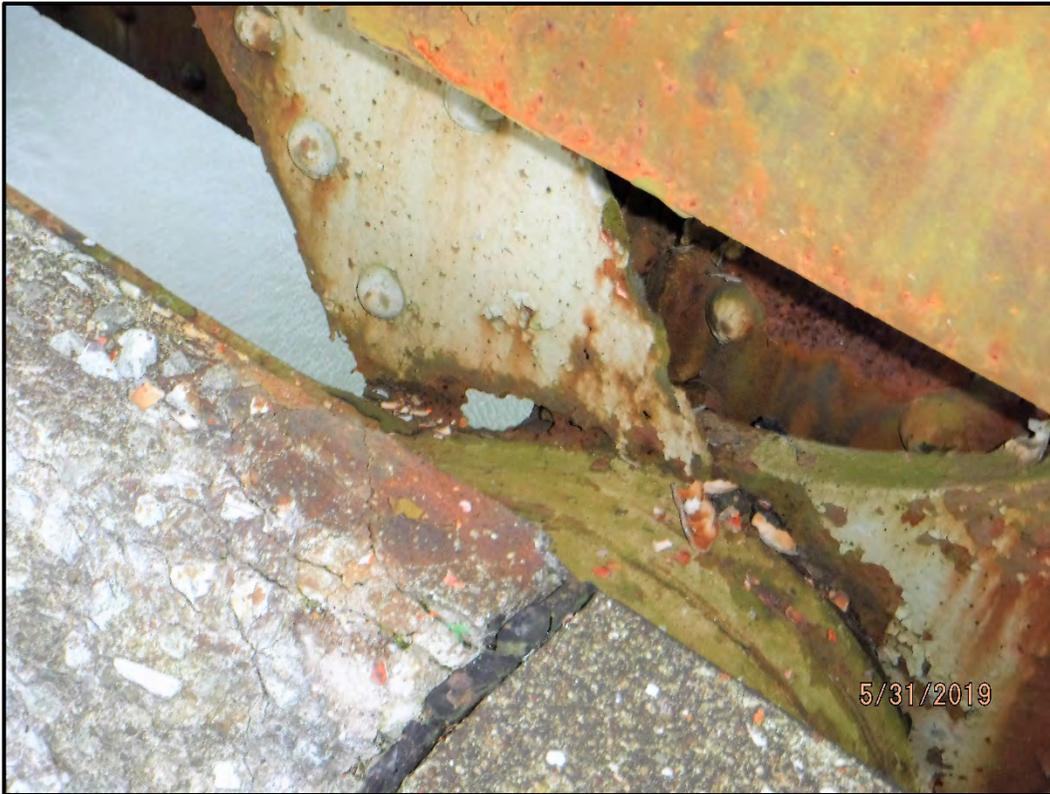
Photo 120-7: 100% section loss on the counter-diagonal pin connection plate at panel point L12 on the upstream truss.

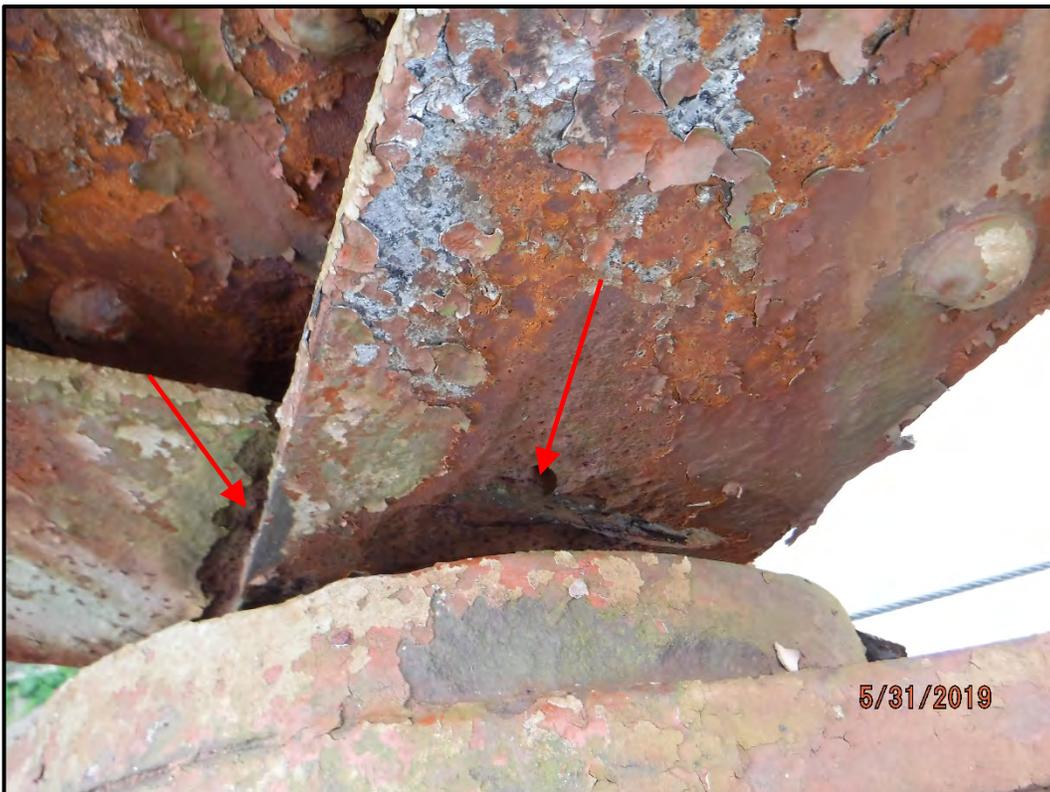
Photo 120-8: 100% section loss on the counter-diagonal pin connection plate at panel point L14 on the downstream truss.

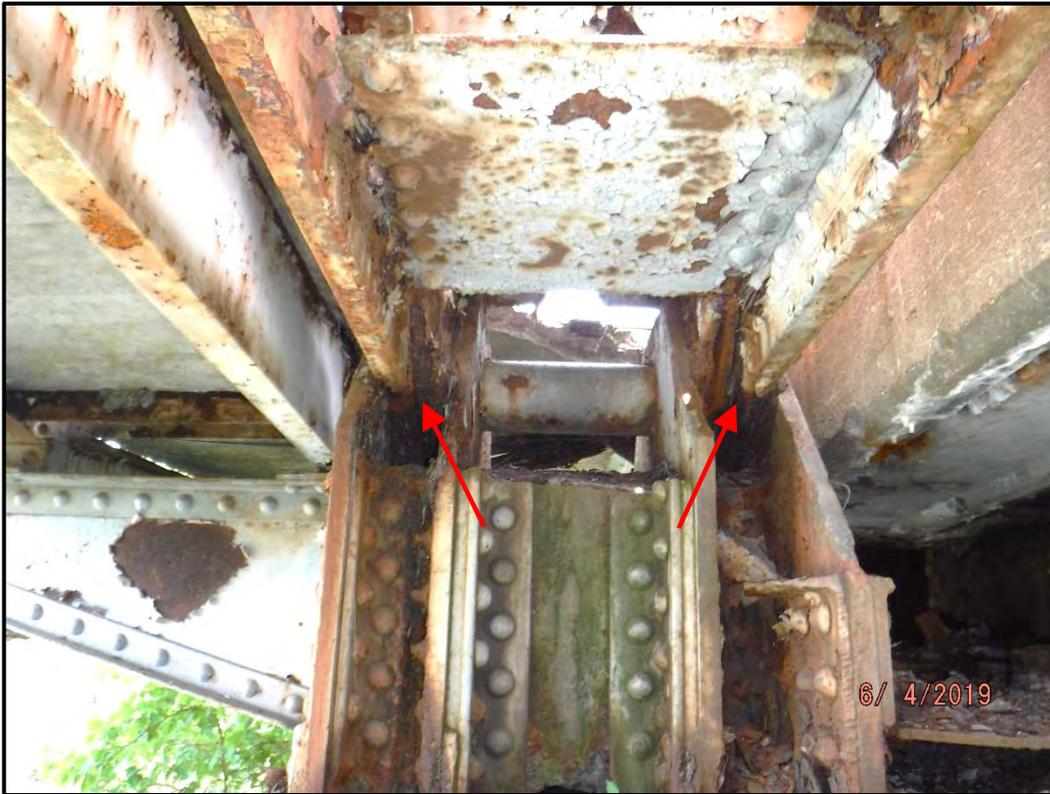
- There is active corrosion with pitting on the primary tension eyebar members.
 - The pitting is worse at the lower panel point connections due to salt spray from vehicular traffic. (See Photos 120-9 through 120-15)

Photo 120-9: 10% section loss of the eyebar heads at panel point L0 on the downstream truss.

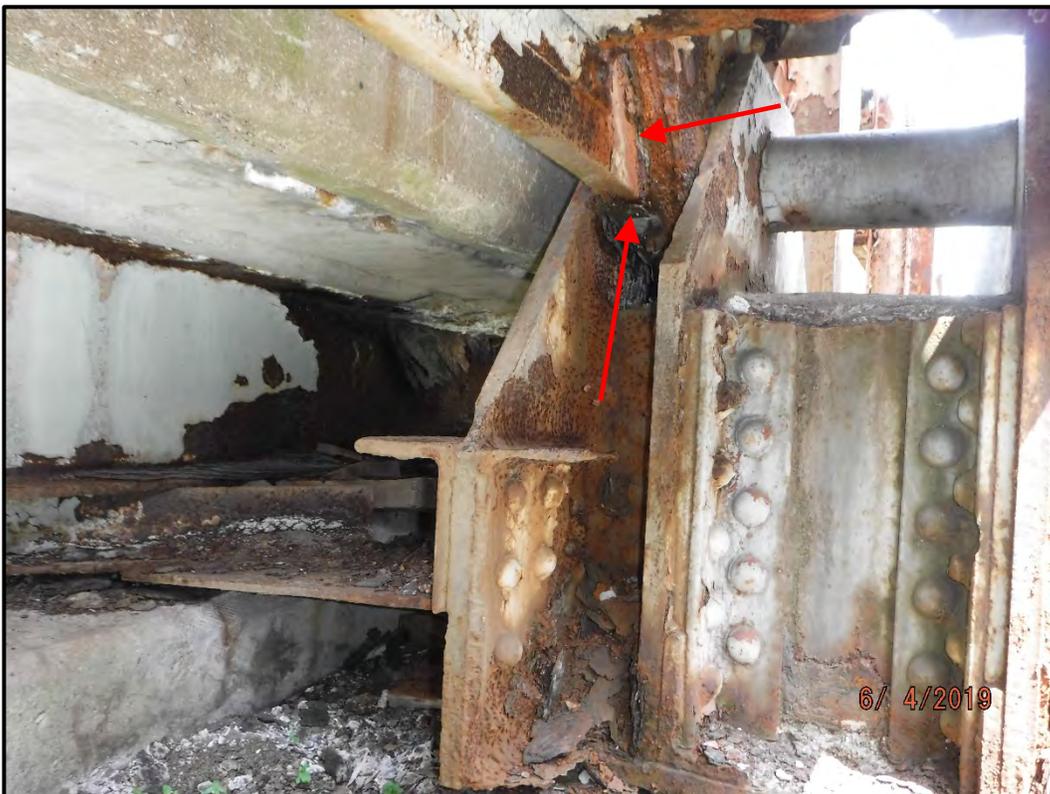
Photo 120-10: 10% section loss of the inboard eyebar head at panel point L0 on the upstream truss. The outboard eyebar is in similar condition.
