August 31, 2019

**Re: Broadway Bridge (KY 3506) over Kentucky River
 Bridge No. 037B00066N
 Frankfort, Kentucky
 In-Depth Bridge Inspection Report**

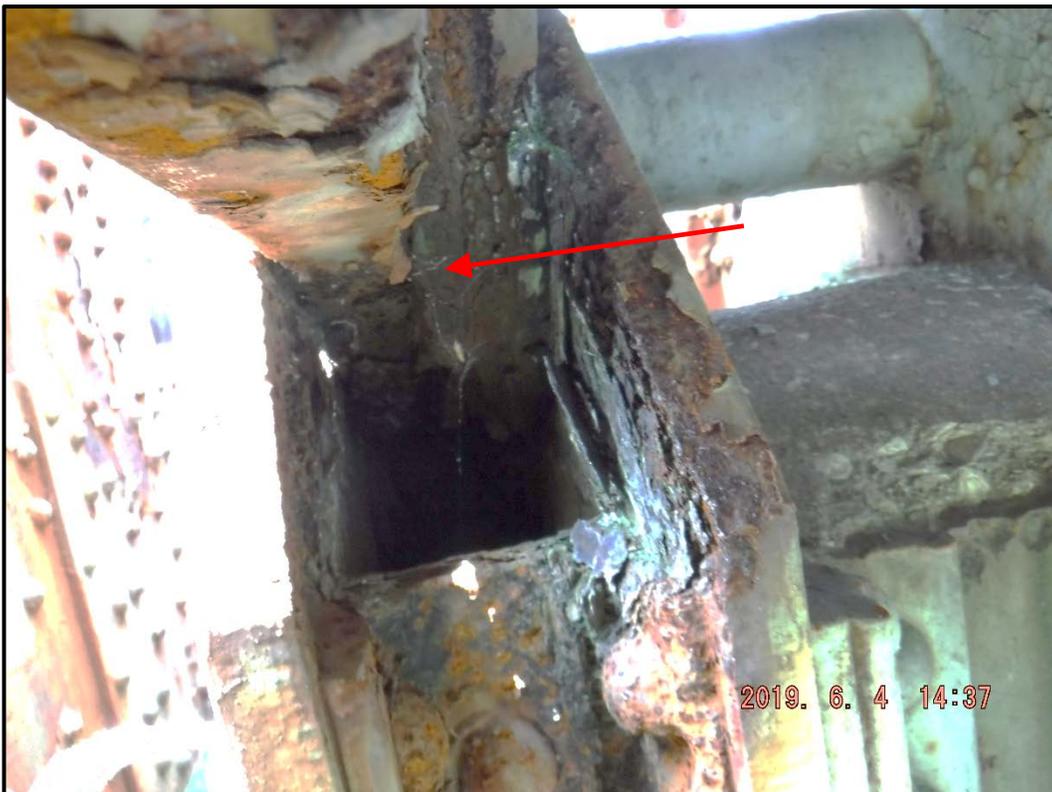
Photo 120-12: 15% section loss of the outboard eyebar head at panel point L16 on the upstream truss. The inboard eyebar is in similar condition.

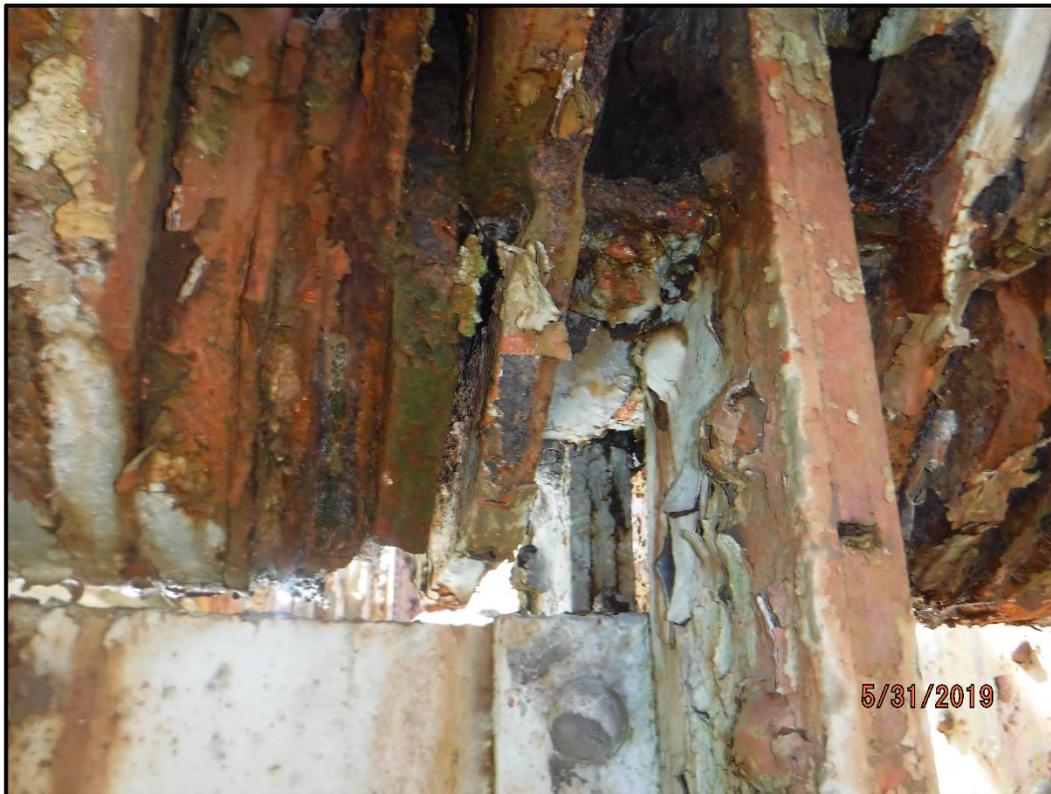
Photo 120-15: Pack rust and section loss on the lower chord pin connection at L8 on the upstream truss.

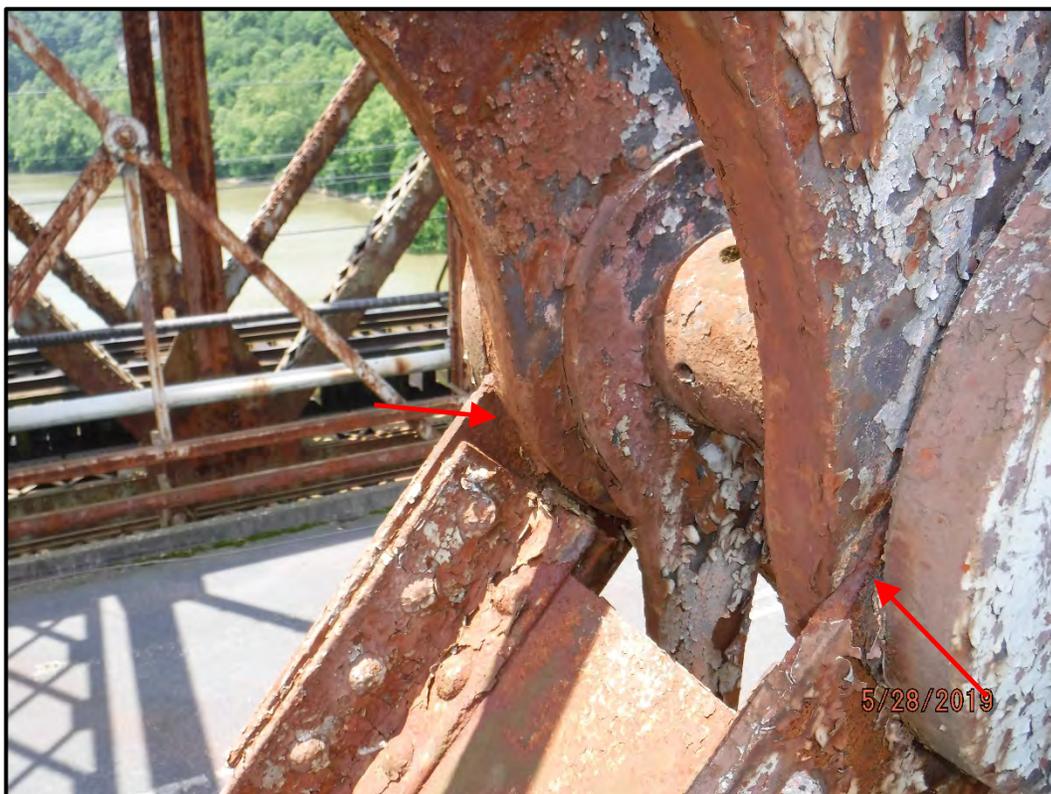
- At the middle panel point connections, the pitting is much less severe with 1/16” deep pitting typical. (See Photos 120-16 through 120-18)
 - At the top panel point connections, the upper chord provides protection from the weather, but there are locations where fretting corrosion and pack rust between the eyebars and upper chord members have caused up to 1/16” section loss. (See Photos 120-19 through 120-21)

Photo 120-16: Eyebars at panel point M3 on the downstream truss have up to 1/16" deep pitting. Note the 50% section loss of the counter-diagonal pin connection plates.

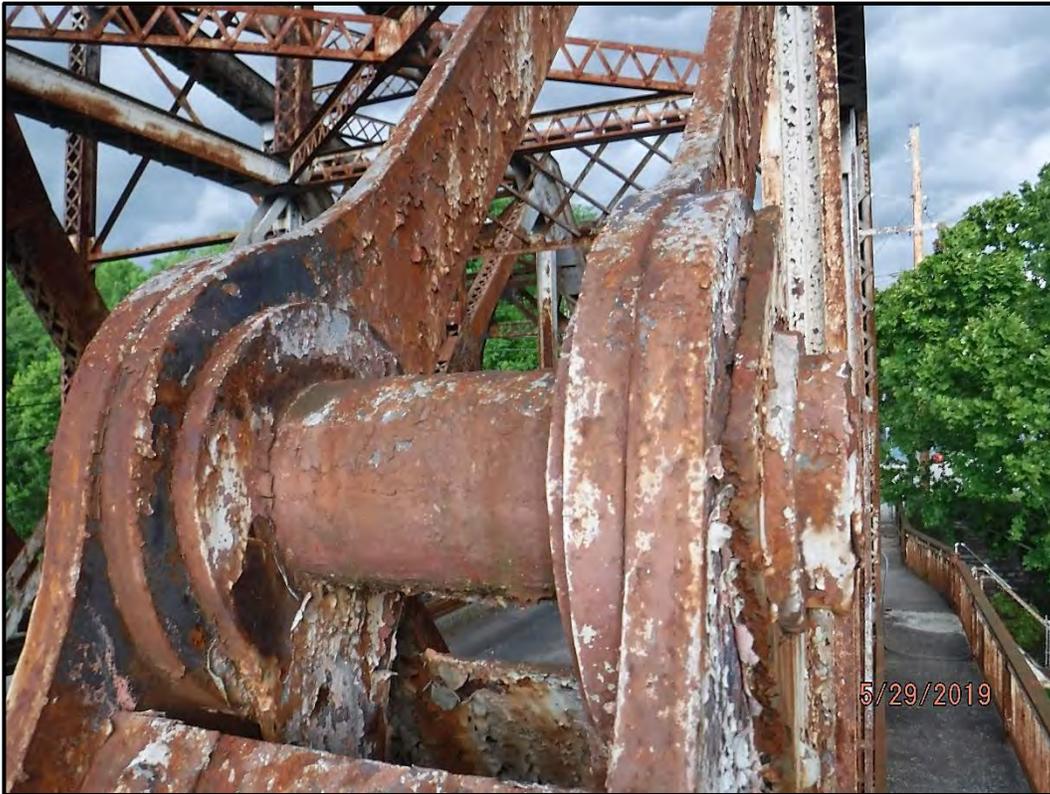
Photo 120-17: Eyebars at panel point M11 on the downstream truss have up to 1/16" deep pitting.

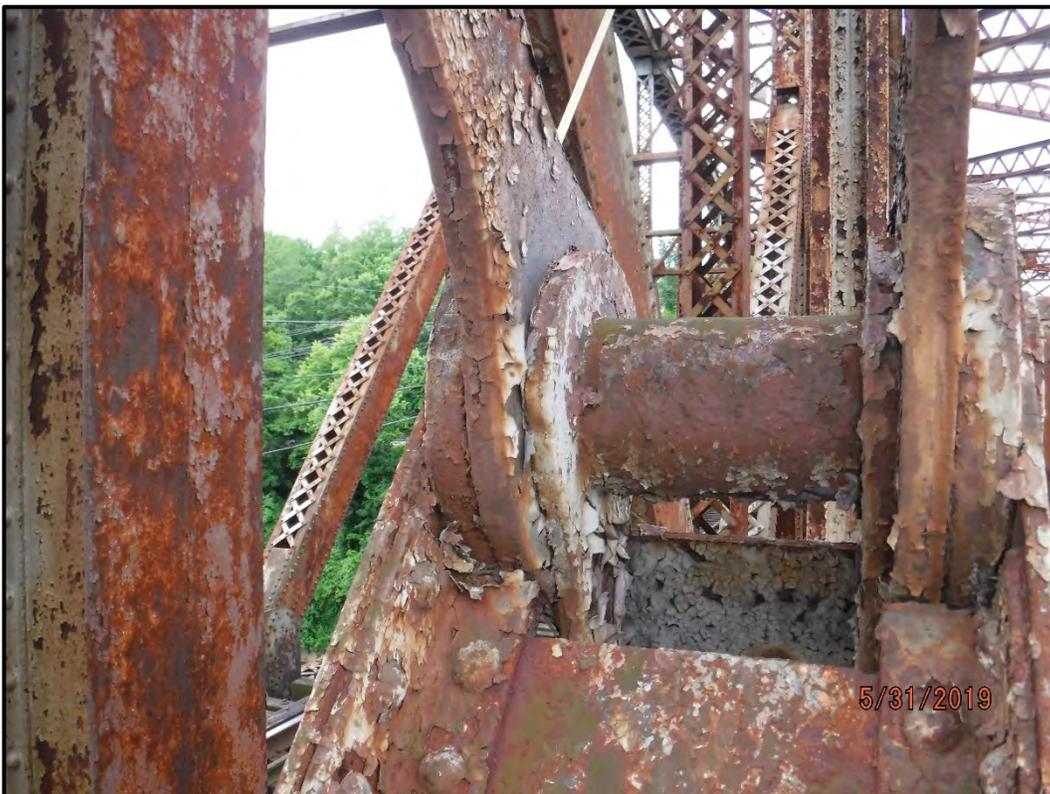
Photo 120-18: Eyebars at panel point M5 on the upstream truss have up to 1/16" deep pitting.

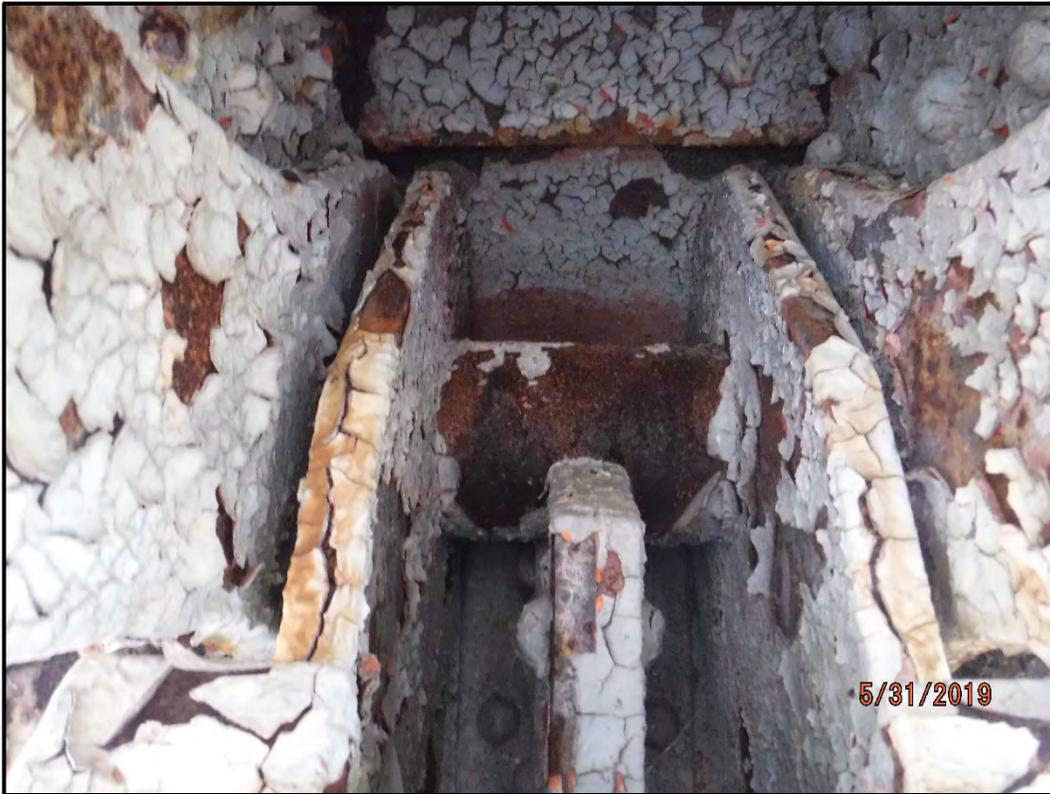
Photo 120-19: No measurable section loss of eyebar members and plates inside the upper chord at panel point U2 on the upstream truss.

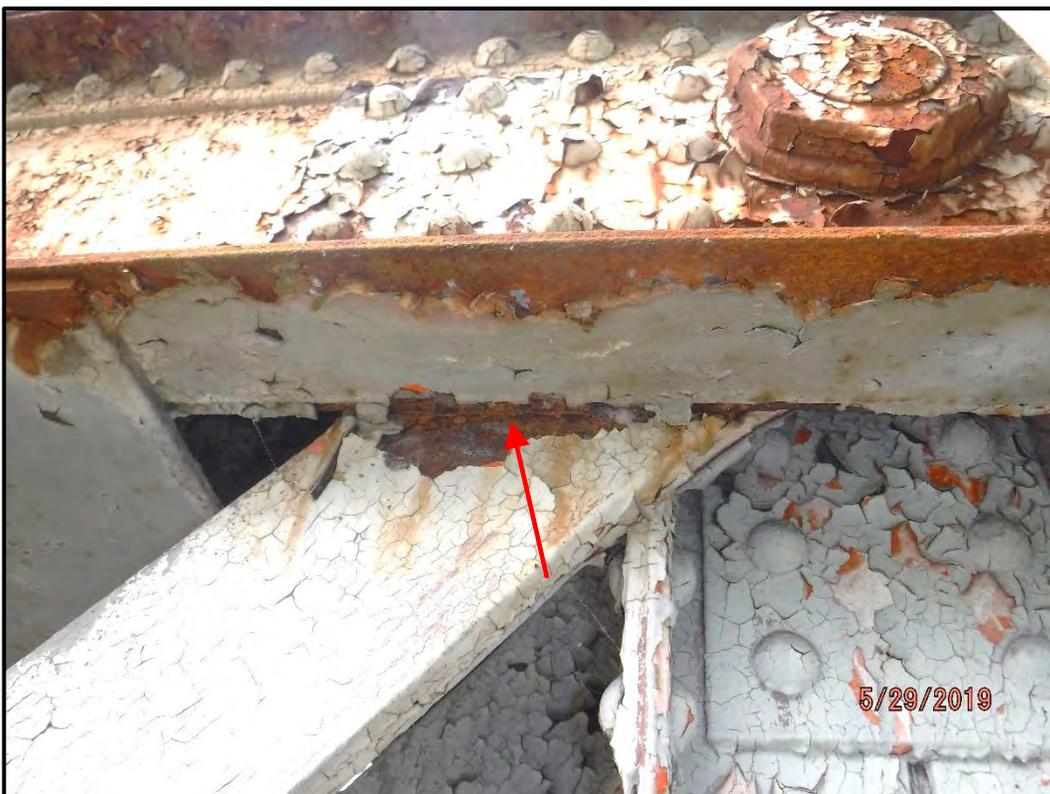
Photo 120-20: Outboard eyebar at panel point U12 on the downstream truss has 1/16" section loss due to fretting corrosion and pack rust between it and the upper chord member.

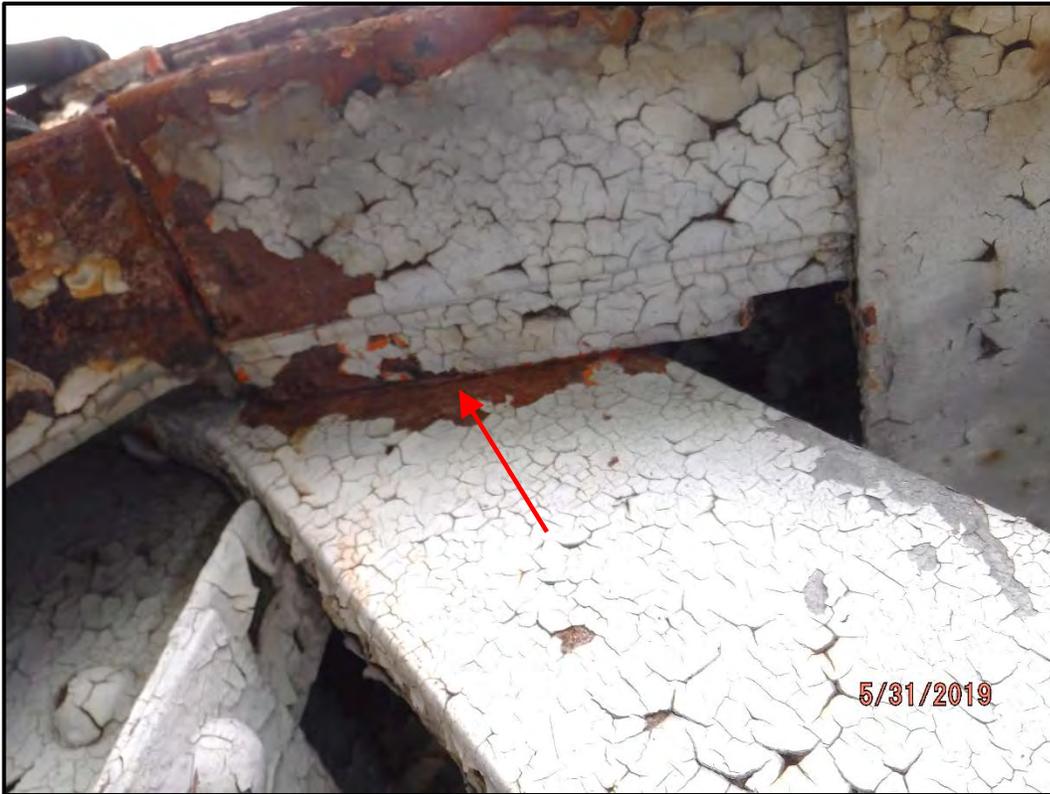
Photo 120-21: Outboard eyebar at panel point U14 on the upstream truss has 1/16" section loss due to fretting corrosion and pack rust between it and the upper chord member.

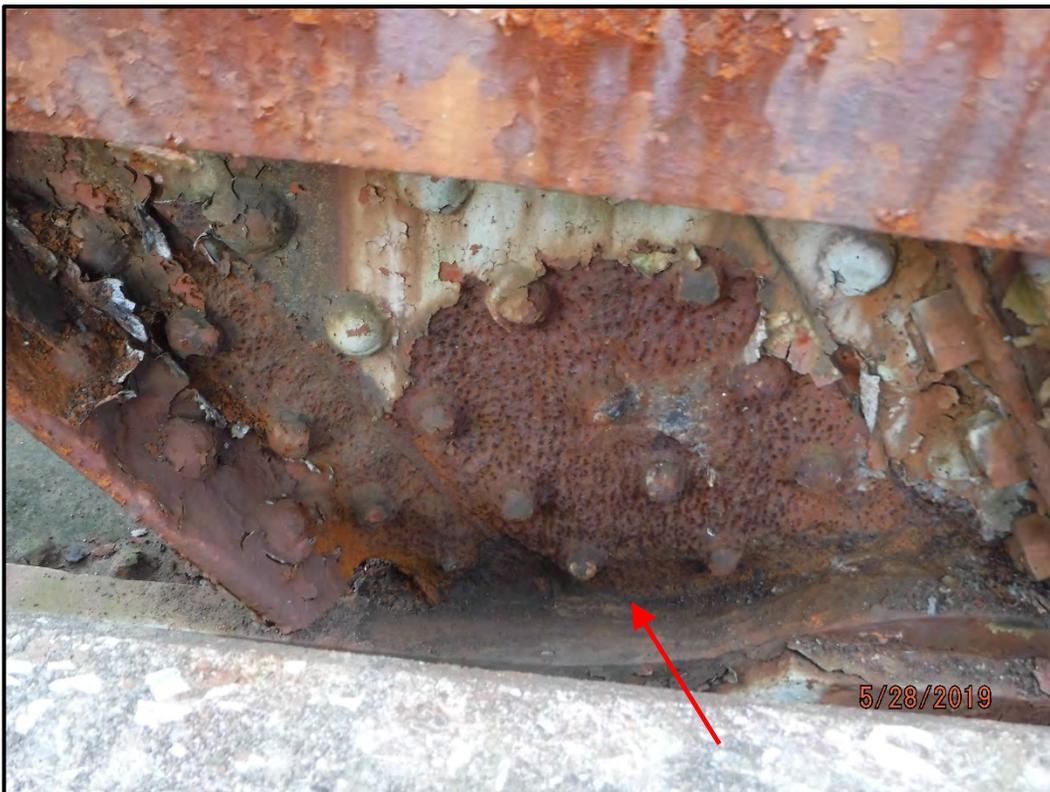
- There is active corrosion, pack rust, pitting, and section loss on the primary compression built-up members.
 - There is heavy pitting and section loss of the 3/4” stiffening plate on the inboard face of both trusses at panel points L0 and L16. (See Photo 120-22)

Photo 120-22: Pitting of the 3/4" stiffening plate on the inboard face of downstream truss member L0-U2 at panel point L0. Note the 50% section loss of the rivet heads directly above the eye bar.

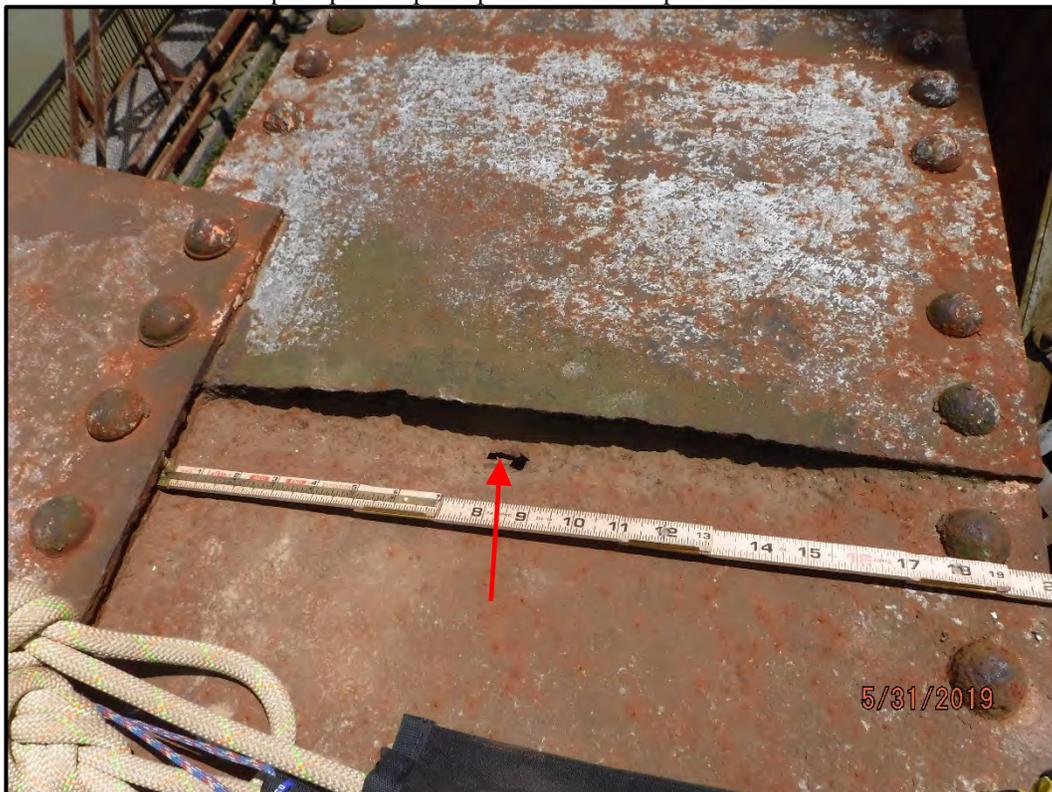
- corrosion hole within this pitting. The nominal thickness of the top flange plate is 1/2" and this is the worst location of pitting on the top flange plate. (See Photos 120-24 and 120-25)

Photo 120-24: 7/8" pack rust and 7/16" deep pitting of the upstream U6-U8 upper chord at panel point U6. The pitting is 1 1/2" wide and extends 15" across the top flange plate with a 1" diameter corrosion hole. The nominal plate thickness is 1/2". This is the worst-case upper chord pitting.

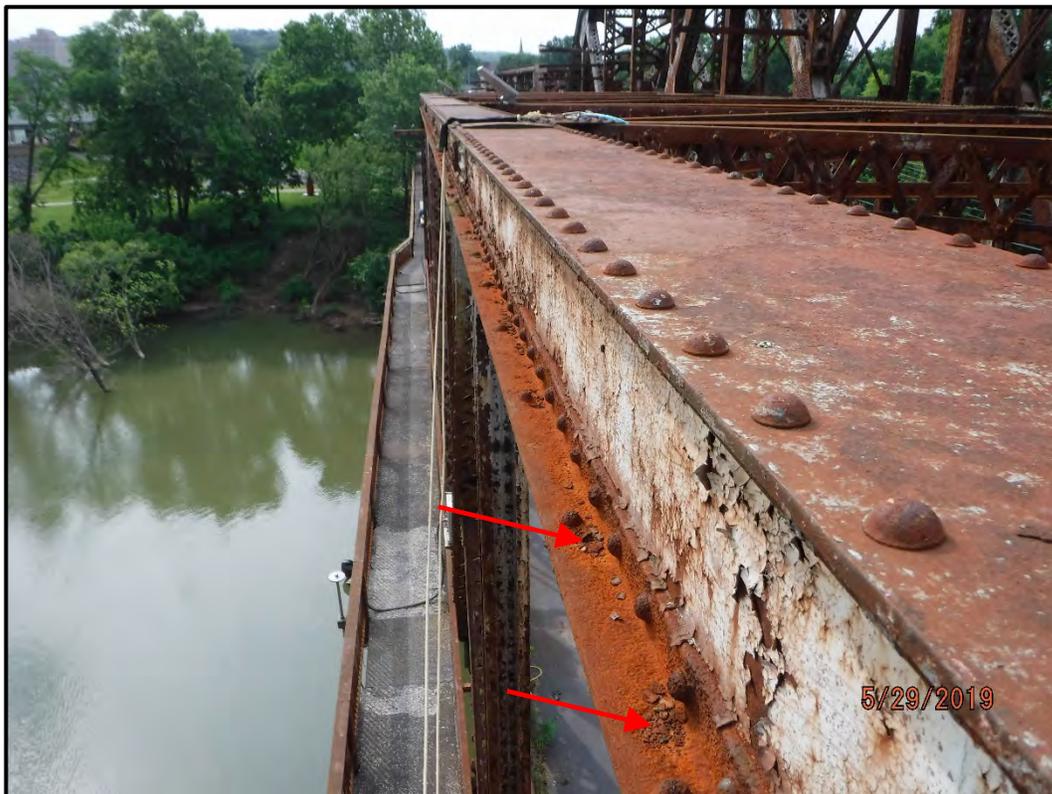
- There is intermittent 1/8" deep pitting of the upper chord bottom flange angle throughout. (See photo 120-26)
 - The worst-case upper chord bottom flange angle deterioration is located on member U2-U4 on the upstream truss. There is pitting up to 7/16" deep located 4 feet from panel point U2. The nominal angle thickness is 5/8". (See Photo 120-27)

Photo 120-26: Typical 1/8" deep pitting that is collecting debris on the upper chord bottom flange angle. Picture is of the downstream truss between panel points U10 and U12.

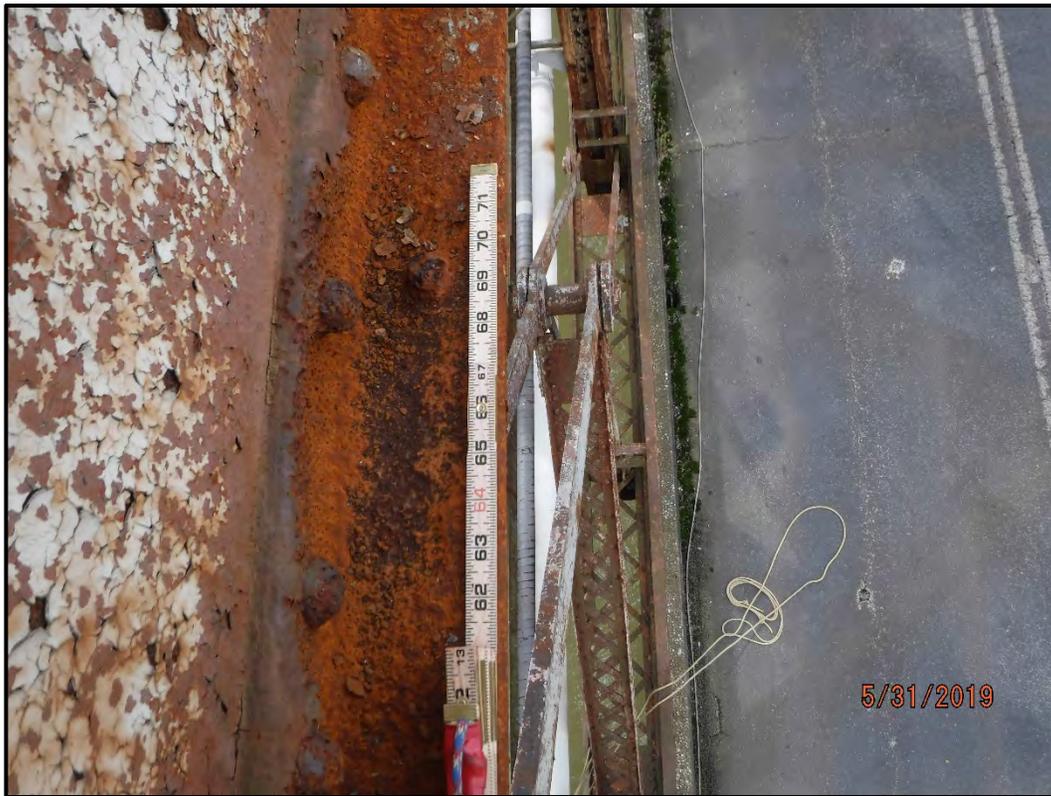
Photo 120-27: 7/16" deep pitting of the upstream truss upper chord member U2-U4 bottom flange angle located 4 feet from panel point U2. The nominal angle thickness is 5/8".

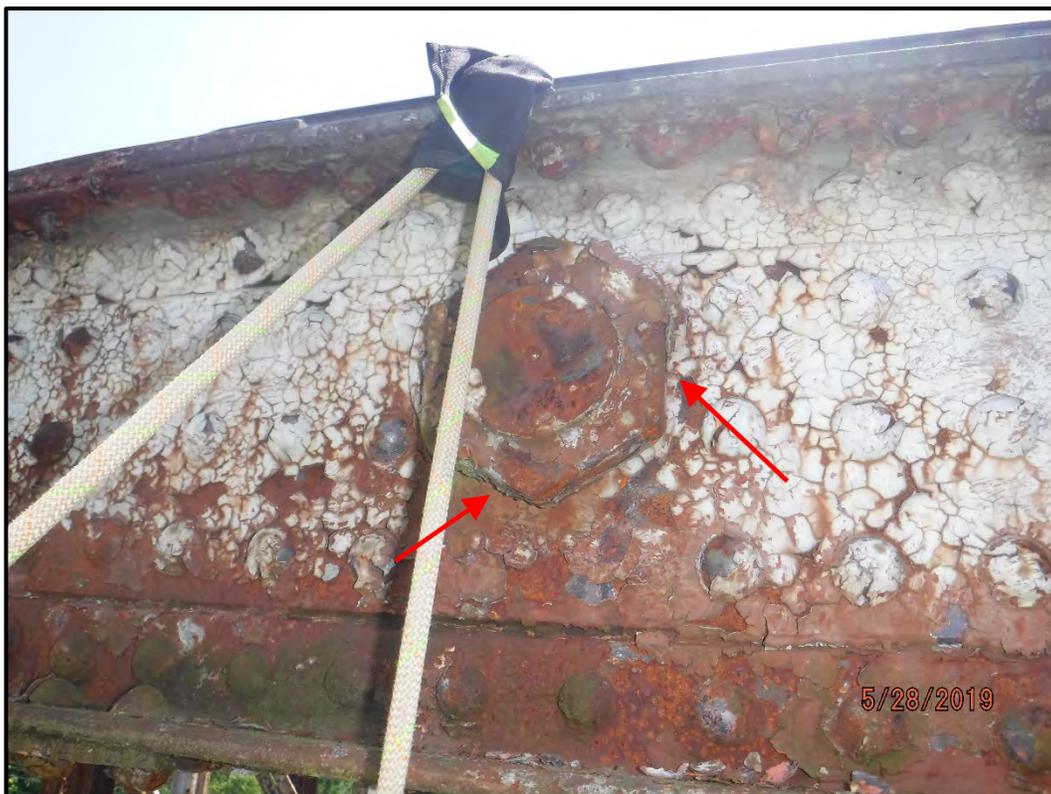
- The washers beneath pin fastening nuts have broken at two locations.
 - The washer on the outboard face of the pin at downstream truss panel point U6 has broken and only 50% of the washer is in contact with the pin nut. (See Photo 120-28)

Photo 120-28: The washer on the outboard face of the pin at downstream truss panel point U6 has broken and only 50% of the washer is in contact with the pin nut.

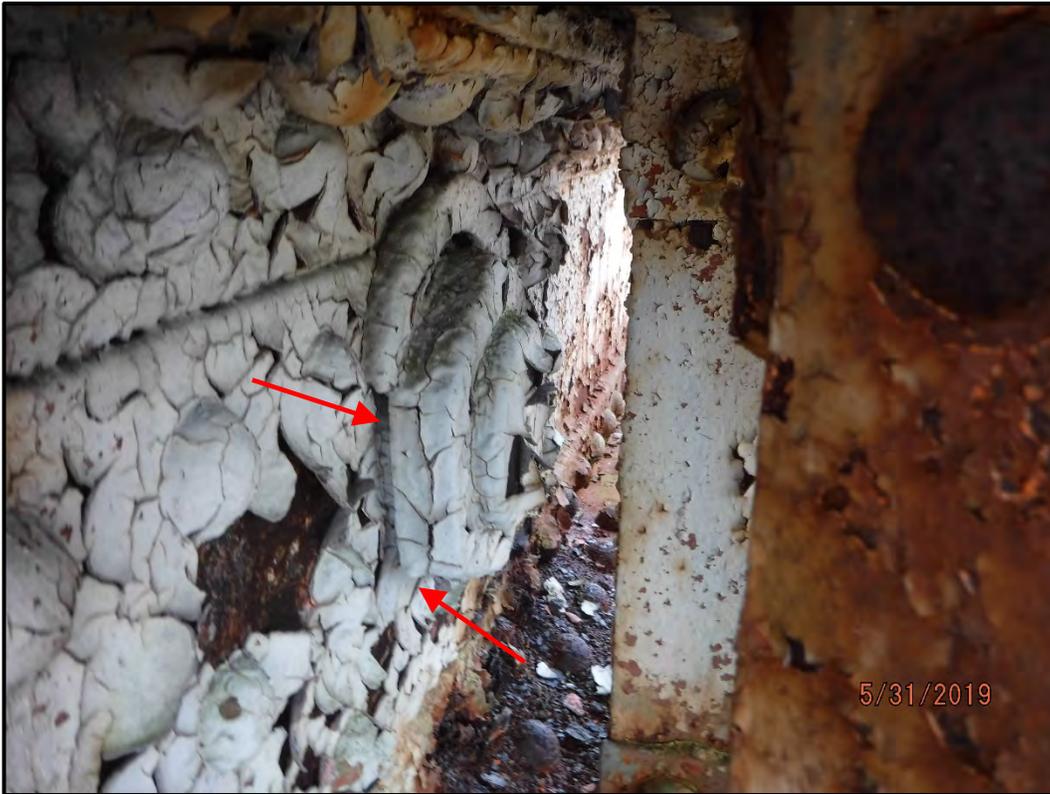
- The washer on the inboard face of the downstream pin at U10 has broken and only 20% of the washer is in contact with the pin nut. (See Photo 120-29)

Photo 120-29: The washer on the inboard face of the downstream pin at U10 has broken and only 20% of the washer is in contact with the pin nut.

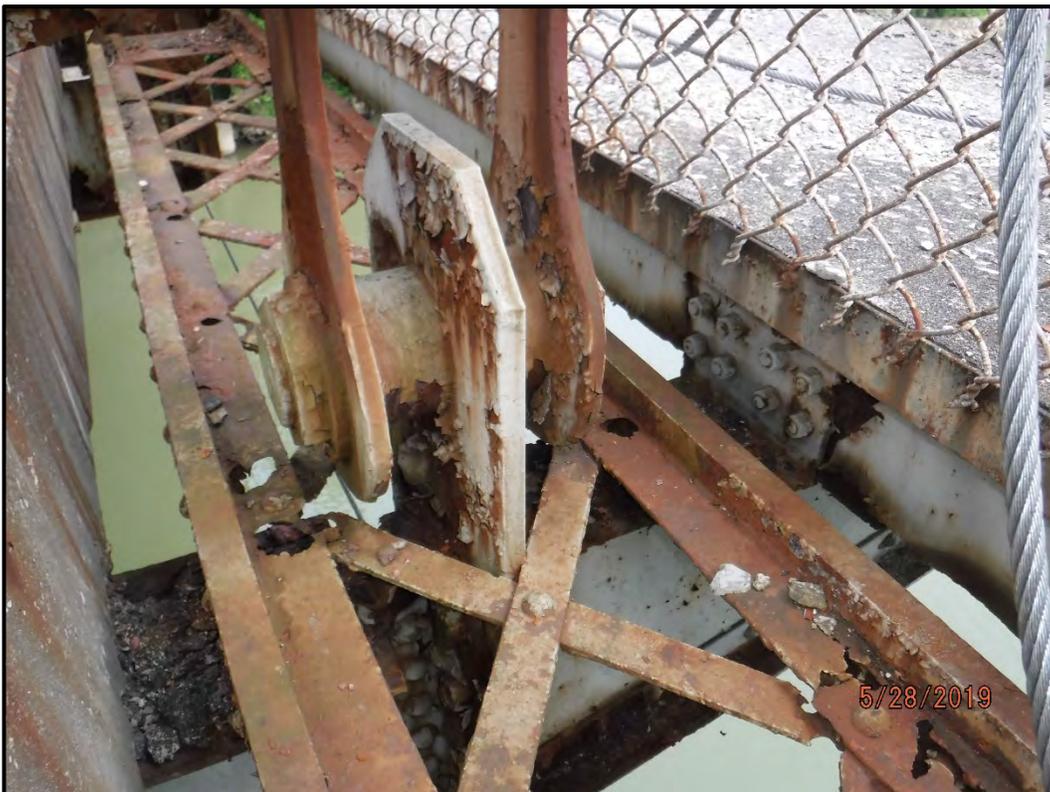
- There is active corrosion with isolated locations of section loss on lacing bars and their connection angles throughout. (See Photos 120-30 and 120-31)

Photo 120-30: Corrosion holes in the lacing bars and connection angles of member L0-L2 on the downstream truss.

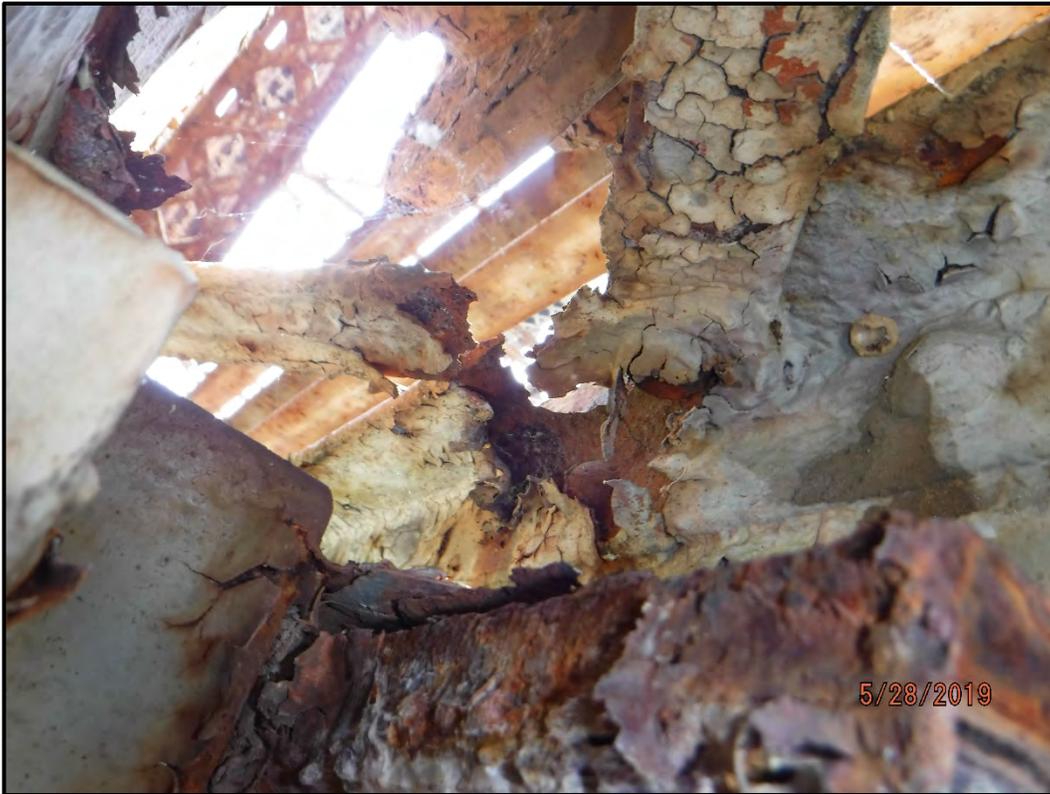
Photo 120-31: Corrosion holes in the lacing bars and connection angles of member L14-L16 on the downstream truss.

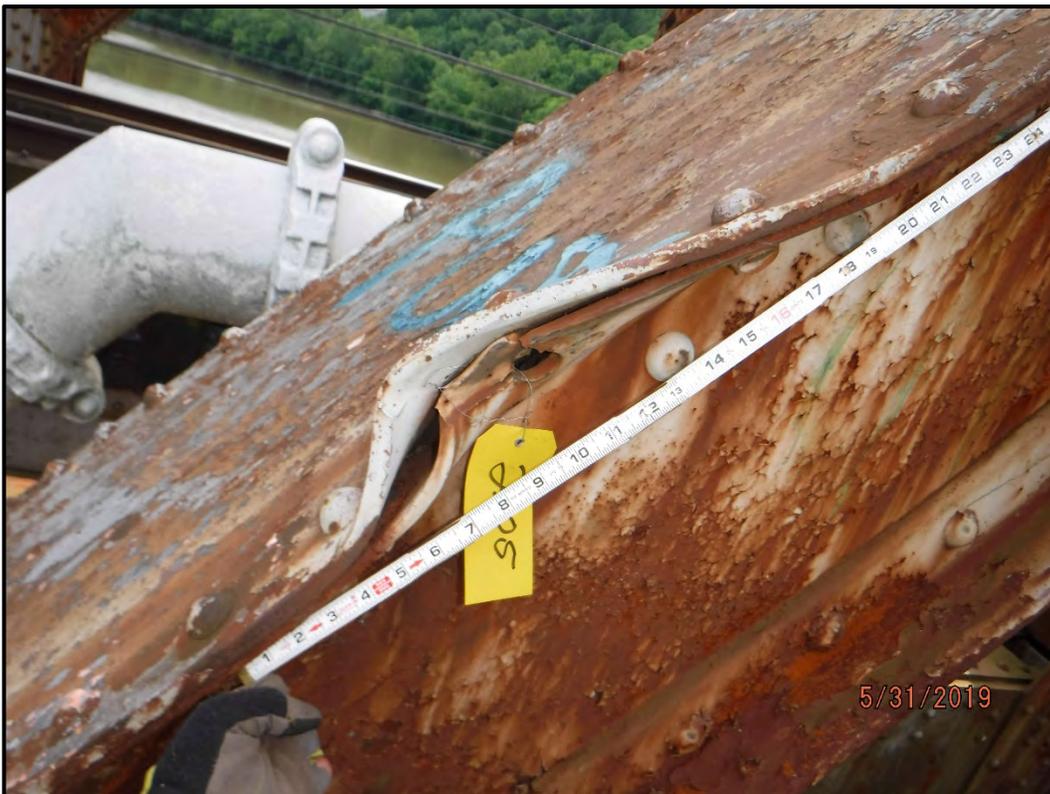
- Two truss members have significant impact damage.
 - Member L0-U2 on the upstream truss is distorted 3" to the east just above the traffic rail. One rivet is severed and there is a tear in the top flange plate connection angle. (See Photo 120-32).

Photo 120-32: Impact damage to member L0-U2 on the upstream truss just above the traffic rail. One rivet is severed and there is a tear in the top flange plate connection angle.

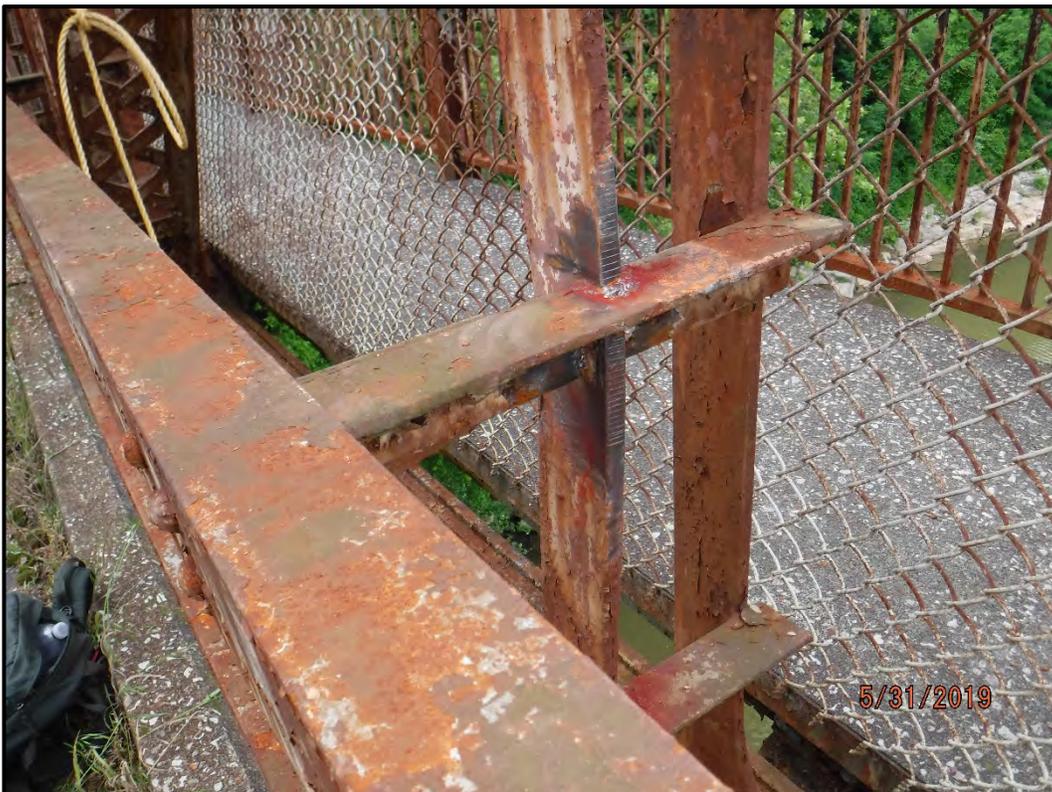
- The inboard eyebar of downstream member L11-M11 is distorted 1 1/2" to the east at the traffic rail welded connection (which is a fatigue-prone detail in and of itself). MT was performed and there were no crack indications. (See Photos 120-33 and 120-34)

Photo 120-34: Impact damage to the inboard eyebar of downstream truss member L11-M11 after MT was performed. No crack indications were found.

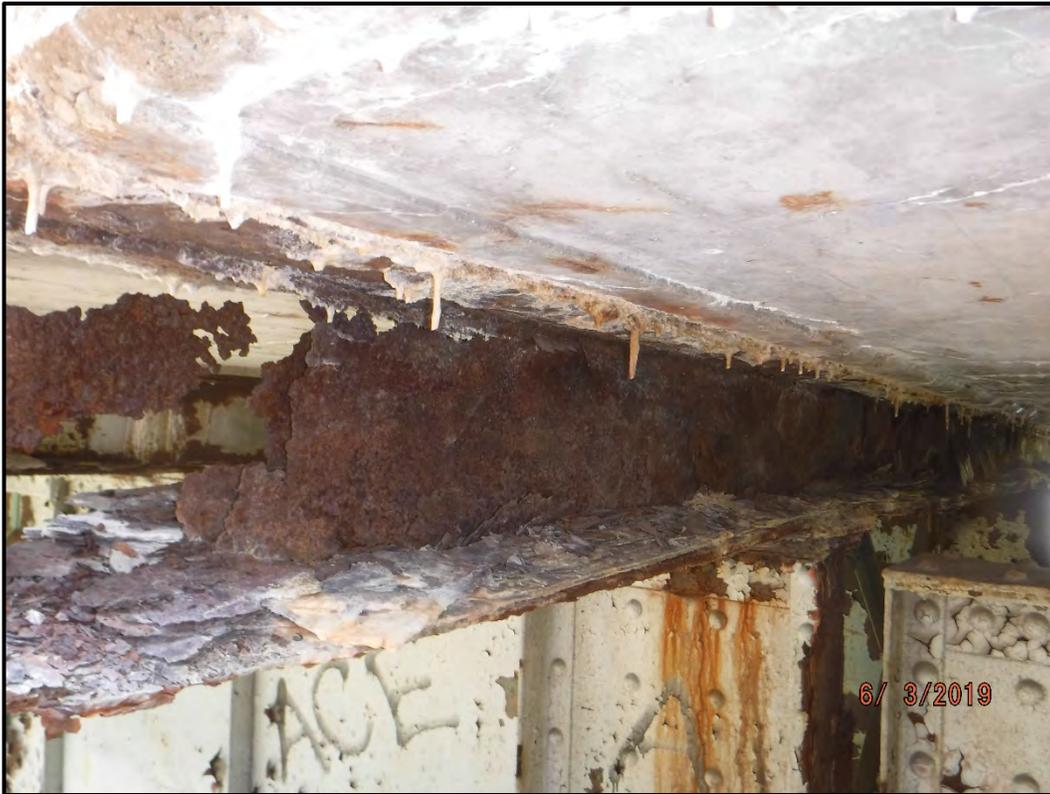
- There is severe active corrosion with up to 100% section loss of the floorbeam webs. (See Photos 152-1 and 152-2)
- There is heavy active corrosion with section loss of the floorbeam flanges. (See Photo 152-3)

Photo 152-1: Severe section loss and multiple holes in the web of the Span 4 floorbeam at Pier 3. Other floorbeams over the piers have similar section loss.

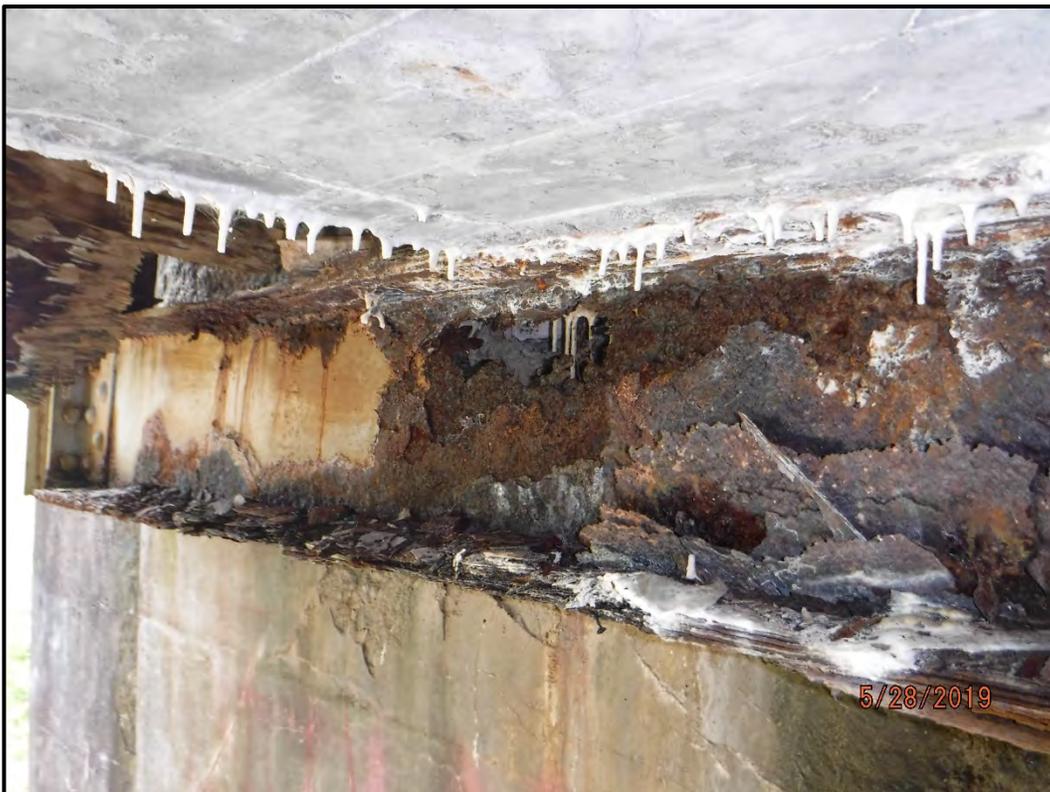
Photo 152-2: There is heavy laminar corrosion with up to 100% section loss in the web of the floorbeam at Abutment 1.

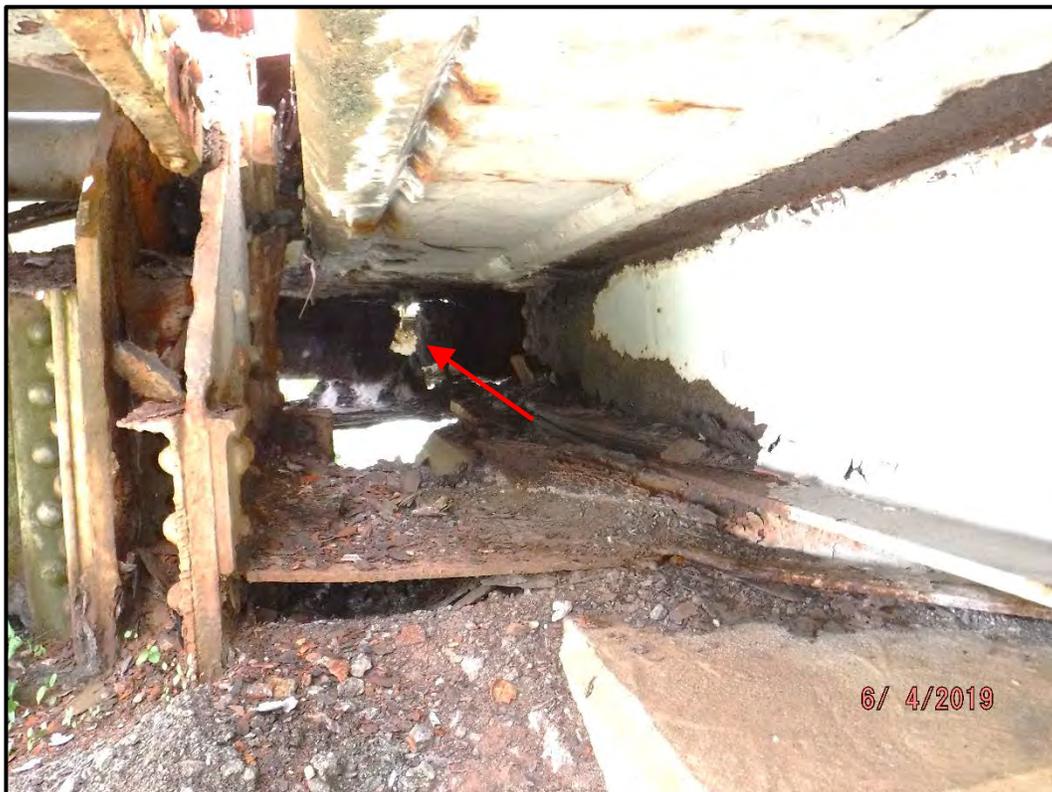
- Floorbeams 0 and 16 have severe active corrosion, and the members are severely deteriorated with failure imminent. (See Photos 152-4 and 152-5)
- The upstream end of Floorbeam 1 has active corrosion with section loss up to 100% in the web. (See Photo 152-6)
- The downstream end of Floorbeam 4 has 100% section loss in the web and heavy corrosion extending onto the bottom flange. (See Photo 152-7)
- Floorbeams 4, 9, 12, and 13 all have active corrosion with section loss on the top flange adjacent to the fascia stringers. The remaining section ranges from 0.25"-0.475". (See Photo 152-8).
- Floorbeams 4, 5, 7, 8, 12, 14 have web pitting with section loss. The remaining section ranges from 0.1875"- 0.5. (See Photo 152-9)
- Floor beams 4, 8, 10, and 15 have bottom flange section loss with 0.3125"-0.5" remaining on the bottom flange. (See Photo 152-10)

Photo 152-4: Floorbeam 0 in the truss span is severely deteriorated with failure imminent.

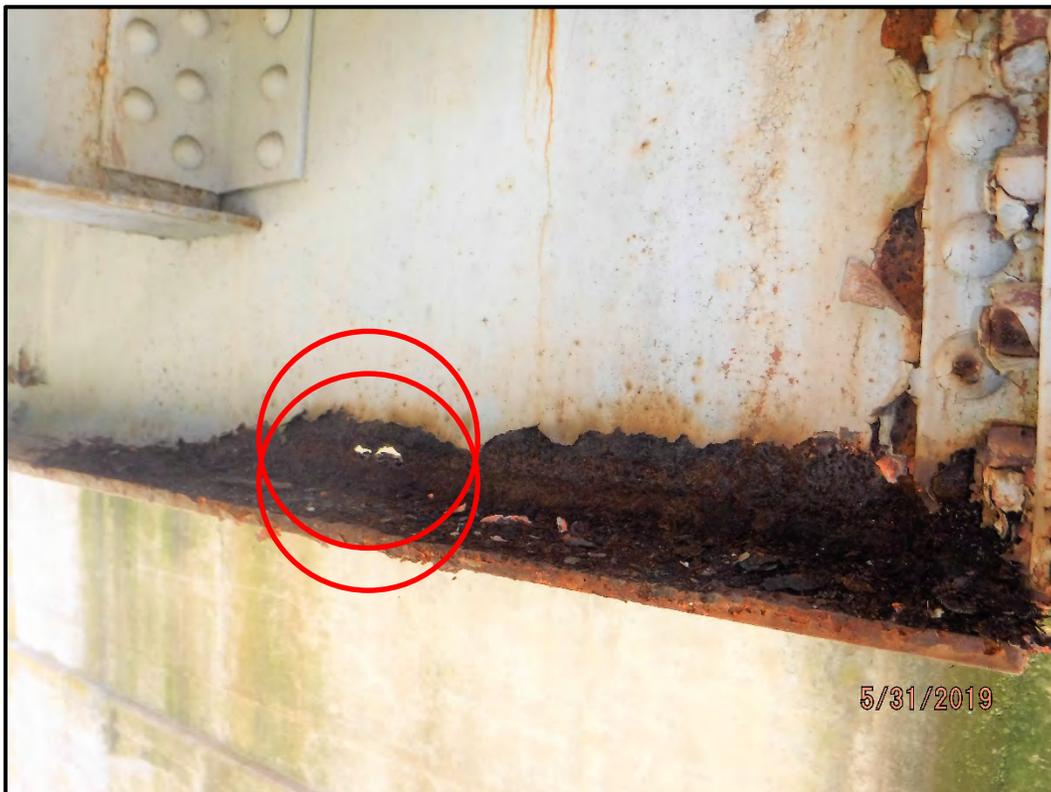
Photo 152-6: There is active corrosion with section loss at the bottom of the web of Floorbeam 1. There is a corrosion hole in the web 2.5' from the upstream end of the floorbeam.

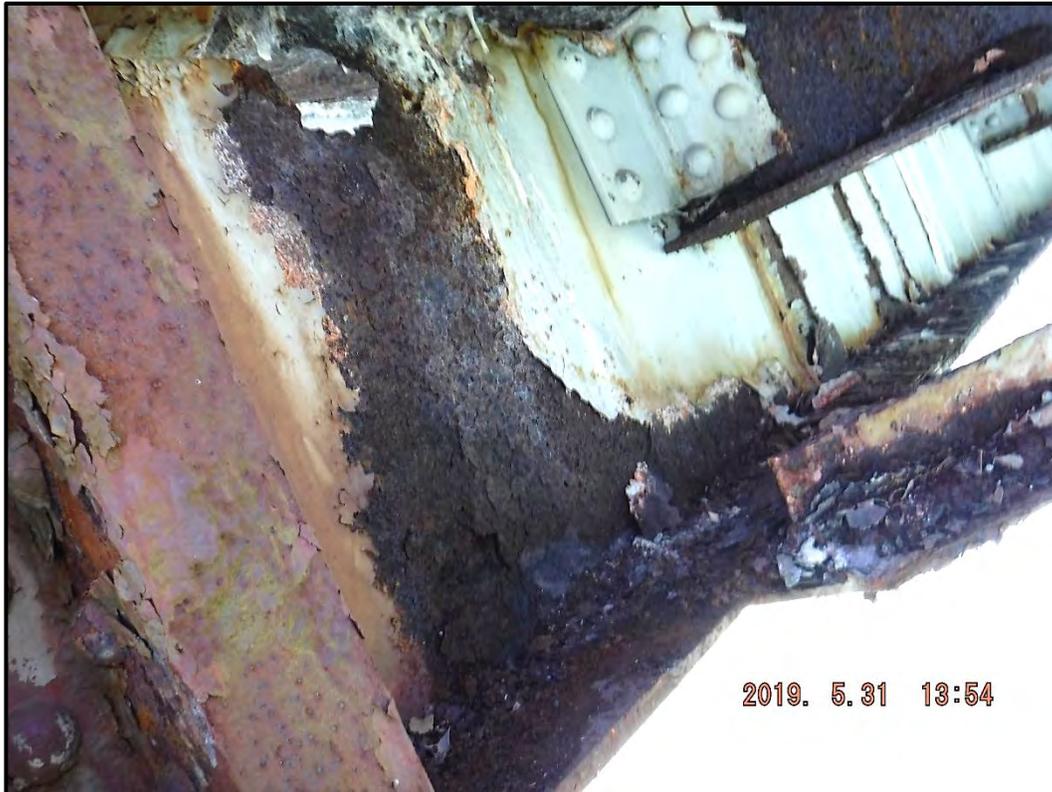
Photo 152-7: There is active corrosion with up to 100% section loss on the web and bottom flange of Floorbeam 4. There is 0.4" section remaining of the bottom flange.

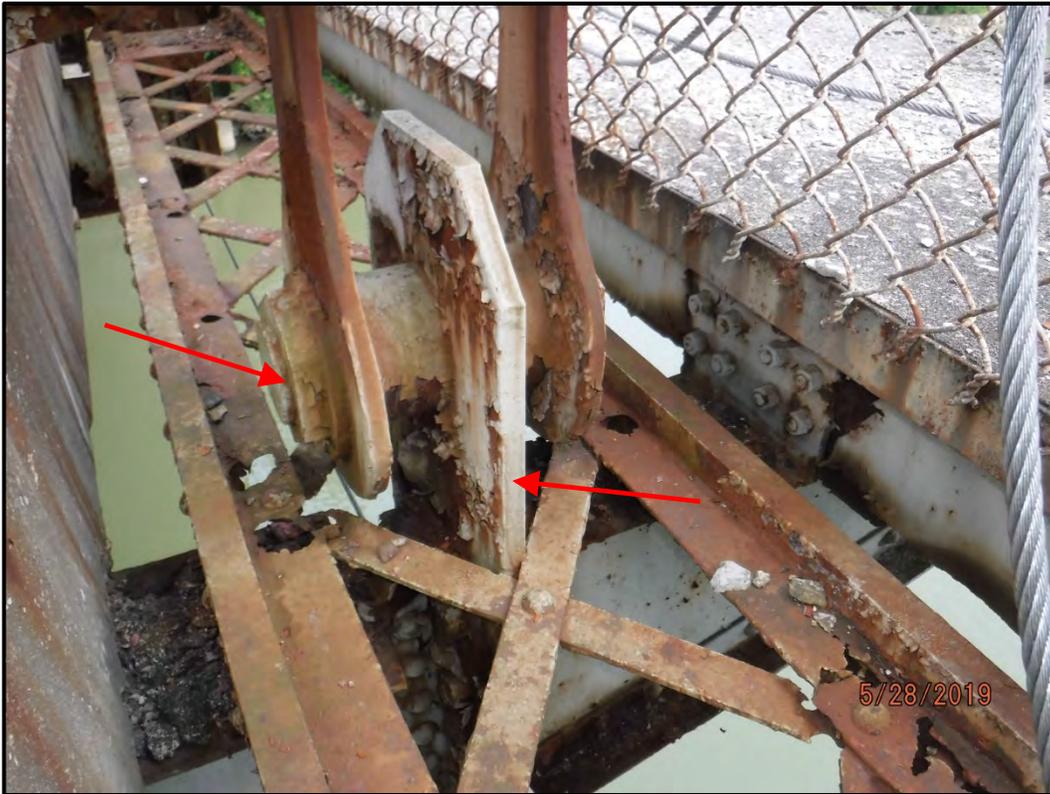
Photo 161-1: Typical truss pin and floorbeam hanger. Panel point L1 on the downstream truss is shown.

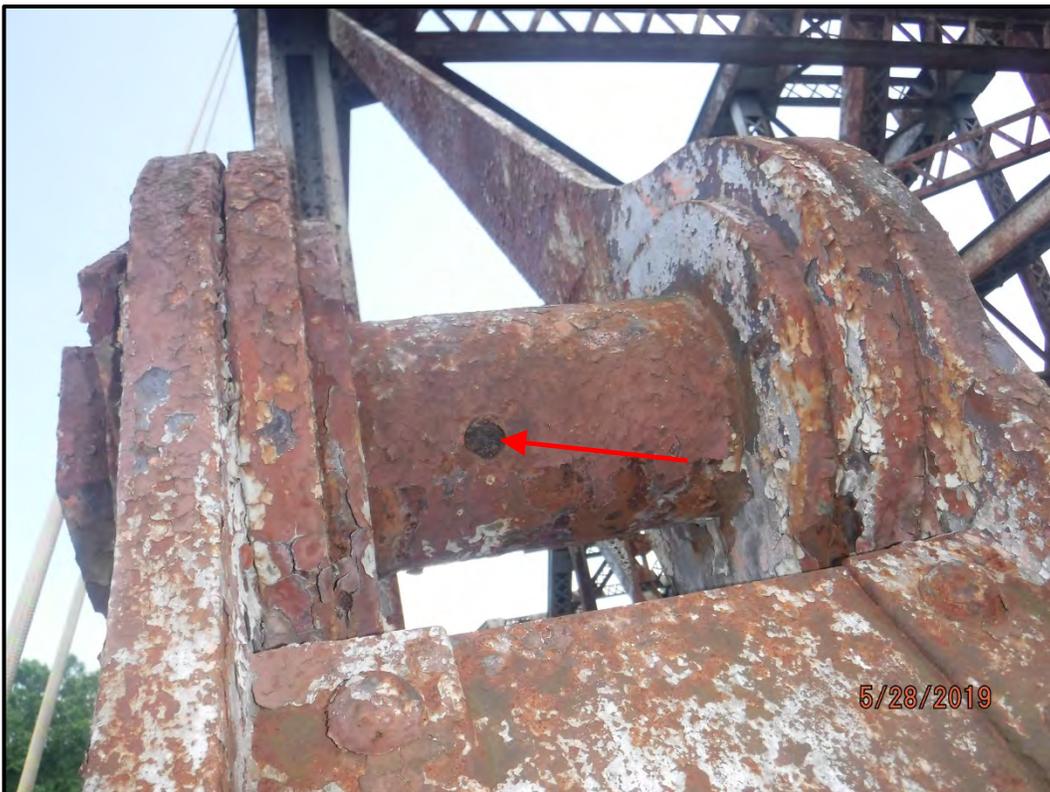
Photo 161-2: Typical mid-height panel point pin and collar. Note the hole in the collar that appears to have been drilled, perhaps to measure the collar thickness and pin diameter.
