August 31, 2019

**Re: Broadway Bridge (KY 3506) over Kentucky River
 Bridge No. 037B00066N
 Frankfort, Kentucky
 In-Depth Bridge Inspection Report**

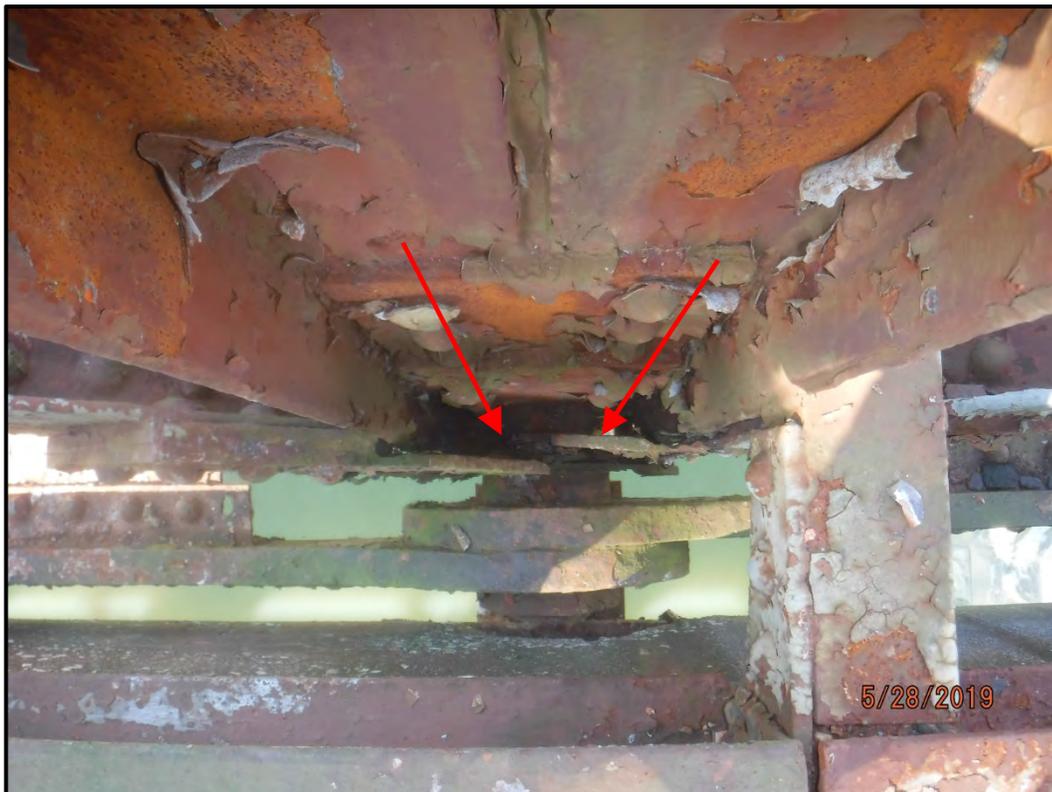
Photo 161-4: Pin at panel point L2 of the downstream truss has 1" of section loss. 4" diameter remains out of a 5" nominal diameter.

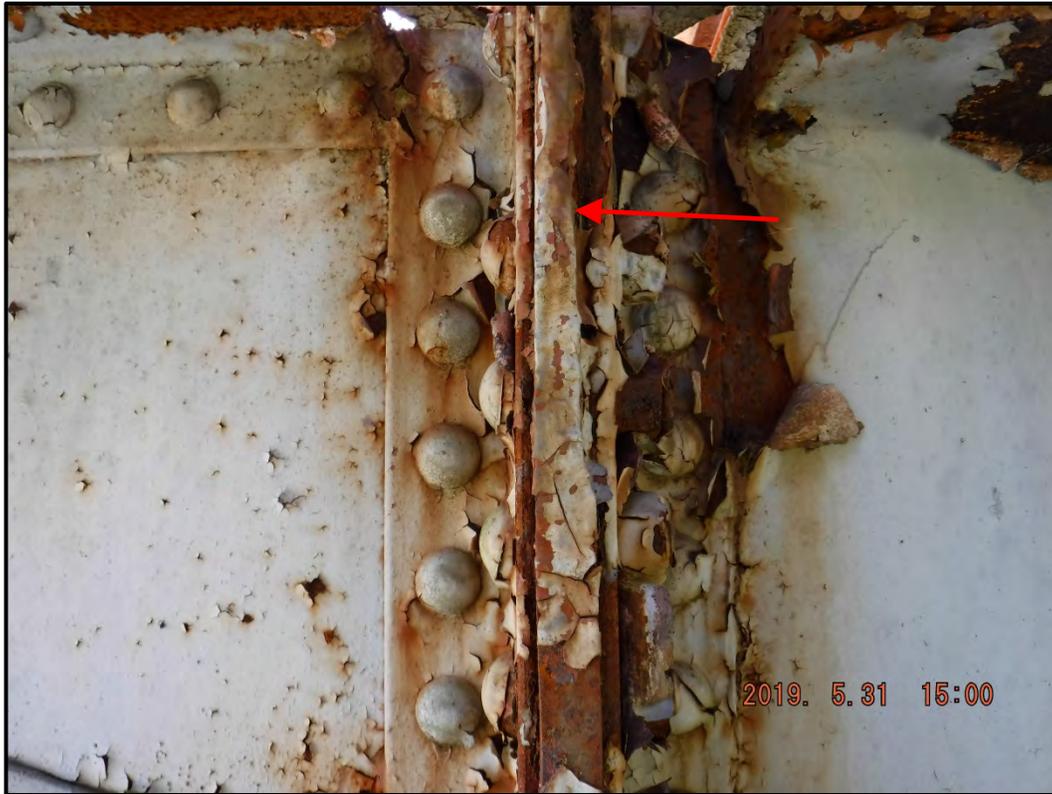
- The pins are in fair condition (NBI Rating is 5 out of 9) and the floorbeam hangers are in poor condition (NBI Rating is 4 out of 9).
- There is active surface corrosion on the pins and collars, especially at the lower chord and mid-height panel points. Minor pitting of the collars is present. (See Photos 161-1 through 161-3)
- The pin at panel point L2 of the downstream truss has 1" of section loss. 4" diameter remains out of a nominal 5" diameter. (See Photo 161-4)
- There is active corrosion with pitting and section loss on the floorbeam hangers. Minimum section remaining is 0.28". (See Photos 161-5 through 161-7)

Photo 161-5: Floorbeam hanger at panel point L1 on the downstream truss exhibits worst case section loss with 0.28" remaining out of 1" nominal thickness.

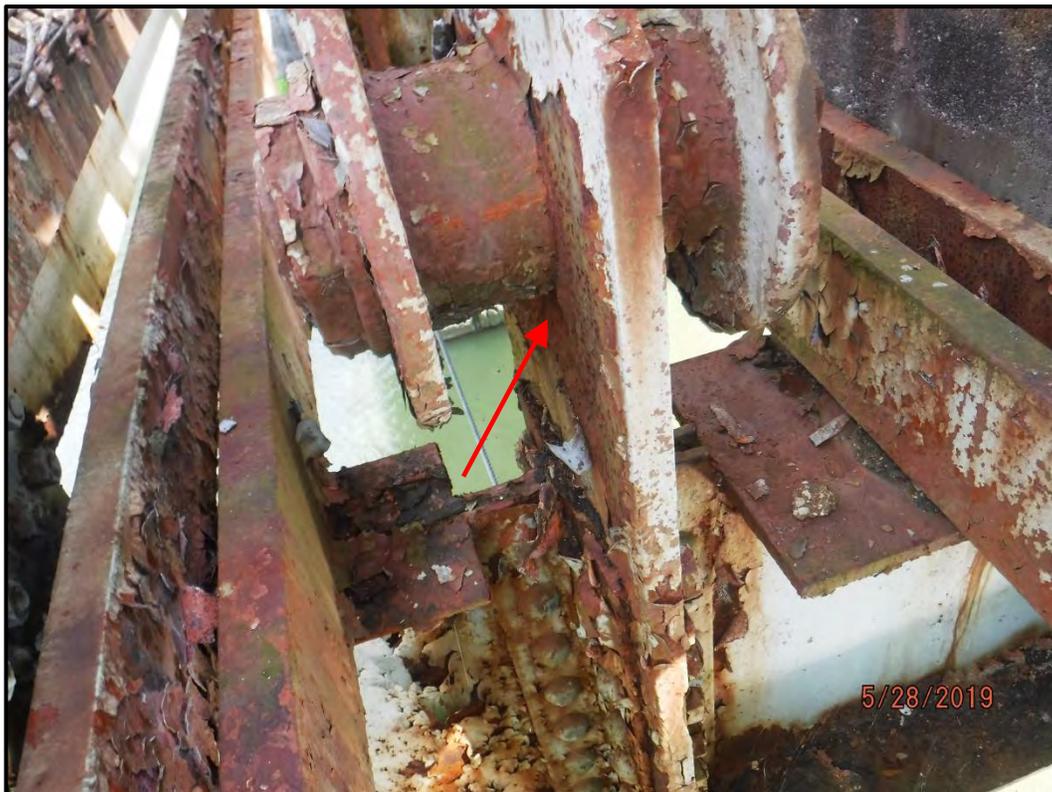
Photo 161-6: 3/8" deep pitting of the floorbeam hanger at panel point L7 downstream. The depicted pitting is typical beneath the pins.

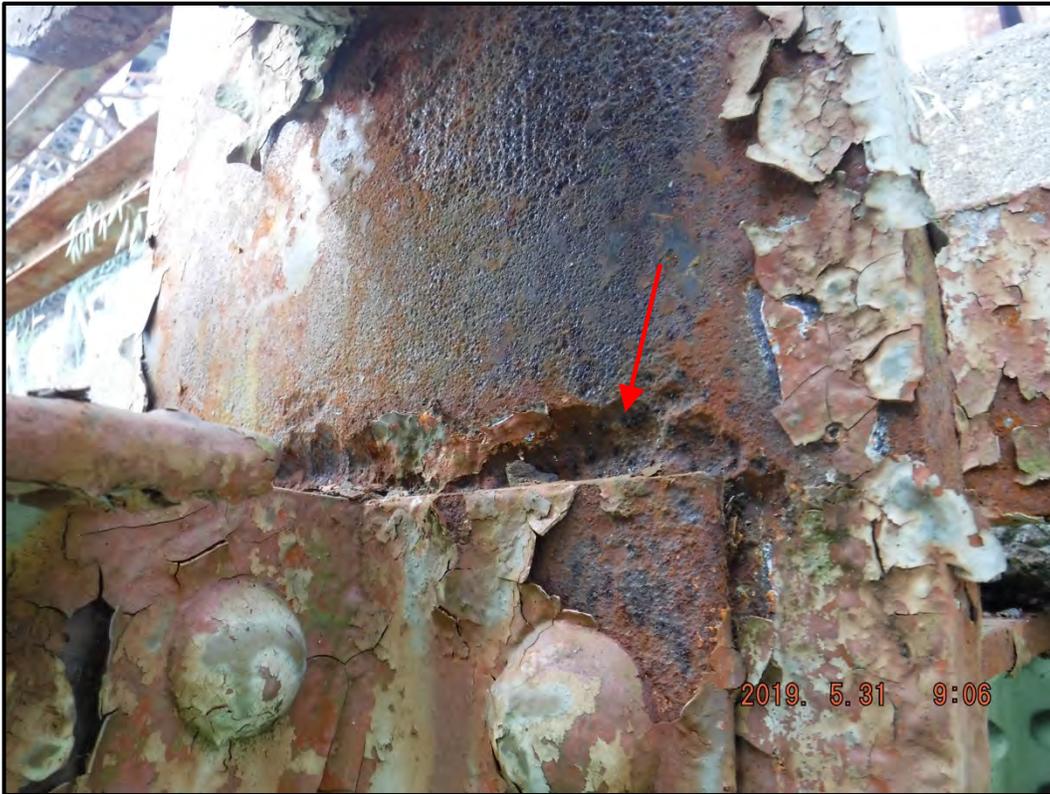
Photo 161-7: 5/16" deep pitting of the floorbeam hanger at panel point L11 downstream. The depicted pitting is typical along the top of the floorbeam connection angles.

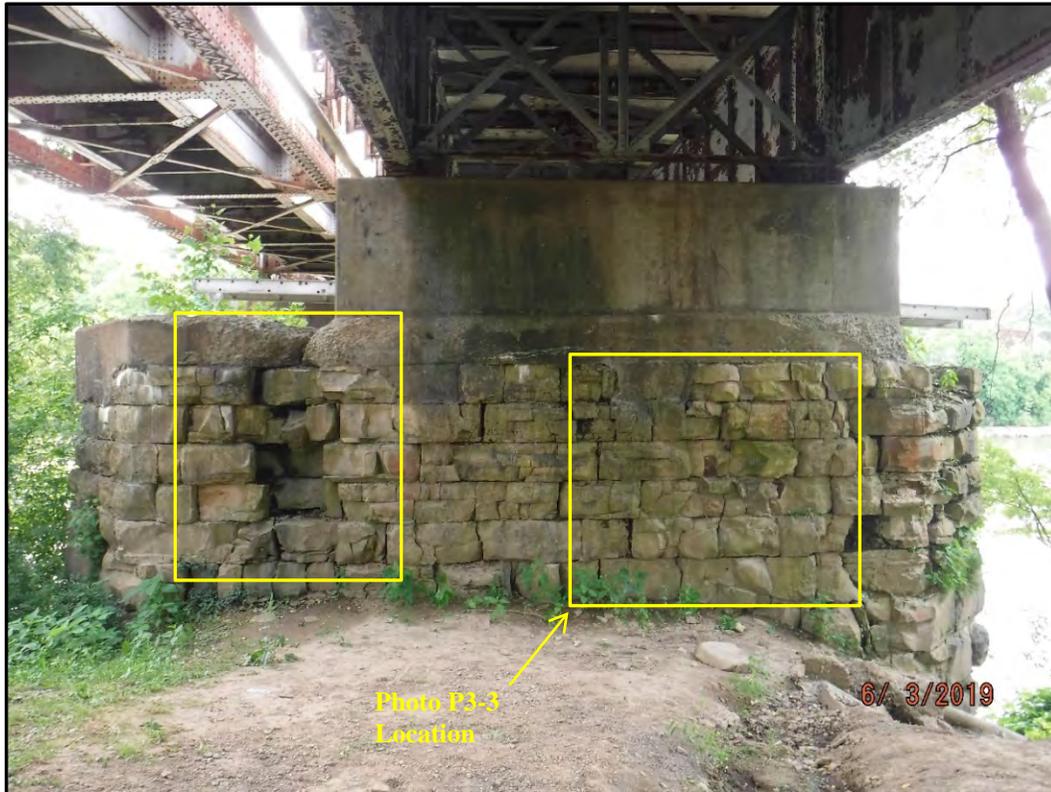
Photo P3-1: East face of Pier 3. Note the heavy cracking of the stones throughout and the large 2ft wide x 5ft tall x 2.5ft deep void at the south end of the concrete beam seat.

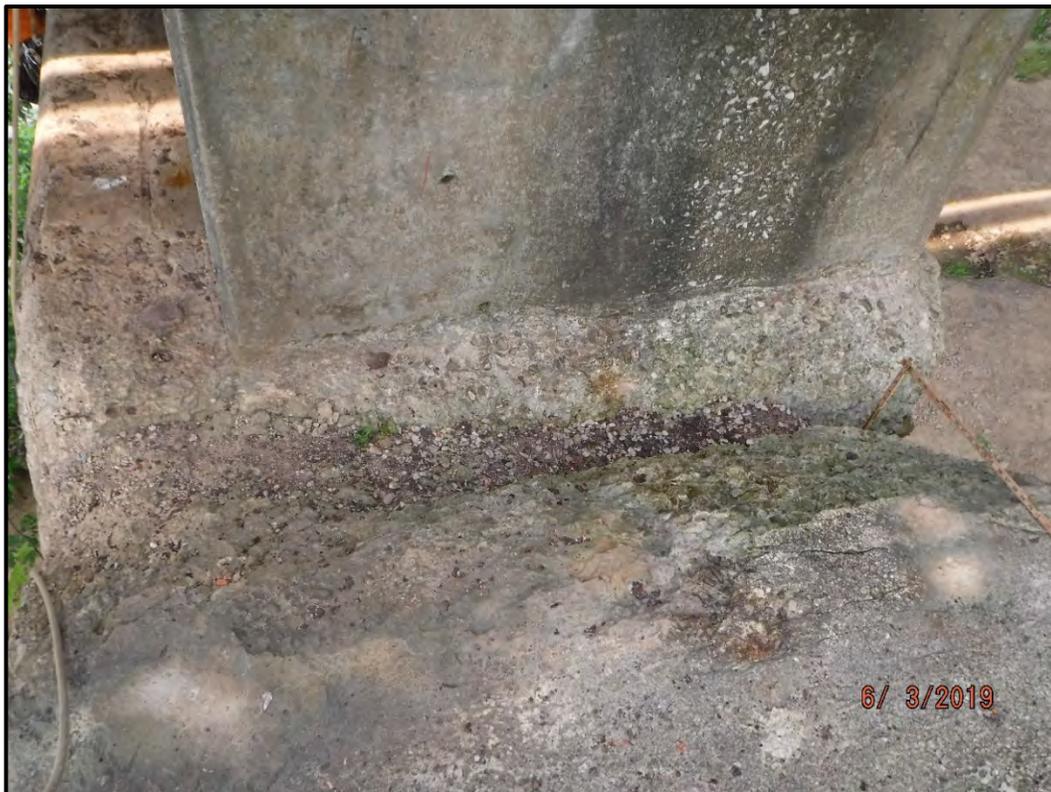
Photo P3-2: A drainage issue has caused heavy deterioration on the south end of the Pier 3 cap adjacent to the beam seat. This deterioration has formed a ditch in the cap that is 30in wide by 18in deep at the east edge of the cap.

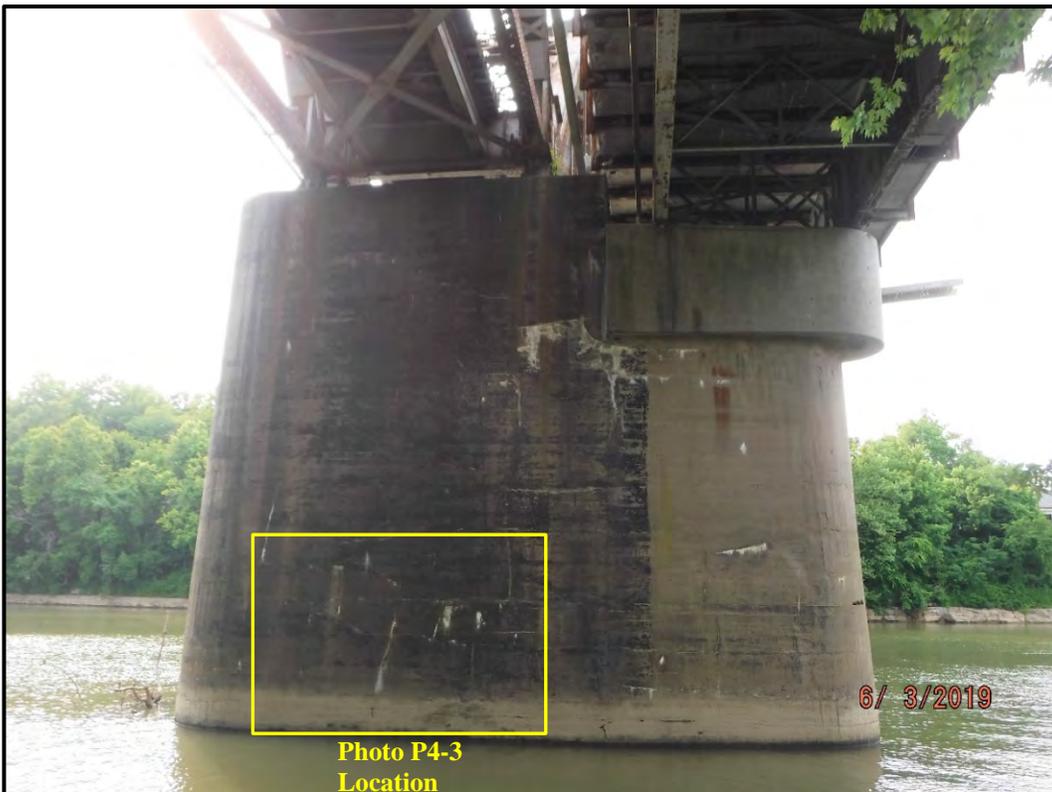
Photo P4-1: East face of Pier 4 has horizontal and vertical cracking with efflorescence throughout.

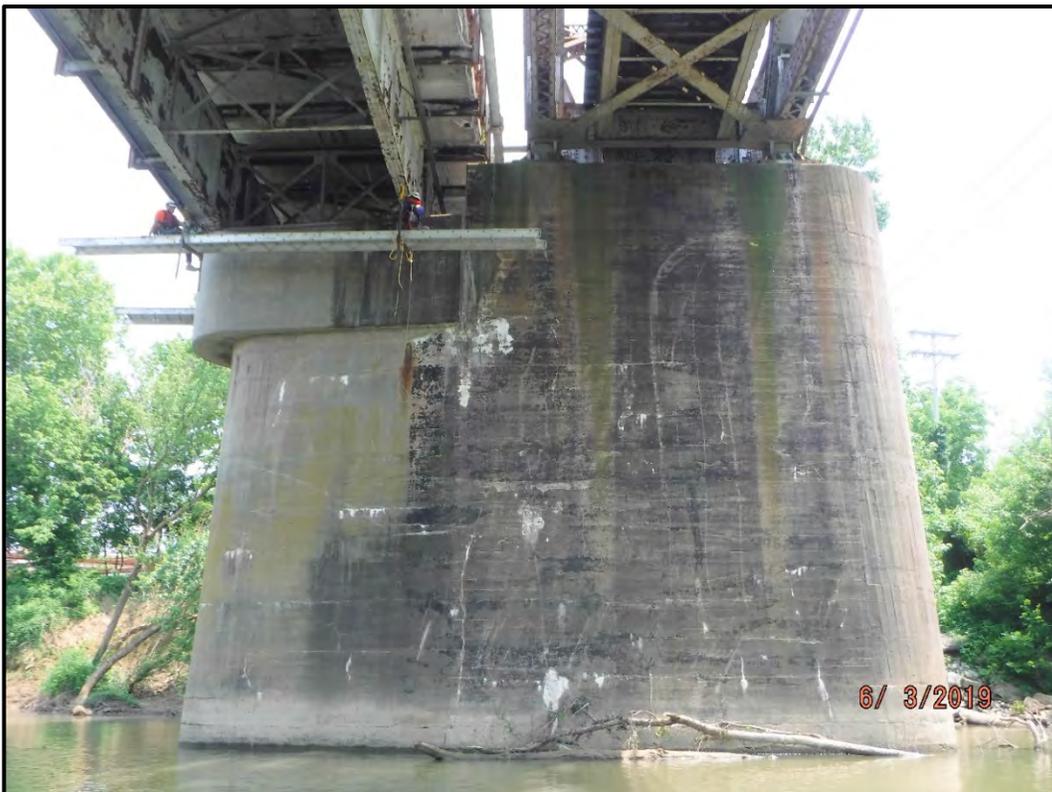
Photo P4-5: West face of Pier 4. Note the cracking with rust staining and efflorescence throughout and the debris collecting on the pier.

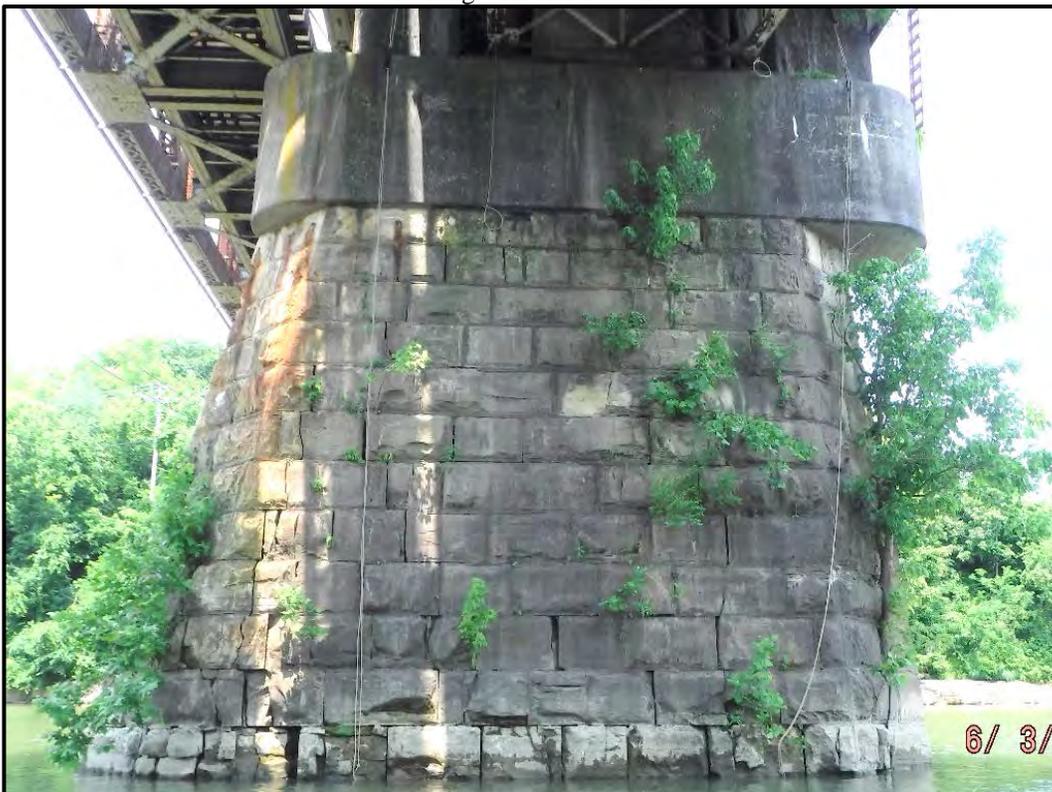
Photo P5-1: East face of Pier 5 with vertical cracks extending the full height of the masonry. Note the large amount of vegetation on the pier and the heavy deterioration of the masonry at the water line.

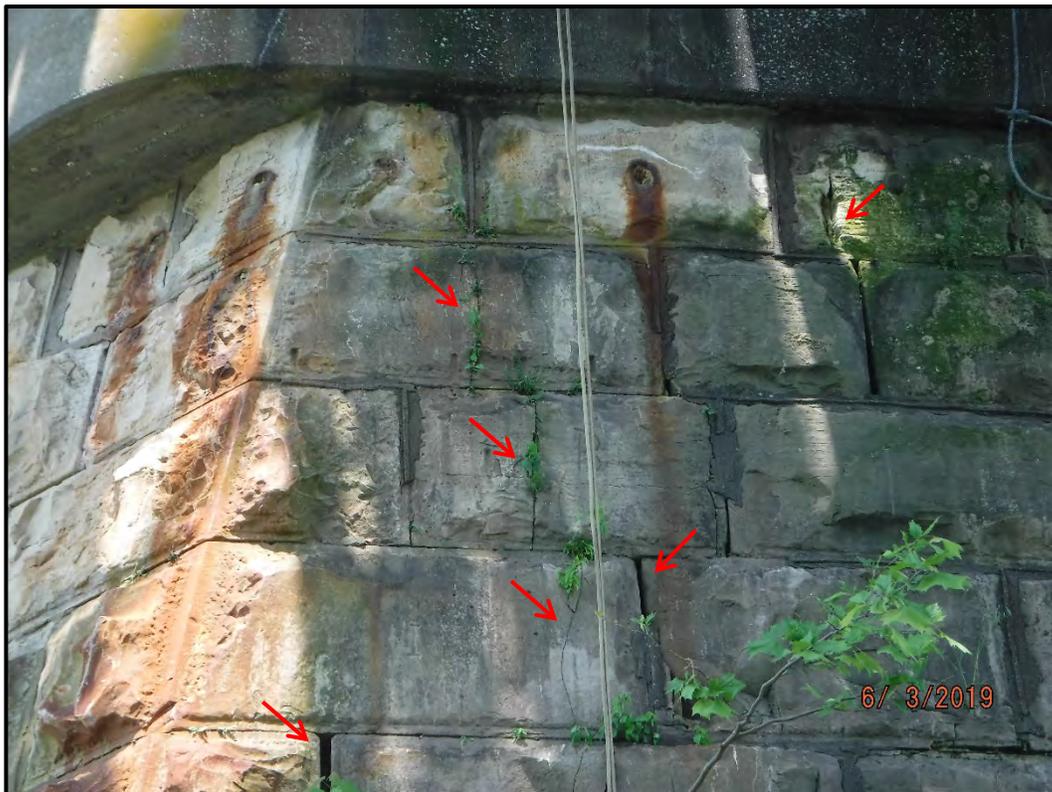
Photo P5-5: Vertical cracking on the east face of Pier 5 that extends from the pier cap, at the south edge of the truss beam seat, to the waterline with the crack width increasing to 7/8in wide at the waterline.

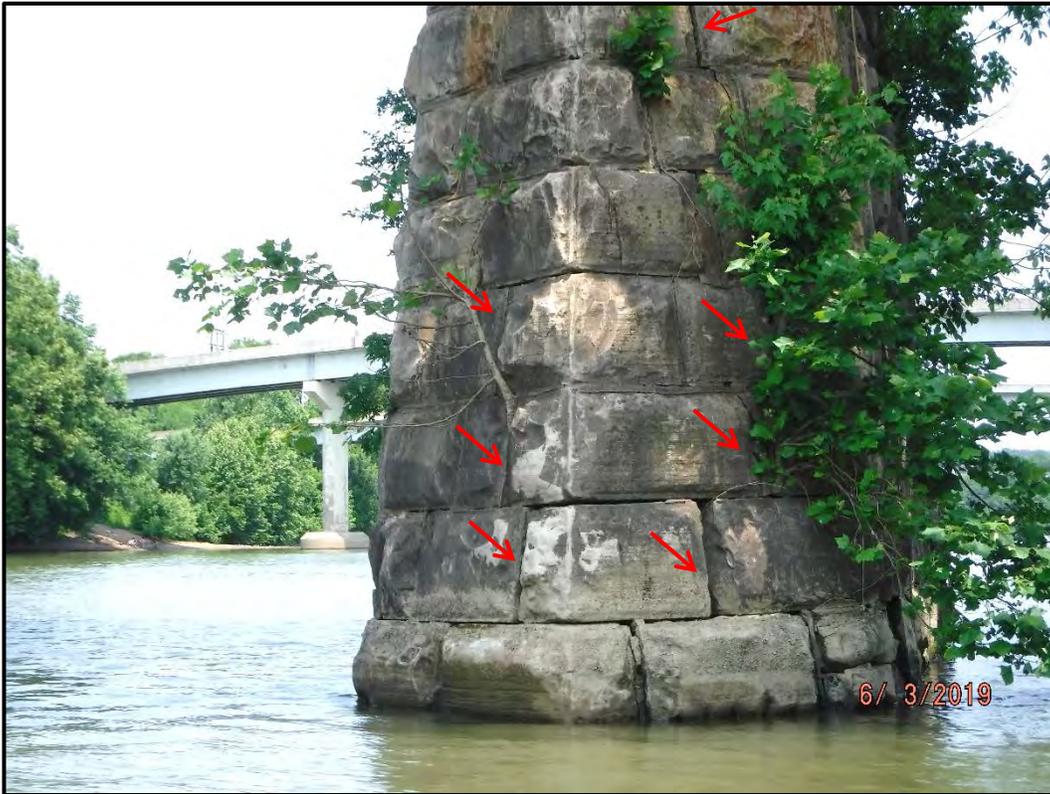
Photo P5-10: Vertical cracking on the south face of Pier 5 that extends from the pier cap to the water line and the vegetation growing in the cracks.

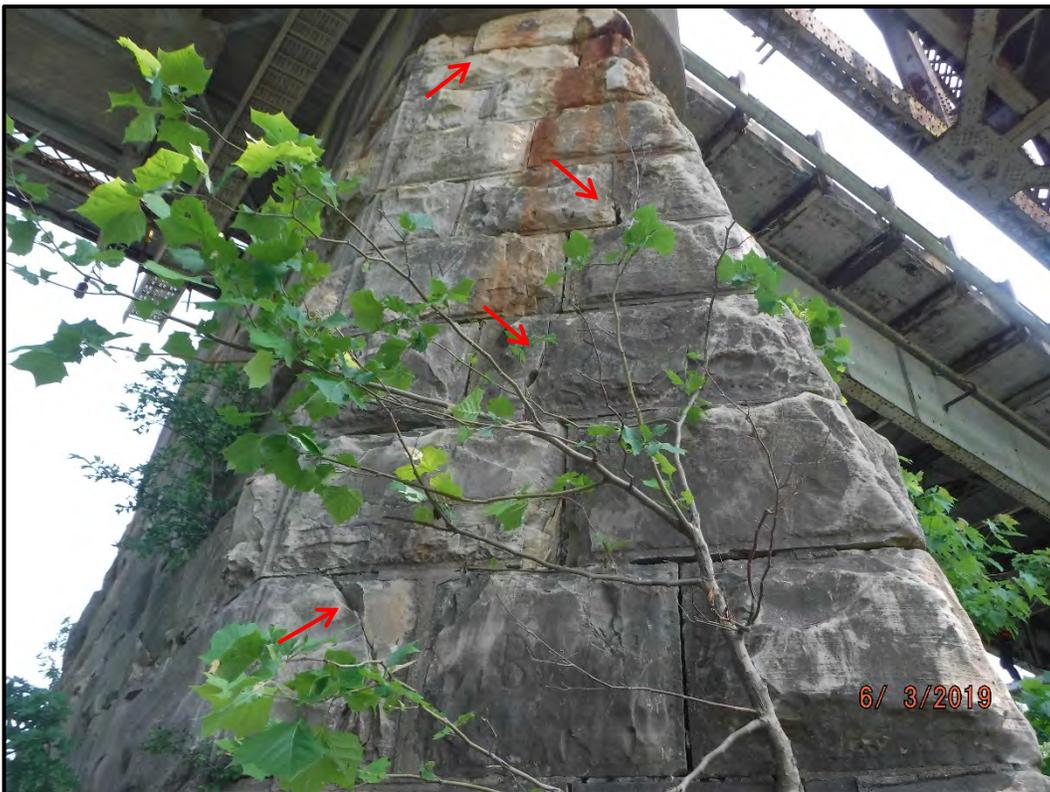
Photo P5-11: Vertical cracking on the south west face of Pier 5 that extends from the pier cap to the water line and the vegetation growing in the cracks.

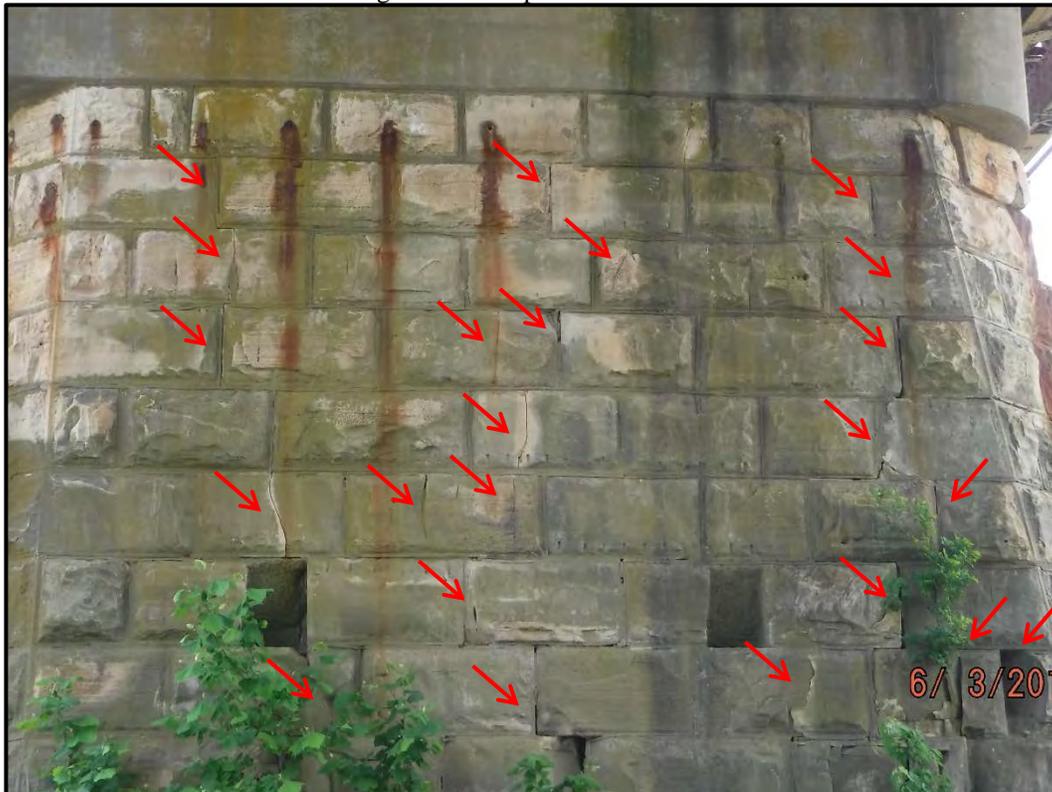
Photo P5-13: West face of Pier 5 has rust staining from the top row of stones and 3 full height vertical cracks, one in the middle and then one on each end.

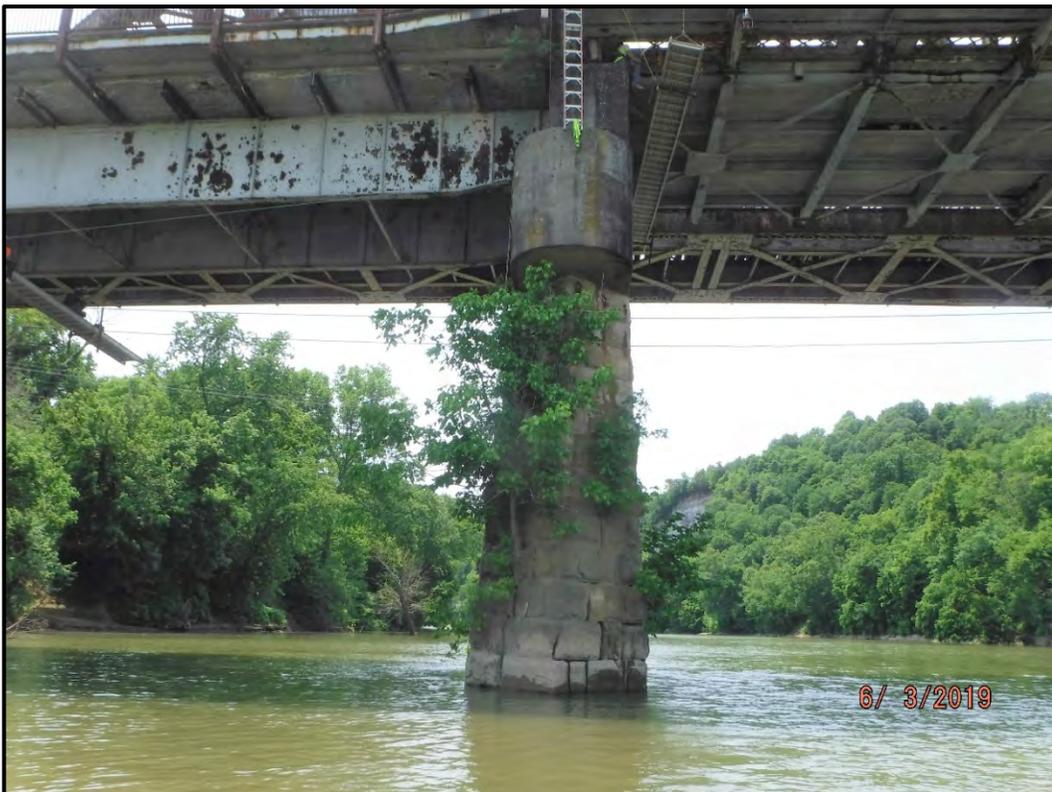
Photo P5-15: North face of Pier 5. Note the 3in diameter tree growing from the pier and the large cracks near the water line.

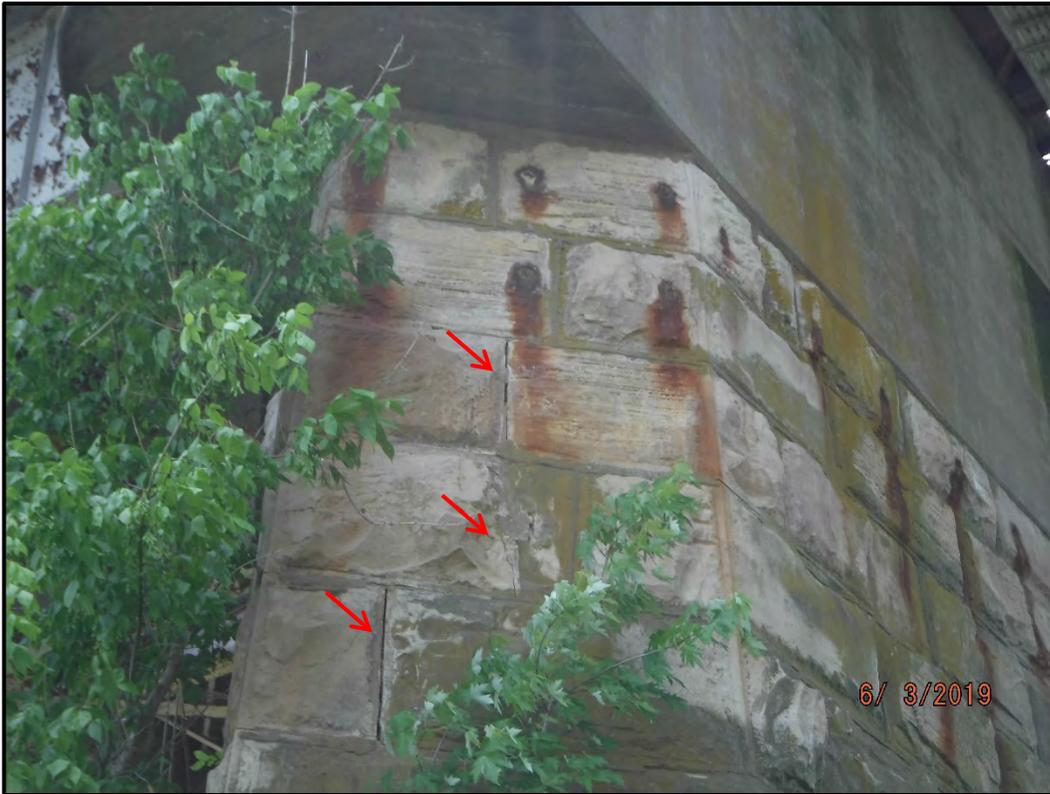
Photo P5-16: Vertical cracking on the northwest face of Pier 5 that extends the full height of the pier.

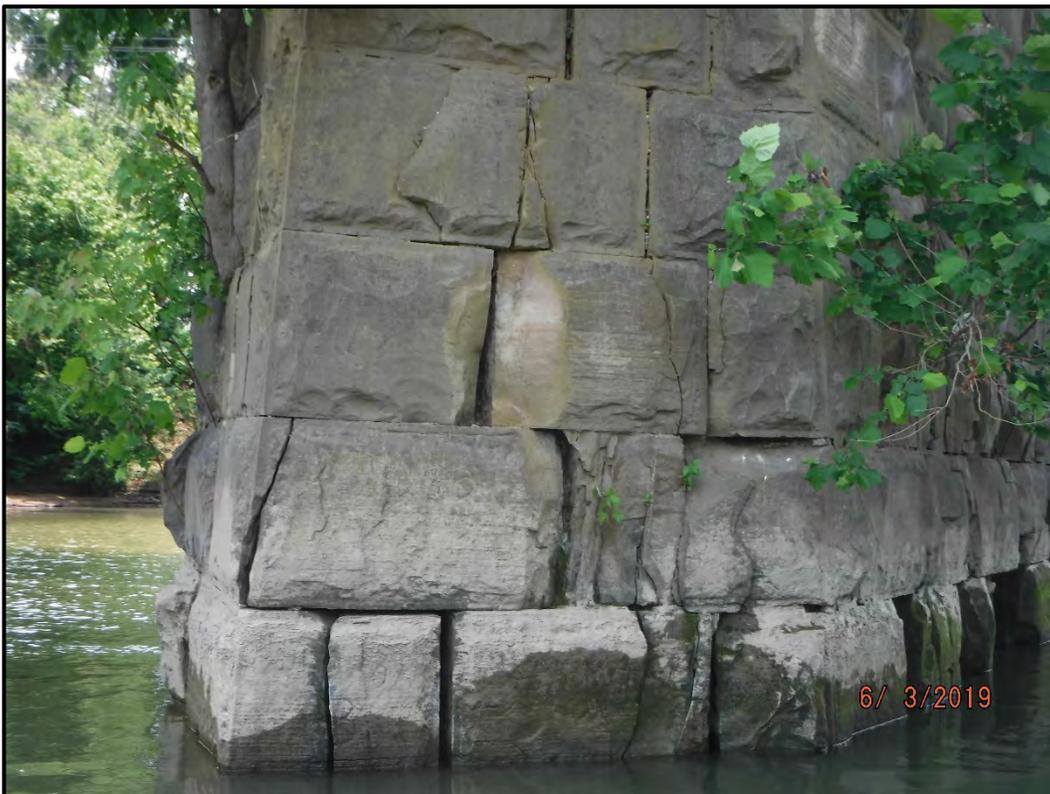
Photo P5-17: Heavy vertical cracking and mortar deterioration on the northwest face of Pier 5 at the water line that extends the full height of the pier.

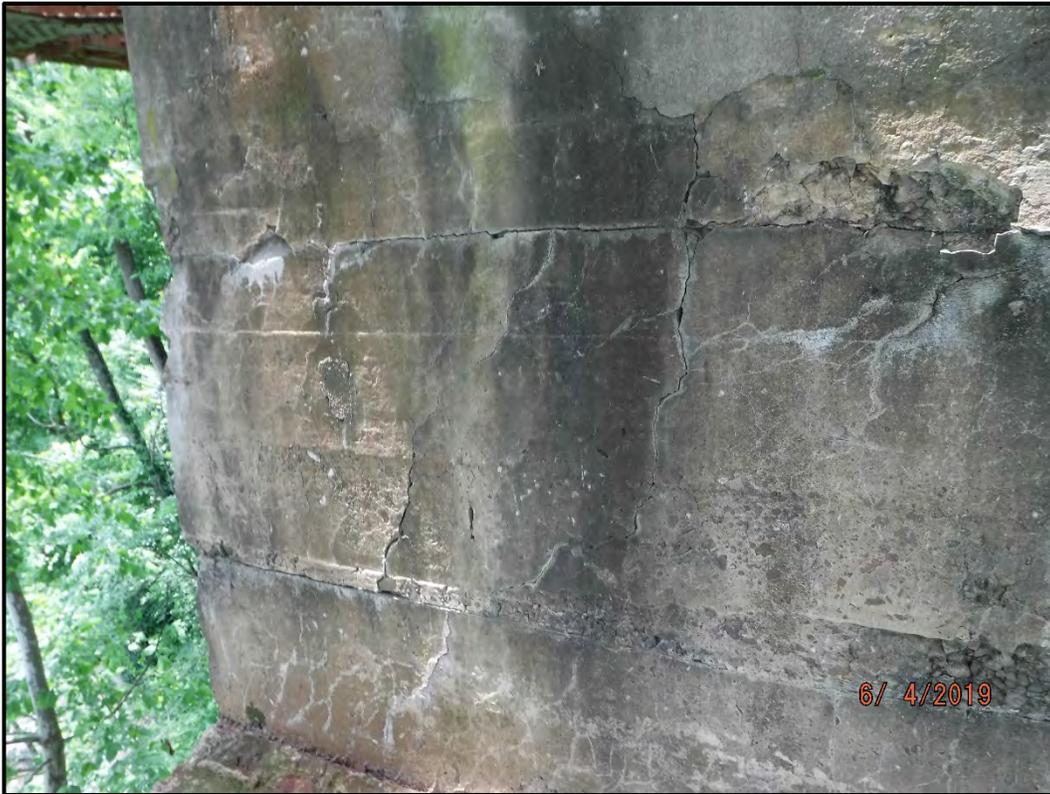
Photo P6-10: 6ft by 6ft area on the south end of the Pier 6 concrete cap east face has heavy map cracking with efflorescence and is delaminated.

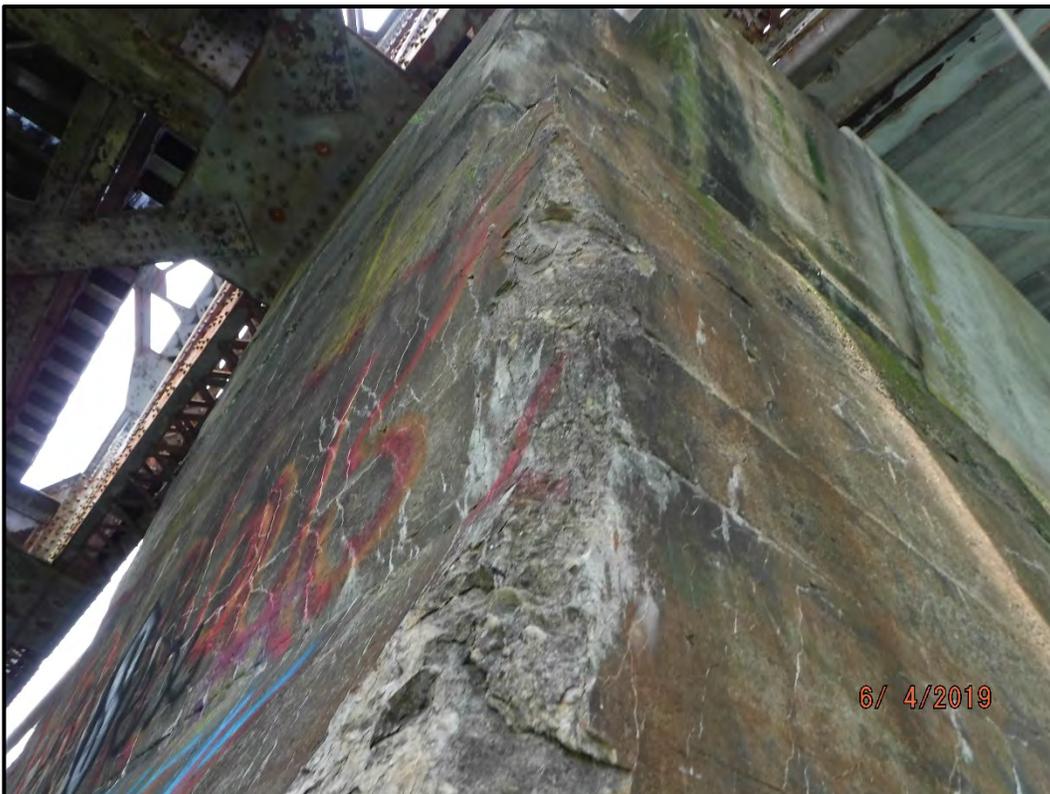
Photo P6-11: Spalling and deterioration on the south east corner of the Pier 6 concrete cap. Note the map cracking with efflorescence throughout. The north east corner of the concrete cap is similar.

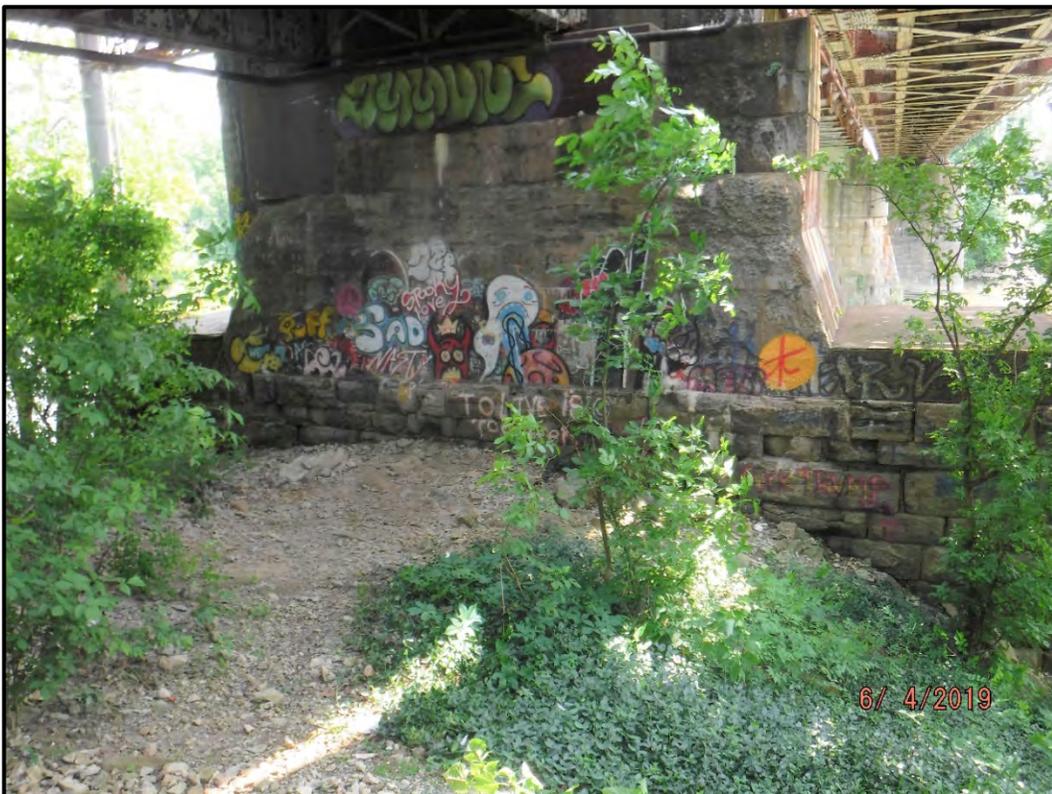
Photo P6-14: West face of Pier 6. Moderate cracking on the south end with delamination of the stone face around the cracks. Note the heavy deterioration of the pier cap concrete and heavy efflorescence, where the outer cement layer is flaking off.

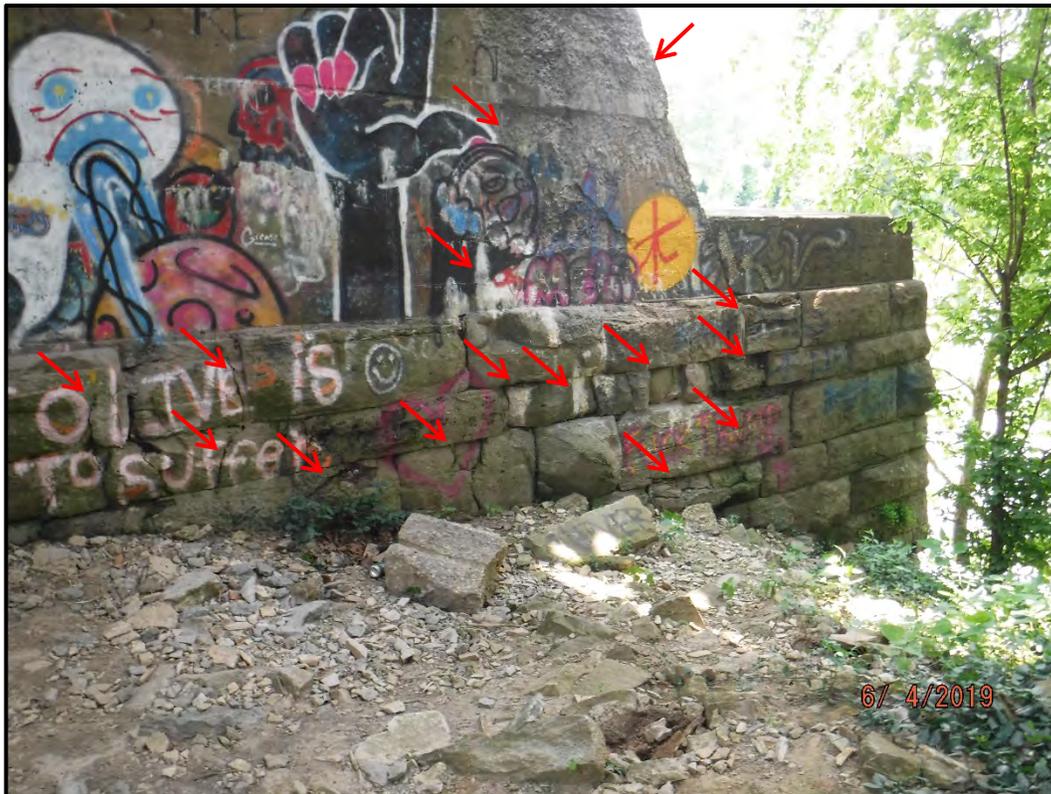
Photo P6-15: Heavy cracking of the stones at the centerline of Pier 6 on the west face. Note the moderate cracking throughout the remaining stones and the graffiti on the concrete face.

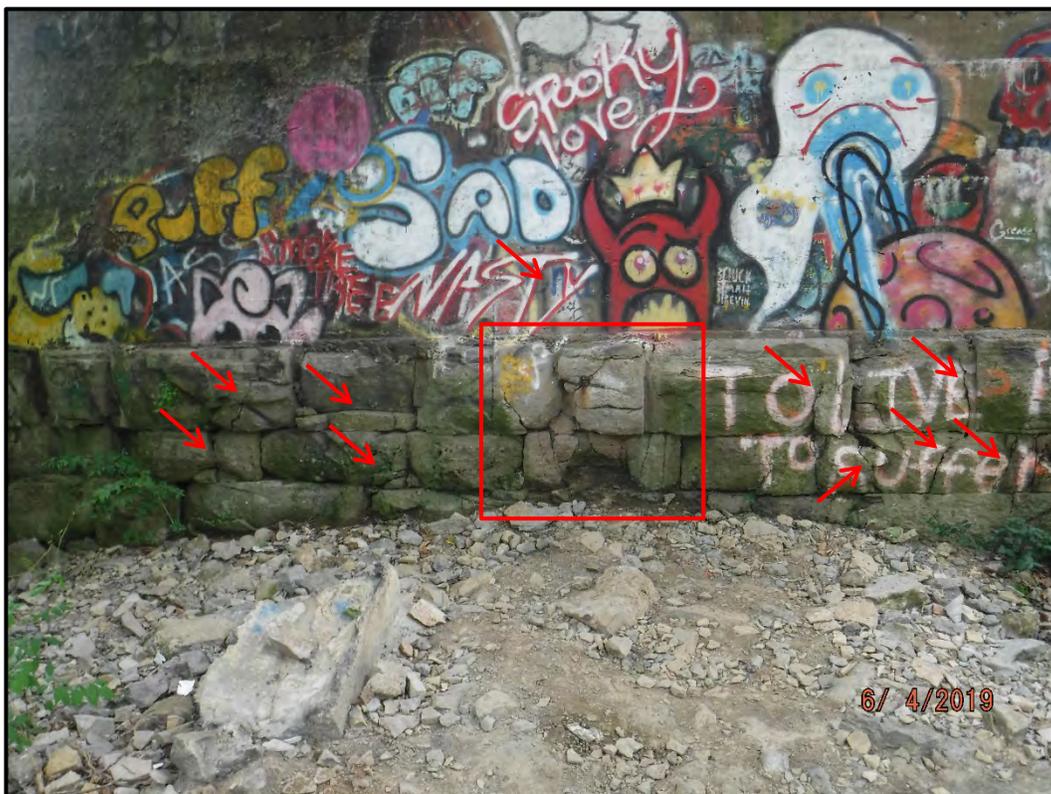
Photo P6-16: Cracking on the north end of the Pier 6 west face. Note the heavy efflorescence on the stone and the deterioration of the concrete cap.

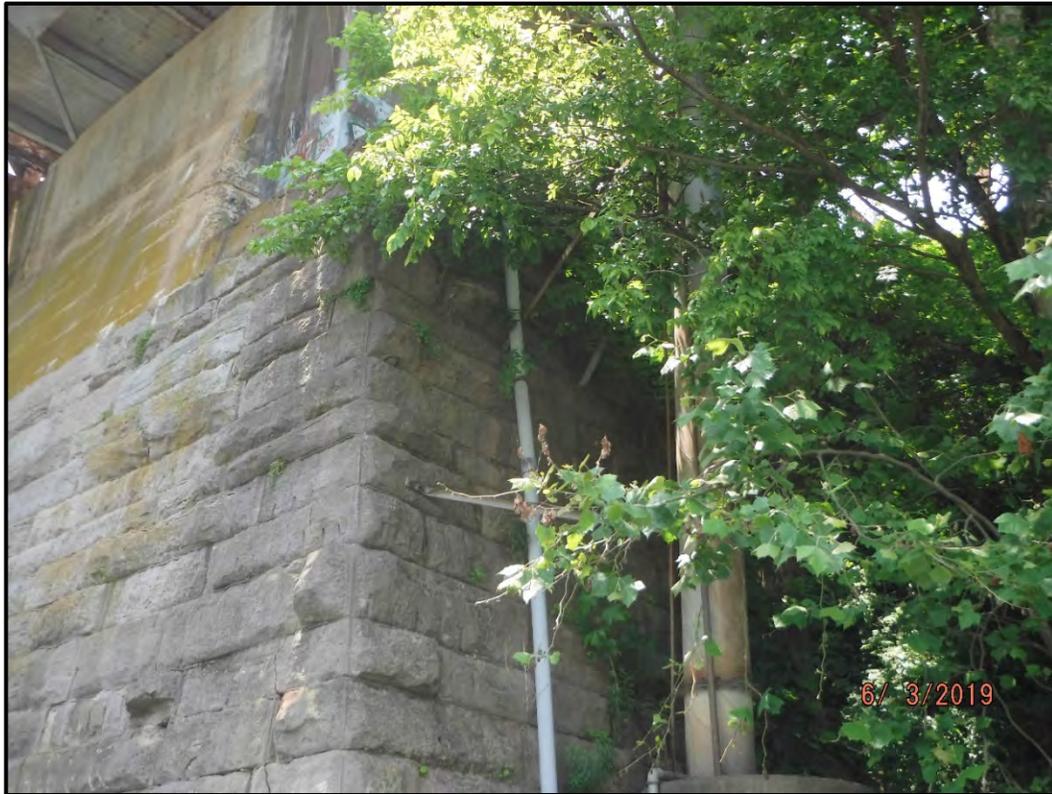
Photo Abt. 7-1: East face of Abutment 7. Note the cracking, mortar deterioration, and voids in the stone.

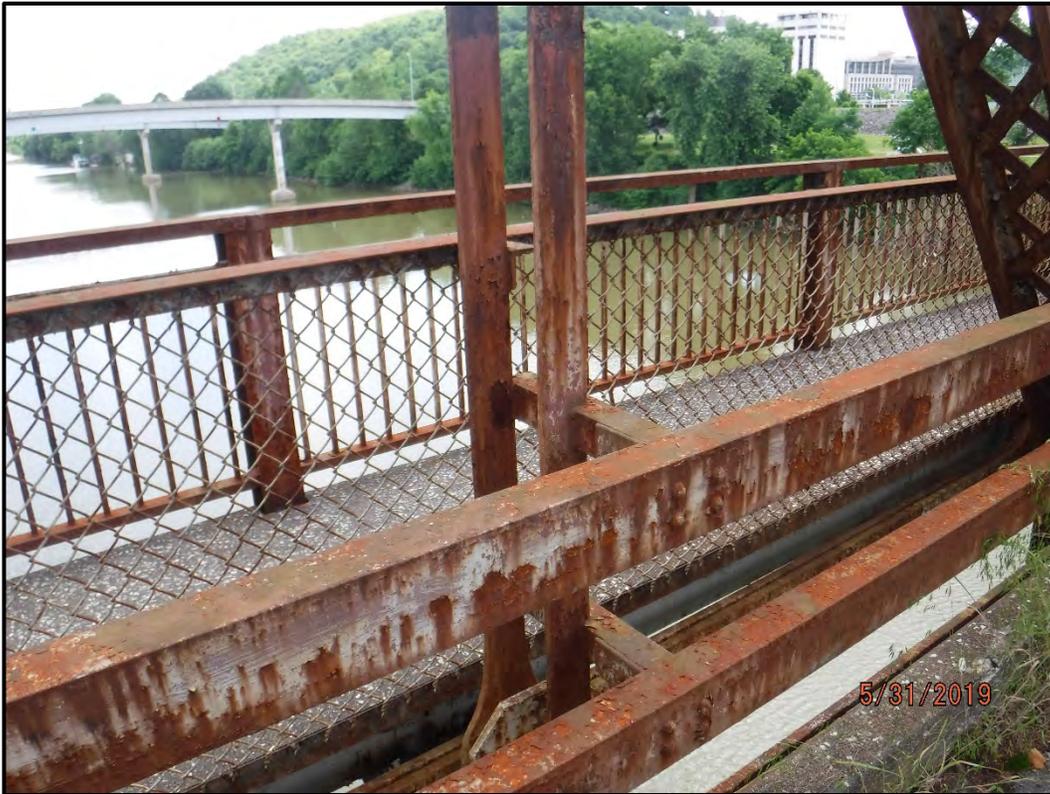
- The bridge railing is in fair condition (NBI Rating is 4 out of 9) and the protective coating has no remaining effectiveness.
- There is active corrosion the entire length of both bridge railings. (See Photo 330-1 and 330-2)
- The pedestrian metal railing is in fair condition with widespread active corrosion. (See Photo 330-3)

Photo 330-1: Typical condition of the downstream metal bridge rail. Active surface corrosion with minor pitting corrosion is typical along both bridge rails for the entire length of the bridge.

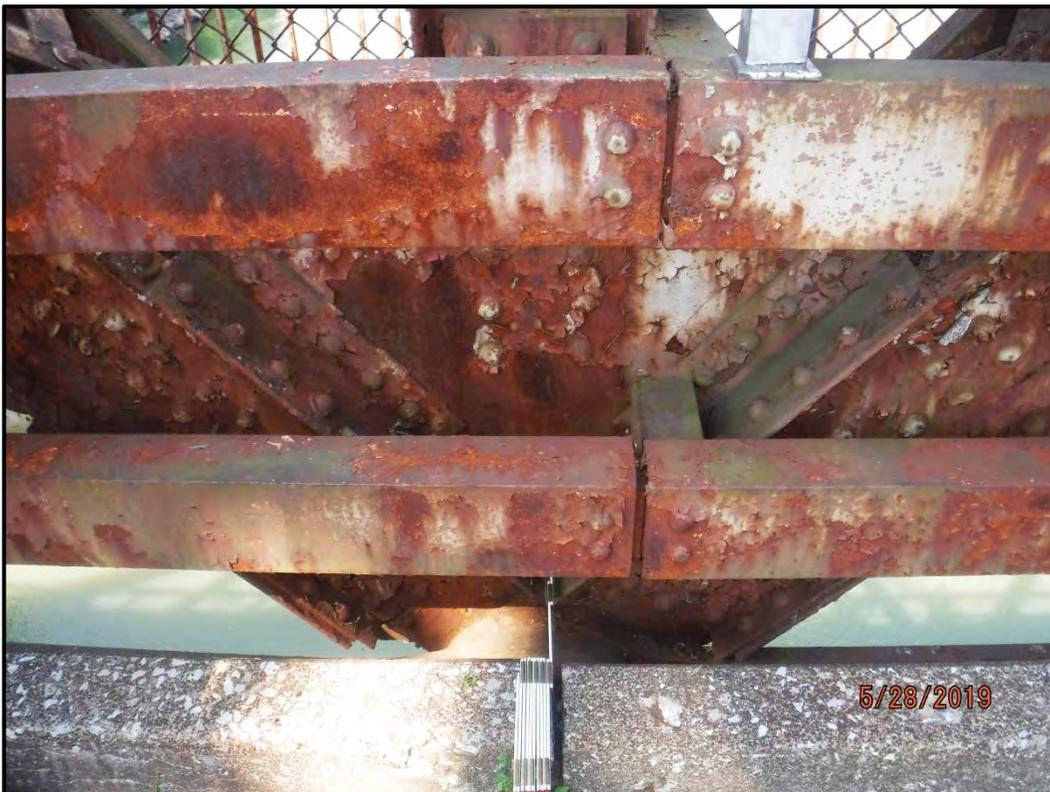
Photo 330-2: Up close view of corrosion on bridge railing. The downstream rail at L8 is shown.

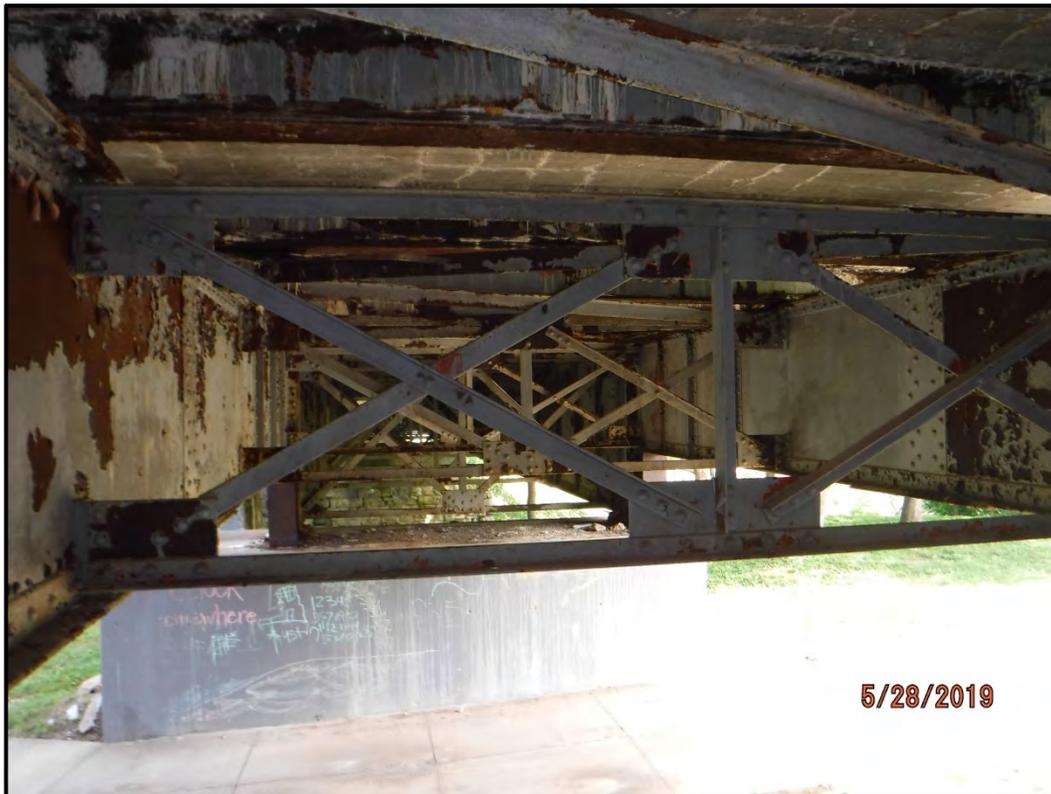
- The lateral bracing in the approach spans has active corrosion. The gusset plates have section loss and there is pack rust between the gusset plates and the lateral bracing members. (See Photos 850-1 through 850-3)
- The lateral bracing below the deck of the truss span has similar corrosion. The lateral bracing gusset plates have section loss up to 100%. (See Photo 850-4 through 850-6)
- There is deformation of the lateral bracing between Floorbeams 7 and 8. (See Photo 850-7)
- The lateral bracing on the top chord of the truss has active corrosion. (See Photo 850-8)

Photo 850-2: Typical lateral bracing in Span 1.
