August 31, 2019

**Re: Broadway Bridge (KY 3506) over Kentucky River
 Bridge No. 037B00066N
 Frankfort, Kentucky
 In-Depth Bridge Inspection Report**

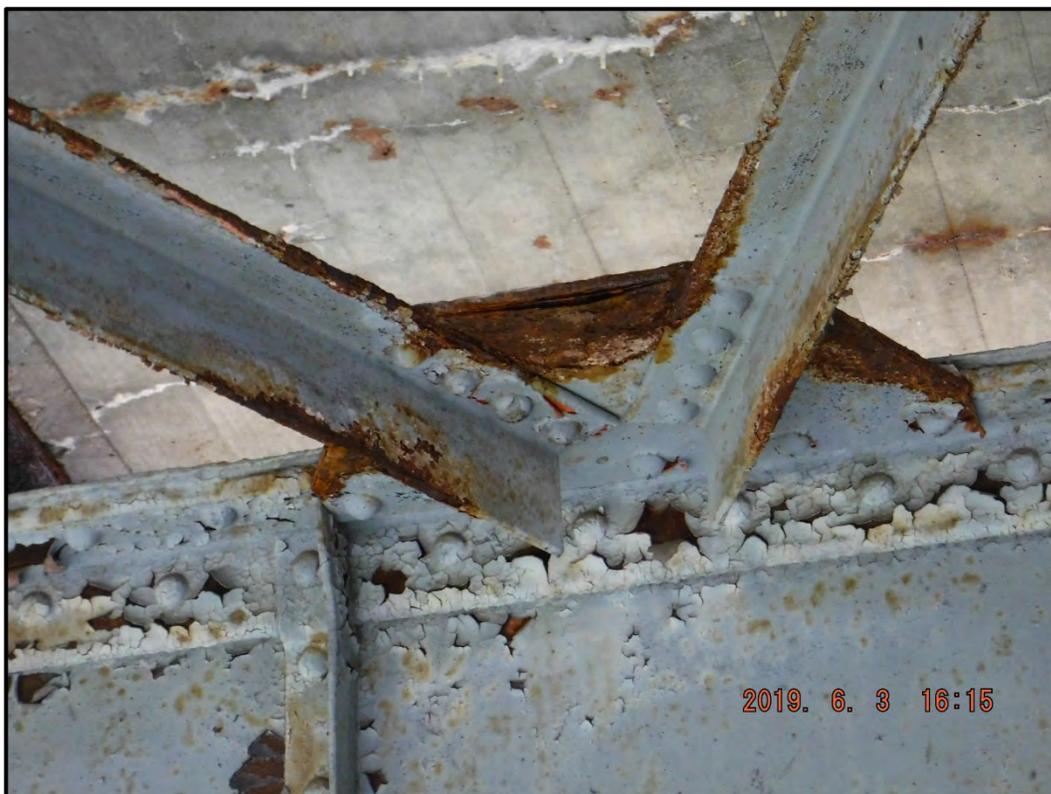
- The lateral bracing in the approach spans has active corrosion. The gusset plates have section loss and there is pack rust between the gusset plates and the lateral bracing members. (See Photos 850-1 through 850-3)
- The lateral bracing below the deck of the truss span has similar corrosion. The lateral bracing gusset plates have section loss up to 100%. (See Photo 850-4 through 850-6)
- There is deformation of the lateral bracing between Floorbeams 7 and 8. (See Photo 850-7)
- The lateral bracing on the top chord of the truss has active corrosion. (See Photo 850-8)

Photo 850-3: Typical top flange lateral bracing connection. There is active corrosion with section loss of the plates with pack rust between the lateral bracing members and the plates.

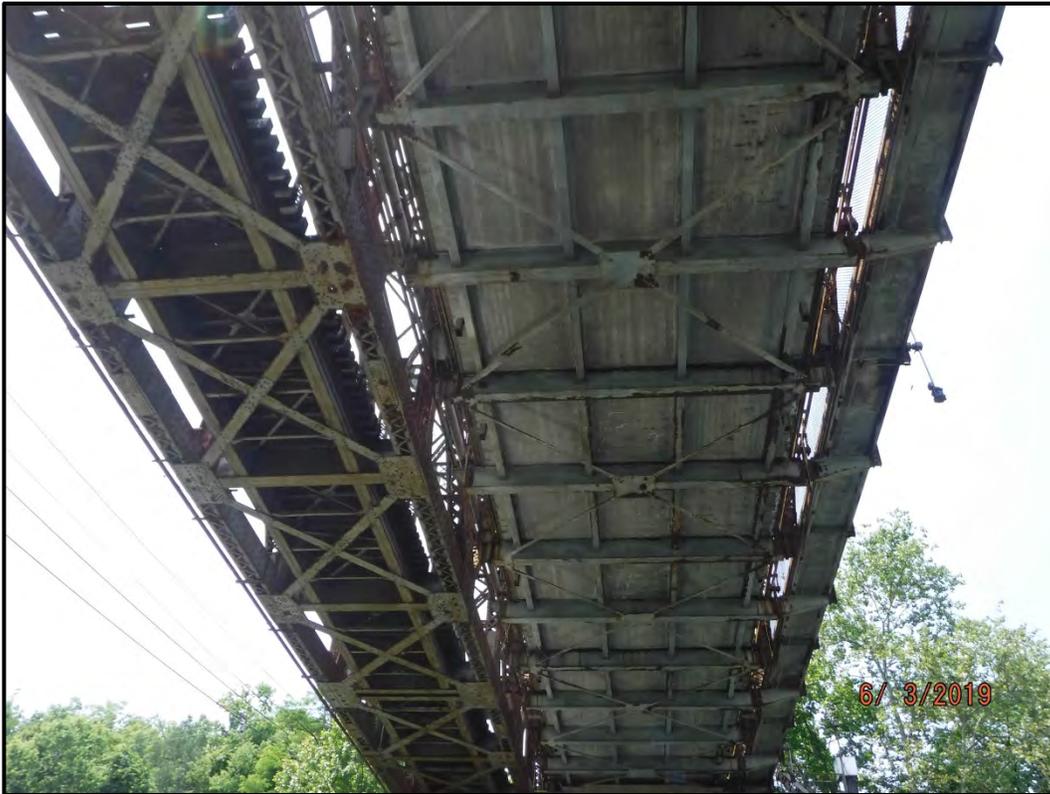
Photo 850-4: Typical underside of Span 5 looking east showing lower lateral bracing in the truss spans.

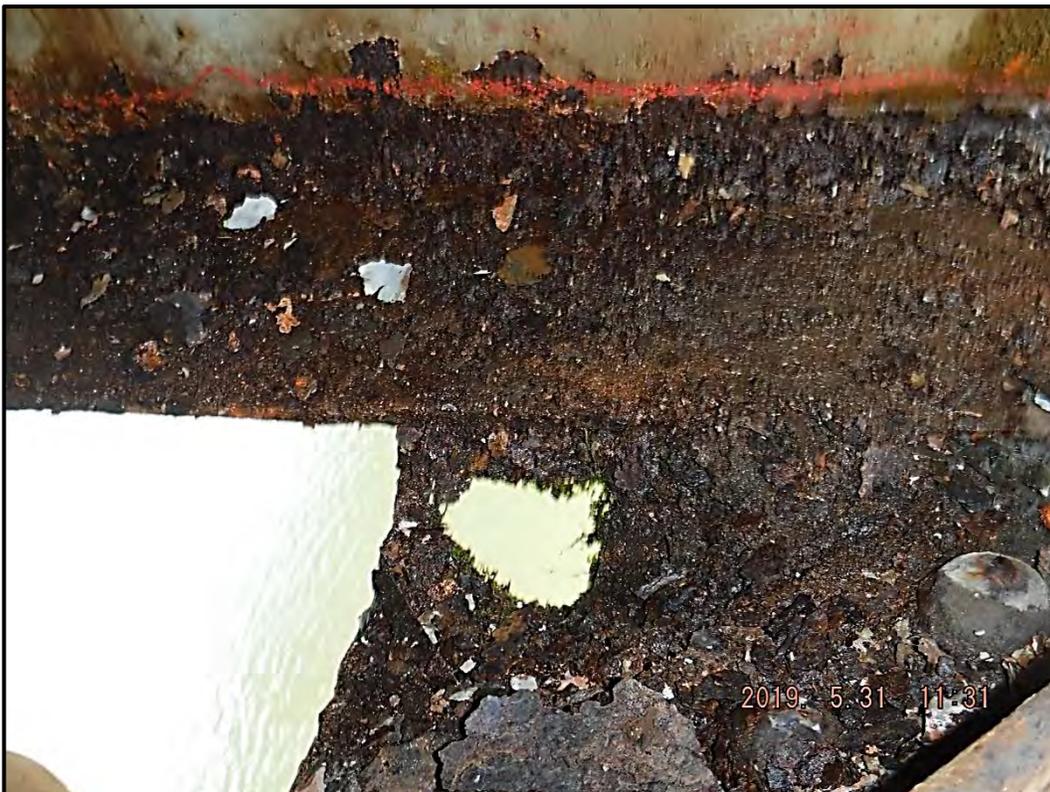
Photo 850-5: Active corrosion with corrosion hole in the lateral bracing gusset plate at the downstream end of Floorbeam 8.

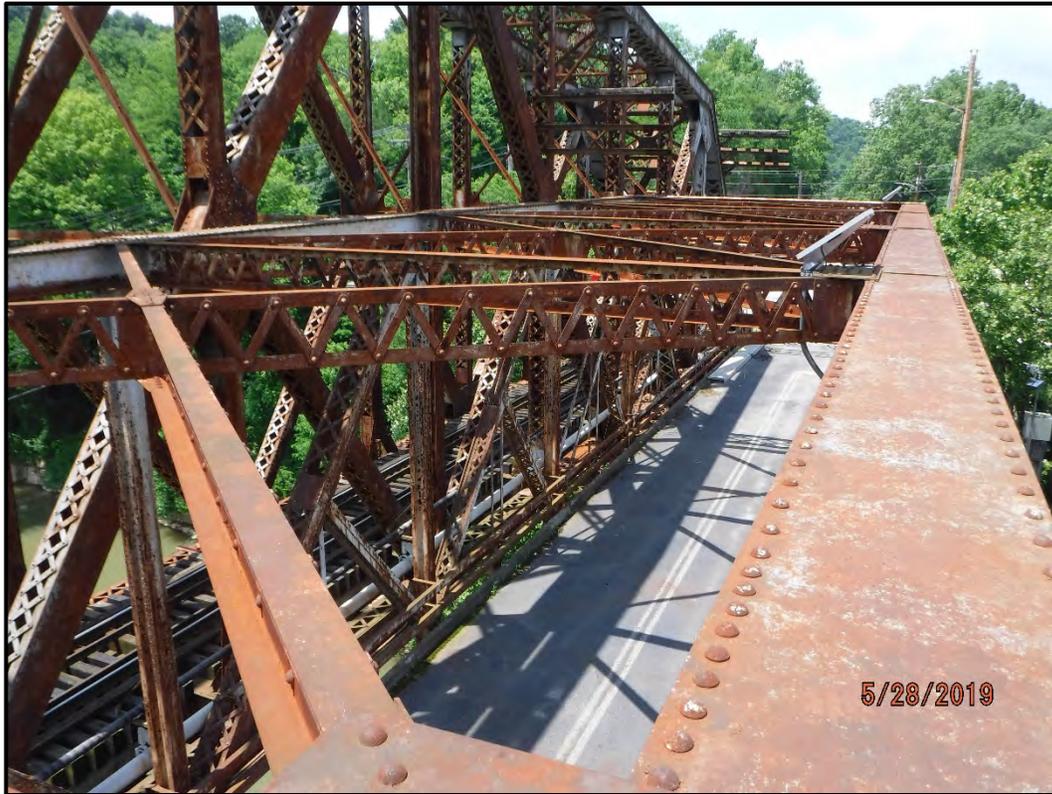
Photo 850-8: Typical active corrosion on the lateral bracing on the top chord of the truss.

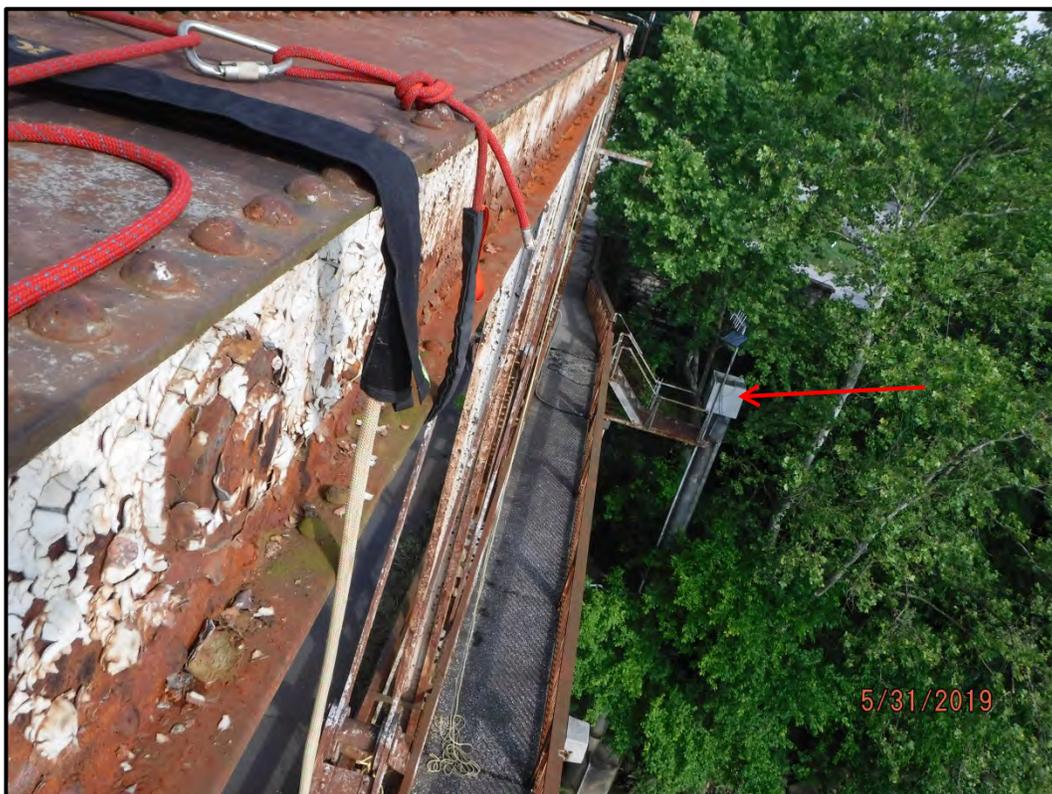
Photo 853-1: The USGS station adjacent to Pier 6 has access coming from the Broadway Bridge sidewalk.

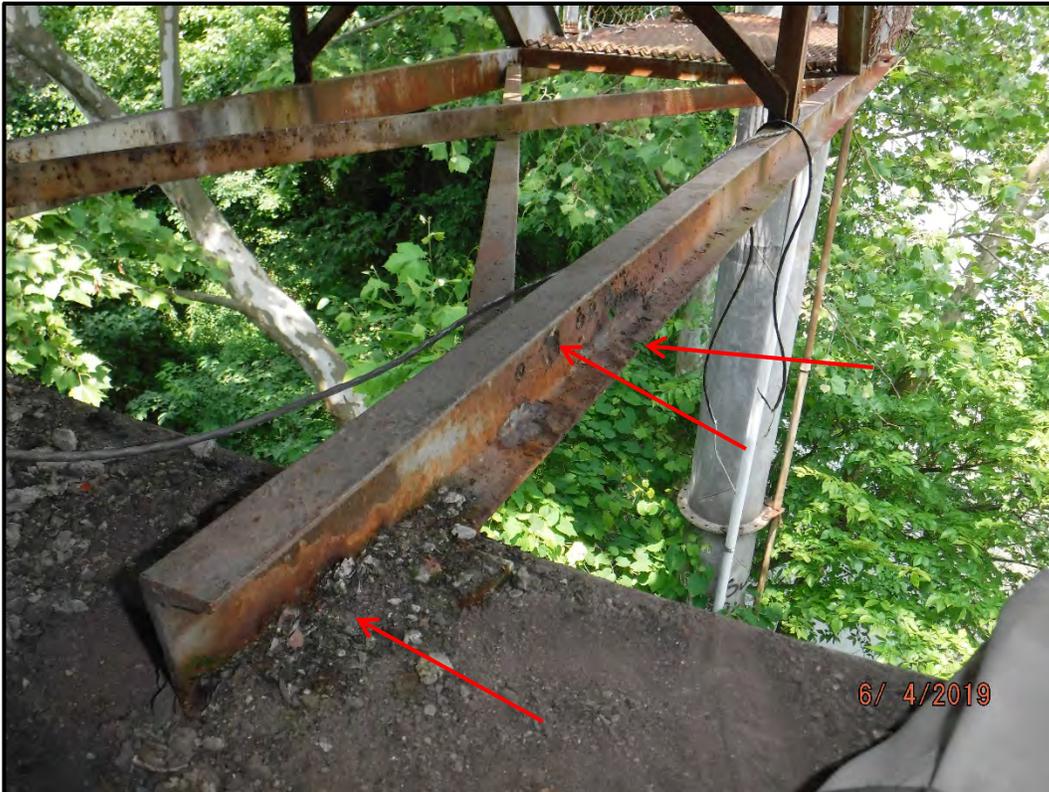
- There is a USGS Water Resource Station attached to the north end of Pier 6. Access to this station attaches to the Broadway Bridge sidewalk. The channels that support the access platform have pack rust and laminating corrosion at their bearings on Piers 6, and there are corrosion holes in the webs and bottom flanges throughout. (See Photos 853-1 and 853-2)
- There are navigation light electric service panels on the downstream truss at panel points L0, L8, and L16 (See Photo 853-3). These navigation lights were checked at dusk for functionality. The red light marking Pier 5 and the green light marking the center of the navigation span were illuminated. The red light marking Pier 6 was not illuminated. (See Photo 853-4)

Photo 853-2: Channels supporting the USGS station have pack rust and laminating corrosion at their bearings on Pier 6, and there are corrosion holes in the webs and bottom flanges.

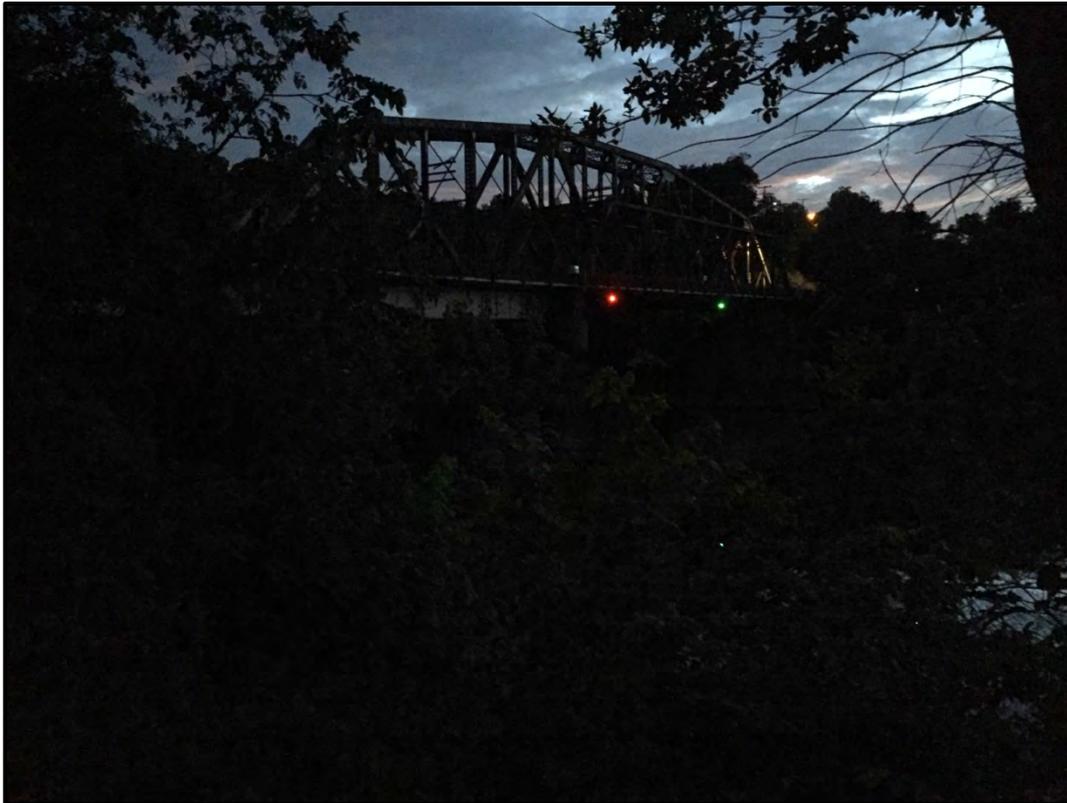
Photo 853-4: The red light marking Pier 5 and the green light marking the center of the navigation span are illuminated at dusk. The red light marking Pier 6 is not illuminated.

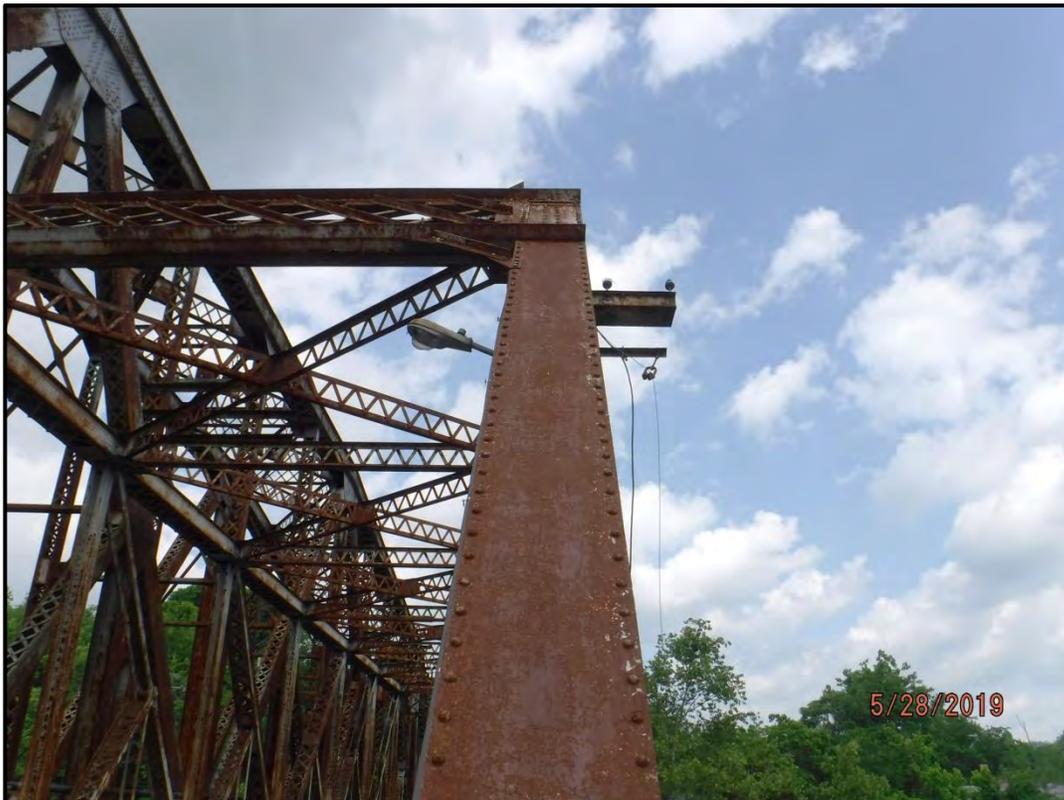
- The street lights on the bridge do not have utility cables running to them and are not functioning. (See Photo 853-5)
- There are solar panels for the navigation lights located at downstream panel points U2, U8, and U15. (See Photo 853-6)
- There is a 5” diameter pipe and an 8.5” diameter pipe, both suspected gas lines, attached to the bridge. (See Photos 853-7 and 853-8)

Photo 853-5: Utility line hanger and street light at downstream panel point U2 not functional.

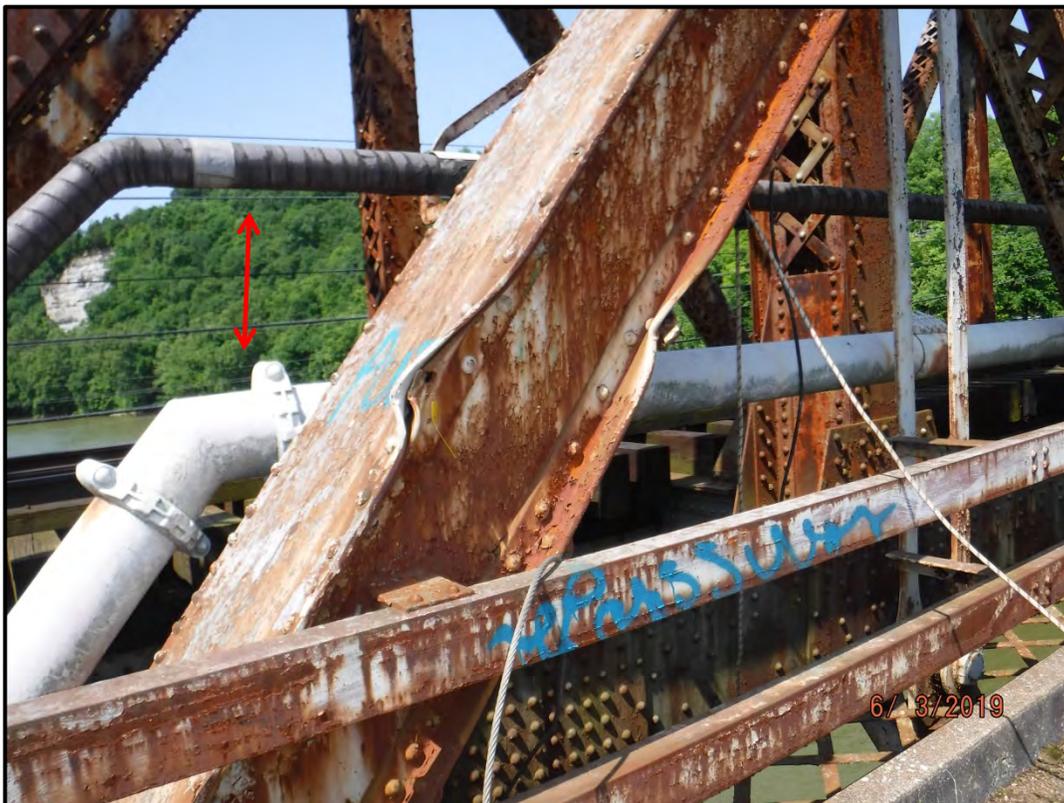
Photo 853-7: Suspected gas lines hanging from the upstream side of the truss. Pipe diameters are 5" and 8.5".

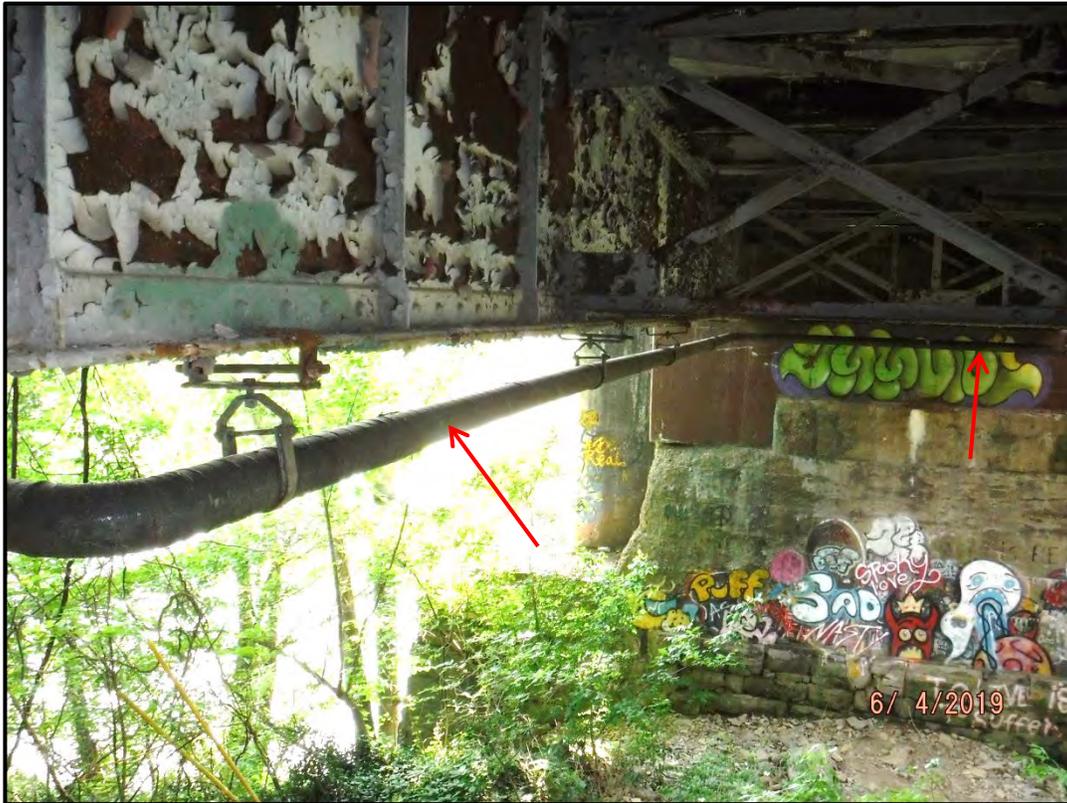
Photo 853-8: Suspected 5" diameter gas line hanging from Girder 2 in Span 6, across the west face of Pier 6, and then along the upstream side of the truss

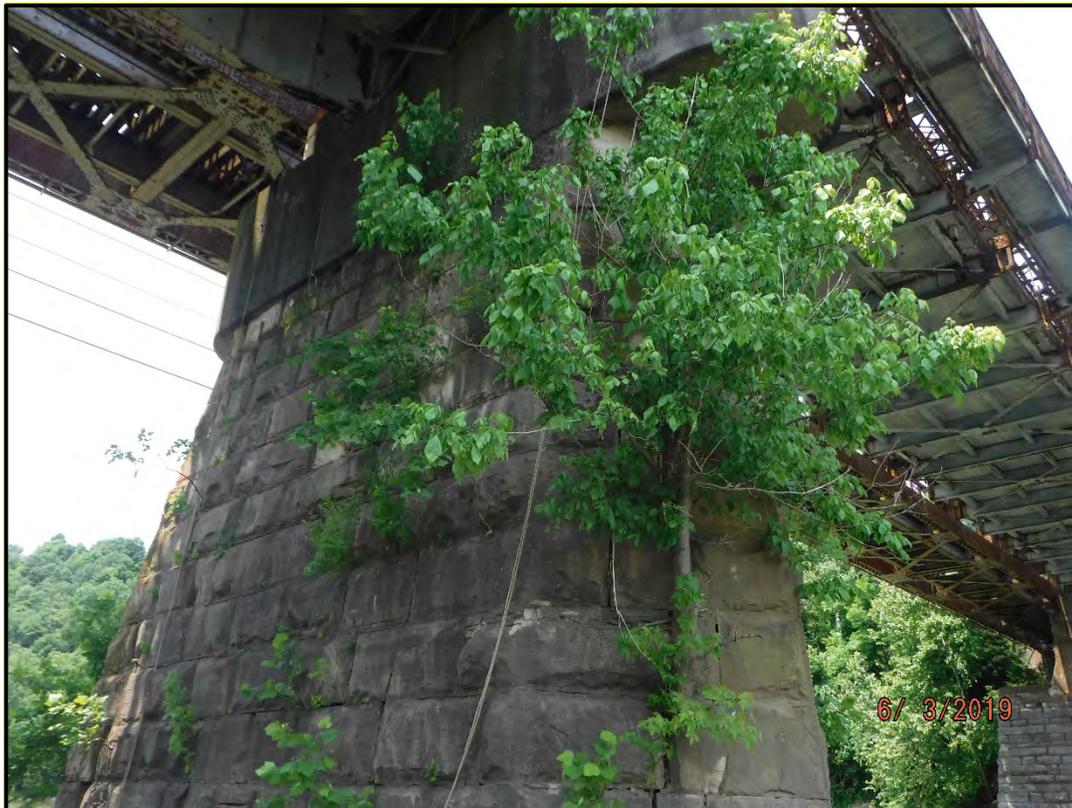
- There is vegetation, including a 3” diameter tree, growing in the masonry joints of the substructure units. There is also vegetation growing the full length of the bridge in both gutter lines, and a tree growing across the deck near Pier 3. (See Photos 859-1 and 859-2)

Photo 859-1: 3" diameter tree and other vegetation growing in the mortar joints on Pier 5. This is the worst case of the substructures.

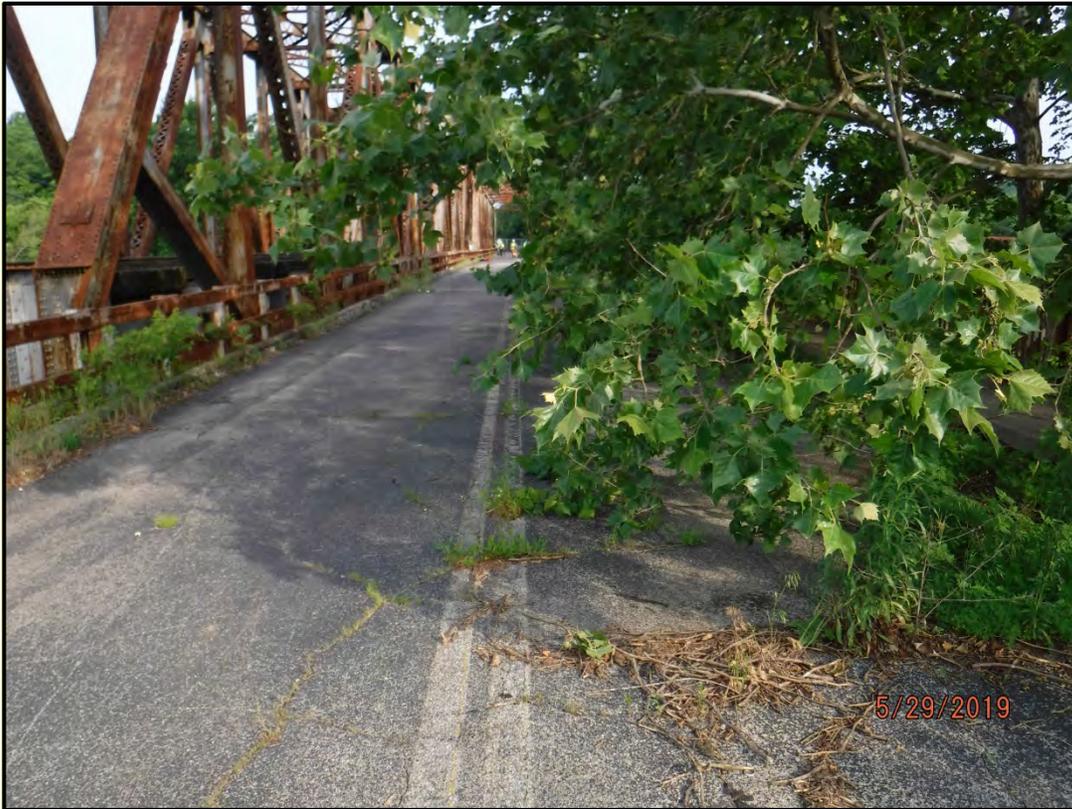
Photo 859-2: Vegetation is growing the full length of the bridge in both gutter lines. There is also a large tree overgrowing across the deck near Pier 3.

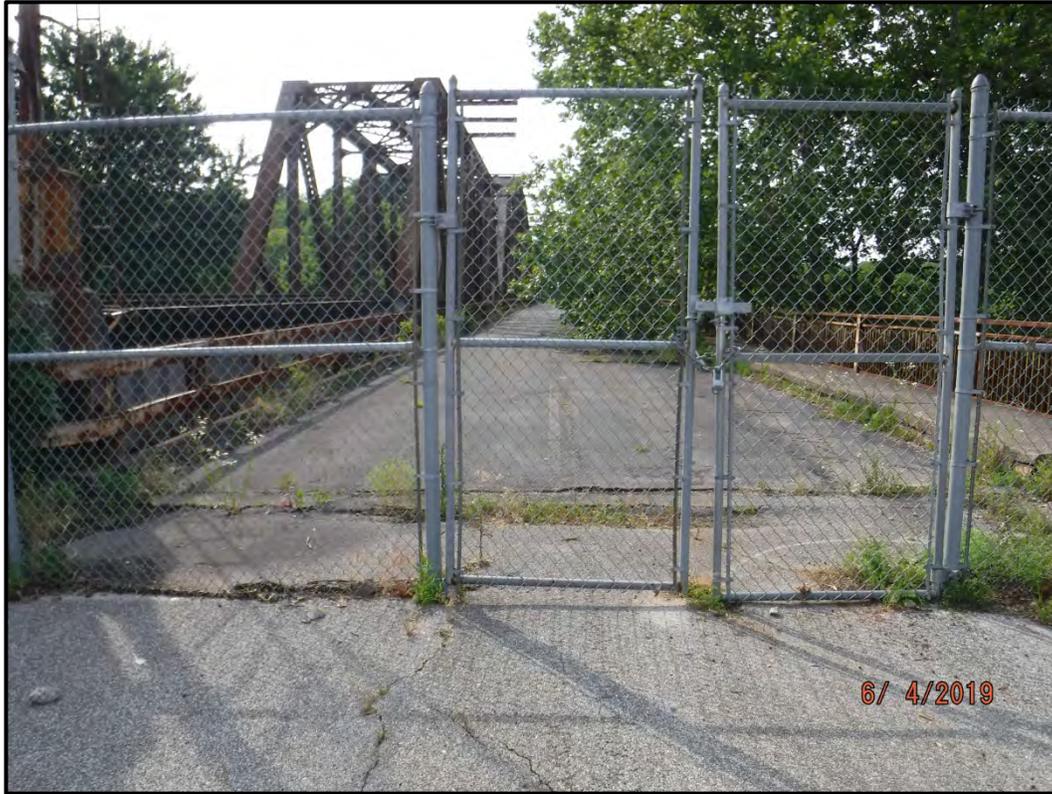
Photo OBC-2: The gate at the east end of the bridge is locked. There is not a “No Trespassing” sign at the east end of the bridge.
