Bridge Inspection Report

056B00250N

01/11/2023

IDENTIFICATION		
Structure Num (8):	056B00250N	
NBI Number:	056B00250N	
Structure Name:	—	
Location (9):	0.4 MI W OF RALPH AVE	
Carries (7):	I-264	
Type of Service (42A):	1 Highway	
Feature Crossed (6):	P&L RAILWAY	
Type of Service (42B):	2 Railroad	
Placecode (4):	Not Applicable	
County (3):	Jefferson (056)	
State (1):	21 Kentucky	
Admin Area:	Inventory	
District:	District 5	
Latitude (16):	38° 12' 49"	
Longitude (17):	85° 49' 23"	
Owner (22):	State Highway Agency	
Maint. Resp. (21):	State Highway Agency	
Year Built (27):	1970	Border State (98A): Not Applicable (P)
Year Recon (106):	2003	Border Number (99):
		% Responsibility (98B): -1

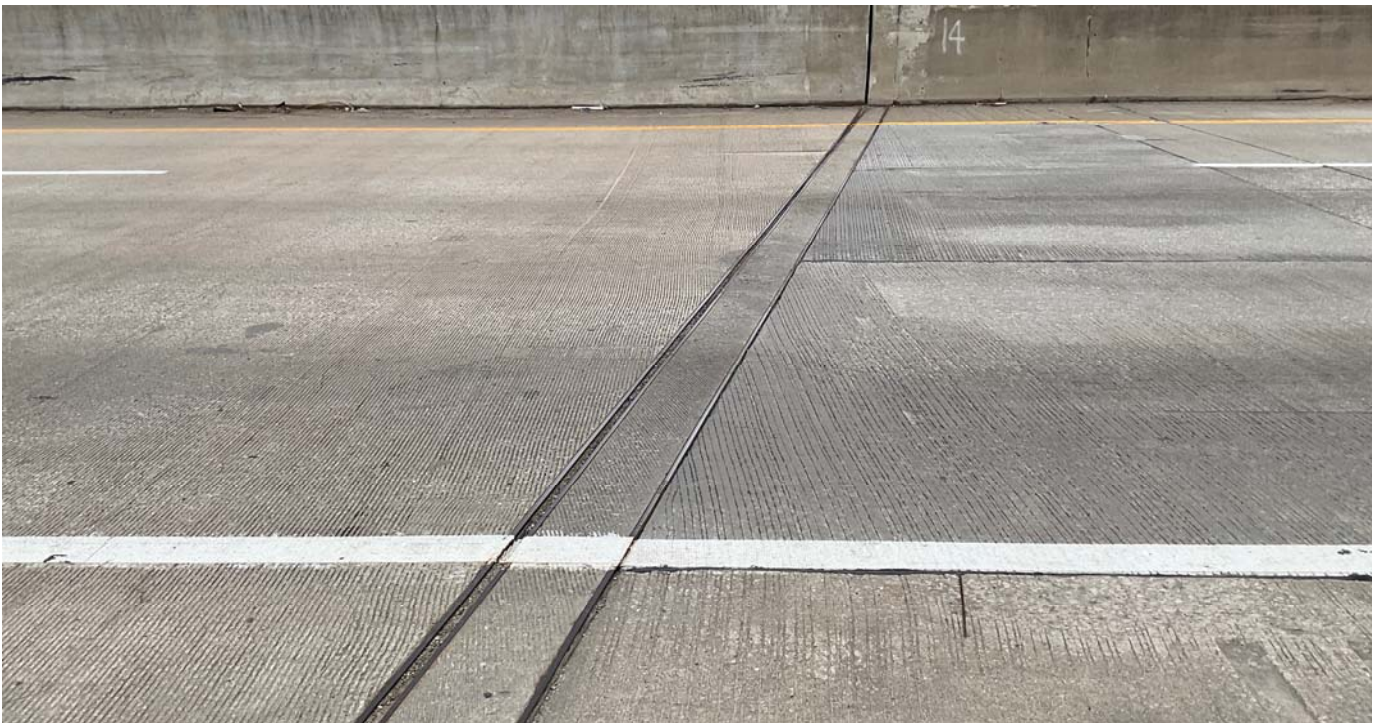
Cardinal Transition WB

Abutment 1 WBL transition repair (concrete repairs to approach roadway) left the fast lane with transition unchanged (approximately 3/4")

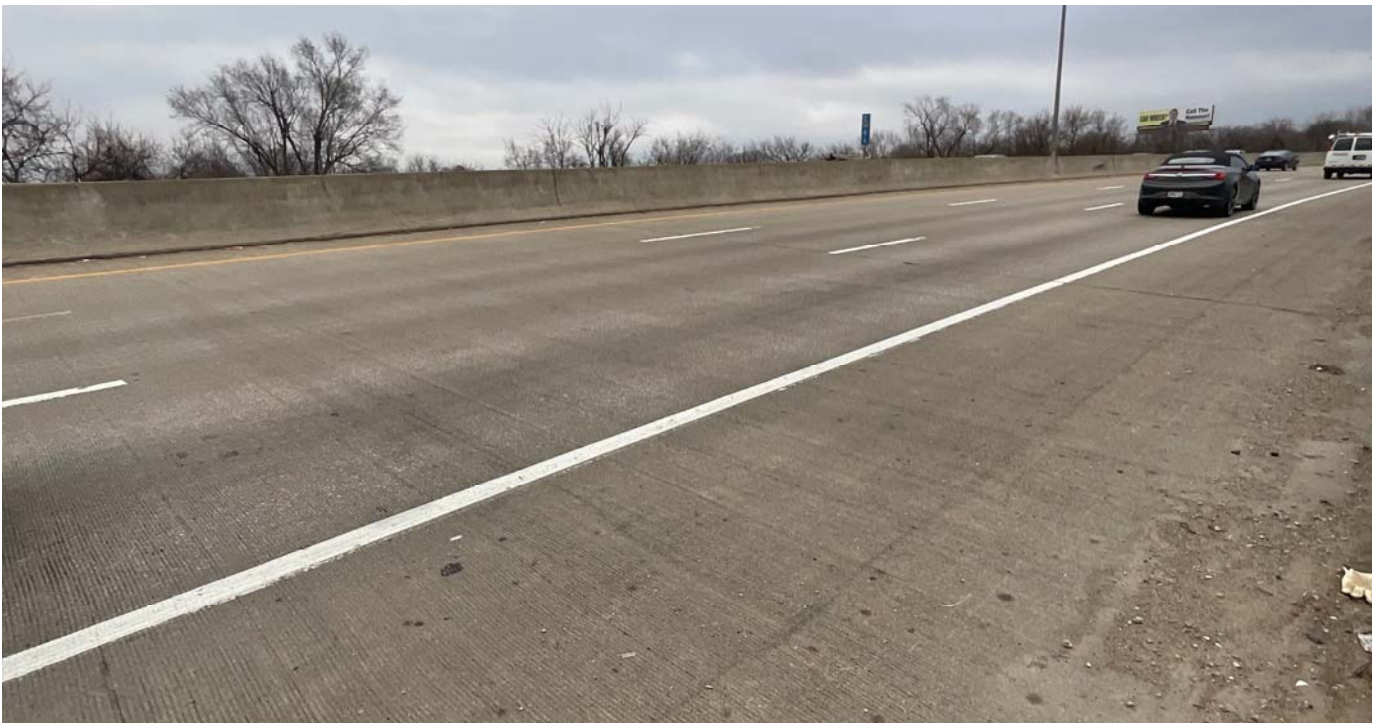
Typical Wearing Surface EB

In 2003, original deck was scarified and a new 10 inch deck with epoxy coated reinforcement was poured on top. Deck over has widespread dense map cracking, some with wide separation. Heavier amounts noted through all but Span 4 of EBL, with similar cracking found the full length of WBL and affecting full lane widths in both directions. There is a fire damaged area of approximately 27 feet X 10 feet in Span 2, near the south barrier wall, that affects mostly the emergency lane and a small portion of the travel lane. There are several spalls throughout concentrated at the bridge ends and at the intermediate joints.

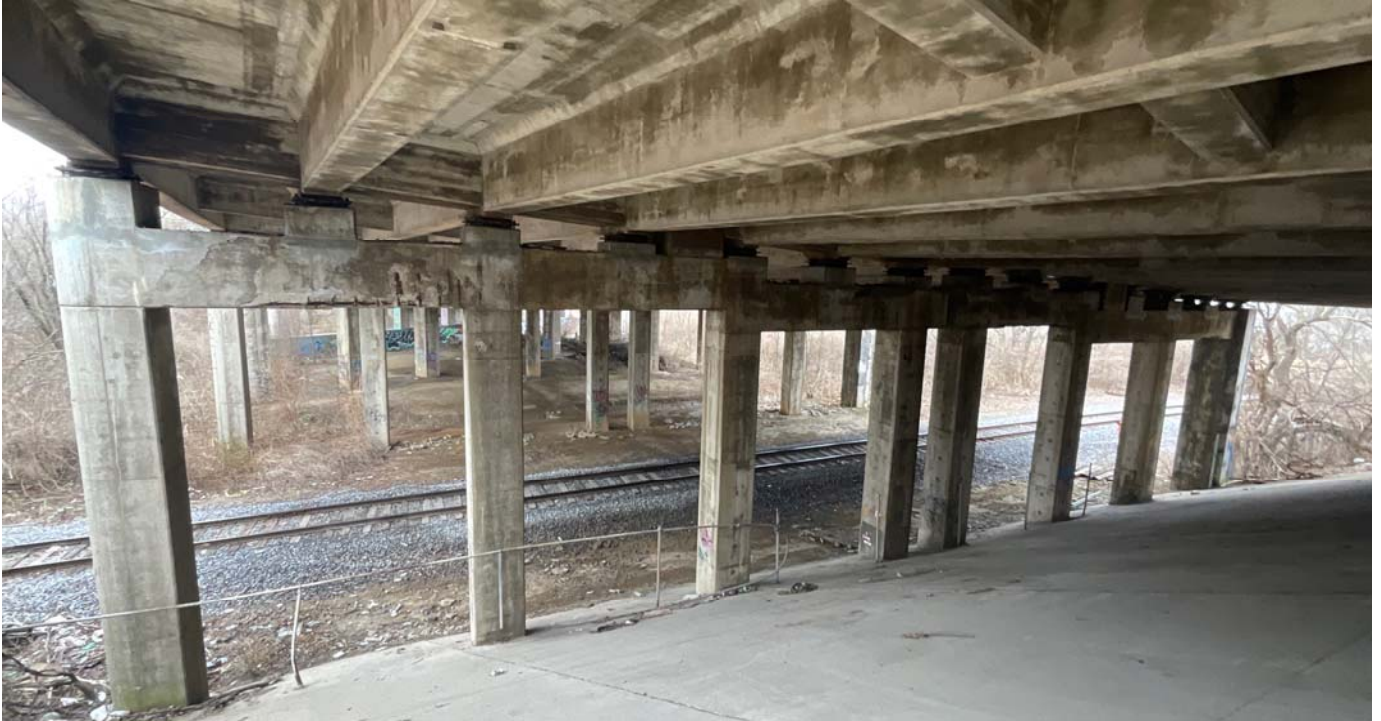
Pier 2 Span 1

Columns have wide vertical cracking (up to 5/8 inch wide), delaminated areas, unsound patches, large spalls, and/or exposed steel reinforcement. Pier 2 Columns 4,6, and 7 have 12" spalls on the Span 1 face. Pier 3 Columns 1-3 and 5-7 have spalls with exposed reinforcement. Column 1 at Pier 4 has 10 feet (vertically) of spalling on the north face. Columns 2-4 also have spalls with exposed steel. All columns at Pier 5 have spalling, with Column 2 having 2 wide vertical cracks, one of which is along a line of epoxy injection completed during 2003 rehab project. Column 5 at Pier 6 has a large spall at the top on the Span 5 side.

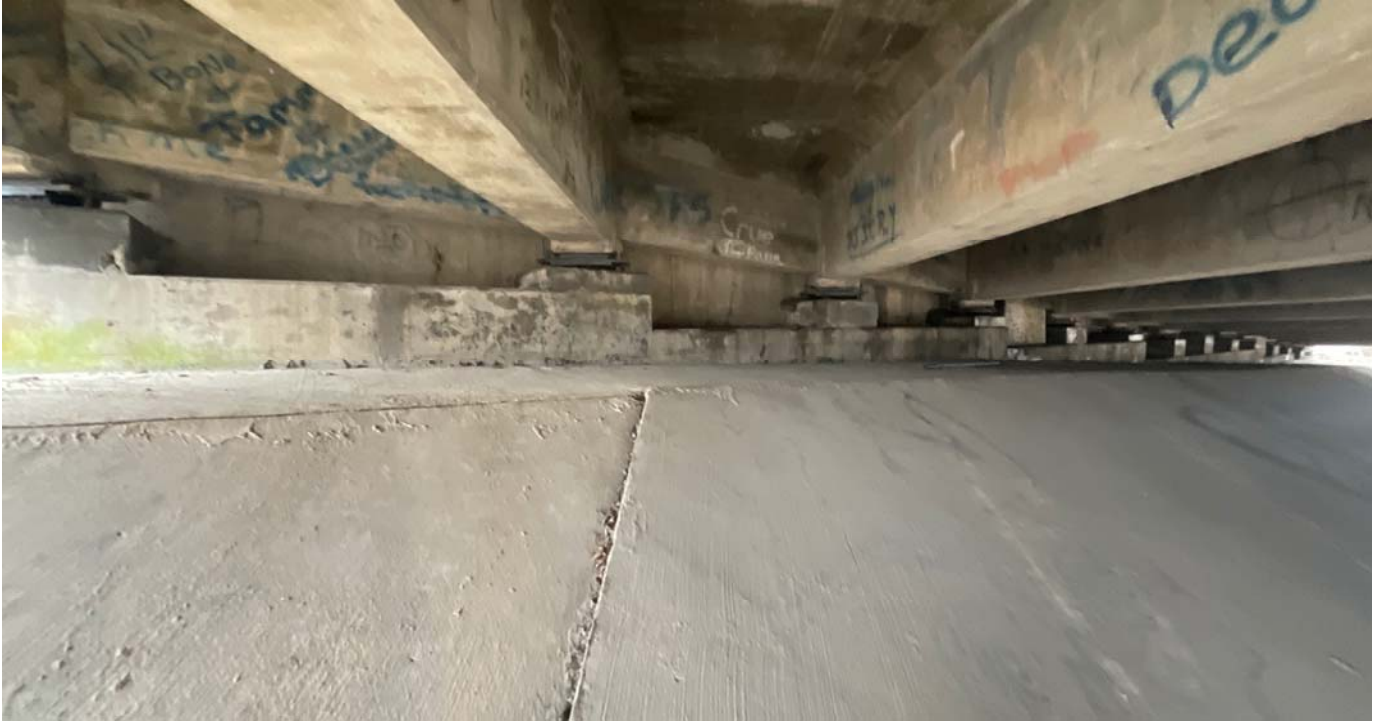
Abutment 8

All bearing pedestals have had concrete repairs, some are cracking. Abutments have moderate to wide vertical cracking, delaminated areas, and a few spalls greater than 6 inches wide with exposed steel reinforcement, some with section loss at Abutment 1 near the south end.

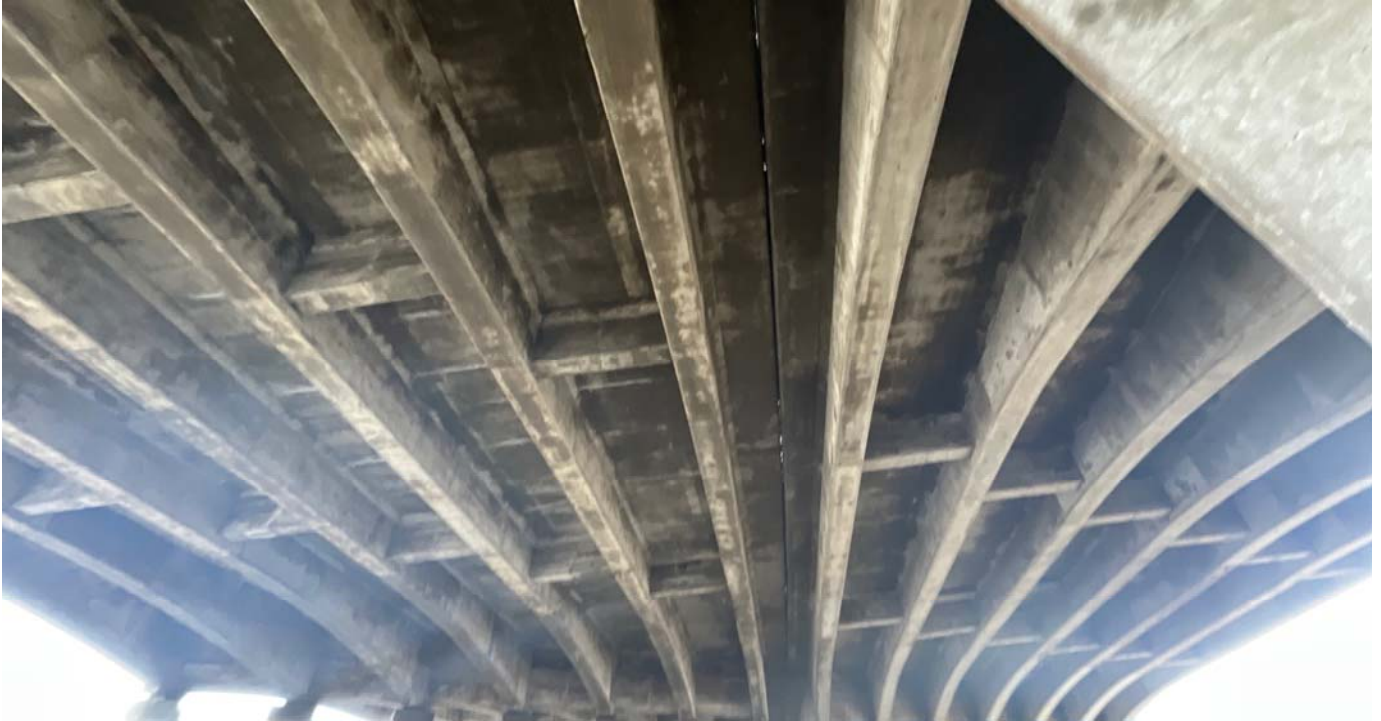
Span 6 Soffit

Top surface cannot be inspected due to 2003 deck rehabilitation. Top flange soffit has transverse cracking with efflorescence in Span 5 along WB half and in Span 6 along EB and WB, and a few other localized areas. North overhang has deep spalling with exposed rebar over Pier 5, and there are a few other spalls scattered throughout, some with exposed steel reinforcement.

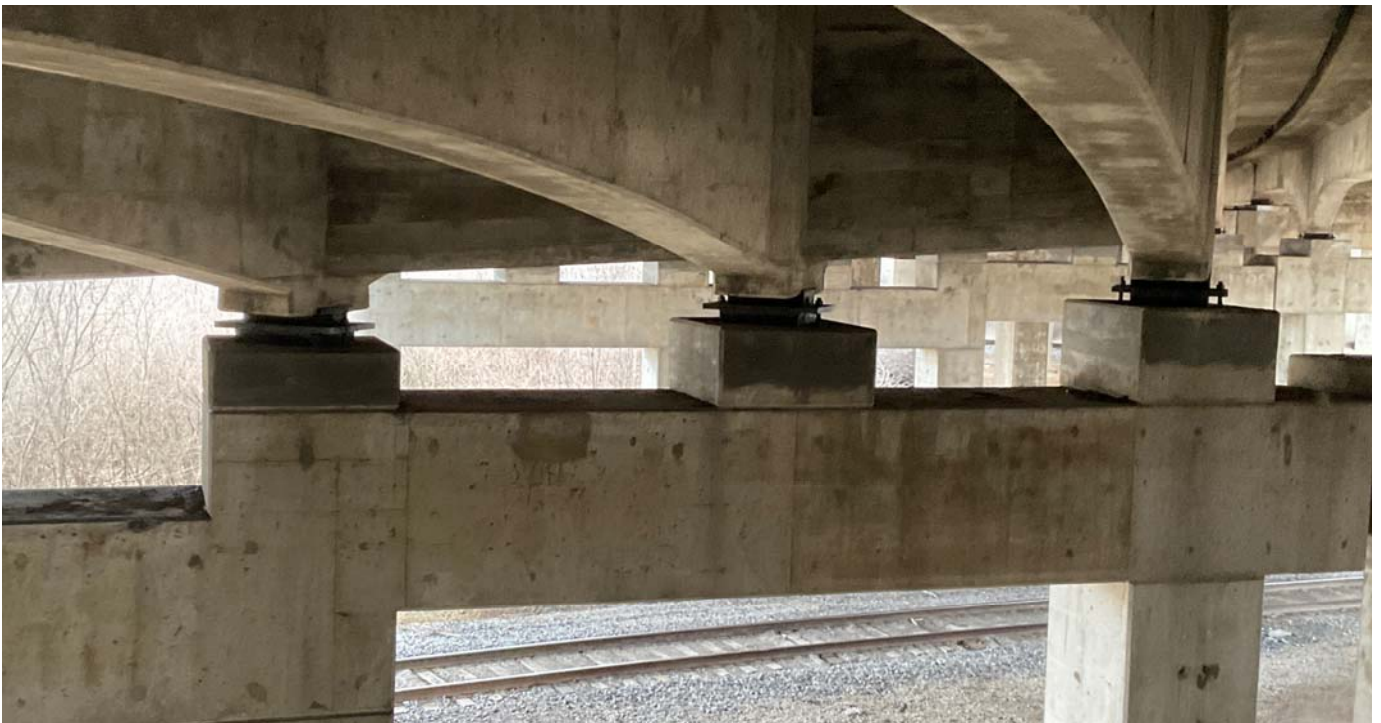
Typical bearing - Pier 7

Bearing assemblies have freckling rust. At Abutment 8, anchor bolts at Girders 1, 8, 10, 11, 13, and 14 appear to have been installed out of vertical plumb. Elastomeric pads for all girders except Girder 12 show no signs of eastward expansion (50 degrees at time of inspection). Beam 5 at Abutment 8 has a missing nut on anchor bolt.

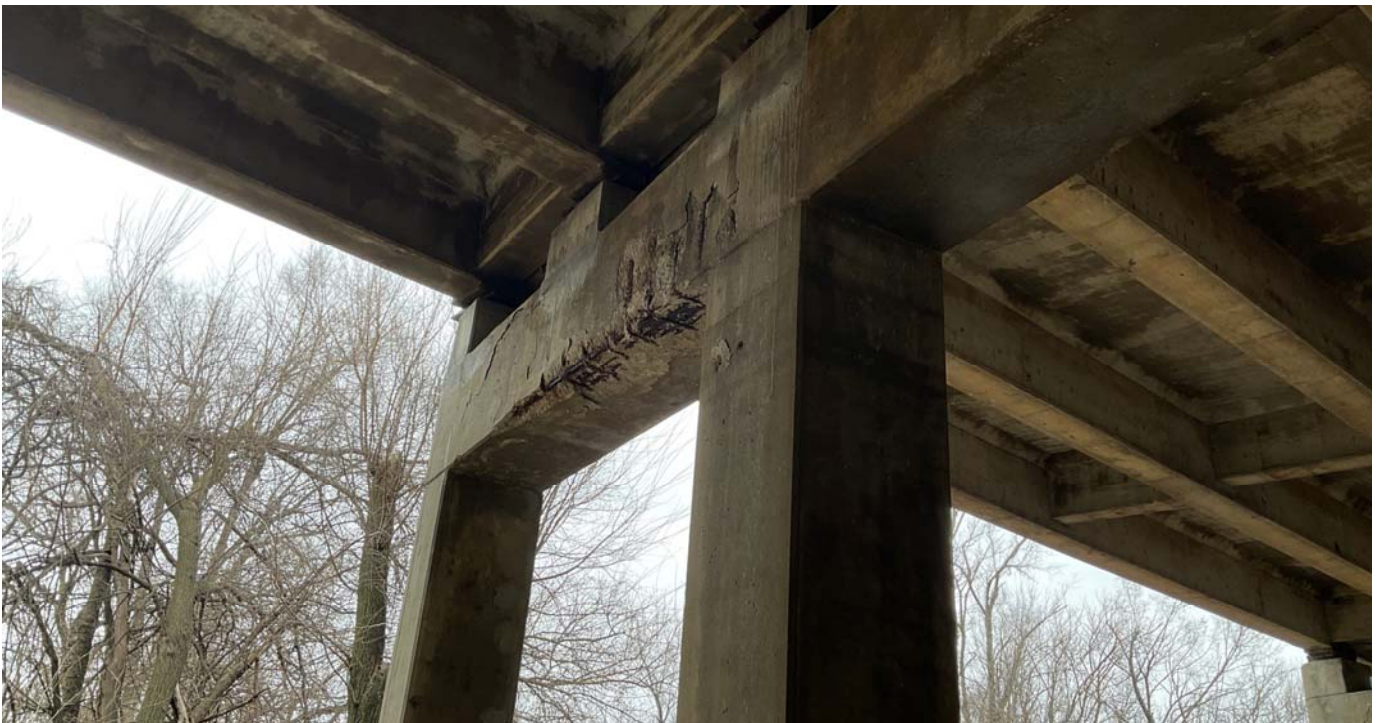
Pier 2 - north end
