Bridge Inspection Report

056B00182N

Inspector: Blake Combs
Entered by: BCOMBSCON
12/10/2024
Standard (24 months)

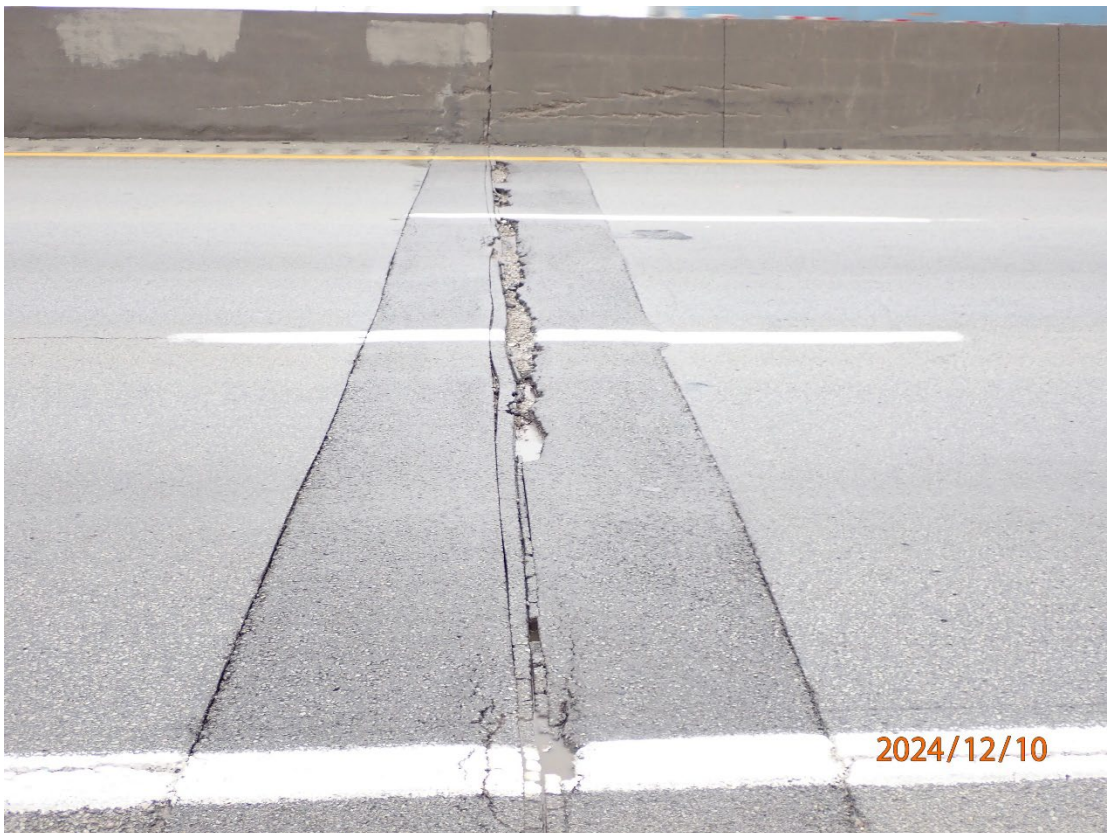
Northbound joint over Abutment 1

Asphalt plug joints were installed over the existing joints in 2012 and plug joints were redone in 2017. Asphalt plug joints have cracking, rutting, and spalling, some spalls with original joints exposed. Water drains moderately to freely onto the elements below. Spalling and patching in the asphalt plug joints is most notable in the southbound lanes over Abutment 4 with most of the asphalt plug having patching.

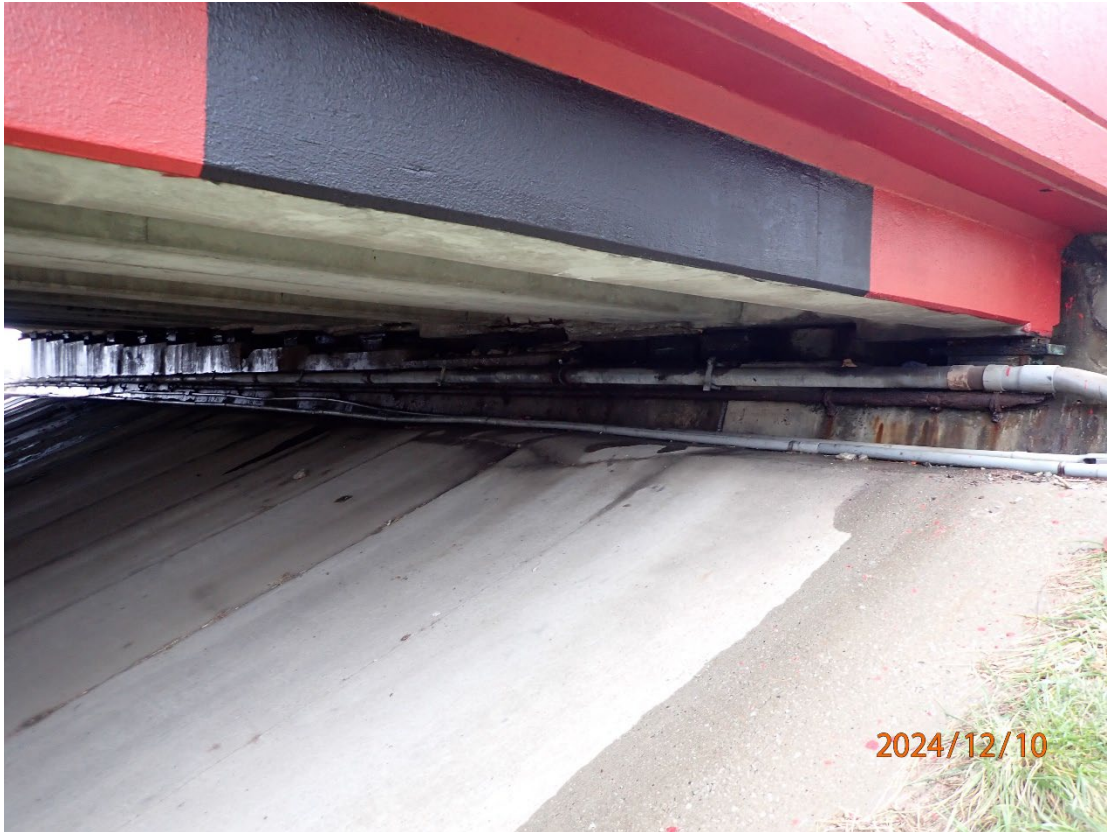
Abutment 4

At Abutment 4, there are four attachments to the breastwall with three being either rusted in two or broken. These three appear to be abandoned with no utilities inside of them. Only the ~4" conduit appears to be used and has only minor surface corrosion.
