# Bridge Inspection Report

056B00191N

12/09/2024

Standard (24 months)

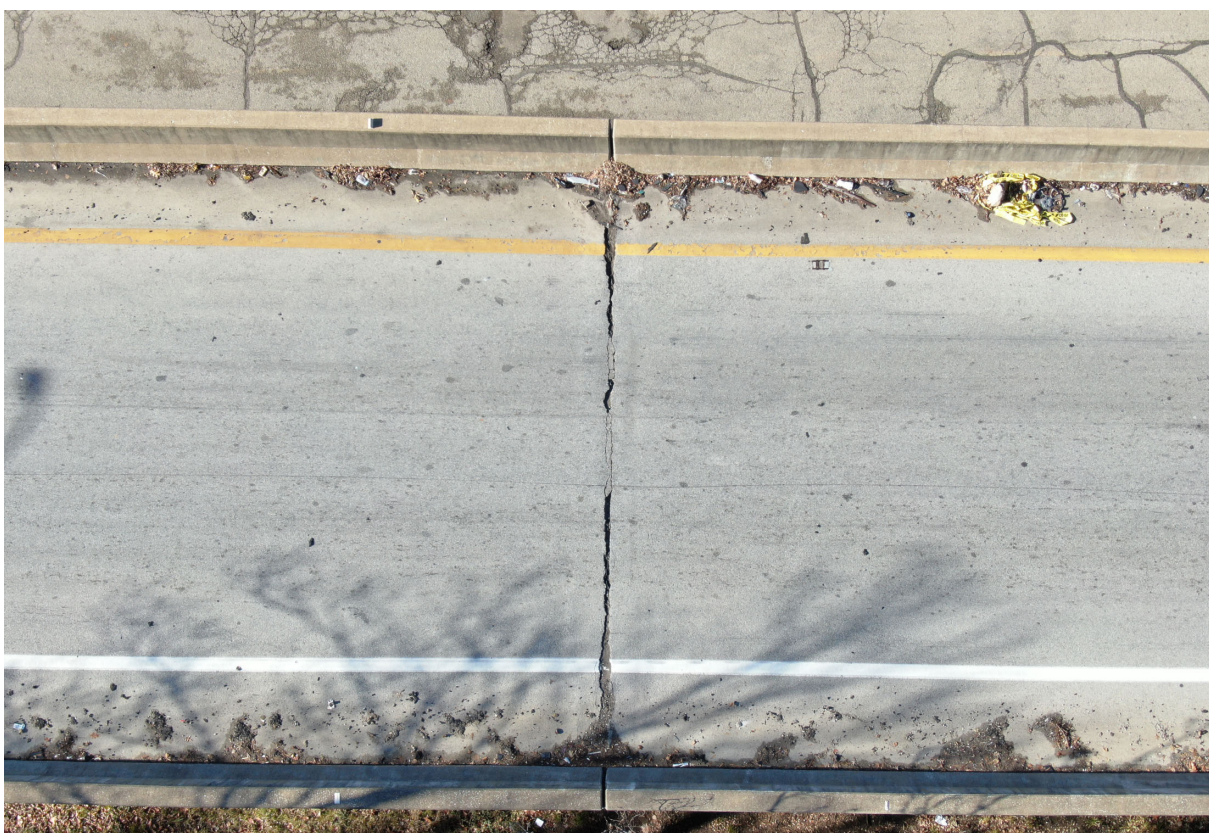
Joint over Pier A-5.

Compression joint seals over Piers A-5, B-1, and B-2 as well as Abutments A and B were paved over in 2012, but asphalt has generally broken up and original joints are exposed. Visible portion of joint seals have partial to full depth tears and adhesion loss throughout, plus are filled with debris. Abutment B joint is the only joint still fully concealed by overlay, considered as CS4 since joint is full of asphalt which restricts movement.

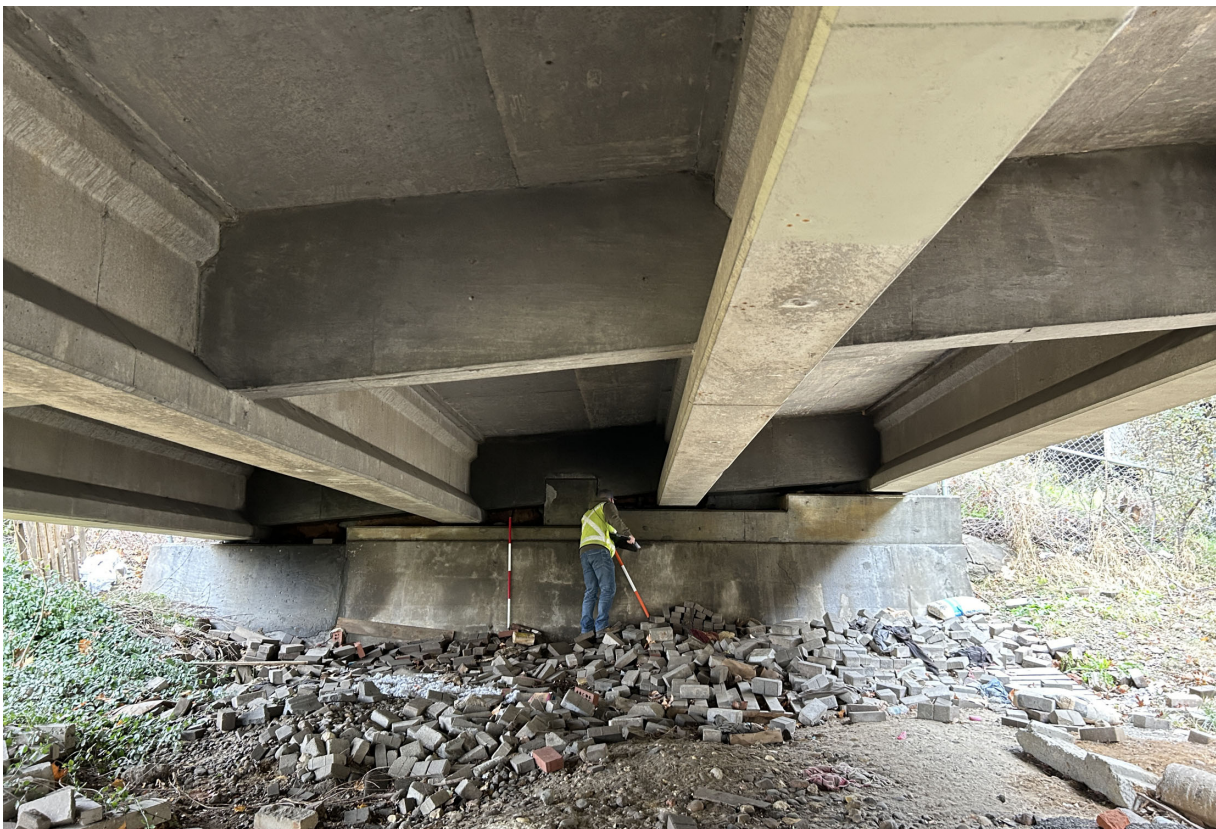
Ramp B: Abutment B

Abutment A has moderate vertical and diagonal cracks, some with efflorescence and/or rust staining at the west end. Abutment B has a few vertical cracks and small delaminations. Abutment C has moderate to wide horizontal cracking, delamination, unsound patches, and several spalls with exposed rebar.
