# Bridge Inspection Report

056B00194N

12/11/2024

<u>IDENTIFICATION</u>			
Structure Num (8):	056B00194N		
NBI Number	056B00194N		
Structure Name:			
Location (9):	0.1 MI S OF 1ST ST		
Carries (7):	I-65 SB ON RAMP		
Type of Service (42A):	1 Highway		
Feature Crossed (6):	E MUHAMMAD ALI BLVD		
Type of Service (42B):	1 Highway		
Placecode (4):	Not Applicable		
County (3):	Jefferson (056)		
State (1):	21 Kentucky		
Admin Area:	Inventory		
District:	District 5		
Latitude (16):	38° 15' 2"		
Longitude (17):	85° 45' 7"		
Owner (22):	State Highway Agency		
Maint. Resp. (21):	State Highway Agency		
Year Built (27):	1963	Border State (98A):	Not Applicable (P)
Year Recon (106):	1980	Border Number (99):	
		% Responsibility (98B):

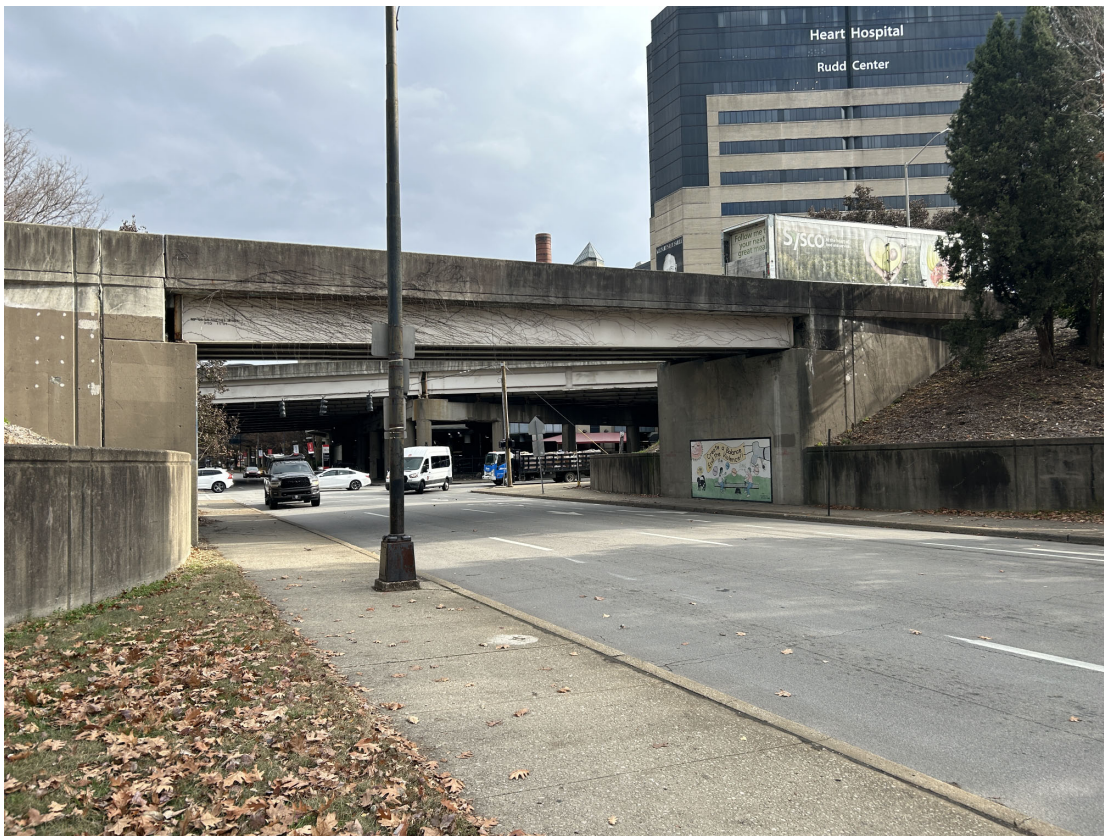
West Profile

West face of the structure, along with much of Abutment 2, is covered in vines, restricting proper inspection.

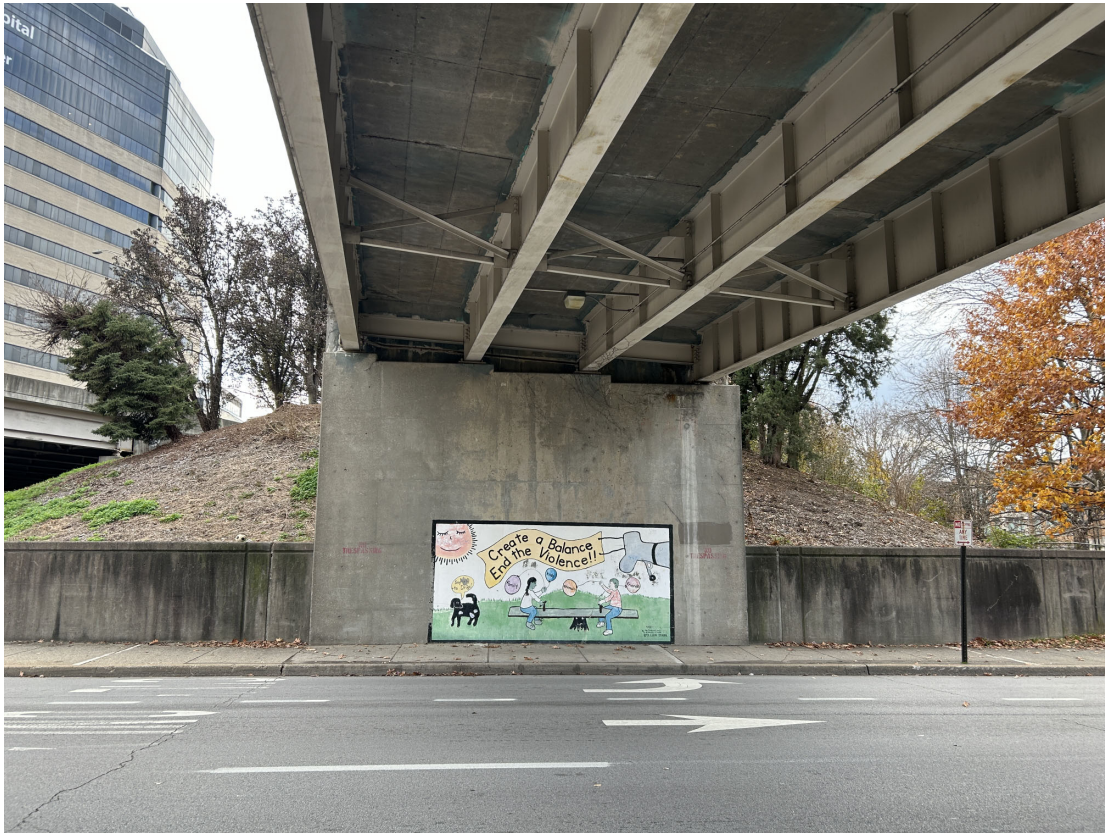
Quantity includes parallel wingwalls at the abutments. Abutments have full height vertical cracks below Beams 2 and 3, plus cracks with efflorescence at the ends of the backwalls. Abutment 1 has dense pattern cracking with efflorescence near the tops of the wingwalls, a 3-foot long by 1-foot high spall in the backwall at the west end/behind Beam 1, and 4 feet of wide horizontal cracking near the top of the breastwall below Bay 1 with rust staining and efflorescence.
