Bridge Inspection Report

056B00195R

12/17/2024

Standard (24 months)

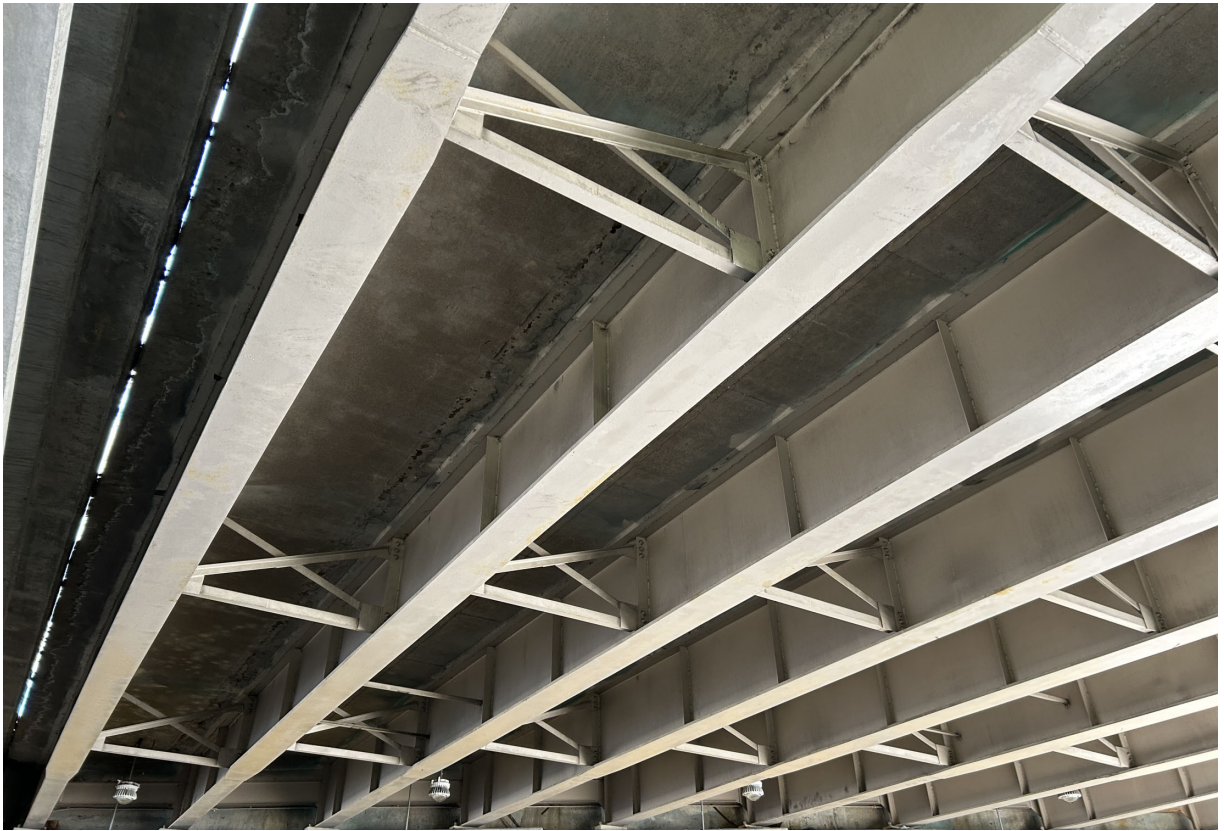
Superstructure

Beams have some surface rust forming, mainly near ends.

Steel protective coating is generally substantially effective, with limited effectiveness where corrosion has initiated.
