Bridge Inspection Report

056B00210N

12/02/2024

<u>IDENTIFICATION</u>			
Structure Num (8):	056B00210N		
NBI Number	056B00210N		
Structure Name:			
Location (9):	0.55 MI N OF I-264		
Carries (7):	I-65		
Type of Service (42A):	1 Highway		
Feature Crossed (6):	MANNING RD		
Type of Service (42B):	1 Highway		
Placecode (4):	Not Applicable		
County (3):	Jefferson (056)		
State (1):	21 Kentucky		
Admin Area:	Inventory		
District:	District 5		
Latitude (16):	38° 11' 51"		
Longitude (17):	85° 44' 2"		
Owner (22):	State Highway Agency		
Maint. Resp. (21):	State Highway Agency		
Year Built (27):	1957	Border State (98A):	Not Applicable (P)
Year Recon (106):	1985	Border Number (99):	
		% Responsibility (98B):

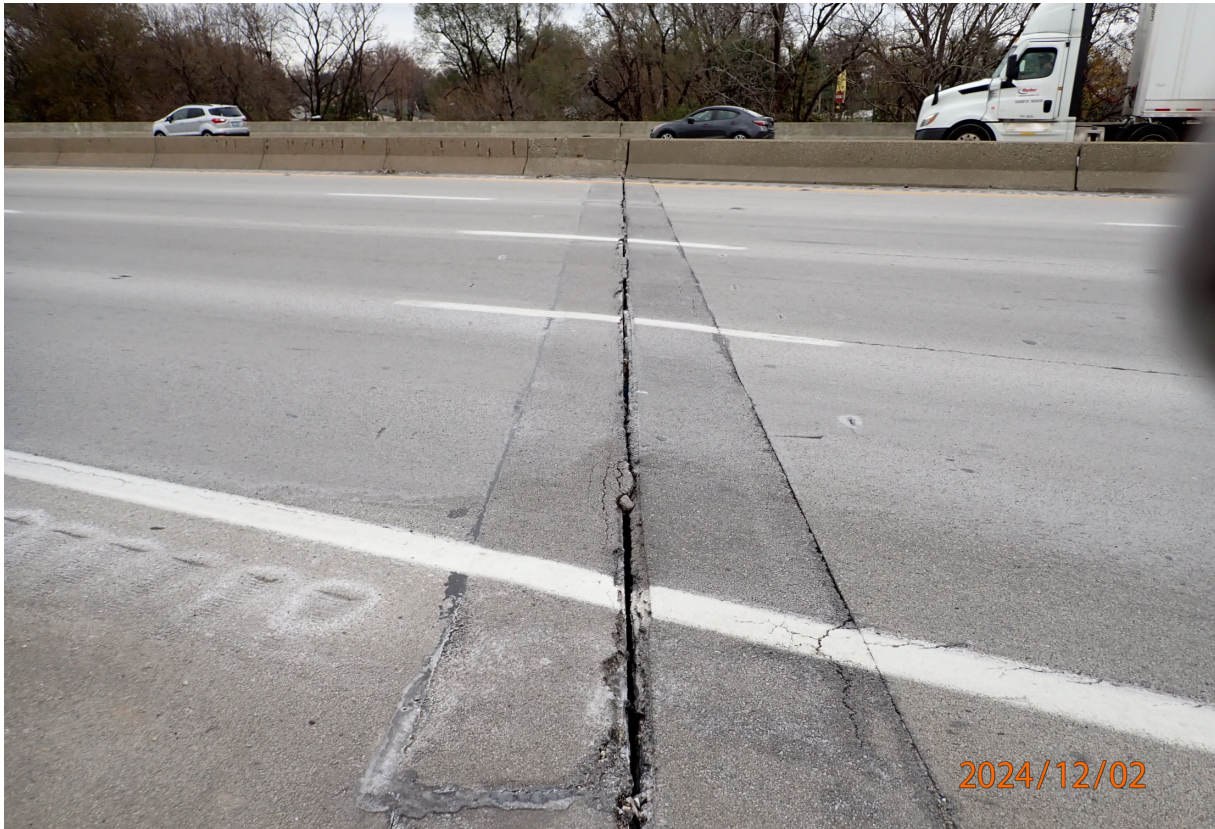
Asphalt plug joints are breaking up and/or missing throughout the traffic lanes, plus the full length of the SB Abutment 1 joint (214' CS4). The joints have debris in the shoulders with some partial depth cracks (46' CS3).

Asphalt plug joint over Abutment 1 (SB)

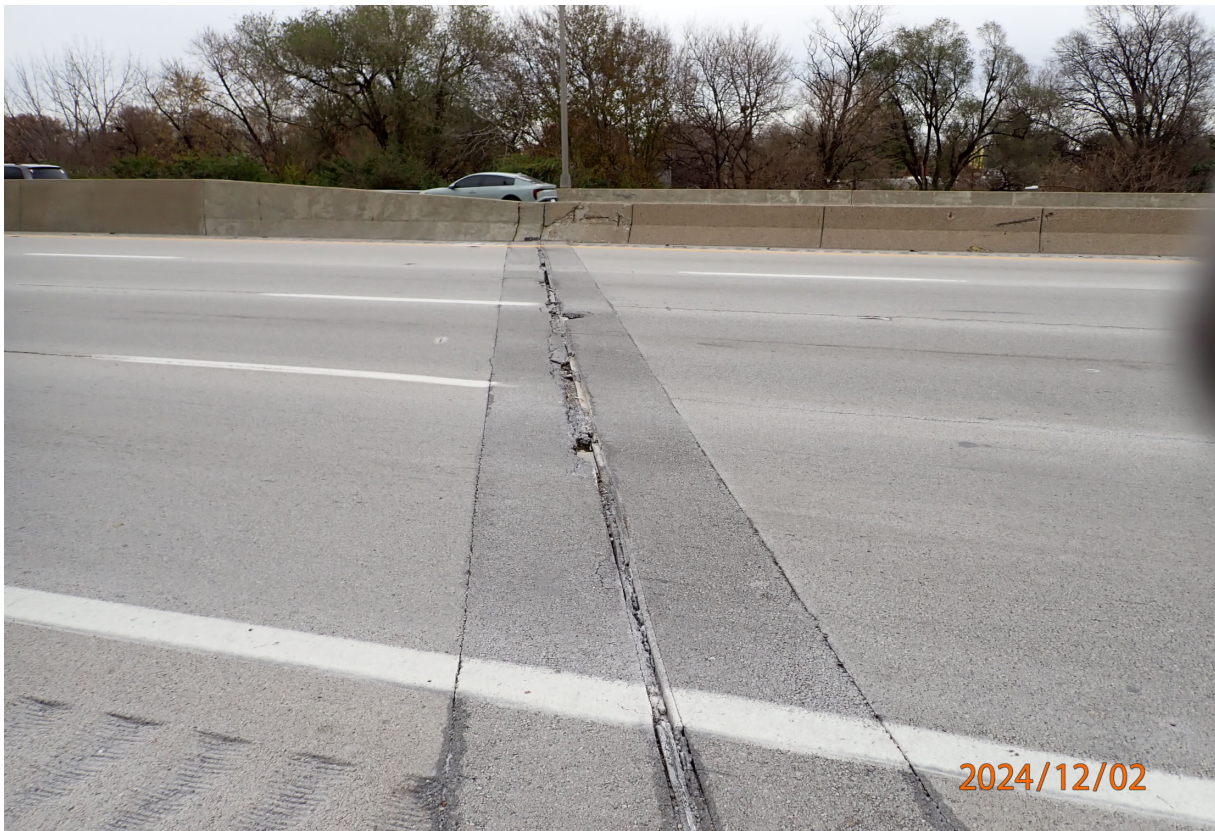
Asphalt plug joint over Abutment 4 (SB)

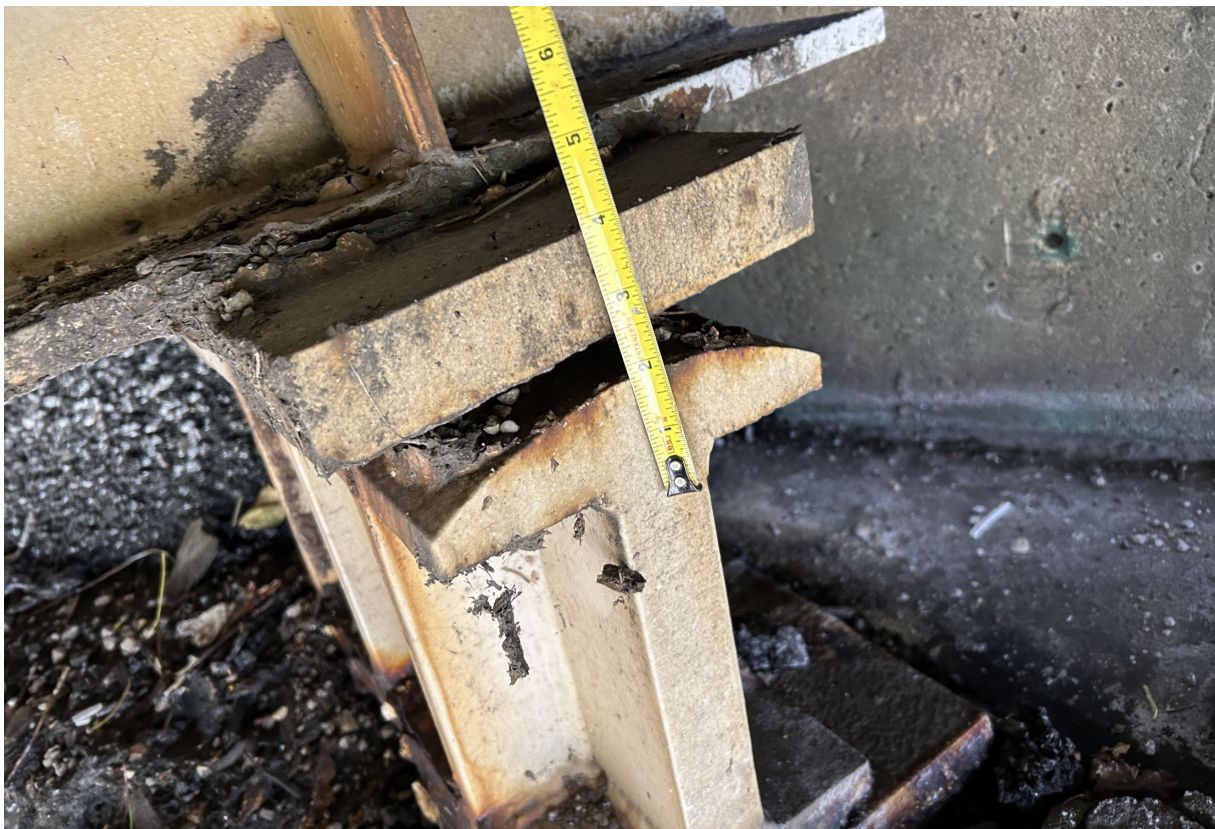
At Abutment 1-Beam 4, the rocker bearing is laterally rotated with an $11/16$ " gap between the sole plate and rocker on the west side only. Note asphalt piled on seat.

Close up

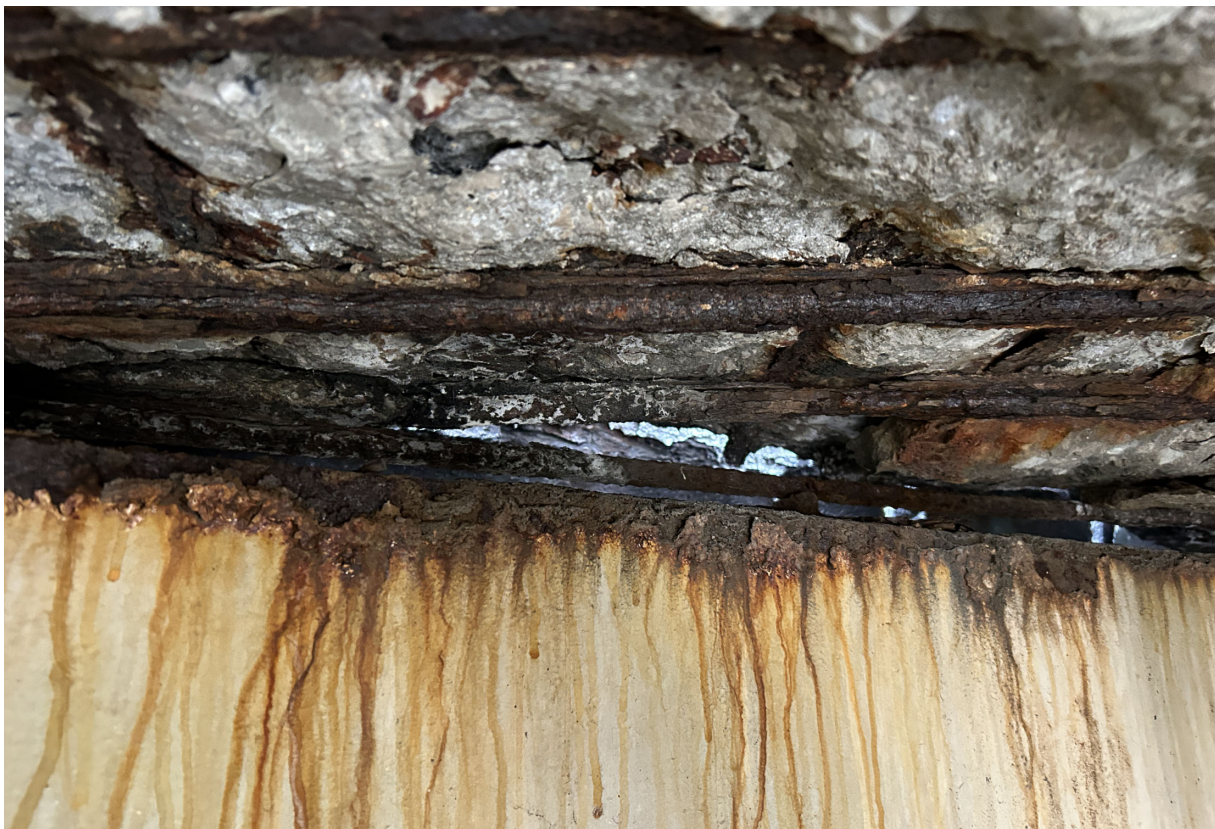
Bay 6 soffit has a 4' W x 2' L x 3" D spall at Abutment 1. Note daylight visible through failed joint.

Close up

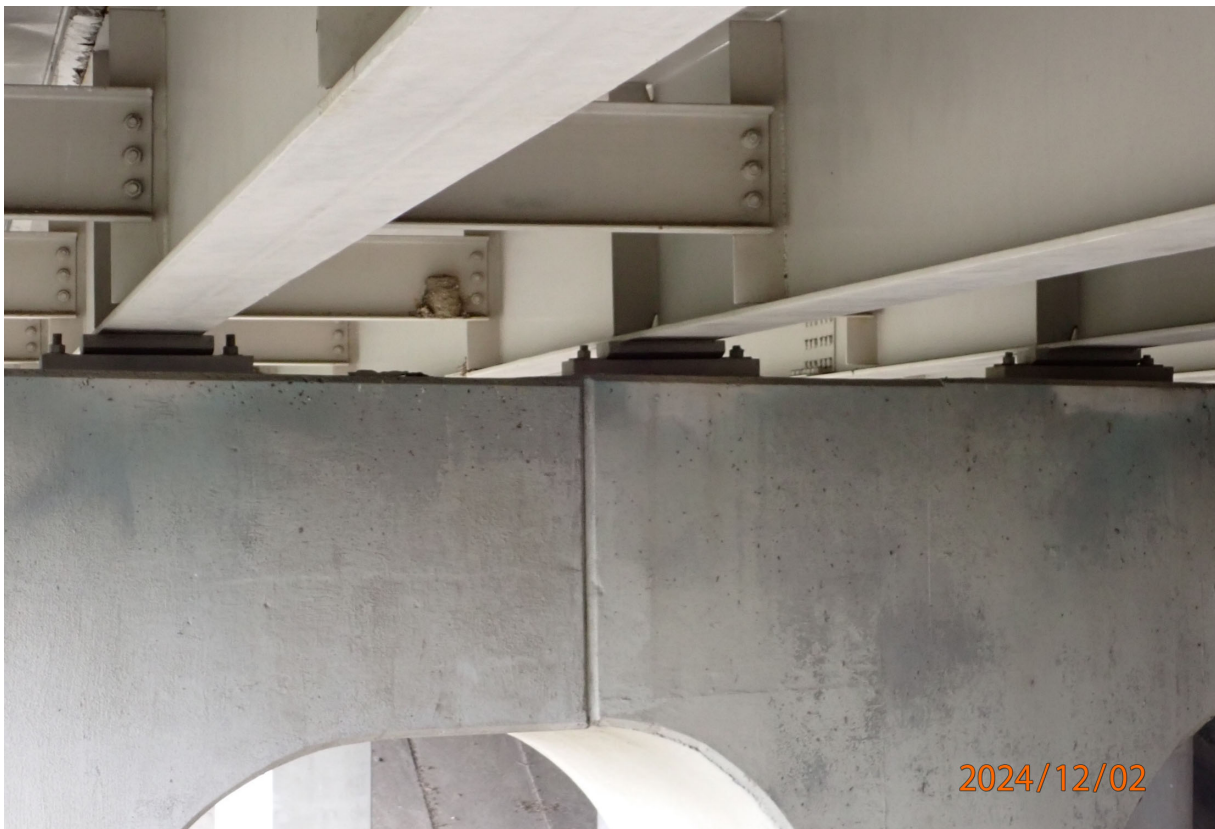
No significant deficiencies noted on the Pier 2 fixed bearings.

Typical fixed bearings at Pier 2

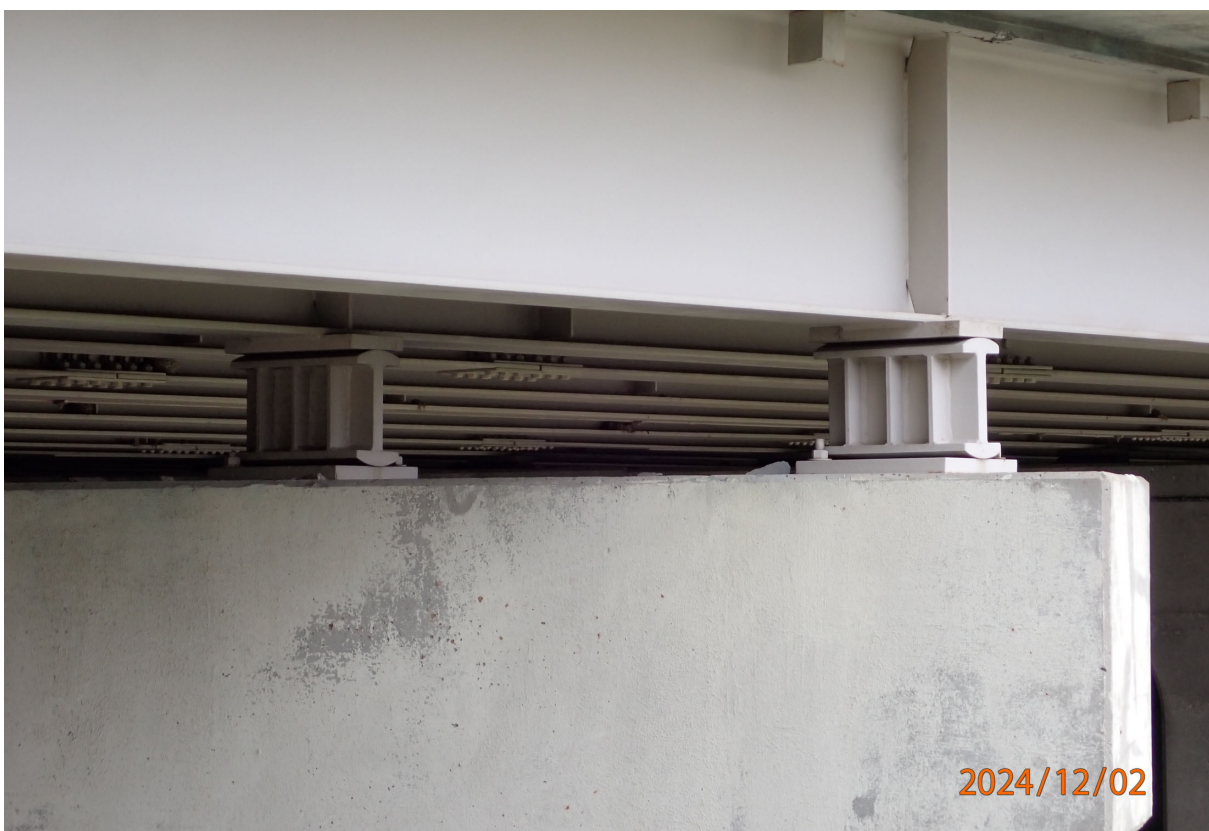
The movable bearings are located at the abutments and Pier 3. Abutment bearings have flaking corrosion and pack rust between the rocker and bearing plates; corrosion is heavier at exterior bearings and near the longitudinal joint. Several abutment bearings have gaps between the plates and rocker and/or below the masonry plates due to pack rust. Abutment bearings are expanded at 28° F (tolerable alignment, inconsistent with temperature). At Abutment 1-Beam 4, the rocker bearing is laterally rotated with an 11/16" gap between the sole plate and rocker on the west side only. No significant deficiencies noted on Pier 3 rocker bearings.

The paint has failed on the abutment bearings. The paint is substantially to fully effective on the Pier 3 rockers.

Typical rocker bearings at Pier 3

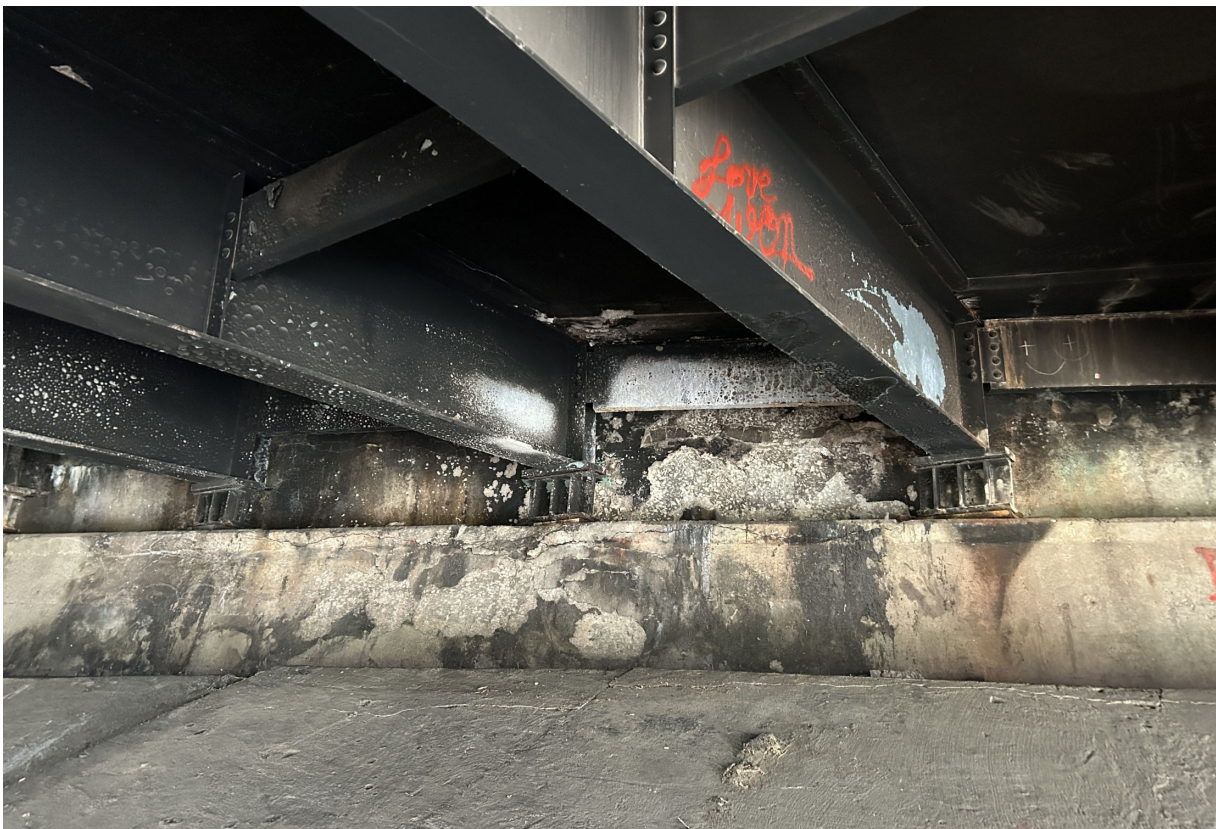
The majority of the paint is substantially effective and dulling, with areas of limited to no effectiveness near the abutments and longitudinal joint. There is soot from fires on Beams 12-20 at Abutment 4; some of these beams have paint bubbling and/or failure, especially Beam 15.

There is soot from fires on Beams 12-20 at Abutment 4.

Closer view at Beams 13-15

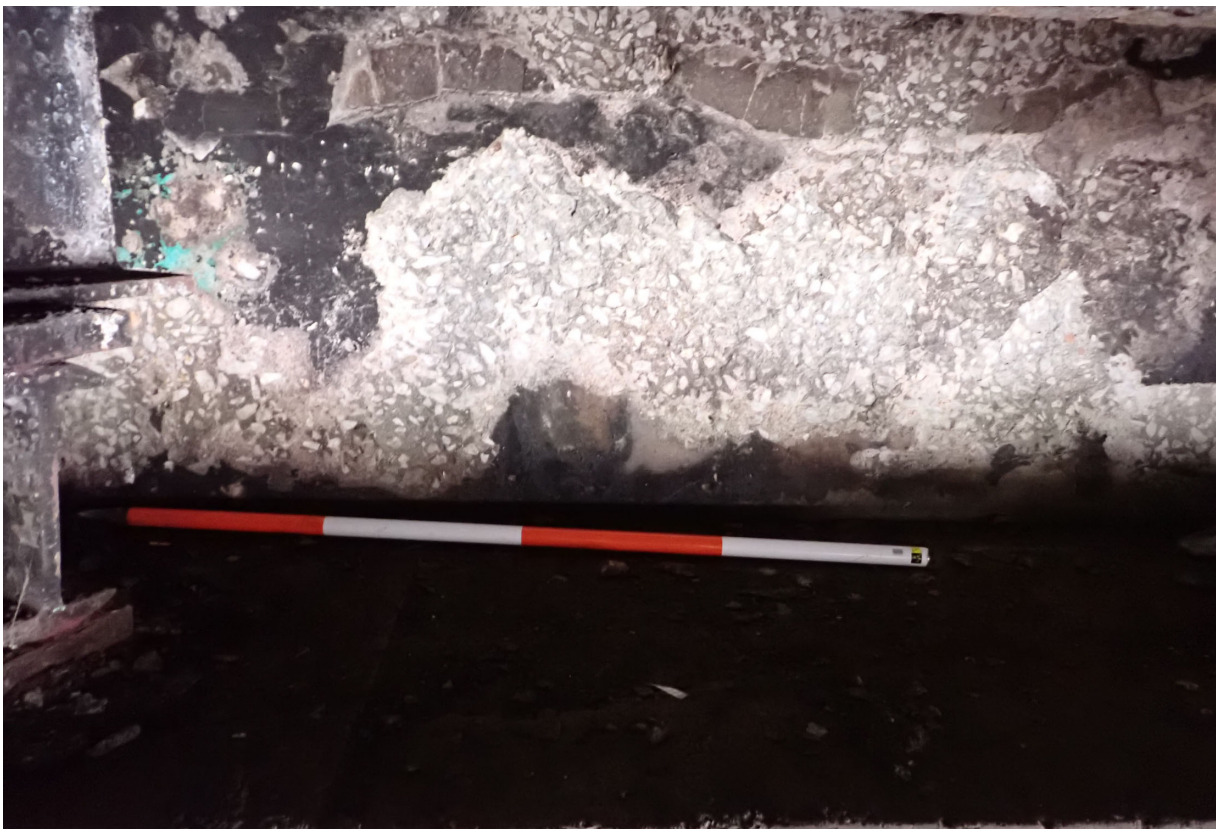
Abutment 4 has wide horizontal cracking plus scaling from fires between Beams 13 and 15 (cap at Beam 14 shown).

Close up of Abutment 4 backwall at Beam 14
