**7-1116.00 KY-152
BRIDGE REPLACEMENT(P)**

Commonwealth of Kentucky DEPARTMENT OF HIGHWAYS	
COUNTY MERCER	
ROUTE KY 152	CROSSING HERRINGTON LAKE
LAYOUT	
PREPARED BY Division of Structural Design	
BRIDGE NUMBER FE02-084-0152-B00005N	
AMERICAN ENGINEERS, INC.	
SHEET 1 S3	DRAWING 2230

**P-001-2011
Mercer-Garrard County
KY 152 over Lake Herrington**

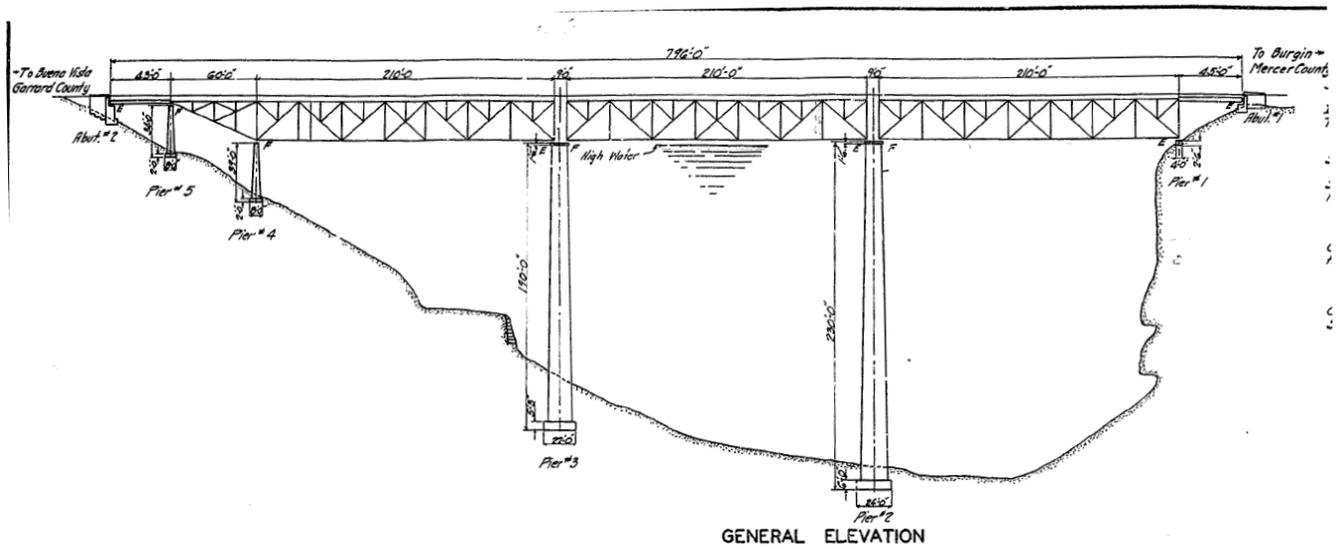
Profile view of the existing bridge

A site visit was performed to review the existing piers. It is unlikely that it would be desirable or economically viable to reuse abutment number 1, abutment number 2, or piers 1, 4 or 5 as shown in the below schematic (retrieved from the Division of Structural Design's plan database). Due to their size and location in the lake, it could be very desirable to reuse piers 2 and/or 3.
