**A
DATA
NEEDS
ANALYSIS
STUDY**

**Item 7-1116.00 Bridge Replacement on Herrington Lake,
KY 152 at Mercer/Garrard County line**

**Prepared By: Division of Planning & District 7
Kentucky Transportation Cabinet
June 6, 2011**

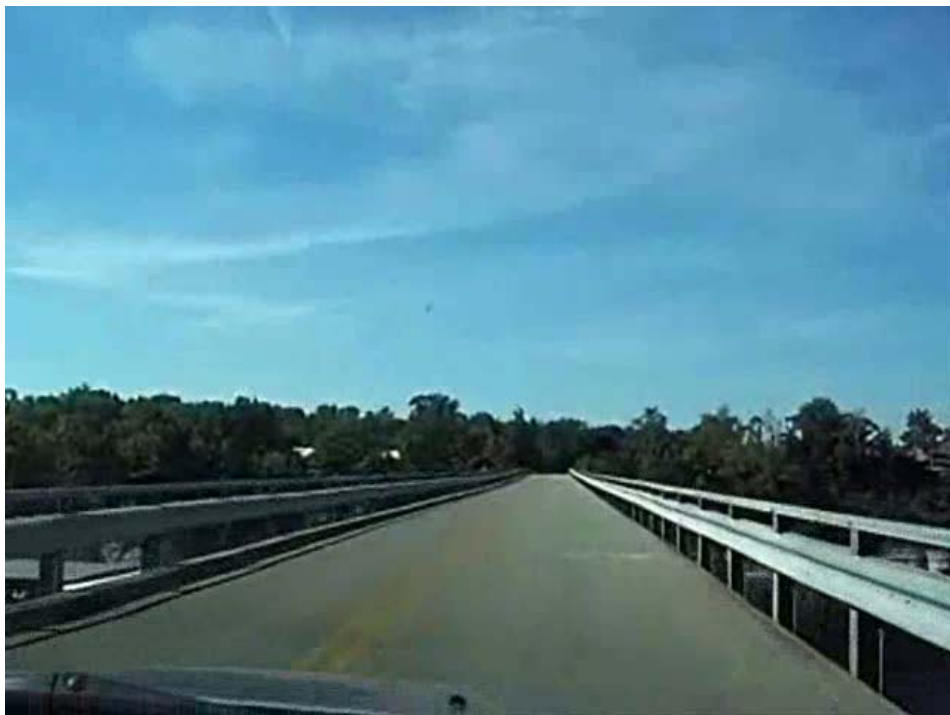
Figure 3: Roadway on Herrington Lake Bridge

The current roadway approach is two 9-10 foot lanes. Shoulder width is 1-3 feet. There are no shoulders on the bridge. There is guardrail at the edge of the pavement on the bridge. Bridge width is 20 feet. KYTC Common Geometric Practices for Rural Collector Roads suggest a lane width of 12 feet and 8 feet shoulders for a speed limit of 35 mph with an ADT over 2000 (Appendix E).

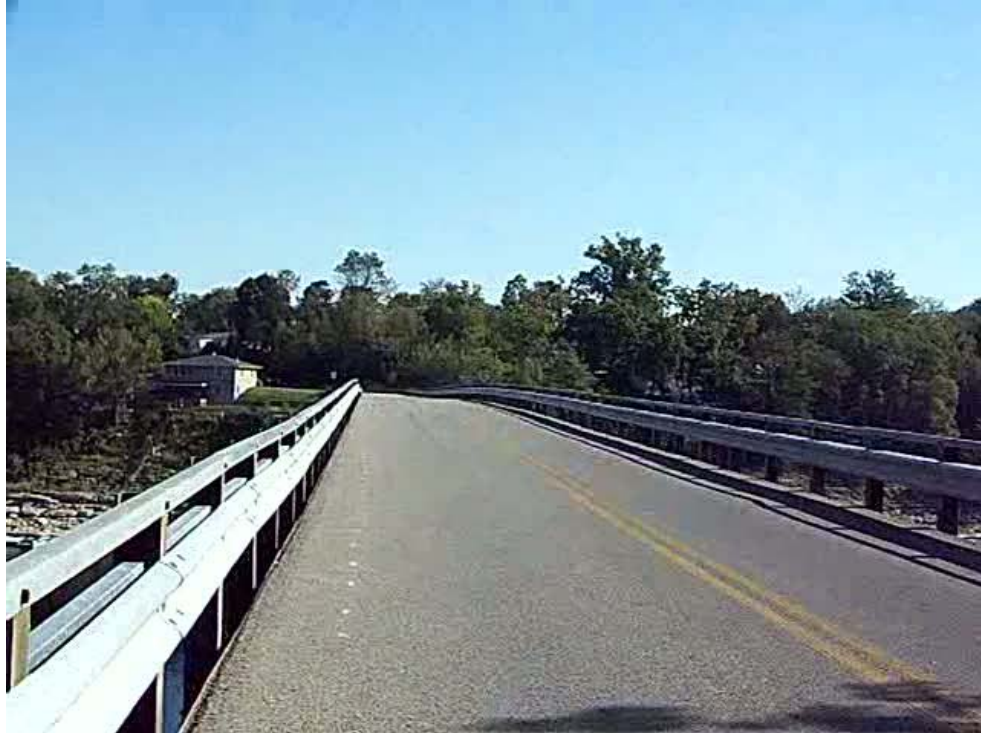
Figure 4: Roadway on Herrington Lake Bridge at the West End

The Composite Adequacy Rating percentile of the roadway is 75.9 in Mercer County and 44.0 in Garrard County. The rating is a composite of roughness (IRI), safety (CRF) and service (VSF) of the roadway and compares this segment to other similar State roads. For example, a rating of 76 means that about 24% of the roads are rated better in that functional class in Kentucky. Figures 3 & 4 show the existing roadway on Herrington Lake bridge. Roadway approaches to the bridge have horizontal curves that do not meet KYTC Current Geometric criteria.

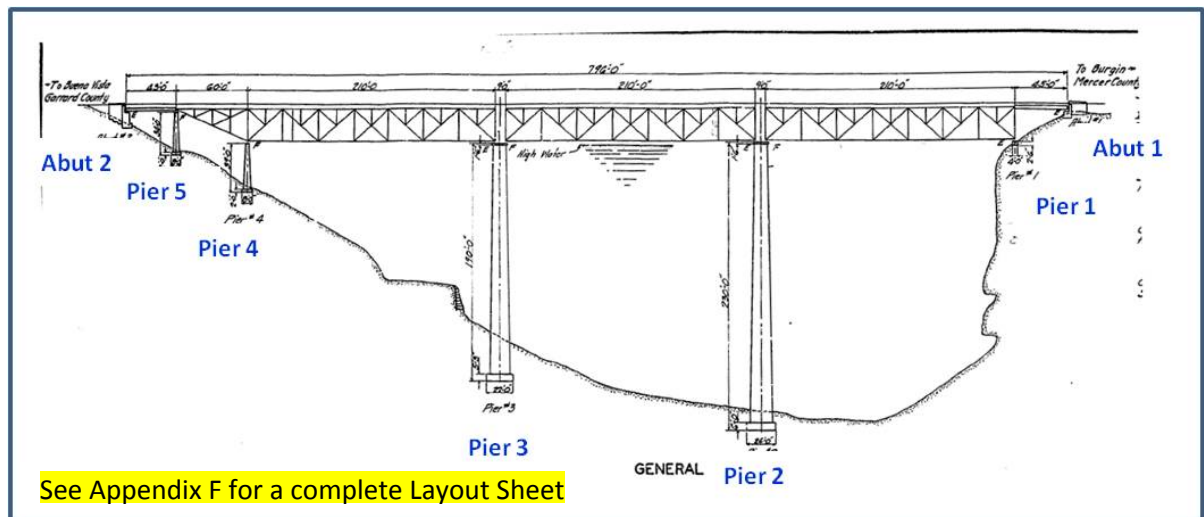
Figure 9: Elevation of the existing bridge

The 797.9 foot bridge was built in 1924. It has six spans total; there are 4 main spans and 2 approach spans (one approach span on each end of the bridge). The main spans are steel deck truss and the approach spans are a girder/floorbeam system. Repairs were done in 1940, 1944, 1991, 2003 and 2009. The bridge had a Sufficiency Rating of 2.00 before the 2009 repairs. The interim repairs improved the Sufficiency Rating to 28.9. The bridge is functionally obsolete because of the geometric deficiencies.

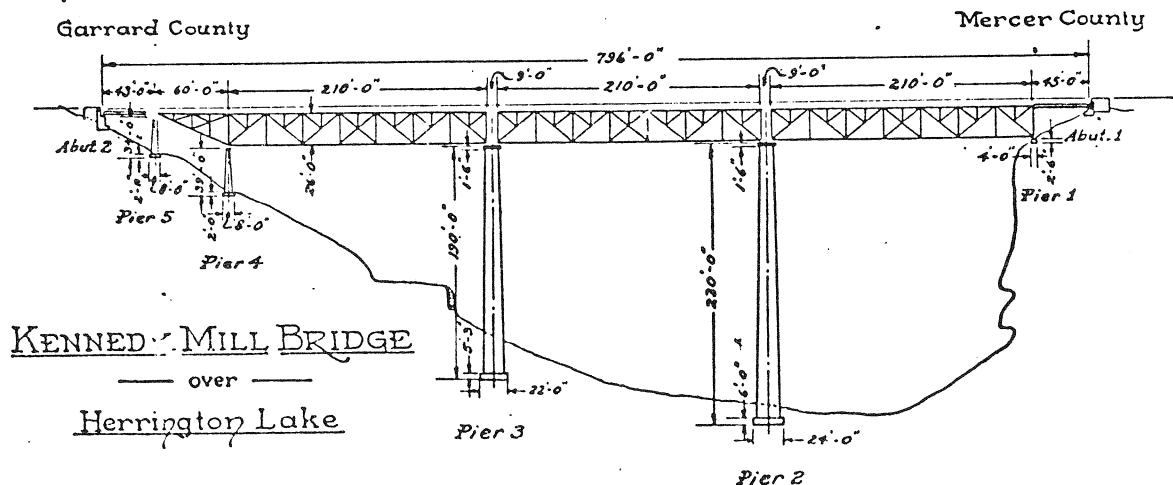
Fig. 1

At about the time the bridge was completed the "Engineering News Record" had a very good description of the two taller piers. (See Figure No. 1.) These piers are hollow reinforced concrete tubes, similar to chimneys. They were built by the Weber Chimney Company of Chicago by its regular chimney building procedure. The foundation for the 230' pier has a 6' 1/2" reinforced concrete slab and the shaft or stack is anchored to the footing with 1" steel bars. The shell thickness at the bottom is 26 7/8". Both piers are 12' wide and 22'-0" long at the top and covered with a concrete slab, and both piers have 3' square ports at top and bottom to permit them to fill with water. They are flat on the sides and round on both ends and the shell thickness gradually decreases toward top.

All substructures were supposed to be on solid rock. A closer inspection of the cliffs, however, reveals that the rock formation is in many layers with thin layers of fireclay between. From best information now obtainable, pier No. 2, the one in question, was judged to have had better foundation at the time of its erection.

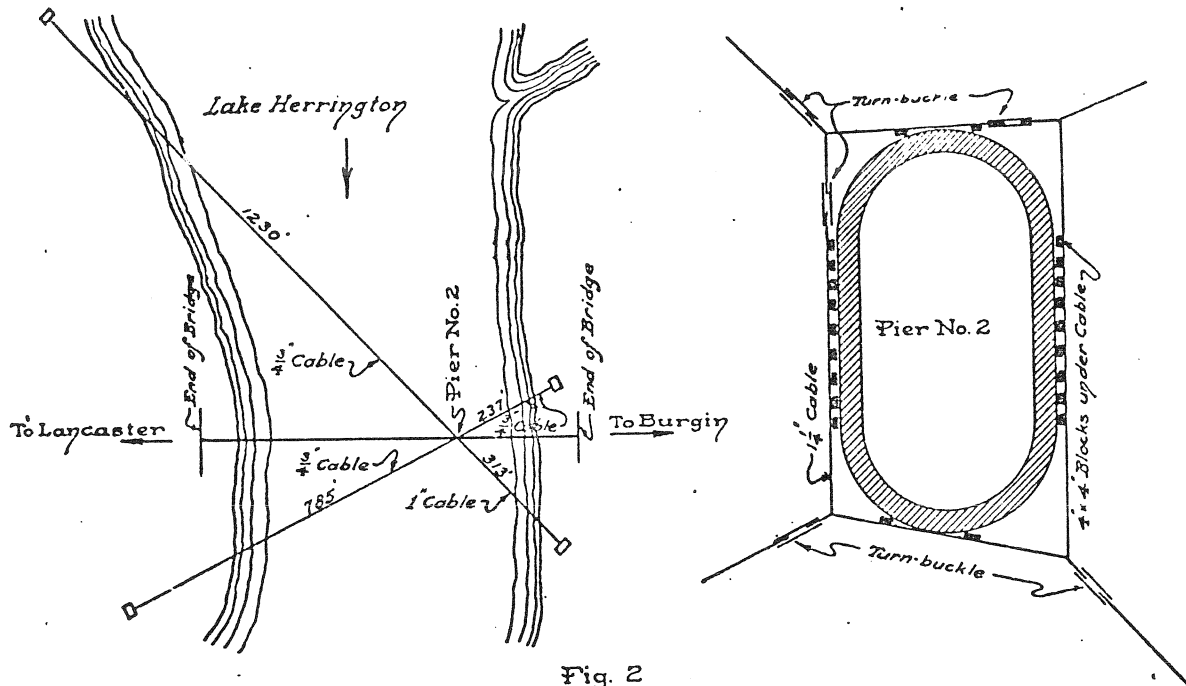
Fig. 2

the pier with 4"x4" wood blocks inserted between the cable and the concrete masonry. From the four corners of the pier, cables were stretched to anchor on the lake shores. Turn buckles were inserted in each line to obtain uniform tension in all cables. (See Figure 2.) Given
