## **Appendix F**

### **Renfro Dam**

# KYTC DAM ASSESSMENT STUDY – RENFRO DAM

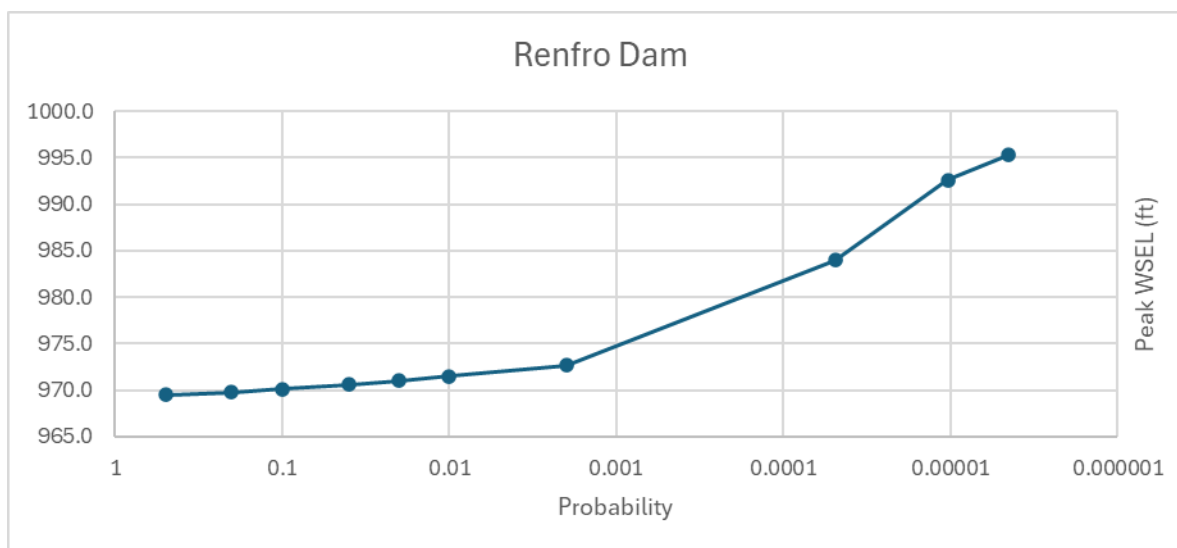
*Renfro Dam Elevation-Frequency Curve*

*Note: Duration of overtopping for the 21.6" rainfall event with the spillway clogged estimated to be 7 hours*

*Note: Duration of overtopping for the PMP rainfall event with the spillway clogged estimated to be 9 hours.*

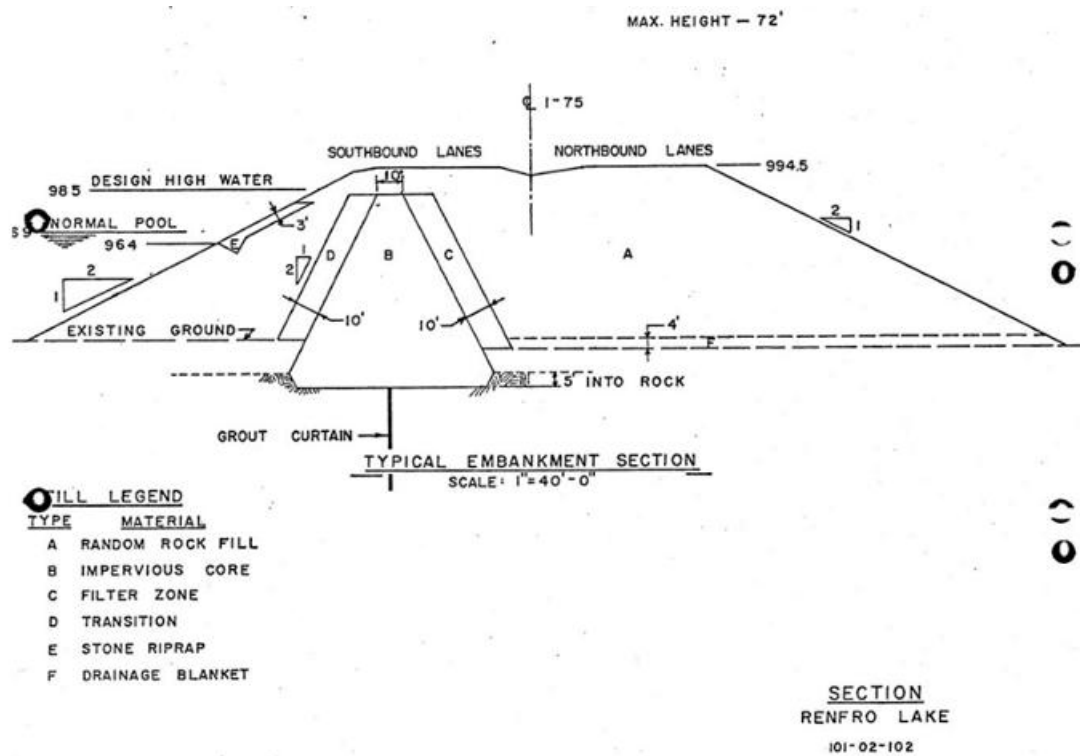
Cross Section (USACE Louisville District, 1978)

| <ul style="list-style-type: none"><li>• Reports of shallow sliding prior to the 2001 modifications</li><li>• Bulge observed in the 2024 KDOW inspection</li></ul> | | <ul style="list-style-type: none"><li>• Wide (140' wide at the crest)</li><li>• 25' of freeboard at normal pool</li><li>• Successful intervention is almost certain</li></ul> | |

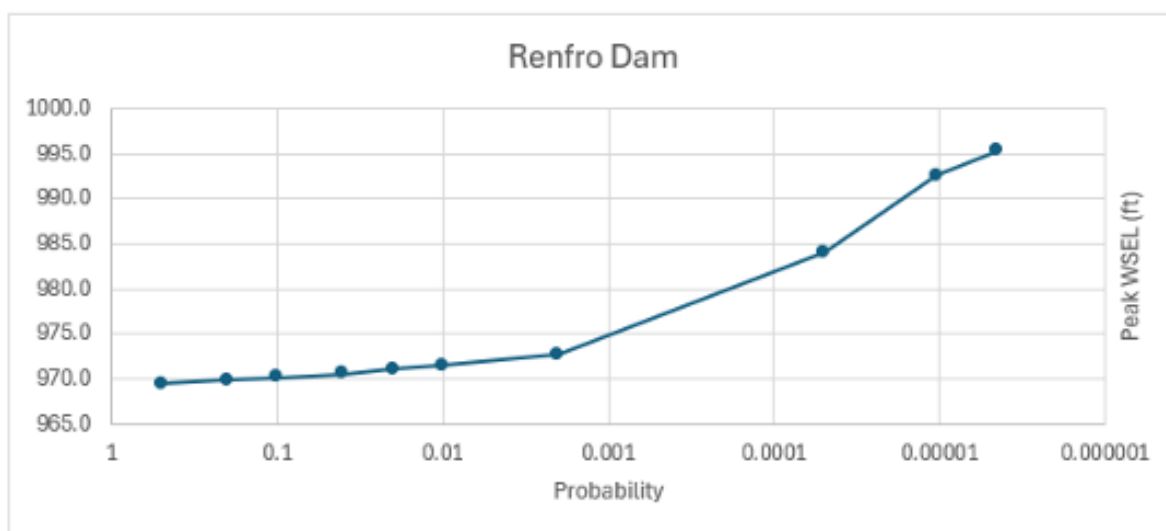
**H&H Results**

Note: Duration of overtopping for the 21.6" rainfall event with the **spillway clogged** estimated to be **7 hours**

Note: Duration of overtopping for the PMP rainfall event with the **spillway clogged** estimated to be **9 hours**
