DNA Study

06-1075.00 – 11th Street (KY 1120) Bridge

06-1070.00 – 15th Street (CS 2097) Bridge

Kentucky Transportation
Cabinet Department of
Highways District 6

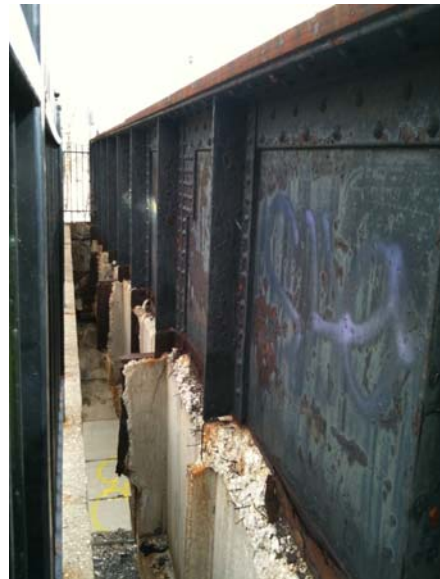
11th Street Space between Bridge and Sidewalk

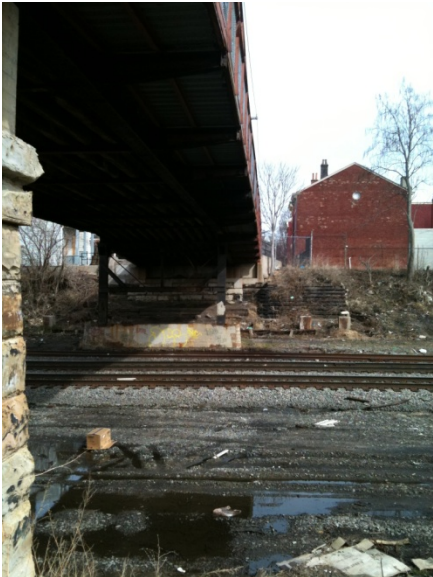
15th Street Bridge Looking East from CSX Railroad

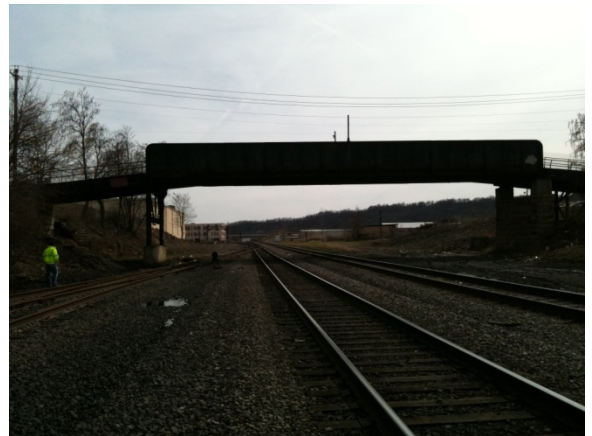
15th Street Bridge Profile

Clearance is also an issue with the 15th Street Bridge. The measured clearance of the bridge over the CSX Railroad was 20.93 feet. This does not meet the 23.5 feet requirement. The Structural Inventory and Appraisal Sheets for the 11th and 15th Street Bridges can be found in Appendix 2A and 3A respectively. The inspection report for the 11th and 15th Street Bridges can be found in Appendix 2B and 3B respectively.

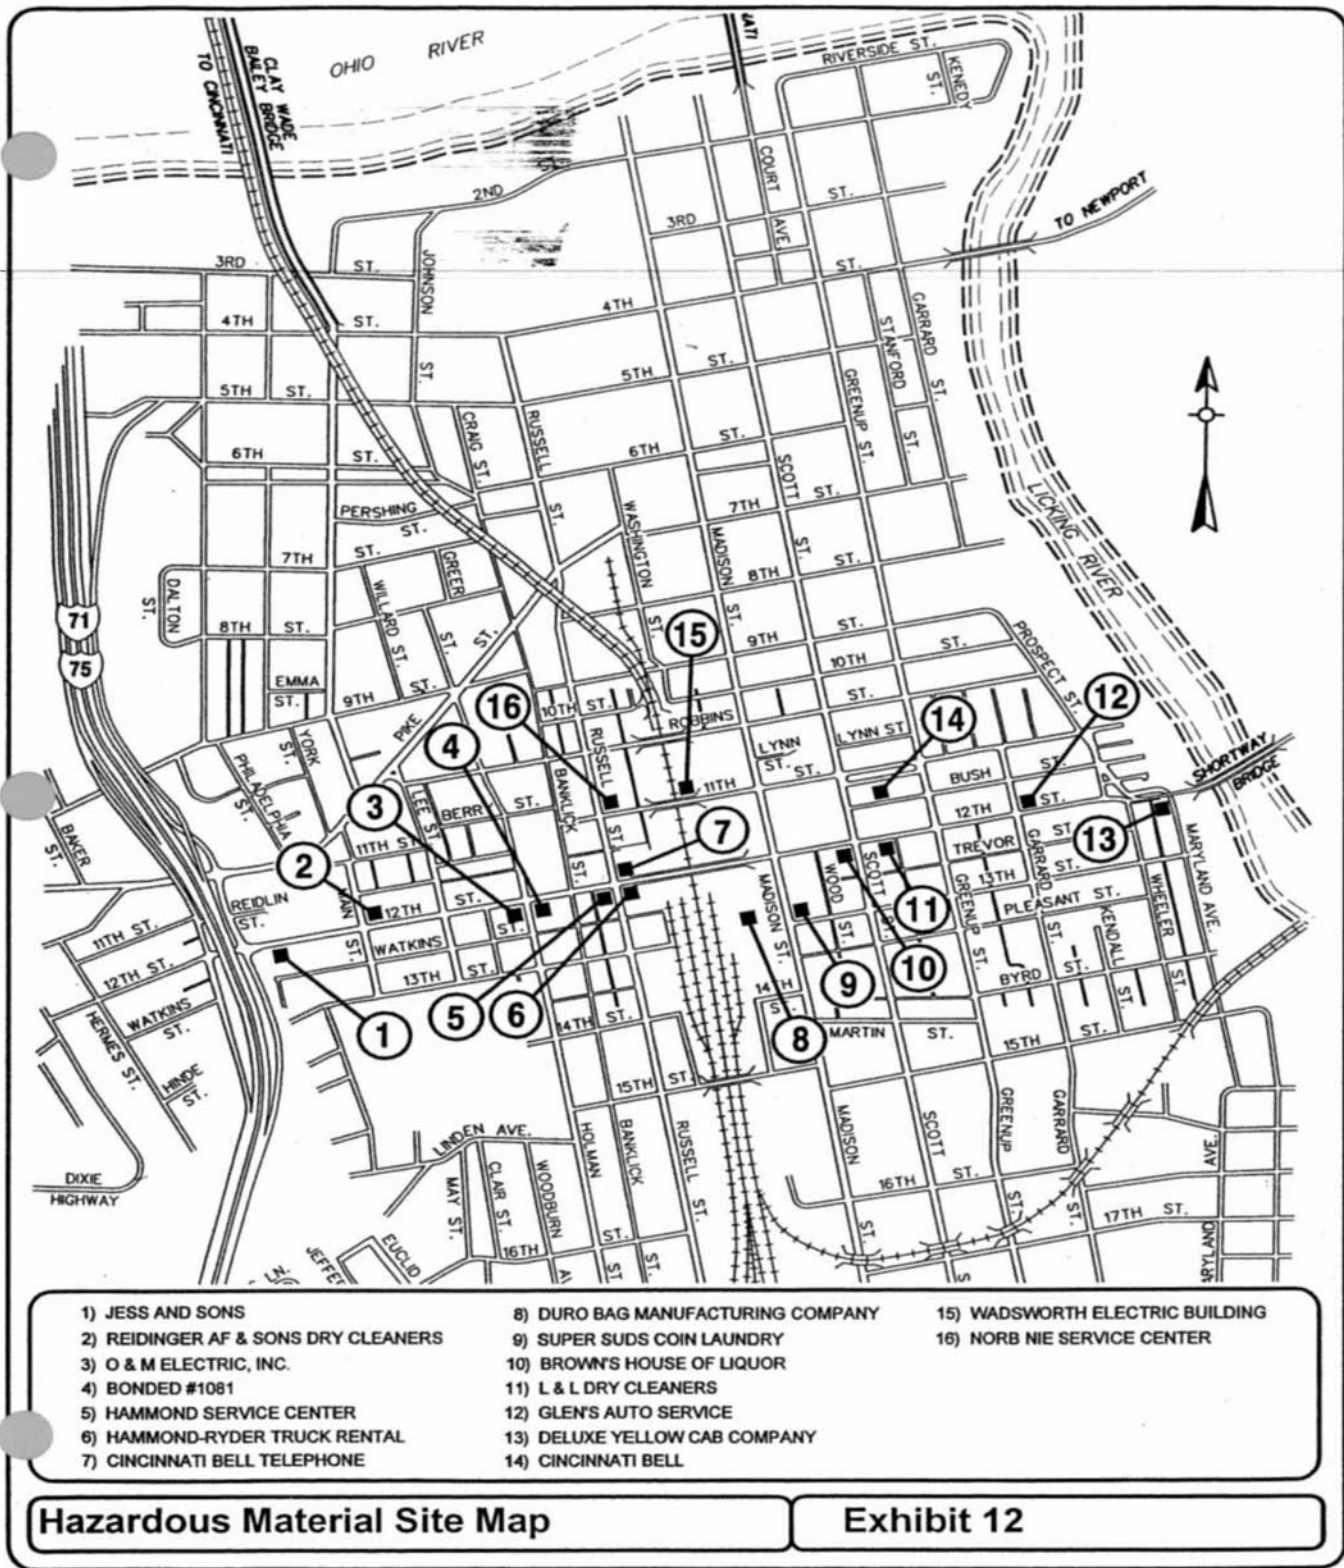
Exhibit 12

Hazardous Material Site Map

Several hazardous material sites were identified with the 12th Street project. These sites will also be a concern for the 11th and 15th Street Bridge projects. Hazardous material sites identified with the 12th Street project in the vicinity of the 11th Street bridge replacement project include the Wadsworth Electric Building and the Norb NE Service Center. A map showing hazardous material sites from the 12th street project can be found in appendix 5. A full survey should be conducted to identify hazardous material sites in the vicinity of the projects.
