DNA Study

Kentucky Transportation Cabinet District 6 Planning Corrin Gulick, PE

06-1074.00 - KY 8 Bridge over Snag Creek

6/2/2011

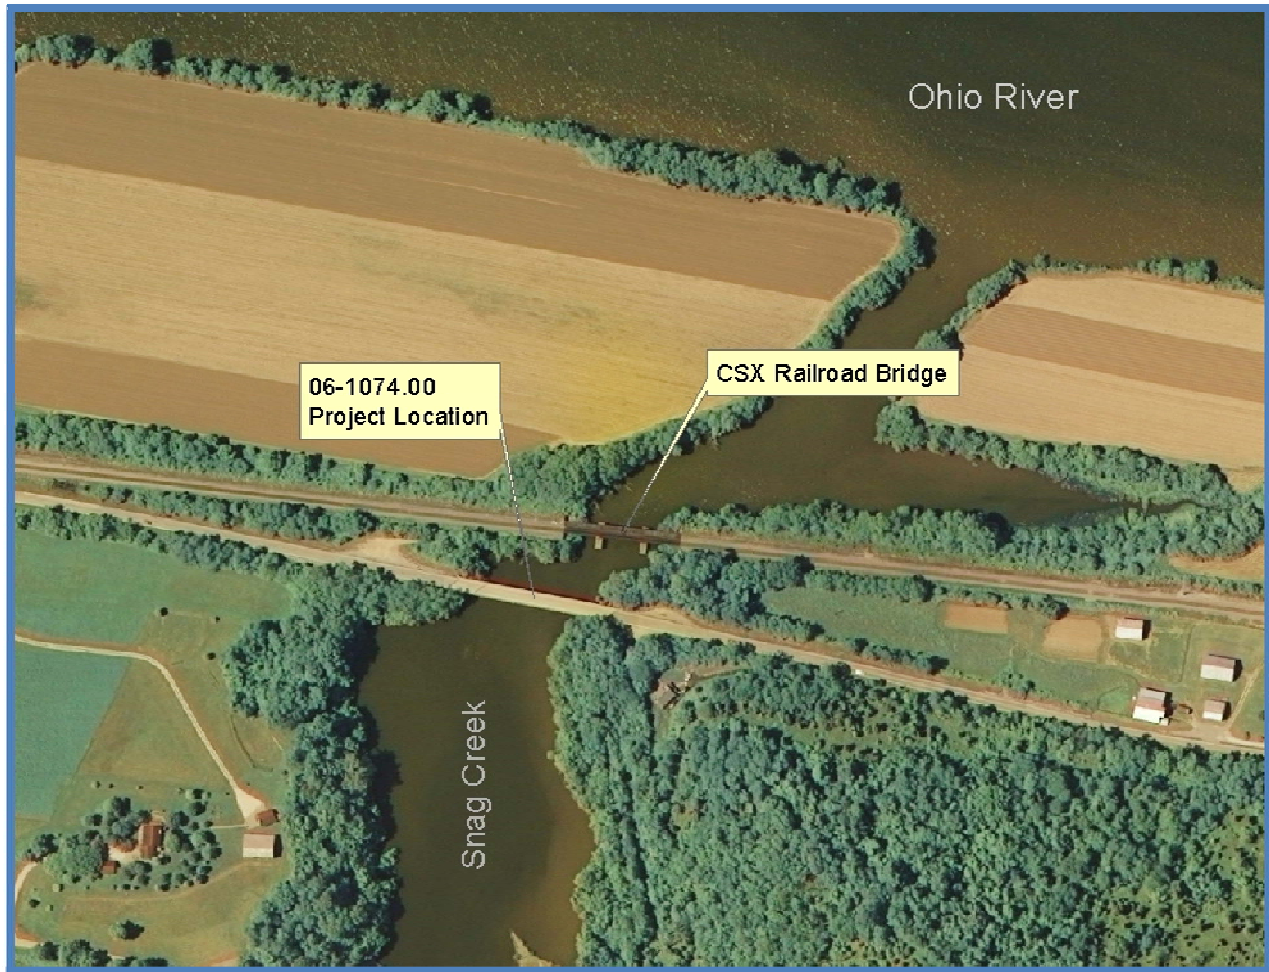
Figure 2 – Aerial of Project Location.

The bridge replacement project studied in this report is located on KY 8 (Mary Ingles Highway), a State Secondary Road located north of KY 9 (AA Highway). KY 8 is a rural, two-lane road that runs parallel to the Ohio River and the CSX Railroad. The bridge is located approximately one mile west of KY 1109 and crosses Snag Creek, a tributary to the Ohio River. This portion of Snag Creek is combined with the backwater from the Ohio River on a year round basis. Figure 2 shows an aerial photograph of the existing KY 8 and CSX Bridges over Snag Creek.

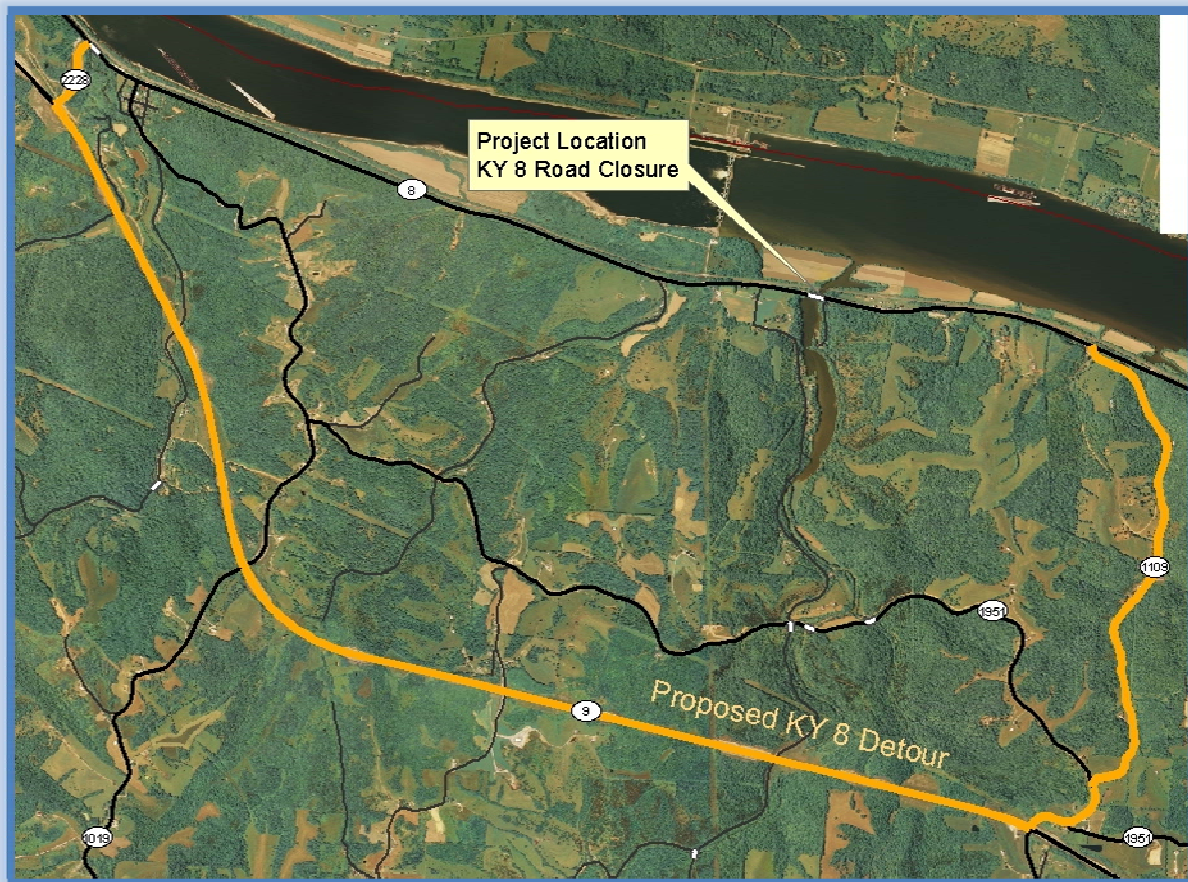
Figure 5 - Proposed Detour Route for KY 8 Closure

This alternate would require KY 8 to be closed during the demolition of the existing bridge and the construction of the bridge. As shown in Figure 5, traffic could be detoured from KY 8 to KY 2228 to KY 9 to KY 1109 to KY 8. This is a total detour of approximately 8 miles. Table 3 shows possible impacts to capacity based on these closures.

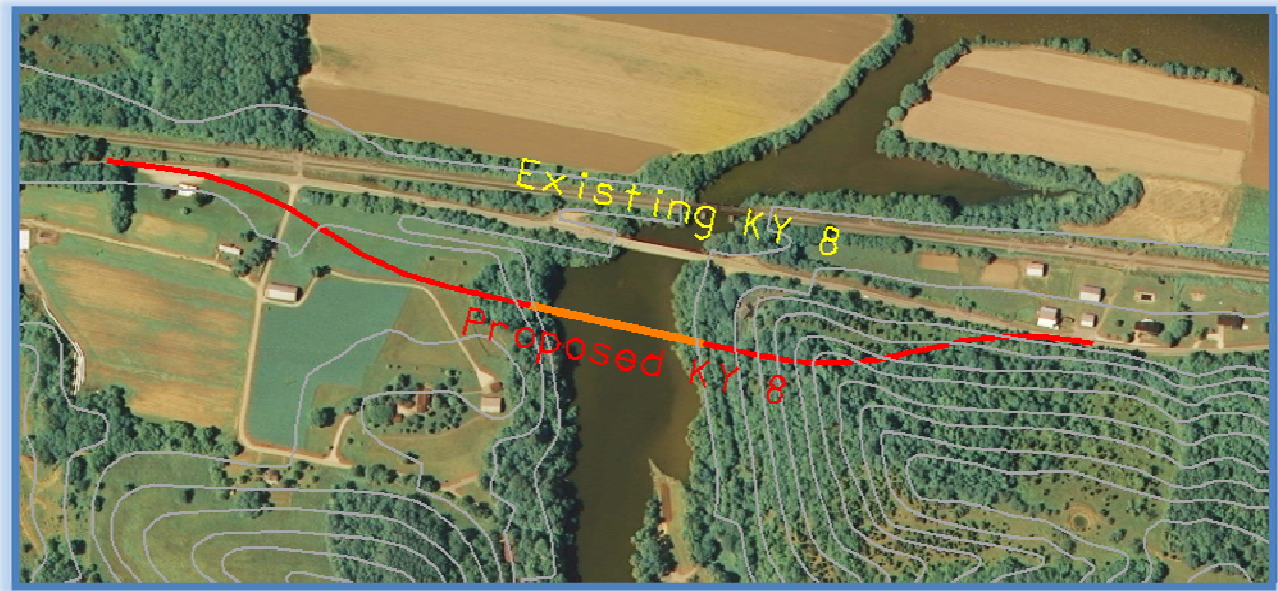
Figure 6 – Preliminary Alignment of Alternate 1

In order to avoid impacts to the CSX Railroad, this alternative shows the new KY 8 alignment to the south of the existing KY 8. The approaches shown in Figure 6 add approximately 0.5 miles of roadwork to the project. However, the actual length of the approaches would be determined during the design process.

Since Snag creek is wider to the south than the existing location of the bridge, the new bridge will need to be longer. The existing bridge is 313 feet in length. If determined by the project team, a hydraulic study could be done to evaluate if the opening for the new bridge would be the same length. The bridge shown in Figure 6 is approximately 550 feet in length.

It is unlikely that the KY 8 Bridge over Snag Creek could be constructed along the existing alignment without a temporary closure of KY 8. Alternate 1 proposes constructing a new alignment for KY 8. The existing bridge could be utilized during construction, eliminating the need for a full closure of KY 8.

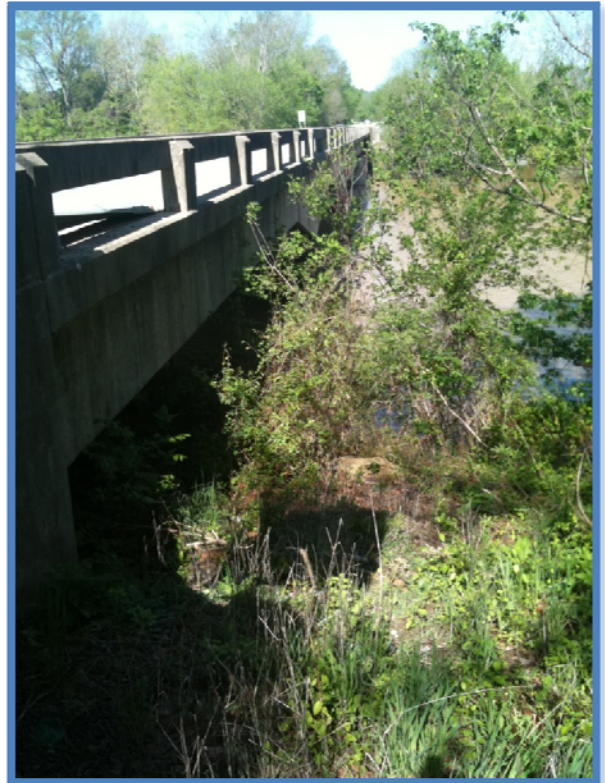
North Side of Bridge Looking West

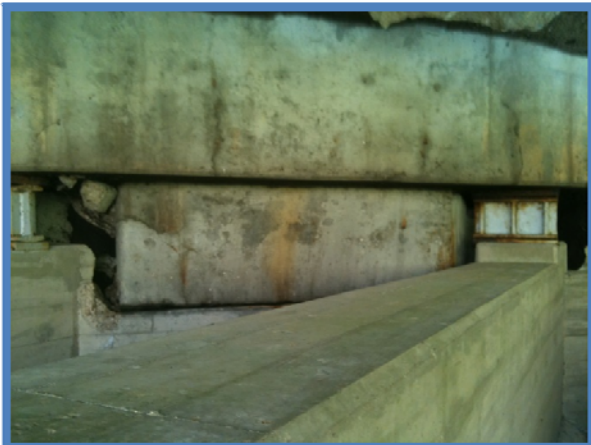
Rockers Under East End of the Bridge

- Advanced section loss, scouring, spalling and deterioration were evident in the structural elements of the substructure.
- Seepage through the expansion joints and general weathering conditions has created issues with the piers, pier caps, abutments and rockers.

- Settlement and heavy amounts of rusting of the moveable bearings has caused vertical and horizontal misalignment throughout the structure.
- There is an existing weight limit on the bridge:

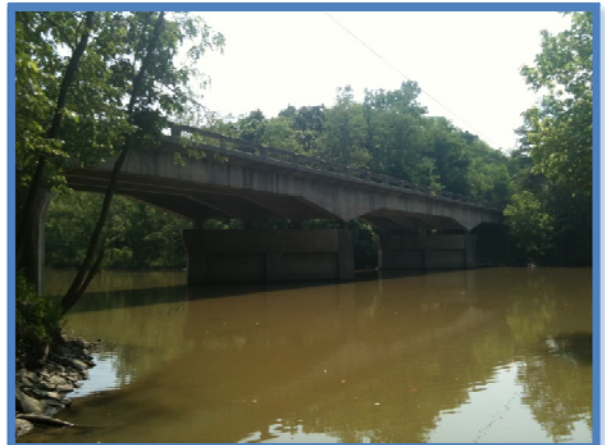
Profile of Bridge Looking South

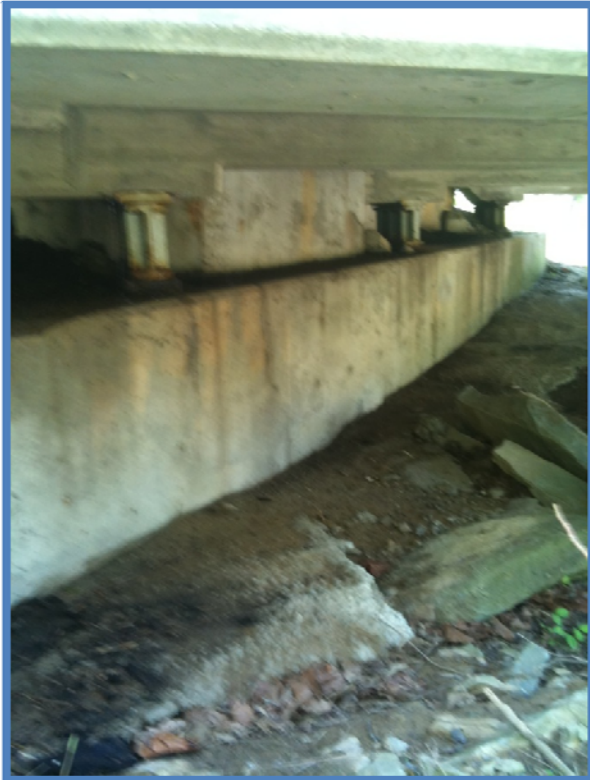
Rockers at East end of the Bridge

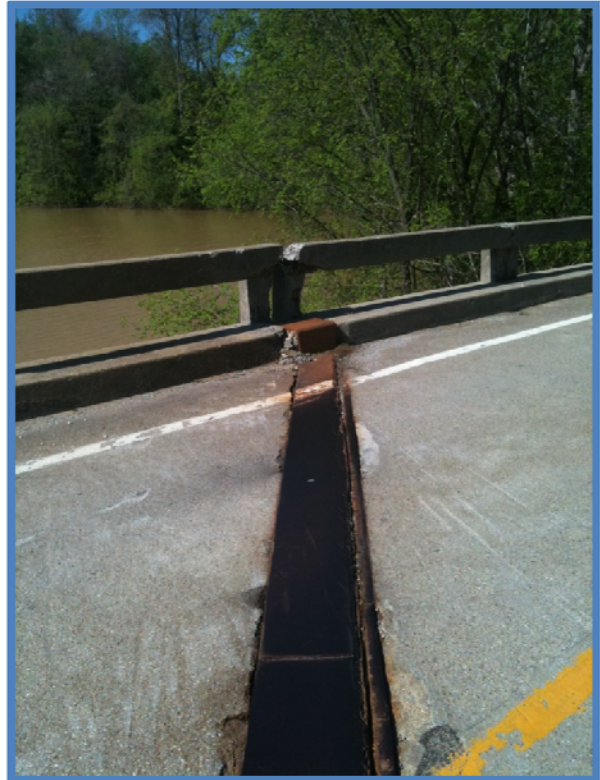
Steel Sliding Plate Expansion Joint

- Seepage through the expansion joints, spalling, cracking, and minor section loss were evident in the superstructure.
- The substructure of the bridge is in poor condition and was given a score of 4 out of 9 (bridges are typically considered for closure once this number drops below a 3).

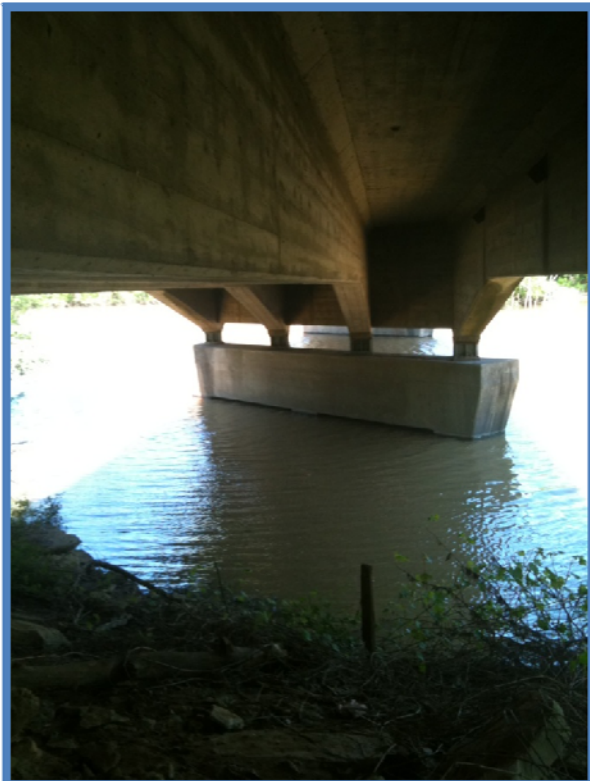
Under Bridge Looking West During High Water Event

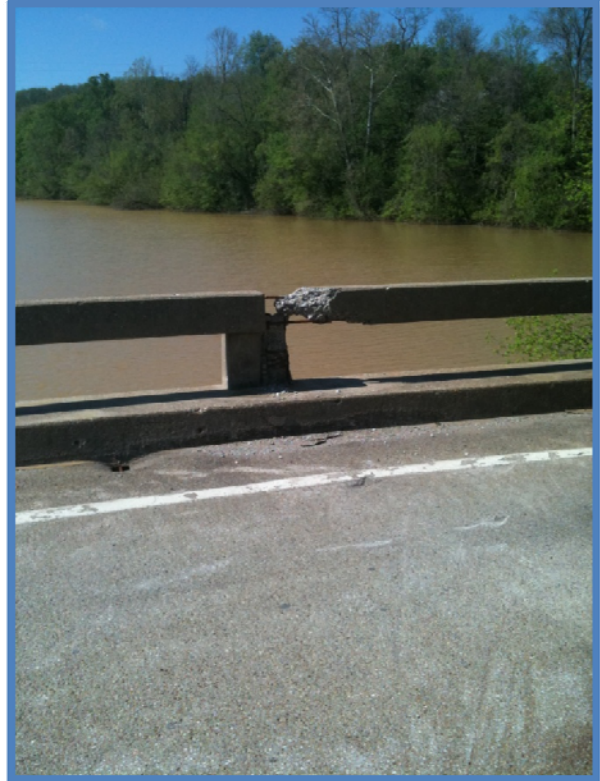
Railing on South Side of Bridge
