DNA Study

06-1075.00 – 11th Street (KY 1120) Bridge

06-1070.00 – 15th Street (CS 2097) Bridge

Kentucky Transportation
Cabinet Department of
Highways District 6

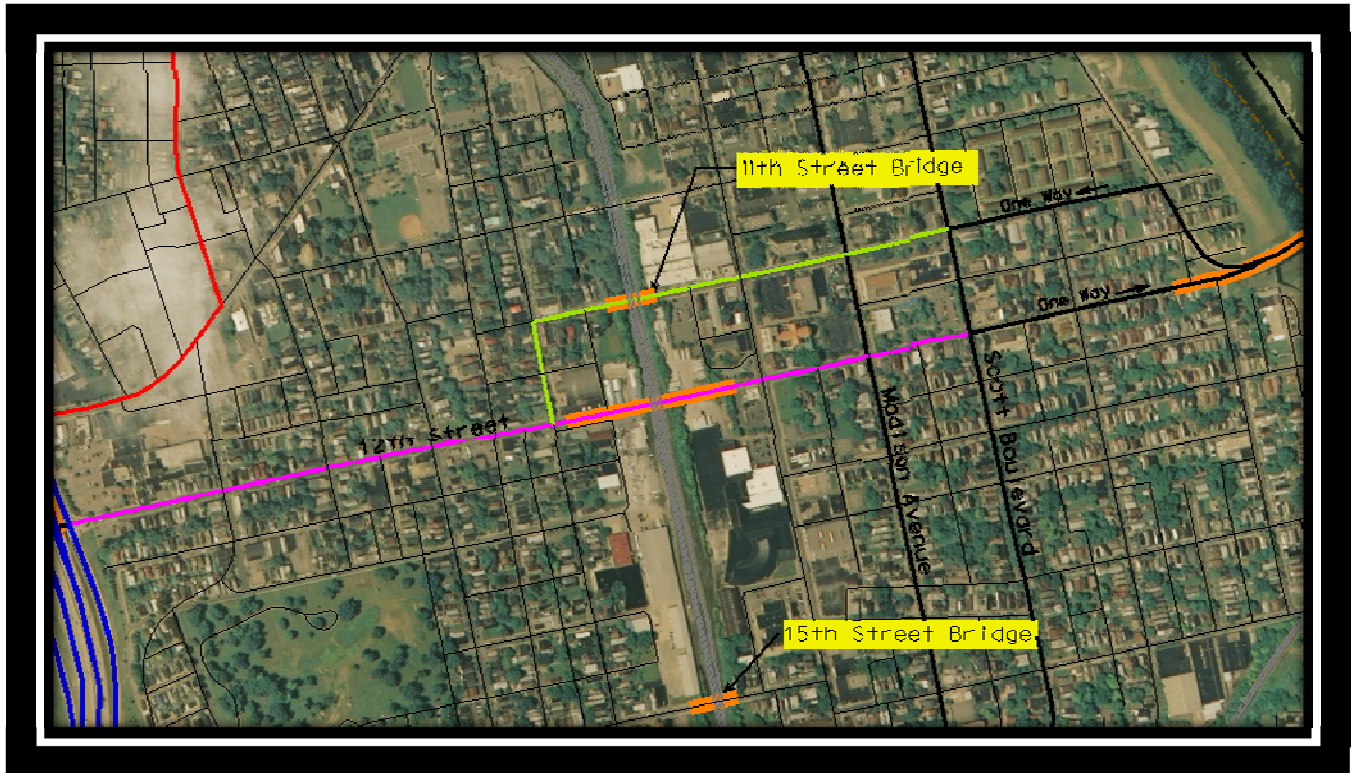
Figure 2 – Aerial view of the project area. The purple line represents the 12th Street widening project, and the green line represents the portion of KY 1120 recommended to be transferred to the local government.

A project to widen 12th Street to two lanes in each direction from Interstate 71/75 to Scott was awarded in construction August 6, 2009. This project is shown as the purple line in Figure 2. Once the project is complete, 12th Street will accommodate two-way traffic for an additional block to the east and the capacity of the roadway will increase. The new limits of the KY 1120 one-way couplet will extend from Scott Boulevard to the bridge over the Licking River.

Since 12th Street will accommodate two-way traffic to Scott Street, KY 1120 from Russell Street to Scott Street will no longer act as part of the one-way couplet. As a result, the Transportation Cabinet recommends converting this segment of KY 1120 (shown as a green line in Figure 2) from a state route to a city street.

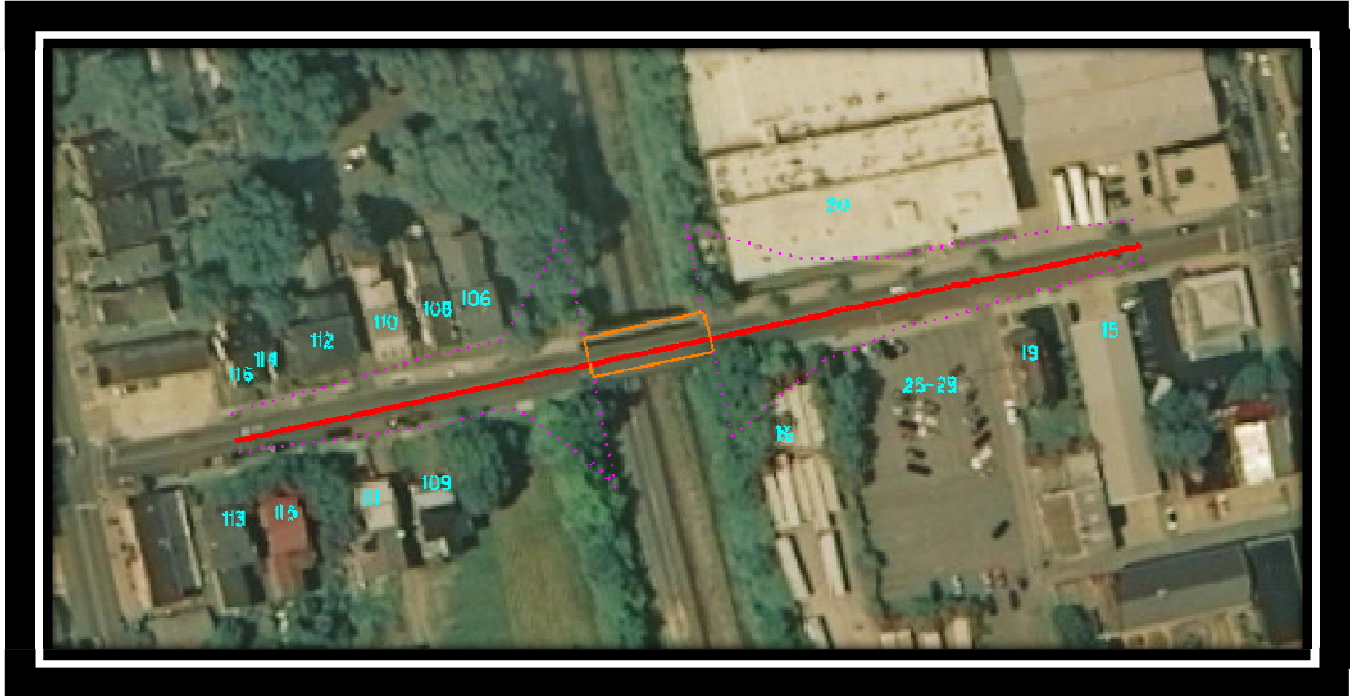
Figure 3 - Preliminary plan view of Alternate 1A. The red line represents the proposed centerline of the new approaches. The orange box represents the proposed bridge, and the purple dotted line shows the approximate disturb limits. The blue numbers depict the addresses of properties along 11th Street.

Alternate 1A, as shown in Figure 3, proposes replacing the existing 11th Street Bridge. The existing 11th Street Bridge does not have sufficient horizontal or vertical clearance. In order to obtain the proper vertical clearance over the CSX Railroad, the new bridge would need to be constructed at a higher elevation than the existing bridge. In order to accommodate the height of the new bridge, the east and west approaches would need to be reconstructed. A design similar to the 12th Street Bridge was considered when determining the disturb limits for this alternate.

The purple dotted line in Figure 3, shows the disturb limits of the east and west approach, assuming a 3:1 fill slope. Most properties along the frontage of the project would be affected by the fill. Consequently, this design would require additional right-of-way and cause historic impacts.

In order to minimize impacts on properties fronting 11th Street, a retaining wall could be considered. However, the height of a retaining wall would impact properties fronting 11th Street. Figure 3 below shows approximate heights of a retaining wall at the center of the frontage along 11th Street. As shown in Figure 3, 16 and 20 11th Street would have an 8.5 to 10 foot wall along the frontage of the property with this alternate. It is important to note that 20 11th Street is the Wadsworth Electric Company.

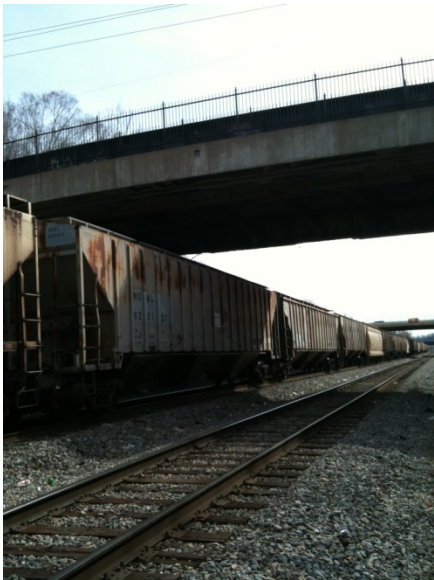
11th Street Bridge from CSX Railroad

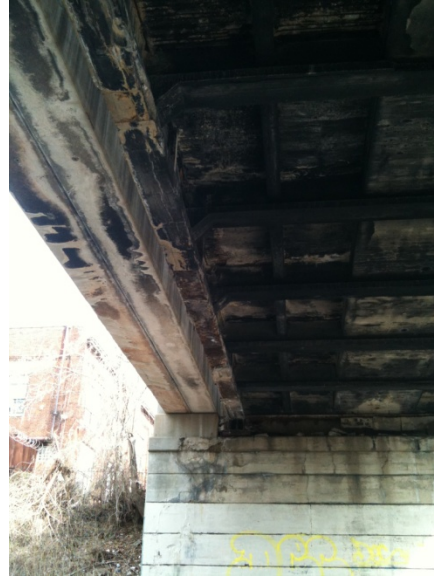
Underneath 11th Street Bridge

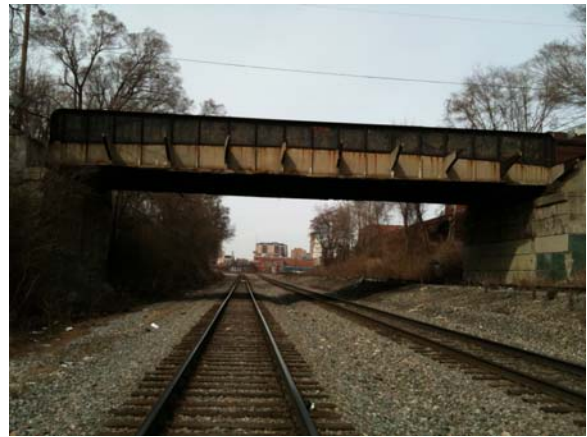
11th Street Bridge from CSX Railroad

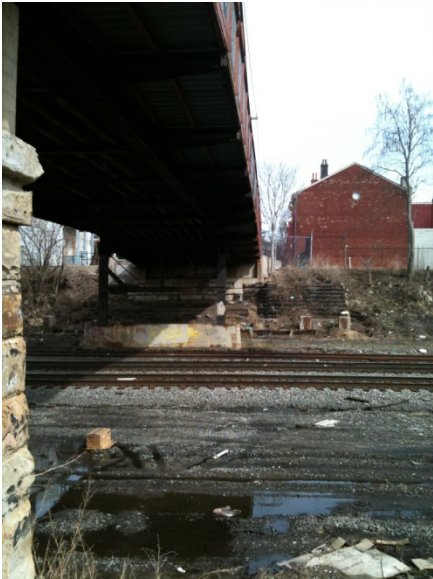
15th Street Bridge Looking East from CSX Railroad

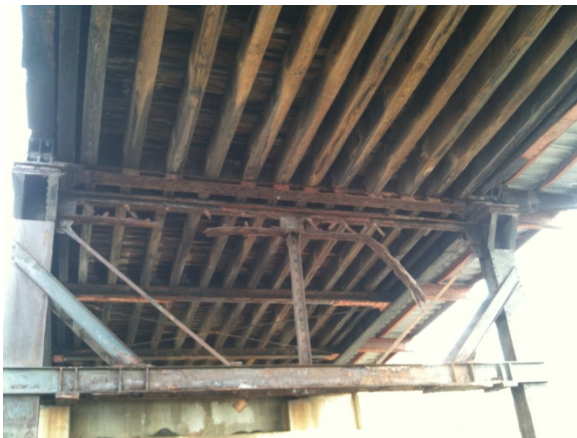
Underneath 15th Street Bridge
