Reconnecting Central Portland to the Riverfront

Appendix B – Transportation Needs

TRANSPORTATION NEEDS

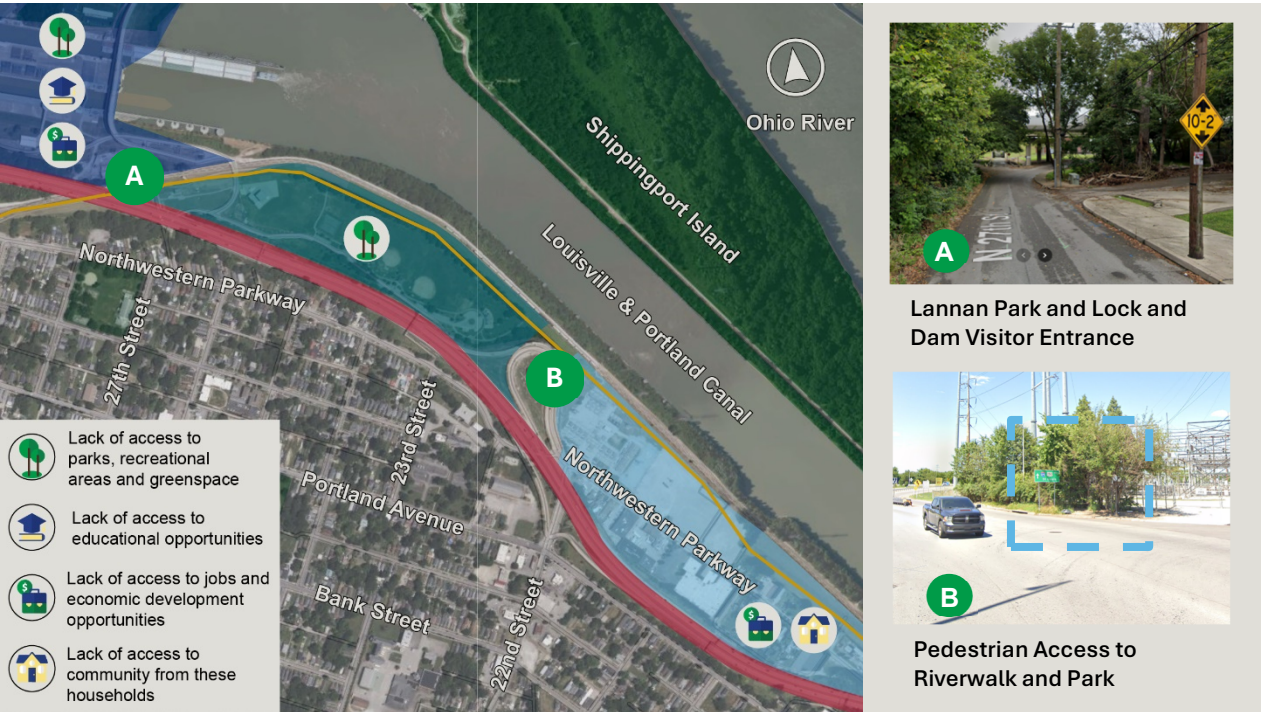
Figure 1: Employment, Recreation and Education Opportunities in Project Area

As illustrated in Figure 1, I-64 separates much of the community from important employment, recreational, and educational opportunities.

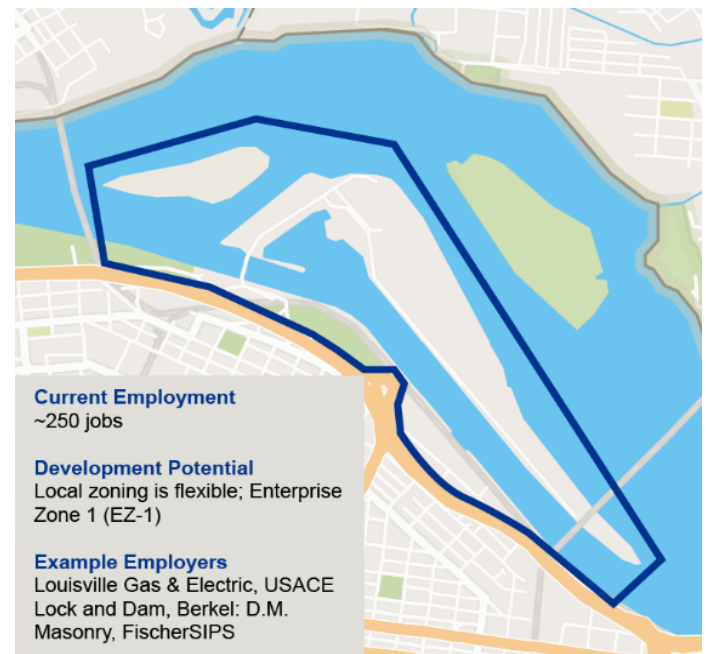
Figure 2: US Census Employment Summary

Development Opportunities – According to the [U.S. Census](#), there are approximately 250 jobs in the hard-to-access areas on the north side of I-64 along Northwestern Parkway (Figure 2), including many well-paying jobs at locations such as the United States Army Corp of Engineers (USACE) McAlpine Lock and Dam as well as manufacturing, construction, and utility firms. Residents need better access to these jobs. This is especially true given that the unemployment rate in the project area is in the 97th percentile according to the [Climate and Economic Justice Screening Tool](#) (CEJST).

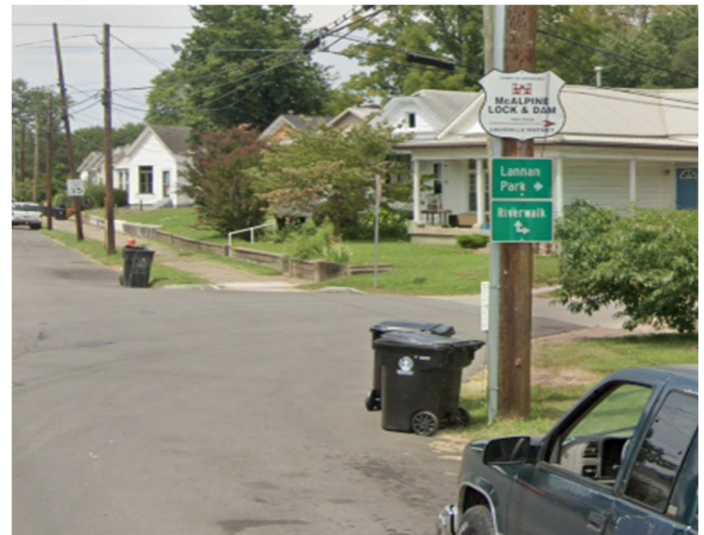
Figure 3: Only Directional Sign to USACE Lock and Dam Visitor Center

The McAlpine Locks and Dam Visitor Center is a unique regional asset that is not easily accessible by members of the community or the region at large. This is an important riverfront resource, which provides educational opportunities and information about the current and historical Ohio River shipping and navigation. The existing entrance is not well signed, see Figure 3. It is also poorly lit and uninviting (see photo in Figure 3).

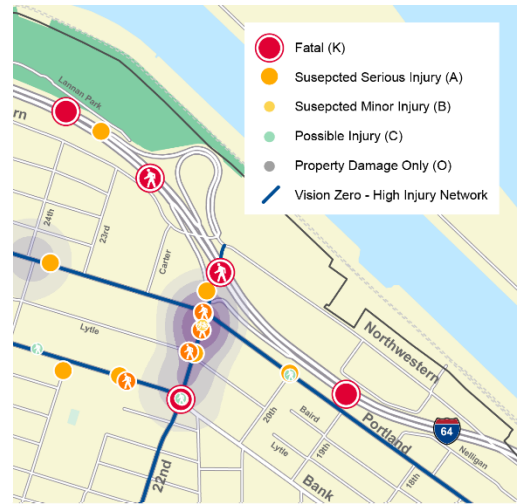
Figure 4: Crashes and the High-Injury Network

Pedestrian and Cyclist Safety – In the five-year period from 2019 to 2023, there were ten pedestrian and bicycle crashes in the vicinity of 22nd Street in the project area. Four of these were serious pedestrian injury crashes. Two were fatal pedestrian crashes that occurred on the interstate and appear to have involved pedestrians crossing the interstate and/or walking in the travel lanes. The primary project area census tract (CT) was identified as the 12th highest risk CT in the state for pedestrians and cyclists ([2023 KY Vulnerable Road User \(VRU\) Safety Assessment](#)). 22nd and Lytle St was listed as the 21st highest risk unsignalized pedestrian location in Louisville ([Understanding Pedestrian Crashes Report 2011-2020](#)). 22nd St and Portland Ave is also a high-priority pedestrian safety intersection. As evidenced by the high number of pedestrian crashes, all of the 22nd Street intersections within the project area are difficult for pedestrians and cyclists to safely navigate. Additionally, the 22nd Street and Portland Avenue intersection is a high priority KYTC Highway Safety Improvement Program Vulnerable Road User upgrade location.

Vehicular Safety – The 22nd Street corridor is the highest crash-density corridor in the Portland neighborhood. From 2019 to 2023 there were 119 crashes in the under half-a-mile section, including one fatal crash, seven severe injury crashes, and 17 minor injury crashes. A KYTC safety analysis showed that the 22nd and Portland Ave and 22nd and Lytle St intersections have experienced more crashes annually than would be expected,

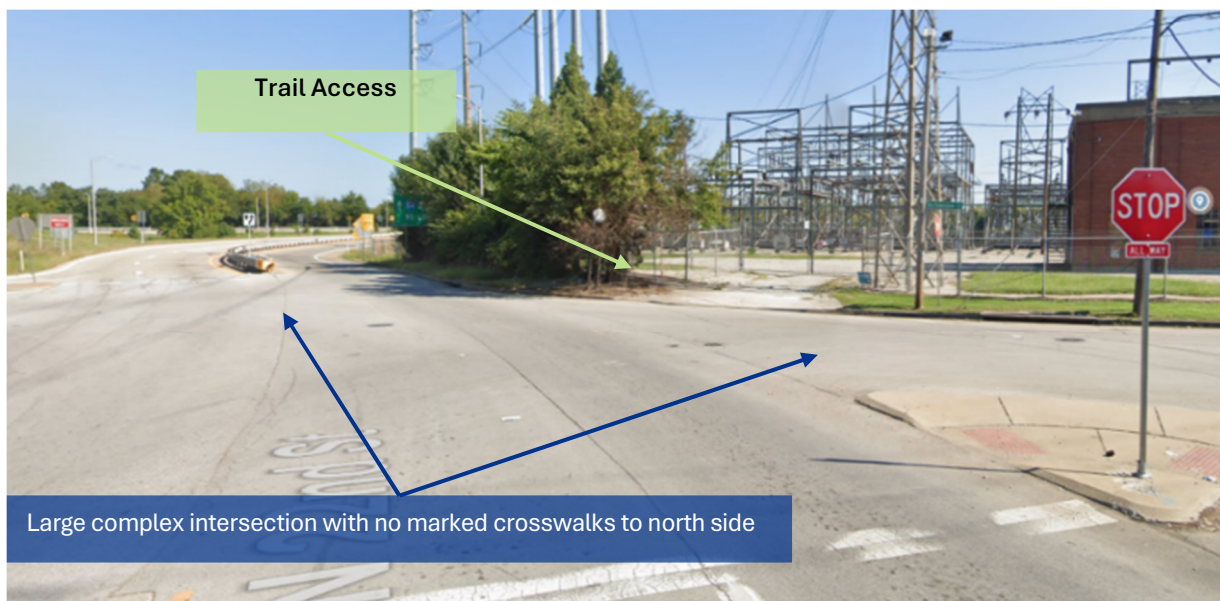
Figure 6: Trail Access at 22nd Street intersection

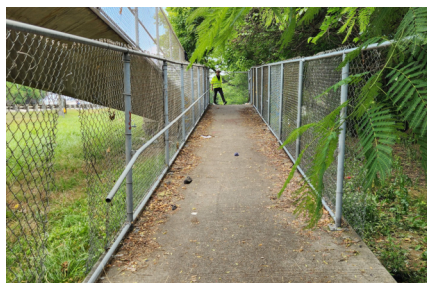
Damaged Fence on approach to Pedestrian Bridge

Figure 8: Pedestrian bridge approaches and 27th Street underpass

Pedestrian Bridges Near 19th and 23rd Streets – These bridges over I-64 have a width of approximately 6 feet 10 inches between the hand railings. This width does not meet the current shared-use path guidelines of a minimum usable width of 10 feet (desirable) or an absolute minimum of 8 feet to allow for pedestrian and bicycle traffic to pass concurrently. With railings present, the actual width should be 10 feet between the railings to account for 1 foot of shy distance from the railings to yield an absolute minimum usable width of 8 feet. The bridges are also in need of critical upgrades (Figure 8).

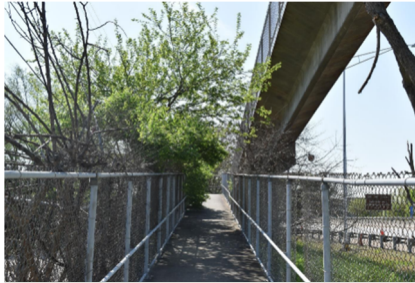
Narrow pedestrian bridge / ramp

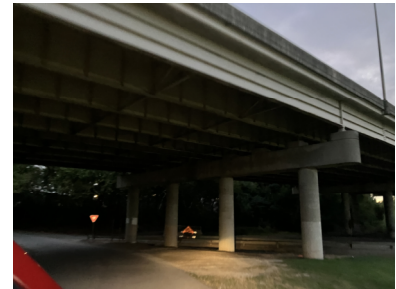
27th Street underpass no overhead lights

27th Street – This underpass that leads to the entrances to Lannan Park and the McAlpine Locks and Dam has a sidewalk which is adjacent to the roadway curb on one side and hand railing on the other, limiting the usable width of the sidewalk due to people’s natural tendencies to shy away from barriers. There are also drainage issues in this area, which when addressed would alleviate standing water and the need for the railing, and also improve the sometimes-unpleasant odor in this area. There are open ditches with steep slopes adjacent to the sidewalk, and using buried stormwater pipes to convey the runoff would allow the steep slopes to be filled in and more level with the sidewalk, eliminating the need for the railing, the standing water, and foul smells associated with the standing water. Additionally, there is no lighting under the I-64 bridge in this area making the area undesirable and uninviting for pedestrians and bicyclists (Figure 8).
