# **APPENDIX A - BRIDGE REPORTS**

### **KYTC Bridge Inspection Report**

059B00037N

Repairs to 4th Street Bridge over Licking R.

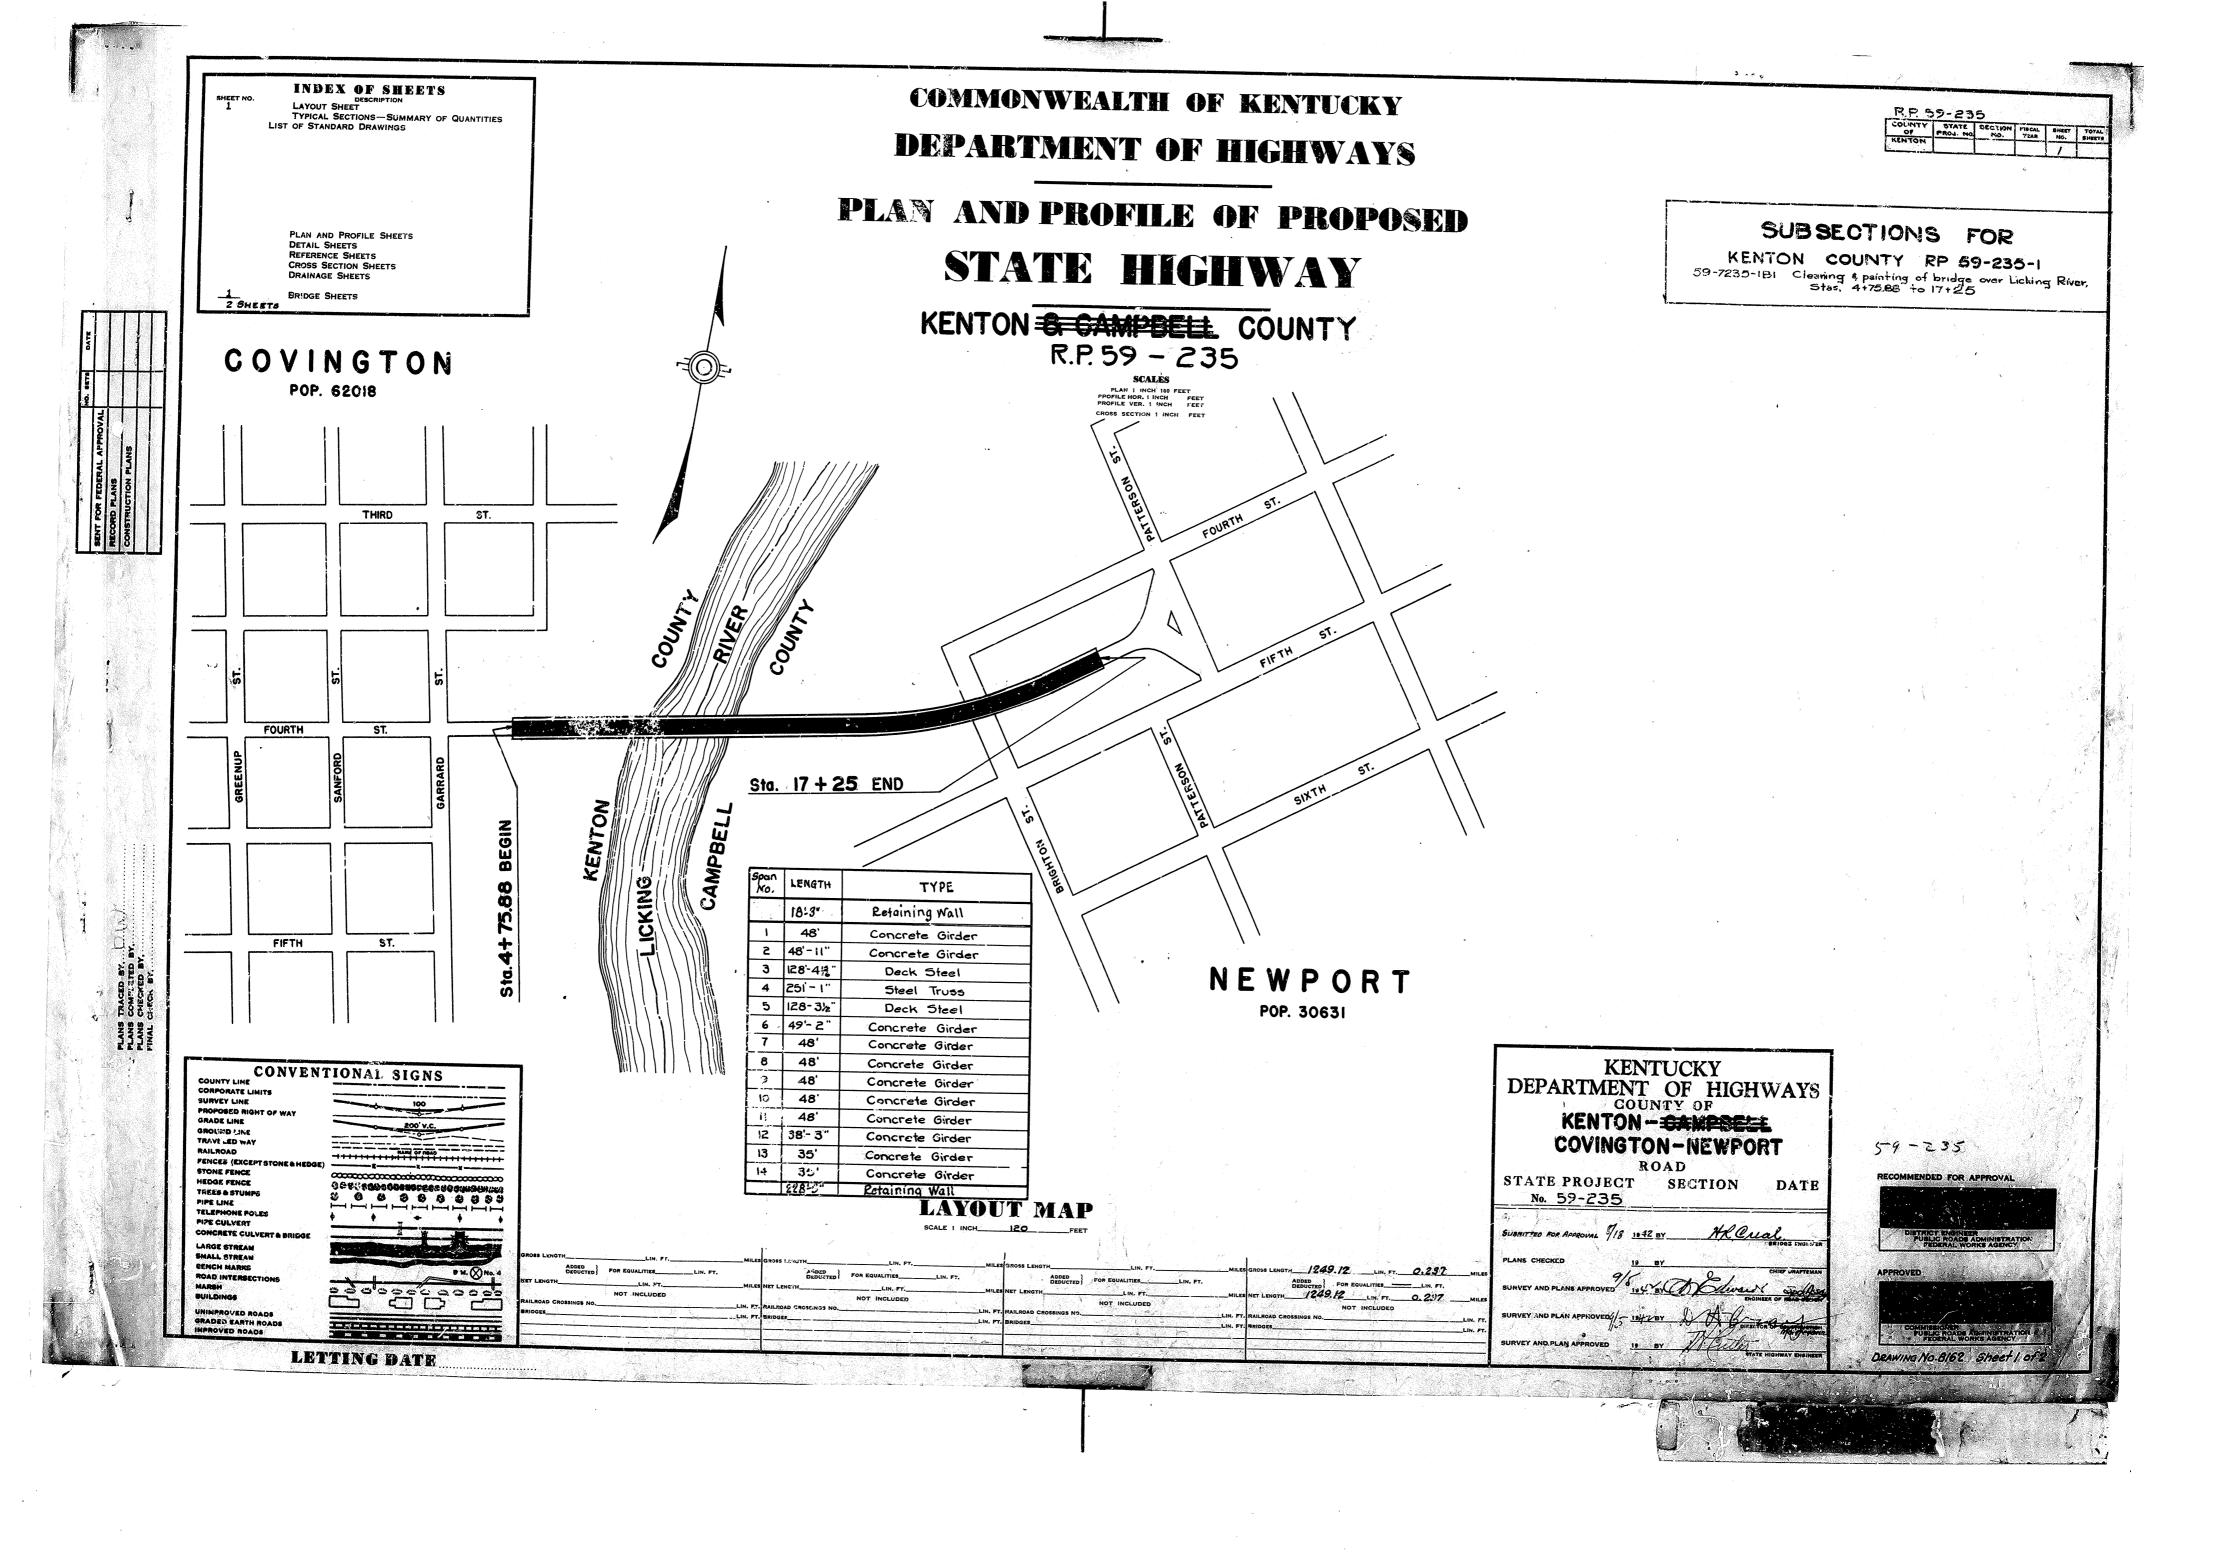
1002-176 Out to out of Spons 228-9" Retaining Wall To COVINGTON TO NEWPORT PIER 9 PIER IO PIER II PIER IZ PIER I3 ABUT. 2 SPAN 4 H PIER I PIER 3 PIER 4 **ELEVATION**

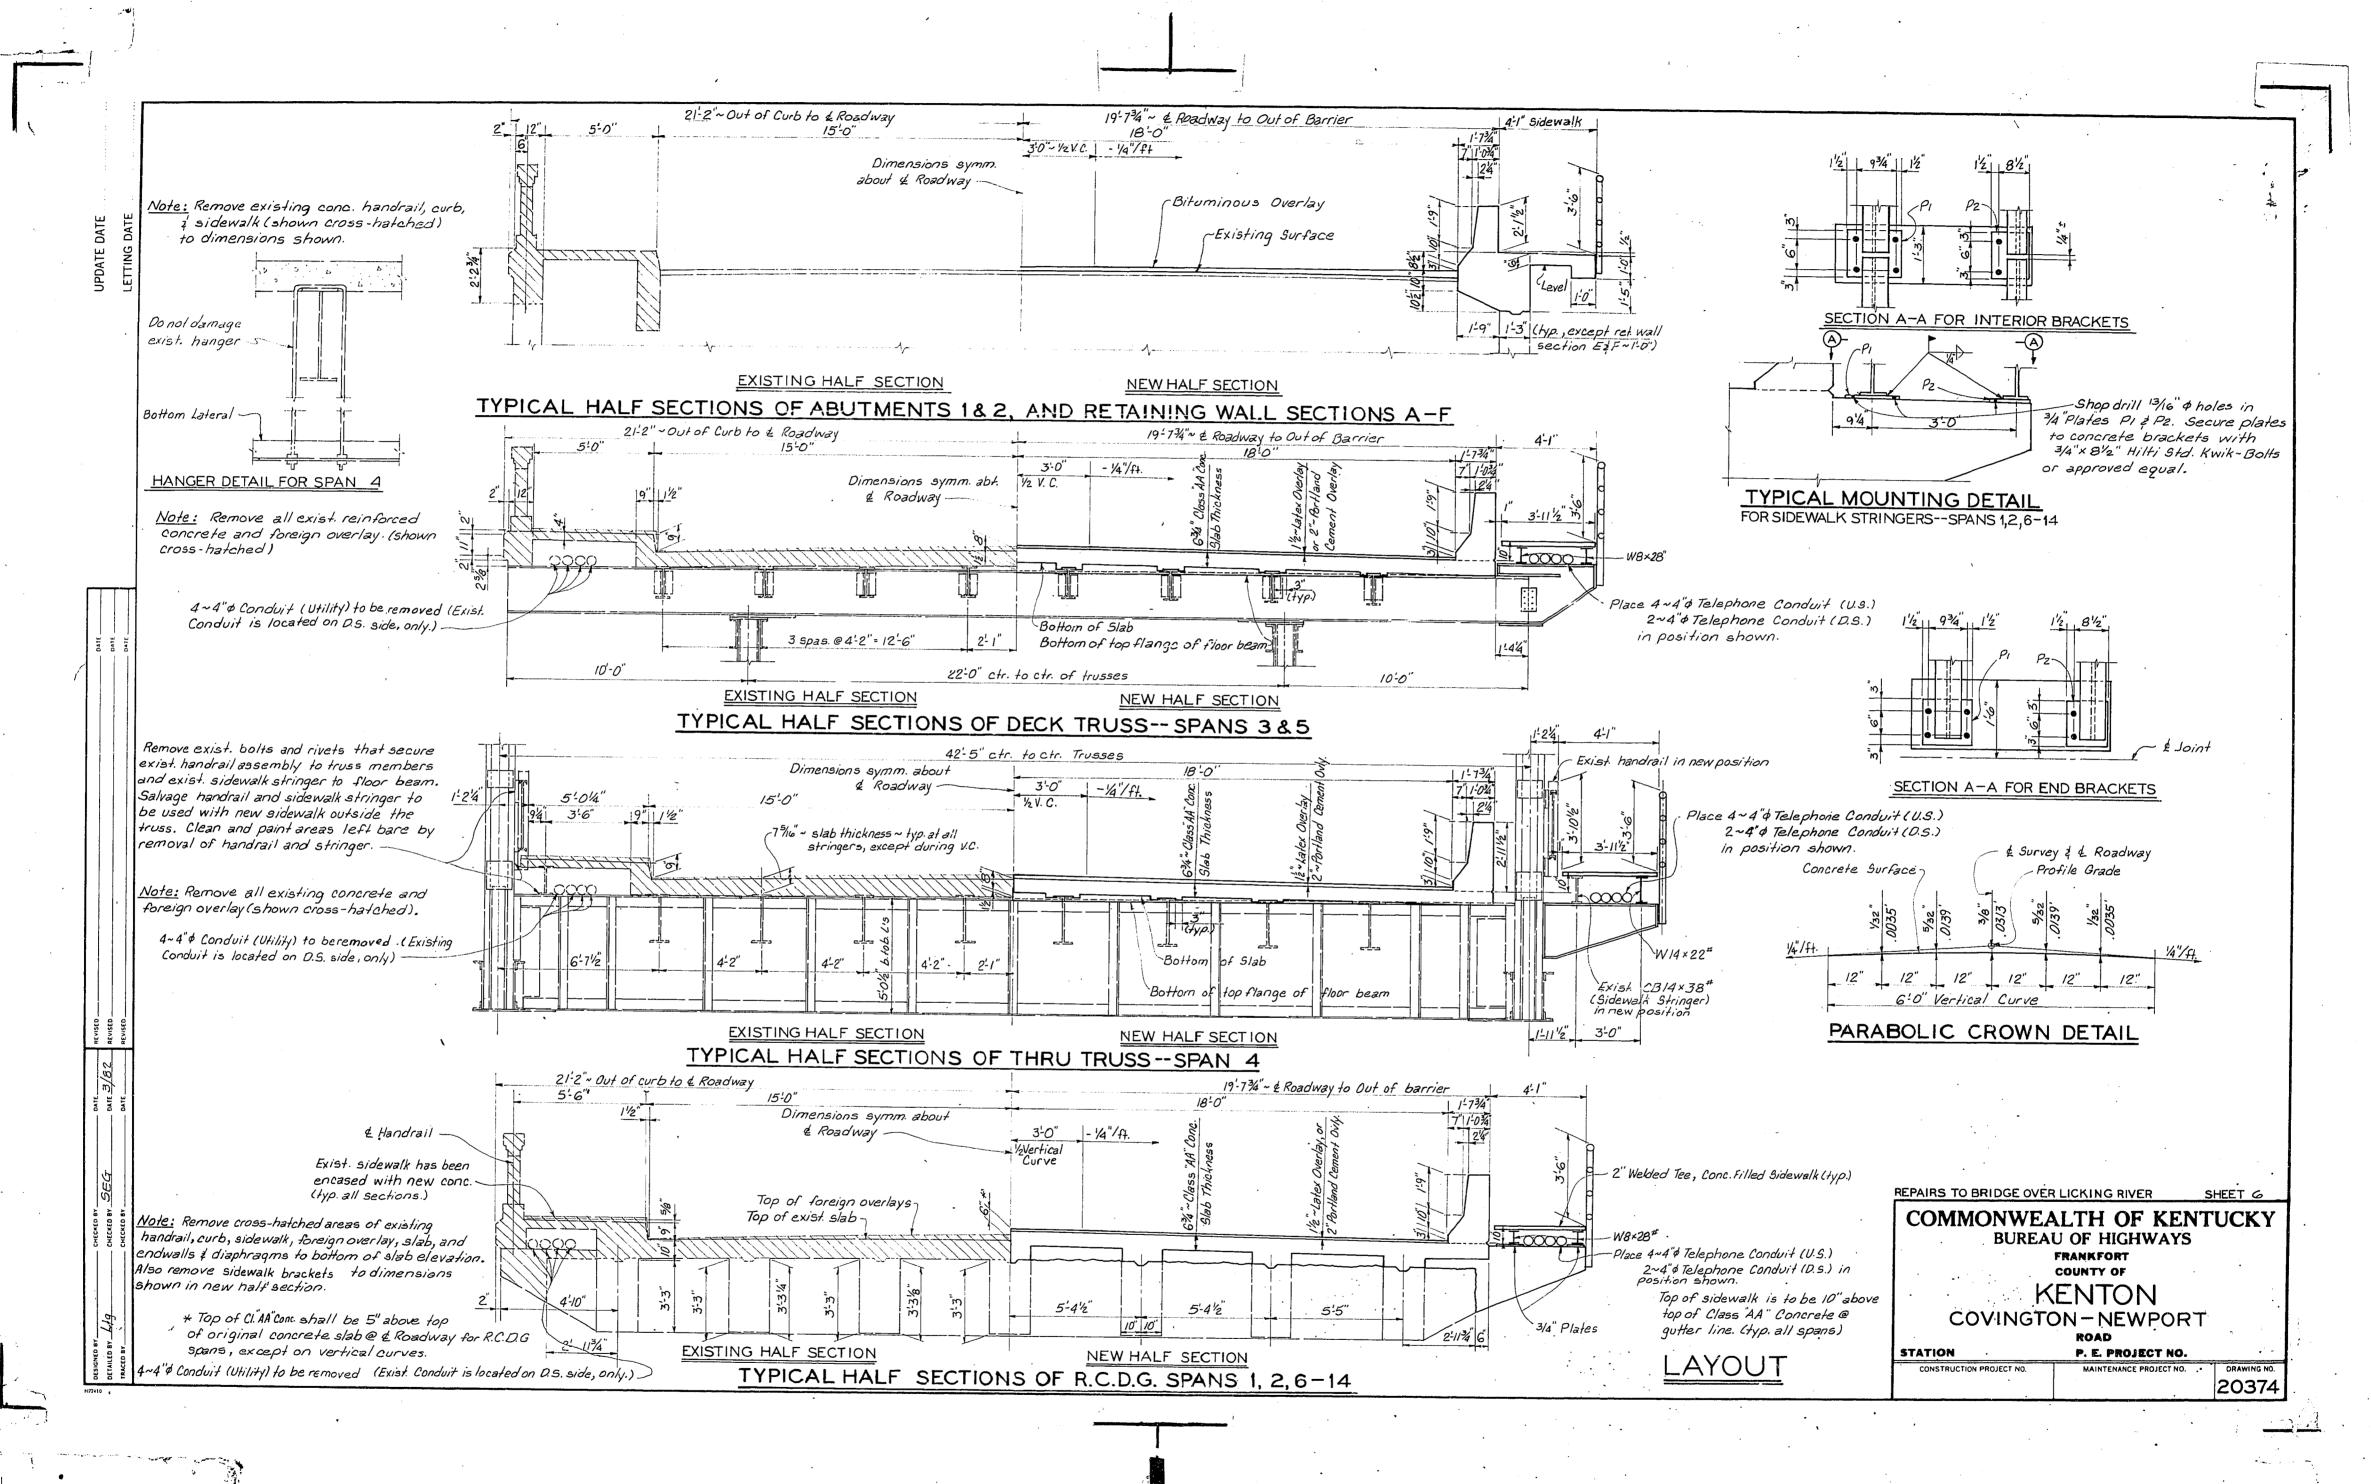
BUREAU OF HIGHWAYS
FRANKFORT COUNTY OF KENTON COVINGTON - NEWPORT
ROAD
P. E. PROJECT NO. STATION 9+95.19 LAYOUT 20374

Profile grade elevations for the bridge shall be established with the 0.0% grade on Span 4 being 0.938' above the top of floor beams. (Profile grade for "AA" Concrete) 1002'-17/6" Out to Out of Slabs 228-9" Retaining Wall Meas along & Roadway +1.25% Grade 105'-8" Vertical Curve 75-10" Vertical Curve Level Grade (0.0% Græde) -4.4% Grade New Grades 64'-0" V.C. +1.25 % Grade Level Grade (0.0% Grade) -4.4 % Grade Existing Grades 18'-3" 48'-0" 48'-11" 25/-/" 37-11" 2"Neoprene Exp. Jt. 2"Neoprene To Covington To Newport 18"Jt, 18" Jt, 18"Jt, 18"Jt, 18"Jt, 18"Jt, ABUT. 1 Relocate bracket for Green navigation Light PIER 11 PIER 12 PIER 13 ABUT, 2 A B C D E
RETAINING WALL SECTIONS Exp. PIER 6 PIER8 PIER PIER 2 Note: A grade on approaches shall be determine by the Engineer. Apply masonry coating finish to existing concrete (See Sh. 9-12 \$ 30) PIER 4 **ELEVATION** Clean & Paint all existing steel. CURVE DATA Widen approach roadway with new curb a gutter and sidewalk. Δ = 23°-52'-30" C = 6°-00'-00" Left T = 201.888' L= 397.917' R= 954.930' Barrier Transition, see sheet 17 To Covington 49'-2" 48'-0" 48'-0" 48'-0" 48'-0" 48'-0" 48'-0" 38'-3" 35'-0" 35'-0" 18'-9" 35' 128'- 415/16" 251'-1" Barrier Transition <u>PLAN</u> Widen approach roadway with new curb & gutter and sidewalk. Note: See Sheet 6 for Typical Sections. DATE DATE REPAIRS TO BRIDGE OVER LICKING RIVER COMMONWEALTH OF KENTUCKY
