# Appendix F

## **Additional Safety and Operational Improvement Concepts**

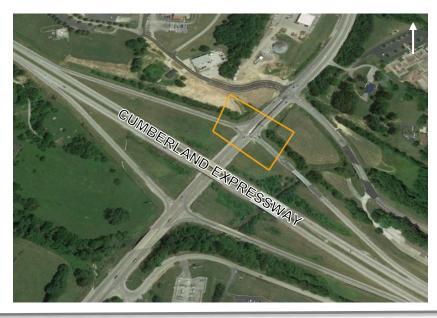
Location of new traffic signal at ramp terminal (left).

**Purpose:** Signalize the Exit 11 (US 31E) westbound ramp terminal.

• The westbound ramp terminal at Exit 11 (US 31E) currently experiences significant delays and queueing during the AM peak.

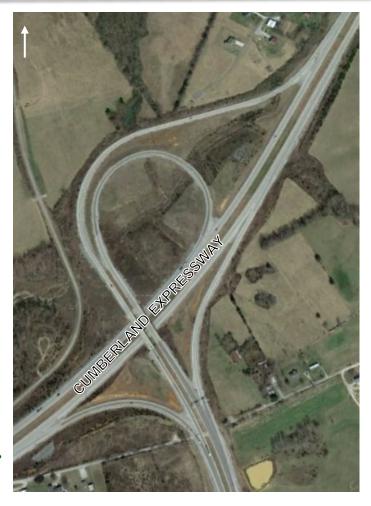
Example of high friction surface treatment (left) [FHWA].

Continue high friction surface treatment on eastbound to southbound ramp (right).

*Improvement Strategy:* Run off road crashes can be prevented with high friction surface treatment for vehicles at high speeds under normal conditions or vehicles driving too fast for weather conditions.
