Leitchfield-Clarkson Small Urban Area Study

Grayson County, Kentucky

Kentucky Transportation Cabinet

July 2011

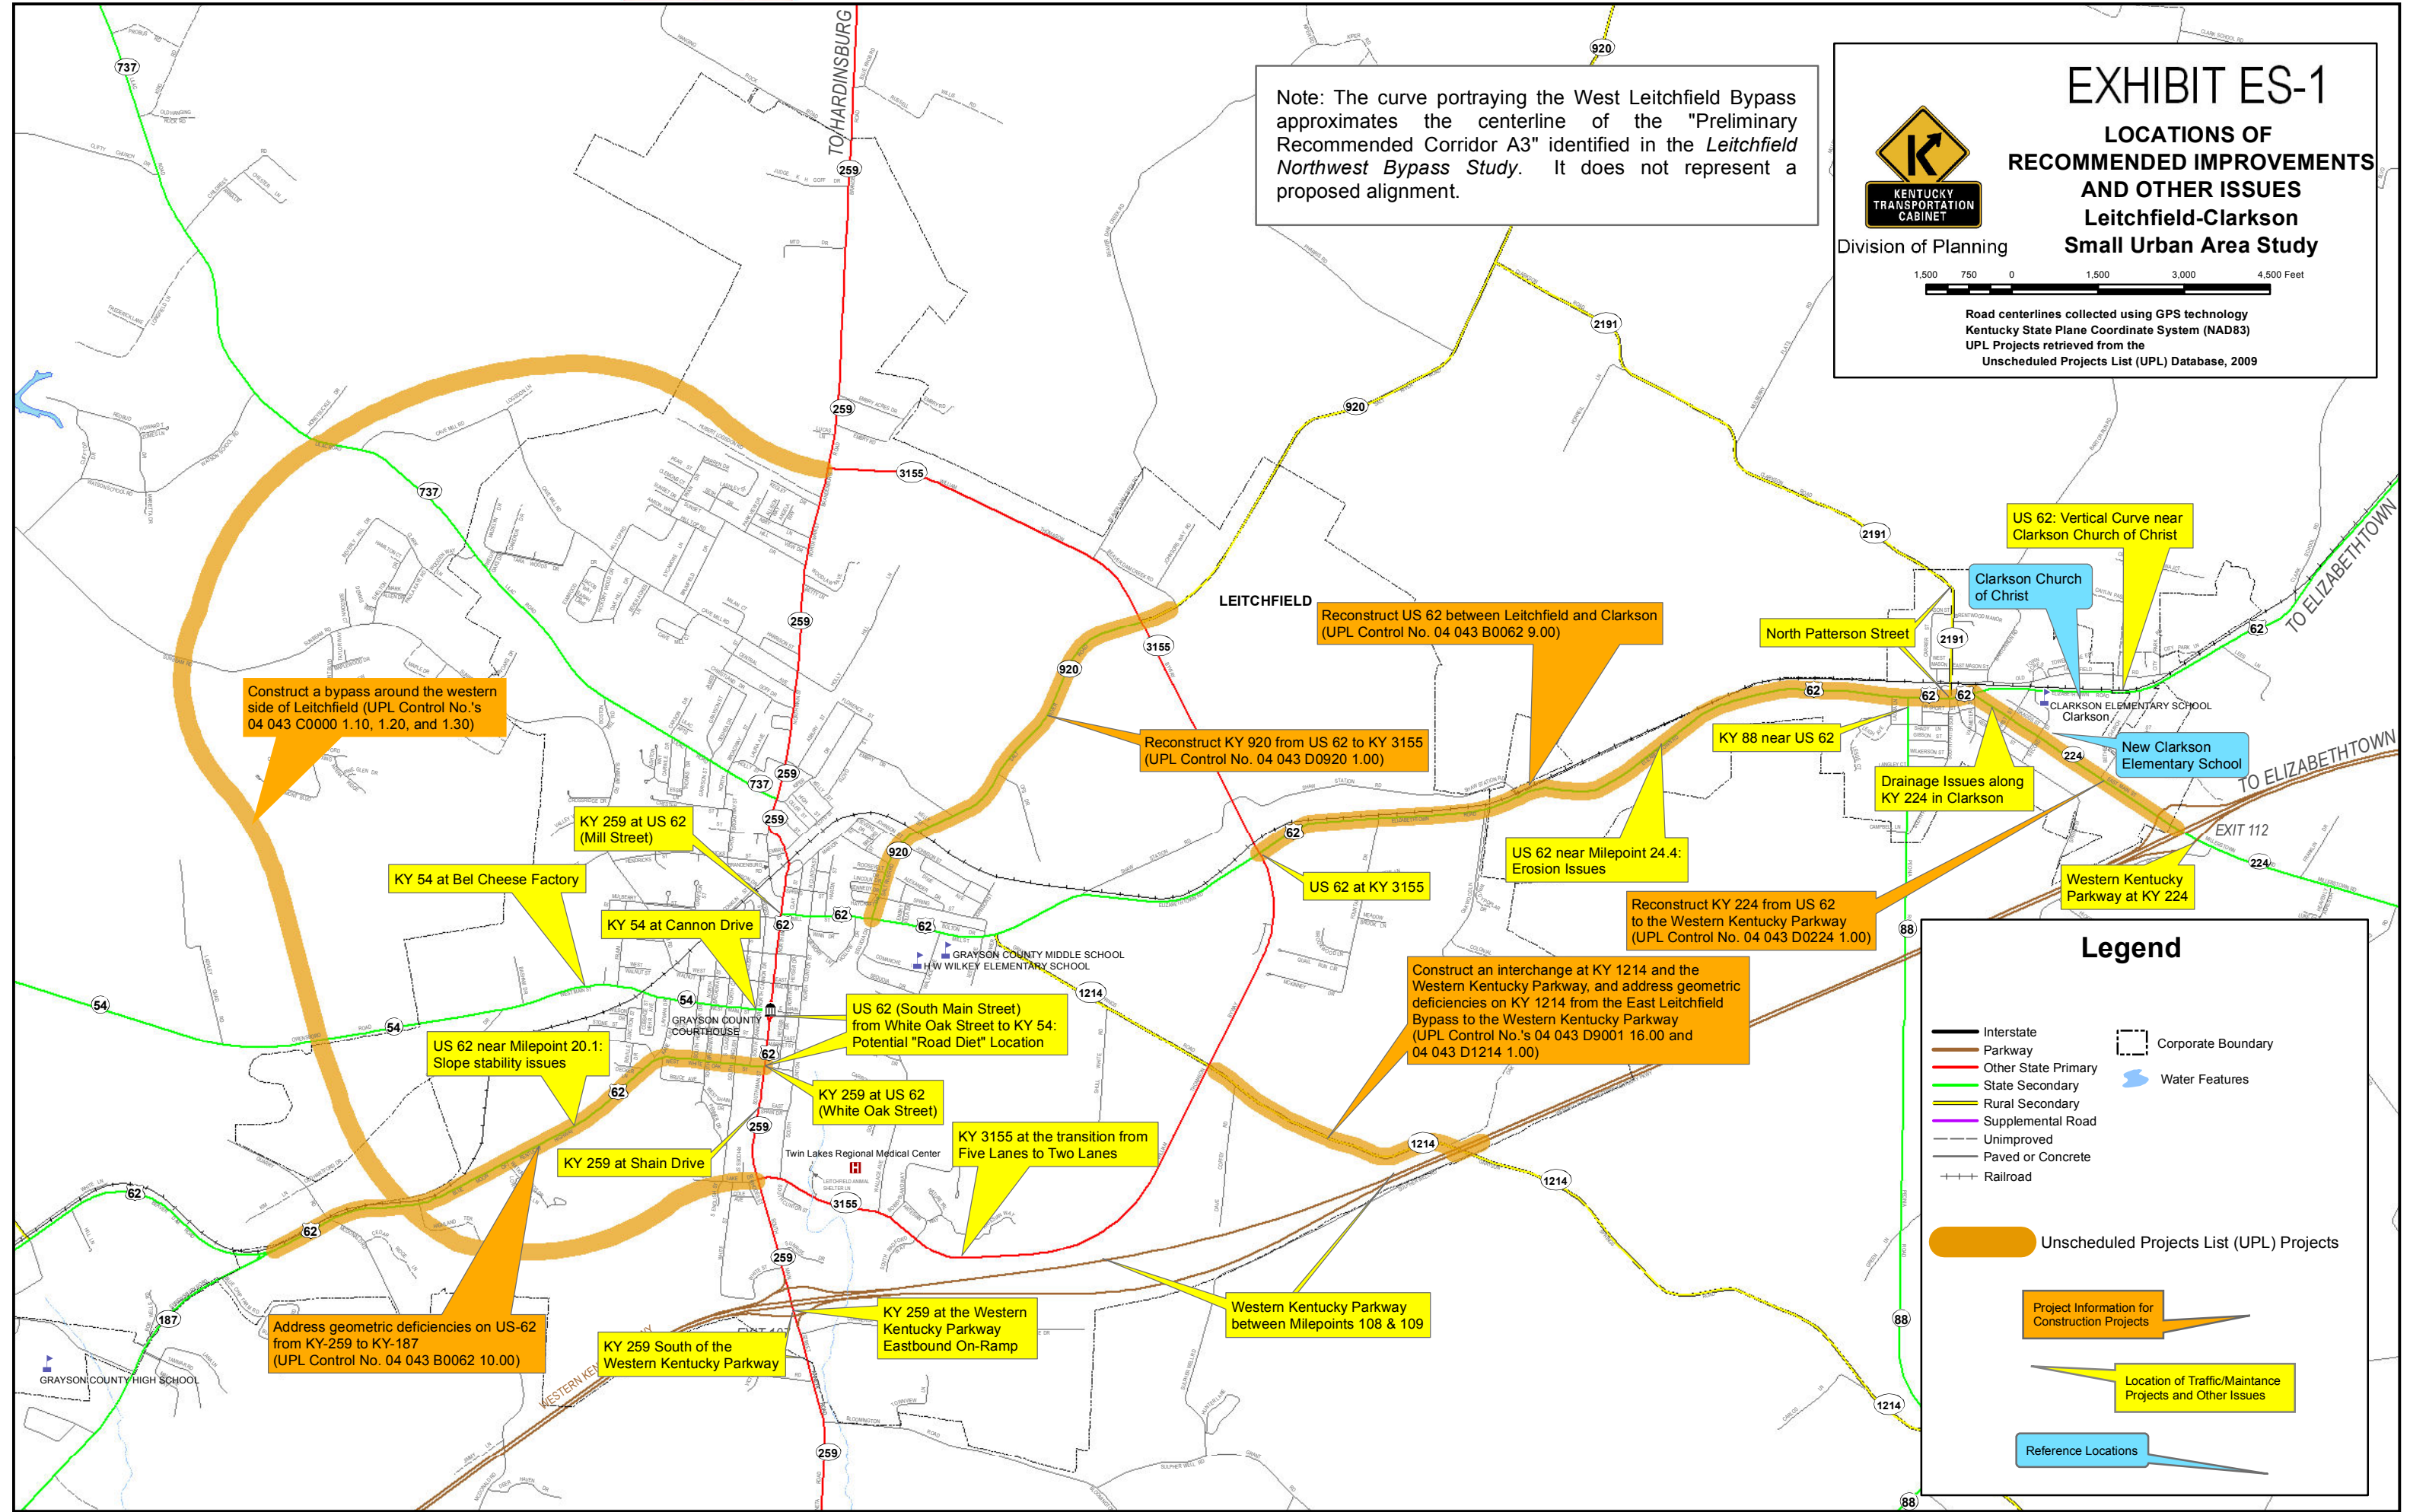
EXHIBIT ES-1
LOCATIONS OF RECOMMENDED IMPROVEMENTS AND OTHER ISSUES
Leitchfield-Clarkson Small Urban Area Study

Road centerlines collected using GPS technology
 Kentucky State Plane Coordinate System (NAD83)
 UPL Projects retrieved from the
 Unscheduled Projects List (UPL) Database, 2009

Note: The curve portraying the West Leitchfield Bypass approximates the centerline of the "Preliminary Recommended Corridor A3" identified in the *Leitchfield Northwest Bypass Study*. It does not represent a proposed alignment.

Construct a bypass around the western side of Leitchfield (UPL Control No.'s 04 043 C0000 1.10, 1.20, and 1.30)

Reconstruct US 62 between Leitchfield and Clarkson (UPL Control No. 04 043 B0062 9.00)

The *Leitchfield-Clarkson Small Urban Area Study* was prepared by the Division of Planning and Highway District 4 of the Kentucky Transportation Cabinet using a project team approach. The purpose of the study was to identify deficiencies in the transportation network in the Leitchfield-Clarkson urban area, and to recommend solutions to address those deficiencies. To assist in this effort, data on highway adequacy ratings, crash rates, traffic volumes, and highway capacity was retrieved and analyzed for state-maintained highways within the urban area. Meetings were also held with local officials and stakeholders from the cities of Leitchfield and Clarkson to obtain additional information on issues of local concern. As a result of this process, a number of transportation-related issues were identified in the urban area. Several traffic and maintenance improvements were identified to address these issues. Many of these improvements have already been implemented as of the writing of this report, while others are ongoing. These projects are listed below, and their locations are mapped in [Exhibit ES-1](#).
