RE: Cultural Historic Overview Study for KY 222 and Its Vicinity in Hardin County, Kentucky
CRA Project No.: K220171
Contract Publication Series: 22-184

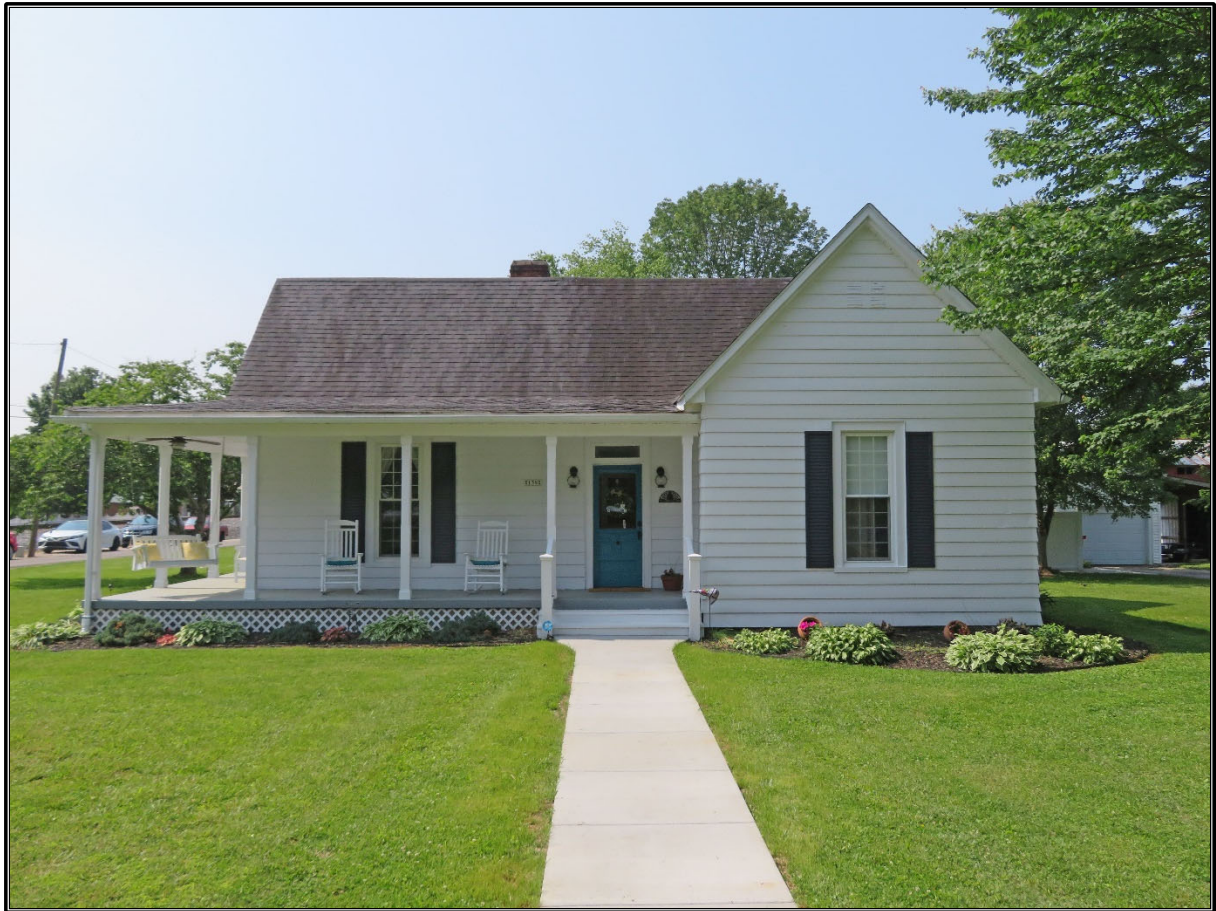
Figure 12. Site 1 (HD 1118): Façade of the residence, looking south.

Oriented north, the one-story, cross-gable, frame T-Plan residence is composed of a one-bay (w), front-gable section and a two-bay (w/d), side-gable section (Figure 12). It rests on a rusticated concrete-block foundation and is clad in replacement aluminum siding. Asphalt shingles cover the roof, which exhibits a moderate pitch. An interior brick chimney pierces the south-facing (rear) slope of the side-gable section's roof. A review of aerial photographs indicates that a narrow, one-and-one-half-story, gable-roof ell projecting from the south (rear) elevation of the side-gable section was present by 1960, and it is most likely an early addition. A second rear addition with a shed roof was constructed between 1960 and 1967, subsuming the southern portion of the front-gable section (USGS 1960, 1967). Simple wood trim surrounds the entry and windows throughout the main block of the residence. Windows throughout the residence contain replacement, one-over-one, double-hung vinyl sashes with simulated divided lights.

The façade of the residence features a single-leaf entry and a window piercing the side-gable section (see Figure 12). The entry contains an original, half-light wood door crowned by a one-light transom. A hip-roof porch shelters the full width of the residence's side-gable section and wraps around to the east elevation of the side-gable section. The porch exhibits original, chamfered wood columns resting on a poured-concrete deck. A window pierces the front-gable section on the residence's façade.

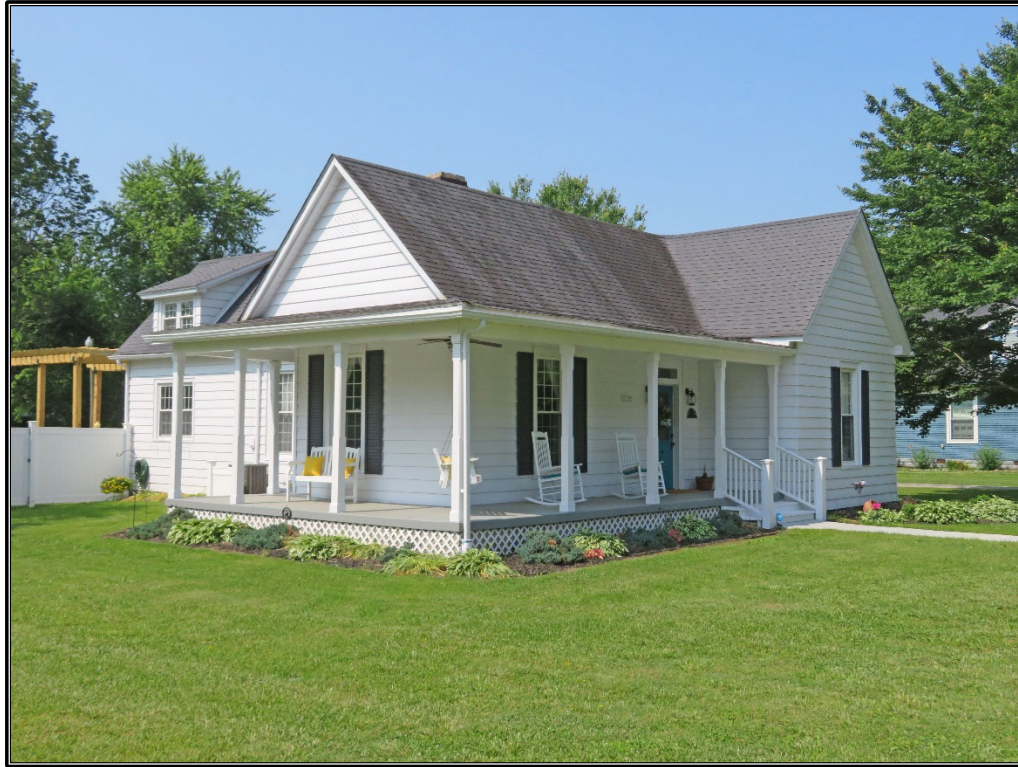
Figure 13. Site 1 (HD 1118): East and façade elevations of the residence, looking southwest.

The residence's east elevation displays a window piercing the side-gable section (Figure 13). Two windows and a pair of windows pierce the first story of the gable-roof ell's east elevation (Figure 14). The east-facing slope of the gable-roof ell's roof is pierced by a shed-roof dormer containing a pair of windows. The west elevation of the residence exhibits a

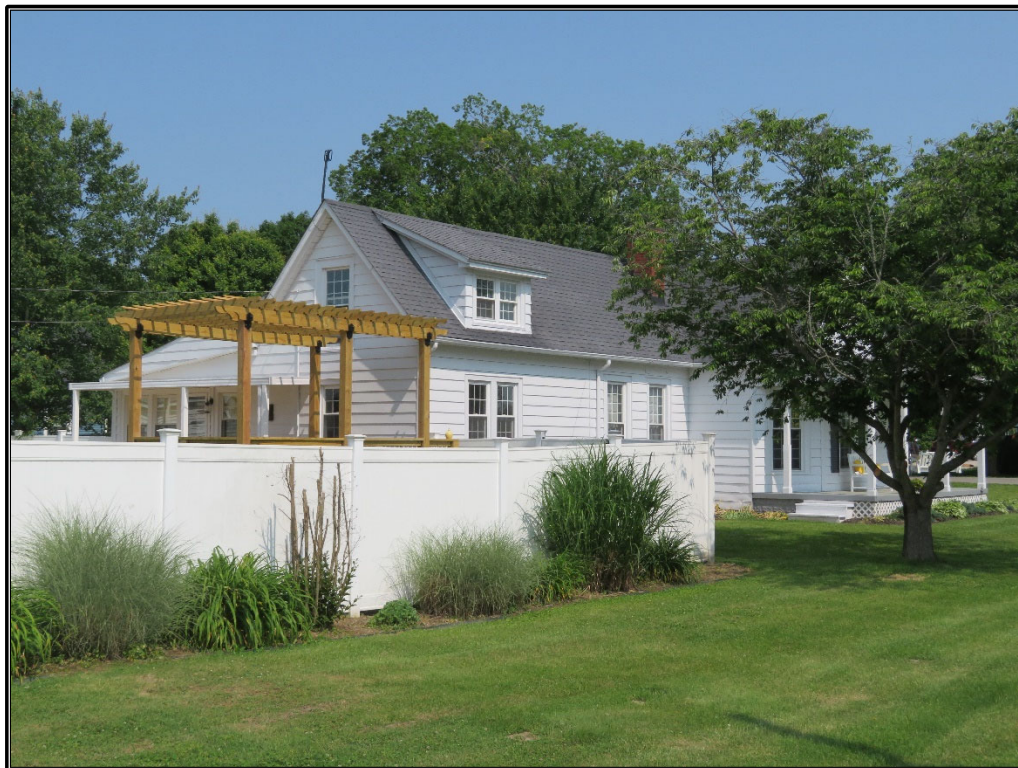
Figure 14. Site 1 (HD 1118): South (rear) and east elevations of the residence, as well as the pergola (Resource A), looking north-northwest.

window and a three-sided, canted bay projection, each face of which is pierced by a window (Figure 15). A ribbon of four windows pierces the west elevation of the rear, shed-roof addition. The residence's south (rear) elevation is only partially visible from the ROW (see Figure 14). A first-story window and an upper-half-story window pierce the rear elevation of the gable-roof ell. A single-leaf entry situated between a pair of windows and a window pierces the rear elevation of the shed-roof addition. This particular fenestration is partially sheltered by a shed-roof porch extending from the west elevation of the gable-roof ell.

A wood-frame pergola (Resource A) is adjacent to the south (rear) elevation of the gable-roof ell (see Figure 14). Recent aerial imagery indicates that the pergola (Resource A) was constructed between 2020 and 2023.

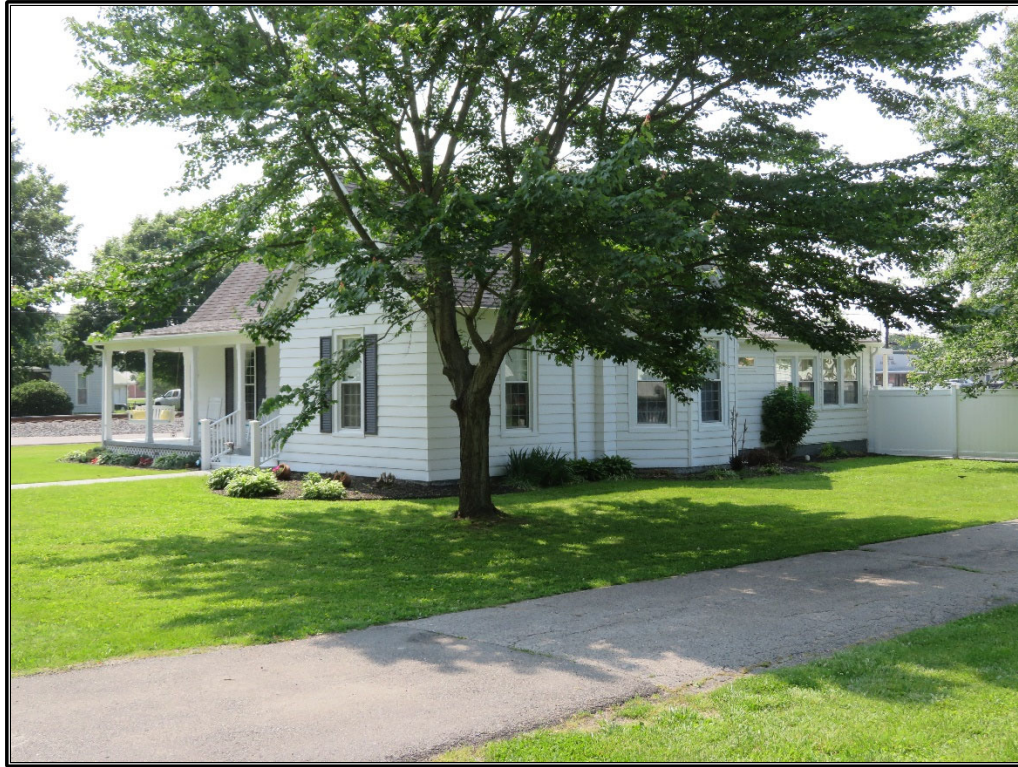
Figure 15. Site 1 (HD 1118): Façade and west elevations of the residence, looking southeast.

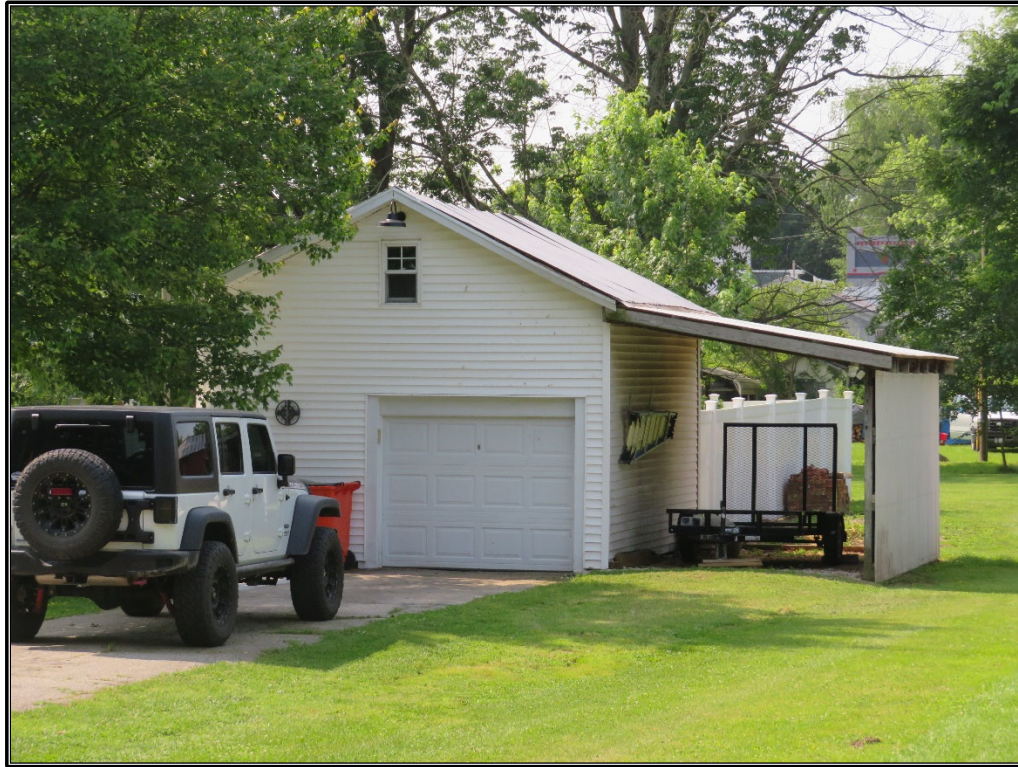
Figure 16. Site 1 (HD 1118): Façade and west elevations of the garage (Resource B), looking south-southeast.

Approximately 25 ft southwest of the residence is a one-and-one-half-story, one-bay (g), front-gable, frame garage (Resource B) (Figure 16). Oriented north, the garage displays a lean-to carport addition on the west elevation. The garage is clad to grade in replacement vinyl siding, and corrugated metal panels cover the roof. The vehicular entry on the façade contains a replacement, sectional metal door with no lights. An upper-half-story window in the gable field contains replacement, one-over-one, double-hung vinyl sashes, the top sash of which has simulated divided lights. The east elevation of the garage is pierced by a single-leaf entry and a window (Figure 17). The west and south (rear) elevations are devoid of fenestration (see Figures 16 and 17). The garage is present in a 1960 aerial photograph and, based on its form and materials, was most likely constructed between circa 1925 and 1950.

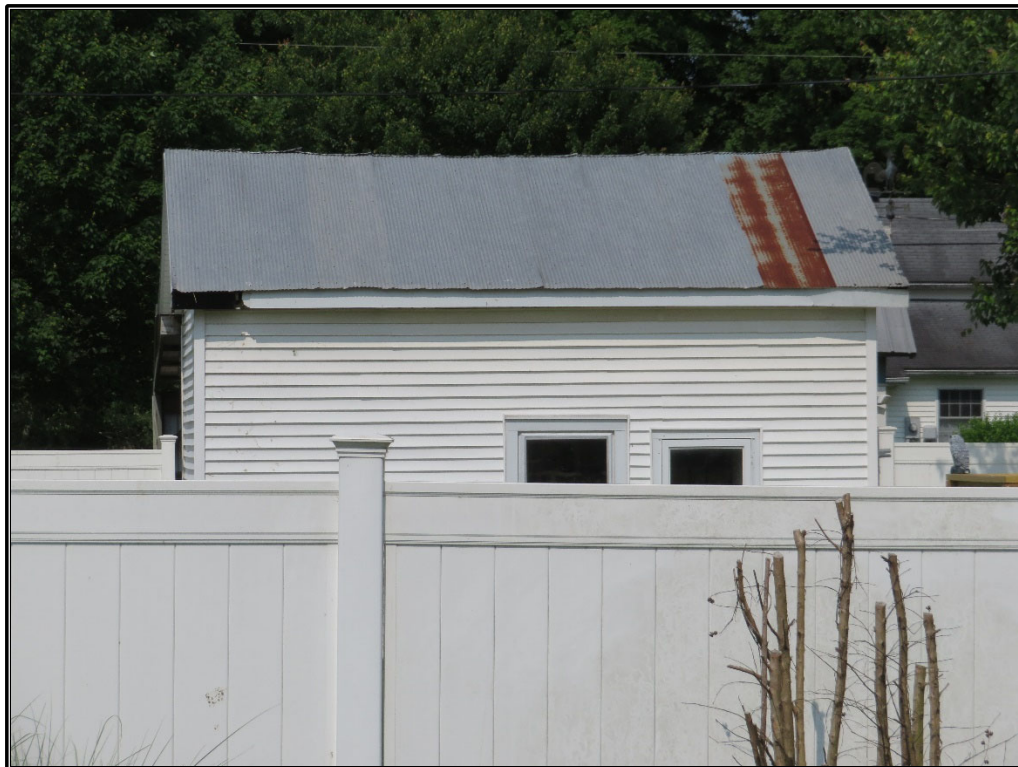
Figure 17. Site 1 (HD 1118): South (rear) and east elevations of the garage (Resource B), looking west-northwest.

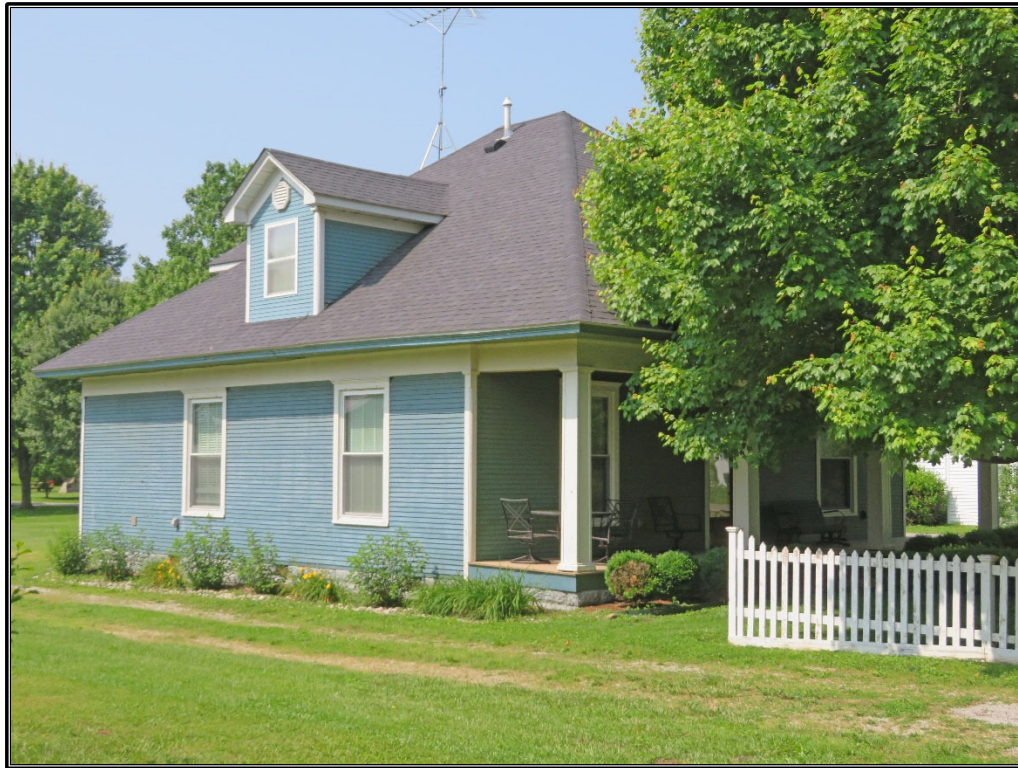
Figure 18. Site 2 (HD 1119): East and façade elevations of the residence, looking southwest.

Oriented north, the one-and-one-half-story, three-bay (w/d/w), hip-roof, frame Pyramidal Cottage rests on a continuous, rusticated concrete-block foundation, is clad in wood weatherboards, and has a roof covered by asphalt shingles (Figures 18 and 19). Gable-roof dormers pierce each slope of the roof. Except for an enclosed porch on the south (rear) elevation, simple wood trim surrounds the windows and primary entry of the residence's first story. Unless otherwise noted, windows throughout the residence contain replacement, one-over-one, double-hung vinyl sashes.

The east elevation of the residence displays two windows piercing the first story and a window piercing the east-facing dormer (see Figure 18). The residence's west elevation exhibits a window and a truncated window piercing the first story and a window piercing the west-facing dormer (see Figure 19). A double-leaf entry crowned by transoms and containing a pair of full-light doors pierces the west elevation of the enclosed, partial-width porch along the south (rear) elevation (see Figure 19). Two ribbons of three windows each, as well as a single window, pierce the south (rear) elevation of the enclosed porch. A rear, single-leaf entry crowned by a transom and containing a full-light door pierces the south (rear) elevation of the residence.

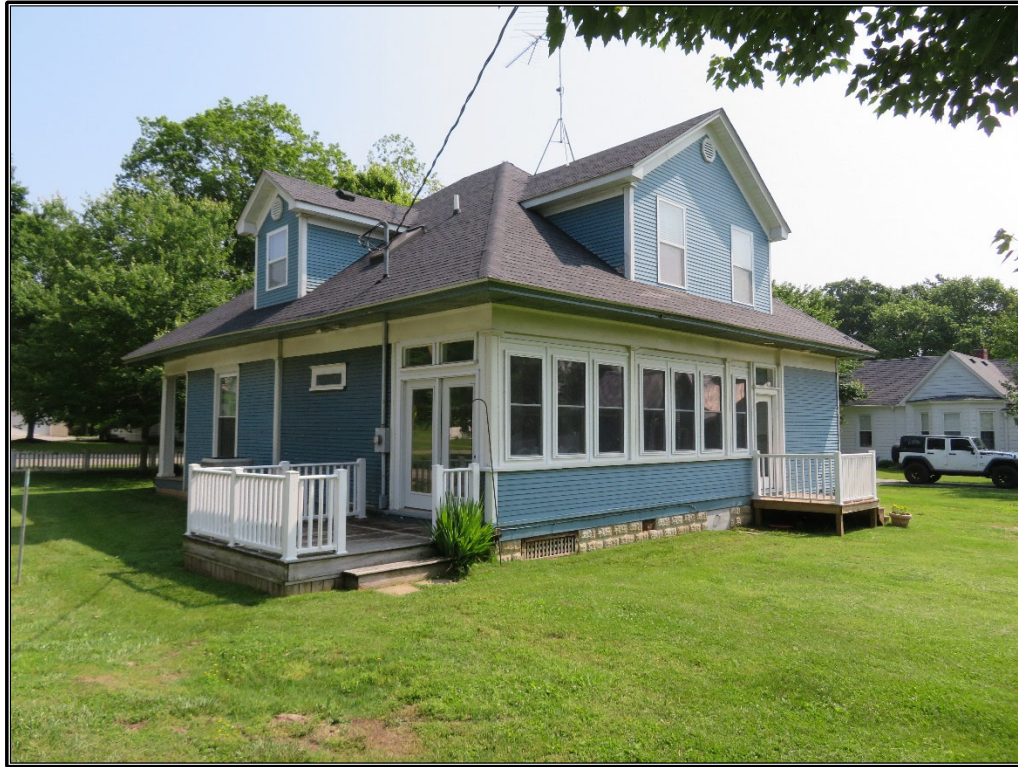
Figure 19. Site 2 (HD 1119): West and south (rear) elevations of the residence, looking northeast.

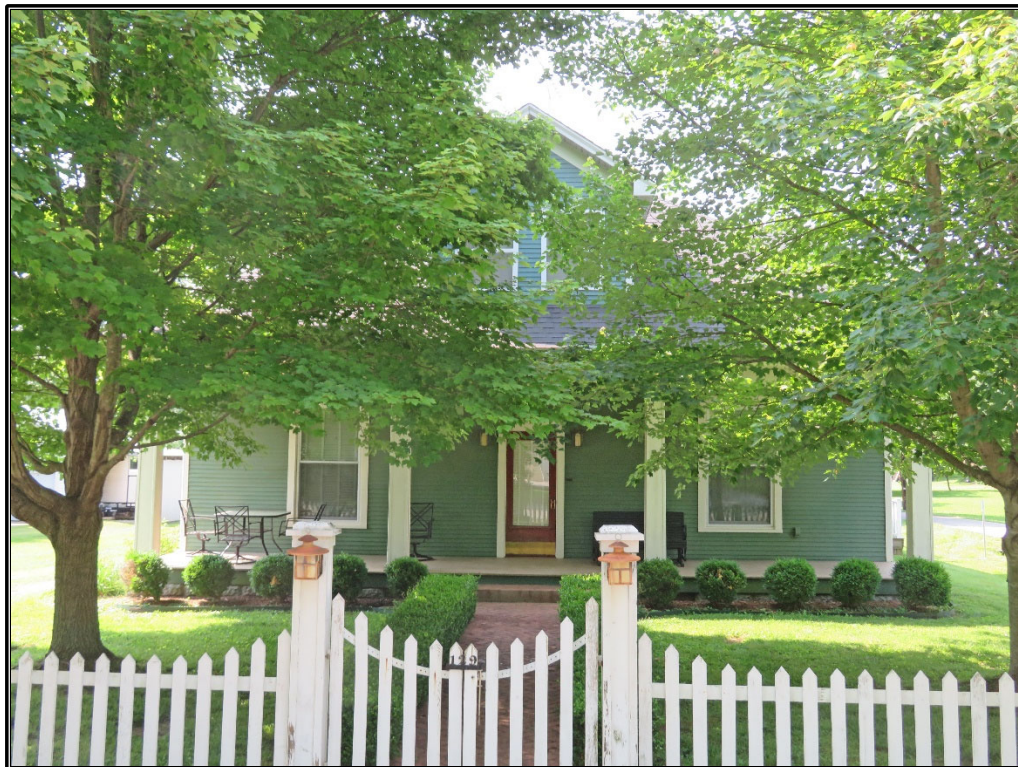
Figure 20. Site 2 (HD 1119): Façade of the residence, looking south.

The façade of the residence features a centered, single-leaf entry containing an original, three-quarter-light wood door (Figure 20). A window pierces the façade on each side

of the entry. A full-width, integral porch shelters the façade. Square wood columns resting on a wood deck support the porch's roof. The front-facing dormer is pierced by two windows.

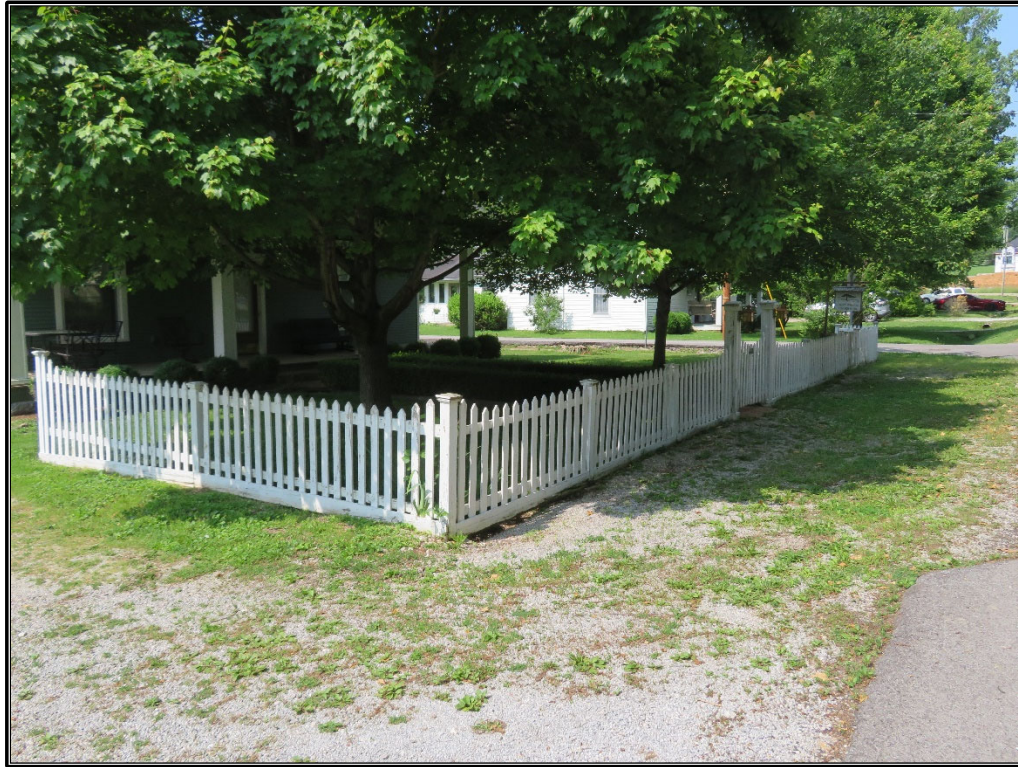
Figure 21. Site 2 (HD 1119): Picket fence (Resource A), looking west-southwest.

A wood picket fence (Resource A) lines the property's frontage and approximately 10 ft of the west side of the property's gravel driveway (Figure 21). The fence is not discernible in aerial photographs; however, based on its form, materials, and degree of weathering, it was most likely constructed between circa 1975 and 2000.

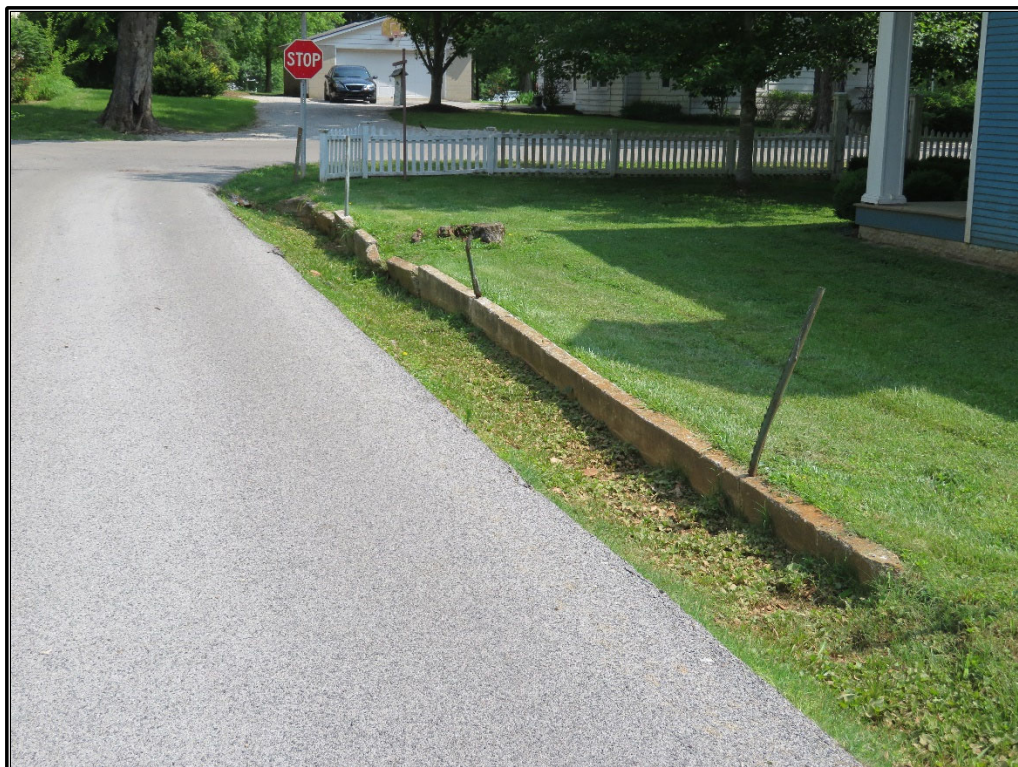
Figure 22. Site 2 (HD 1119): Concrete retaining wall (Resource B), looking north-northeast.

Approximately 15 ft west of the residence and lining a portion of the property's frontage along Bell Avenue is a poured-concrete retaining wall (Resource B) (Figure 22). The wall is approximately 1 ft to 2 ft in height and approximately 30 ft in length. The wall is not discernible in aerial photographs; however, based on its form, materials, and degree of weathering, it was most likely built contemporarily with the residence, circa 1916.

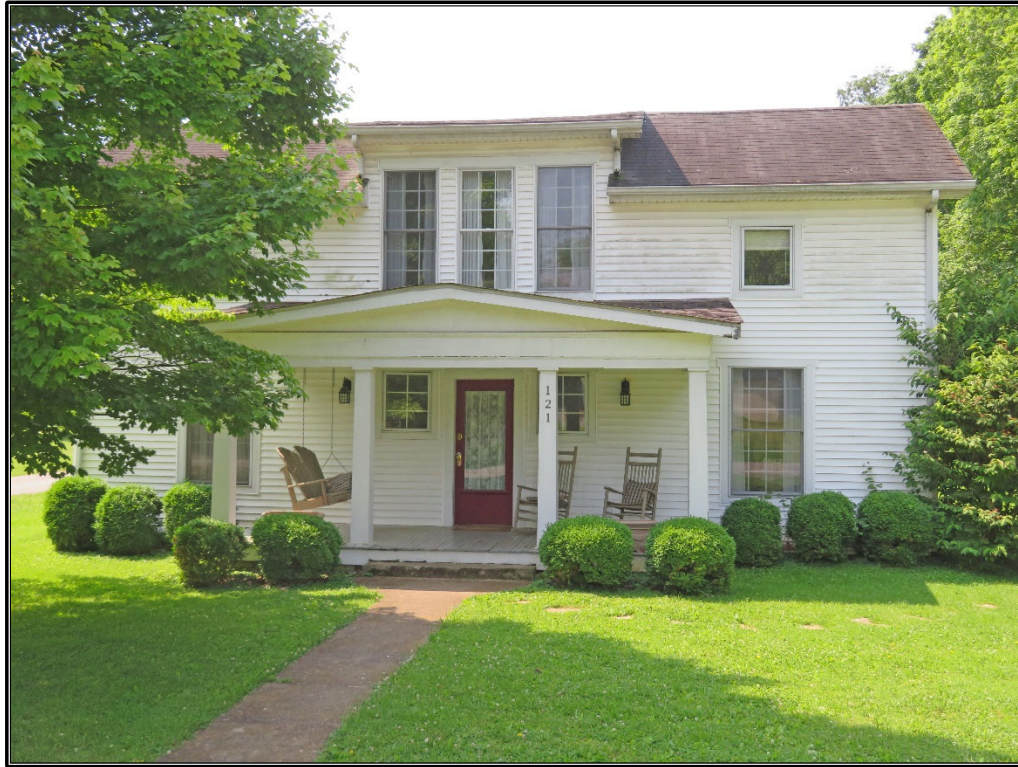
Figure 27. Site 3 (HD 1120): Façade of the residence, looking south.

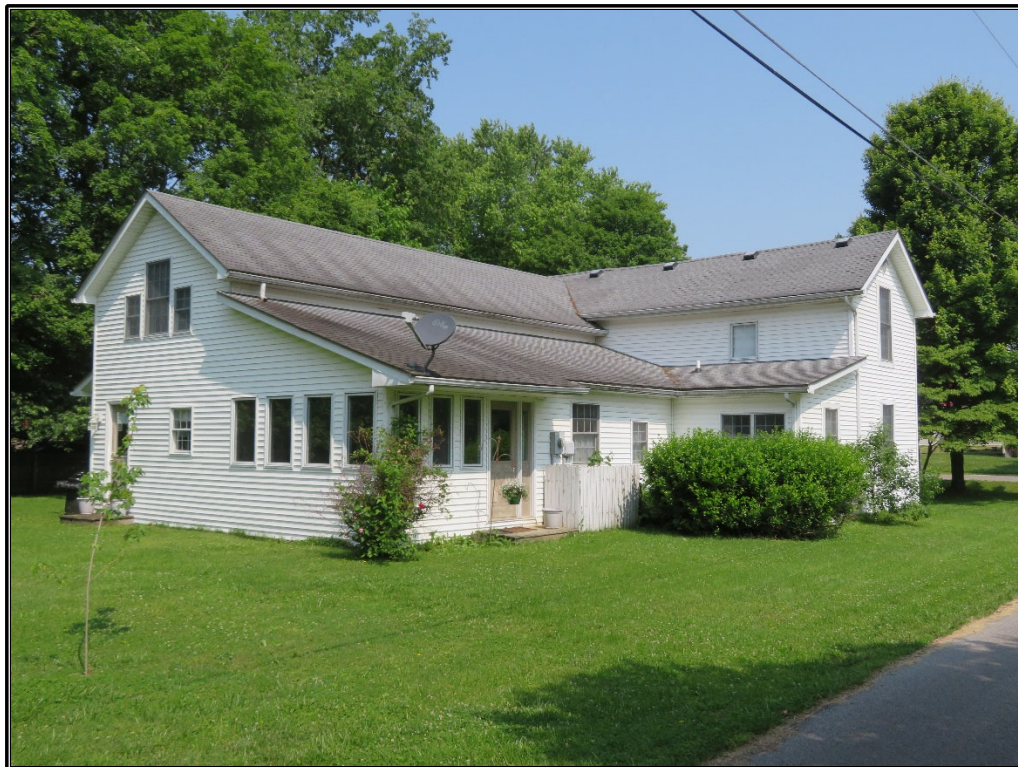
Figure 28. Site 3 (HD 1120): South and east elevations of the residence, looking northwest.

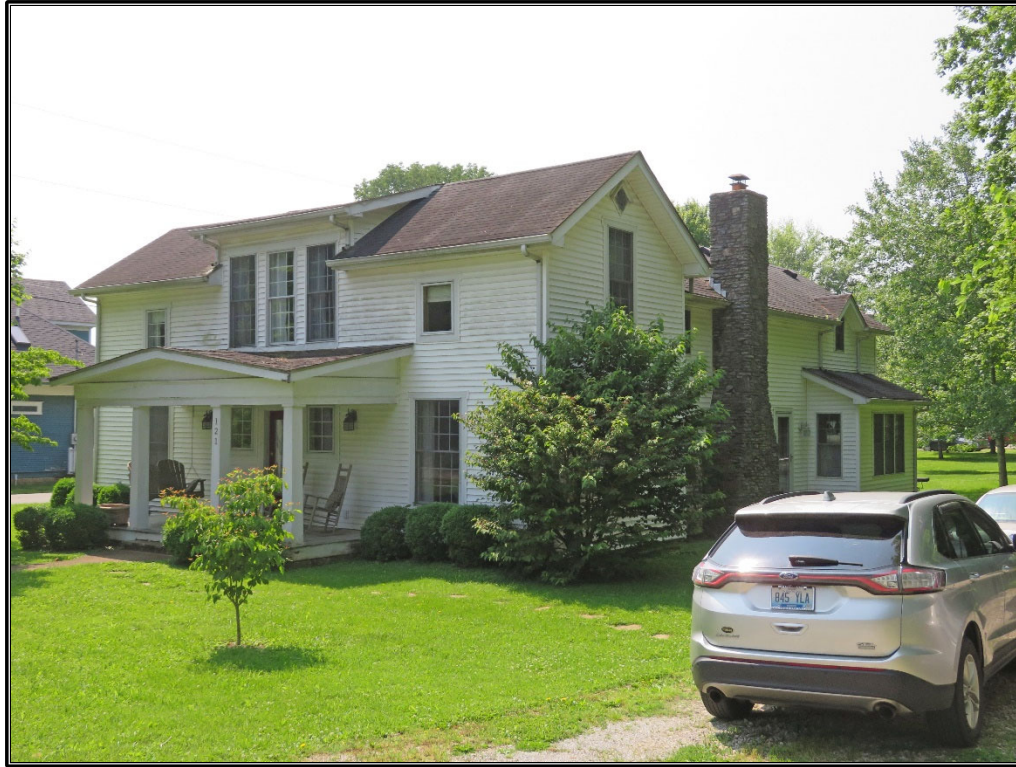
Figure 29. Site 3 (HD 1120): Façade and west elevation of the residence, looking south-southeast.

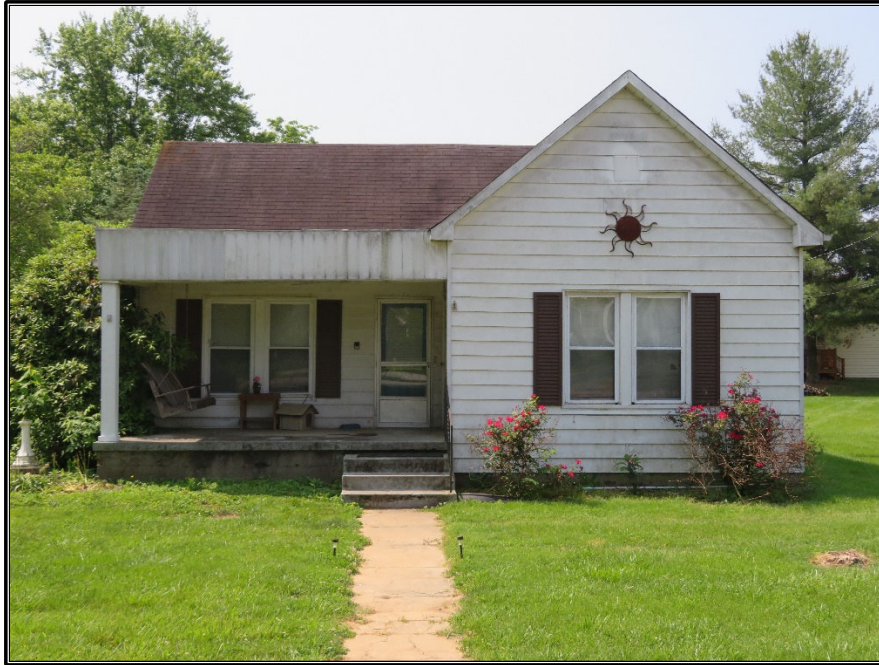
Oriented north, the one-story, cross-gable, frame T-Plan residence is composed of a one-bay (ww), front-gable section and a two-bay (ww/d), side-gable section (Figure 30). The

Figure 30. Site 4 (HD 1297): Façade of the residence, looking south.

The façade of the residence features a single-leaf entry piercing the side-gable section and a single-leaf entry piercing the east elevation of the front-gable section (see Figure 30; Figure 31). Both entries contain original, half-light wood doors. A hip-roof porch with a vinyl-clad parapet shelters the full length of the side-gable section's façade. A square wood column resting on a poured-concrete deck supports the porch's roof. A pair of windows pierces the side-gable section next to the entry, and a pair of windows also pierces the façade of the front-gable section.

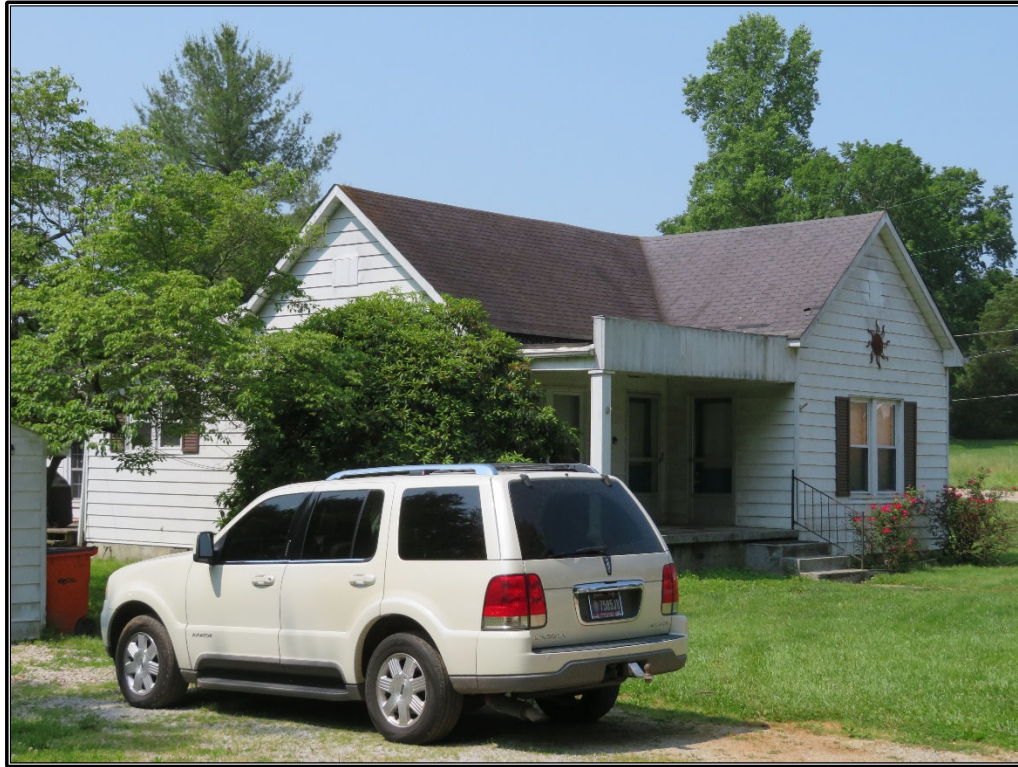
Figure 31. Site 4 (HD 1297): East and façade elevations of the residence, looking west-southwest.

the ROW; however, a pair of windows pierces the east elevation of the rear shed-roof projection (see Figure 31). Two windows pierce the west elevation of the residence (Figure 32). The residence's south (rear) elevation displays a window piercing the main block and a window piercing the west elevations of the hyphen and the rear ell (see Figure 32).

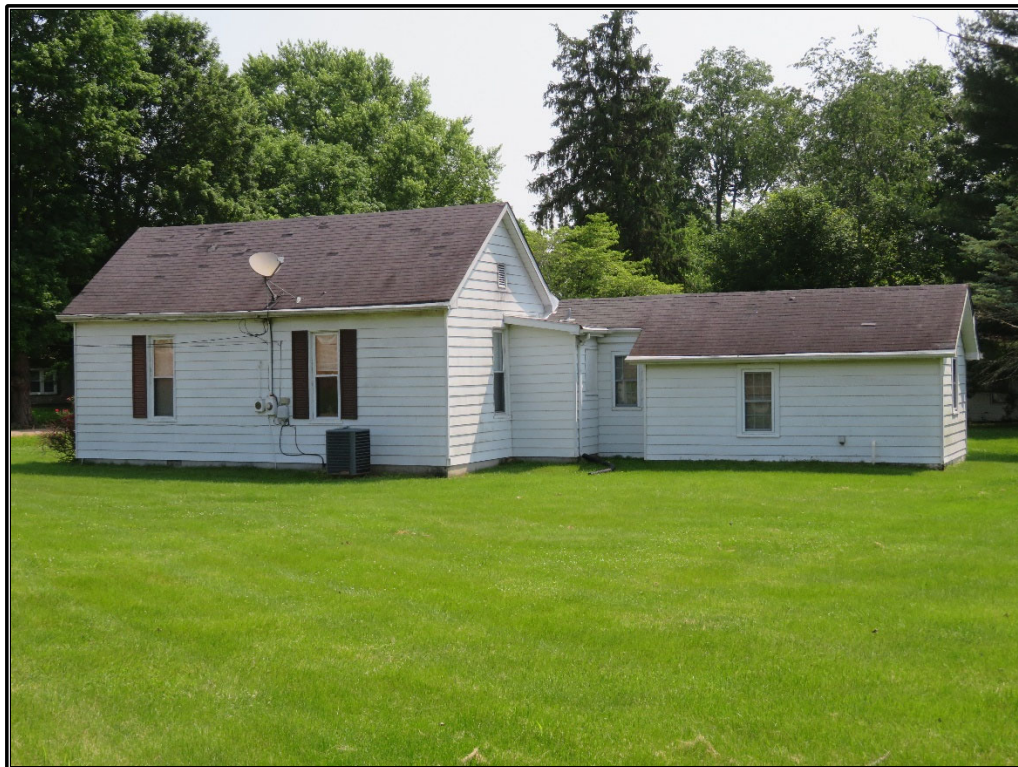
Figure 32. Site 4 (HD 1297): West and south (rear) elevations of the residence, looking east-northeast.

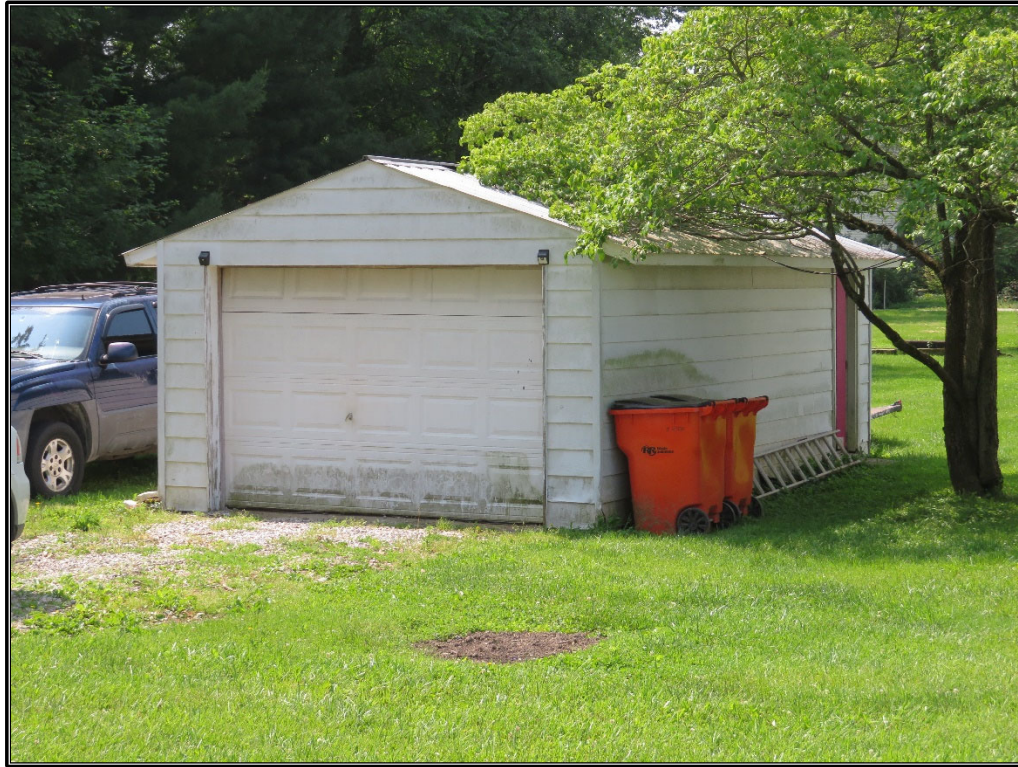
Figure 33. Site 4 (HD 1297): Façade and west elevations of the garage (Resource A), looking south-southeast.

Approximately 15 ft east of the residence is a one-story, one-bay (g), front-gable, frame garage (Resource A), which is clad to grade in aluminum siding and has a metal-panel roof (Figure 33). The foundation is not visible from the ROW. Oriented north, the façade of the garage features a vehicular entry containing a replacement, sectional metal door with no lights. The west elevation displays a single-leaf entry, the door to which was not visible during the survey. A window containing two-over-two, double-hung wood sashes pierces the east and south (rear) elevations of the garage (Figure 34). Although the property's PVA record states that the garage (Resource B) was built in 1960, a review of aerial photographs indicates that it was actually constructed between 1967 and 1988 (USGS 1967a, 1988).

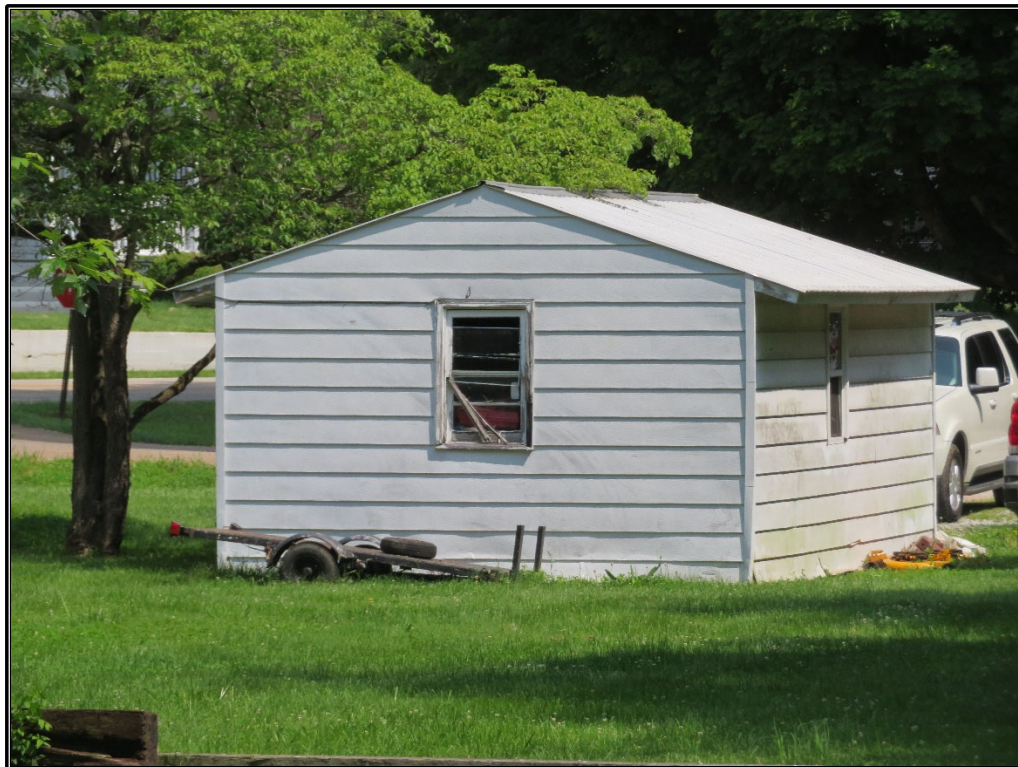
Figure 34. Site 4 (HD 1297): South (rear) and east elevations of the garage (Resource A), looking north.

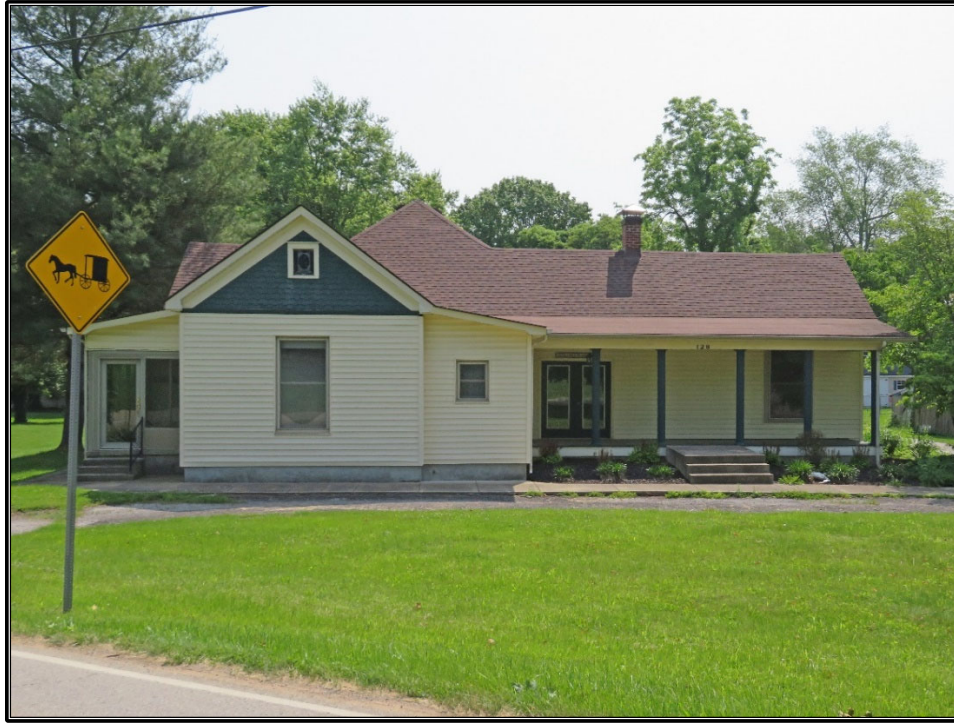
Oriented west, the one-story, four-bay (w/w/dd/w), frame Composite Cottage features a pyramidal roof with intersecting, gable-roof projections extending from the west-facing (front), north-facing, and south-facing slopes (Figure 35). The gable-roof projections are present in a 1960 aerial photograph and are most likely original features; however, an extension of the southern projection is most likely an early addition. Shed-roof projections on the south and north elevations of the west-facing (front) gable-roof projection were most

Figure 35. Site 5 (HD 1298): Façade of the residence, looking west.

The façade of the residence features a double-leaf entry which pierces the main block and contains a pair of replacement, full-light doors (see Figure 35). A window pierces the façade of the south-facing projection's extension. The double-leaf entry and the window are sheltered by a partial-width, shed-roof porch. Square wood columns resting on a wood deck support the porch's roof. A window pierces the first story and an attic window containing a fixed pane of stained glass pierces the front-facing projection. A window pierces the west elevation of the front-facing projection's southern shed-roof projection. A

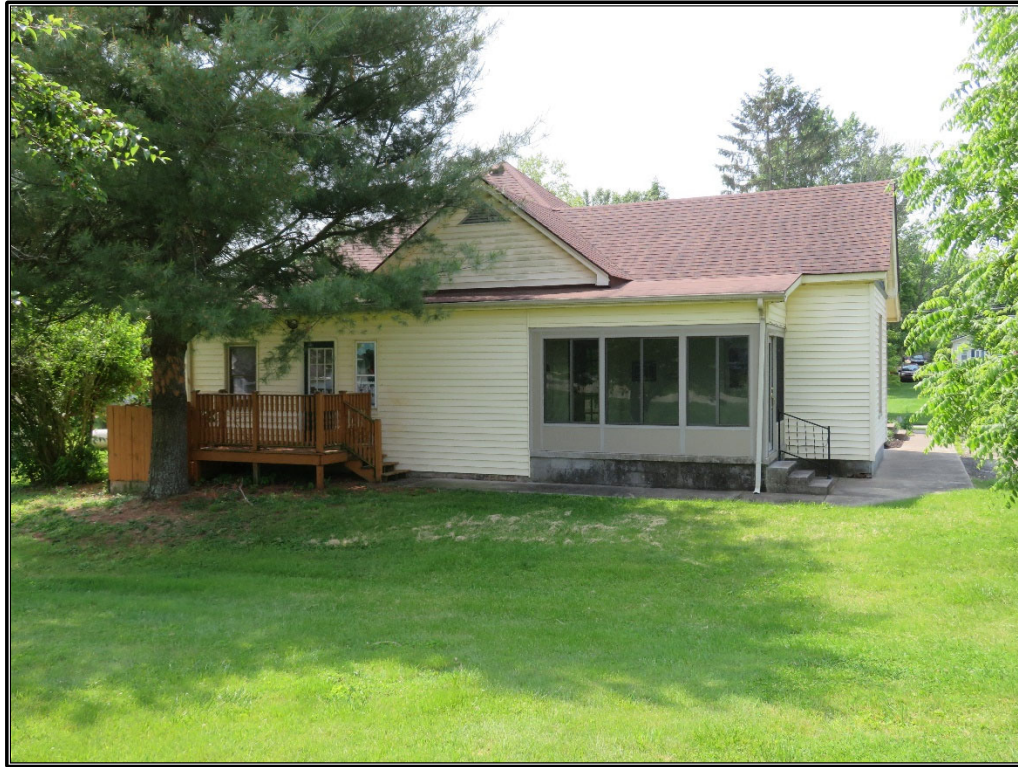
Figure 36. Site 5 (HD 1298): North elevation of the residence, looking south.

The north elevation of the residence exhibits a glass and frame enclosure of the front-facing projection's northern shed-roof projection (Figure 36). Farther to the east (rear) of the same projection is a single-leaf entry with a replacement half-light door that is flanked by two windows. A window pierces the south elevation of the south-facing gable-roof projection (Figure 37). The east (rear) elevation of the residence exhibits a single-leaf entry, which pierces the main block and contains a replacement, half-light door. The entry opens onto a raised wood deck (see Figure 37). Two windows also pierce the rear elevation of the main block. A shed-roof projection extends from the east (rear) elevation south-facing gable-roof projection (see Figure 37). A window pierces the south elevation and two windows pierce the east (rear) elevation of the south-facing gable-roof projection's rear shed-roof projection.

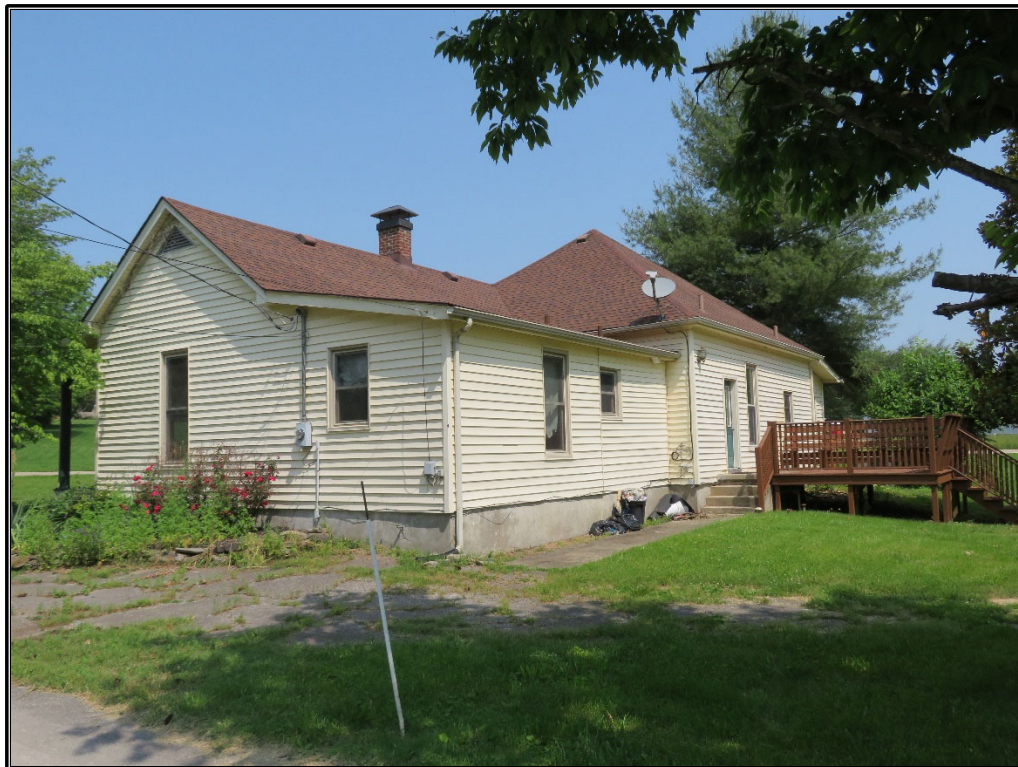
Figure 37. Site 5 (HD 1298): South and east (rear) elevations of the residence, looking north-northwest.

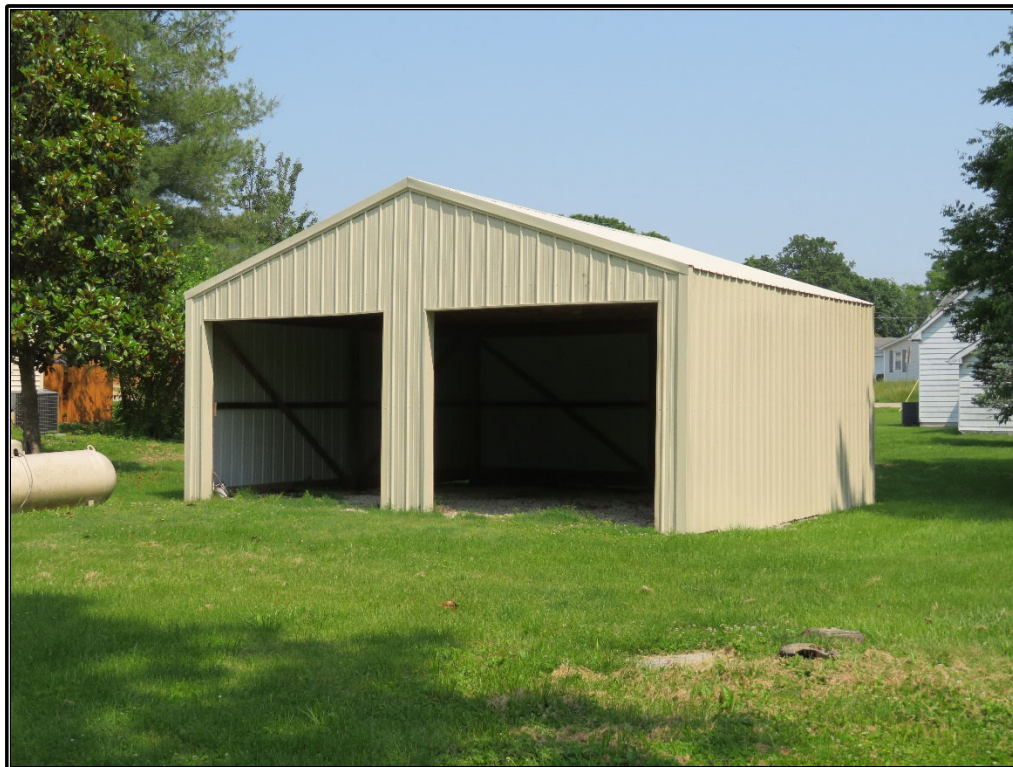
Figure 38. Site 5 (HD 1298): Garage (Resource A), looking north-northwest.

A one-story, two-bay, front-gable, frame garage (Resource A) is oriented south and located approximately 40 ft east of the residence (Figure 38). The garage's structural posts rest on-grade. Metal panels cover the walls and roof of the structure. Recent aerial imagery indicates that the garage (Resource A) replaced an earlier outbuilding in approximately the same location between 2014 and 2020.

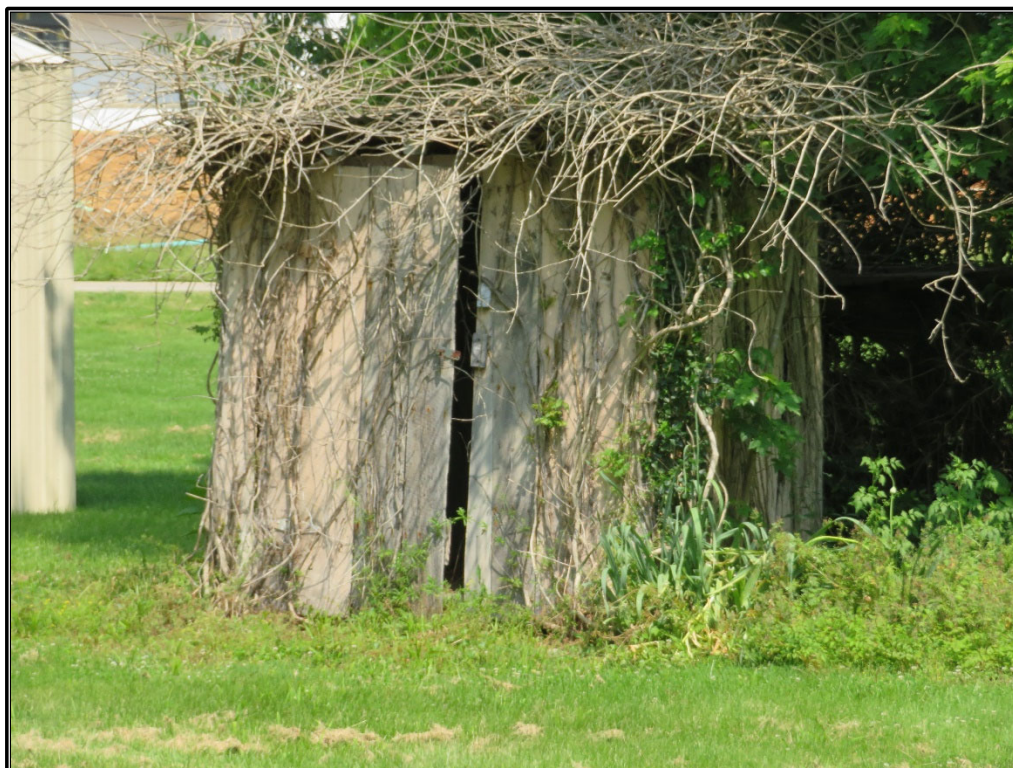
Figure 39. Site 5 (HD 1298): Façade and northeast elevation of the outbuilding (Resource B), looking north-northeast.

Approximately 85 ft east-northeast of the residence and oriented southeast is a one-story, one-bay (d), single-room, shed-roof, frame outbuilding (Resource B), which is clad in vertical boards and covered with overgrown vegetation (Figure 39). The façade displays a single-leaf entry containing a hinged, vertical-board door. No other fenestration is visible from the ROW. The outbuilding (Resource B) is visible in a 1960 aerial photograph (USGS 1960). Based on its form and materials, the outbuilding (Resource B) was most likely built between circa 1925 and 1950.
