RE: Cultural Historic Overview Study for KY 222 and Its Vicinity in Hardin County, Kentucky
CRA Project No.: K220171
Contract Publication Series: 22-184

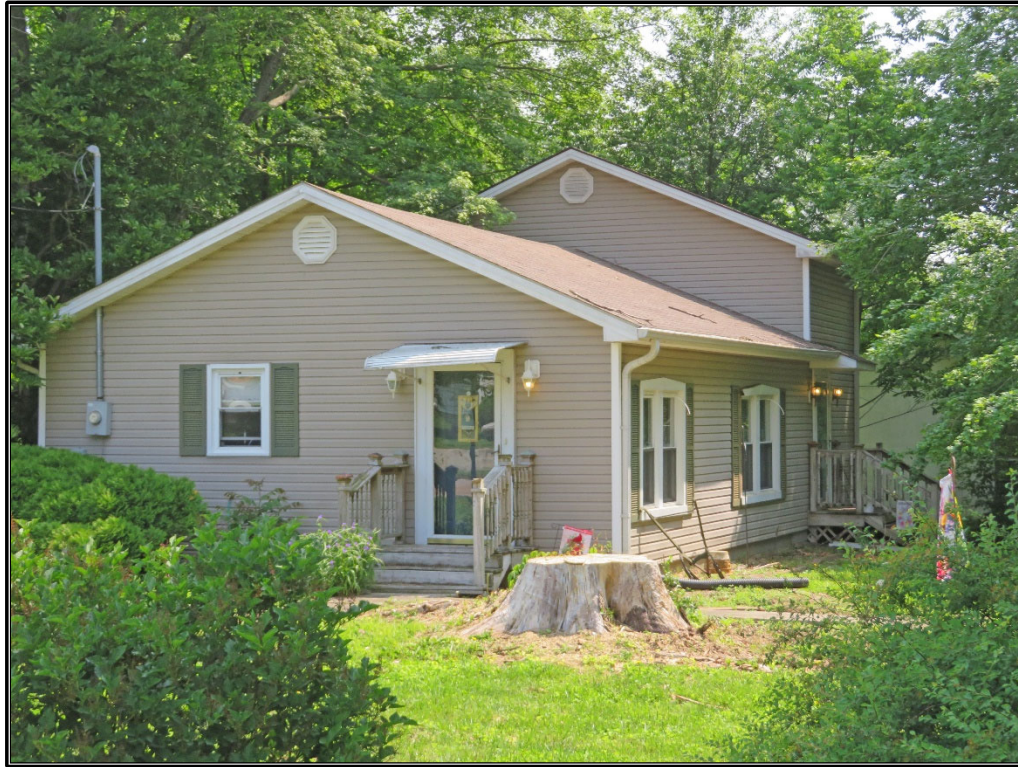
Figure 40. Site 6 (HD 1299): Façade and south elevations of the residence, looking east-northeast.

Oriented west, the one-story, two-bay (w/d), front-gable, frame residence rests on a continuous, concrete-block foundation and is clad in replacement vinyl siding (Figure 40). A review of aerial photographs indicates that the easternmost (rearmost) pile of the residence was most likely added between 1967 and 1988 (USGS 1967a, 1988). The roof of the rear-most pile rises above the principal roof. Asphalt shingles cover both roofs. Unless otherwise noted, windows throughout the residence contain replacement, one-over-one, double-hung vinyl sashes.

The façade of the residence features a single-leaf entry containing a replacement, one-light door (see Figure 40). A metal-panel hood shelters the entry. A window pierces the façade north (left) of the entry.

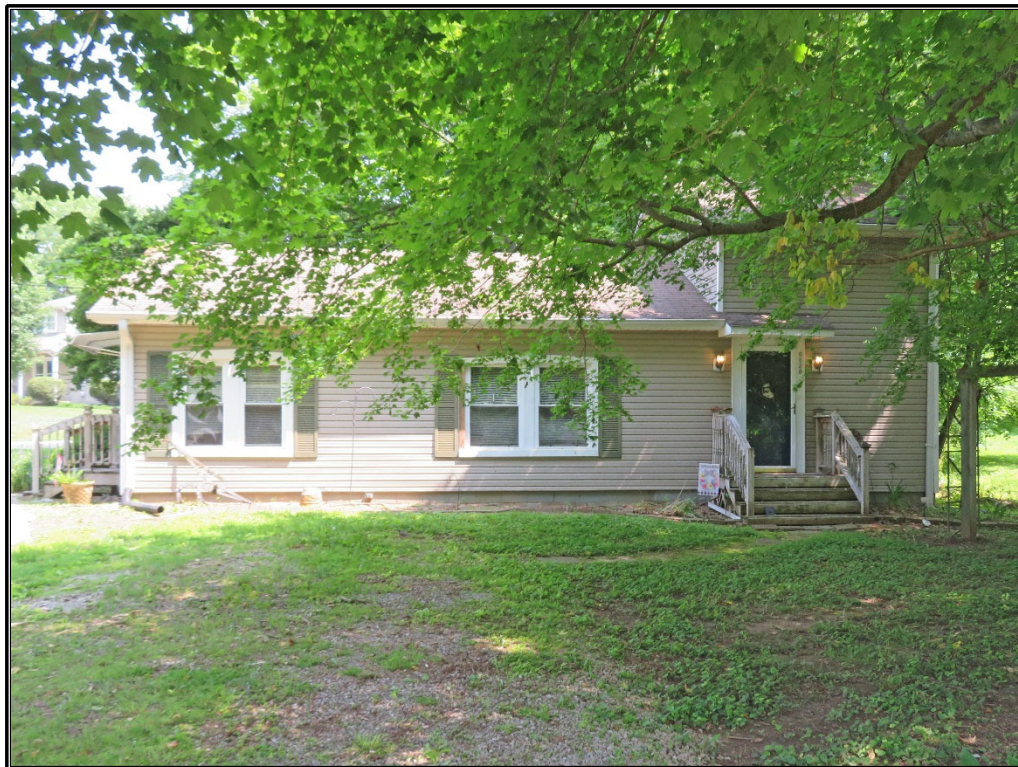
Figure 41. Site 6 (HD 1299): South elevation of the residence, looking north-northeast.

The north elevation of the residence is not visible from the ROW. The residence's south elevation exhibits two pairs of windows piercing the main block and a single-leaf entry piercing the rear addition (Figure 41). The entry contains a replacement door with no lights and is sheltered by a pent roof. An upper-half-story window pierces the east (rear) elevation of the residence (Figure 42).

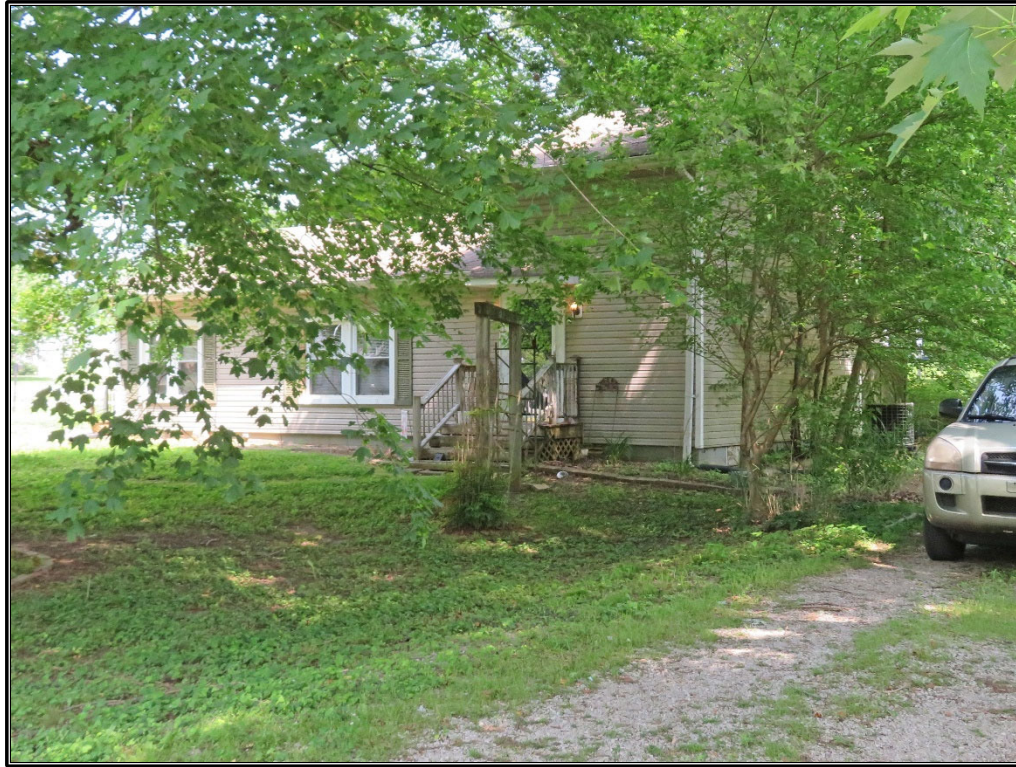
Figure 42. Site 6 (HD 1299): South and east (rear) elevations of the residence, looking north-northwest.

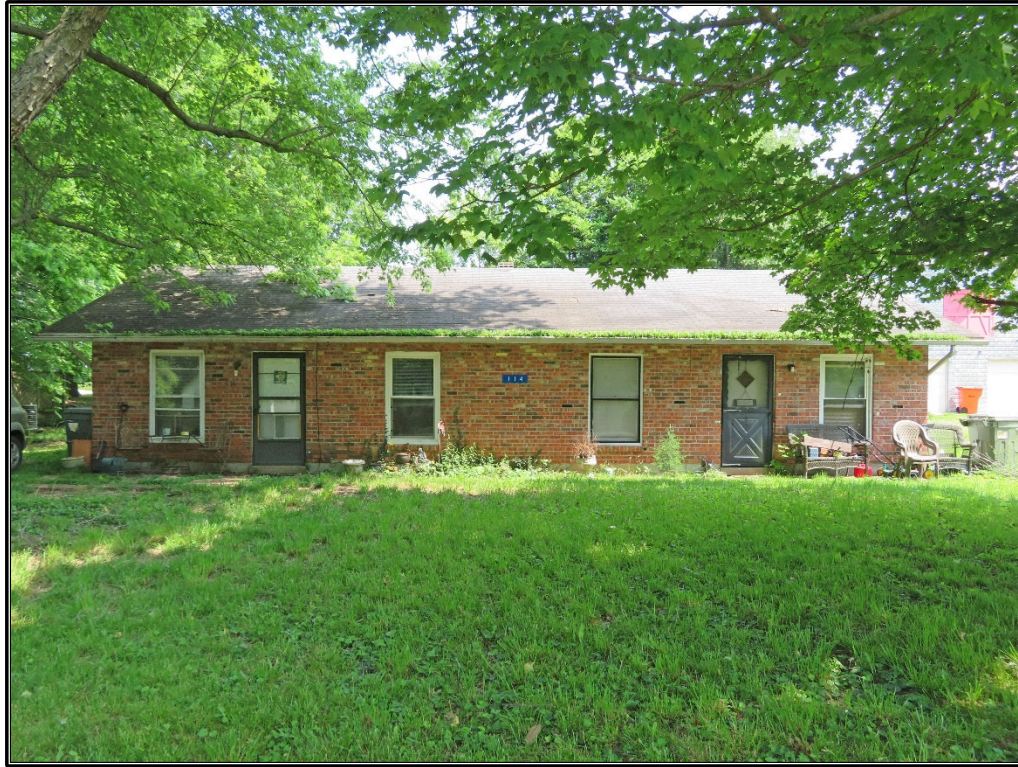
Oriented south, the one-story, six-bay (w/d/w/w/d/w), double-pile, side-gable, frame duplex Linear Ranch house rests on a continuous, concrete-block foundation (Figure 43). The façade is clad in a brick veneer, and the west and east elevations are clad in stucco. Asphalt shingles cover the roof. Windows in the western unit of the duplex contain replacement, one-over-one, double-hung vinyl sashes. Windows in the eastern unit of the duplex contain original, one-over-one, double-hung wood sashes.

Figure 43. Site 7 (HD 1300): Façade of the duplex, looking north.

The façade of the duplex features two single-leaf entries, the western unit contains a replacement door with no lights, and the eastern unit contains an original, one-light wood door (see Figure 43). Windows are located on each side of the entries.

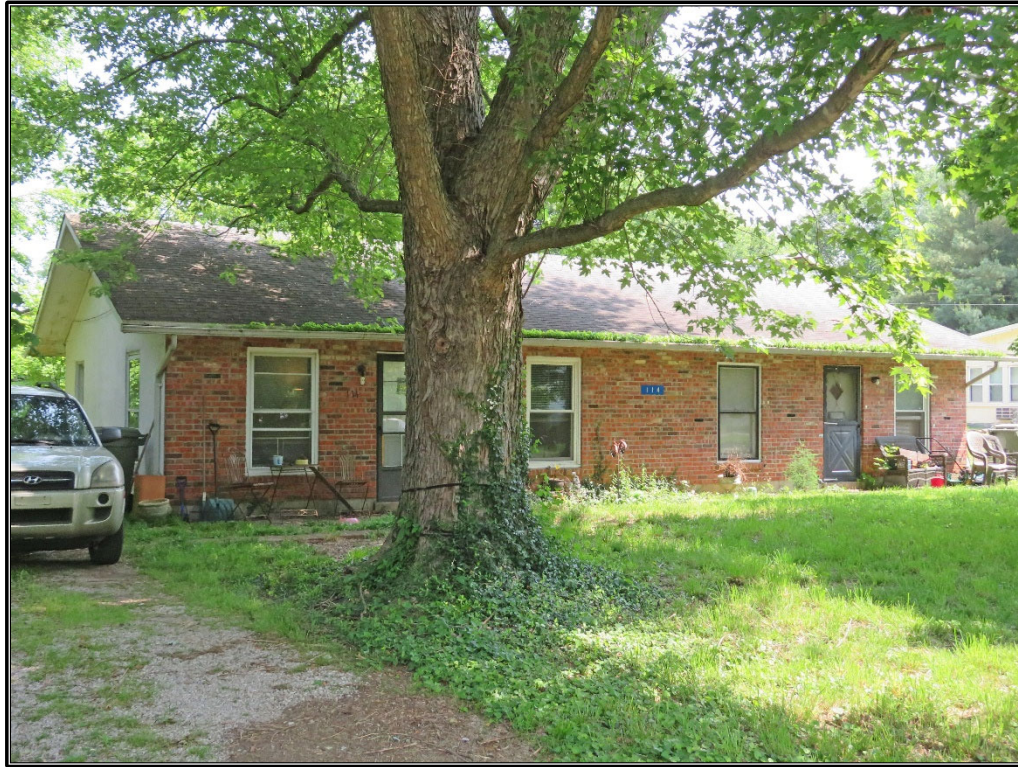
Figure 44. Site 7 (HD 1300): West and façade elevations of the duplex, looking north-northeast.

Two windows pierce the west elevation and two windows pierce the east elevation of the duplex (Figures 44 and 45). One of the windows on the east elevation has been enclosed to accommodate an air-conditioning unit. The north (rear) elevation of the duplex is not visible from the ROW.

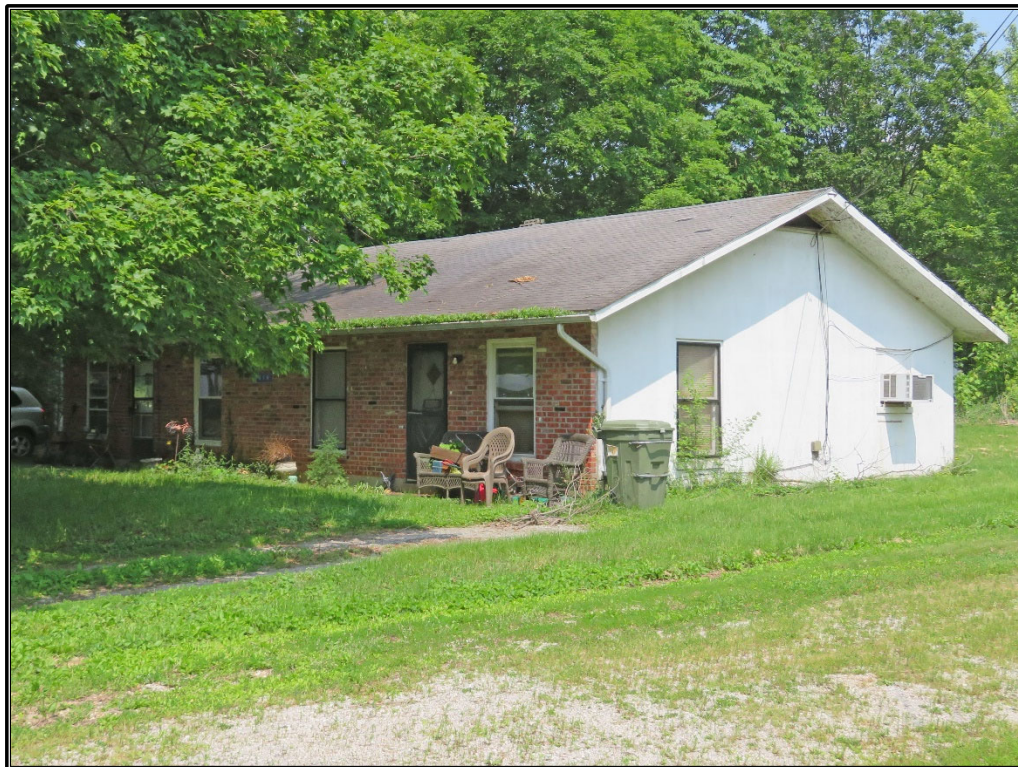
Figure 45. Site 7 (HD 1300): Façade and east elevations of the duplex, looking west-northwest.

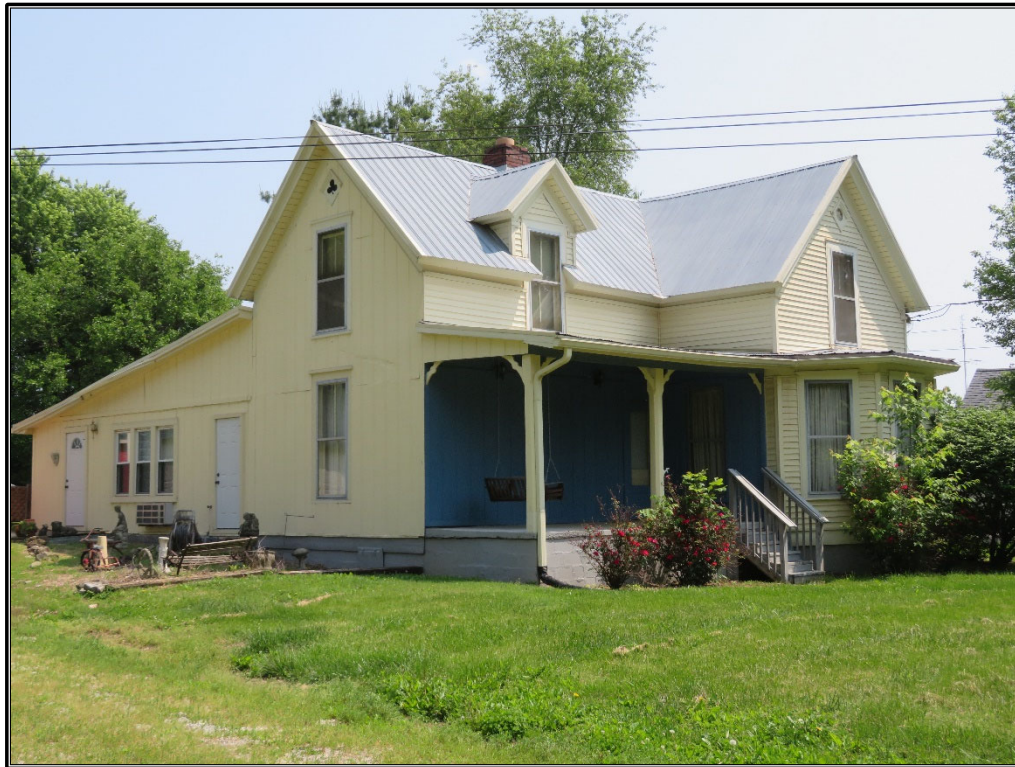
Oriented south, the residence presents a one-and-one-half-story, four-bay (d/w/w/w), single-pile, frame, T-plan form consisting of an intersecting front-gable and side-gable section (Figure 46). A shed-roof addition projects from the north (rear) elevation. The dwelling rests on a parged concrete block foundation, is clad in vertical pressed wood siding and replacement

Figure 46. Site 8 (HD 1301): Façade and west elevations of the residence, looking east-northeast.

The façade of the side-gable section of the residence is pierced by an off-center, single-leaf entry filled with a half-light wood panel door set behind a three-quarter glazed wooden storm door (see Figure 46). The entry opens onto a partial-width, shed-roof porch supported by chamfered square posts with decorative flanking brackets. The posts rest directly on a poured concrete porch deck. A gable-roof wall dormer pierces the half-story of the cross-gable section. The facade of the front-gable section is pierced by a canted, three-sided, projecting bay on its first floor. A single window pierces the half-story and is topped by a decorative, diamond shaped, vent. The gable-field of the front-gable section includes an unembellished frieze.

The west elevation of the side-gable section is pierced by a single window (see Figure 46). The half-story is pierced by a single window topped by a decorative shamrock vent. The east elevation of the front-gable section is pierced by two windows (Figure 47). The half-story exhibits two front-gable wall dormers. A one-story, shed-roof frame addition projects from the north (rear) elevation. The west elevation of the addition is pierced by two single-leaf entries; one filled with a fan-light metal panel door and a second filled with an unglazed metal panel door (see Figure 46). A ribbon of three windows is situated between the entrances. The east elevation of the addition is void of fenestration (see Figure 47). The north (rear) elevation was not visible from the ROW.

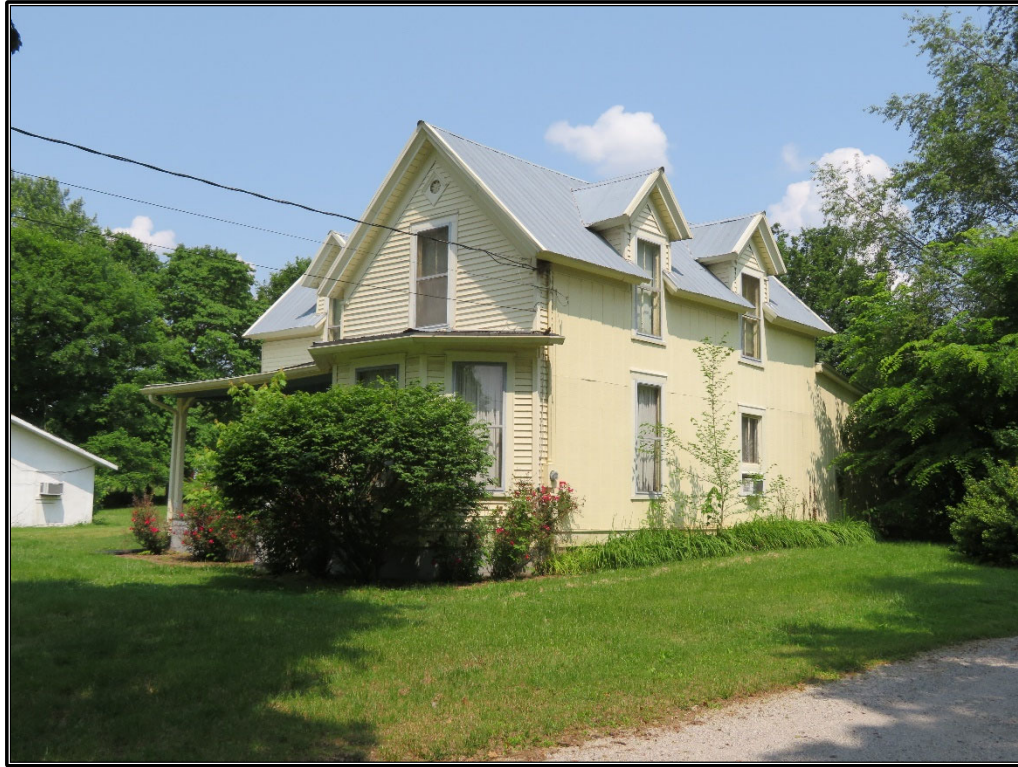
Figure 47. Site 8 (HD 1301): Façade and east elevations of the residence, looking north-northwest.

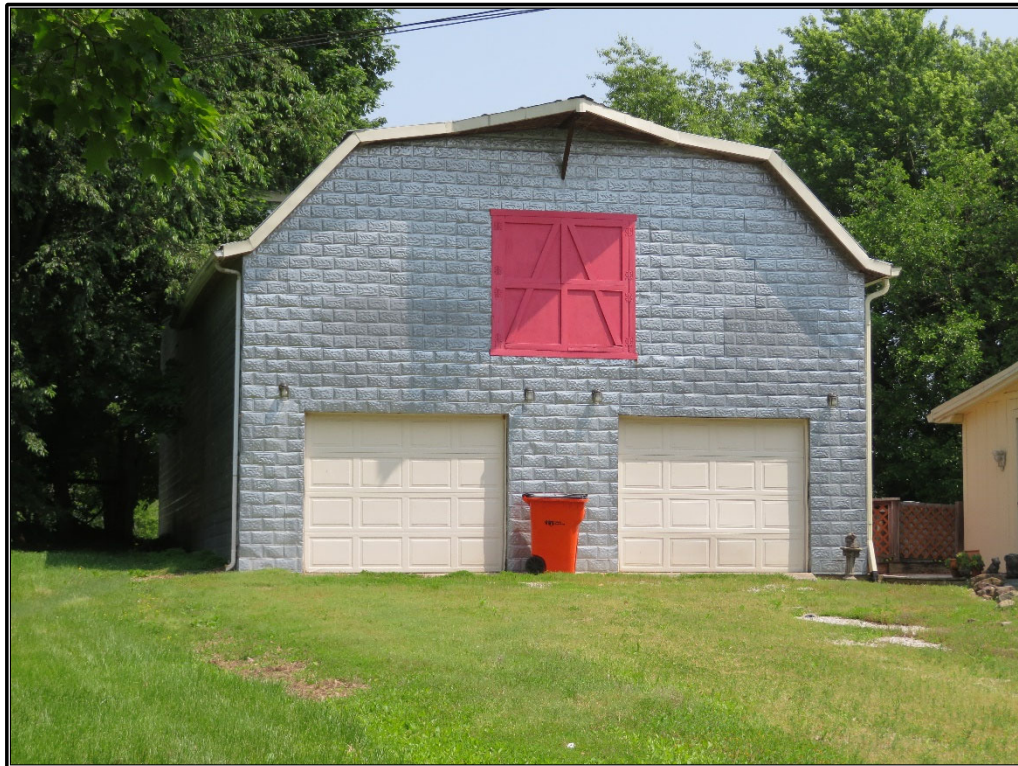
Figure 48. Site 8 (HD 1301): South and west elevations of the detached garage (Resource A), looking north-northeast.

A one-and-one-half-story, gambrel-roof, frame garage (Resource A) is located approximately 5 ft west-northwest of the residence (Figure 48). The garage is clad in aluminum siding resembling rusticated concrete block and is sheltered beneath a metal roof. The windows present one-over-one, double-hung, wood sashes. The primary (south) elevation of the garage is pierced by

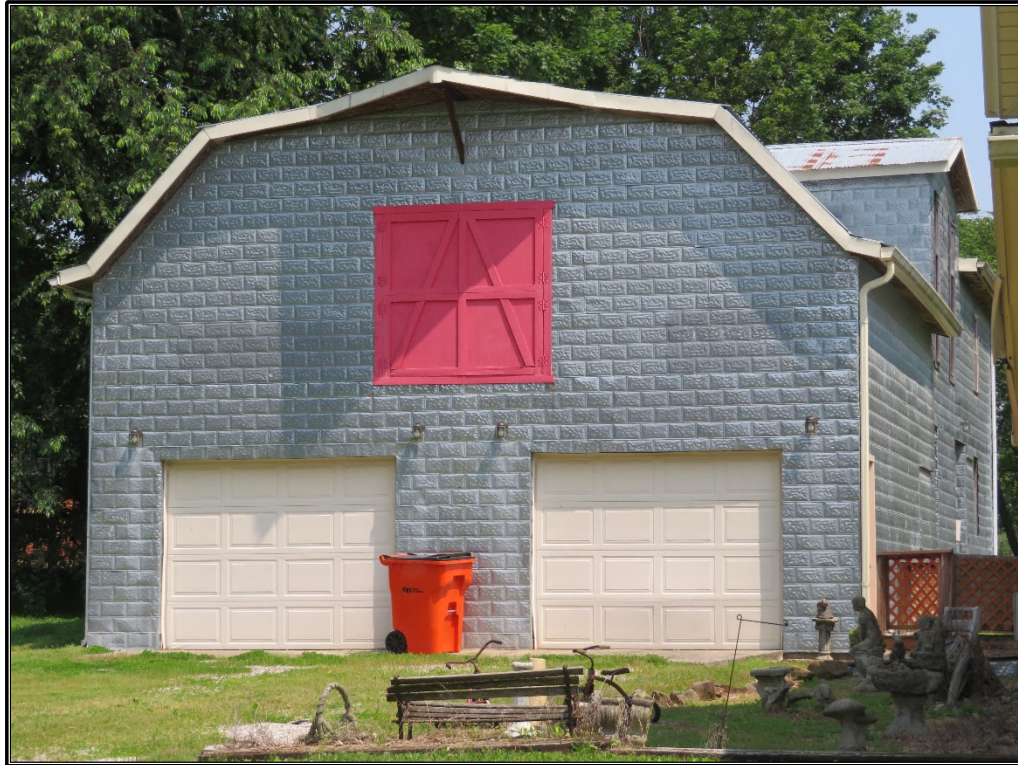
Figure 49. Site 8 (HD 1301): South and east elevations of the detached garage (Resource A), looking north-northwest.

two vehicular bays filled with unglazed overhead metal panel doors. A double-leaf entry pierces the half-story and is filled with wood doors sheltered beneath a hay-hood. The west elevation is void of fenestration. A single-leaf entry pierces the east elevation of the garage's primary mass (Figure 49). The door material was not visible from the ROW. Multiple additions project from the north (rear) elevation of the garage. The east elevation of the addition exhibits a single-leaf entry clad in metal sheets resembling rusticated concrete block (Figure 50). A single window to the north has been covered. A recessed stairwell pierces the east elevation and includes a chamfered window. The half-story includes a gable-roof wall dormer pierced by two windows and single window beneath the eaves (see Figure 48). The north (rear) elevation was not visible from the ROW. The garage (Resource A) is first depicted on the 1960 aerial photograph (USGS 1960). Therefore, based on its form and materials, as well as its first aerial depiction, Resource A was likely built between 1925 and 1950.

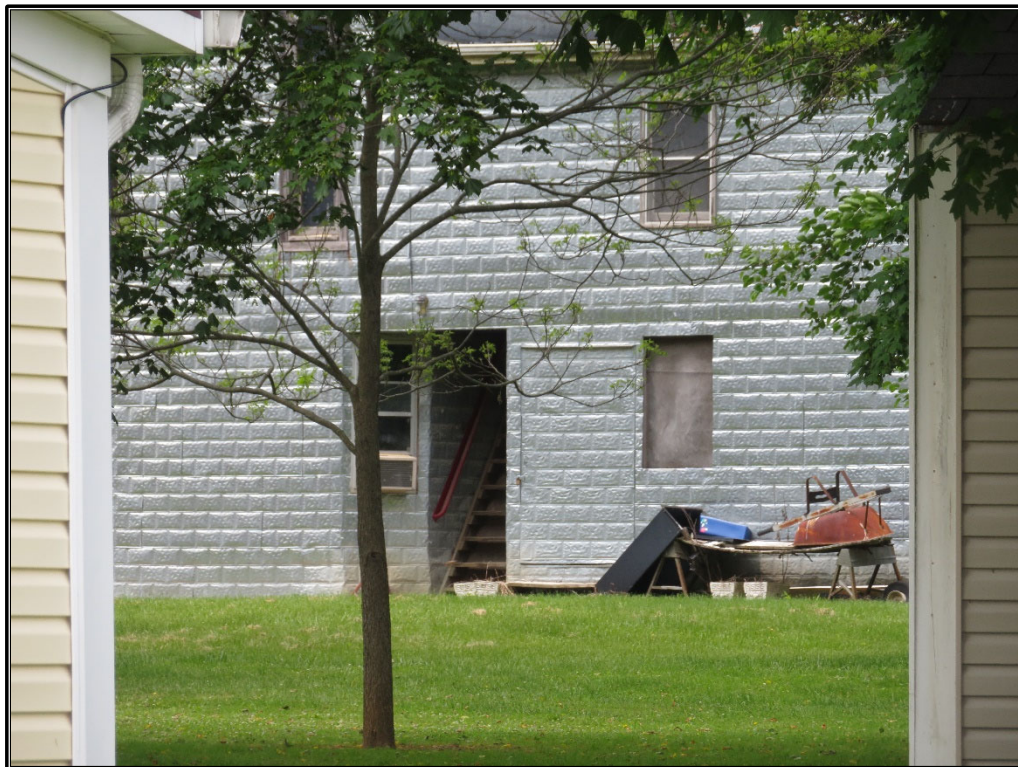
Figure 50. Site 8 (HD 1301): East elevation of the detached garage (Resource A), looking west-southwest.

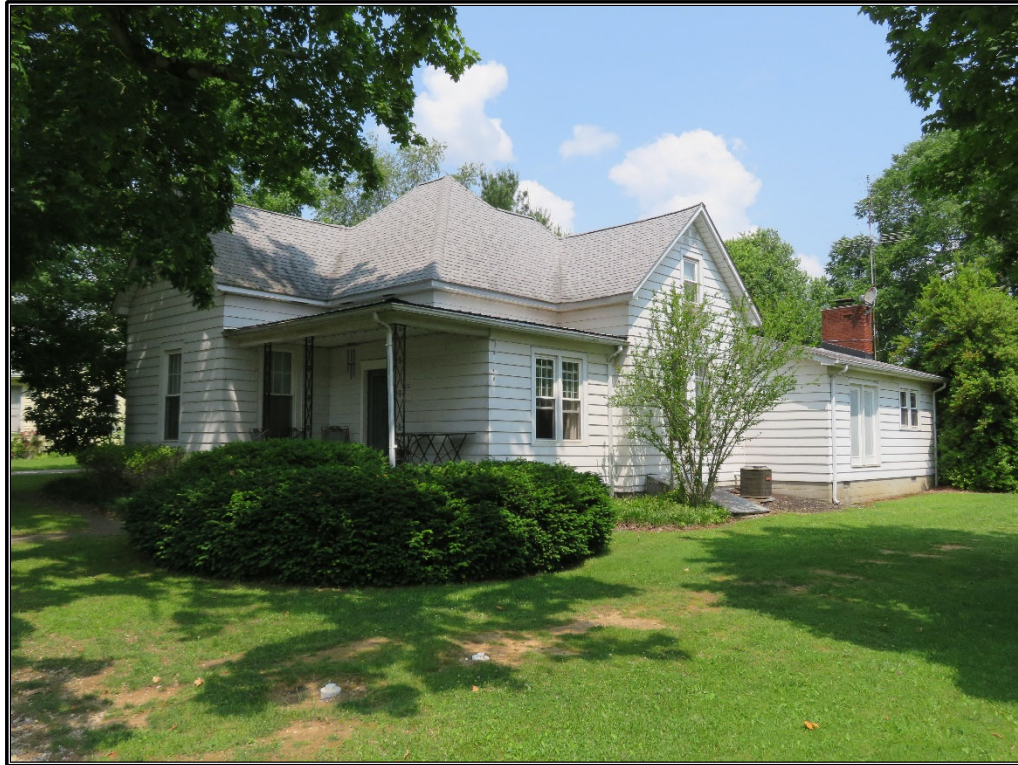
Oriented south, the one-and-one-half-story, two-bay (w/d), double-pile, hip-roof, frame Composite Cottage is clad in vinyl siding (Figure 51). Asphalt shingles cover the principal roof and the roofs of multiple projections and intersecting gables. A gable projection is located on the façade, east, west, and north (rear) elevations of the residence. A one-story gable-roof addition projects from the north (rear) elevation. An interior brick chimney pierces the east-facing slope of the rear gable-roof addition. Windows throughout the residence contain replacement, one-over-one, double-hung vinyl sashes, some of which display simulated divided lights.

Figure 51. Site 9 (HD 1302): Façade and east elevations of the residence, looking northwest.

The façade of the residence features a single-leaf entry filled with a full-light replacement door (see Figure 51). The entry opens onto a partial-width, shed-roof porch supported by scrollwork metal posts resting directly on a poured-concrete deck. A window pierces the perpendicular plane of the south front-gable projection and is sheltered beneath the porch roof. A window and a rectangular, louvered attic vent pierce the façade of the front-gable projection.

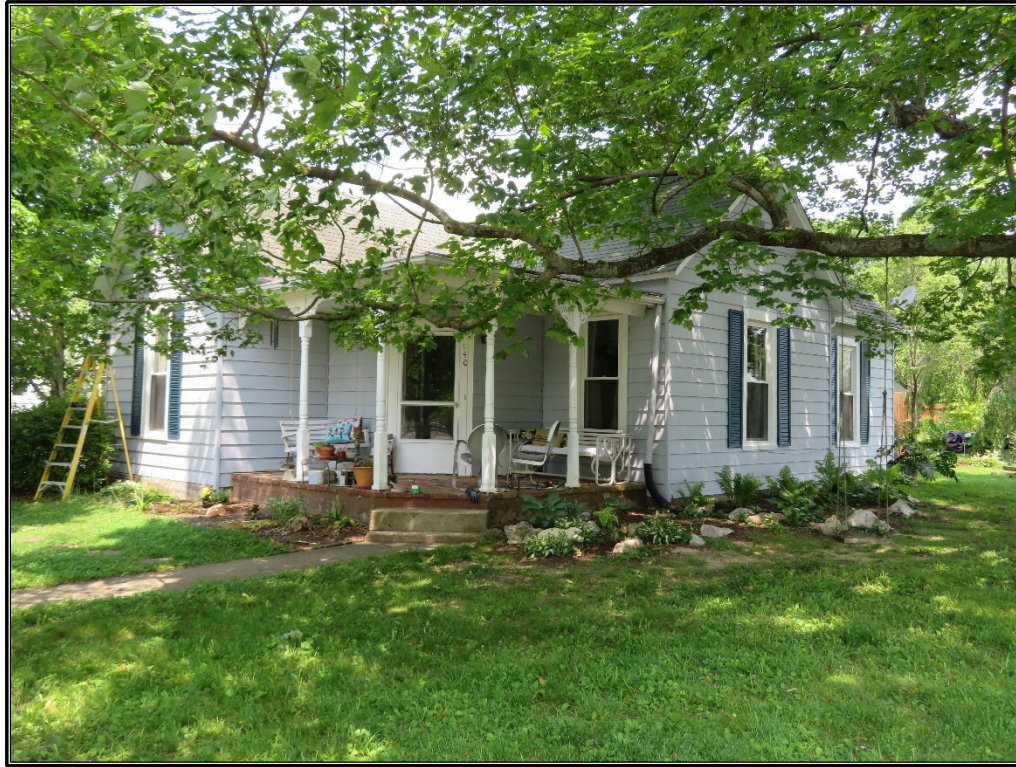
Figure 54. Site 10 (HD 1121): Façade and east elevations of the residence, looking northwest.

Oriented south, the residence presents a one-and-one-half-story, three-bay (w/d/w), double-pile, T-Plan form consisting of an intersecting front-gable and side-gable section (Figure 54). Multiple additions project from the north (rear) elevation. The dwelling rests on a parged concrete block foundation, is clad in

The façade of the side-gable section of the residence is pierced by an off-center, canted, single-leaf entry filled with a three-quarter light wood panel door set behind a three-quarter glazed wooden storm door (see Figure 54). The entry opens onto a partial-width, flat-roof porch supported by turned posts with decorative flanking brackets. The porch posts rest directly on a brick veneer deck. A single window is sheltered beneath the porch roof. The facade of the front-gable section is pierced by a single window.

The east elevation of the side-gable section is pierced by a single window (see Figure 54). The west elevation of the front-gable section is pierced by a single window (Figure 55). The west elevation of the side-gable section is pierced by a single window. A one-story, shed-roof frame addition projects from the north

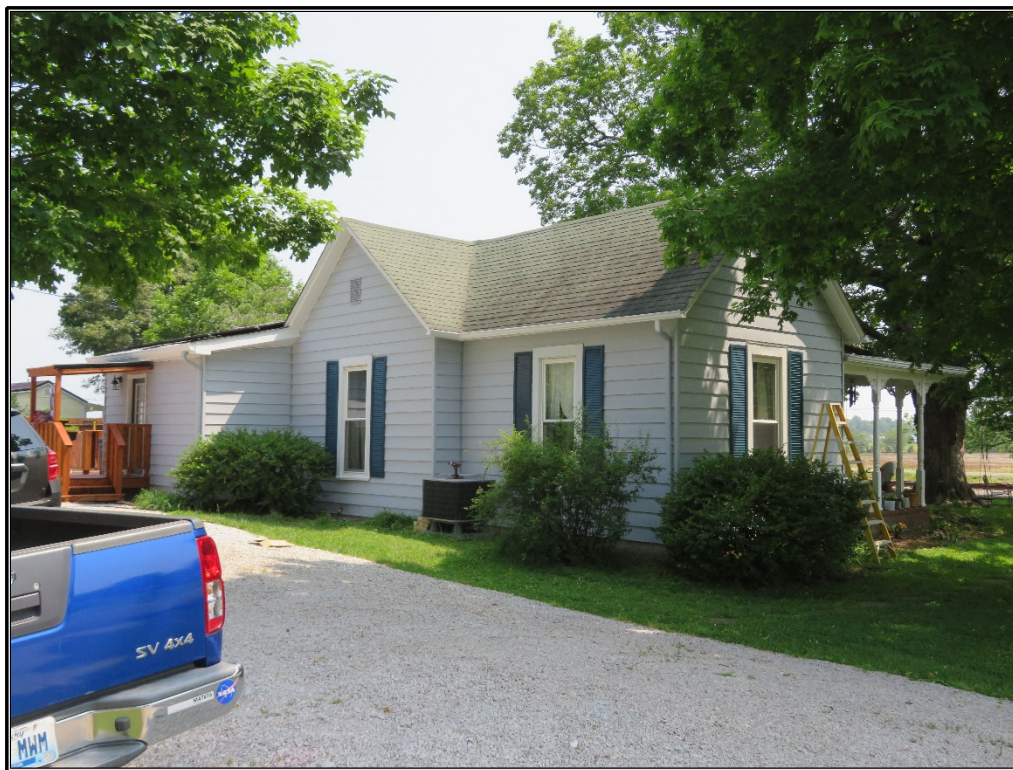
Figure 55. Site 10 (HD 1121): Façade and west elevations of the residence, looking east-northeast.

(rear) elevation of the side-gable section and is pierced by a single-leaf entry (see Figure 55). The entry opens onto a frame deck. A gable-roof addition projects from the north elevation of the cross-gable section (Figure 56). The east elevation of the projection is pierced by a single window. A single window pierces the first floor of the north (rear) elevation with a single window in the half-story. A one-story, gable-roof, frame addition projects from the north (rear) elevation of the shed-roof addition (Figure 57). Vegetation and a privacy fence obstructed views of the north (rear) elevation from the ROW.

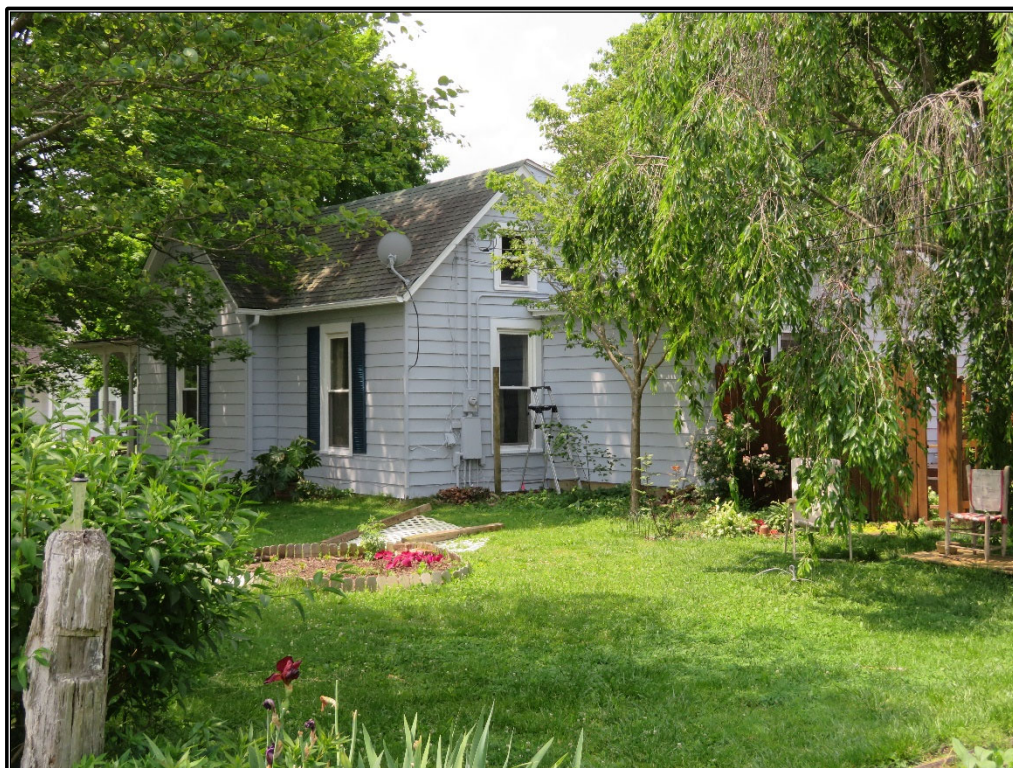
Figure 56. Site 10 (HD 1121): North (rear) and east elevations of the residence, looking southwest.

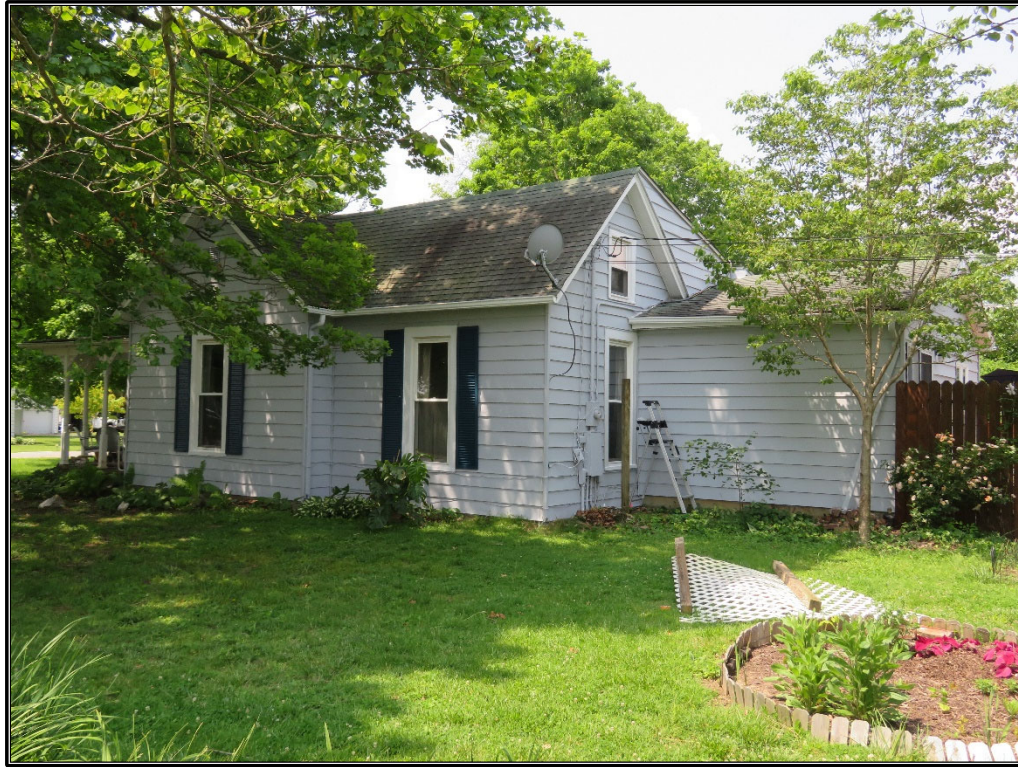
Figure 57. Site 10 (HD 1121): North (rear) and east elevations showing multiple additions, looking west-southwest.

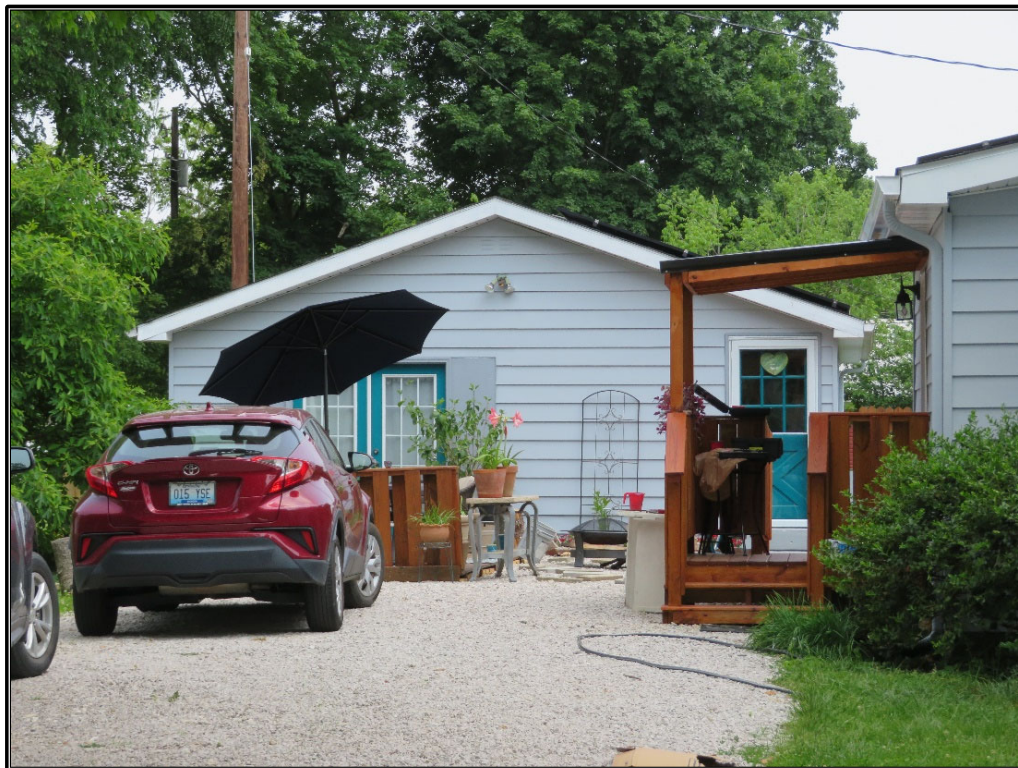
Figure 58. Site 10 (HD 1121): South elevation of the detached garage (Resource A), looking north.

Located approximately 5 ft northwest of the residence is a one-story, front-gable, frame garage (Resource A) oriented to the south (Figure 58). Clad in vinyl siding, the garage is sheltered beneath an asphalt shingle roof that includes solar panels on its east facing slope. The south elevation is pierced by an off-center single-leaf entry filled with a nine-light metal panel door. A double-leaf entry is west of the entry and likely replaced the vehicular bay.

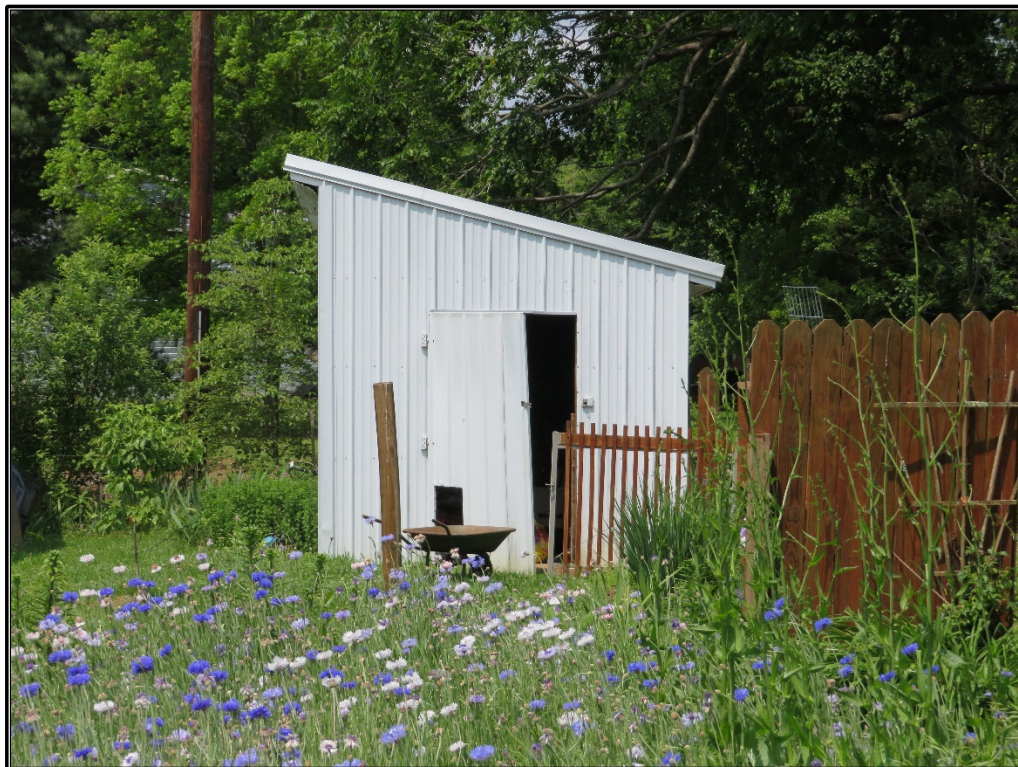
Figure 60. Site 10 (HD 1121): East elevation of the shed (Resource B), looking west.

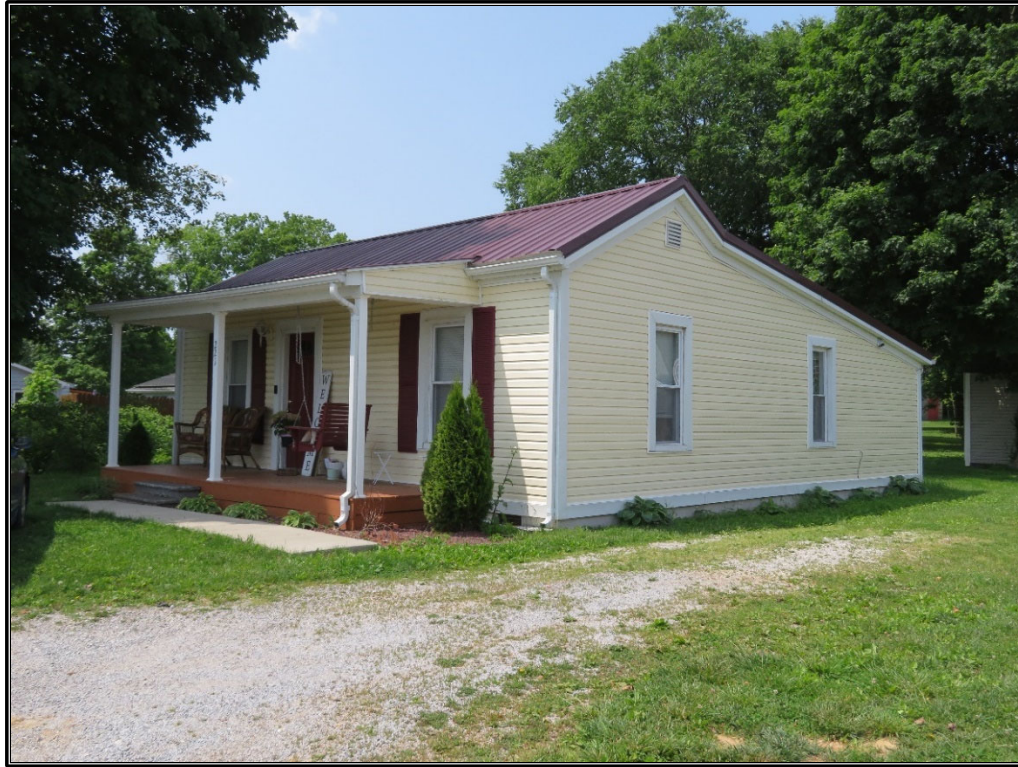
Figure 61. Site 11 (HD 1122): Façade and north elevations of the residence, looking southwest.

Oriented east, the residence is a one-story, three-bay (w/d/w), single-pile, side-gable, frame vernacular dwelling with a rear addition (Figure 61). Clad in replacement vinyl siding, the residence is sheltered beneath a metal panel roof. A metal panel skirt covers the residence's foundation. Windows throughout the residence

An off-center, single-leaf entry pierces the façade and is filled with a replacement fan-light door and includes a wooden surround (see Figure 61). The entry opens onto a three-quarter-width porch sheltered beneath a shed-roof supported by replacement square metal columns resting directly on a poured-concrete deck. Windows flank the entry and are sheltered beneath the porch roof.

The north elevation of the residence's primary mass is pierced by a centrally placed window and includes a square louvered vent in the gable-field (see Figure 61; Figure 62). The south elevation mirrors the north elevation (see Figure 62). A one-story, shed-roof addition projects from the west (rear) elevation and is pierced by a single window on its north and south elevations (see Figures 61 and 62). The west (rear) elevation was not visible from the ROW. An integral shed-roof porch was visible on the west (rear) elevation from the ROW.

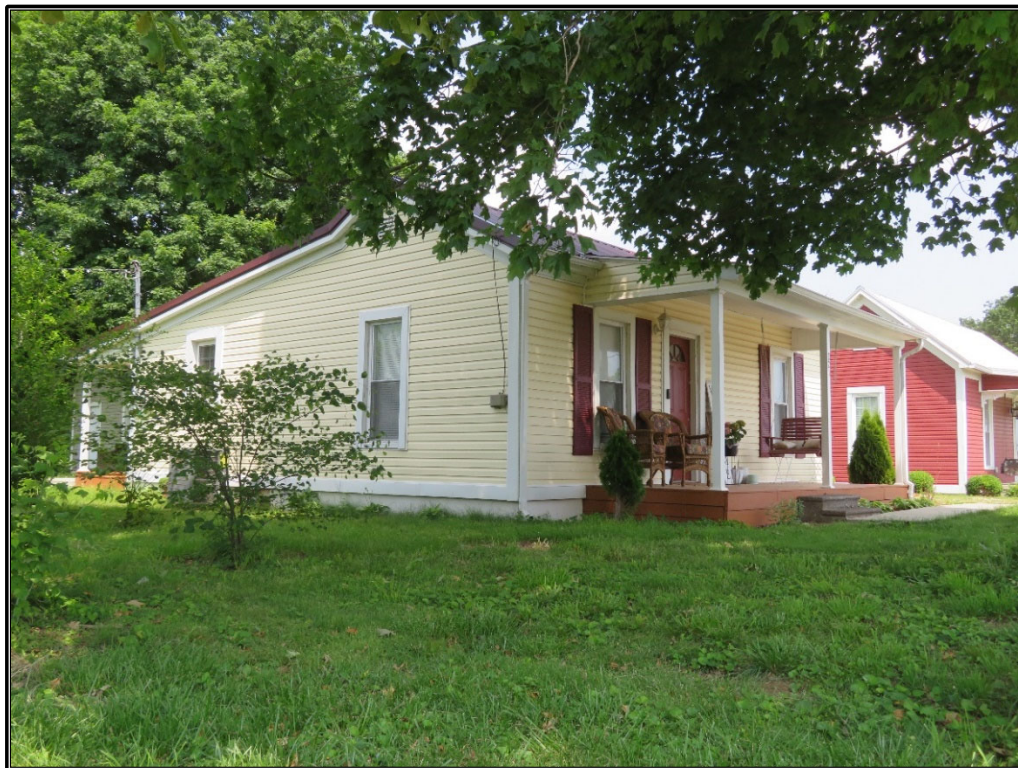
Figure 62. Site 11 (HD 1122): Façade and south elevations of the residence, looking northwest.

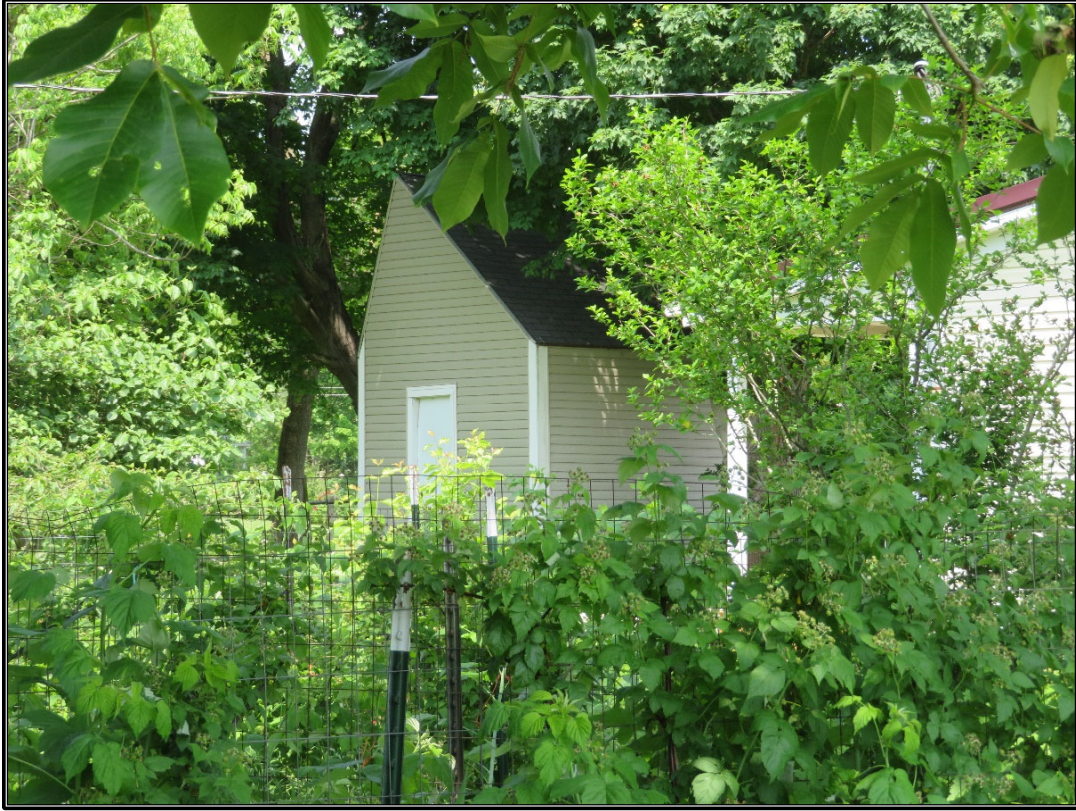
Figure 63. Site 11 (HD 1122): South and east elevations of the outbuilding (Resource A), looking west-northwest.

Located approximately 30 ft west of the residence is a one-story, asymmetrical front-gable, frame, outbuilding (Resource A) (Figure 63). Oriented south, the outbuilding rests on concrete block piers, is clad in vinyl siding, and is sheltered beneath an asphalt shingle roof. A single-leaf entry pierces the south elevation and is filled with an unglazed frame door. The east elevation is void of fenestration; an off-center paired window, filled with vinyl sashes, pierces the north elevation. The west elevation was not visible from the ROW. An outbuilding is first depicted at the location of Resource A in the 1997 aerial photograph. Therefore, Resource A was likely built between 1988 and 1997 (USGS 1988, 1997).

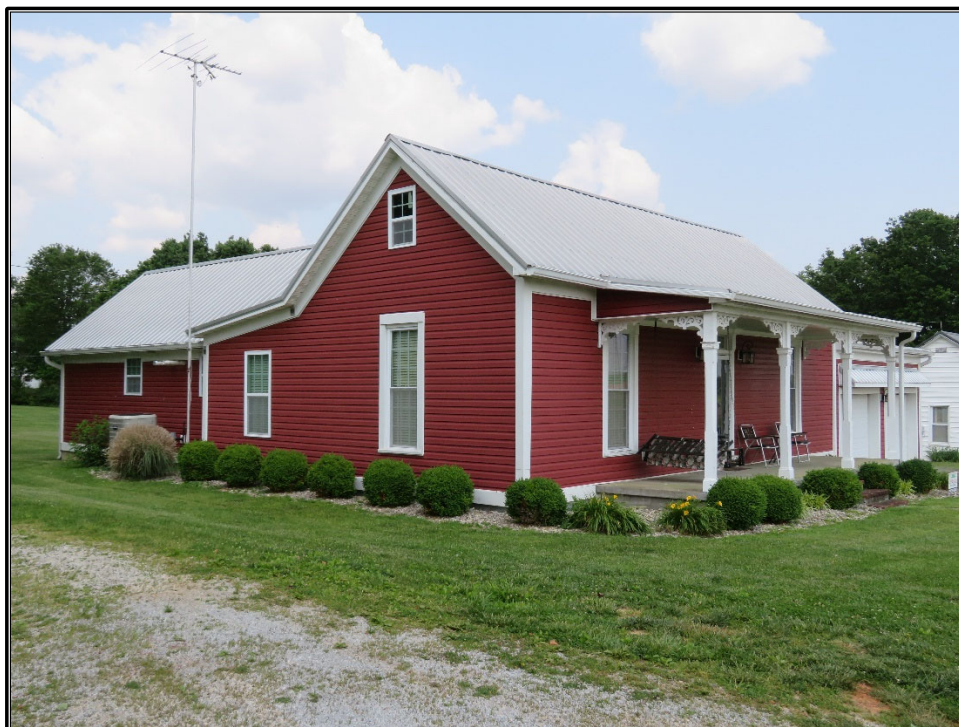
Figure 64. Site 12 (HD 1133): Façade and south elevations of the residence, looking northwest.

Oriented east, the residence is a one-and-one-half-story, three-bay (w/d/w), single-pile, side-gable, frame vernacular dwelling with multiple additions (Figure 64). Clad in replacement vinyl siding, the residence is sheltered beneath a metal panel roof. A plain frieze is located below the eaves. Views of the residence's foundation were obstructed by a

A centrally placed window pierces the south elevation of the residence's primary mass (see Figure 64). A window pierces the gable-field. A one-story, frame, garage addition projects from the residence's north elevation (Figure 66). A review of aerial photographs indicates that the addition was built between

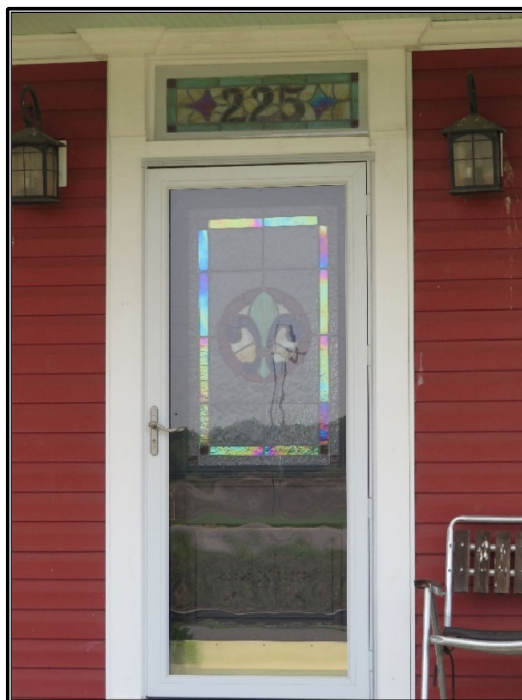
Figure 65. Site 12 (HD 1133): Façade entry detail, looking west.

A centrally placed, single-leaf entry pierces the façade and is filled with an original half-light wood panel door set behind a replacement, fully-glazed, metal storm door. The primary door contains stained glass that features a fleur-de-lis pattern. Stained glass set over the top of the door indicates the residence's address (Figure 65). The entry opens onto a three-quarter-width porch sheltered beneath a shed-roof supported by wood posts that feature chamfered edges, an embellished capital and base, and rest directly on the frame deck. Scrolled wood brackets flank the posts. Windows flank the entry and are sheltered beneath the porch roof.

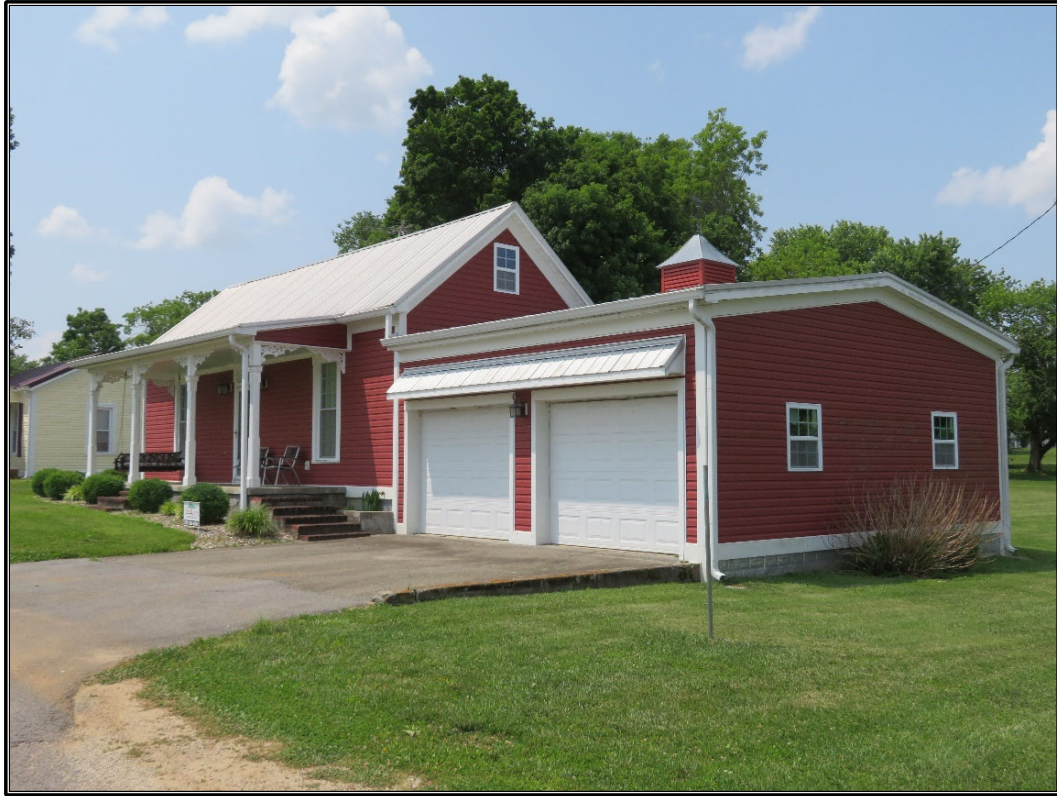
Figure 66. Site 12 (HD 1133): Façade and north elevations of the residence, looking southwest.

1967 and 1988 (USGS 1967a, 1988). Clad in vinyl siding, the garage's east (façade) elevation is pierced by two single-bay vehicular entries filled with unglazed overhead metal panel doors. The vehicular bays are sheltered beneath a pent-roof. Two evenly spaced windows pierce the garage's north elevation. A cupola pierces the ridgeline of the garage addition. A window pierces the gable-field of the residence's primary mass. A one-story, shed-roof addition projects from the west (rear) elevation and rests on a concrete block foundation. A single window pierces the south elevation of the shed-roof addition (see Figure 64). Three windows pierce the west (rear) elevation of the rear shed-roof addition (Figure 67). A one-story, gable-roof, frame ell projects from the residence's west (rear) elevation (see Figure 64). Resting on a concrete block foundation, a single-leaf entry pierces the ell's north elevation and is sheltered beneath a shed-roof. A single window is west of the entry. The ell's south and west (rear) elevations are both pierced by two evenly spaced windows (see Figures 64 and 67). Remaining fenestration of the residence's west (rear) elevation includes a single-leaf entry and window.
