RE: Cultural Historic Overview Study for KY 222 and Its Vicinity in Hardin County, Kentucky
CRA Project No.: K220171
Contract Publication Series: 22-184

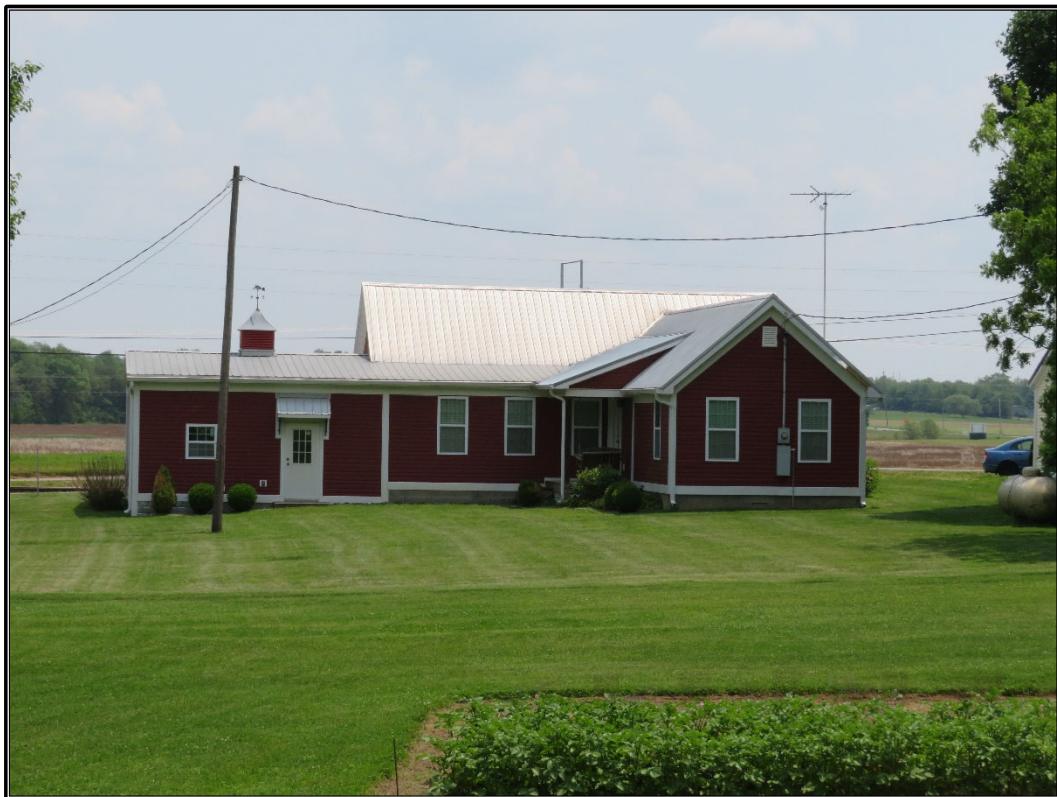
Figure 67. Site 12 (HD 1133): West (rear) elevation of the residence, looking east-southeast.

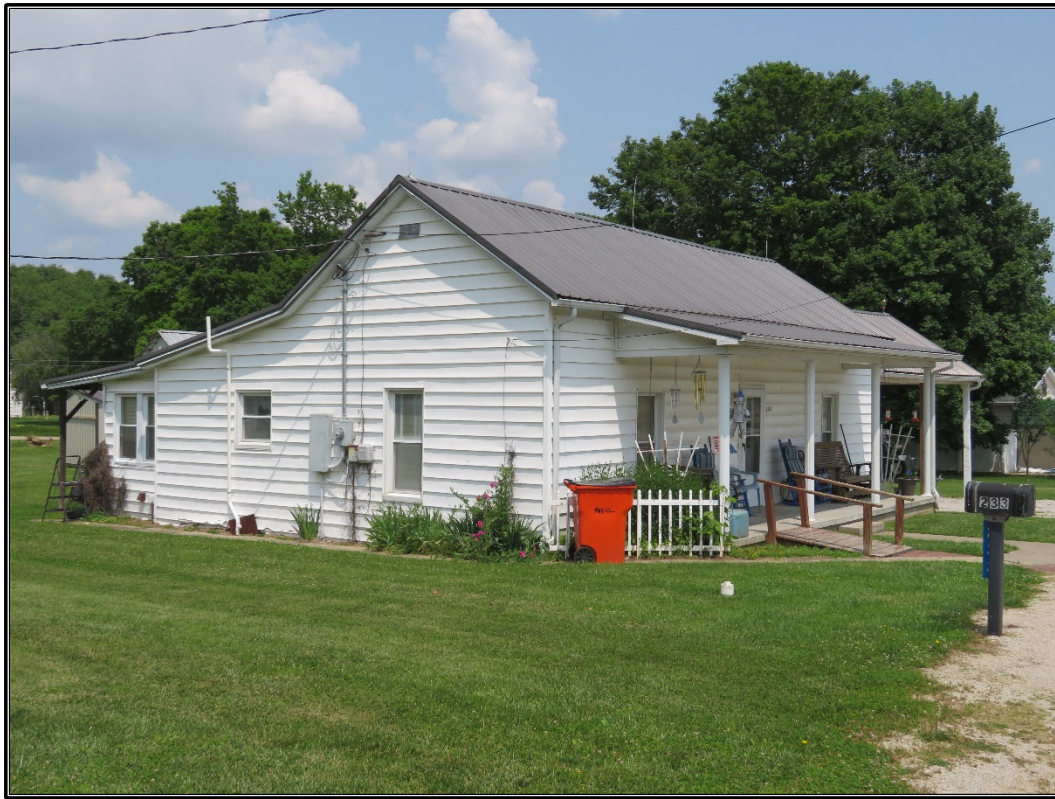
Figure 68. Site 13 (HD 1307): Façade and south elevation of the residence, looking northwest.

Oriented east, the residence is a one-story, three-bay (w/d/w), single-pile, side-gable, frame vernacular dwelling with a rear addition (Figure 68). Clad in replacement vinyl siding, the residence is sheltered beneath a metal panel roof. A corrugated metal skirt covers the residence's foundation. Unless otherwise indicated, windows throughout the residence are filled with one-over-one, double-hung replacement vinyl sashes.

A centrally placed, single-leaf entry pierces the façade and is filled with a replacement nine-light door set behind a three-quarter light metal storm door (see Figure 68). The entry opens onto a three-quarter-width porch sheltered beneath a shed-roof supported by replacement fluted metal columns resting directly on a poured-concrete deck. Windows flank the entry and are sheltered beneath the porch roof.

The south elevation of the residence's primary mass is pierced by a centrally placed window filled with three-over-one, double-hung wood sashes (see Figure 68). The north elevation's fenestration pattern mirrors the south elevation (Figure 69). An open-frame, gable-roof, carport projects from the residence's north elevation and includes square wooden posts resting directly on grade. Aerial photographs reviewed indicate the carport was constructed between 1988 and 1997 (USGS 1988, 1997). A full-width shed-roof addition projects from the residence's west (rear) elevation and is pierced by a single window on its south and north elevations (see Figures 68 and 69). A second, quarter-width, shed-roof addition is present on the west (rear) elevation and is pierced by a paired window on its south elevation. An integral shed-roof porch projects from its west (rear) elevation. The west (rear) elevation was not visible from the ROW.

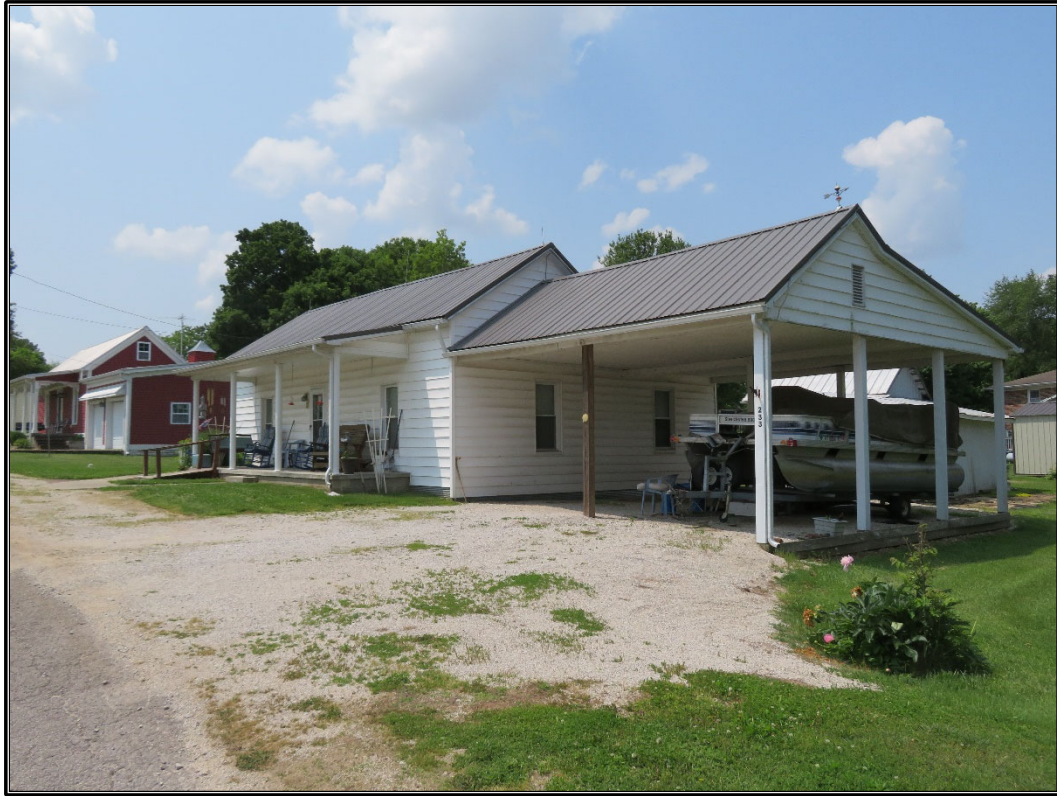
Figure 69. Site 13 (HD 1307): Façade and north elevations of the residence, looking southwest.

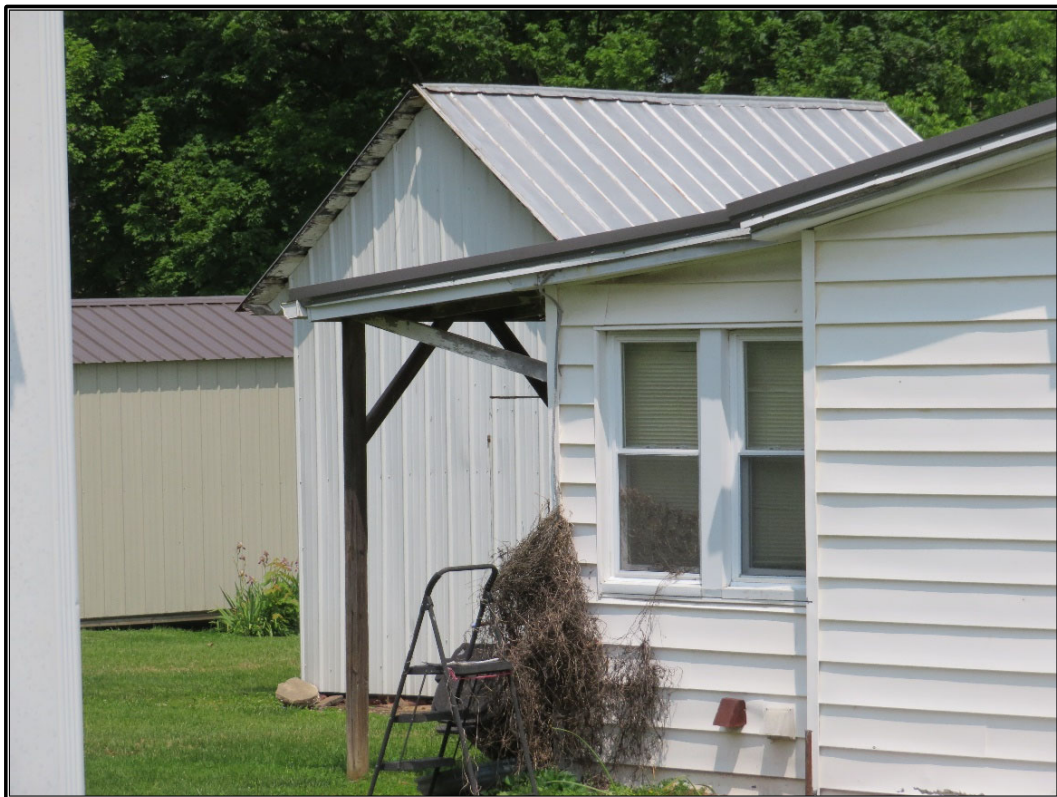
Figure 70. Site 13 (HD 1307): South elevation of the gable-roof outbuilding (Resource A), looking northwest.

(Figure 70). The outbuilding is clad and sheltered beneath metal panels. The foundation material was not visible from the ROW. Views of the outbuilding were obstructed from the ROW; however, a single-leaf entry may pierce the south elevation. A shed-roof, frame, addition projects from the outbuilding's north elevation and is clad in corrugated metal and metal panels (Figure 71). An outbuilding is first depicted at the location of Resource A on the 1960 aerial photograph (USGS 1960). Based on its form and materials, as well as its earliest aerial appearance, it seems likely that Resource A was built between 1925 and 1950.

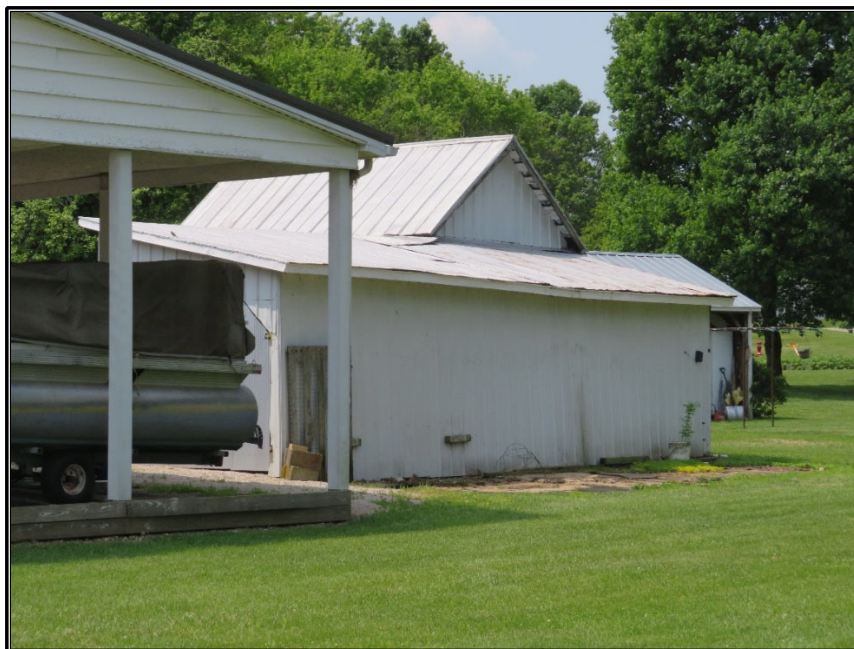
Figure 71. Site 13 (HD 1307): North elevation of the gable-roof outbuilding and shed-roof addition (Resource A), looking southwest.

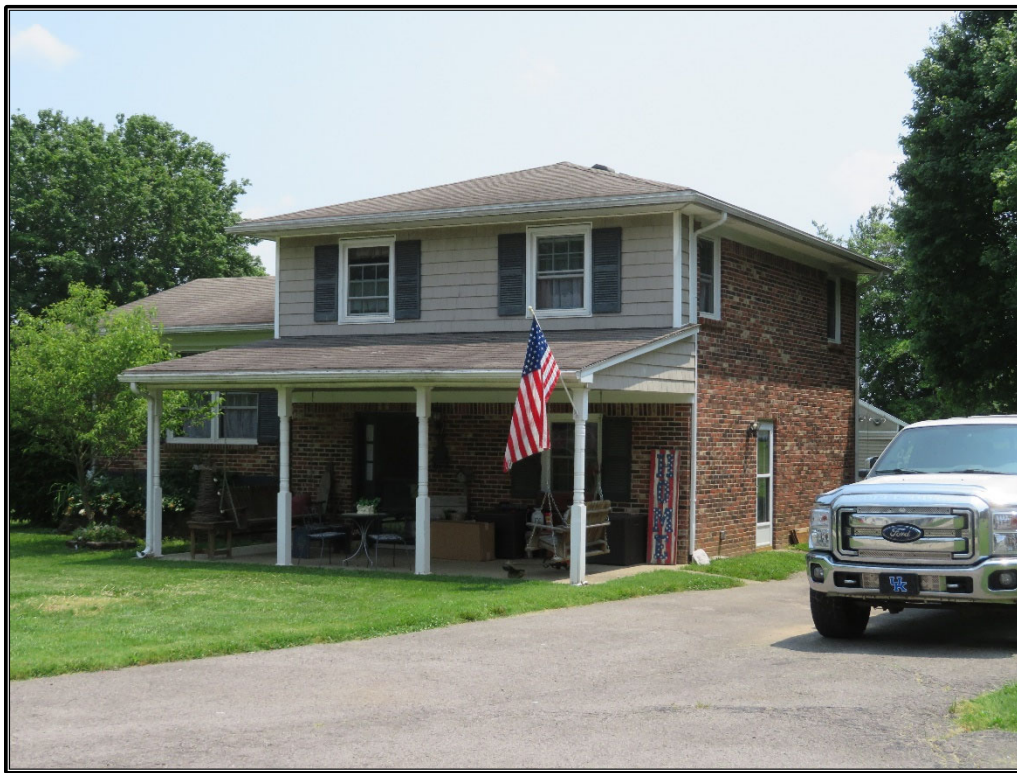
Figure 72. Site 14 (HD 1303): Façade and southwest elevations of the residence, looking east.

Oriented northwest, the frame Split-Level house is composed of a two-story, two-bay (d/w), double-pile, hip-roof section with a one-story, single-bay (ww), double-pile, side-gable section positioned between the two stories on the northeast elevation of the two-story section (Figure 72). The bottom level of the two-story section and one-story section are clad in a brick veneer to grade. A soldier course is located beneath a plain frieze on both sections of the residence. The façade of the second-floor of the two-story section is clad in wood shingles. Asphalt shingles cover the roofs of the two sections. Windows throughout the residence contain one-over-one, double-hung replacement vinyl sashes with snap-in grids.

A single-leaf entry pierces the façade of the residence's two-story section and includes a replacement, full-light storm door (see Figure 72). A single, three-light, wood panel side-light is northeast of the entry. The entry opens onto a partial-width porch that extends the length of the two-story section and is sheltered beneath a

shed-roof supported by evenly spaced, turned wood columns resting on the poured-concrete deck. A single window is southwest of the entry and is sheltered beneath the porch roof. Two evenly placed windows pierce the second-floor. The façade of the one-story section is pierced by a paired window (see Figure 72).

The southwest elevation of the residence is pierced by a single-leaf entry set behind a three-quarter light storm door (see Figure 72). The door material was not visible from the ROW. Two windows pierce the second-floor of the southwest elevation. A single, off-center, window pierces the northeast elevation (Figure 73). A frame deck projects from the southeast (rear) elevation of the one-story section and is sheltered beneath a gable-roof supported by square wooden posts (see Figure 73). The southeast elevation was not visible from the ROW.

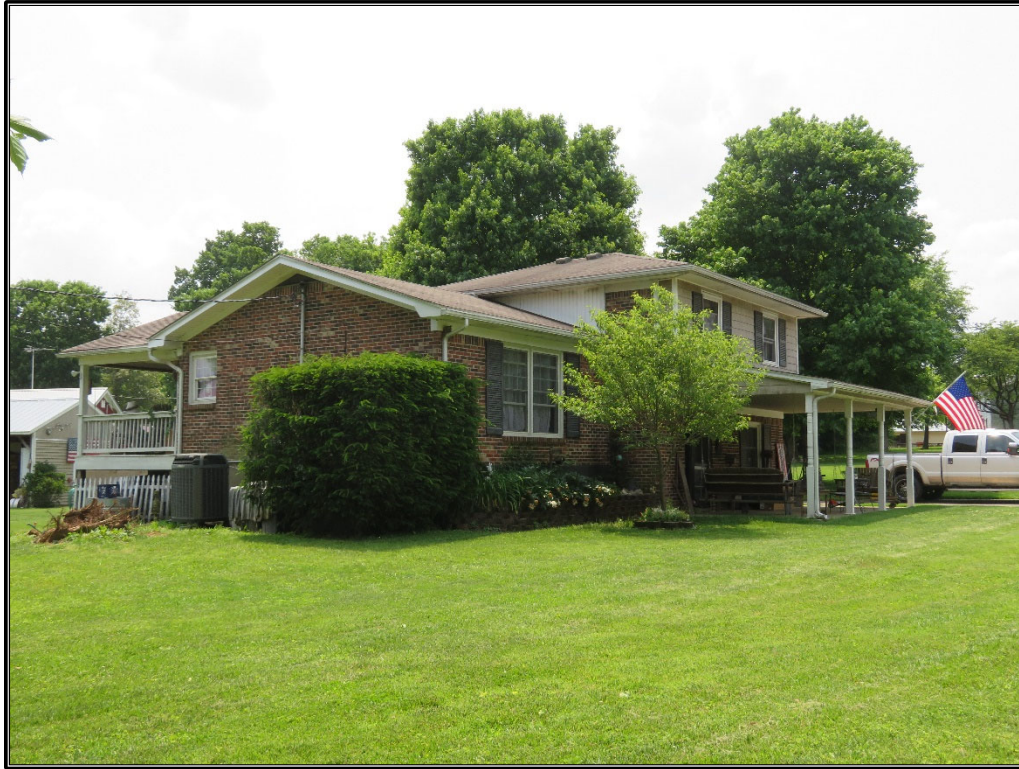
Figure 73. Site 14 (HD 1303): Façade and northeast elevations of the residence, looking south.

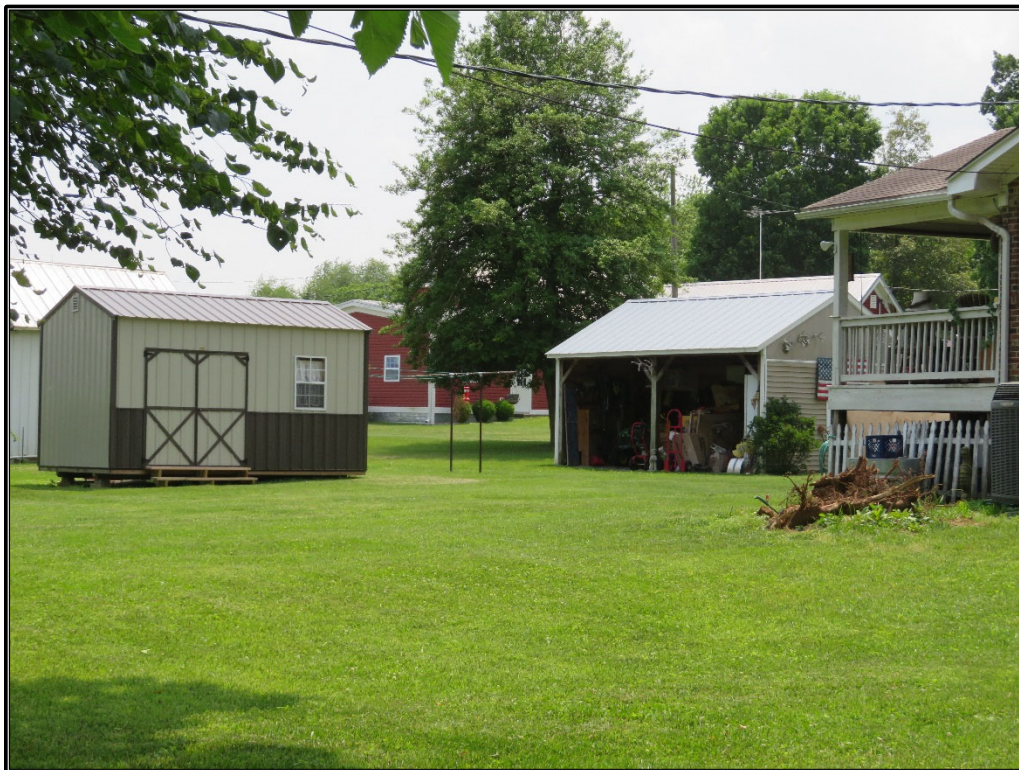
Figure 74. Site 14 (HD 1303): Overview of the frame outbuildings (right to left, Resources A and B), looking southeast.

Located approximately 30 ft southeast of the residence is a one-story, side-gable, frame, outbuilding (Resource A) (Figure 74). Oriented north, the outbuilding is clad in vinyl siding and is sheltered beneath a metal panel roof. The north elevation is open and features two open bays that are formed by square wood posts set directly into the ground. The west elevation is void of fenestration. The east and south (rear) elevations are not visible from the ROW. An outbuilding is first depicted at the location of Resource A on the 2012 aerial. Therefore, Resource A was likely built between 2010 and 2012.

A prefabricated, one-story, side-gable, frame outbuilding (Resource B) is located approximately 35 ft east of the residence (see Figure 74). Oriented west, the outbuilding rests on piers comprised of stacked concrete pavestones, is clad in metal panel siding and sheltered beneath metal panels. An off-center, double-leaf entry pierces the west elevation. A single window is south of the entry. The north elevation is void of fenestration. Subsequent elevations were not visible from the ROW. Aerial photographs reviewed indicate Resource B was moved to this location sometime between 2020 and 2023.

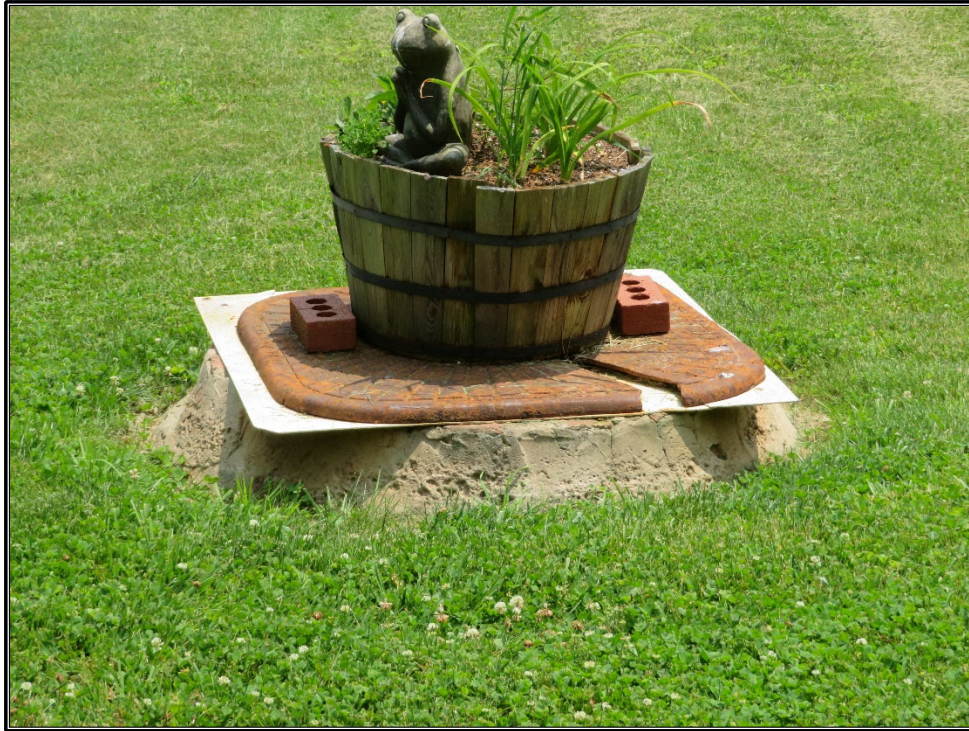
Figure 75. Site 14 (HD 1303): Overview of the well (Resource C), looking east-southeast.

The well (Resource C), is in a deteriorated condition, which compromises its integrity of design, materials, and workmanship. Therefore, lacking integrity, the well (Resource C) is not eligible for individual listing in the NRHP under Criterion C.

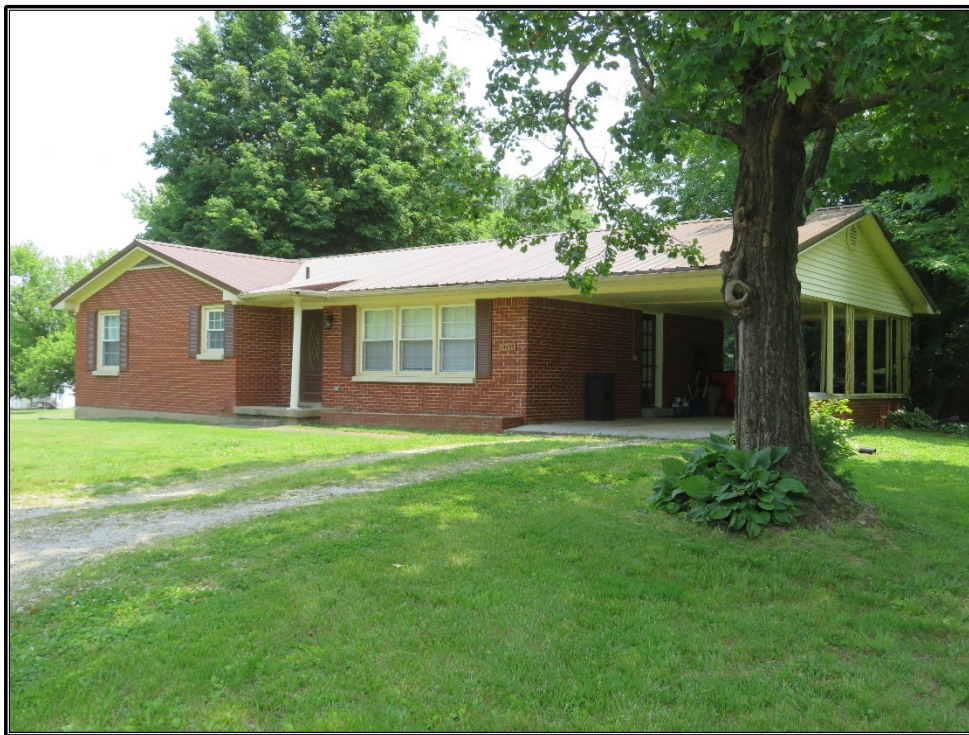
Figure 76. Site 15 (HD 1304): Façade and southwest elevations of the residence, looking east.

The façade of the residence features a single-leaf entry containing a replacement, oval-light door (see Figure 76). The entry opens onto an entry-width porch sheltered beneath a shed-roof that is supported by a single replacement fluted metal column. A ribbon of three windows pierces the façade southwest of the entry. Two windows pierce the gable-roof projection. An integral carport projects from the southeast elevation and is supported by decorative metal posts and 2-x-4s resting on a brick veneer knee wall. The southwest gable-field exhibits replacement vinyl cladding and is pierced by an octagonal louvered vent.

door and opens into the integral carport (see Figure 76). Two evenly spaced windows pierce the northeast elevation (Figure 77). A single horizontal sliding sash window pierces the basement foundation. The southeast (rear) elevation was not visible from the ROW.

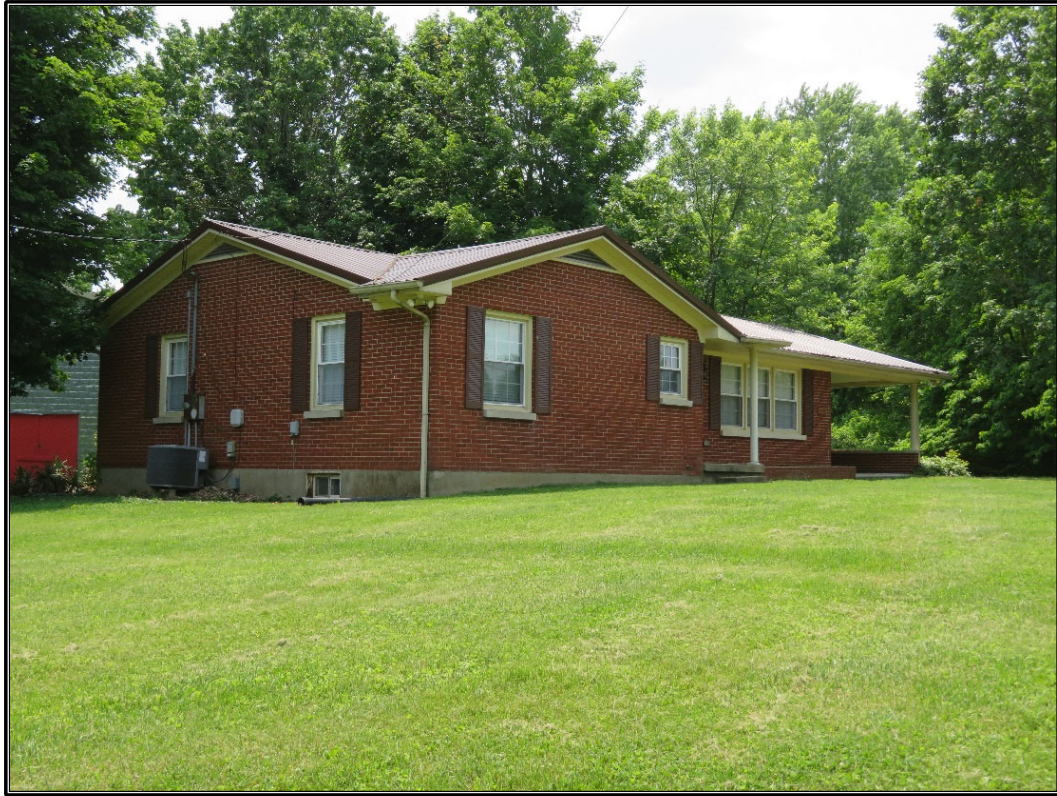
Figure 77. Site 15 (HD 1304): Façade and northeast elevations of the residence, looking south.

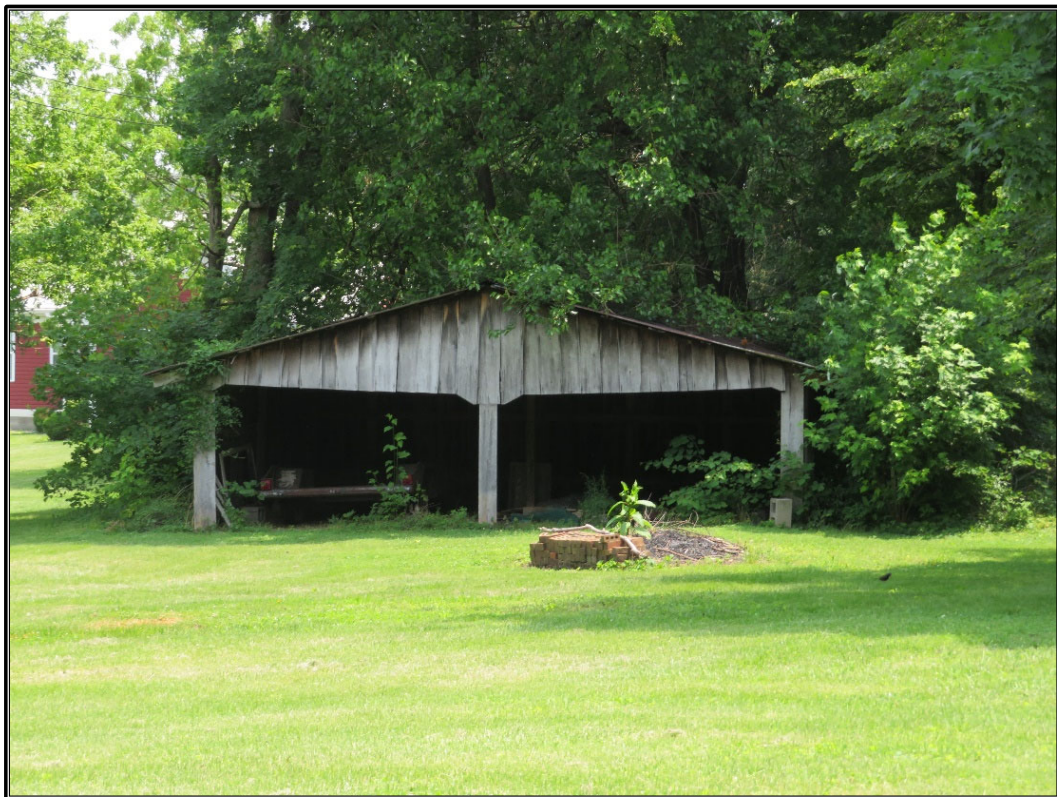
Figure 78. Site 15 (HD 1304): Northwest elevation of the garage (Resource A), looking east-southeast.

Oriented northwest, a single-story, two-bay, front-gable, frame garage is located approximately 85 ft northeast of the residence (Figure 78). Clad in vertical board siding, the garage is sheltered beneath a metal roof. The garage's foundation material was not visible from the ROW. Two unobstructed single-bay vehicular entries pierce the northwest elevation. The northeast and southeast (rear) elevations are void of fenestration. The southwest elevation was not visible from the ROW. A review of aerial photographs indicates that the garage (Resource A) was most likely built between 1967 and 1988 (USGS 1967a, 1988).

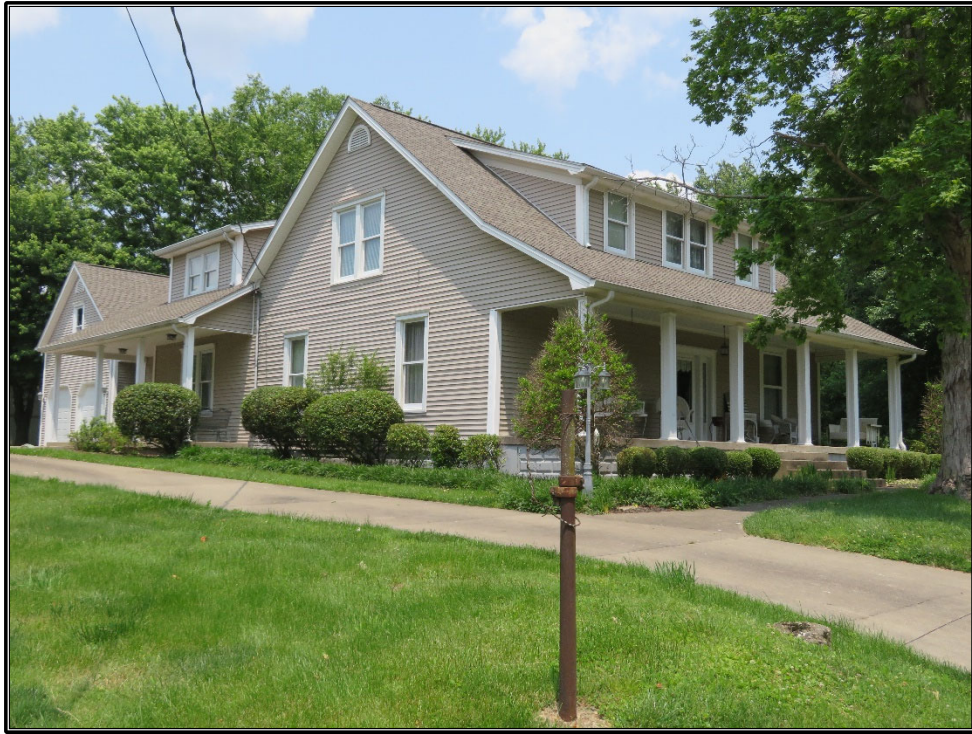
Figure 79. Site 16 (HD 1117): Façade and southwest elevations of the residence, looking north.

Oriented southeast, the residence is a one-and-one-half-story, three-bay (w/wdw/w), double-pile, side-gable, frame American Bungalow with multiple additions (Figure 79). Resting on a concrete block foundation, the residence is clad in vinyl siding and sheltered by an asphalt shingle roof. Windows throughout the residence are filled with one-over-one, double-hung replacement vinyl sashes and include decorative surrounds.

The southwest elevation of the residence's primary mass is pierced by two evenly spaced windows along the first story (see Figure 79). A paired window and arched louvered vent are present in the gable-field. The northeast elevation of the residence's primary mass is pierced by a single and paired window along the first story (Figure 81). The gable-field exhibits a paired window. A one-and-one-half-story, gable-roof addition extends from the northwest (rear) elevation (see Figure 79). A recessed, single-leaf entry, flanked by sidelights, pierces the southwest elevation of the gable-roof addition (Figure 82). The entry opens onto an integral porch supported by square wooden columns. A paired window is

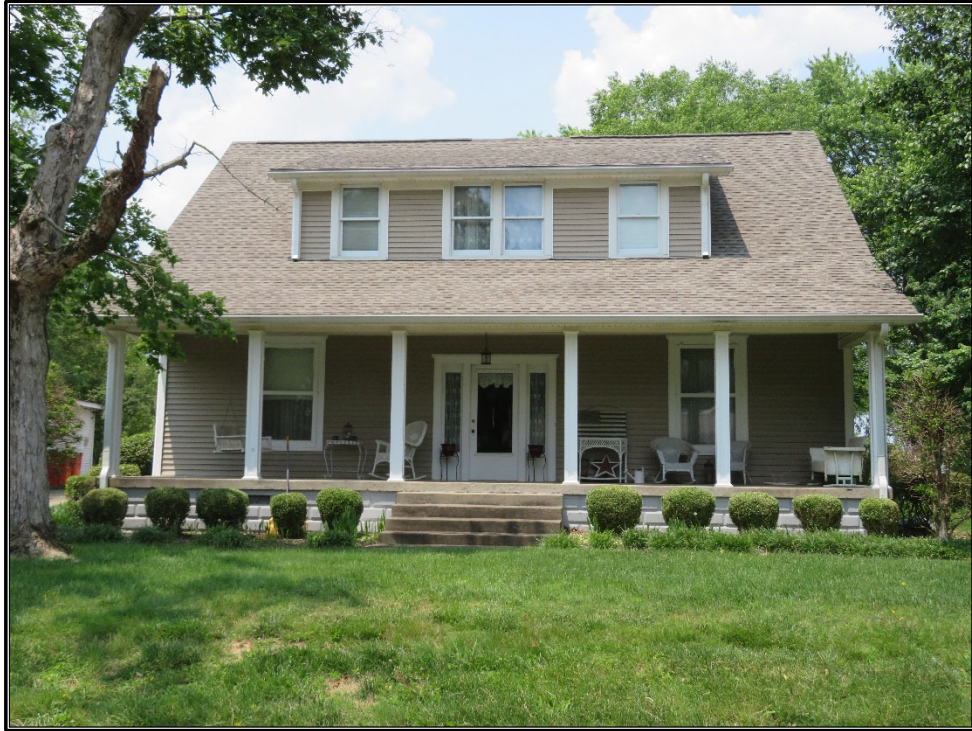
Figure 80. Site 16 (HD 1117): Façade of the residence, looking northwest.

The façade of the residence is pierced by a centrally placed, single-leaf entry filled by an original three-quarter light wood door framed by three-quarter single-light sidelights (Figure 80). The entry opens onto a full-width, integral porch supported by square wooden columns set on a poured concrete deck. Windows flank the entry. A shed-roof dormer pierces the southeast slope of the roof and exhibits a paired window and two single windows.

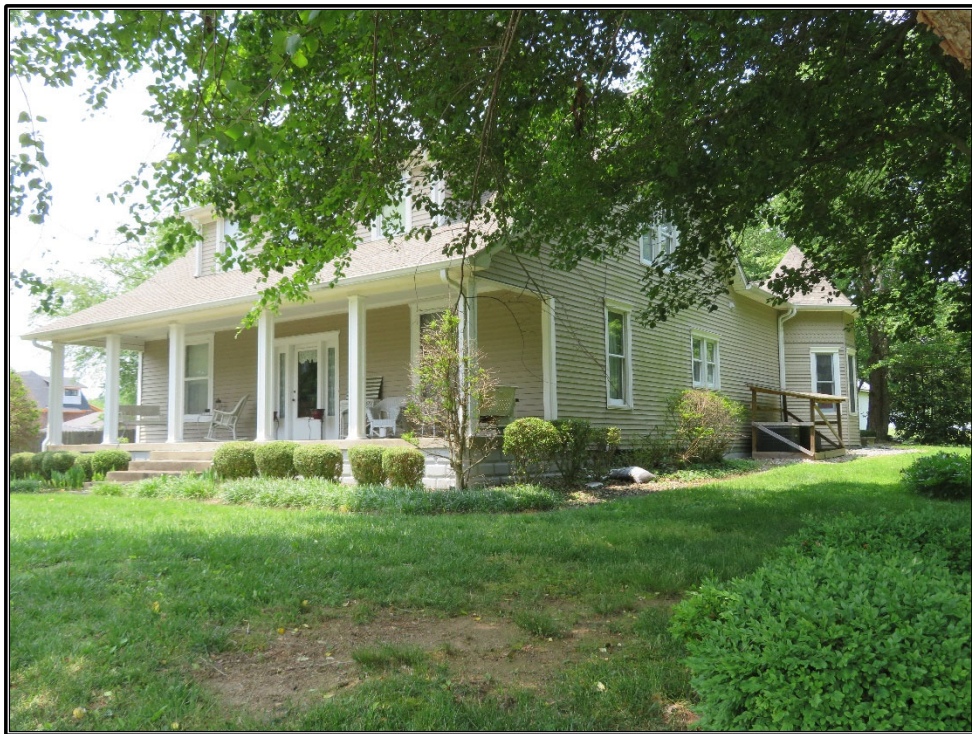
Figure 81. Site 16 (HD 1117): Façade and northeast elevation of the residence, looking west.

southeast of the entry. A shed-roof dormer pierces the southwest slope of the roof of the rear gable-roof addition and is pierced by a paired window. The northeast elevation of the rear gable-roof addition is void of fenestration (see Figure 81). A one-story, canted, frame turret projects from the northeast corner of the rear gable-roof addition and features scalloped shingles beneath the eaves. The northwest (rear) elevation of the gable-roof addition is pierced by a single-leaf entry filled with a three-quarter light metal panel door. An unobstructed gable-roof breezeway provides access to a one-and-one-half-story, gable-roof, frame garage from the rear gable-roof addition (see Figures 79 and 82). Clad in vinyl siding and sheltered beneath an asphalt shingle roof, the southwest elevation of the garage is pierced by two, single-bay, vehicular entries filled with unglazed overhead metal panel doors. A single window and an arched louvered vent pierce the gable-field above the garage bays. The northwest elevation is void of fenestration (see Figure 82). All subsequent elevations were not visible from the ROW.

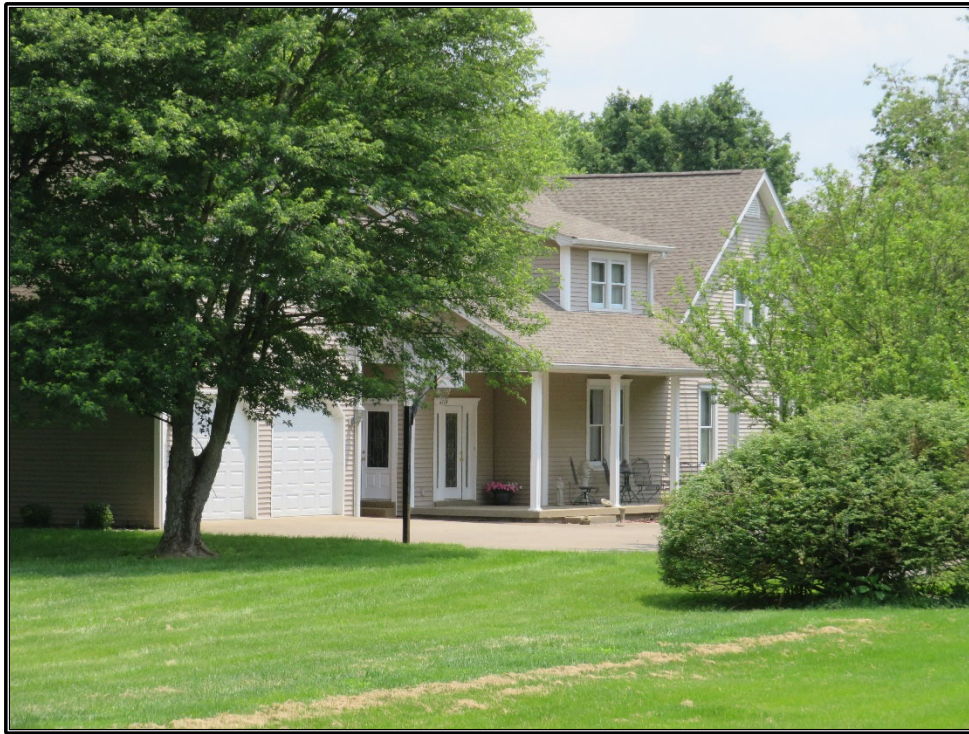
Figure 82. Site 16 (HD 1117): Northwest (rear) and southwest elevations of the residence, looking east-southeast.

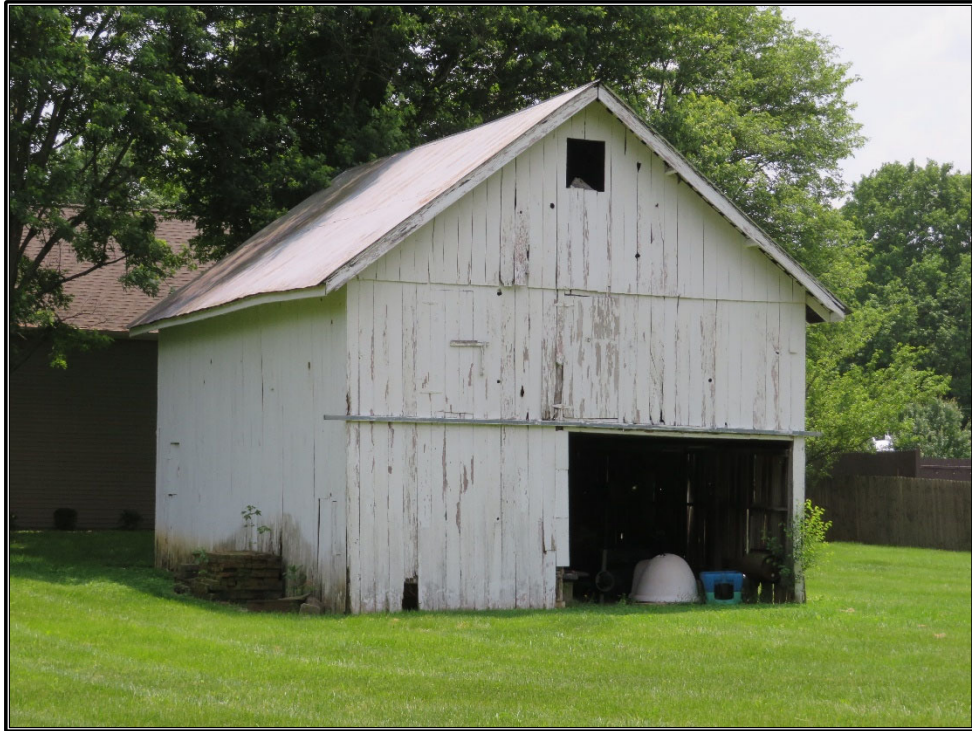
Figure 83. Site 16 (HD 1117): Northwest and northeast elevations of the barn (Resource A), looking south-southeast.

Located approximately 35 ft northwest of the residence is a barn (Resource A) (Figure 83). Oriented northwest to southeast, the barn is clad in vertical board siding and sheltered beneath a metal panel roof. The foundation material was not visible from the ROW. An unobstructed off-center single-bay entry pierces the northwest elevation. Hardware observed above the entry indicates a horizontal sliding door previously enclosed the entry. Two single-leaf entries, filled with vertical board doors and attached to the barn's main mass with strap hinges, pierce the gable-field. An unobstructed opening pierces the top of the gable-field. The northeast and southwest elevations are void of fenestration. The southeast elevation was not visible from the ROW. The barn is first depicted on the 1960 aerial (USGS 1960). Based on its form, materials, and earliest aerial appearance, as well as the approximate construction date of the associated residence, the barn (Resource A) was most likely constructed contemporaneously with the residence, circa 1918.

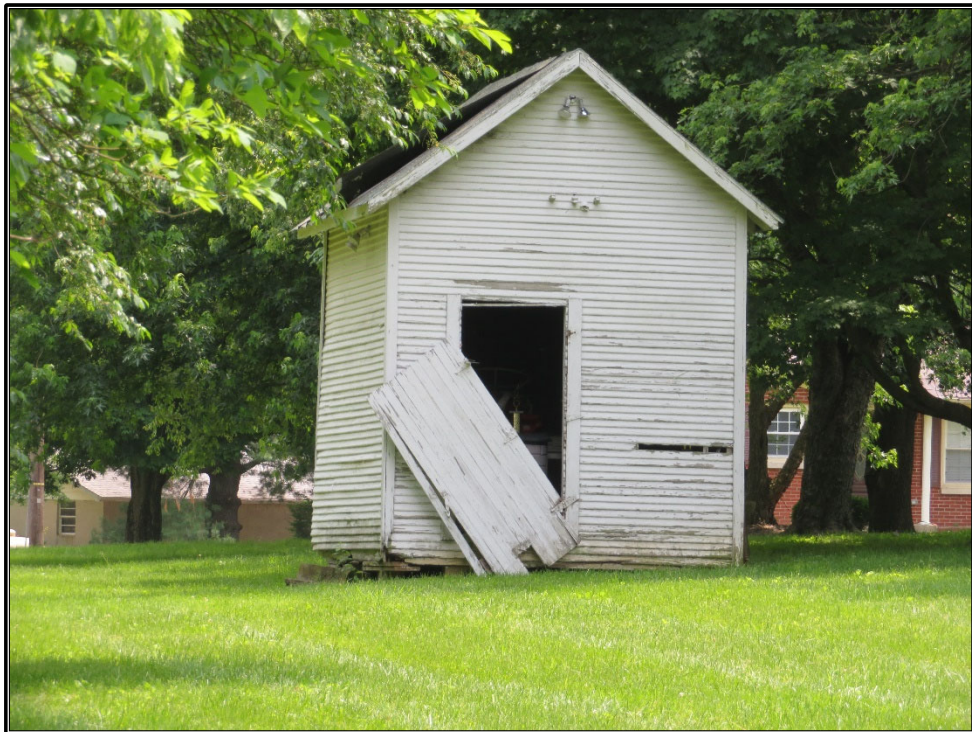
Figure 84. Site 16 (HD 1117): Northwest and northeast elevations of the outbuilding (Resource B), looking south-southeast.

Oriented northwest, a one-story, gable-roof, frame outbuilding (Resource B) clad in weatherboard siding and sheltered beneath an asphalt shingle roof is located approximately 55 ft northeast of the residence (Figure 84). The outbuilding's foundation material was not visible from the ROW. An off-center, single-leaf entry pierces the northwest elevation and includes a vertical board door attached to the outbuilding's main mass with strap hinges. The door's top hinge has become detached from the outbuilding. The northeast and southwest elevations are void of fenestration. The southeast elevation was not visible from the ROW. Due to the scale and quality of the aerial photographs reviewed, Resource B is first depicted on the 1988 aerial photograph (USGS 1960, 1967a, 1988). However, based on its form and materials and the approximate construction date of the associated residence, the outbuilding (Resource B) was most likely constructed contemporaneously with the residence, circa 1918.

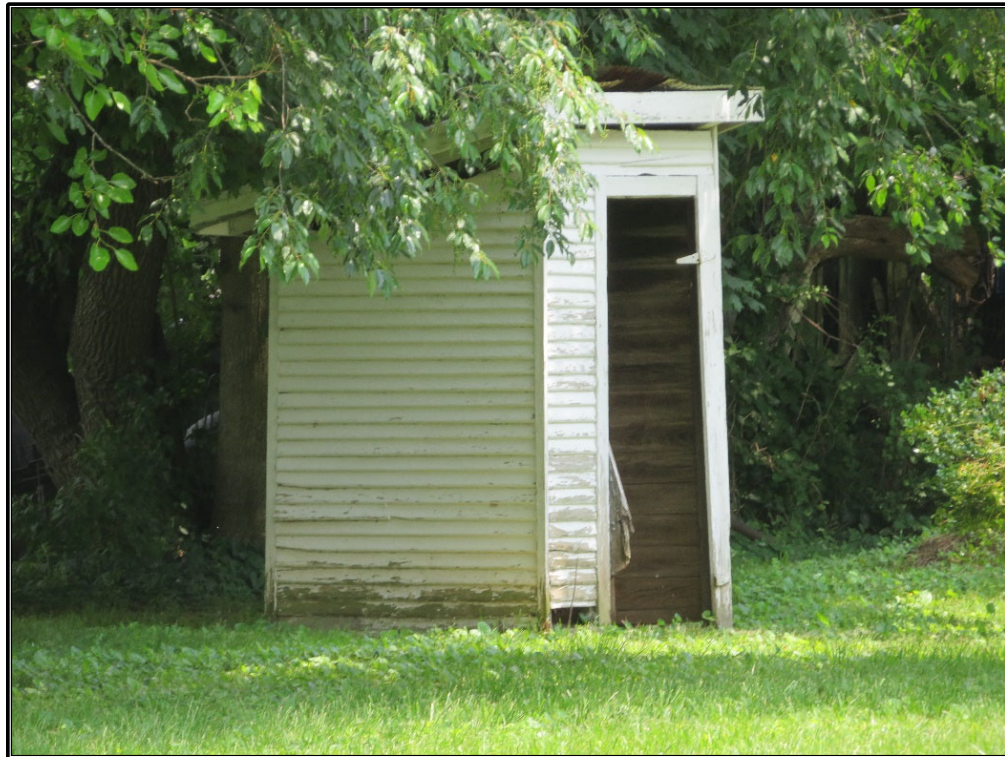
Figure 85. Site 16 (HD 1117): Southwest and northwest elevations of the privy (Resource C), east-southeast.

Approximately 105 ft north of the residence, and oriented southwest, is a one-story, one-bay, shed-roof, frame privy (Resource C) (Figure 85). Clad in weatherboard siding, the privy is sheltered beneath a corrugated metal roof. A single-leaf entry pierces the southwest elevation and is void of its entry door. Strap hinges are present on the privy's main mass. The northwest and southeast elevations are void of fenestration. The northeast elevation was not visible from the ROW. Due to the scale and quality of the aerial photographs reviewed, the privy is not depicted on any of the aerial photographs (USGS 1960, 1967a, 1988). However, based on its form and materials and the approximate construction date of the associated residence, the privy (Resource C) was most likely constructed contemporaneously with the residence, circa 1918.

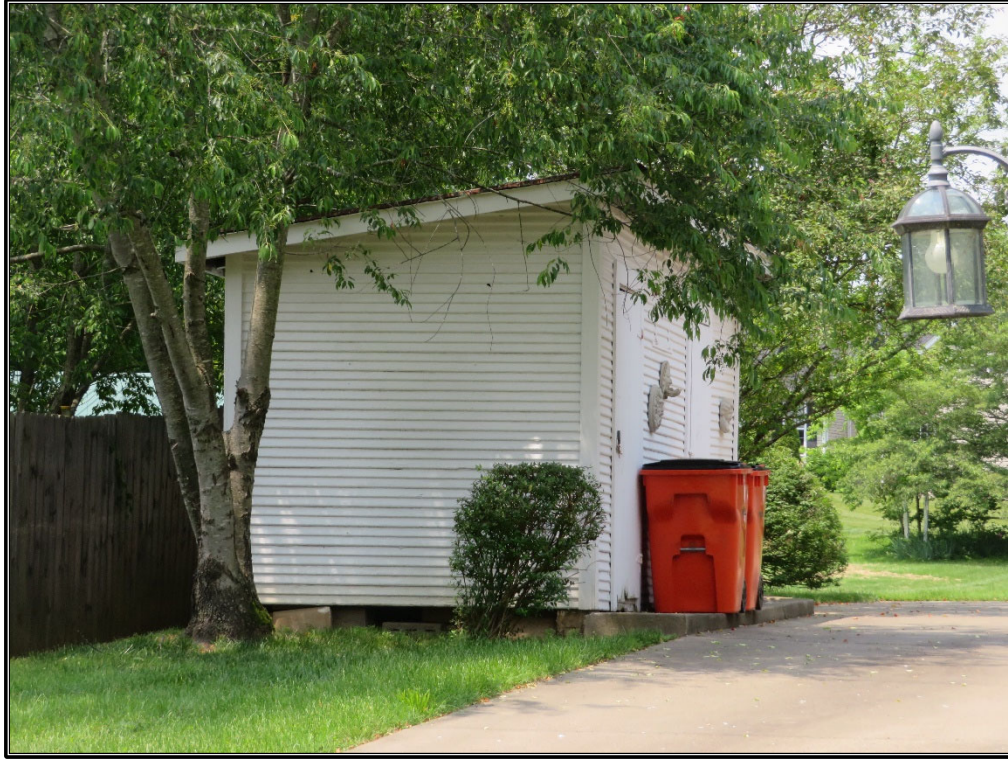
Figure 86. Site 16 (HD 1117): Southeast and façade elevations of the shed-roof outbuilding (Resource D), looking west-northwest.

Approximately 20 ft southwest of the residence is a one-story, two-bay (d/d), single-pile, shed-roof, frame outbuilding (Resource D) (Figure 86). The structure rests on concrete-block piers, is clad in wood weatherboards, and has a metal-panel roof. Oriented northeast, the

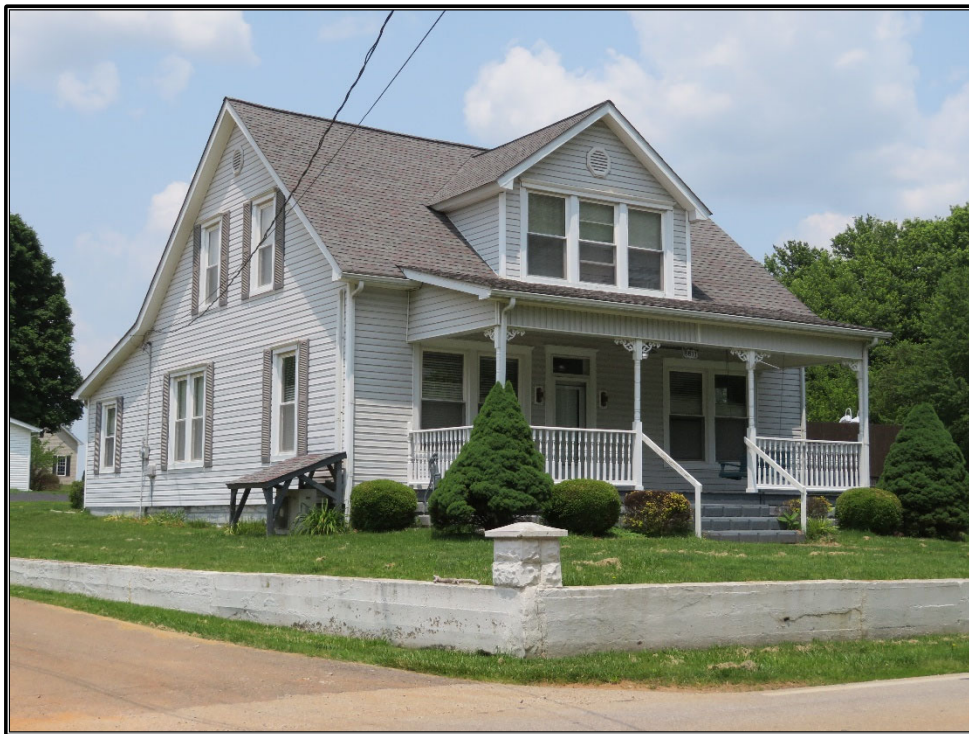
Figure 87. Site 17 (HD 1116): Façade and southwest elevations of the residence, looking north-northwest.

Oriented southeast, the residence is a one-and-one-half-story, three-bay (ww/d/ww), double-pile, side-gable, frame American Bungalow with a rear addition (Figure 87). Resting on a concrete block foundation, the

An off-center single-leaf entry pierces the façade and is filled with a three-quarter light wood door set behind a fully-glazed metal storm door (see Figure 87). The entry includes a decorative surround topped by a one-light transom. The entry opens onto a three-quarter width, shed-roof porch supported by turned columns set on a frame deck and flanked by scrolled wood brackets. Paired windows flank the entry. A gable-roof dormer pierces the southeast slope of the roof and exhibits a ribbon of three windows. An octagonal louvered vent pierces the dormer's gable field.

The southwest elevation of the residence's primary mass is pierced by a paired and single window along the first story (see Figure 87). Two single windows and an octagonal louvered vent pierce the gable-field. The northeast elevation of the residence mirrors the southwest (Figure 88). A one-story, shed-roof, frame addition projects from the northwest (rear) elevation. A single window pierces the addition's southwest elevation (see Figure 87). The addition's northeast elevation is void of fenestration (see Figure 88). A single-leaf entry, filled with a nine-light replacement metal panel door set behind a metal storm door, pierces the northwest (rear) elevation of the addition (Figure 89). Windows flank the entry. The northwest (rear) facing slope of the residence's principal mass is pierced by a shed-roof dormer that exhibits a ribbon of three windows.

A concrete block retaining wall (Resource C) is located along the edge of the ROW to the southeast and southwest of the residence (see Figure 87; Figure 92). In total, the retaining wall extends along approximately 140 ft of the ROW and measures 2-3 ft in height. A concrete block pier, topped by a pyramidal precast-concrete cap, is located at the corner of North Beech Street and West Maple Street. The retaining wall's southeast elevation features a set of stairs flanked by concrete block piers that provide access to the front yard lot. Due to the scale and quality of the aerials reviewed, the retaining wall was not visible. However, based on its form and materials, it seems likely that the retaining wall (Resource C) was built between 1925 and 1950.

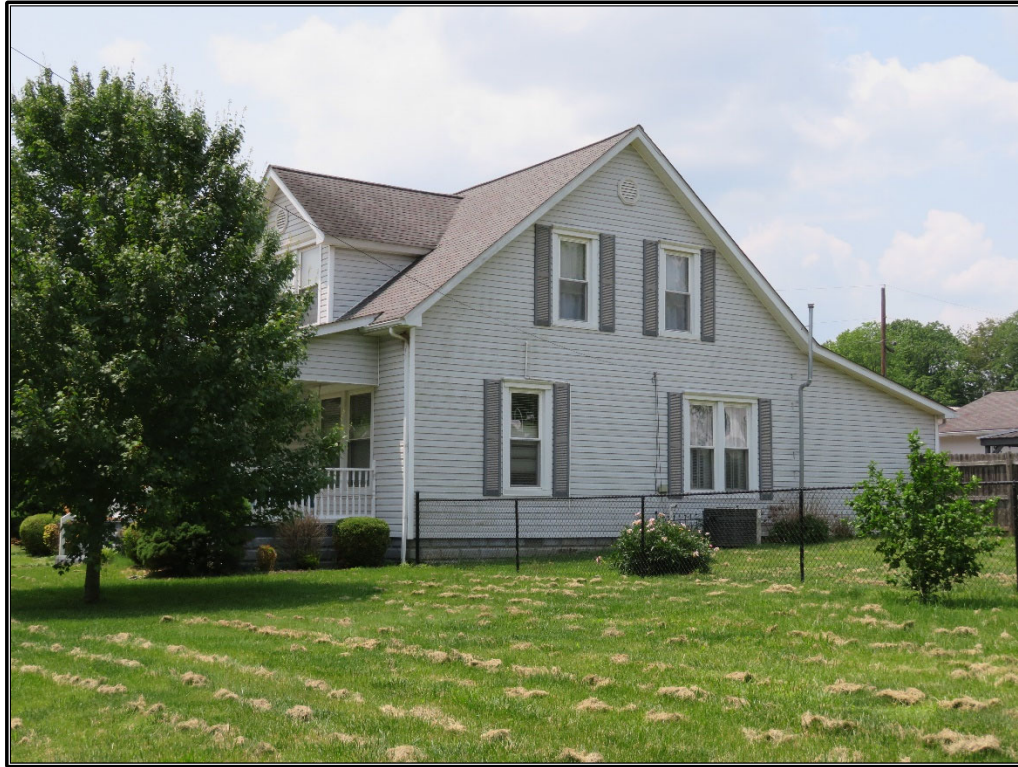
Figure 88. Site 17 (HD 1116): Façade and northeast elevations of the residence, looking west-southwest.

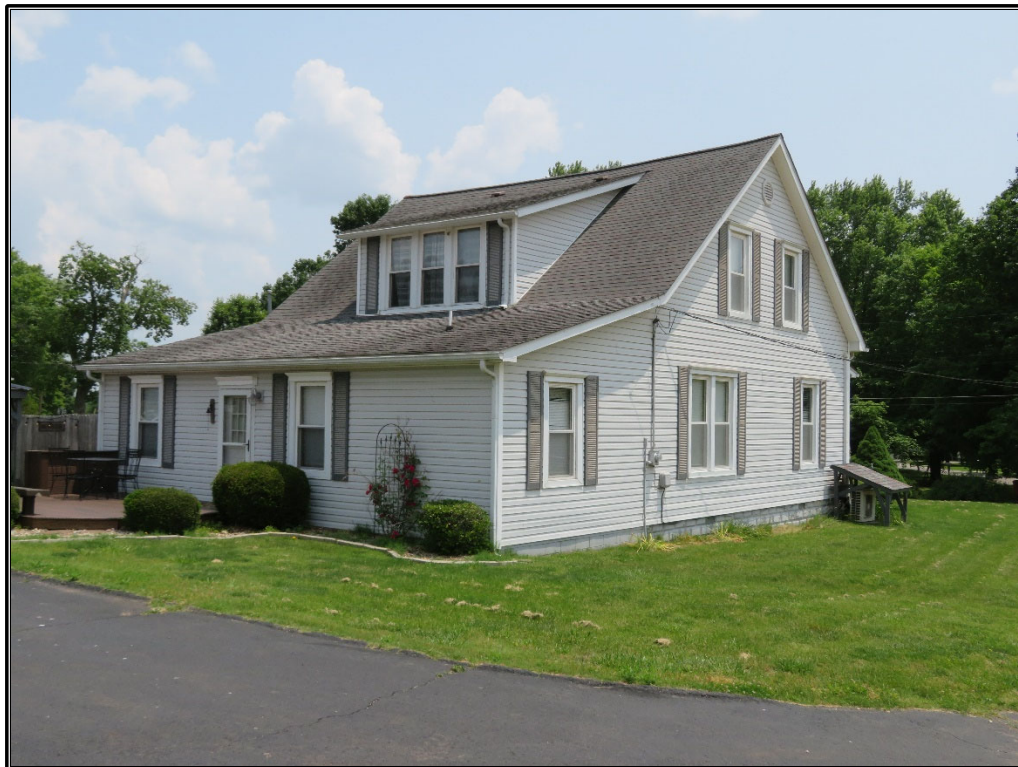
Figure 89. Site 17 (HD 1116): Northwest (rear) and southwest elevations of the residence, looking east.
