RE: Cultural Historic Overview Study for KY 222 and Its Vicinity in Hardin County, Kentucky
CRA Project No.: K220171
Contract Publication Series: 22-184

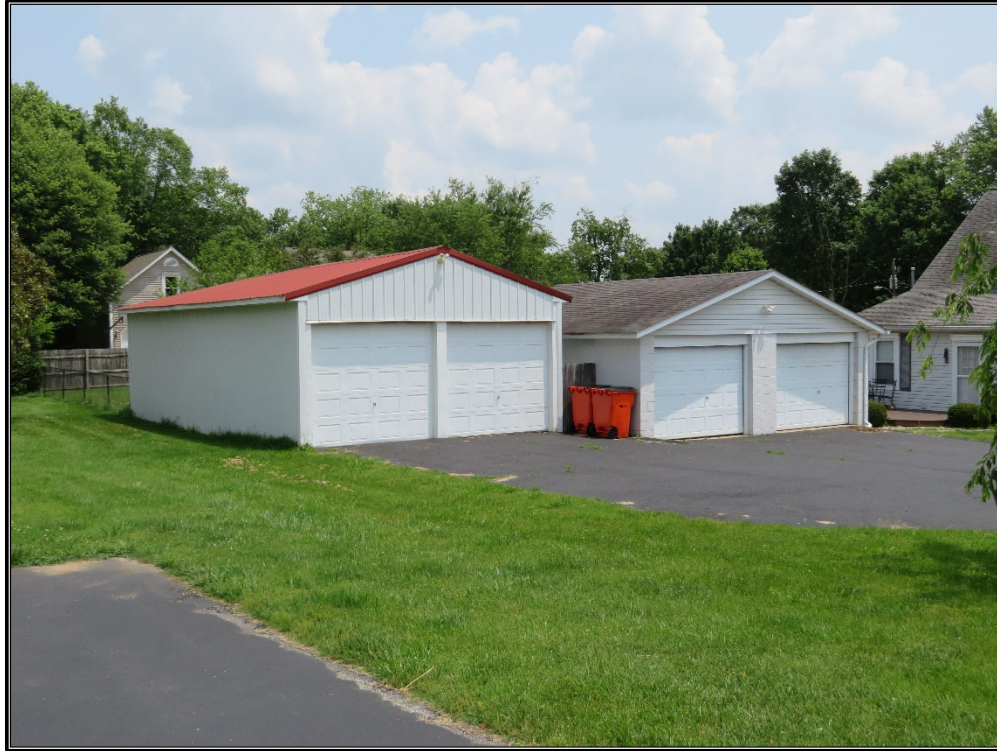
Figure 90. Site 17 (HD 1116): Right to left: Overview of the concrete block garage (Resource A) and frame garage (Resource B), looking east-northeast.

Located approximately 15 ft northwest of the residence is a one-story, front-gable, concrete block garage (Resource A) oriented to the southwest (Figure 90). Vinyl cladding is present in the gable fields. Sheltered beneath an asphalt shingle roof, the garage's principal elevation (southwest) is pierced by two vehicular bays filled with unglazed overhead metal doors. A single-leaf entry pierces the southeast elevation and was largely obstructed from the ROW (Figure 91). The northeast (rear) elevation is pierced by a single window. The northwest elevation is void of fenestration. Resource A is first depicted at Site 17 on the 1960 aerial (USGS 1960). Based on its form and materials, as well as its first aerial appearance, it seems likely that the garage (Resource A) was constructed between 1950 and 1960.

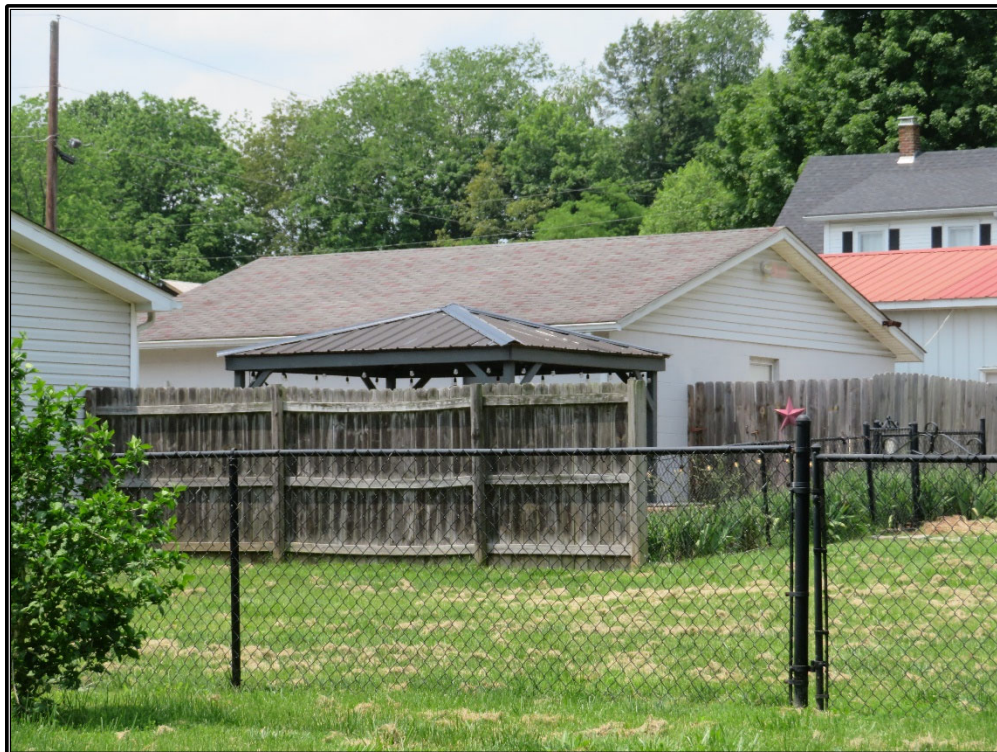
Figure 91. Site 17 (HD 1116): Northeast (rear) and southeast elevations of the concrete block garage (Resource A) and the frame gazebo (Resource D), looking west.

Oriented southwest, a one-story, front-gable, frame garage (Resource B) clad in metal siding and sheltered beneath a metal roof is located approximately 45 ft northwest of the residence (see Figure 91). The garage's foundation material was not visible from the ROW. Two vehicular bays, filled with unglazed overhead metal doors, pierce the principle (southwest) elevation. The northwest elevation is void of fenestration. The southeast and northeast (rear) elevations are not visible

Approximately 5 ft northwest of the residence is a frame gazebo (Resource D) (see Figure 91). Comprised of four square wooden posts with brackets, the gazebo is sheltered beneath a pyramidal roof clad in metal panels. Views of the gazebo were obstructed by a wooden privacy fence. Based on aerials reviewed, the gazebo (Resource D) was constructed between 2020 and 2023.

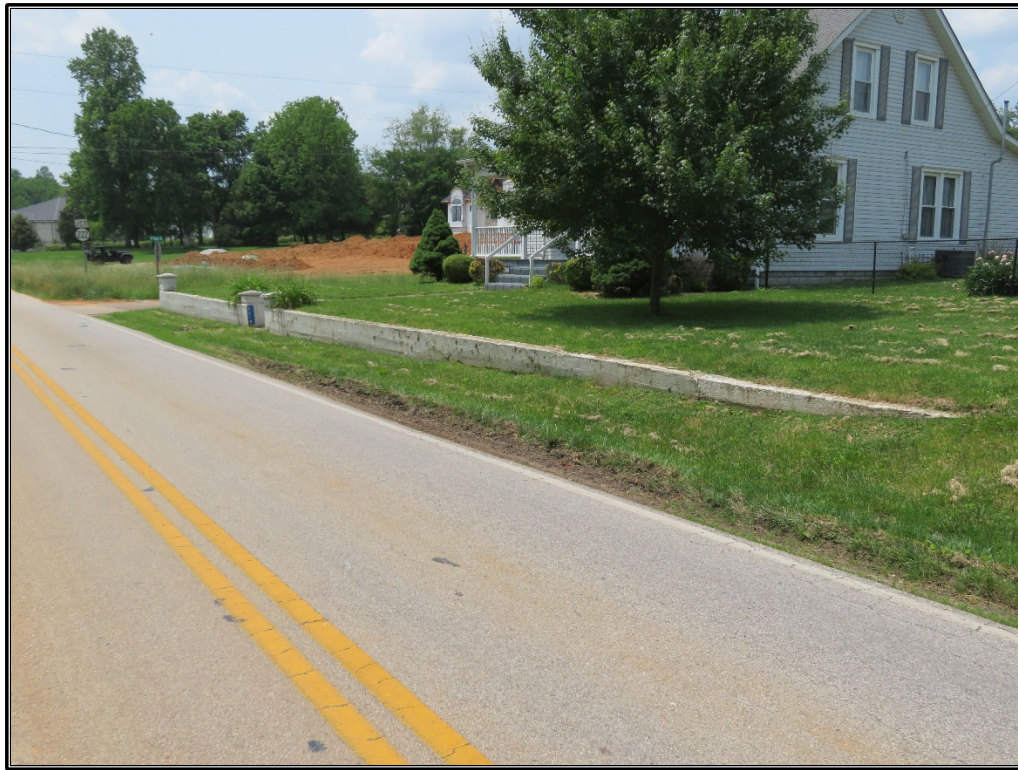
Figure 92. Site 17 (HD 1116): Overview of the concrete block retaining wall (Resource C), looking west-southwest.

A concrete block retaining wall (Resource C) is located along the edge of the ROW to the southeast and southwest of the residence (see Figure 87; Figure 92). In total, the retaining wall extends along approximately 140 ft of the ROW and measures 2-3 ft in height. A concrete block pier, topped by a pyramidal precast-concrete cap, is located at the corner of North Beech Street and West Maple Street. The retaining wall's southeast elevation features a set of stairs flanked by concrete block piers that provide access to the front yard lot. Due to the scale and quality of the aerials reviewed, the retaining wall was not visible. However, based on its form and materials, it seems likely that the retaining wall (Resource C) was built between 1925 and 1950.

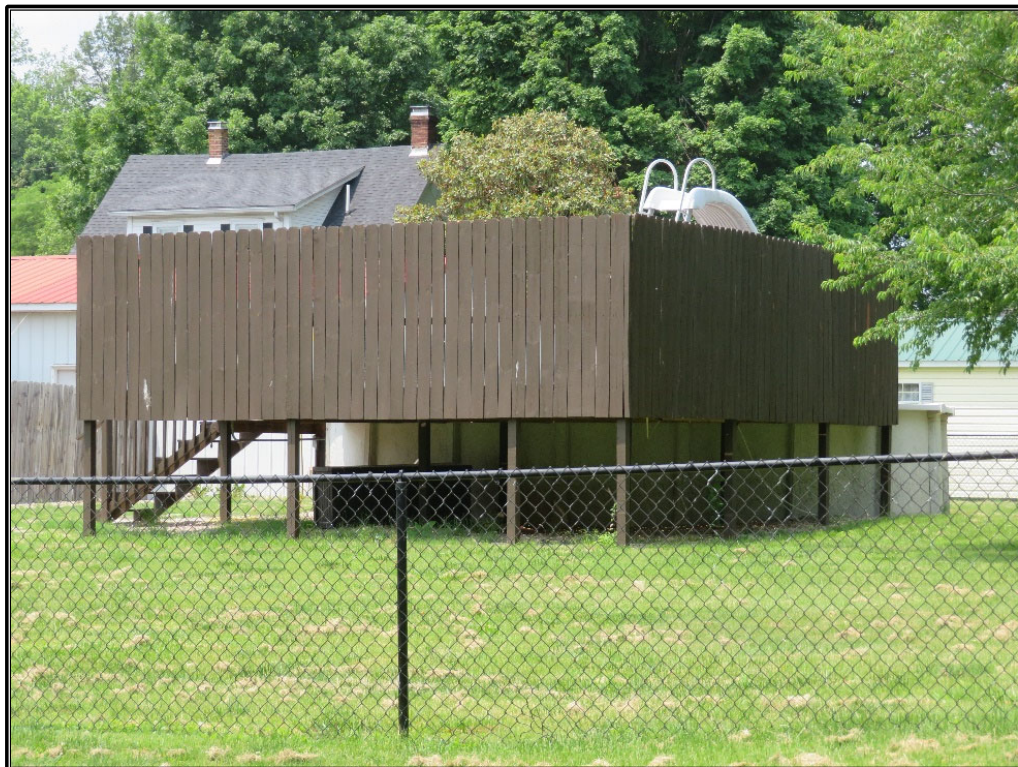
Figure 93. Site 17 (HD 1116): Overview of the aboveground pool (Resource E), looking west-southwest.

A circular, aboveground swimming pool (Resource E) is located approximately 65 ft north-northwest of the residence (Figure 93). The pool includes a frame deck on its southeast elevation. Aerials reviewed indicate the swimming pool was constructed between 2014 and 2020.

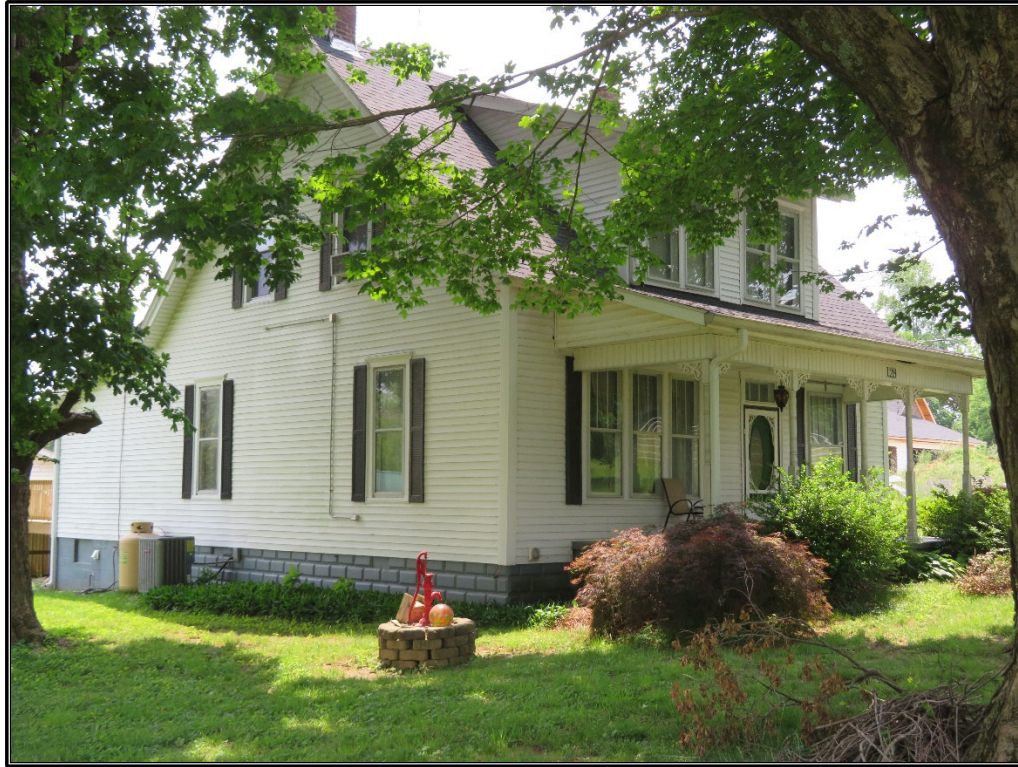
Figure 94. Site 18 (HD 1115): Façade and northeast elevations of the residence, looking south.

Oriented northwest, the residence is a one-and-one-half-story, three-bay (www/d/w), double-pile, side-gable, frame American Bungalow with a rear addition (Figure 94).

An off-center single-leaf entry pierces the façade and is filled with a replacement oval-light door set behind a three-quarter glazed decorative wood storm door. A three-light transom tops the entry (see Figure 94). The entry opens onto a three-quarter width, shed-roof porch supported by turned columns set on a poured-concrete deck and flanked by scrolled wood brackets. A ribbon of three windows pierces the façade northeast of the entry and is filled with three-over-one, double-hung wood sashes. A single window pierces the façade southwest of the entry and is filled with five-over-one, double-hung wood sashes. A shed-roof dormer pierces the northwest slope of the roof and is pierced by two sets of paired windows.

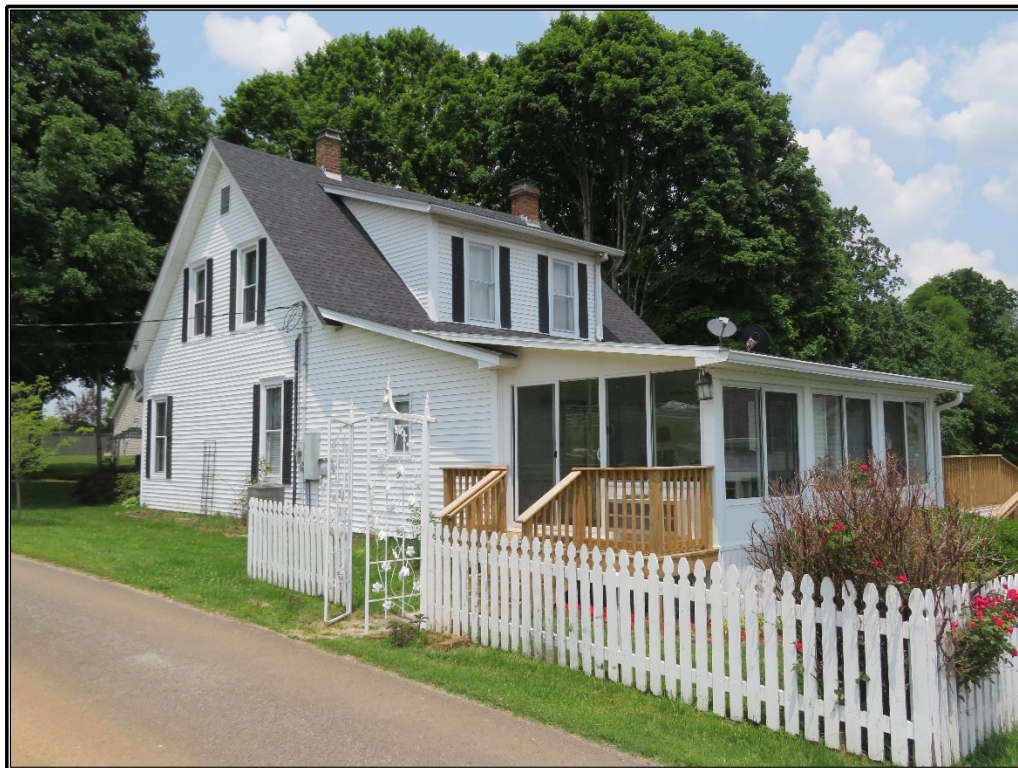
Figure 95. Site 18 (HD 1115): Southeast (rear) and southwest elevations of the residence, looking north.

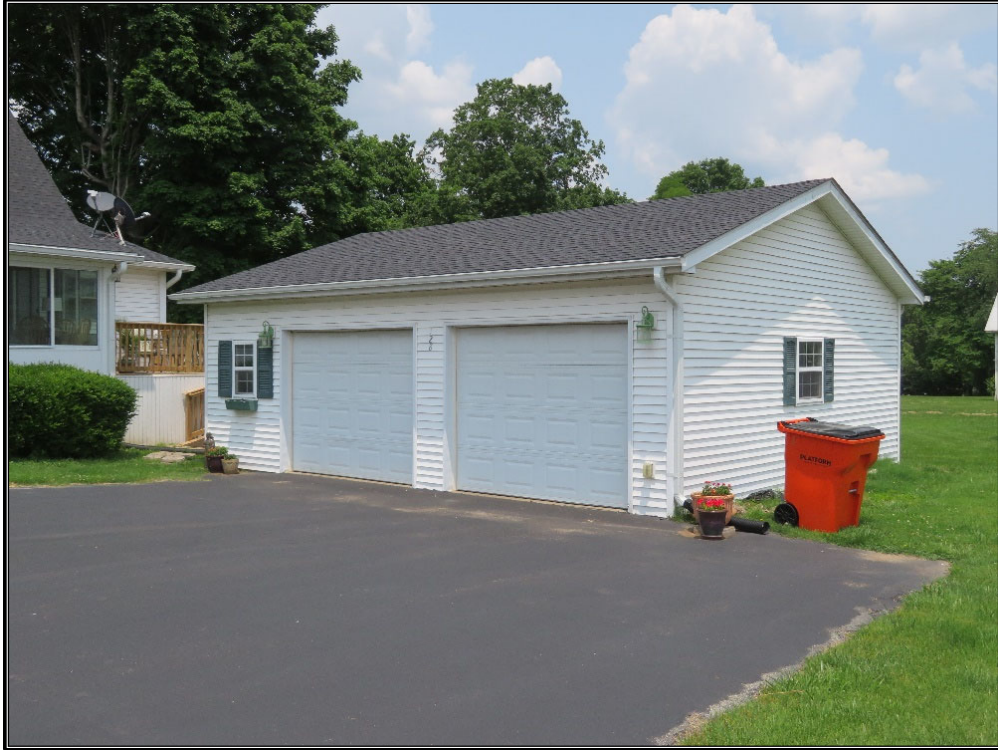
Figure 96. Site 18 (HD 1115): Southwest and southeast elevations of the detached garage (Resource A), looking north.

southwest (Figure 96). Clad in vinyl siding, the garage is sheltered beneath an asphalt shingle roof. The garage's principal elevation (southwest) is pierced by two vehicular bays filled with unglazed overhead metal doors. A single window is northwest of the vehicular bays. The southeast elevation is pierced by a single window. The northwest elevation is void of fenestration. The northeast elevation was not visible from the ROW. The garage (Resource A) is first depicted at Site 18 on the 2006 aerial photograph and likely replaced an earlier outbuilding.

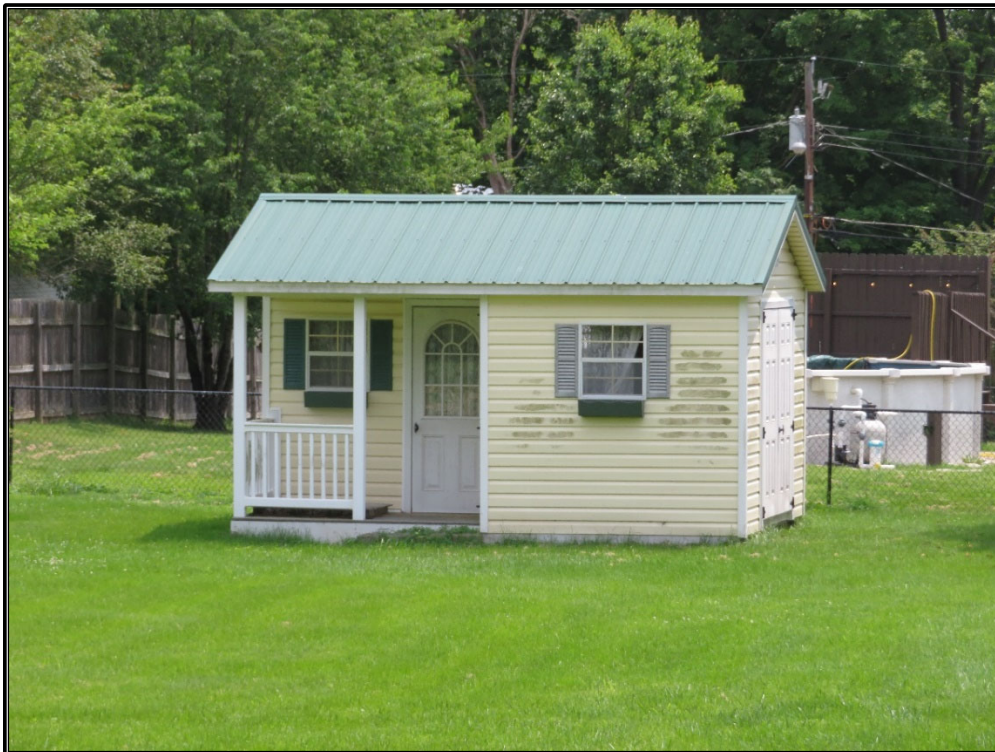
Figure 97. Site 18 (HD 1115): Northwest and southwest elevations of the prefabricated outbuilding (Resource B), looking east-southeast.

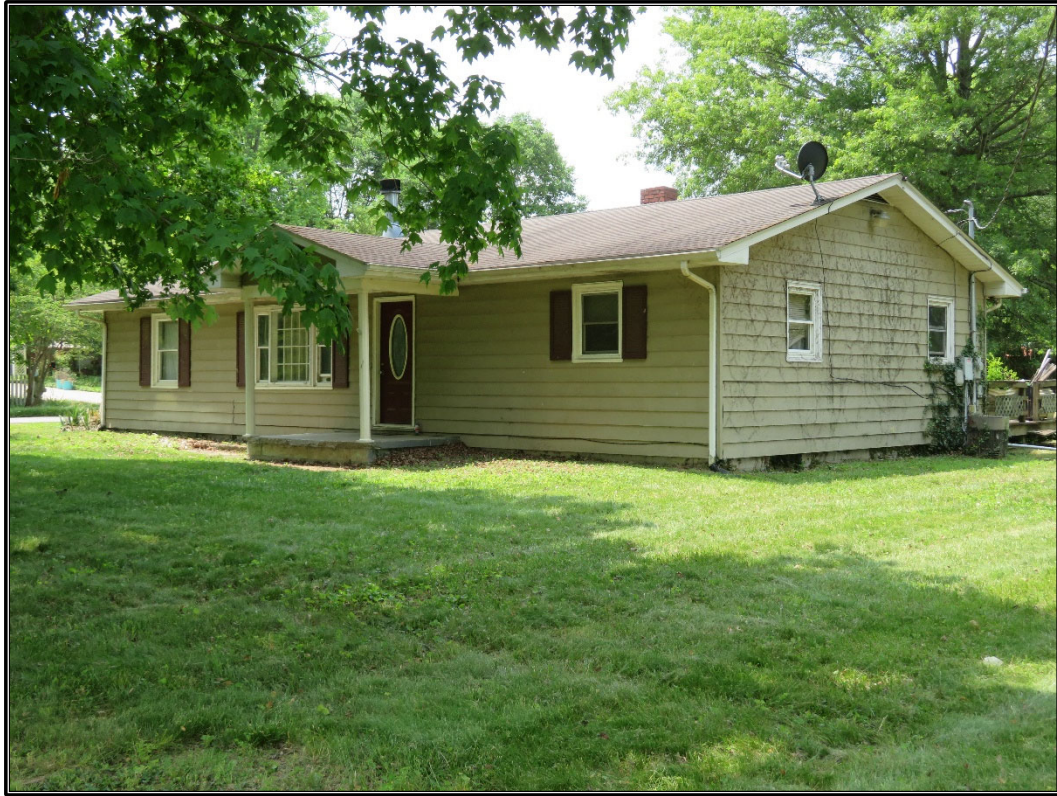
Figure 98. Site 19 (HD 1305): Façade and northeast elevations of the residence, looking west.

Oriented southeast, the one-story, frame Linear Ranch house is composed of a four-bay (w/www/d/w), double-pile, gable-roof (Figure 98). The residence rests on a continuous, concrete-block foundation, is clad in vinyl siding, and is sheltered beneath an asphalt shingle roof. An interior brick chimney pierces the northwest-facing slope of the roof. A circular metal smokestack pierces the southeast-facing slope of the roof. Windows throughout the residence contain replacement, one-over-one, double-hung vinyl sashes. Windows on the residence’s façade are flanked by inoperable louvered vinyl shutters.

The façade of the residence is pierced by an off-center single-leaf entry containing a replacement, oval-light door (see Figure 98). An entry-width porch with an intersecting, front-gable roof shelters the entry and is supported by two fluted metal columns resting directly on a poured concrete deck. A picture window with flanking sidelights and a single window pierce the façade southwest of the entry. The picture window features snap-in grids. A single window is northeast of the entry.

Two evenly spaced windows pierce the northeast elevation (see Figure 98). A triangular louvered vent pierces the apex of the gable-field. The southwest elevation mirrors the northeast elevation (Figure 99). A single-leaf entry, filled with a replacement nine-light metal panel door, pierces the northwest (rear) elevation. Sheltered beneath the eaves, the entry opens onto a frame deck. A single window is southwest of the entry. Remaining fenestration, northeast of the entry, includes four single windows and a single-leaf entry.

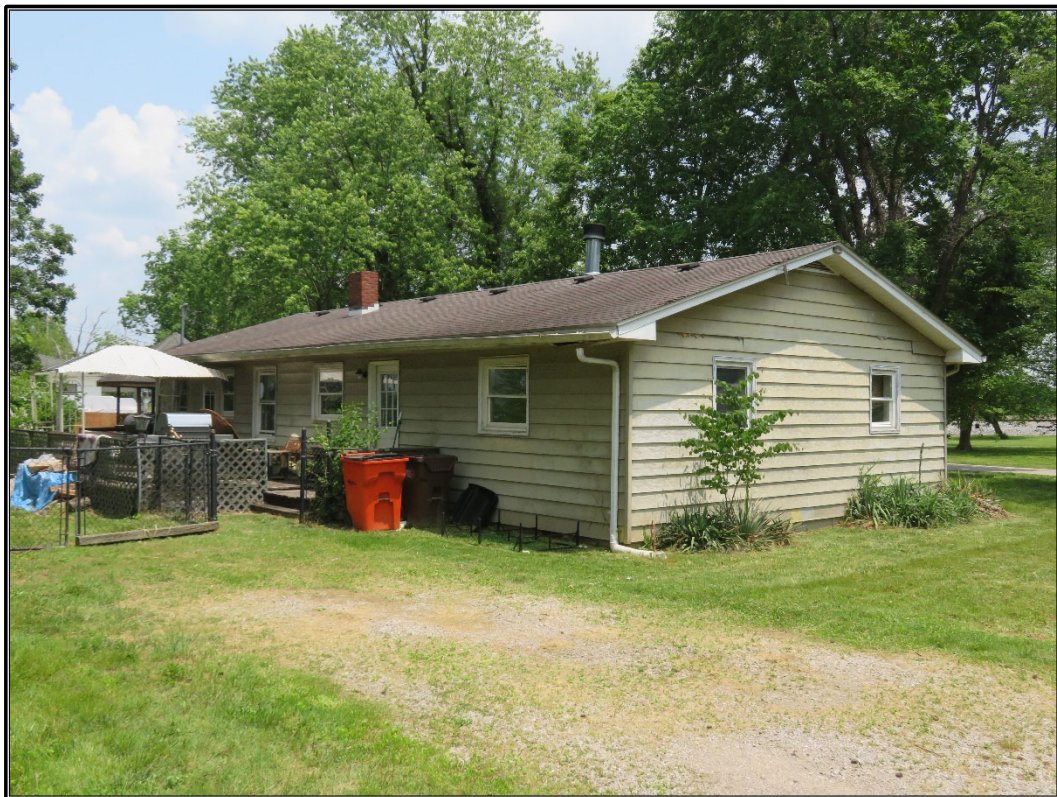
Figure 99. Site 19 (HD 1305): Northwest (rear) and southwest elevations of the residence, looking east.

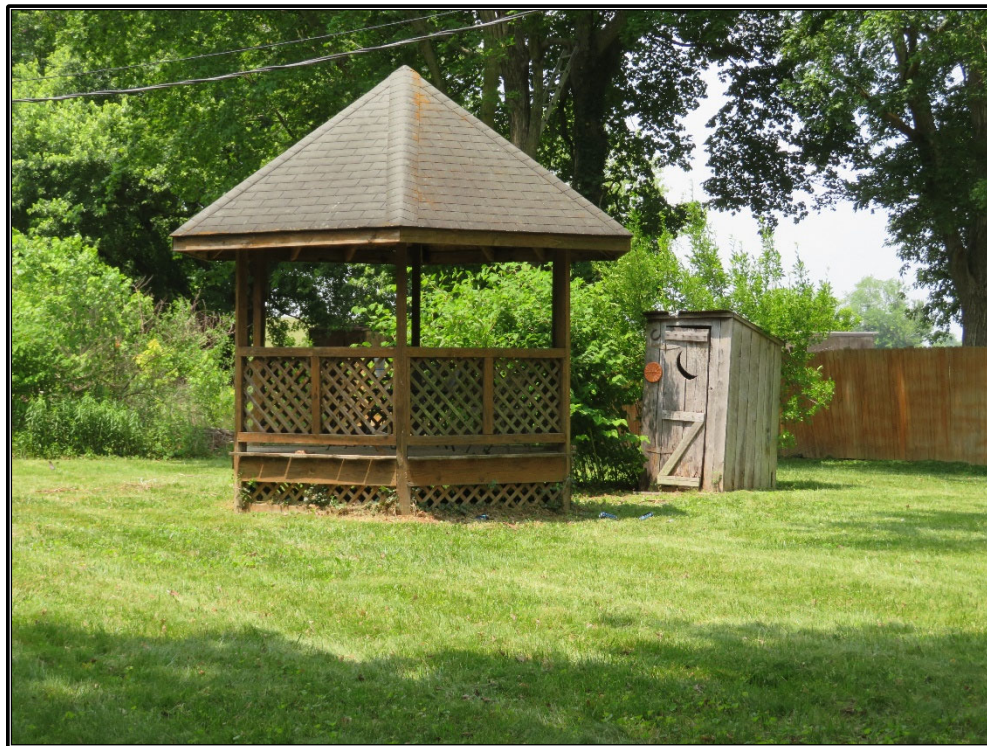
Figure 100. Site 19 (HD 1305): Overview of the gazebo (Resource A) and privy (Resource B), looking north-northwest.

Approximately 15 ft northeast of the residence is a hexagonal, prefabricated frame gazebo (Resource A) (Figure 100). Resting on square wooden posts set directly into the ground, the gazebo is sheltered beneath an asphalt shingle roof. A wooden railing that includes latticework encloses the gazebo. The shed does not appear to be present in a 1988 aerial photograph and was likely constructed between 1988 and 1997 (USGS 1988).

Approximately 35 ft north of the residence, and oriented south, is a one-story, one-bay, shed-roof, frame, decorative privy (Resource B) (see Figure 100). Clad in vertical board siding, the privy is sheltered beneath a corrugated metal roof. A single-leaf entry pierces the south elevation and is filled with a vertical board door attached to the privy's main mass with strap hinges. A crescent moon is cut into the door. The east elevation is void of fenestration. The north and west elevations are not visible from the ROW. Aerial photographs reviewed indicate the privy (Resource B) was either moved or built at this location sometime between 1997 and 2013.

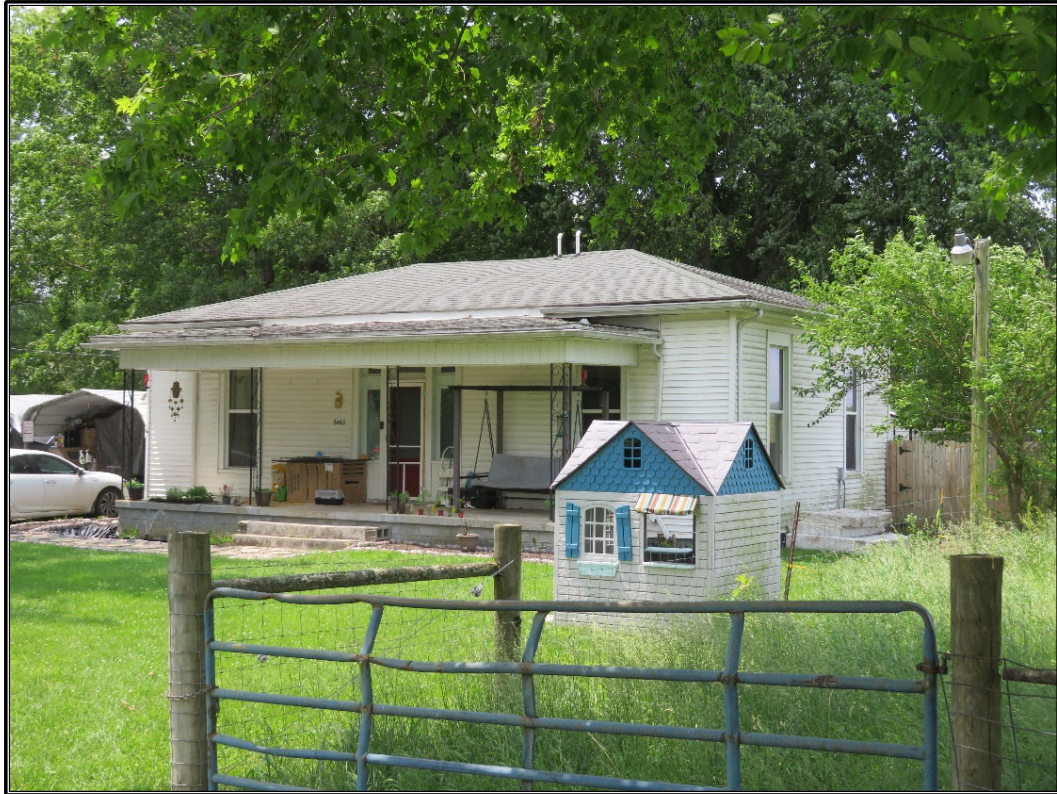
Figure 101. Site 20 (HD 1306): Façade and northeast elevations of the residence, looking west.

Oriented southeast, the residence is a one-story, three-bay (w/wdw/w), double-pile, hip-roof, frame vernacular dwelling (Figure 101). Clad in replacement vinyl siding, the residence is sheltered beneath an asphalt shingle roof. The residence’s foundation was not visible from the ROW. Windows throughout the residence are filled with one-over-one, double-hung replacement vinyl sashes that include wooden surrounds.

A centrally placed single-leaf entry pierces the façade and is filled with a three-quarter light wooden door set behind a wooden screen door and topped by a one-light transom (see Figure 101). Three-quarter light sidelights flank the entry and are topped by smaller fixed-pane windows which align with the transom above the entry. The entry opens onto a three-quarter-width porch sheltered beneath a hip-roof and supported by scrollwork metal posts resting directly on a poured-concrete deck. Windows flank the entry and are sheltered beneath the porch roof.

The northeast elevation of the residence is pierced by two evenly spaced windows (see Figure 101). A paired and single window pierce the southwest elevation, views of which were partially obstructed from the ROW (Figure 102). The northwest (rear) elevation was not visible from the ROW.
