DATE: 10/06/2023	REVISION	CHECKED BY	DATE
DESIGNED BY: M SNYDER		S ROGAN	
DETAILED BY: A CAPLINGER		A WELTER	
<b>Commonwealth of Kentucky</b> DEPARTMENT OF HIGHWAYS			
COUNTY <b>HARLAN</b>			
ROUTE <b>US-119</b>	CROSSING <b>Poor FK Cumberland River</b>		
<b>FRAMING PLAN</b>			
PREPARED BY			
			SHEET NO. <b>54</b>
			DRAWING NO. <b>28681</b>

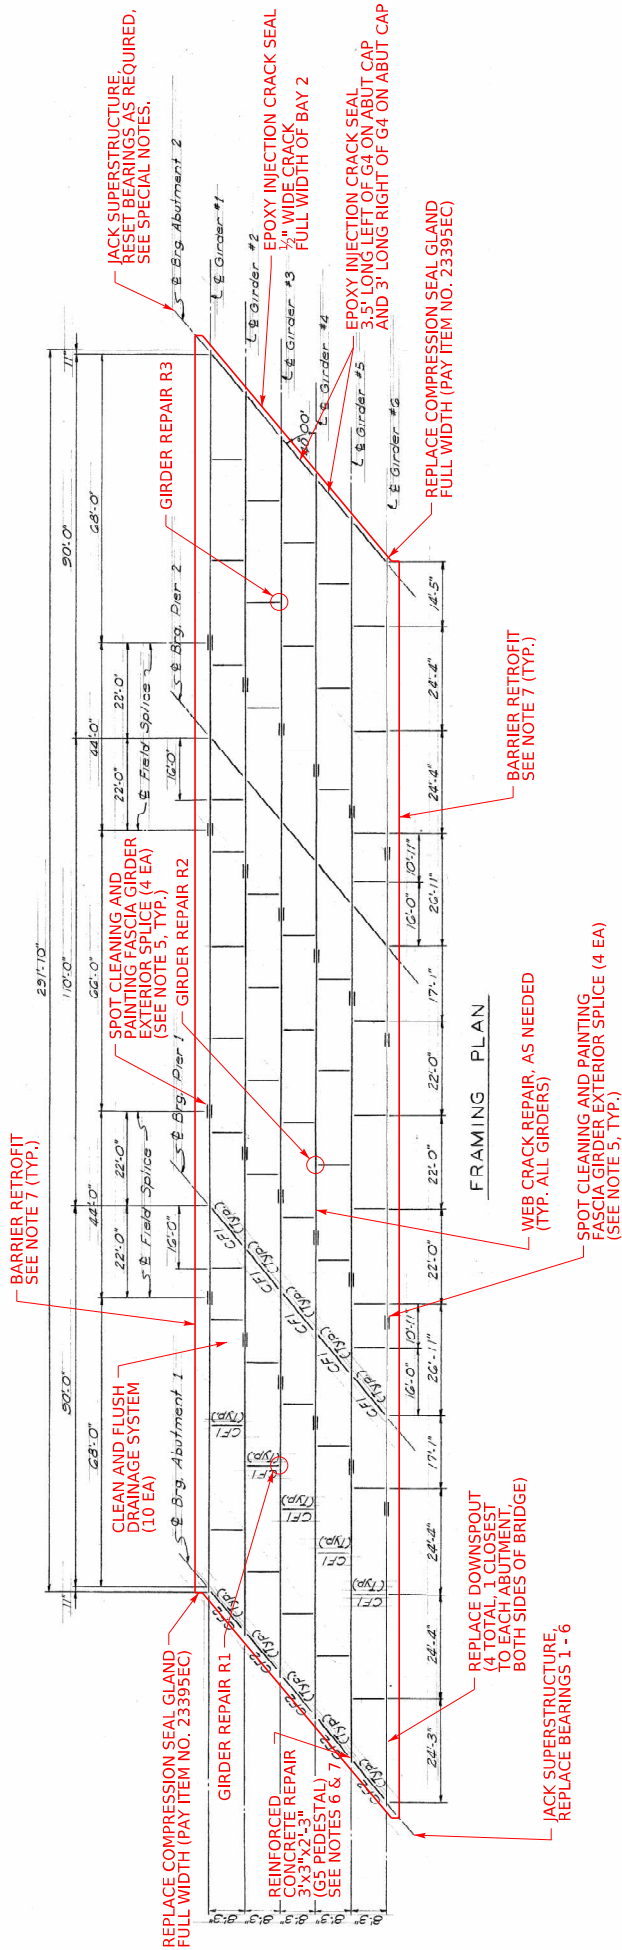
### CONSTRUCTION SEQUENCE

- PERFORM FABRICATED STRUCTURAL STEEL GIRDER REPAIRS (PAY ITEM NO. 23298EC, STEEL REPAIR).
- JACK BRIDGE SUPERSTRUCTURE AND PERFORM BEARING REPLACEMENTS AND RESETTling. SEE BEARING NOTES FOR ADDITIONAL JACKING SEQUENCE INFORMATION.

- PERFORM COMPRESSION SEAL REPAIR WORK.
- ALL REMAINING WORK MAY BE PERFORMED IN ANY ORDER. THIS REMAINING WORK IS TO BE PERFORMED AFTER ITEMS 1-3.
- THE CLEANING AND PAINTING AT THE SPLICE LOCATIONS INCLUDES 2' OF GIRDER LENGTH AS MEASURED FROM EACH SIDE OF THE CENTERLINE OF SPLICE, FOR A TOTAL OF 4' WIDTH. THE FULL HEIGHT OF THE GIRDER IS TO BE CLEANED AND PAINTED, EXTERIOR FACE ONLY, INCLUDING THE BOTTOM OF THE TOP FLANGE AND THE TOP OF THE BOTTOM FLANGE. PAINTING IS NOT REQUIRED ON THE BOTTOM OF THE BOTTOM FLANGE. CLEAN THE EXISTING STEEL TO AN SSPC-SP15 (COMMERCIAL GRADE POWER TOOL CLEANING) SIMILAR TO GUIDANCE PROVIDED IN THE SPECIAL NOTE FOR PAINTING STRUCTURAL STEEL REPAIRS, SECTION III-A (SPOT PAINTING AS INDICATED IS INCIDENTAL TO PAY ITEM NO. 23298EC, STEEL REPAIR).
