PANBOWL DAM PROJECT

Virtual Public Meeting

January 27, 2022

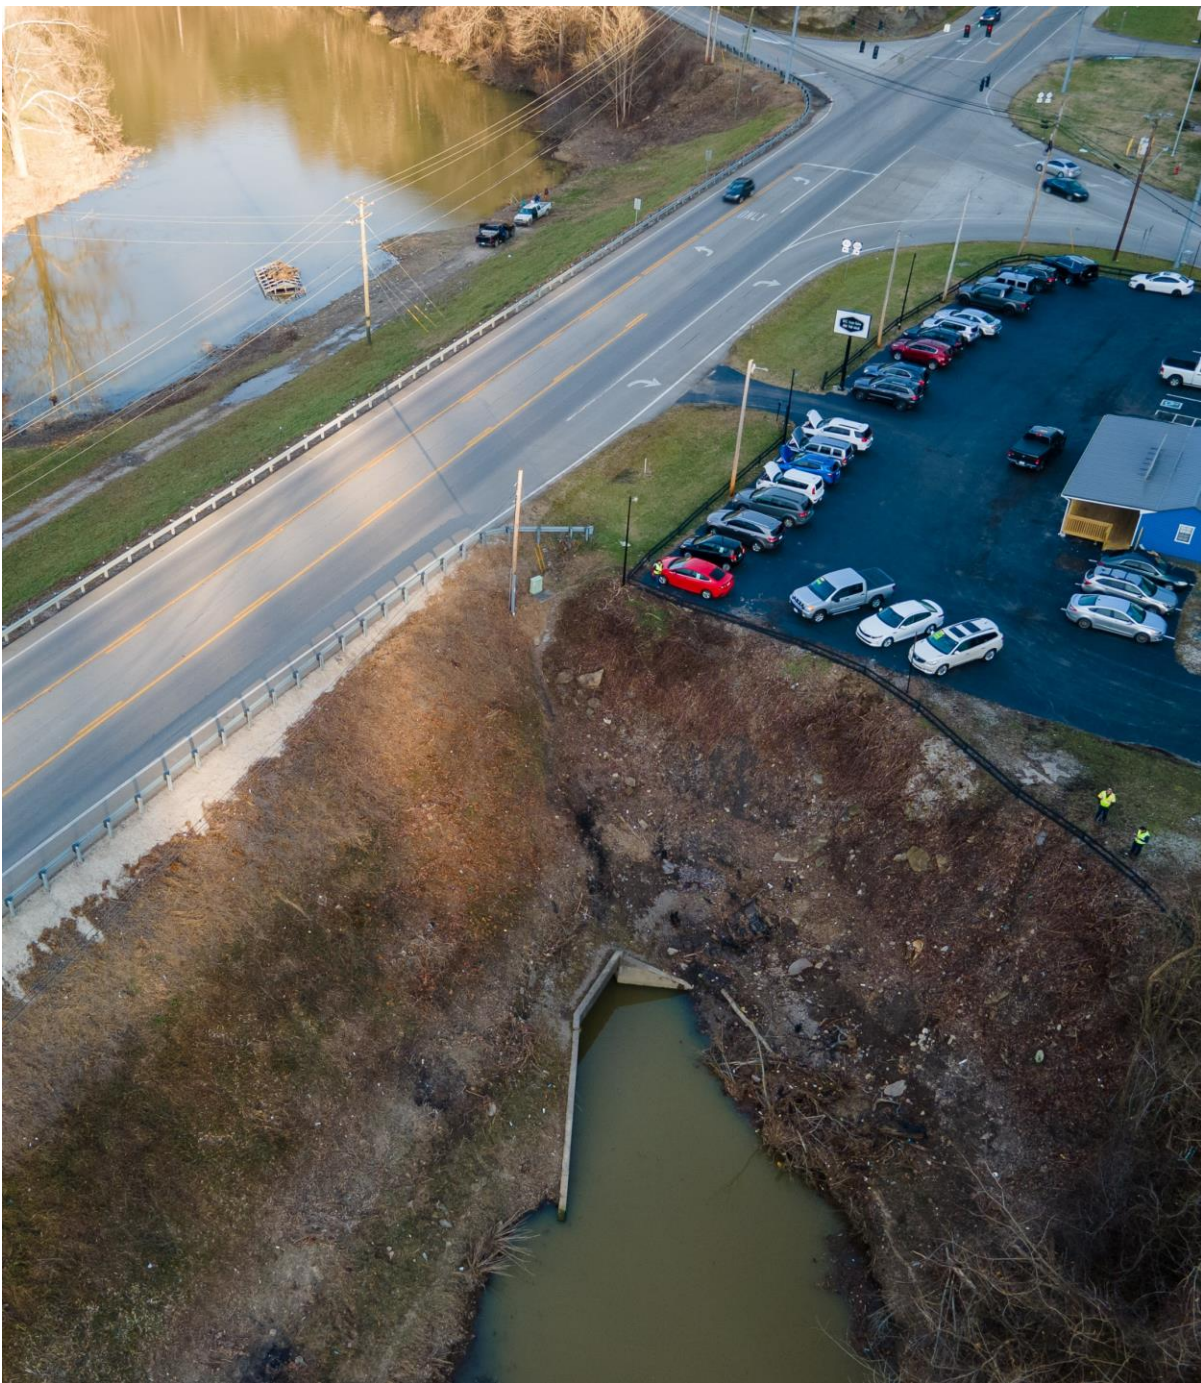
EAST EMBANKMENT

- 975 feet long
- Crest elevation up to 744 feet
- Slope ratios range from 1.5H:1V to 3.3H:1V

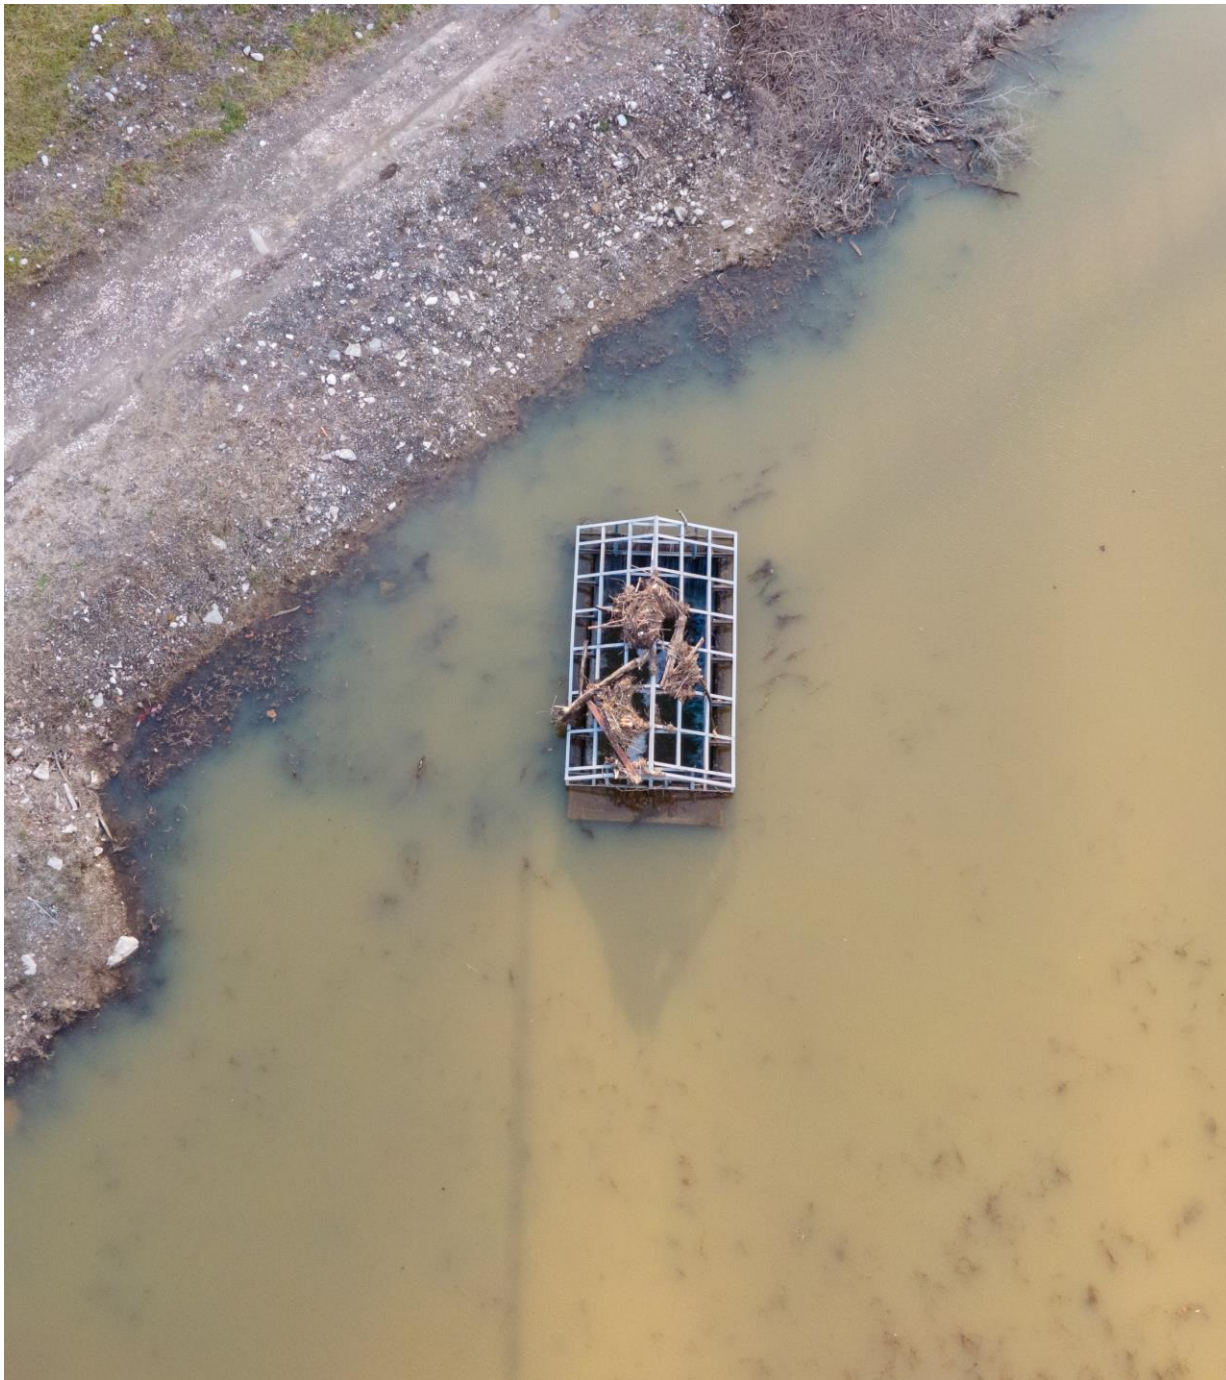
STANDPIPE RISER

- 20' x 9.6' spillway pipe leading to box culvert under KY 15
- Elevation = 713 feet

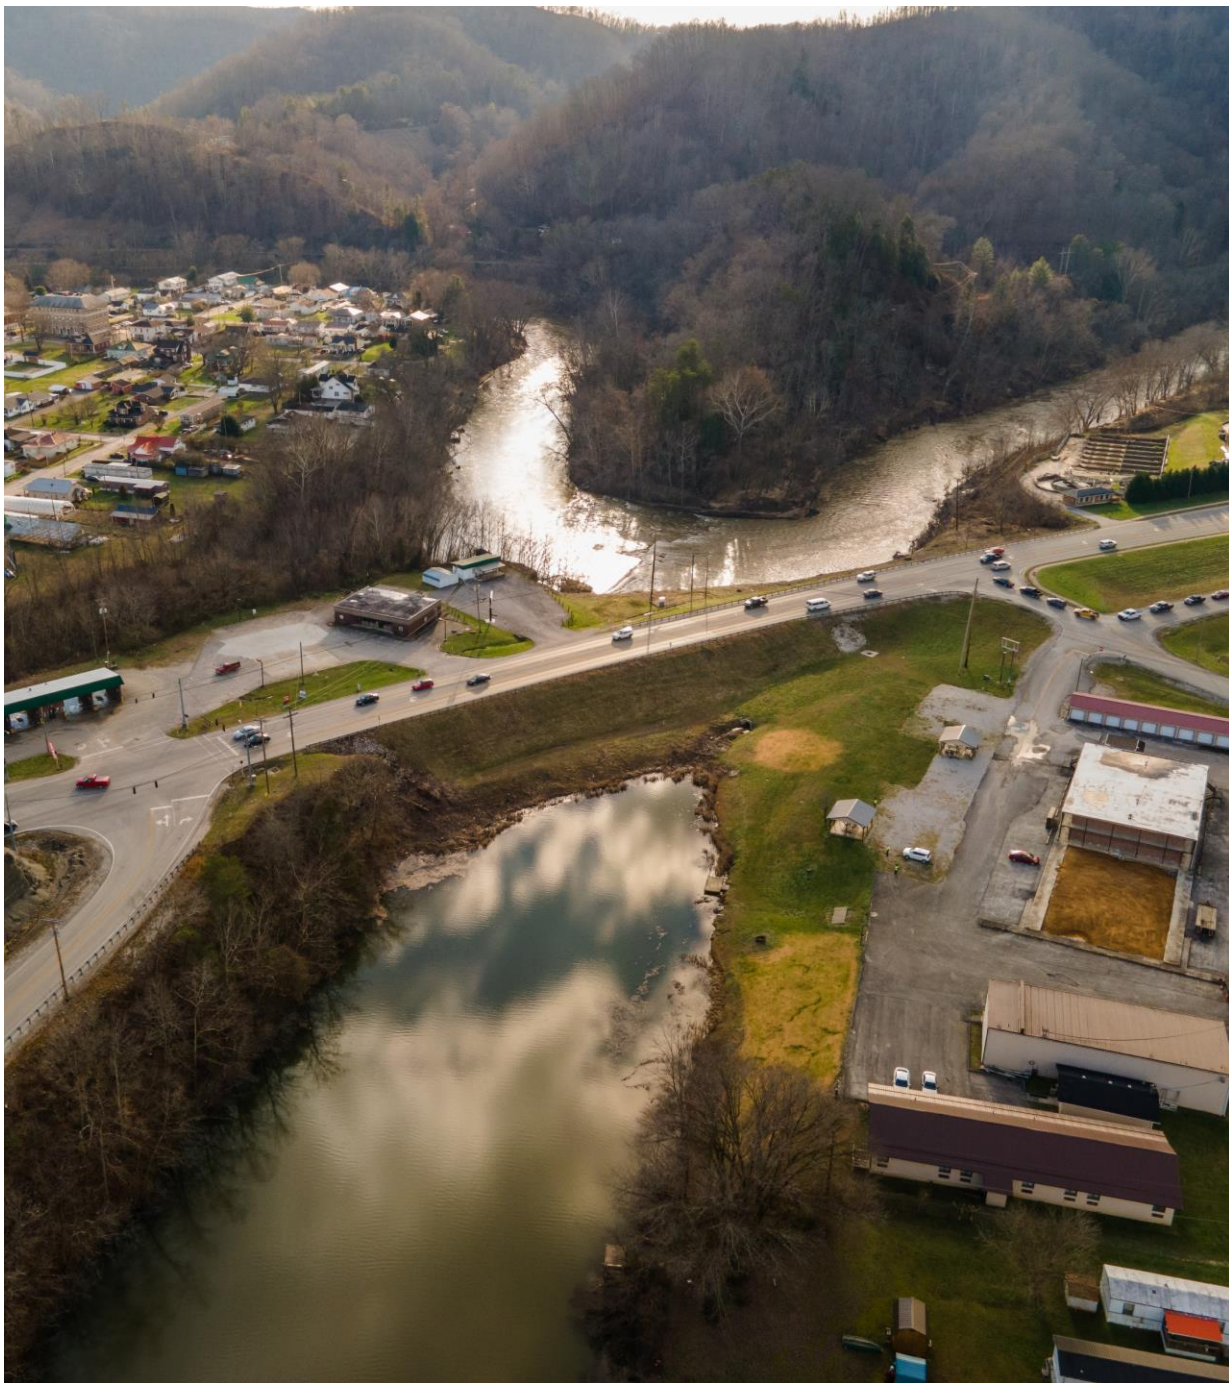
WEST EMBANKMENT

- 1,035 feet long
- Crest elevation up to 741 feet
- Slope ratios range from 2H:1V (lake side) to 1.2H:1V (river side)

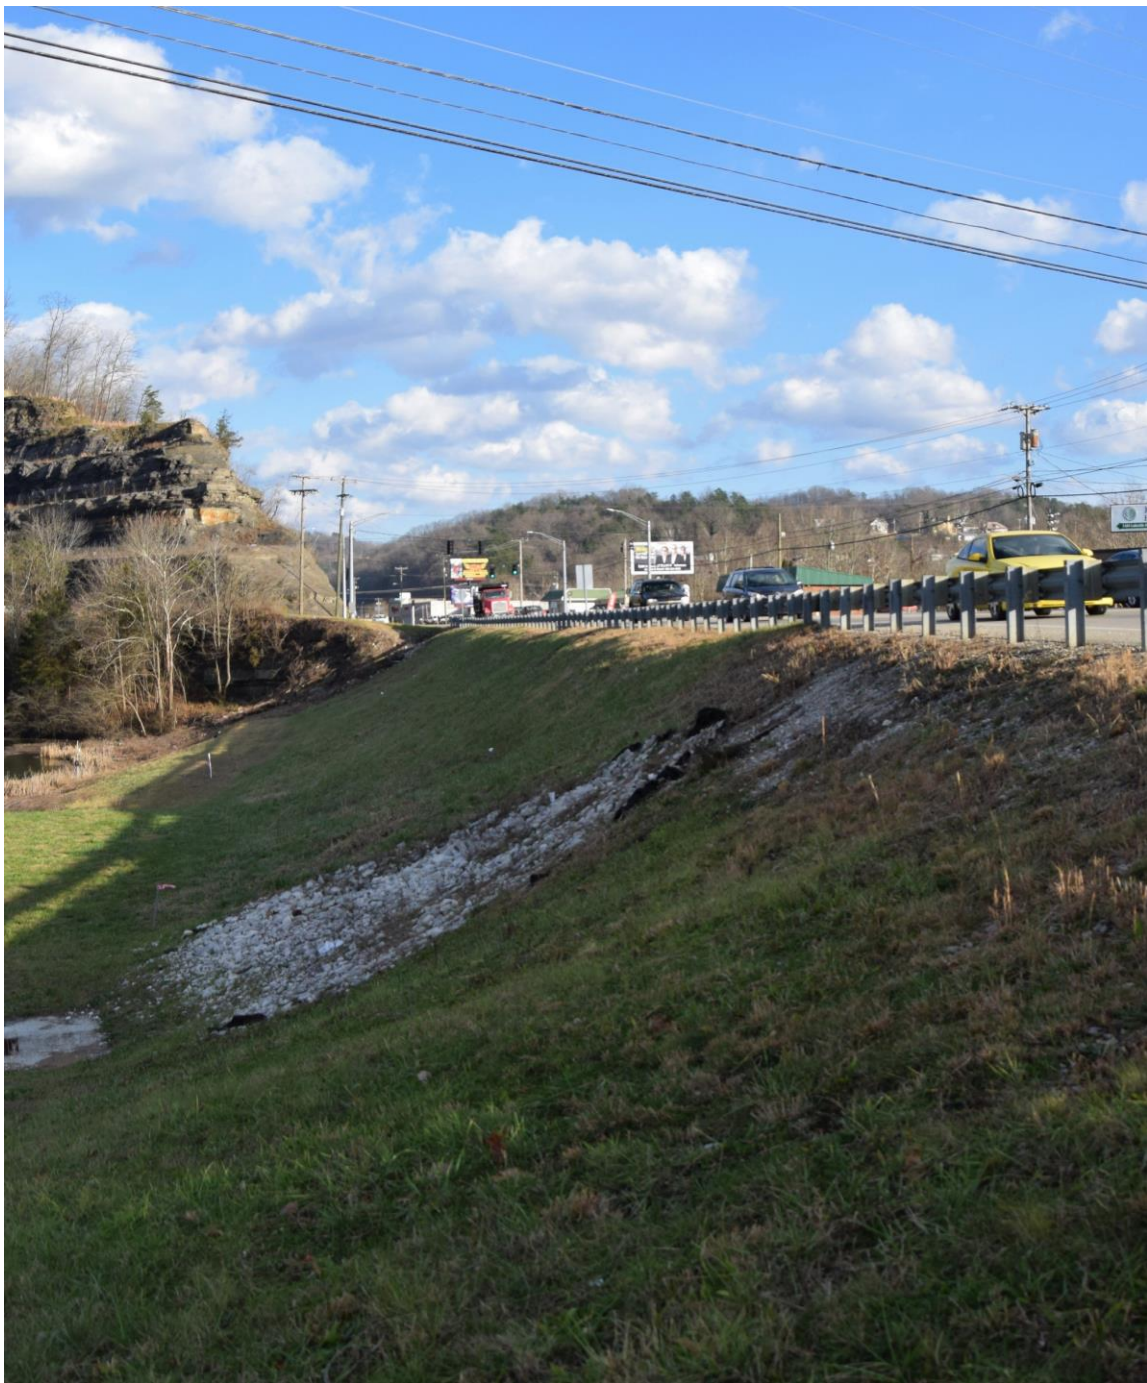
EMBANKMENT MATERIAL

- Both east and west embankments were built with clay cap/blanket
- Archived plans show various clay thickness up to 12 feet, but this is likely inaccurate

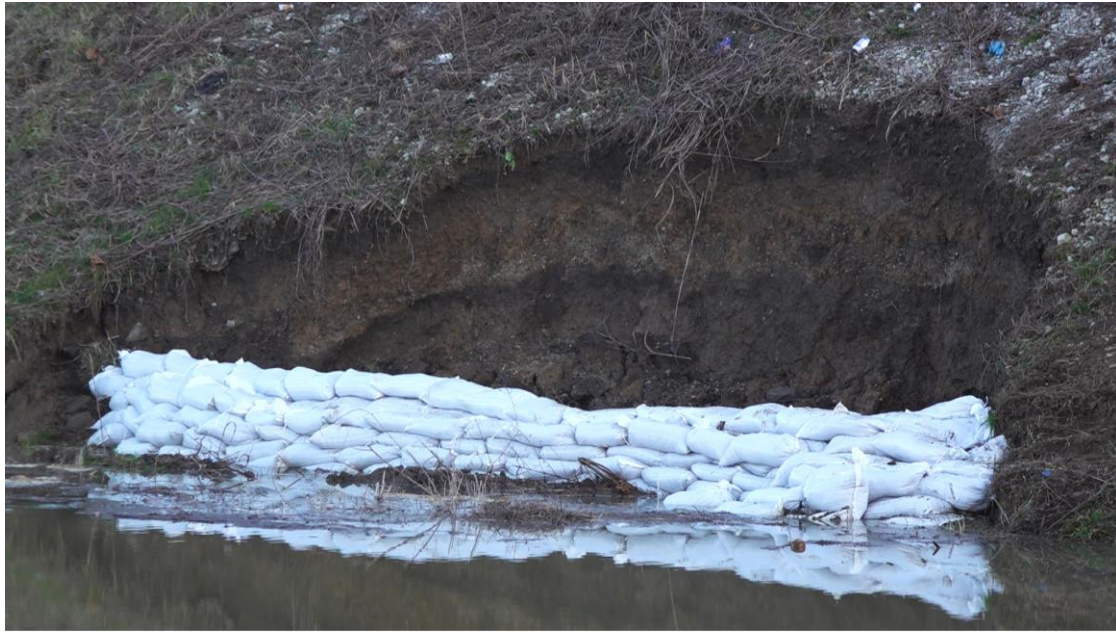
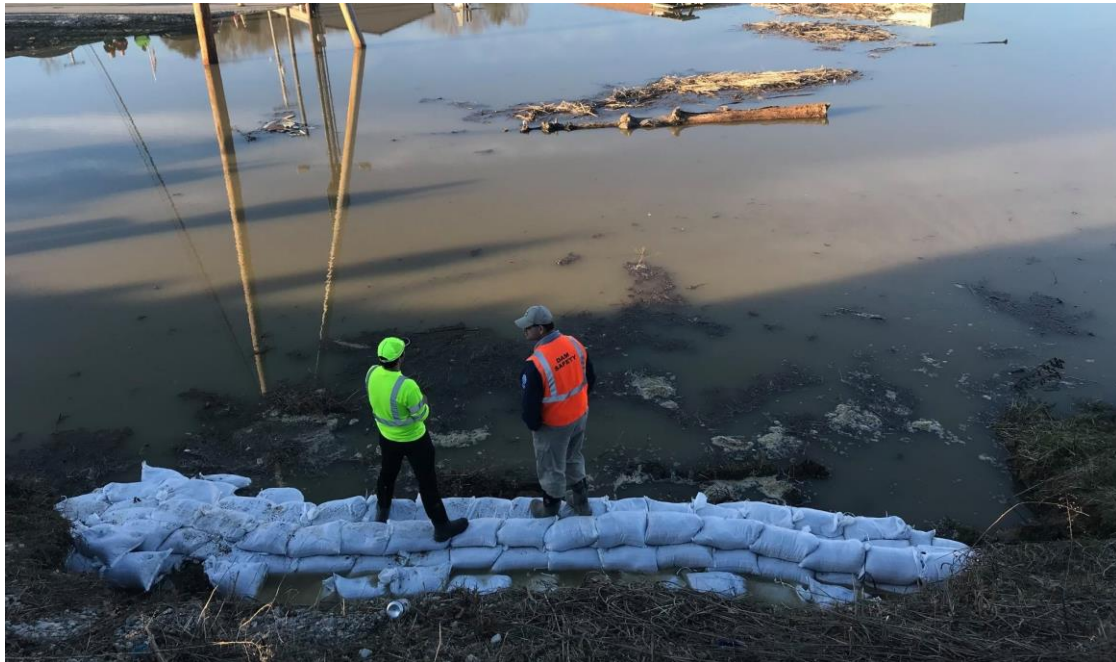
EMBANKMENT SLIP

- Water seeped from river through west embankment
- Soil began to slough on the lake side embankment

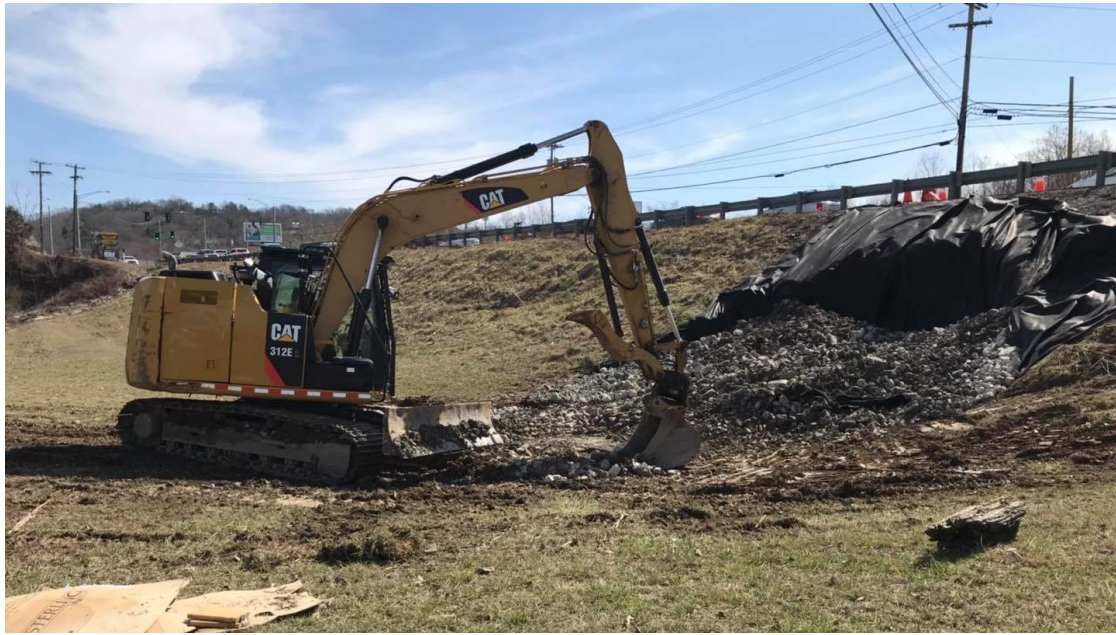
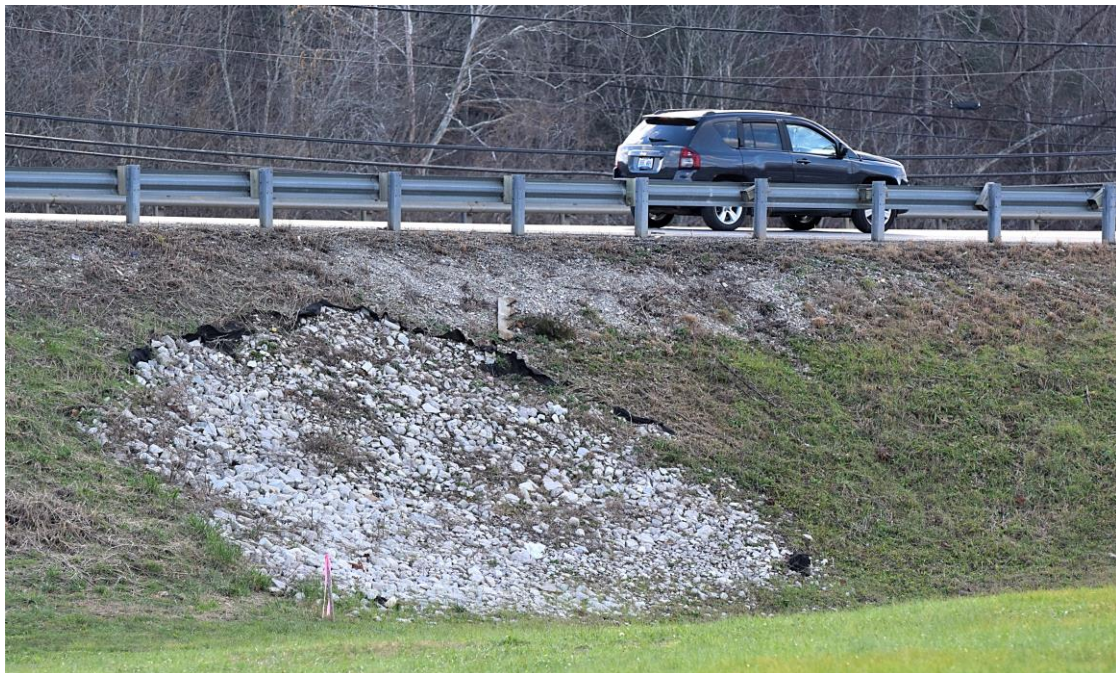
EMBANKMENT SLIP

- Sandbags, geotextile fabric and rock fill were used to make a temporary repair

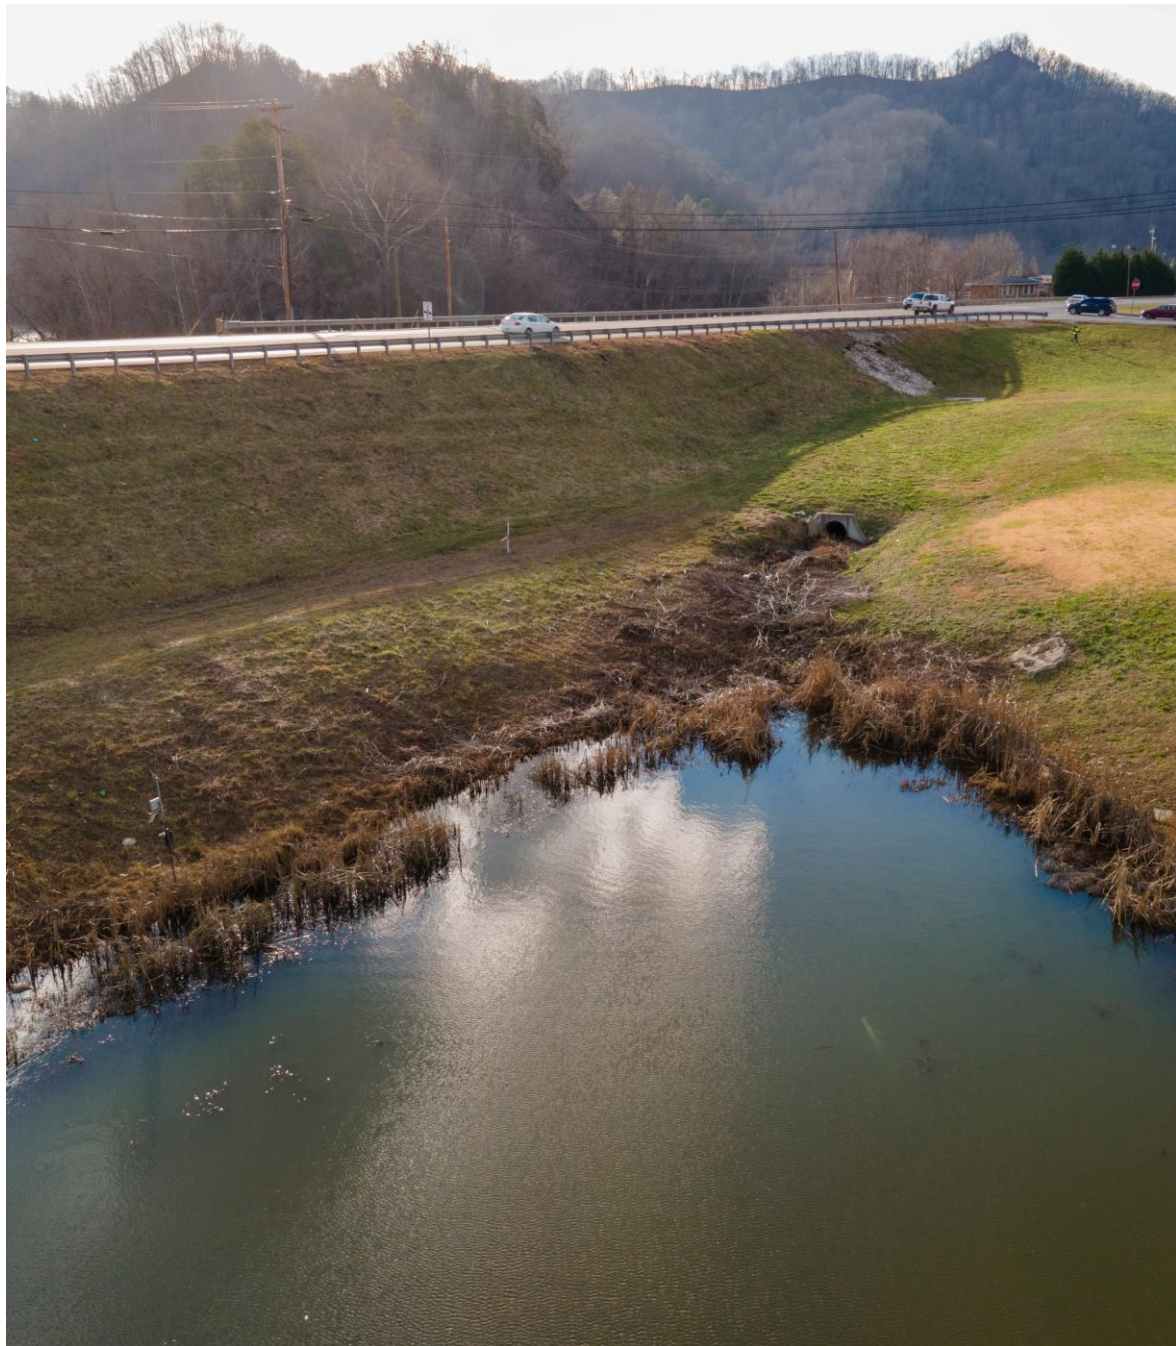
SLOPE STABILITY

- When the river level is high or the lake level is above normal AND there is steady water seepage, the factor of safety is considered too low.

- Factor of safety evaluated for all embankments
- Different conditions considered with steady water seepage
- The factor of safety for the embankments was determined to be acceptable *when lake and river levels are normal.*

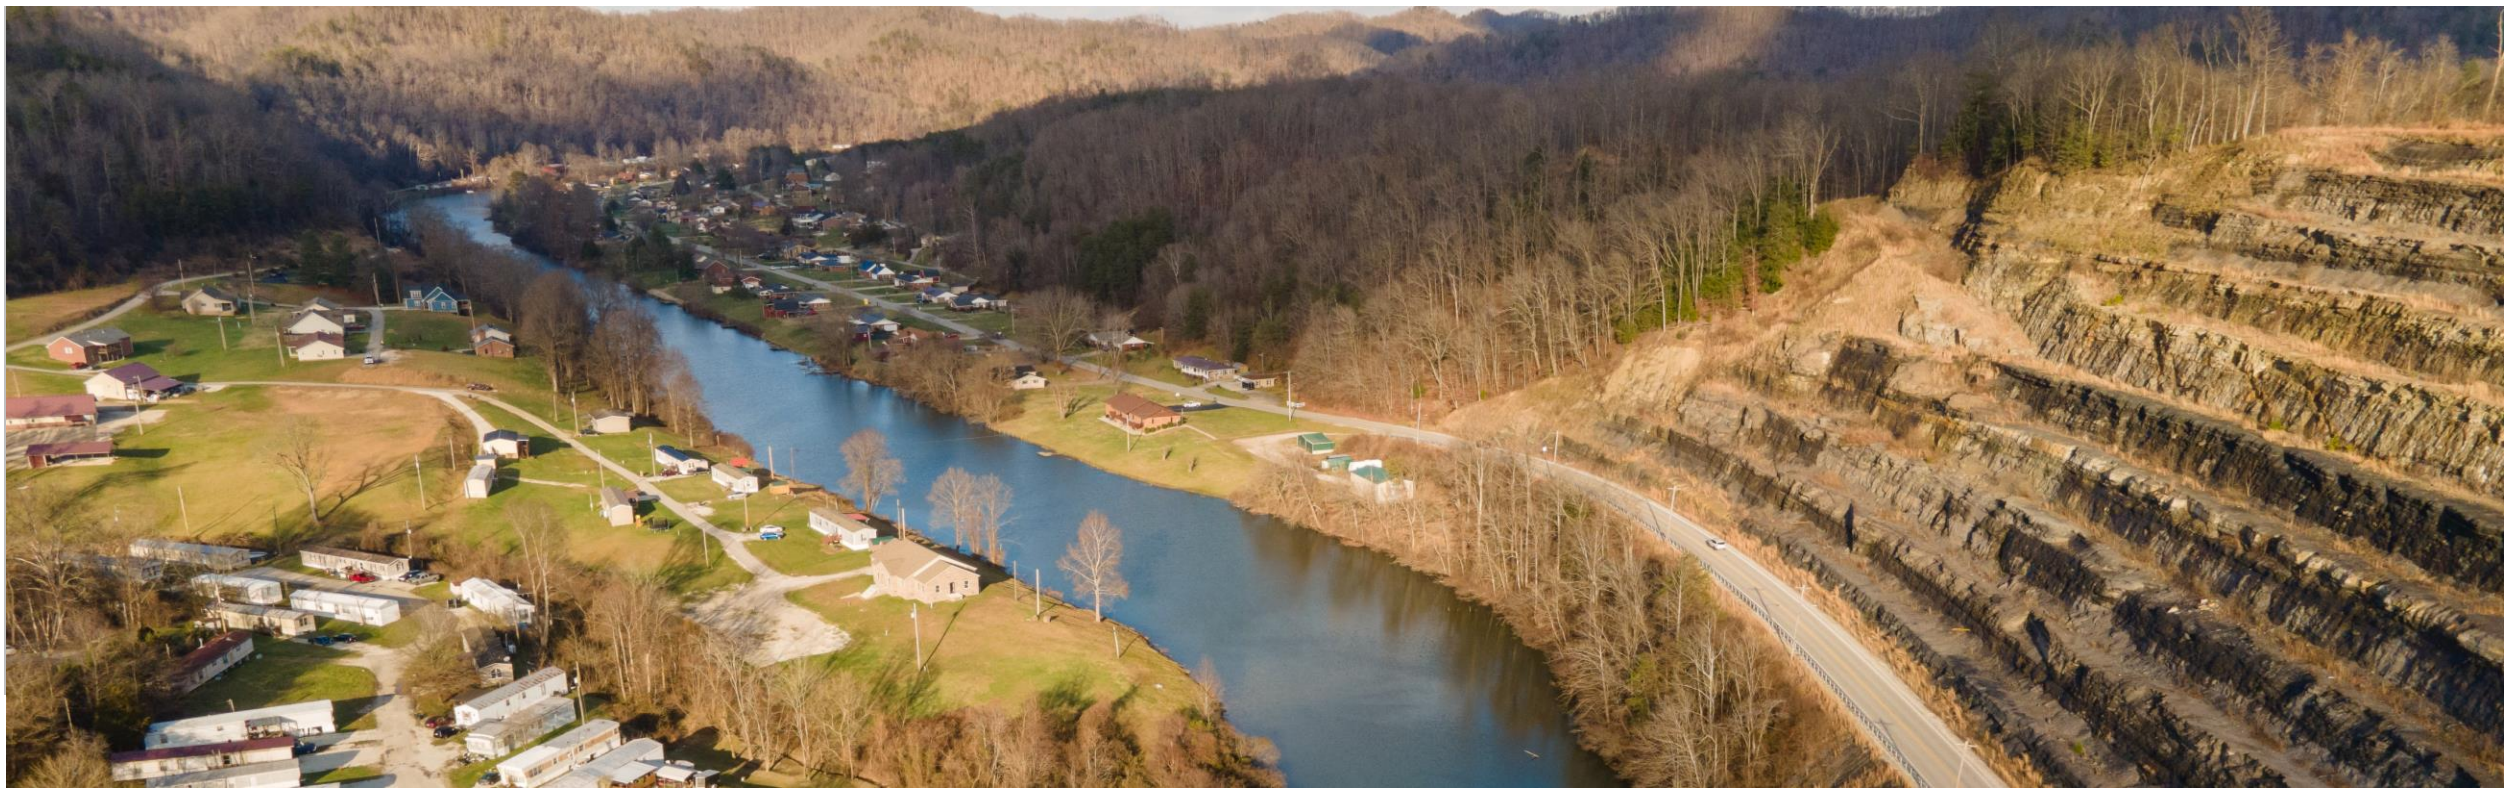
H & H REPORT

- Hydrologic modeling of 2021 storm and beyond
- Panbowl Lake has sufficient capacity to pass a 6-hour Probable Maximum Precipitation Design Storm
