Appendix I KYTC Geotechnical Report

SUBJECT: Pike County KY 194/KY 632 US 119 to Phelps, KY 12FO C35 D625 12 FH02 0410 C098 E143 Mars 8931407P Preliminary Geotechnical Assessment

P-006-2014 Pike County KY 194/KY 632

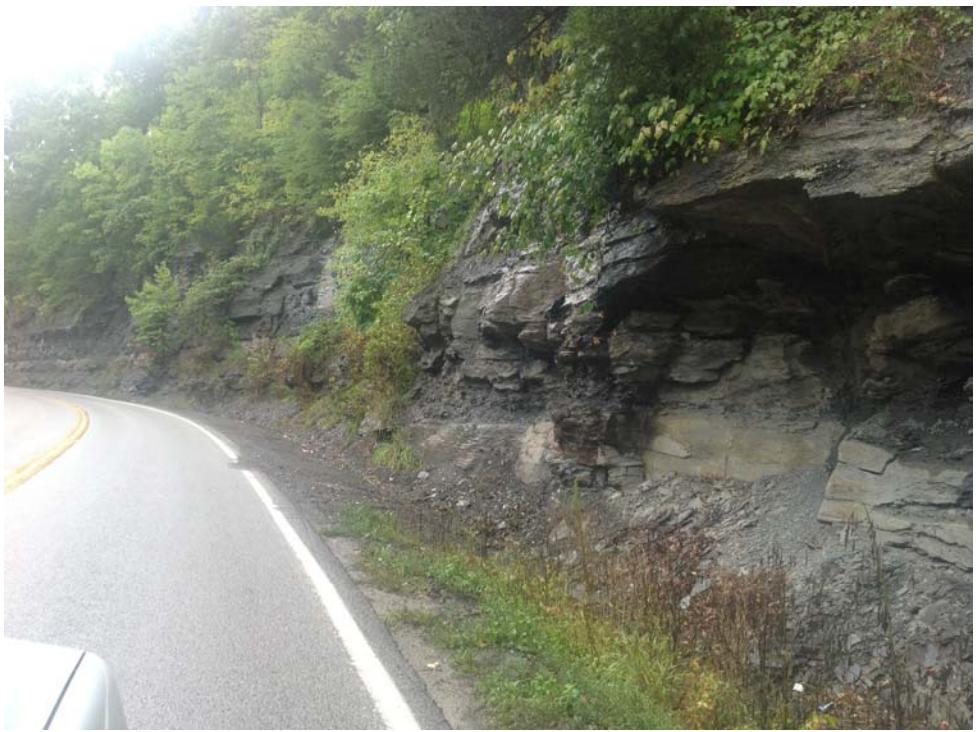
Existing cut slope in Breathitt Formation showing undercut due to highly weatherable shales

Available geologic mapping indicates that the project is underlain by bedrock of the Breathitt Formation. The general dip of the bedrock is from the Southeast to the Northwest. Alluvium is present near the waterways. The Breathitt Formation consists of shale, limestone, siltstone, sandstone, coal and clay. The sandstones can be friable and the shales can be highly weatherable. For estimation of right of way for rock cuts in this area it is typical to assume from a 1V:1H to 1.5V:1H for cut slopes. Previous mine works can have a substantial impact on cut slope design. There will be numerous places throughout the area where manmade fills are present. These could be from mining operations or previous grading for various projects. Some of these areas will not be compacted and will require remediation for a roadway project.

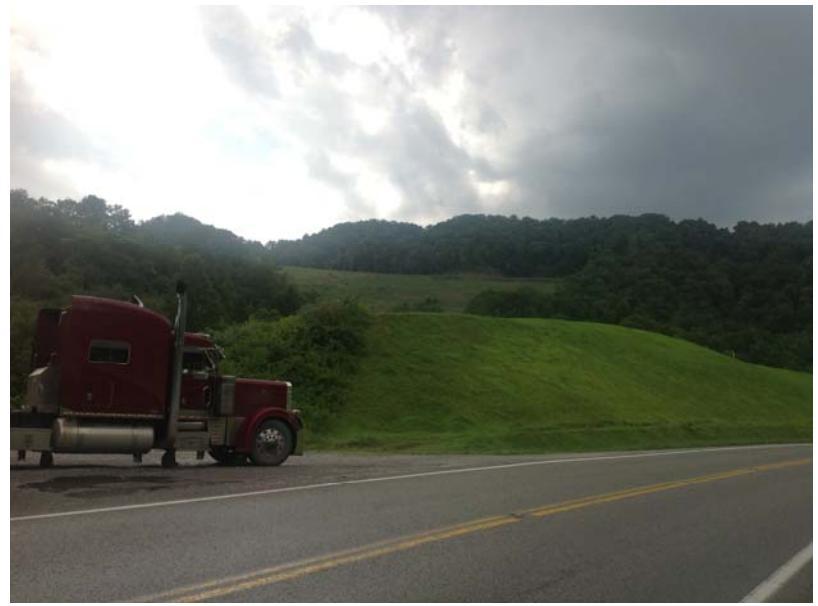
Coal Refuse Waste area near current alignment

Numerous mines are located throughout the study area. It appears that strip mining, auger mining and multi level deep mining have taken place in the area. It is also likely that there are numerous locations where small scale "house coal" mining operations have taken place. The extent of these small scale mines is not known. In some areas mine maps are available for indepth study of future alignments. Numerous mine areas with potential alignment overlays are located in the appendix. These overlays indicate deep mining for various seams. Additional mines not noted on the attached map could be encountered during design and construction. Deep mines encountered during construction likely will contain water. Mitigation of the mining areas may be required. It is likely that areas of uncompacted or loosely compacted mine spoil exist in the area. These areas can be problematic for road construction.

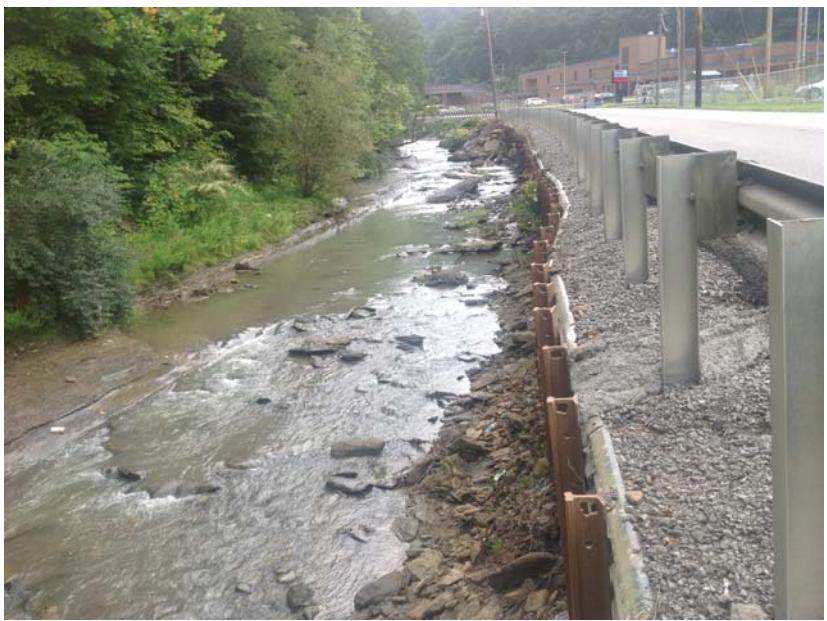
Railroad Rail Retaining Wall near school

There are likely numerous potentially unstable Talus areas in the study area. Talus areas are problematic in drainage areas and may require extensive excavation to remediate. Numerous places where railroad rails are in use as a landslide abatement measure (holding up the downhill side of the road at the creek) were viewed during the site visit. Some of the existing slopes have shown movement in the past and it is likely that many of the existing soil slopes range from marginally stable to unstable.

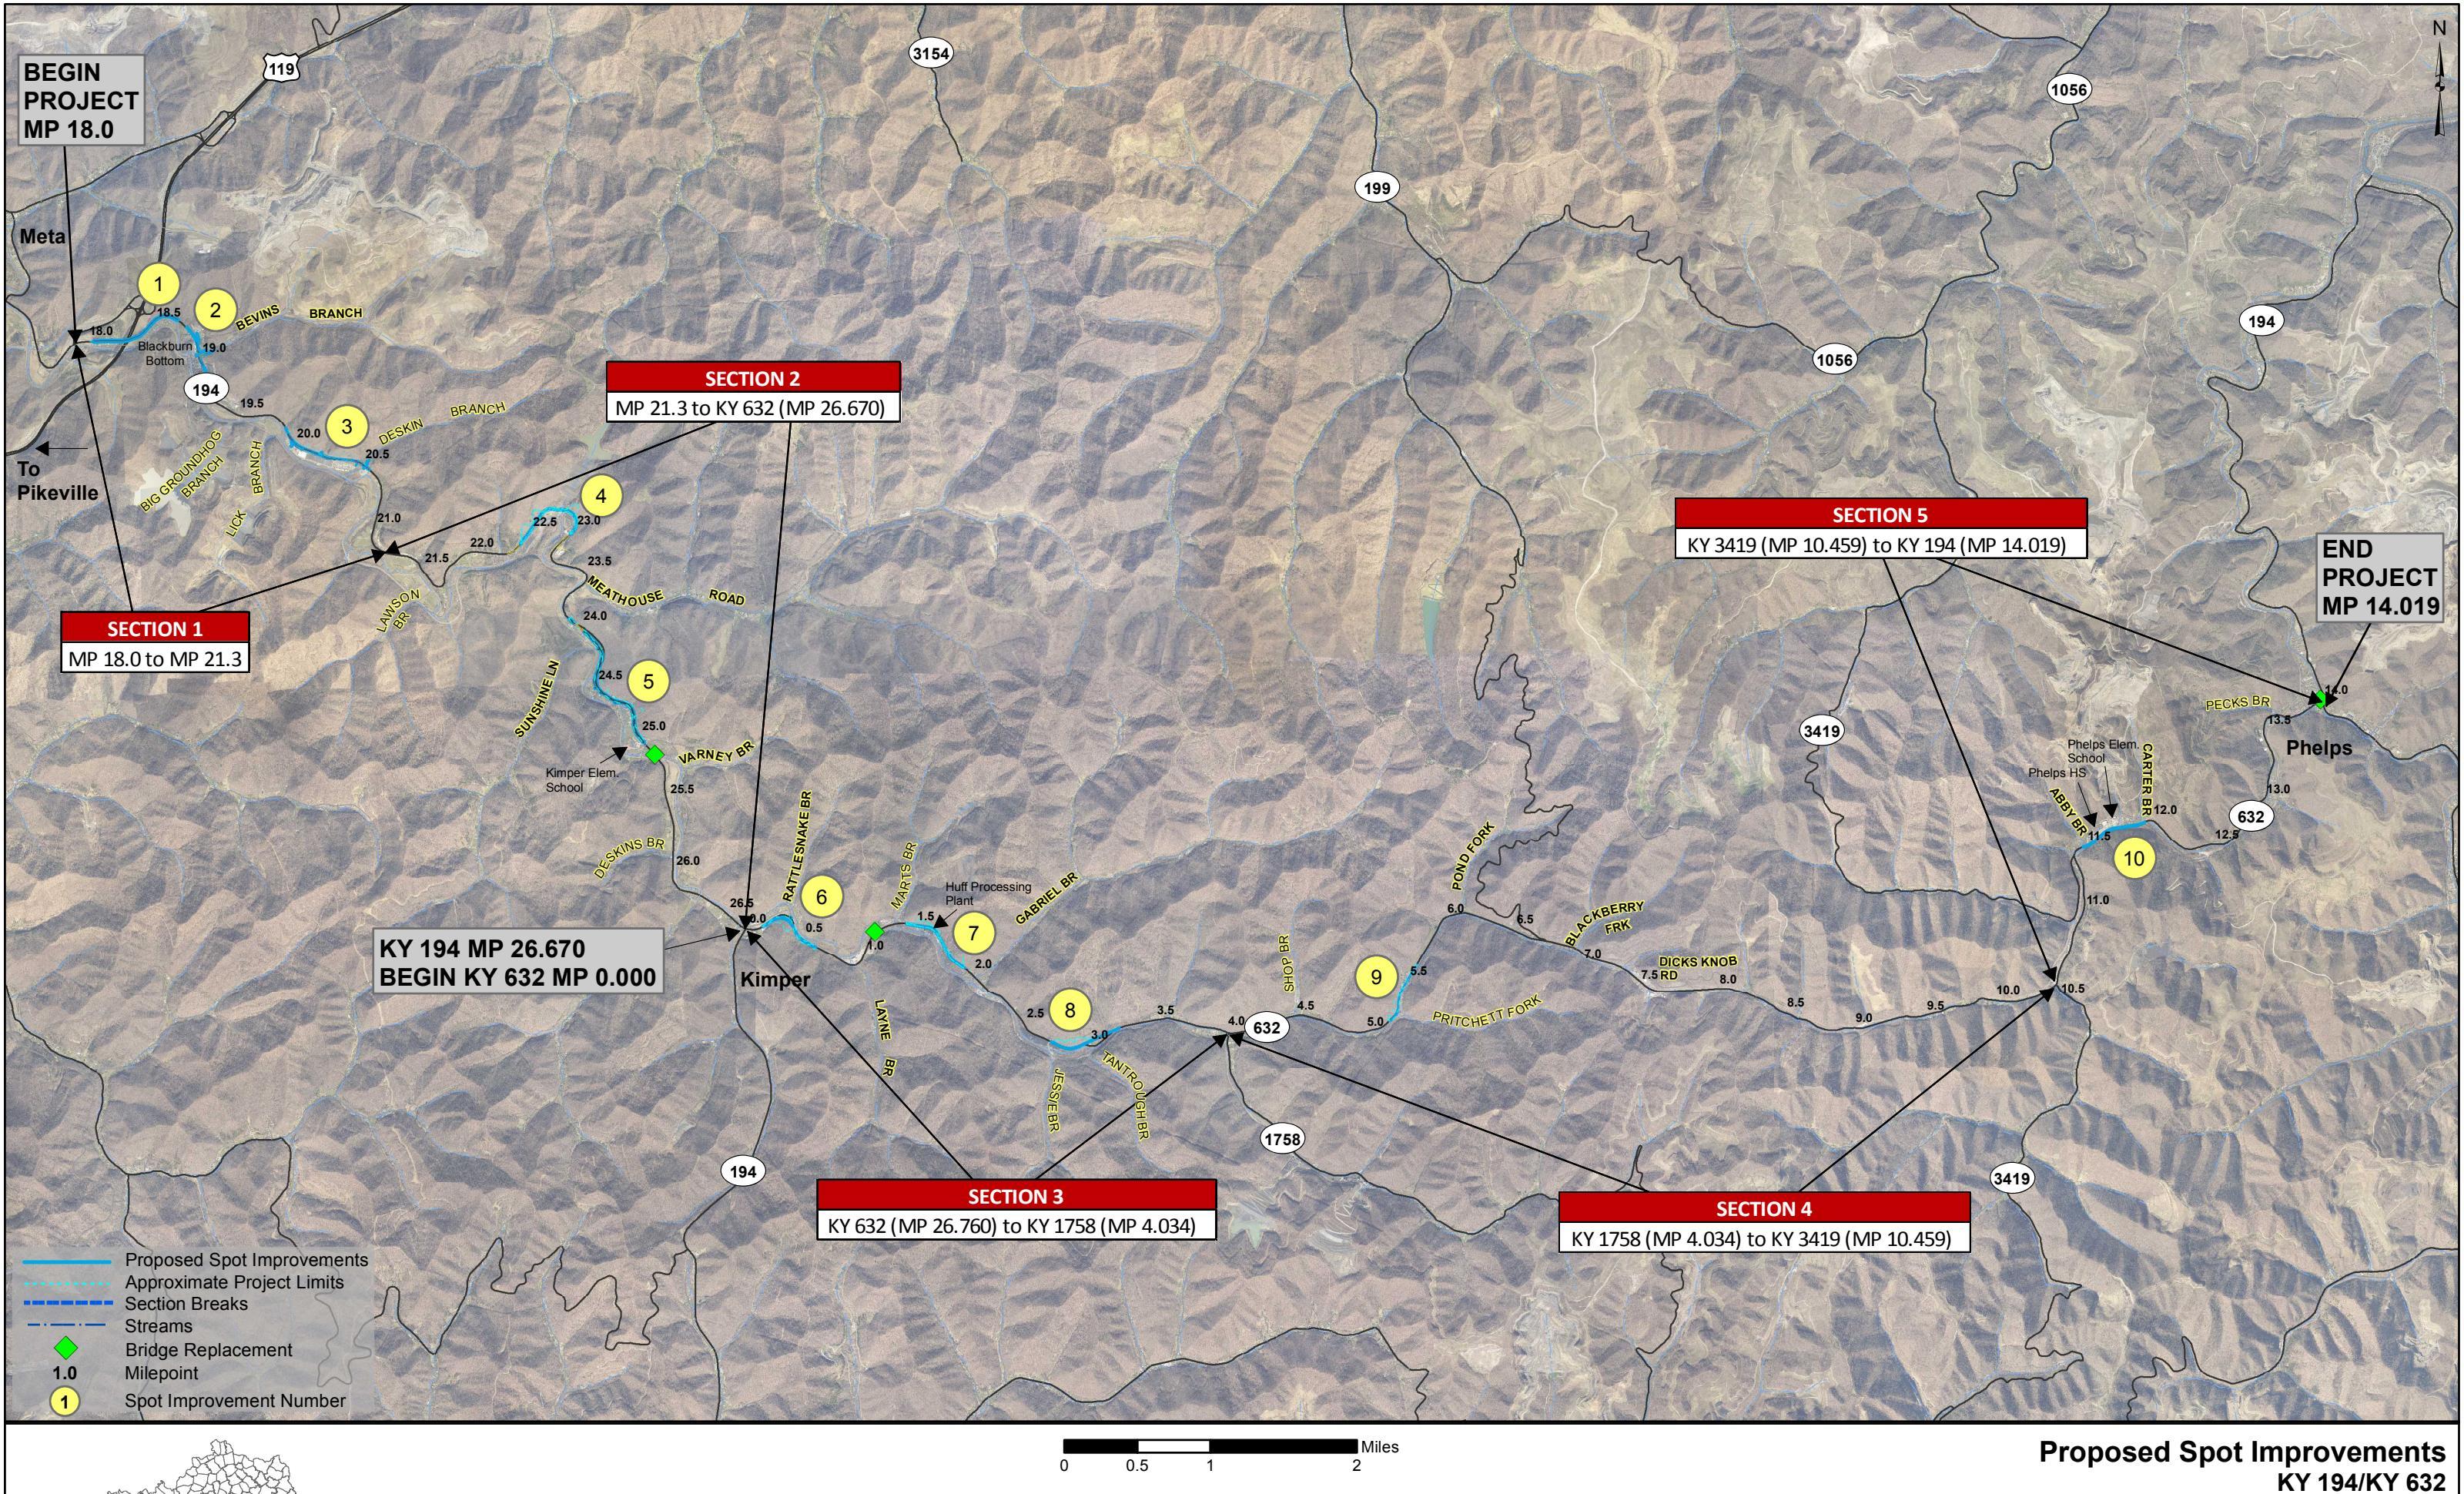
Proposed Spot Improvements KY 194/KY 632 US 119 to Phelps, KY Pike County

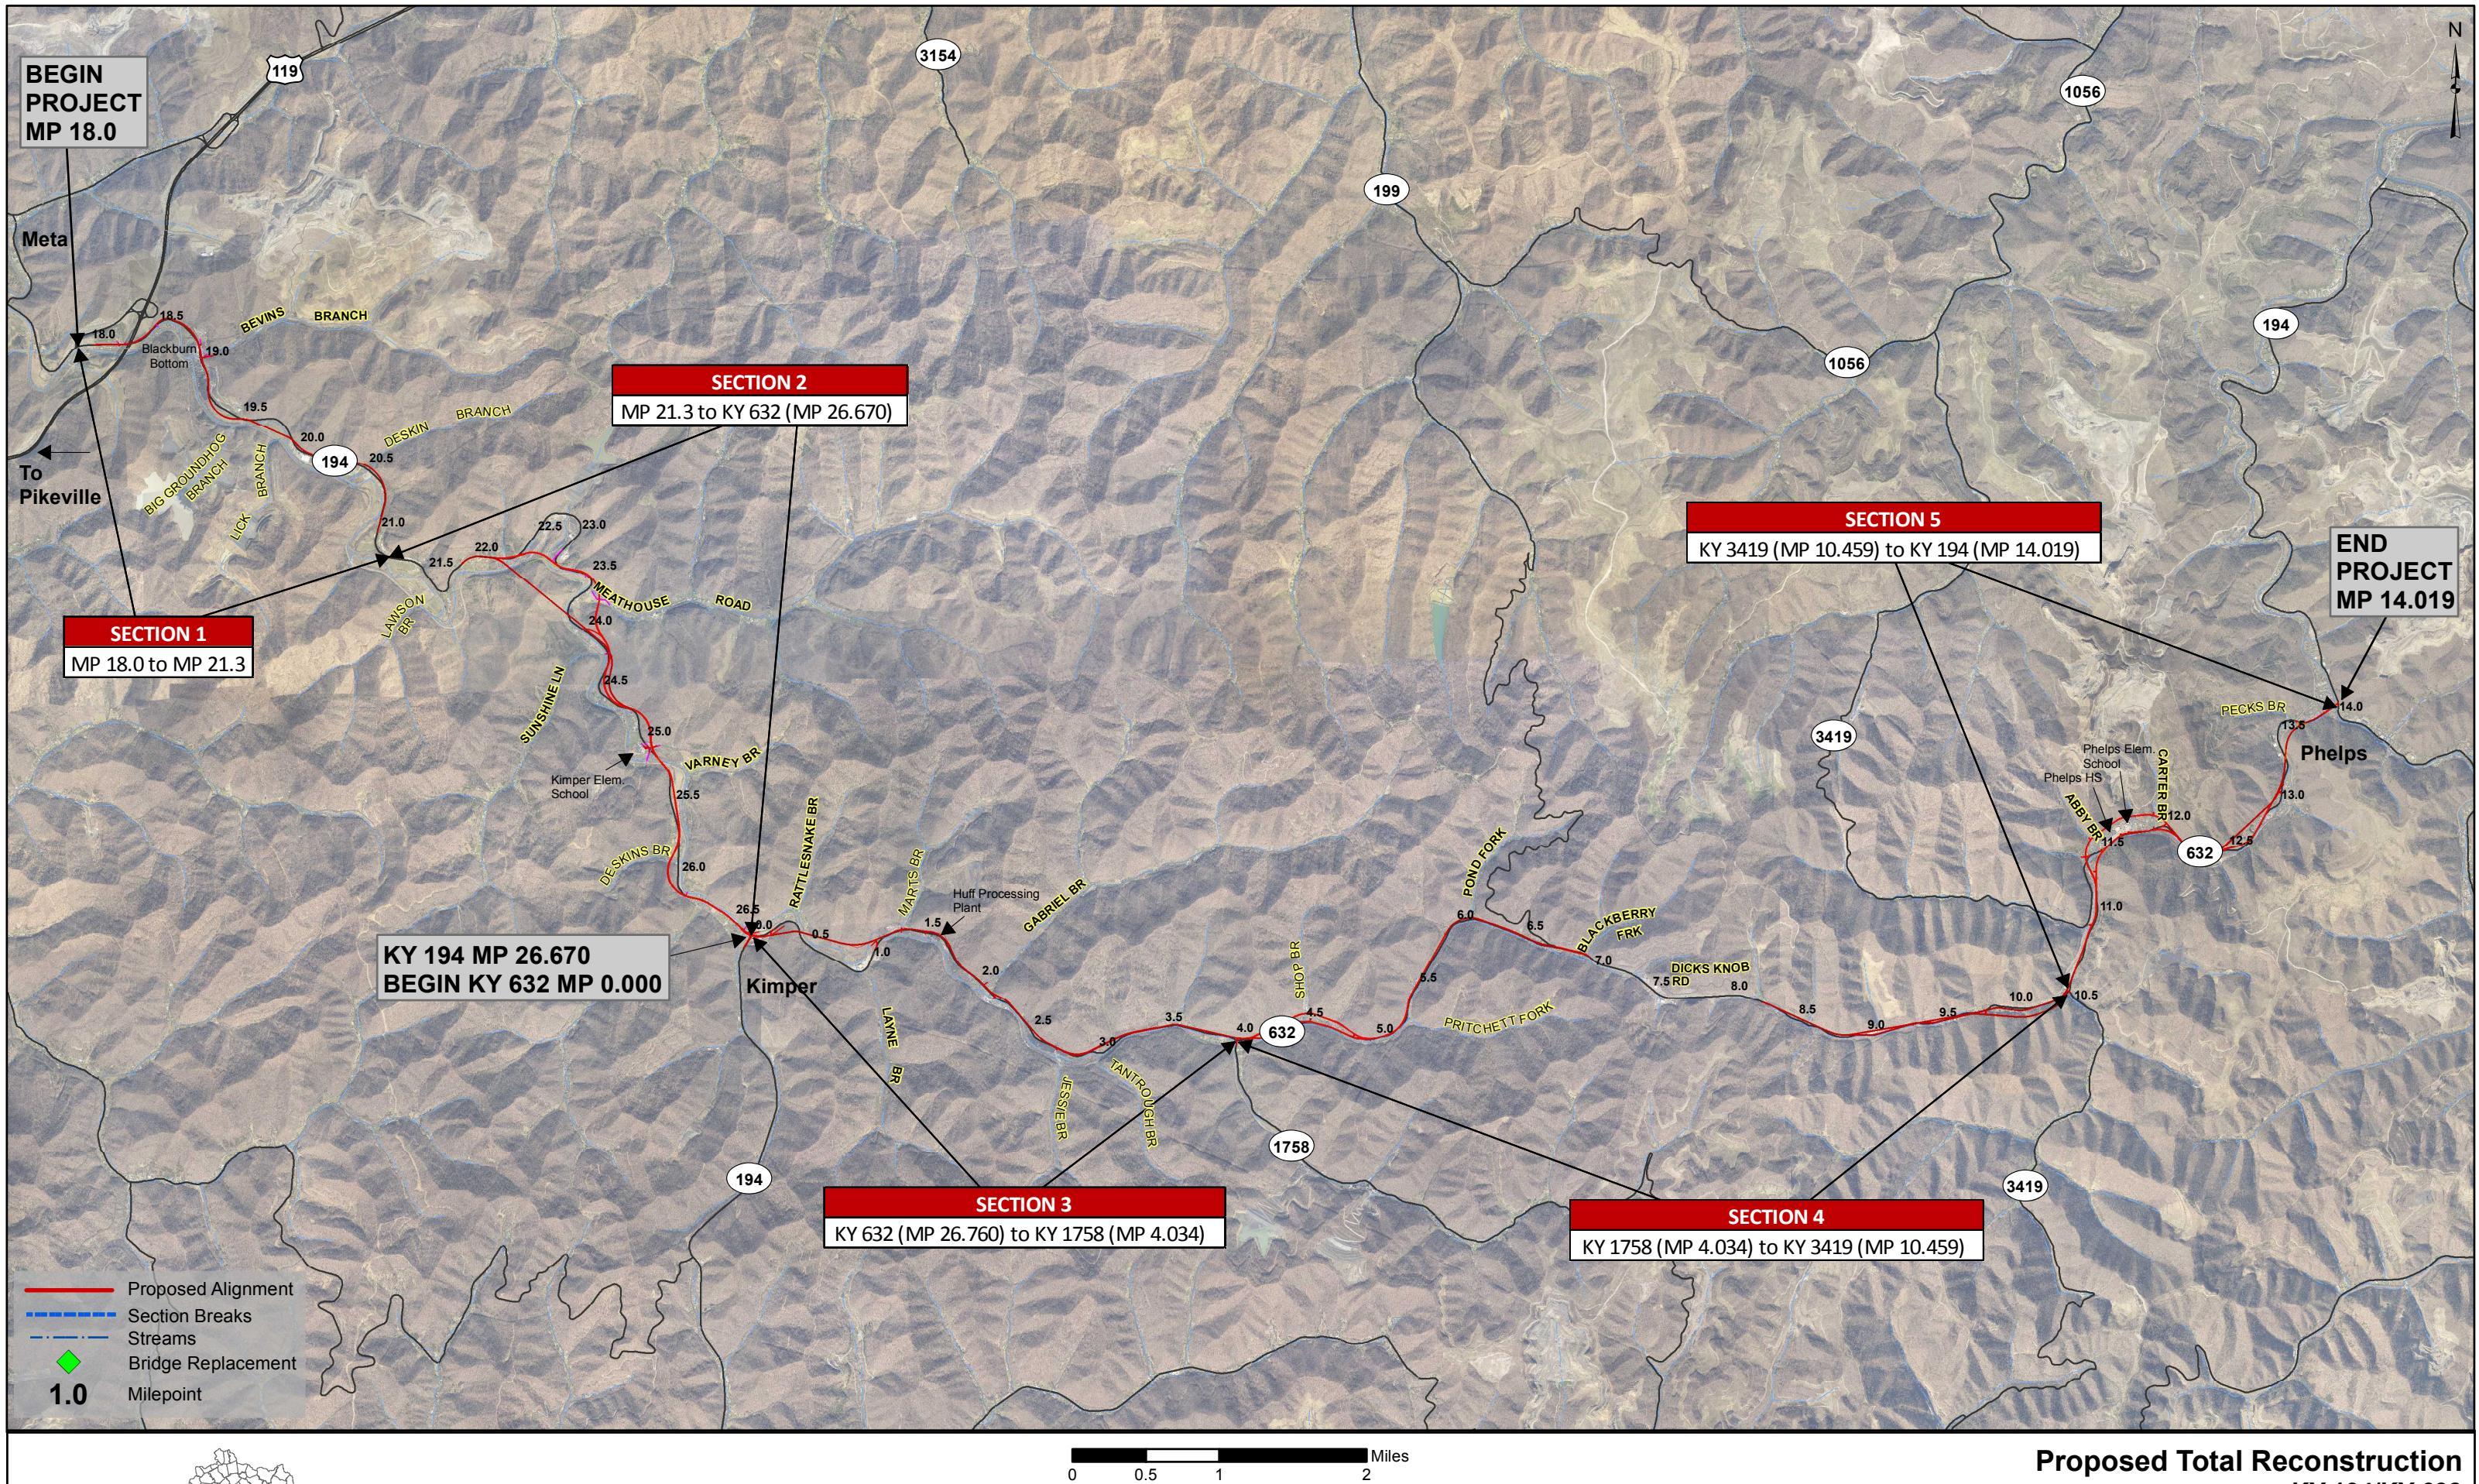
Proposed Total Reconstruction KY 194/KY 632 US 119 to Phelps, KY Pike County
