FINAL REPORT

KY 69 Scoping Study Hancock County KYTC Item No. 2-8708.00

March 2016

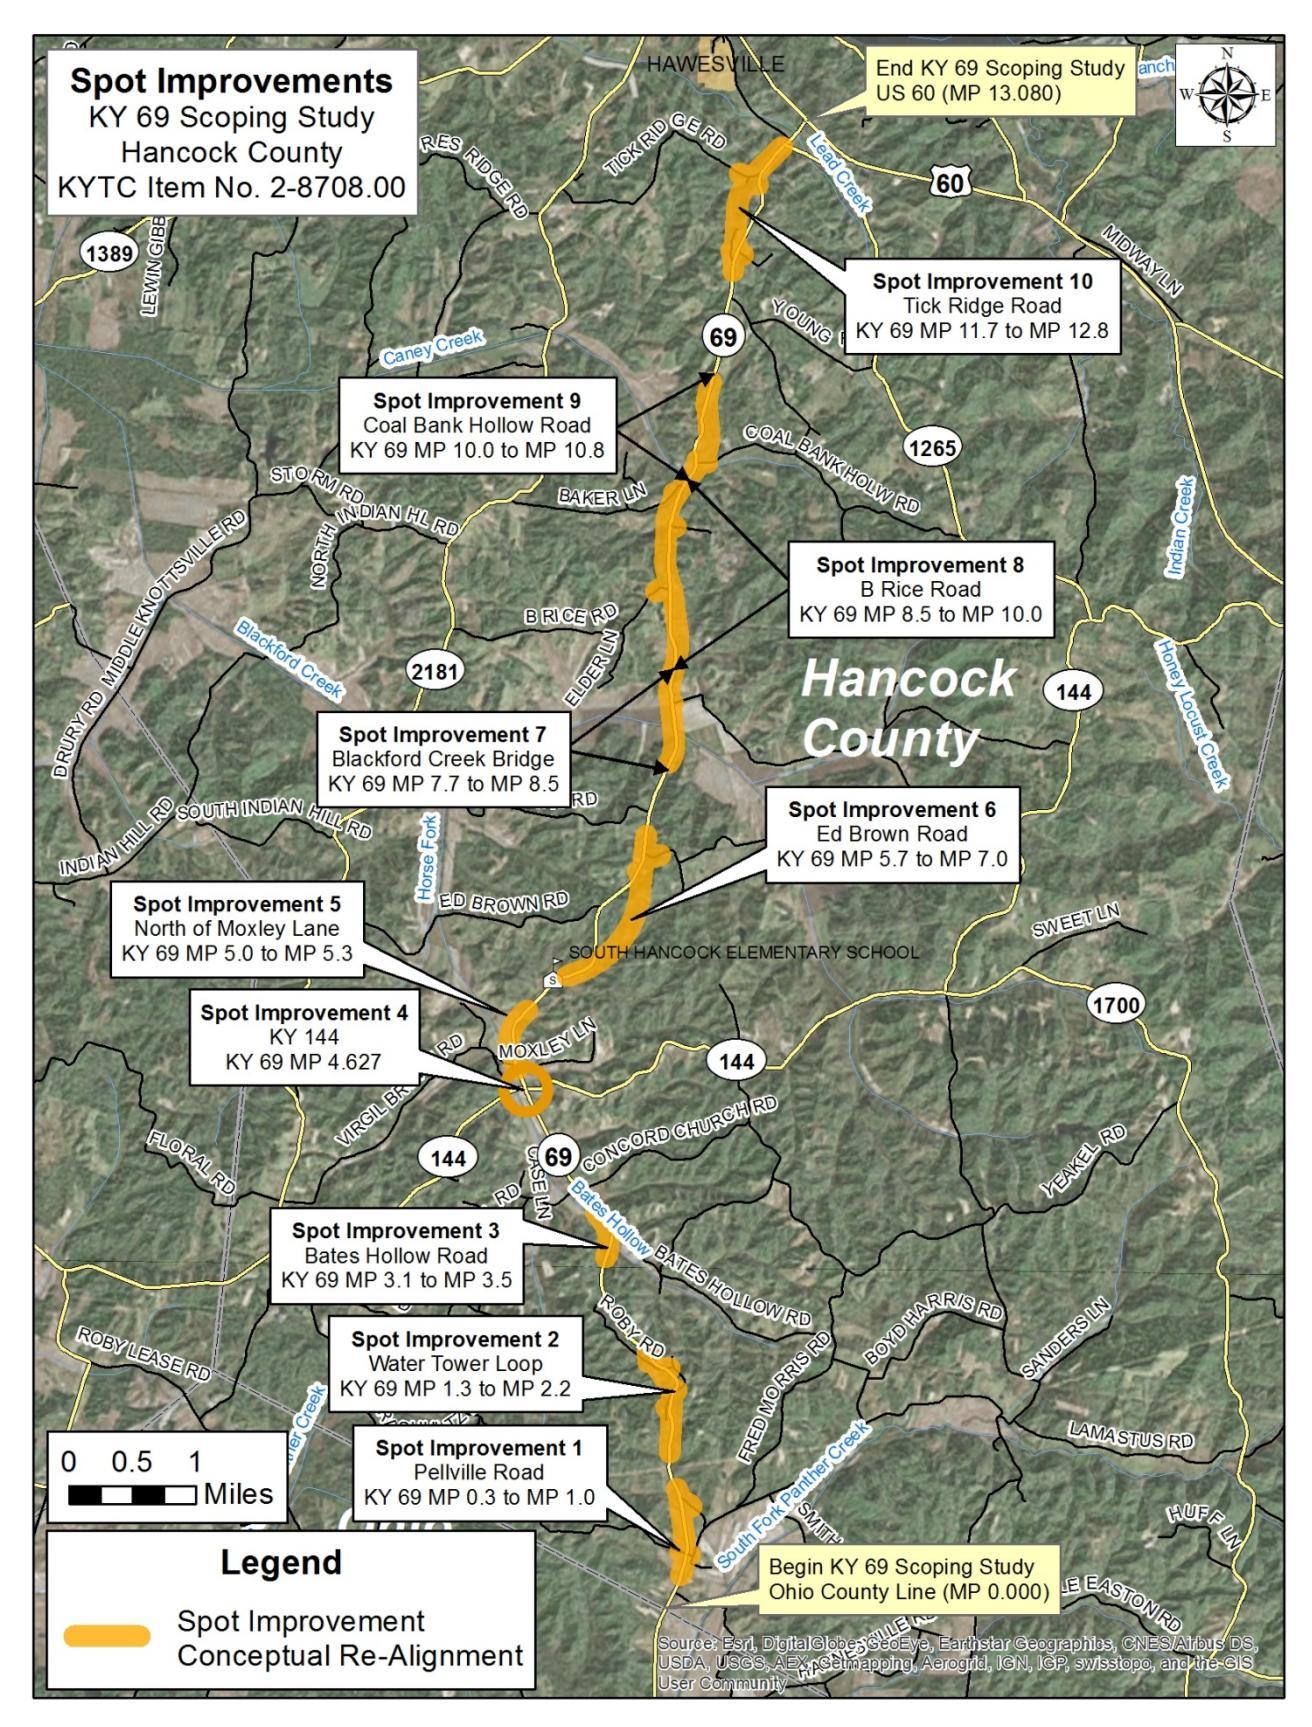
Figure ES-1: Spot Improvements

The Spot Improvements generally include short segments of the corridor with relatively lower cost improvements that can be implemented individually. Ten locations were identified as spot improvement projects, shown in **Figure ES-1**. In order to improve the vertical alignment and maintain traffic during construction, most of these spot improvements are shown on new alignment. However, the deficiencies found at each spot could be addressed in a number of ways and thus the ultimate alignment and design details will need to be examined in subsequent project phases.

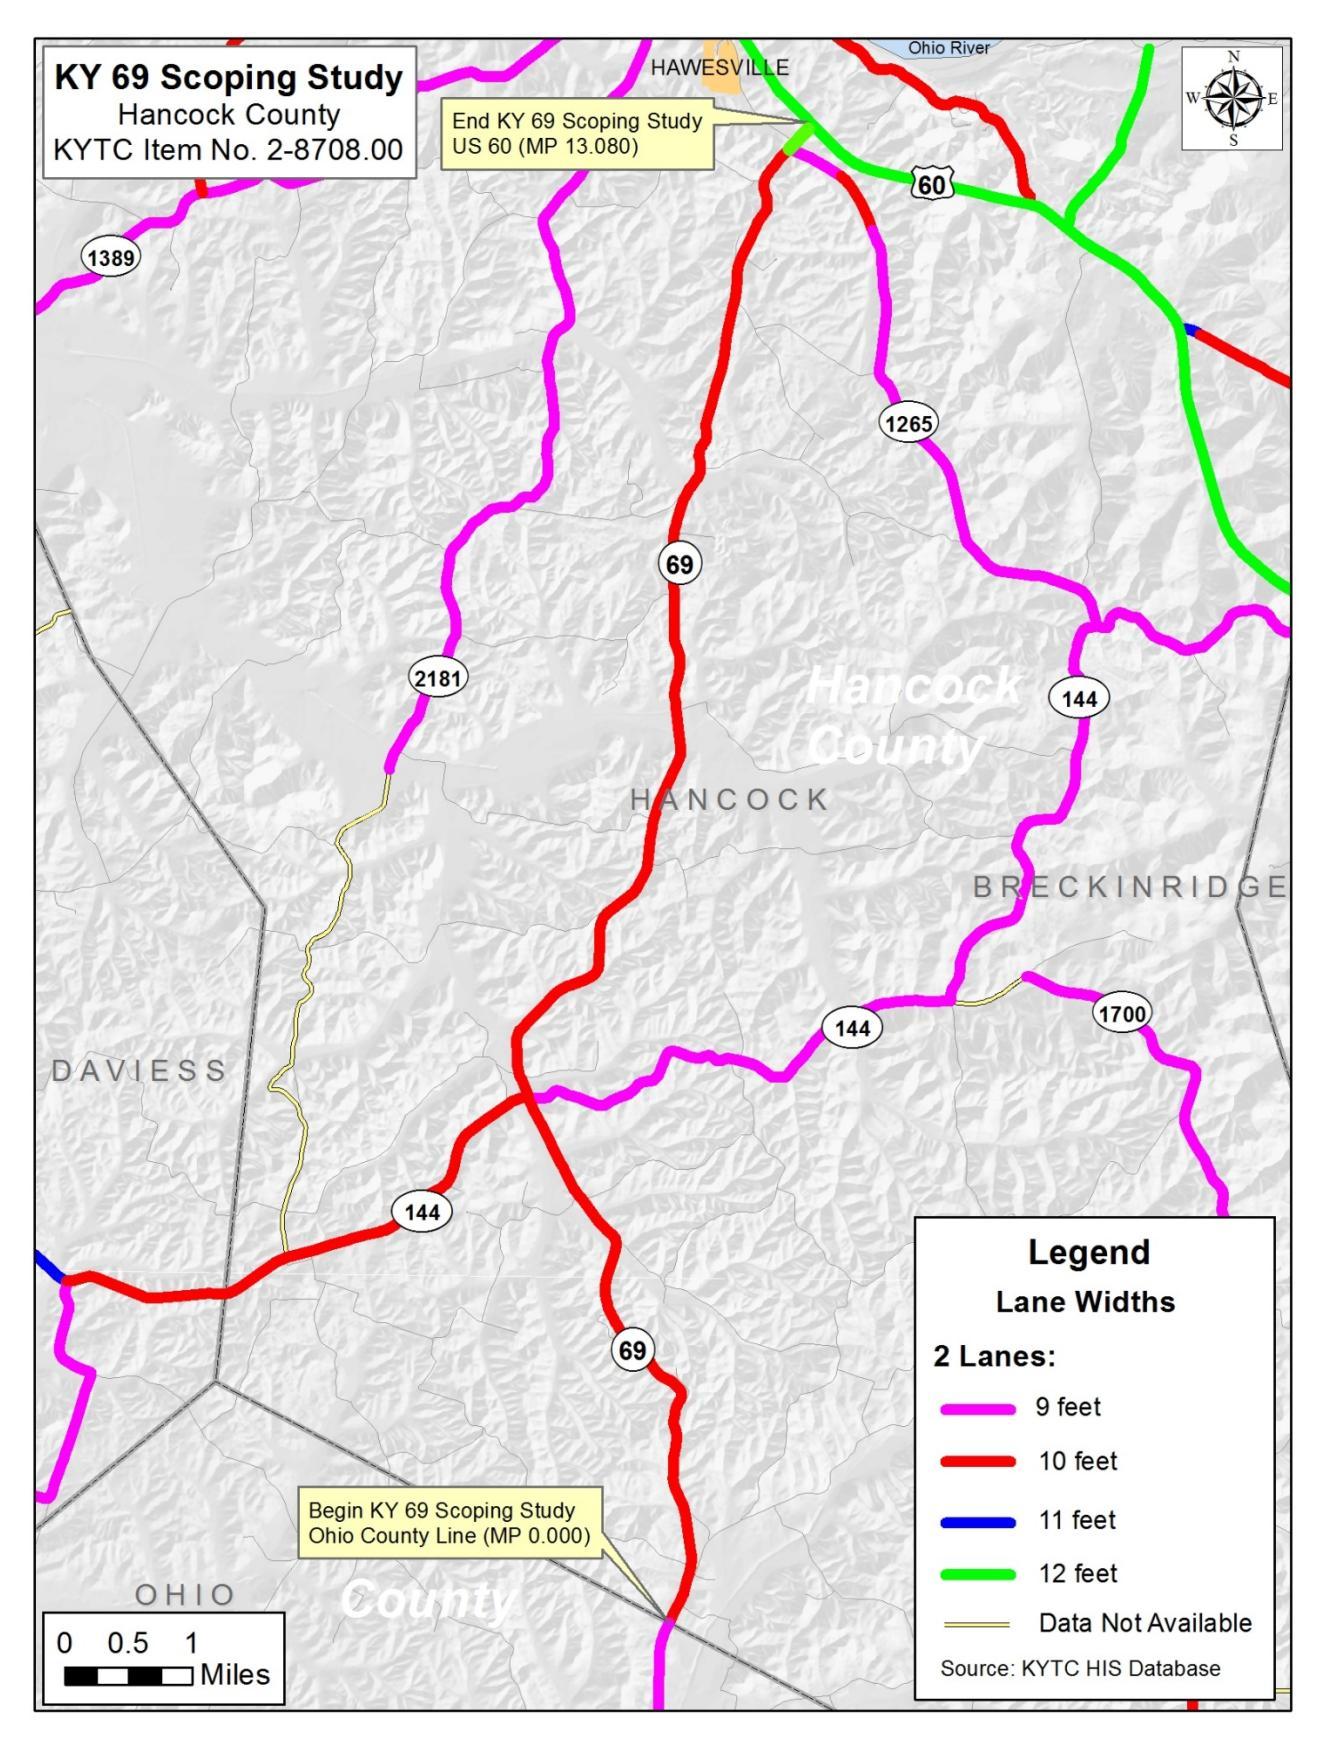
Figure 4: Lane Widths

The estimated lane widths throughout study area roadways are shown on **Figure 4**. Current Green Book design guidelines suggest a minimum of 11-foot wide lanes on rural collector roadways with an ADT between 400 and 1,500 vpd and 12-foot wide lanes on rural collector roadways with an ADT greater than 2,000 vpd (Green Book Table 6-5). For roadways to be reconstructed, a 22-foot traveled way may be retained where the alignment is satisfactory and there is no crash pattern suggesting the need for widening. KY 69 has 10-foot-wide lanes throughout the study area, which is less than the recommended minimum widths in the Green Book.

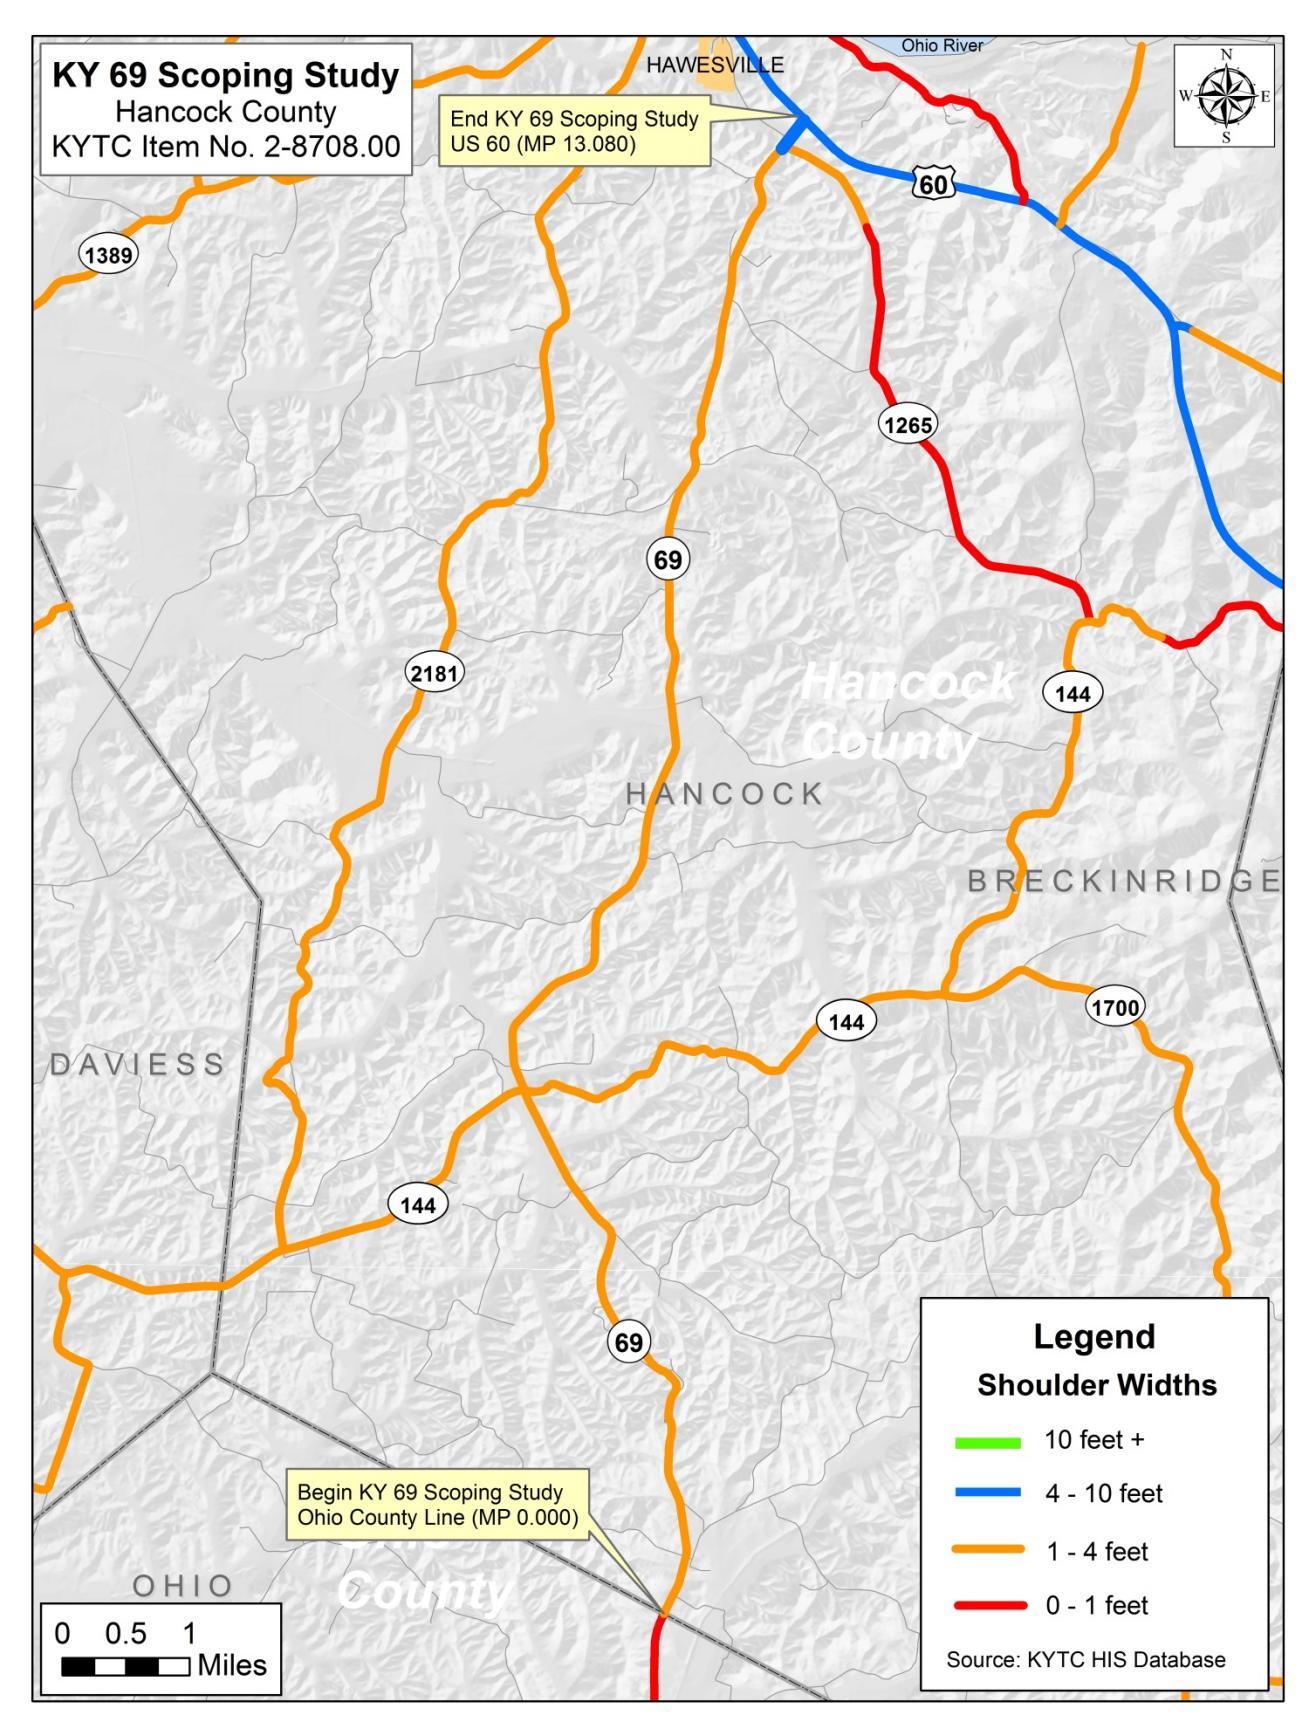
Figure 5: Shoulder Widths

Estimated shoulder widths throughout the study area are shown in **Figure 5**. KY 69 in the study area has two-foot-wide paved shoulders, which is less than the recommended minimum widths in the Green Book. Five-foot shoulder widths are recommended for rural collector roadways with an ADT between 400 and 1,500 vpd (Green Book Table 6-5). Shoulder widths may be reduced for this traffic volume range for design speeds greater than 30 mph provided a minimum roadway width of 30 feet is maintained. Where the ADT is greater than 2,000 vpd, eight-foot wide shoulders are recommended (Green Book Table 6-5). Where roadside barriers are included (i.e., retaining walls or bridge walls), a minimum offset of four feet from the traveled way to the barrier should be provided, wherever practical (Green Book Section 6.2.2).

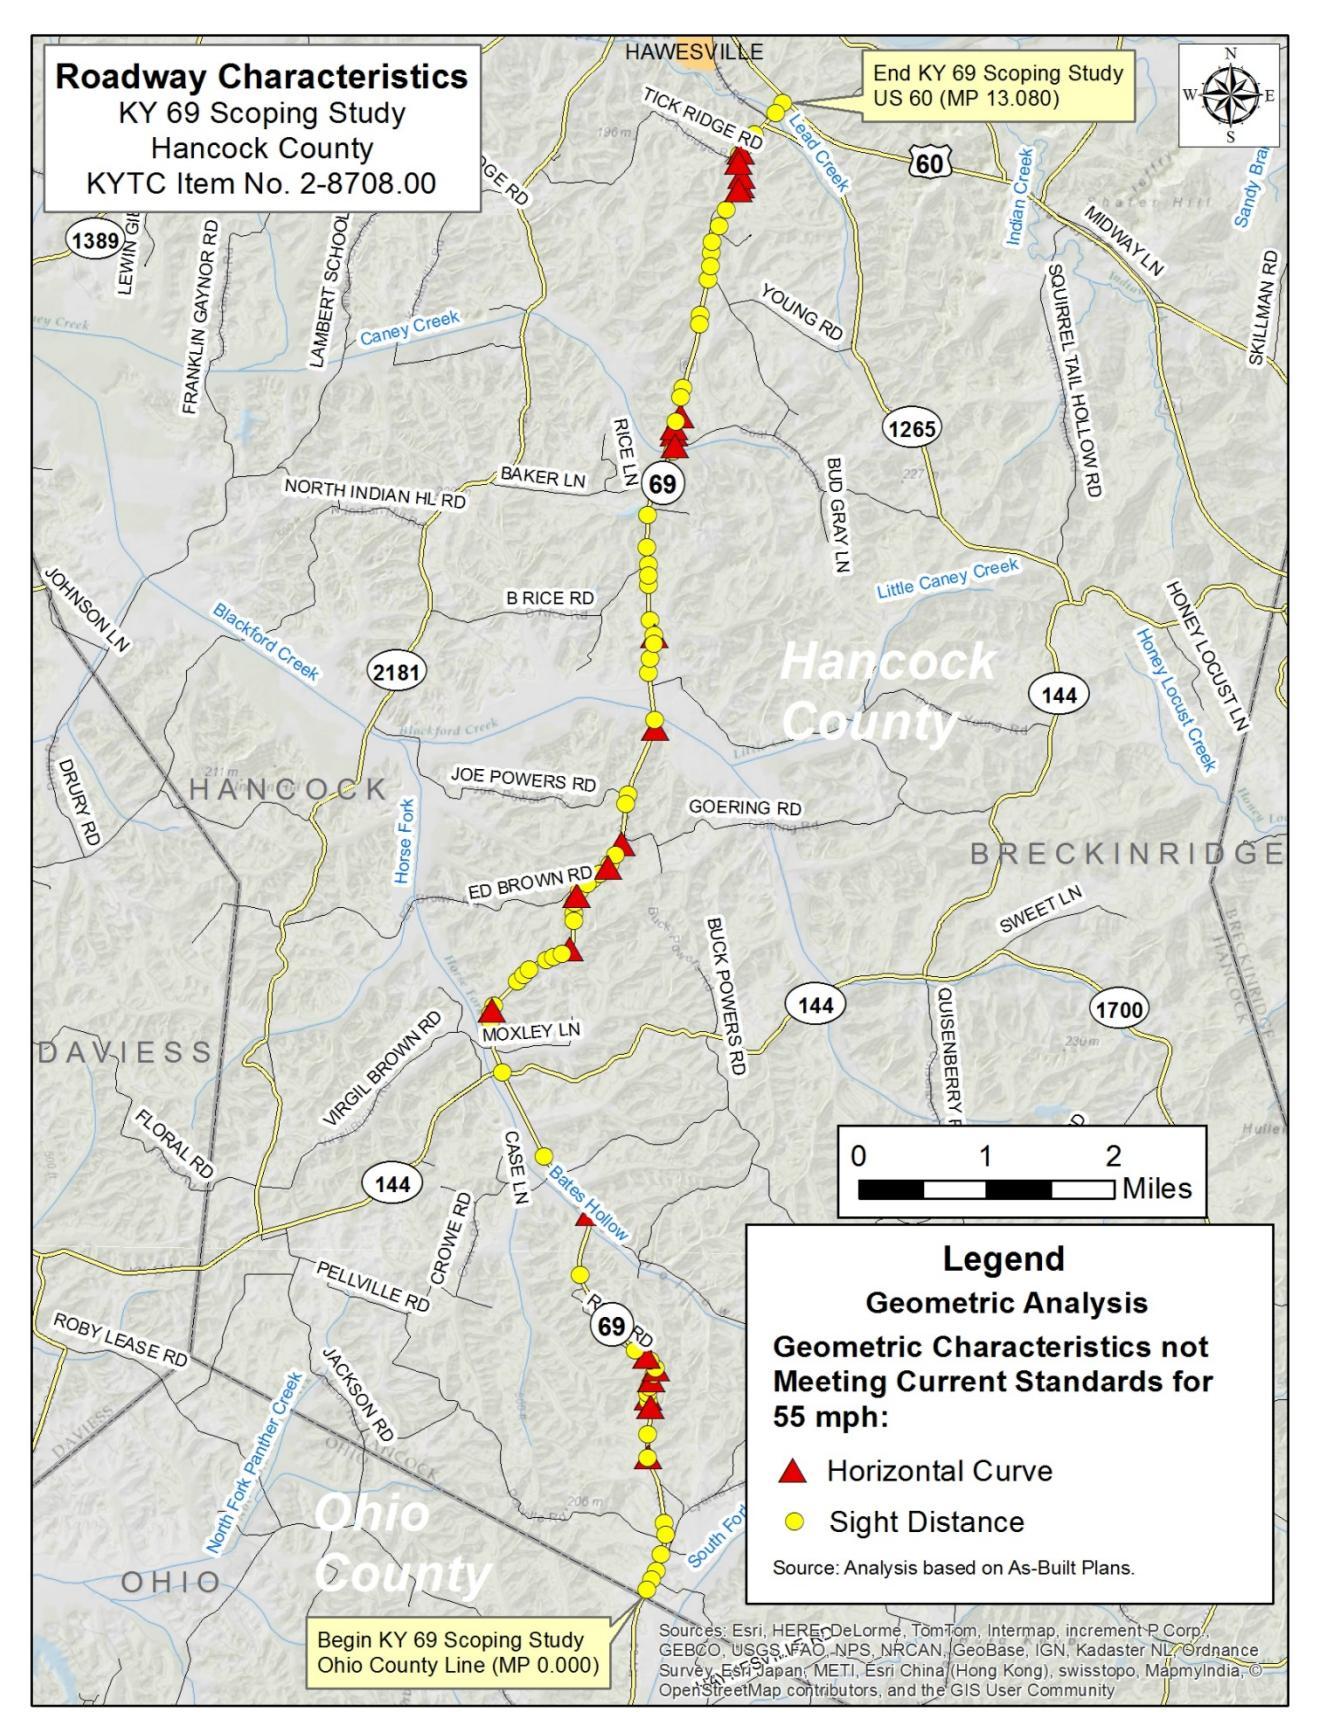
Figure 6: KY 69 Geometric Analyses from As-Built Plans

A review of the as-built plans for KY 69 reveals there are 63 horizontal curves in the study area, 23 (37 percent) of which have radii less than 960 feet indicating they do not satisfy a 55 mph design speed (Green Book Table 3-10b). Of the 114 vertical curves in the study area, 67 (59 percent) have stopping sight distance less than 495 feet which would not satisfy a 55 mph design speed (Green Book Table 6-3). No grades along the corridor exceed the maximum seven percent requirement (Green Book Table 6-4). The detailed geometric analysis and standards for KY 69 are located in **Appendix A** as well as shown in more detail in **Figure 6**.

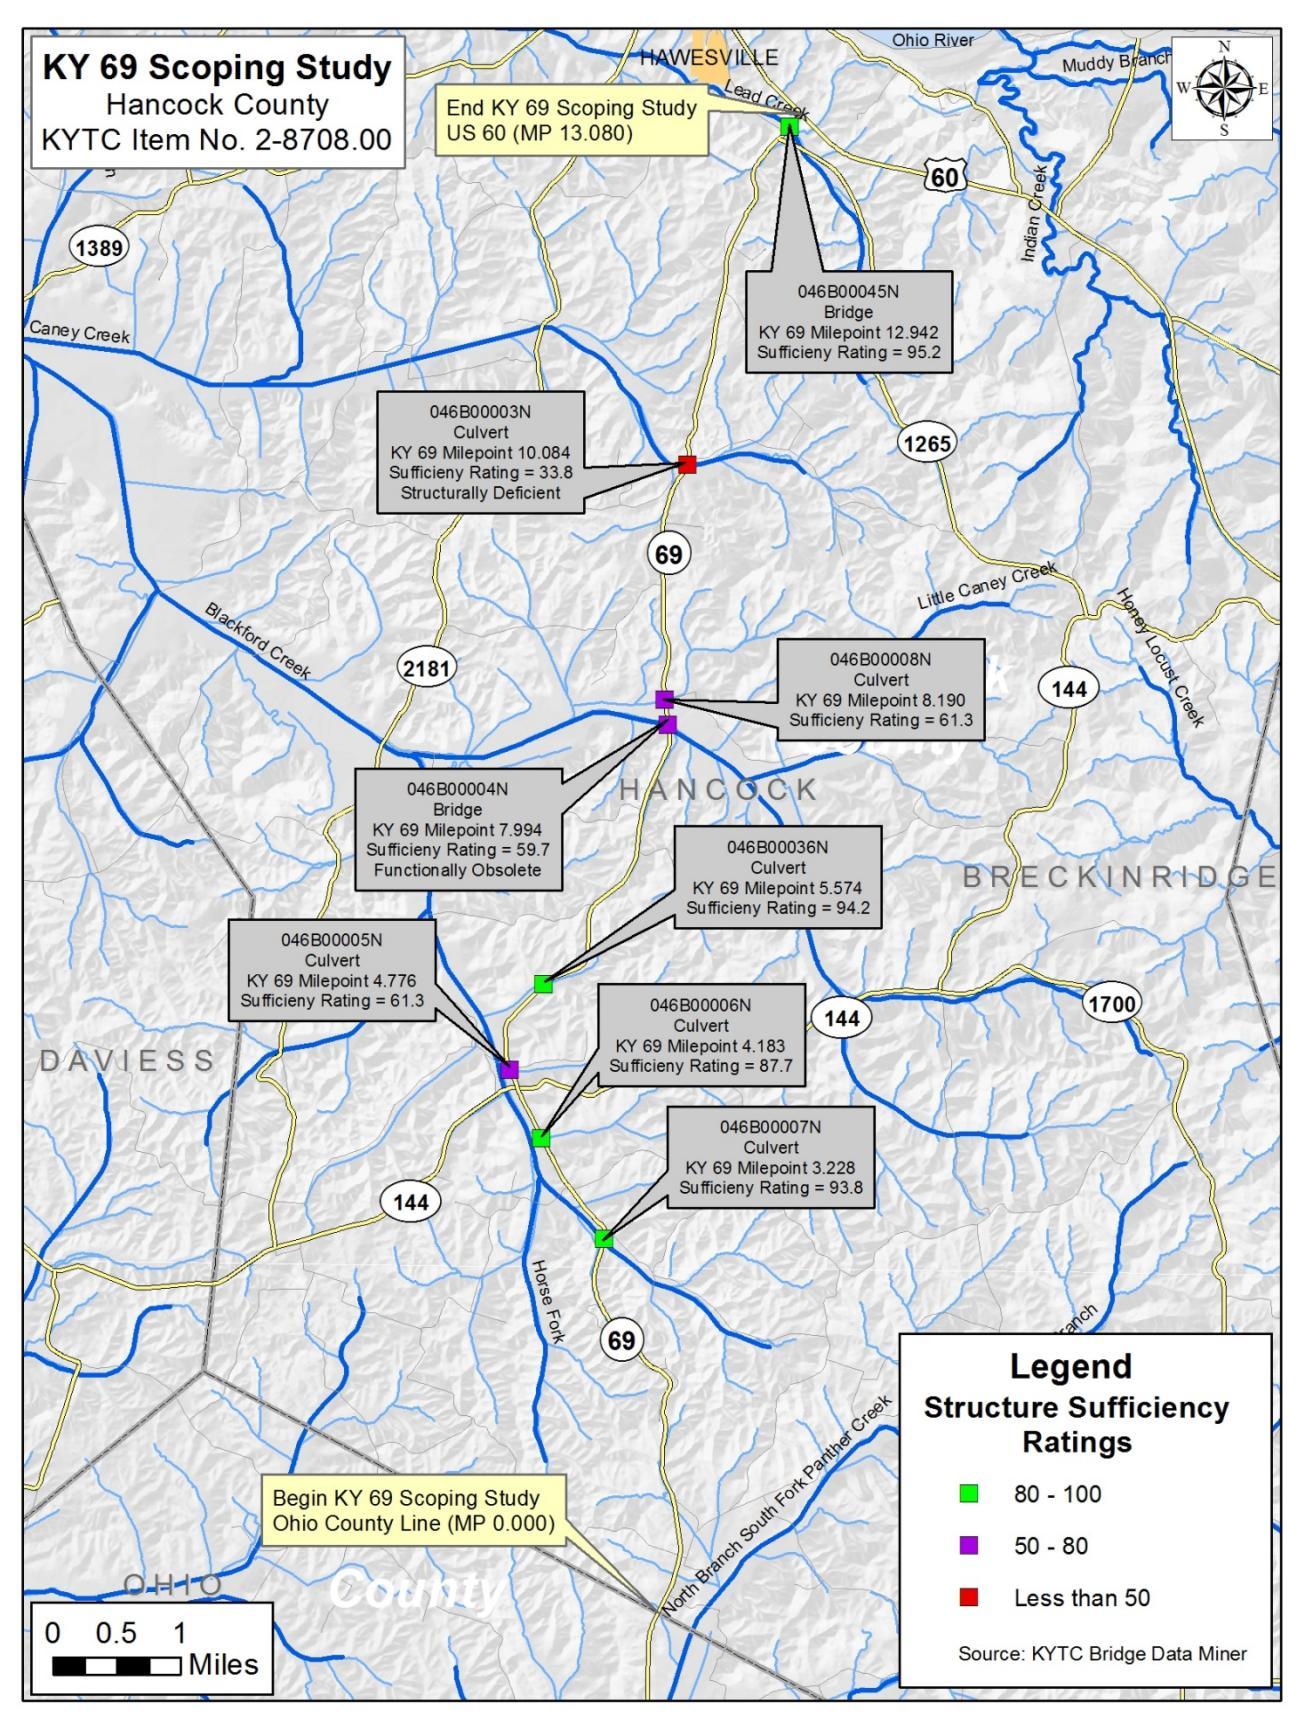
Figure 7: Structure Locations and Sufficiency Ratings

Numerous culverts and two bridges are located along the study corridor, as summarized in **Figure 7**. From the KYTC Bridge Data Miner, existing structure sufficiency ratings were identified during 2011 bridge inspections. This rating assigns individual structures with a measure of "sufficiency" to remain in service. The higher sufficiency rating a bridge has, the better the condition of the bridge. Bridges considered structurally deficient or functionally obsolete with a sufficiency rating less than 50.0 are regularly considered for funding to replace or rehabilitate. Those with a sufficiency rating of 80.0 or less are regularly considered for funding to rehabilitate. Bridges are considered structurally deficient if significant load carrying elements are found to be in poor condition due to deterioration and and/or damage, or the adequacy of the waterway opening provided by the bridge is determined to be extremely insufficient to the point of causing overtopping with intolerable traffic interruptions. Bridges are considered functionally obsolete if they do not meet geometric design standards of today.

There are six culverts along the corridor, three of which have a sufficiency rating below 80 percent and one is considered structurally deficient with a sufficiency rating of 33.8 percent. There are two bridges along KY 69, one of which (Blackford Creek bridge) has a sufficiency rating of 59.7 percent and is considered functionally obsolete because of its narrow deck width. The second bridge over Lead Creek was replaced in 1994 and has a sufficiency rating of 95.2 percent. All of the structure and sufficiency ratings are shown on **Figure 7**.

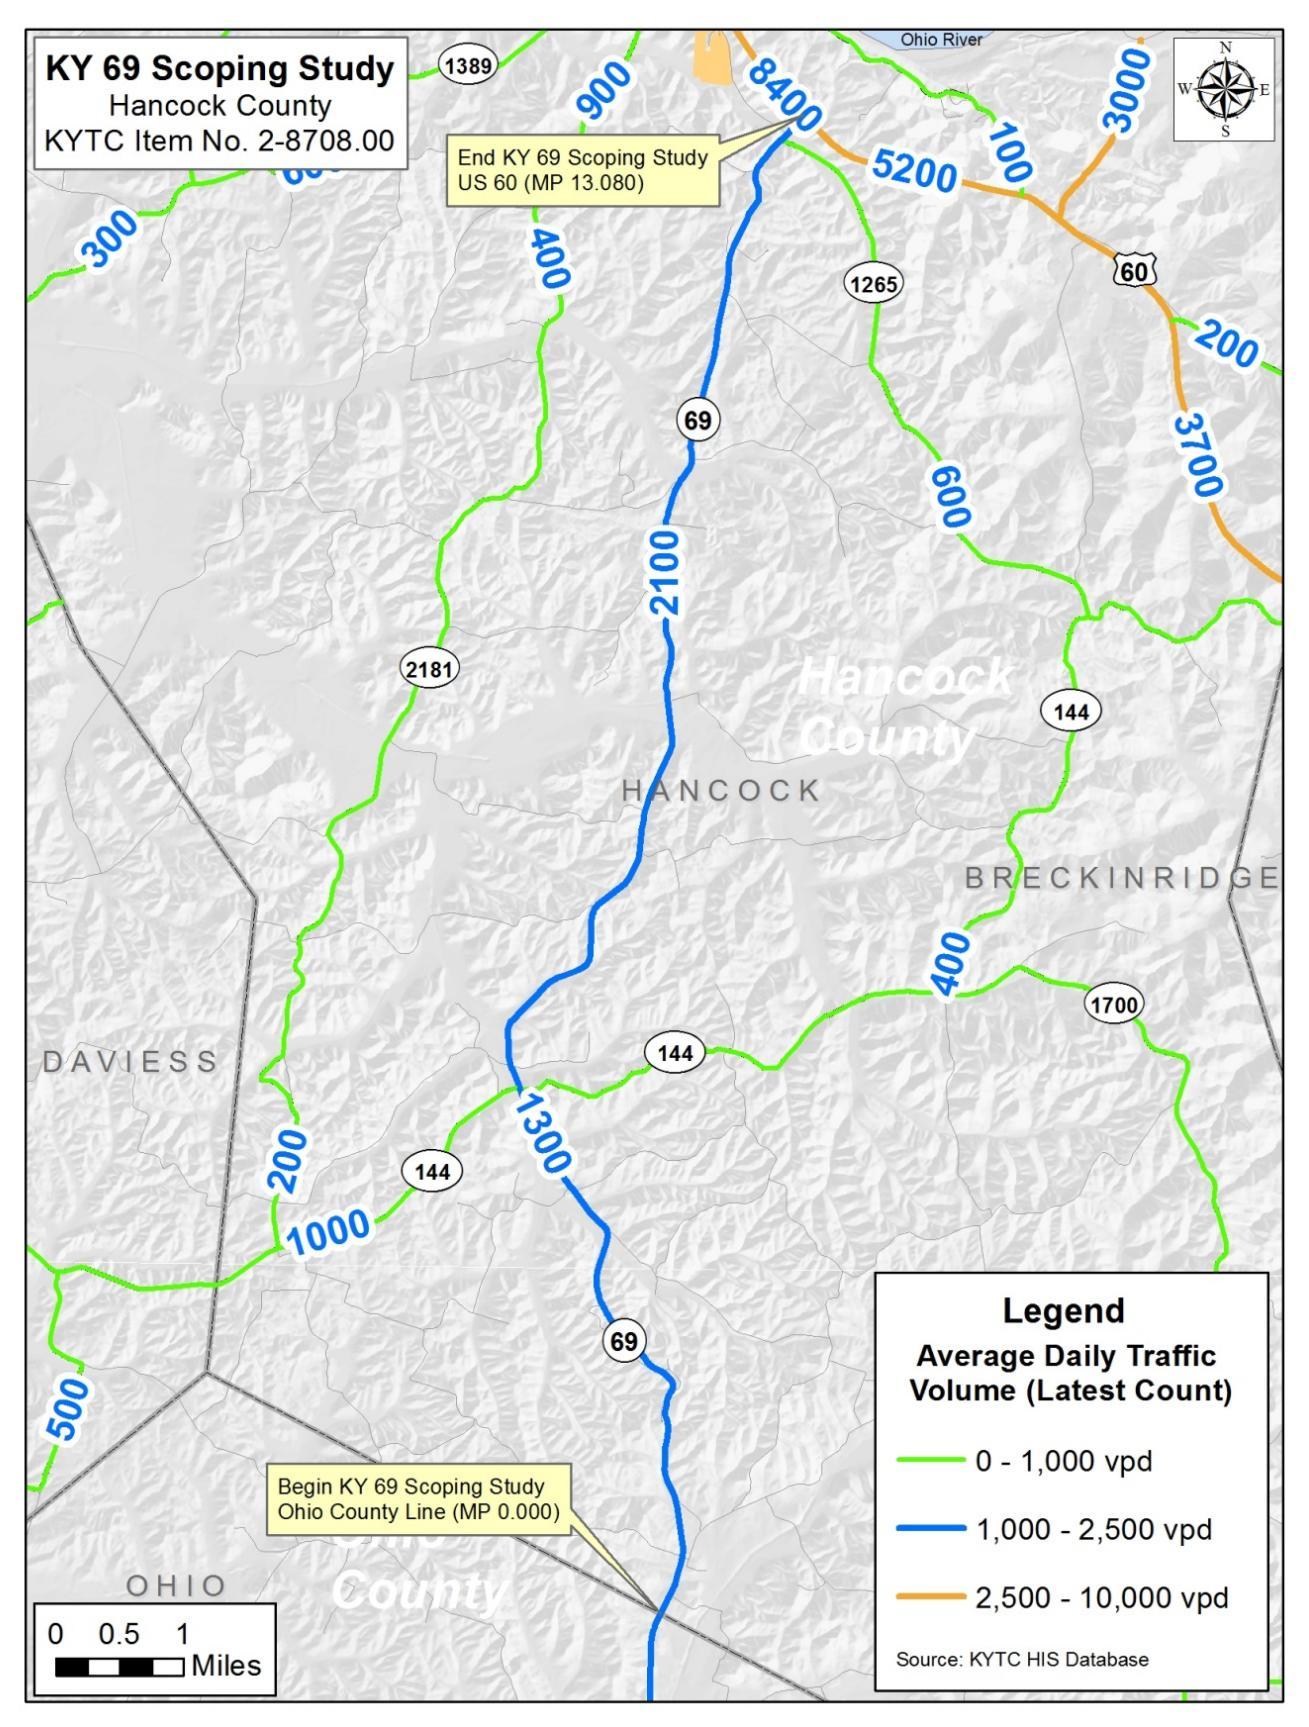
Figure 8: Average Daily Traffic (ADT) Volumes

As part of this study, traffic counts were conducted by the KYTC in January 2015 at traffic stations 046509 (KY 69 MP 1.9), 046503 (KY 69 MP 7.3), as well as a turning movement count at the KY 69/US 60 intersection. Based on the 2015 counts, the current average daily traffic (ADT) volumes on KY 69 range from 1,300 vehicles per day (vpd) at the southern end of the study area to 3,000 vpd near the northern end of the study area, with 13.7 percent of the ADT being trucks.

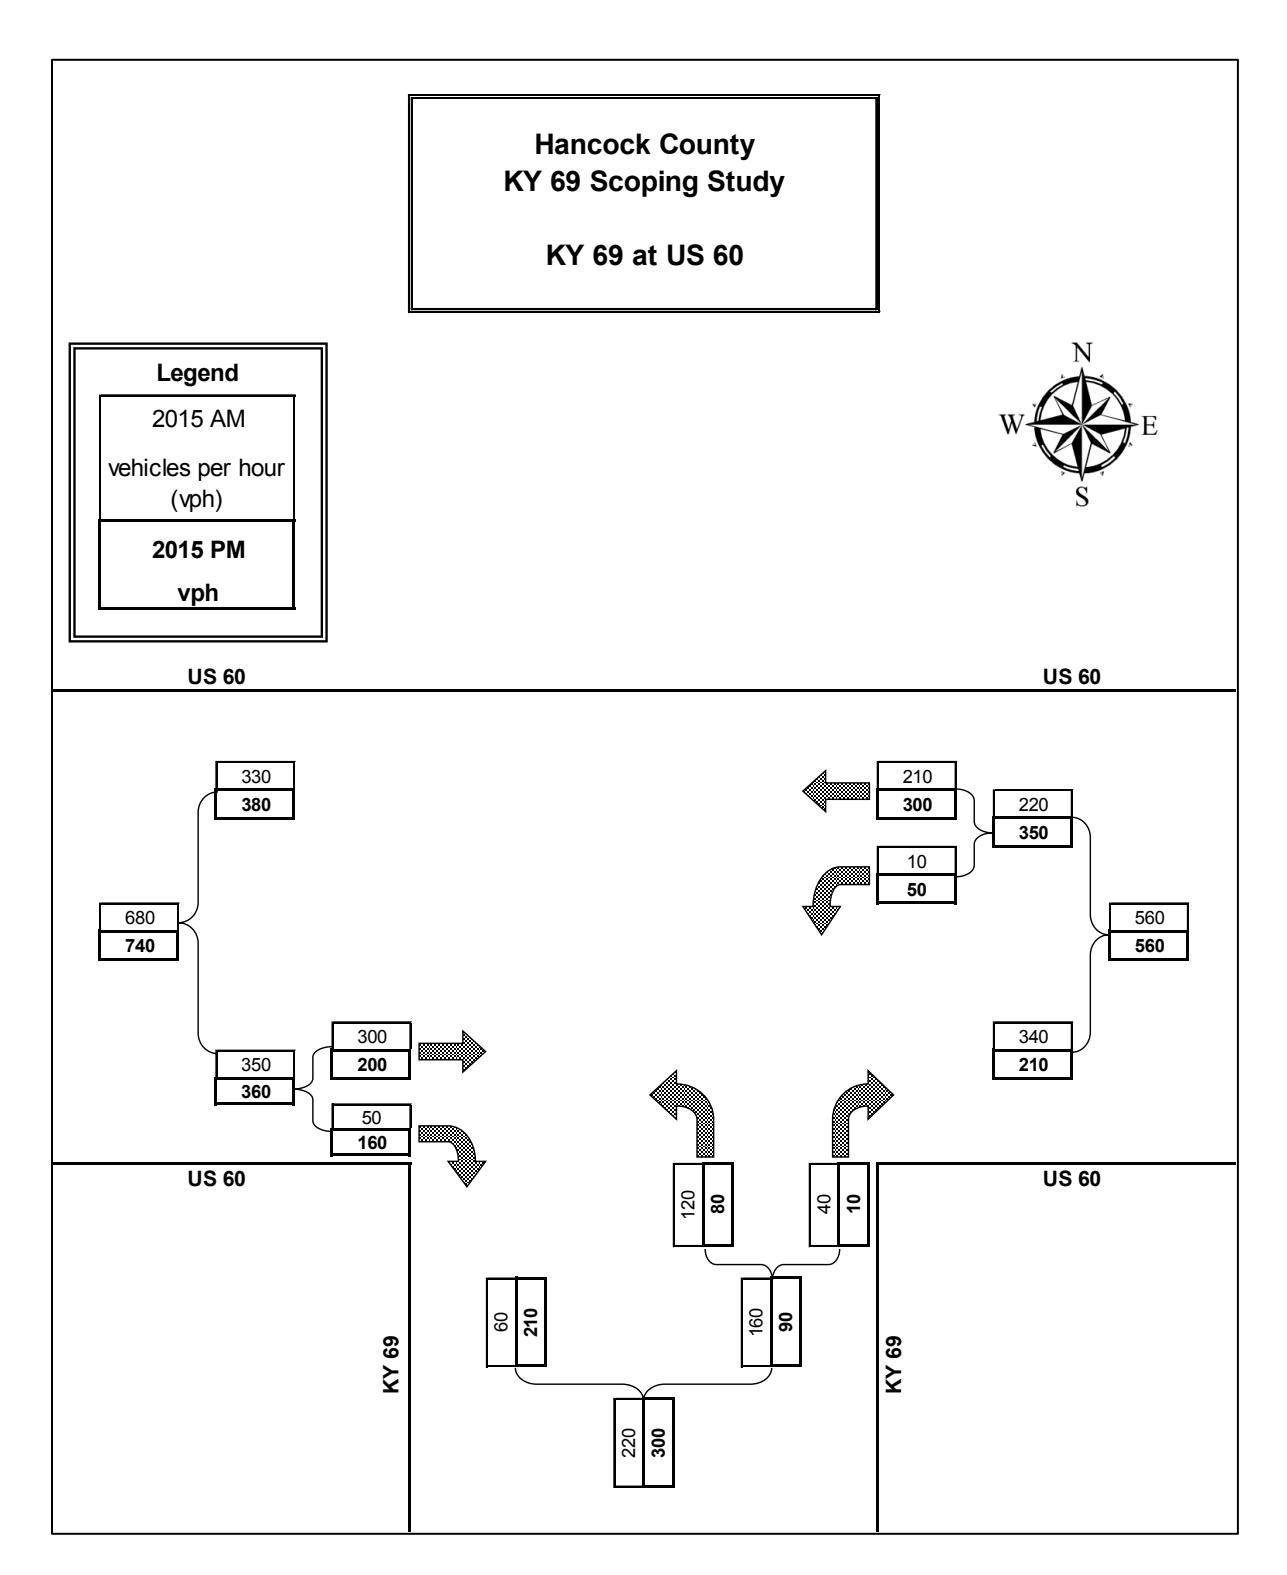
Figure 9: 2015 Peak Hour Turning Movement Counts at KY 69/US 60 Intersection

Intersection	LOS	Approach	Delay (sec/veh)	LOS
KY 69 at US 60	в (В)	Westbound US 60 Turning Left	8 (8)	A (A)
		Northbound KY 69 Turning Left	14 (15)	B (B)
		Northbound KY 69 Turning Right	9 (9)	A (A)

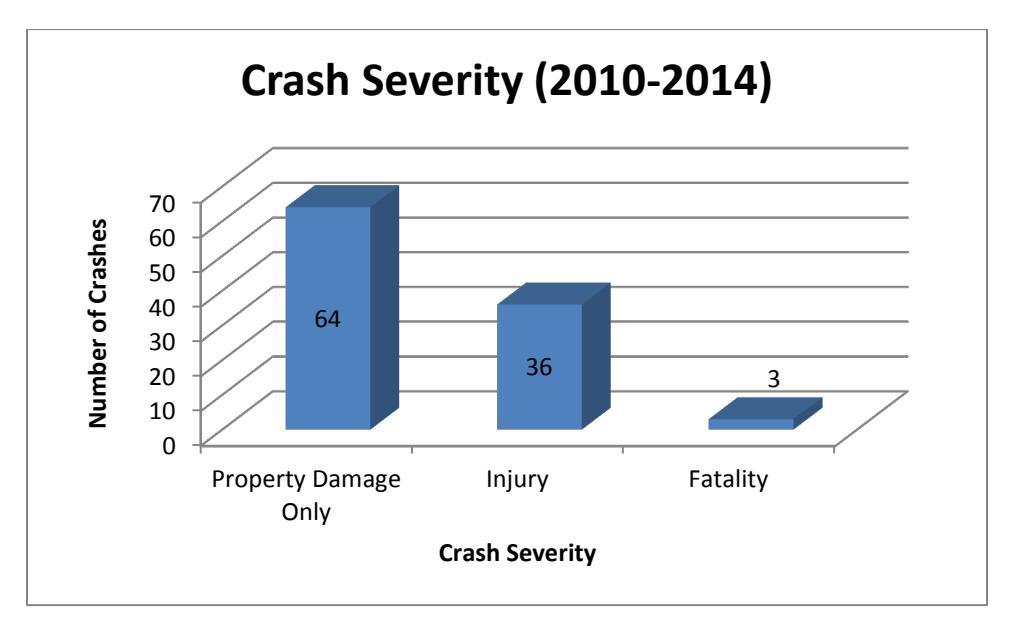
Figure 10: Distribution of Crashes by Severity

Over the analysis period, there were 103 reported crashes along the 13.08-mile corridor. Of these, three crashes resulted in fatalities and 36 resulted in injuries. **Figure 10** summarizes the distribution of crashes by crash severity. Two of the fatal crashes were single vehicle collisions where the vehicle ran off the road. The third fatal crash involved a head on collision where one of the vehicles crossed the centerline in a curve.

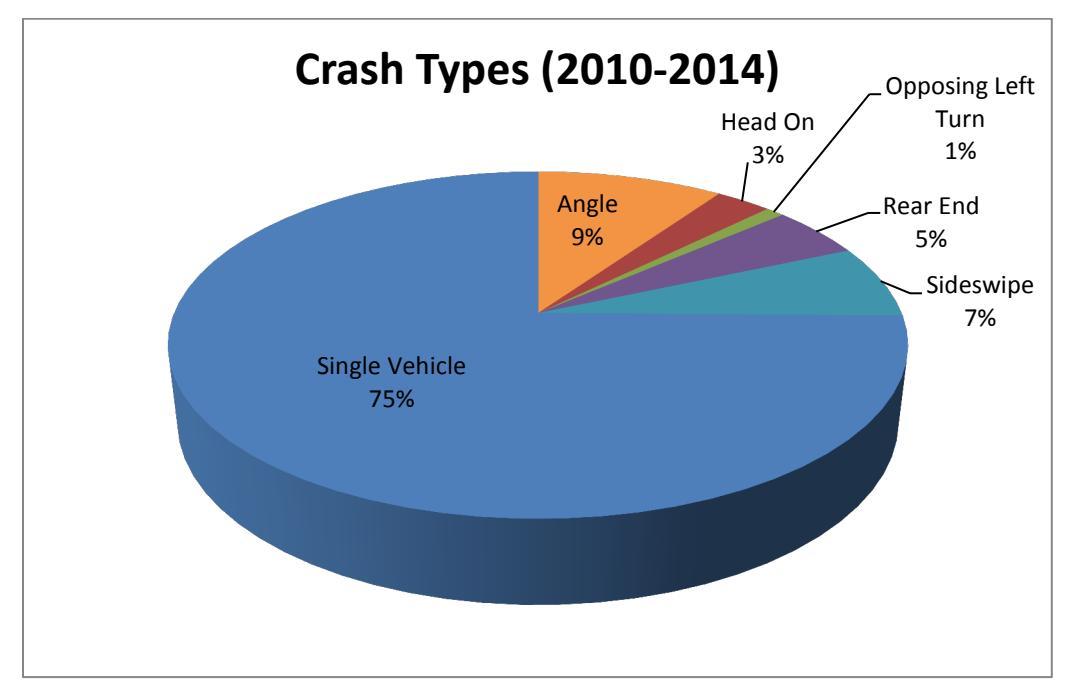
Figure 11: Distribution of Crashes by Type

To help better understand the crash records along this corridor, the crash type was examined. Single vehicle crashes were the most commonly reported crash type (77 crashes, 75 percent). Of the 77 single vehicle crashes, 21 were collisions with an animal. The remaining 56 single vehicle crashes were usually the result of a vehicle running off the road. **Figure 11** and **Figure 12** demonstrate the distribution of crashes by crash type.

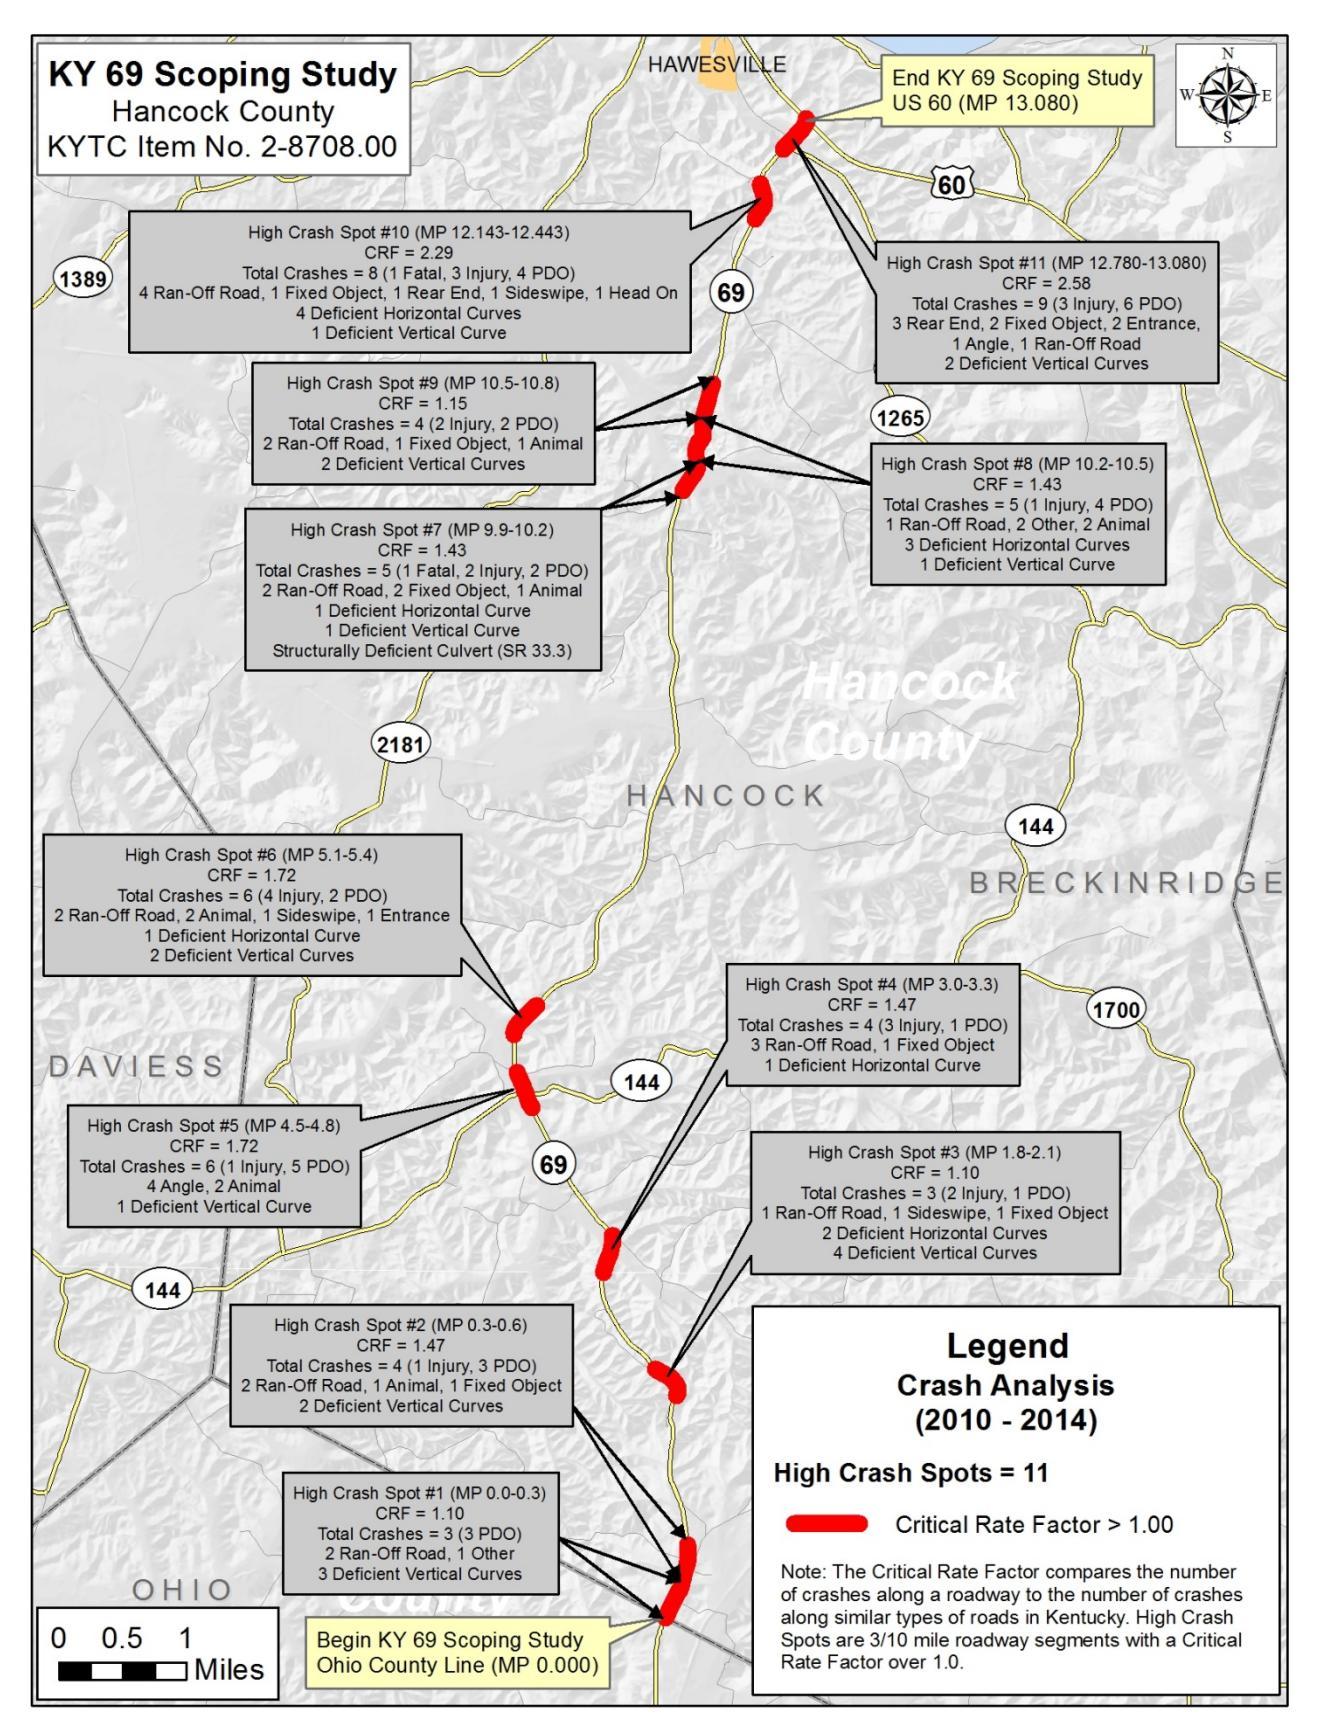
Figure 13: Critical Crash Rate Factors

Analysis of segments along KY 69 did not yield any locations with a CRF over the 1.00 threshold. CRF values ranged from 0.62 to 0.68 for roadway segments. Along the study corridor, eleven 3/10 mile spots were found to have a CRF greater than 1.00, as shown in detail in **Figure 13**.
