FINAL REPORT

KY 69 Scoping Study Hancock County KYTC Item No. 2-8708.00

March 2016

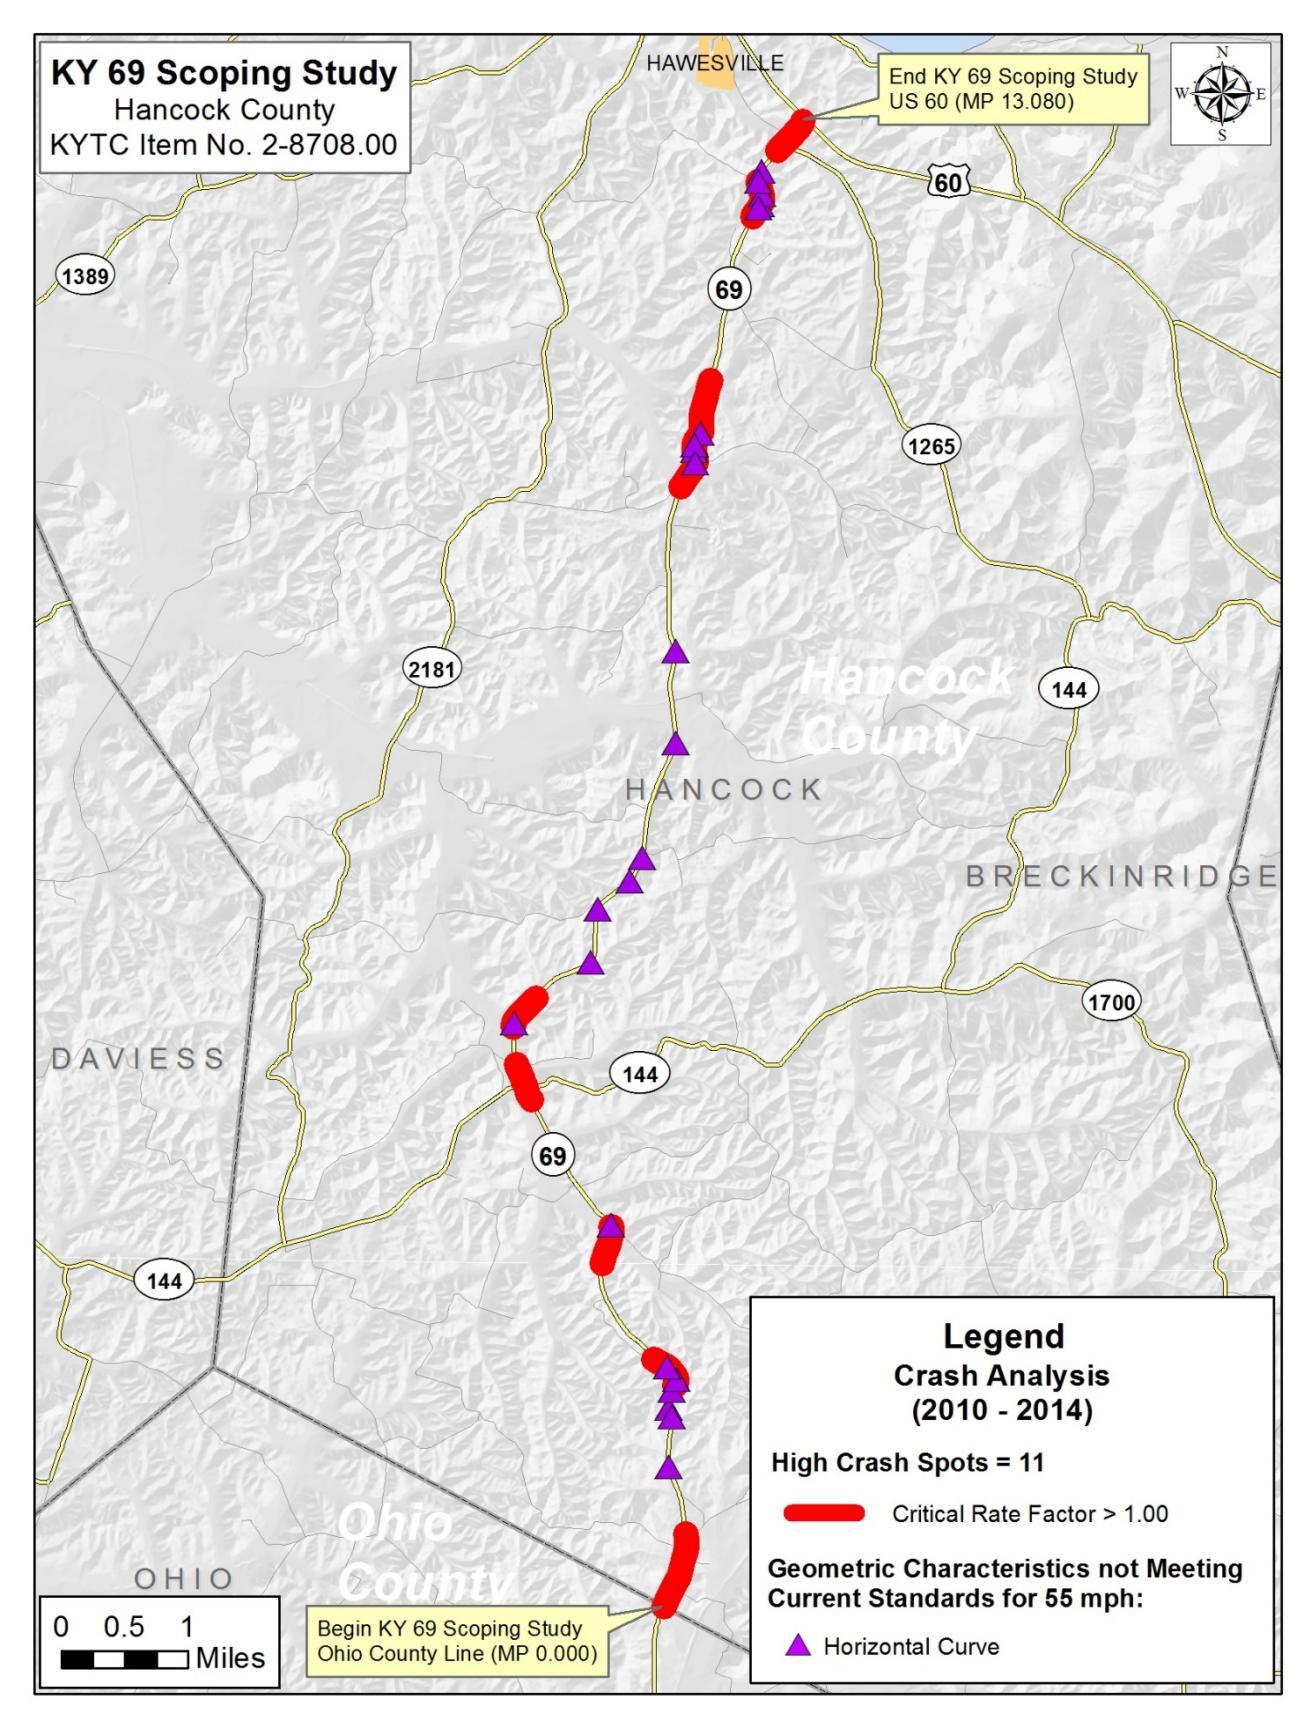
Figure 14: Horizontal Alignment versus High Crash Spots

A contributing factor to the high crash spot locations is likely the narrow roadway width and deficient roadway alignment. Six of eleven high crash spots have horizontal curves that do not meet current design guidelines for 55 MPH and ten of eleven high crash spots have vertical curves that do not satisfy a 55 mph design speed, as shown in **Figure 14** and **Figure 15**, respectively.

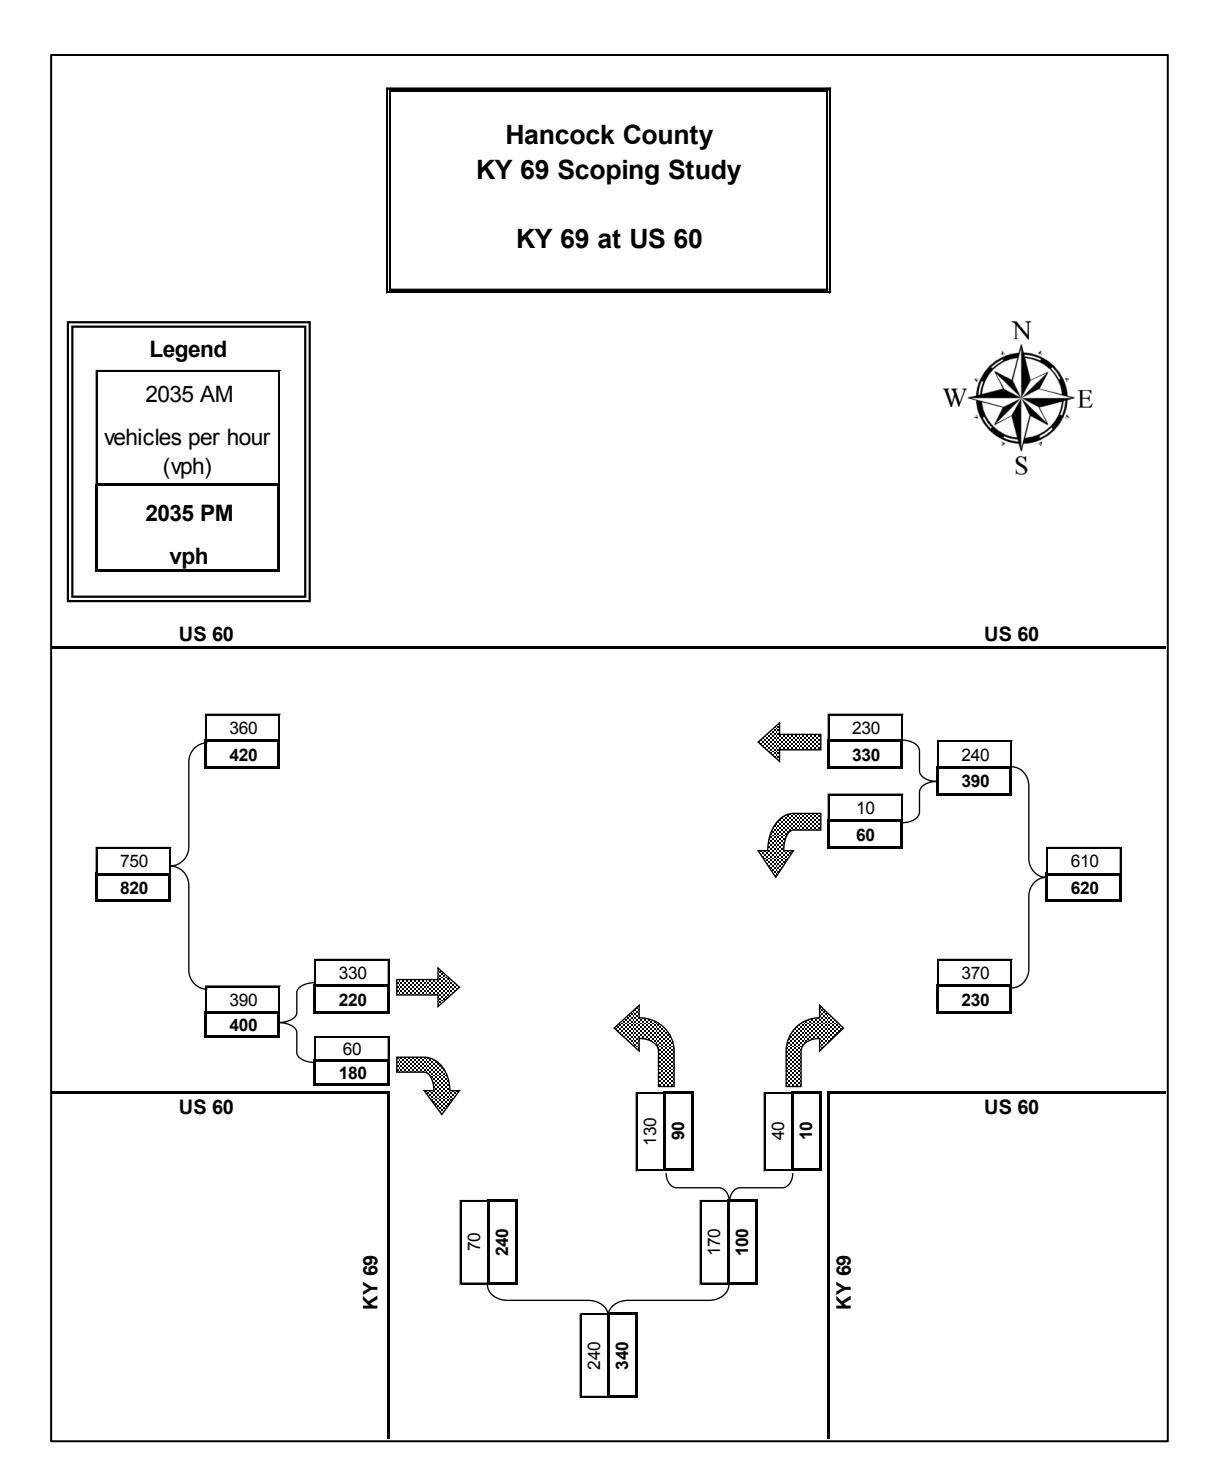
Figure 20: 2035 Peak Hour Turn Movement Forecast at KY 69/US 60 Intersection

Intersection	LOS	Approach	Delay (sec/veh)	LOS
	в (С)	Westbound US 60 Turning Left	8 (8)	A (A)
KY 69 at US 60		Northbound KY 69 Turning Left	15 (17)	C (C)
		Northbound KY 69 Turning Right	9 (9)	A (A)

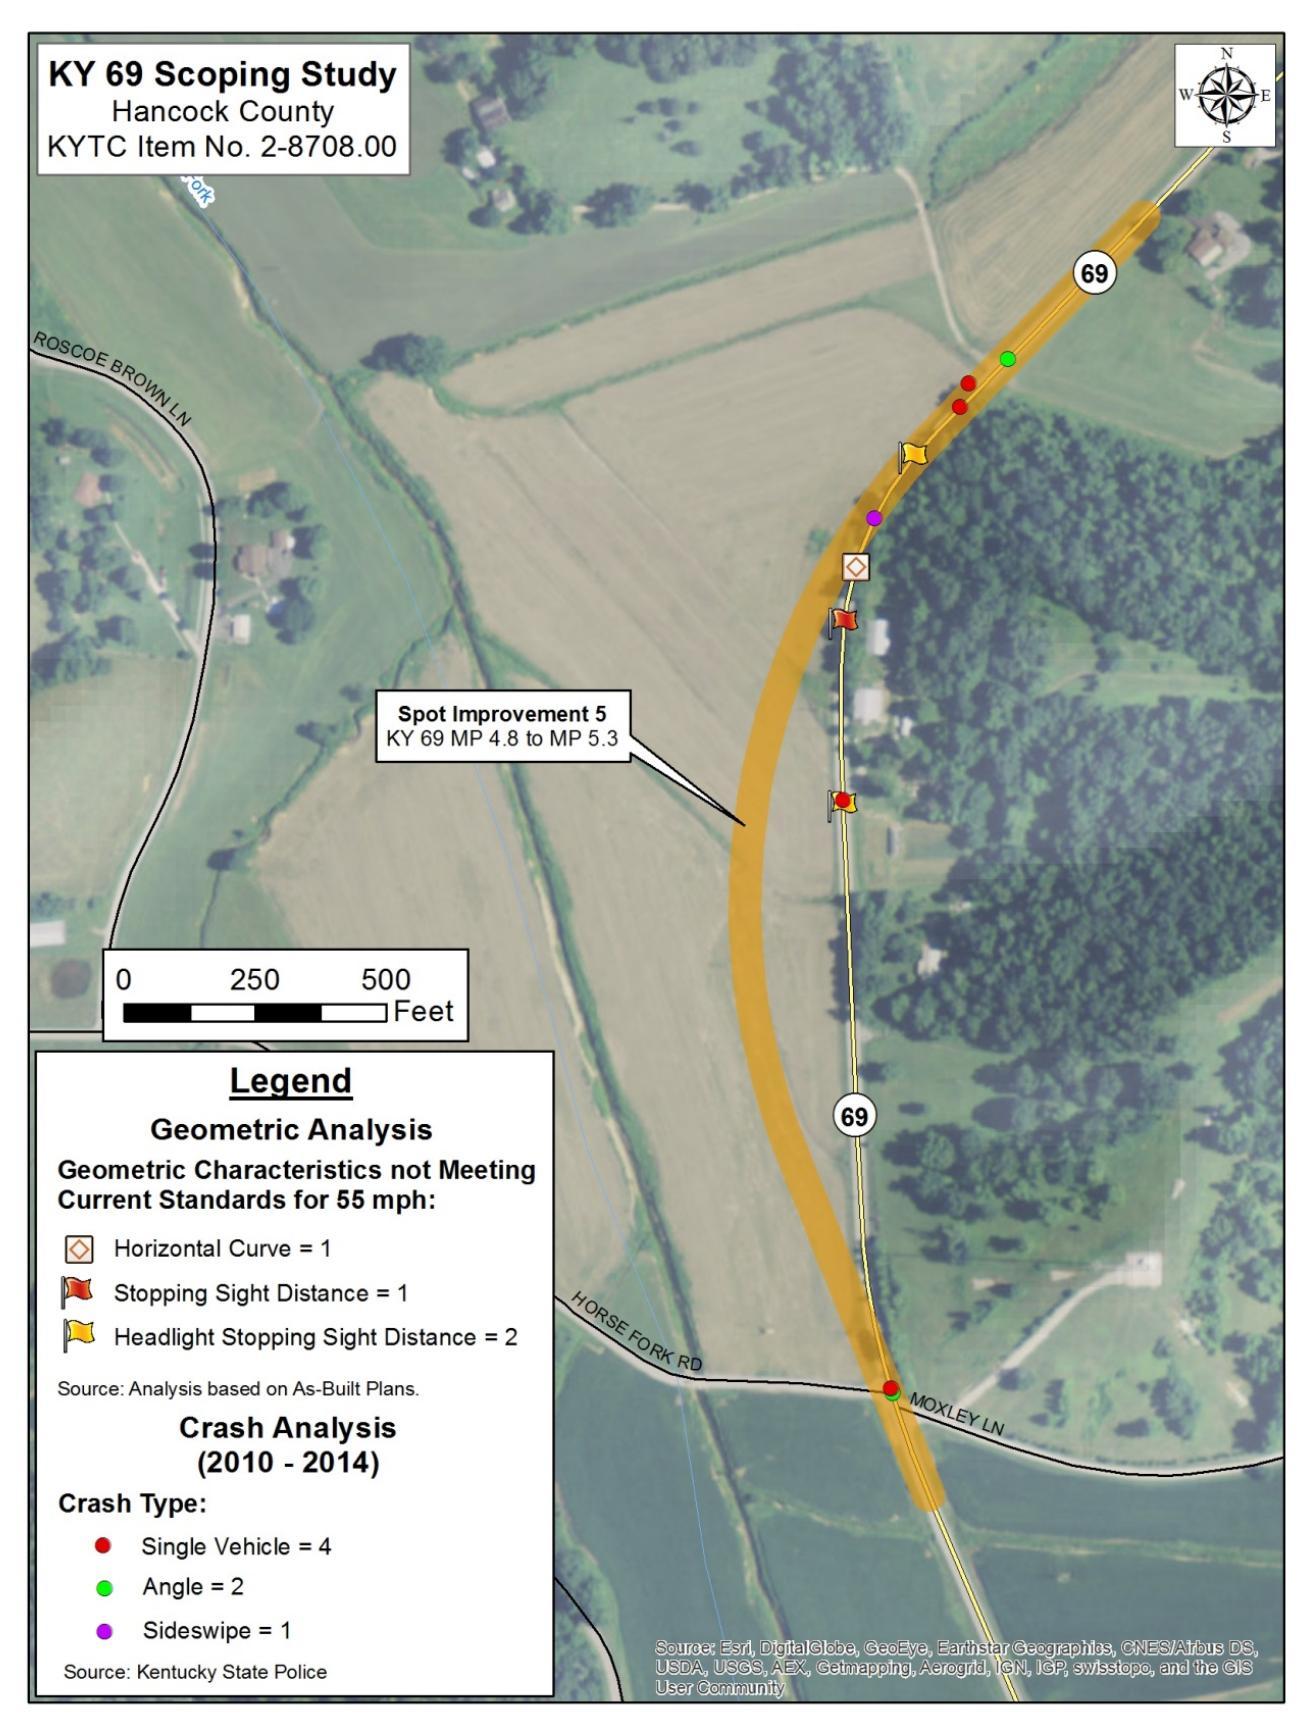
Figure 29: Spot Improvement 5 – Moxley Lane

- **Spot Improvement 5 Moxley Lane**: This concept improves the existing roadway geometry to 55 mph along 0.5 miles of KY 69 near Moxley Lane. This portion of KY 69 has a CRF of 2.00, one deficient horizontal curve, and three deficient vertical curves. The proposed alignment goes west to avoid the two homes along the existing road. The proposed conceptual improvements are shown in more detail in **Figure 29**.

- **Spot Improvement 5 Moxley Lane**: This concept improves the existing roadway geometry to 55 mph along 0.5 miles of KY 69 near Moxley Lane. This portion of KY 69 has a CRF of 2.00, one deficient horizontal curve, and three deficient vertical curves. The proposed alignment goes west to avoid the two homes along the existing road.

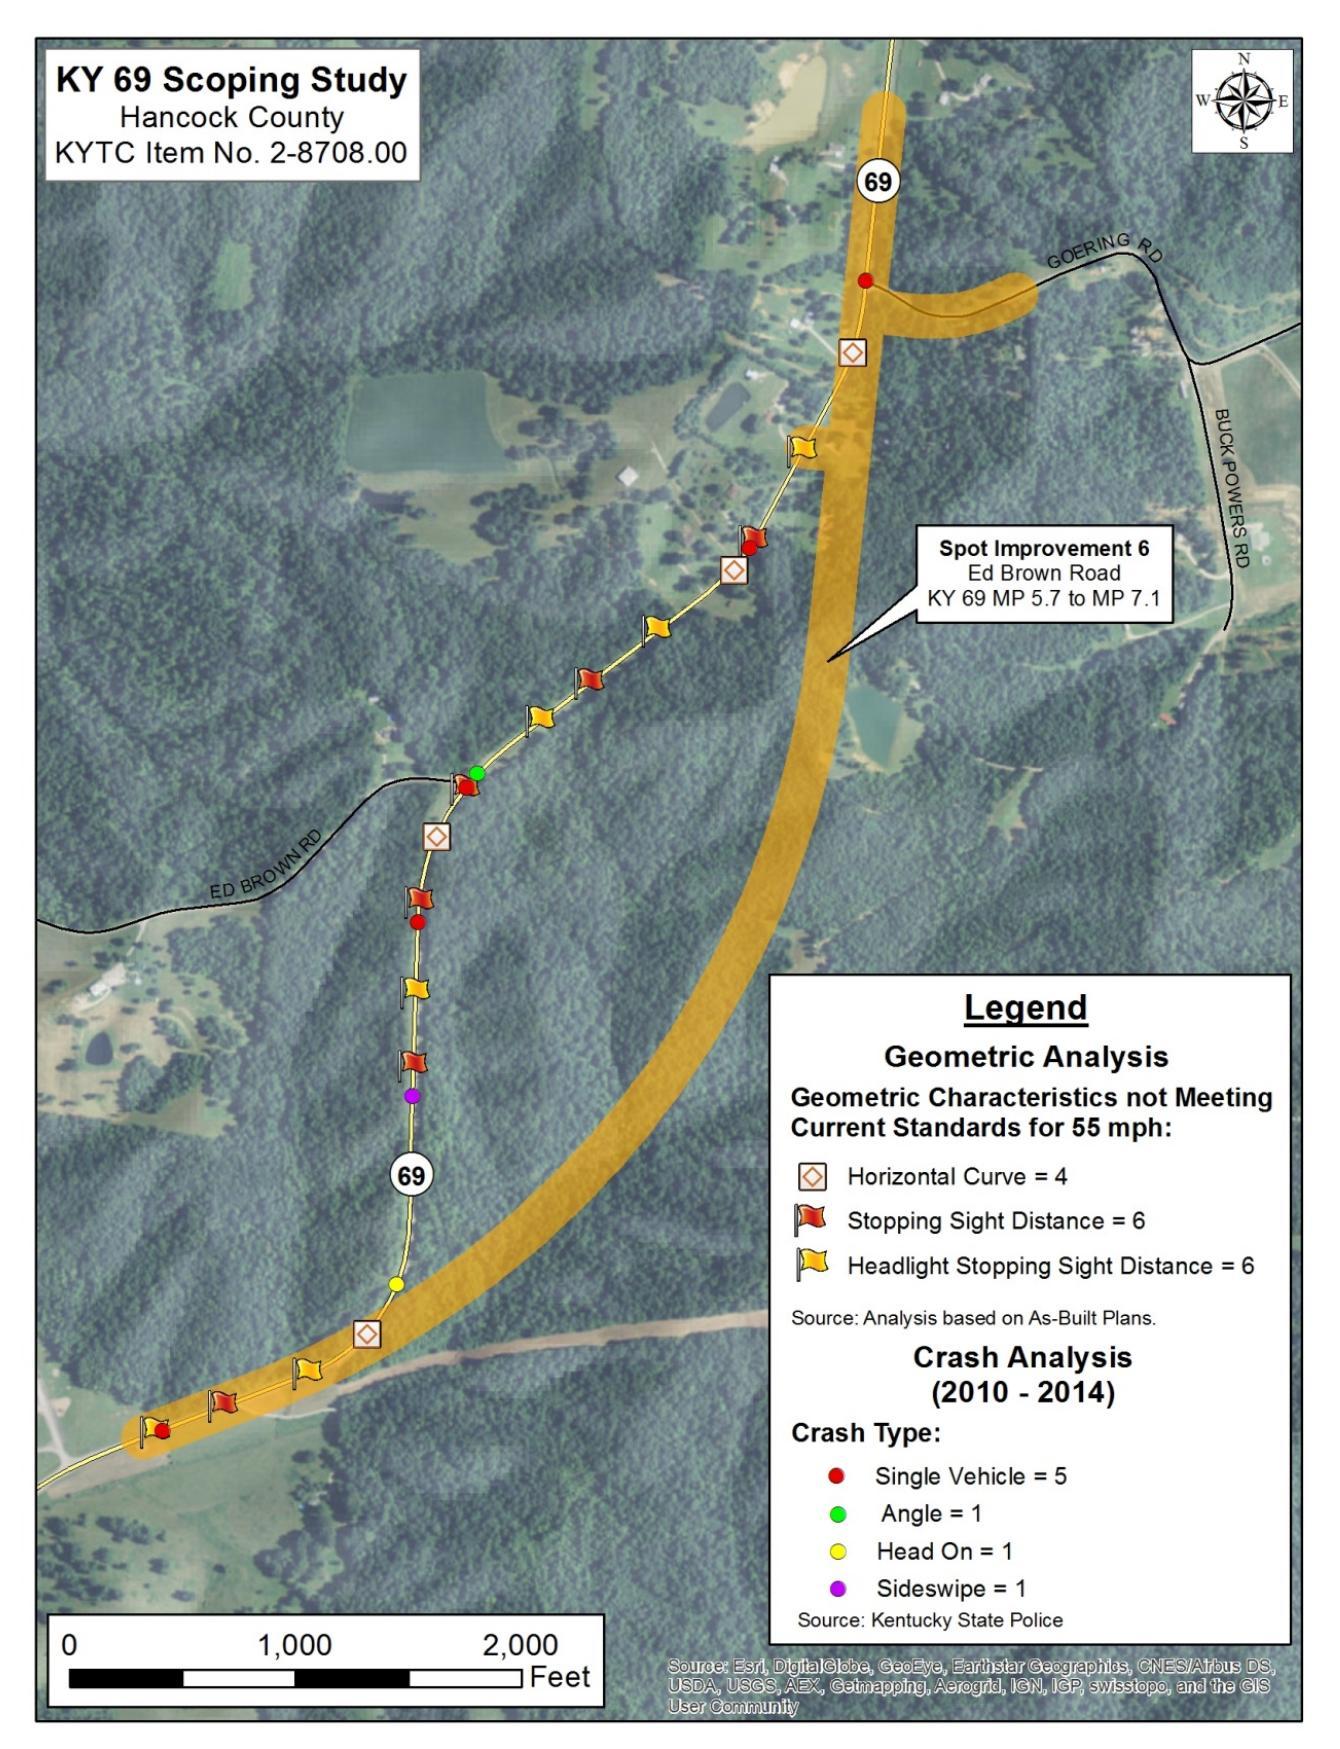
Figure 30: Spot Improvement 6 – Ed Brown Road

- Spot Improvement 6 Ed Brown Road: This concept improves the existing roadway geometry to 55 mph along 1.4 miles of KY 69 near Ed Brown Road. There are steep grades at this location. As a result the proposed improvement also adds northbound and southbound passing/truck-climbing lanes for vehicles that get stuck behind slow moving trucks. This portion of KY 69 has a CRF of 1.15, four deficient horizontal curves, and twelve deficient vertical curves. The proposed conceptual improvements are shown in more detail in Figure 30.

- Spot Improvement 6 Ed Brown Road: This concept improves the existing roadway geometry to 55 mph along 1.4 miles of KY 69 near Ed Brown Road. There are steep grades at this location. As a result the proposed improvement also adds northbound and southbound passing lanes/truck-climbing lanes for vehicles that get stuck behind slow moving trucks. This portion of KY 69 has a CRF of 1.15, four deficient horizontal curves, and twelve deficient vertical curves.

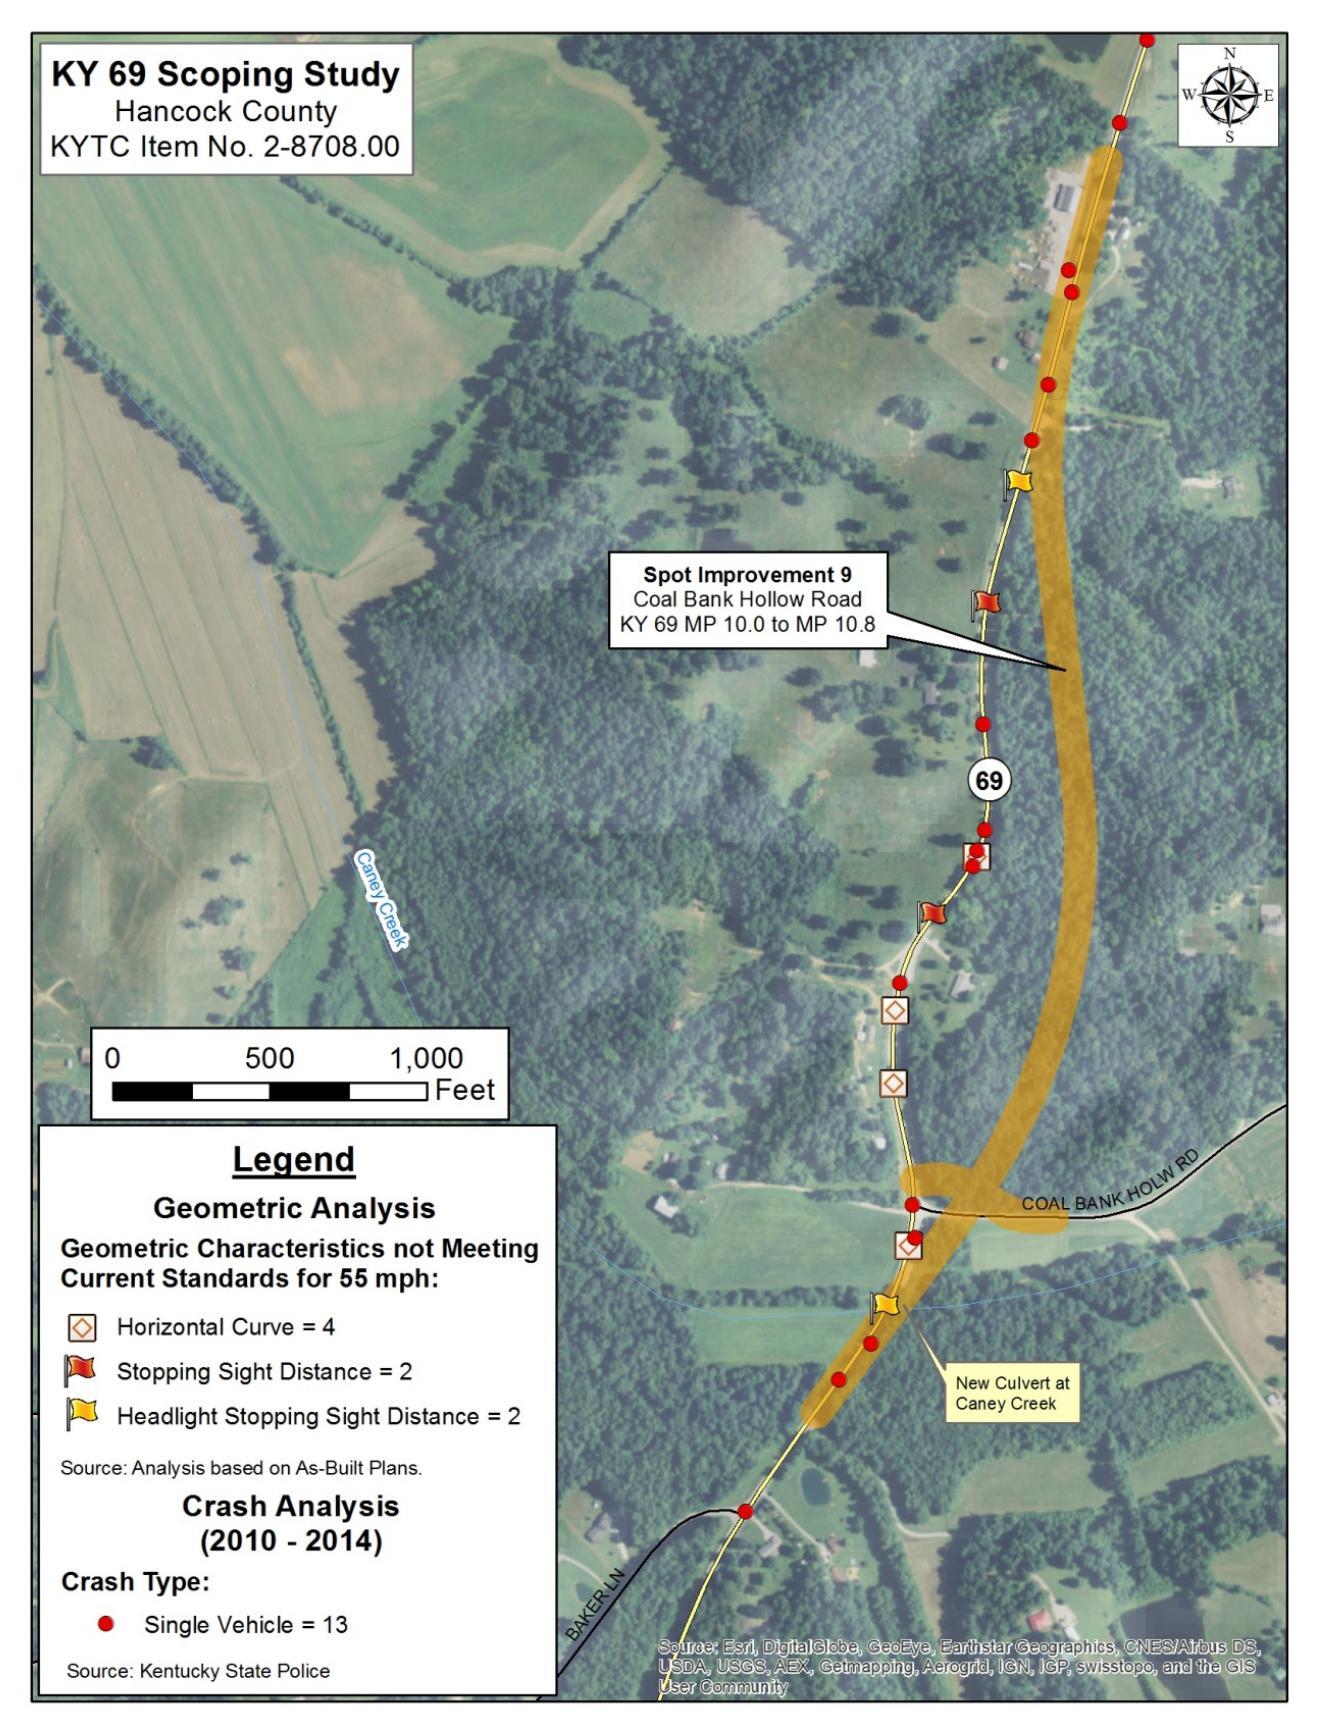
Figure 33: Spot Improvement 9 – Coal Bank Hollow Road

- Spot Improvement 9 Coal Bank Hollow Road: This concept improves the existing
 roadway geometry to 55 mph along 0.8 miles of KY 69 near Coal Bank Hollow Road. The
 proposed improvement also replaces the 1932 structurally deficient culvert for Caney
 Creek (SR 33.8). This portion of KY 69 has a CRF of 1.43, four deficient horizontal curves,
 and four deficient vertical curves. This location is on KYTC's Unscheduled Needs list as PIF
 02 046 D0069 78.43. The proposed conceptual improvements are shown in more detail in
 Figure 33.

- Spot Improvement 9 Coal Bank Hollow Road: This concept improves the existing roadway geometry to 55 mph along 0.8 miles of KY 69 near Coal Bank Hollow Road. The proposed improvement also replaces the 1932 structurally deficient culvert for Caney Creek (SR 33.8). This portion of KY 69 has a CRF of 1.43, four deficient horizontal curves, and four deficient vertical curves. This location is on KYTC's Unscheduled Needs list as PIF 02 046 D0069 78.43.

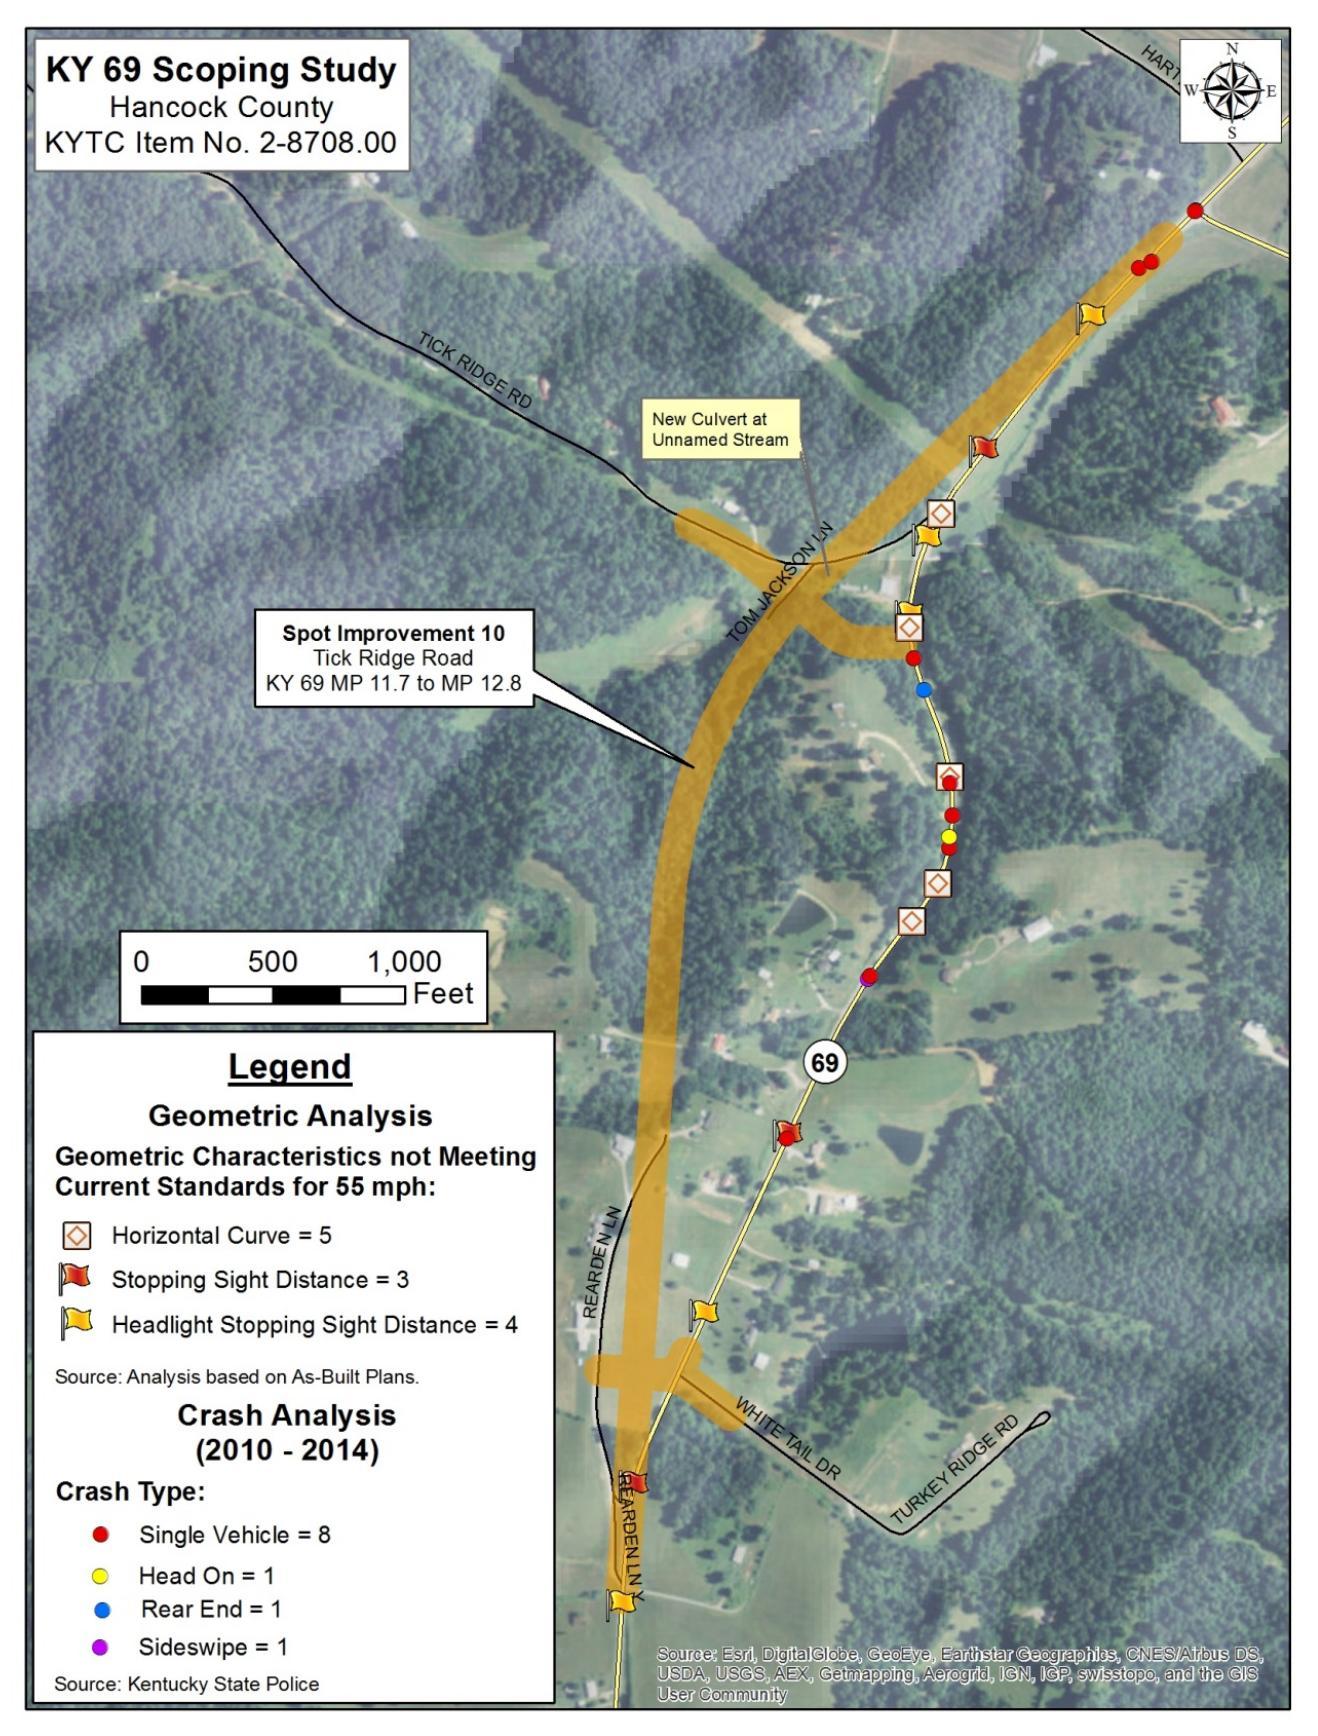
Figure 34: Spot Improvement 10 – Tick Ridge Road
6.3.2 Complete Reconstruction Alternative

- Spot Improvement 10 Tick Ridge Road: This concept improves the existing roadway geometry to 55 mph along 1.1 miles of KY 69 near Tick Ridge Road. The proposed improvement also corrects the skew at the Tick Ridge Road intersection and ties back to the 1994 improved portion of KY 69 near Happy Hollow Road (KY 1265). This portion of KY 69 has a CRF of 2.29, five deficient horizontal curves, and seven deficient vertical curves. This location is on KYTC's Unscheduled Needs list as PIF 02 046 D0069 78.44. The proposed conceptual improvements are shown in more detail in Figure 34.

- High Priority (in order)
 - Spot Improvement 10 Tick Ridge Road: This concept improves the existing roadway geometry to 55 mph along 1.1 miles of KY 69 near Tick Ridge Road. The proposed improvement also corrects the skew at the Tick Ridge Road intersection and ties back to the improved portion of KY 69 near Happy Hollow Road (KY 1265). This portion of KY 69 has a critical rate factor (CRF)² of 2.29, five deficient horizontal curves, and seven deficient vertical curves. This location is on KYTC's Unscheduled Needs list as PIF 02 046 D0069 78.44.

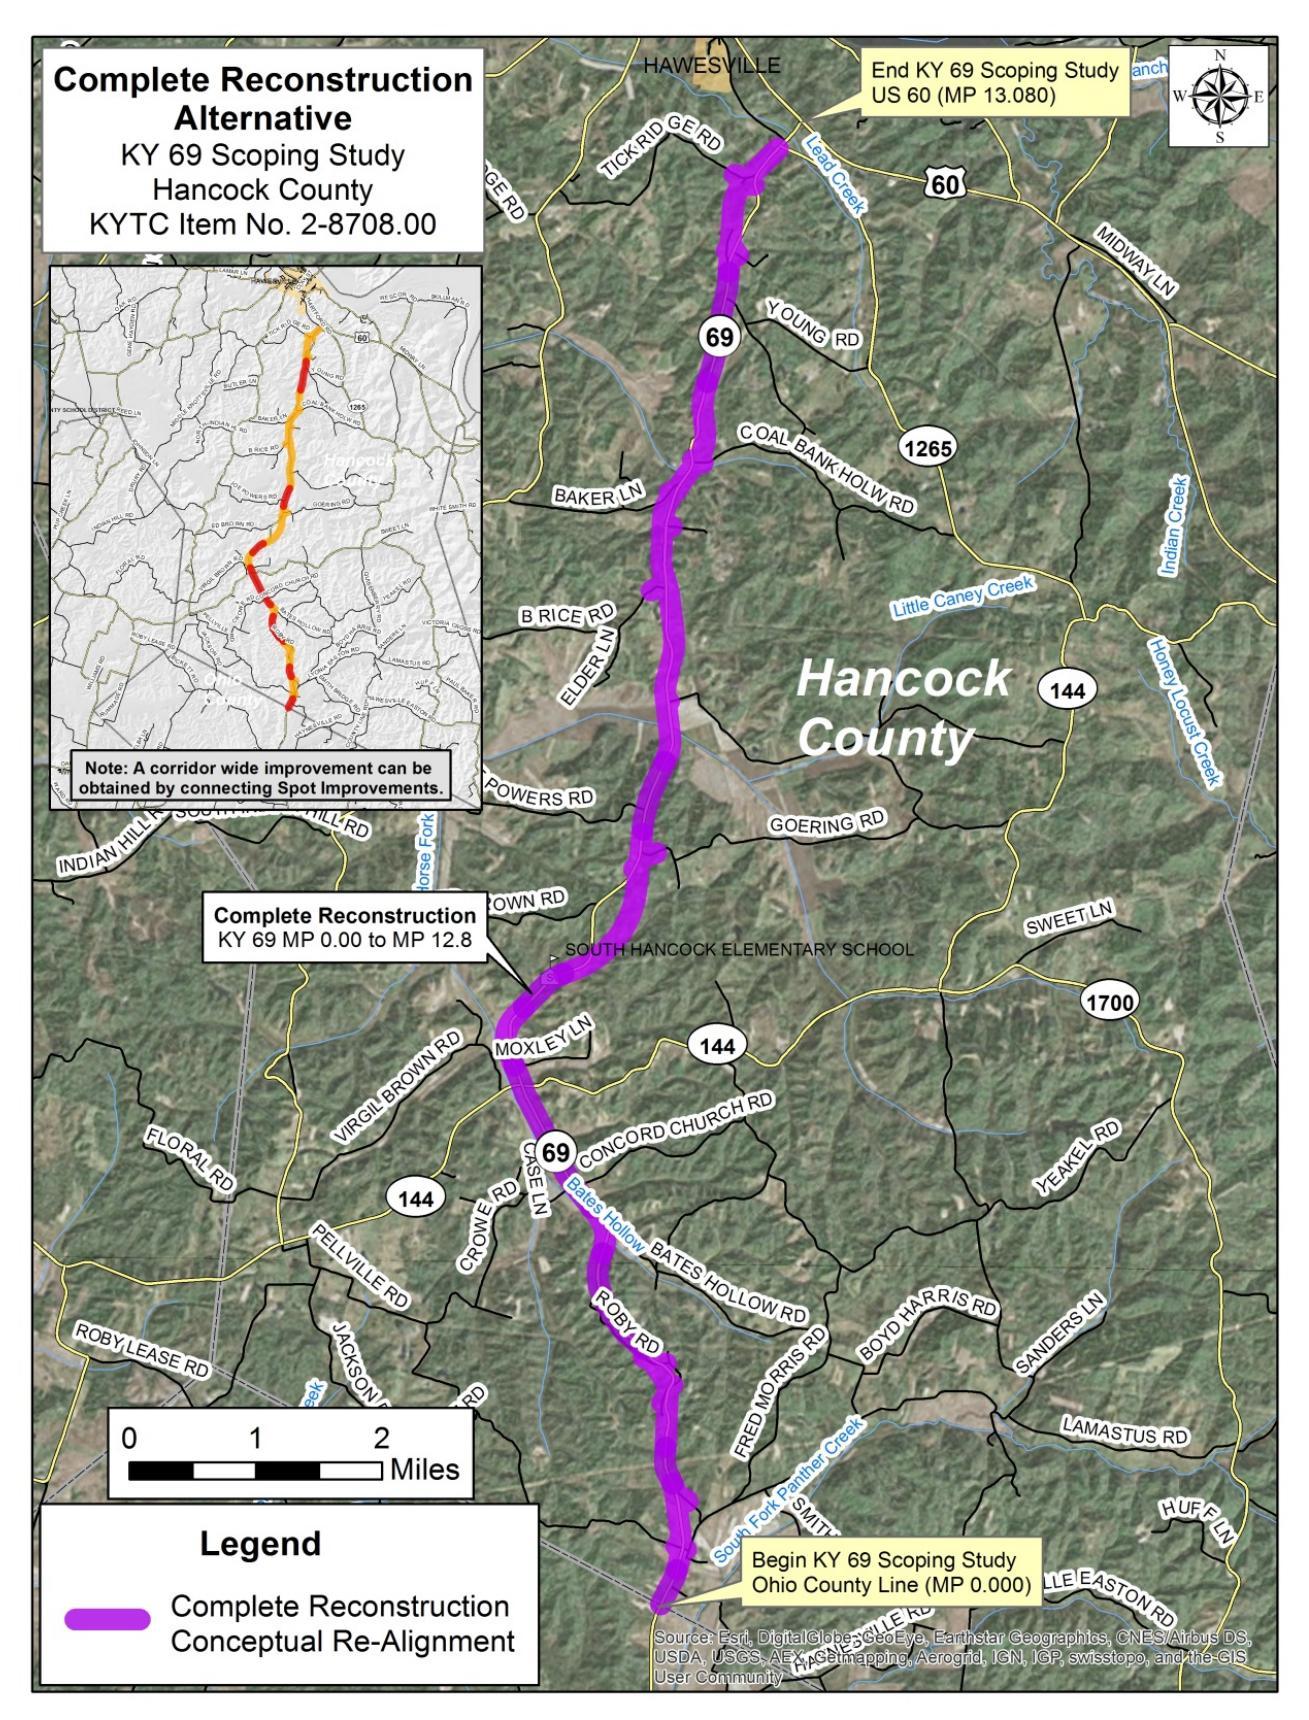
Figure 35: Complete Reconstruction Alternative

In addition to Spot Improvements, the project team was also tasked with developing a Complete Reconstruction Alternative than could be implemented if funding becomes available. The Complete Reconstruction Alternative widens KY 69 and improves the existing roadway alignment to a 55 mph design speed from the Ohio County Line to the improved portion of KY 69 near Happy Hollow Road (KY 1265). It would also replace or widen the existing structures. The conceptual layout is presented in **Figure 35**.

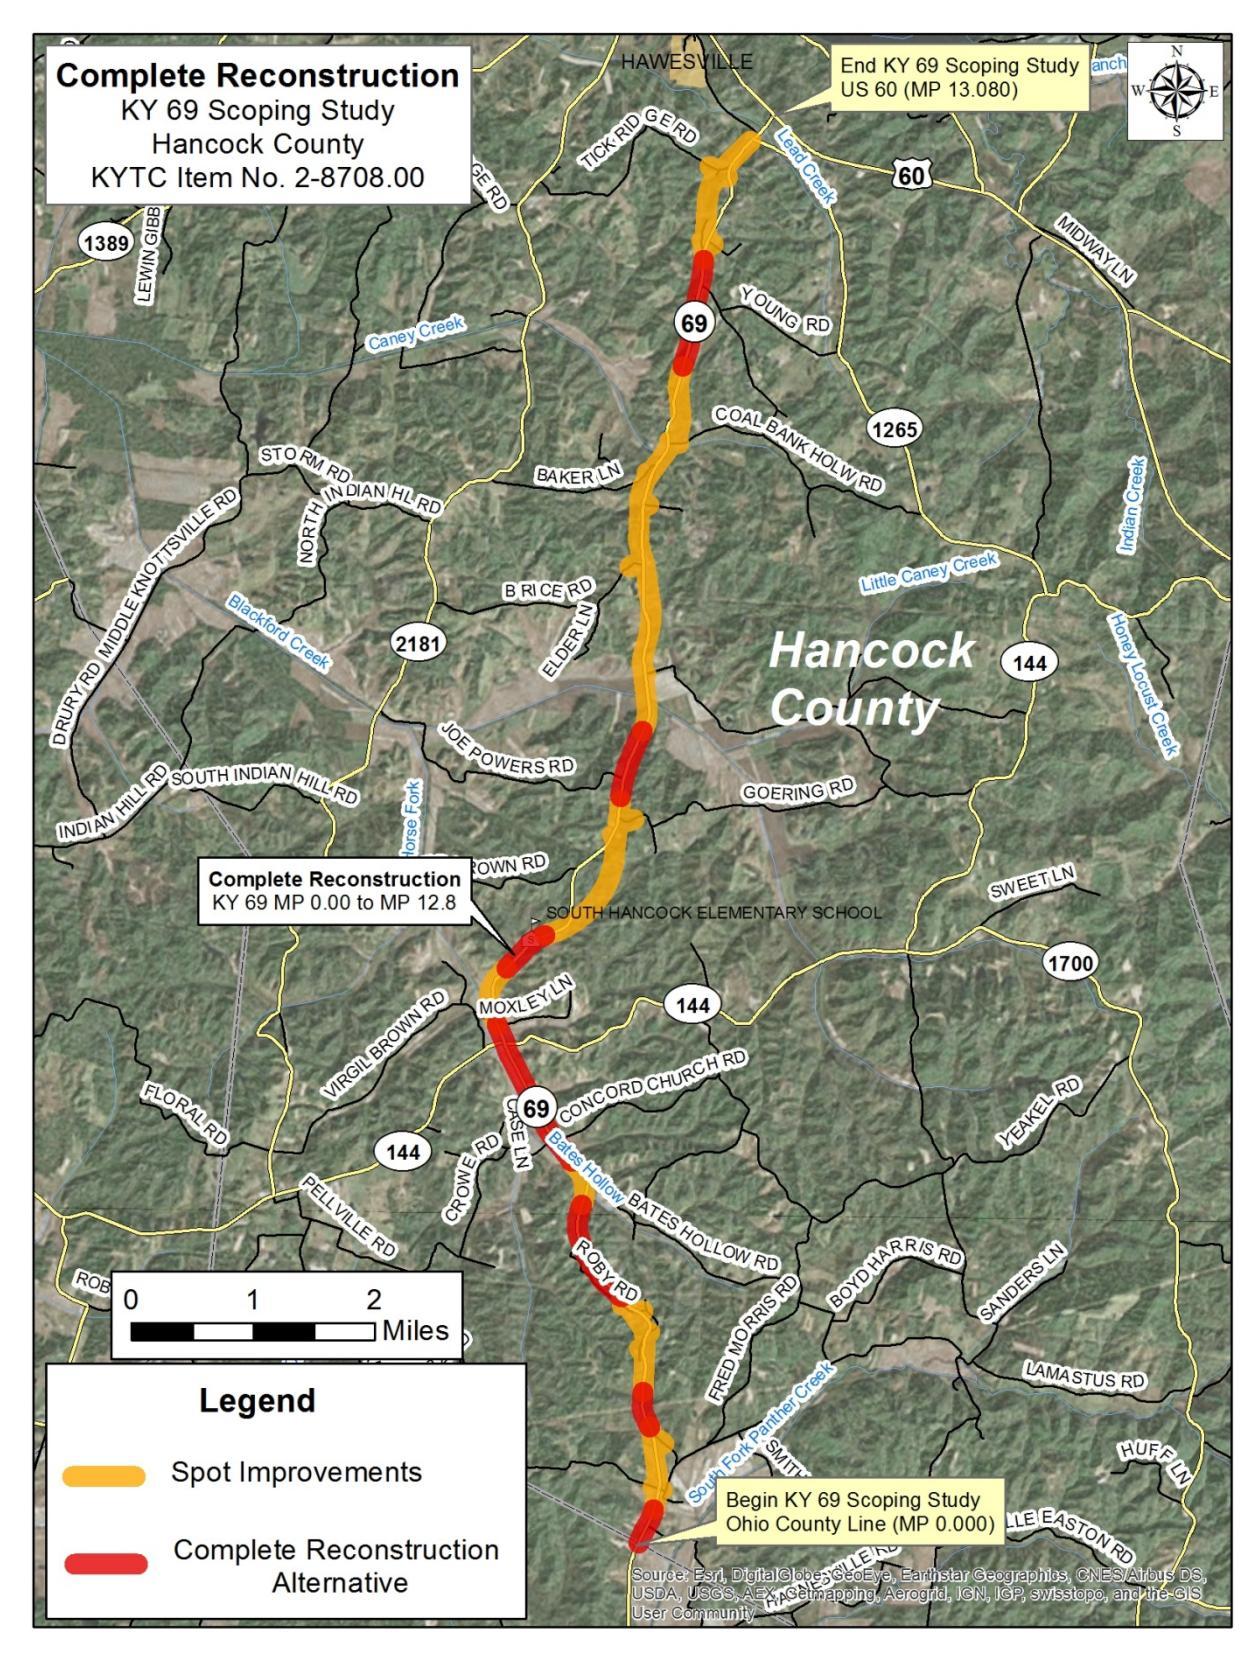
Figure 36: Connecting Spot Improvements to achieve Complete Reconstruction

This corridor-wide improvement can be obtained over time by connecting Spot Improvements 1 through 10, as shown in **Figure 36**. The Complete Reconstruction Alternative uses the proposed alignment from the spot improvements so resources would not be wasted if any or all of the spot improvements were built first. The Spot Improvements correct 8.1 miles of the study area, leaving 4.7 miles of additional reconstruction to achieve a corridor-wide improvement.

A corridor-wide improvement can be obtained over time by connecting all the spot improvements. The spot improvements correct 8.1 miles of the route, leaving 4.7 miles of additional reconstruction to achieve a corridor-wide improvement. Studies have demonstrated that greater pavement widths encourage higher driving speeds, which is a concern for the spot improvement projects where improved sections could be located within a larger unimproved portion of the route. As a result, the project team recommended spot improvements include 11foot lanes and six-foot shoulders (two-foot paved, four-foot graded) – a typical section that meets design guidelines, improves safety, and is more compatible with adjacent sections that may not be improved at the same time. This will provide a greater level of consistency between
