March 22, 2024

Re: Report of Geotechnical Engineering Subsurface Characterization
Evaluation of Mine Spoil Site for Residential Development
Grand View Neighborhood aka Johnson Property
Jenkins (Letcher County), Kentucky
Vector Project Number 24050001SHE

MASW Survey
Vector Engineers, Inc.
Proposed Grand View Neighborhood
Jenkins, KY

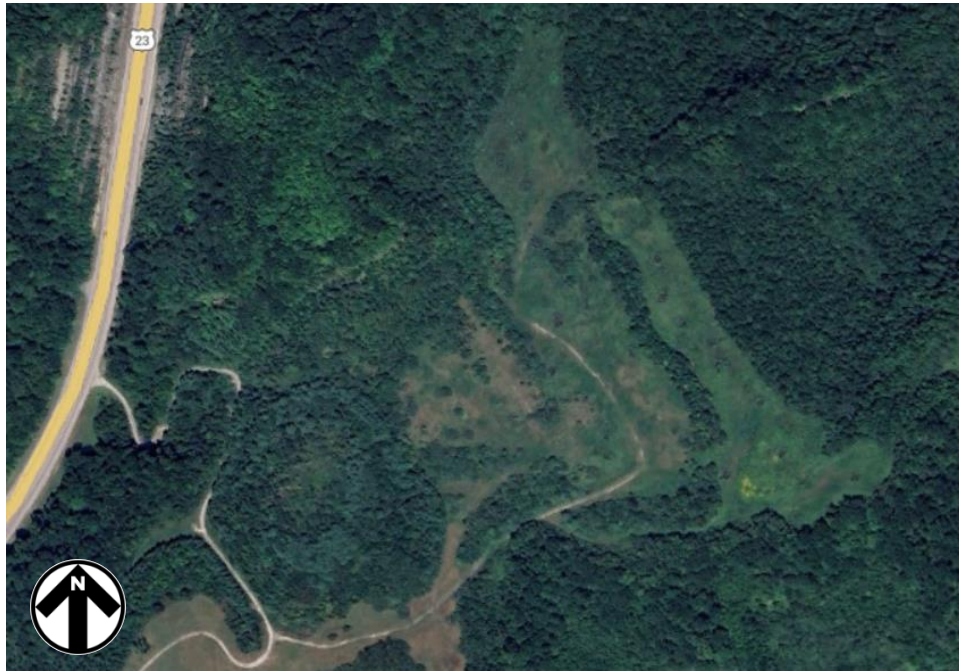
Figure 2: Aerial View of the site (Google Maps)

The site is located off Highway 23, in Jenkins, KY (Letcher County). The site is an old strip mine site with several tens of feet of mine spoil placed over top of a bedrock bench. The bench was created during past strip-mining activity.

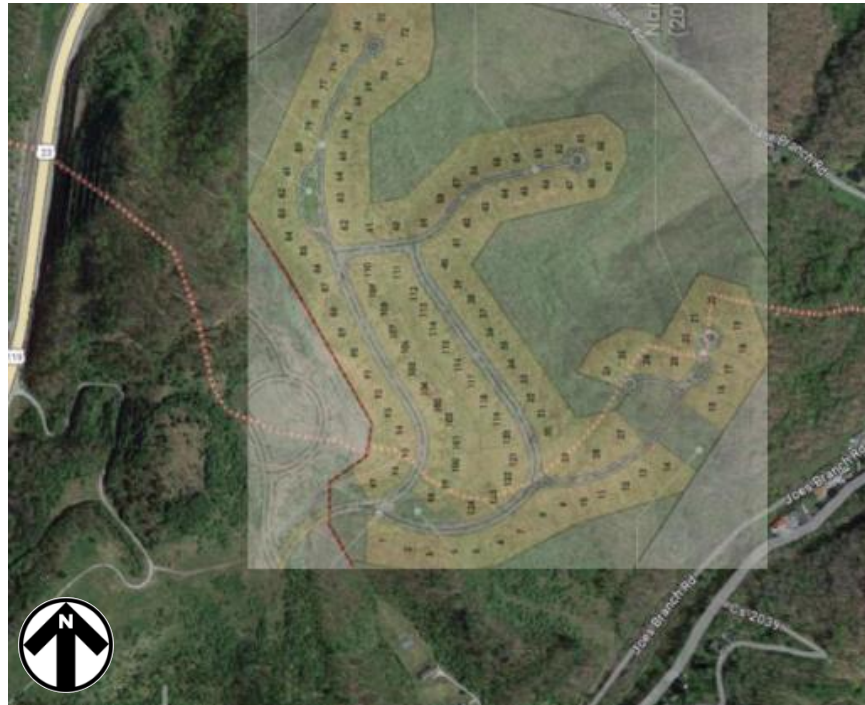
An overlay of the conceptual plan to the aerial photograph gives a general indication of the site boundary.

Figure 4: Overlay of the conceptual plan on the aerial photograph of the site.

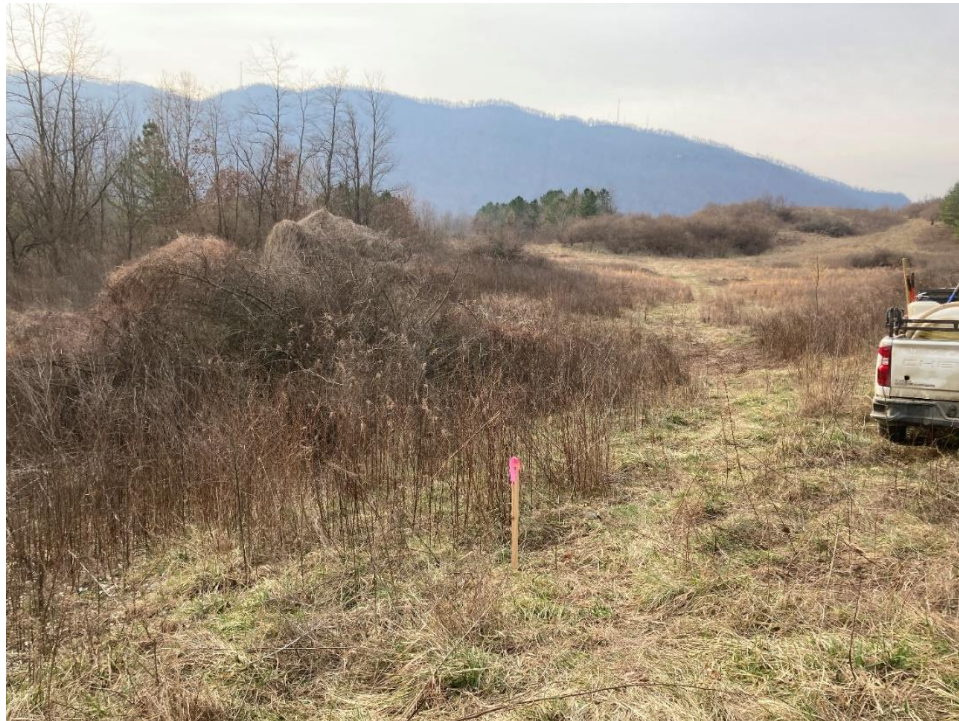
Photograph No. 1: View looking south with a stake at Boring B-6.

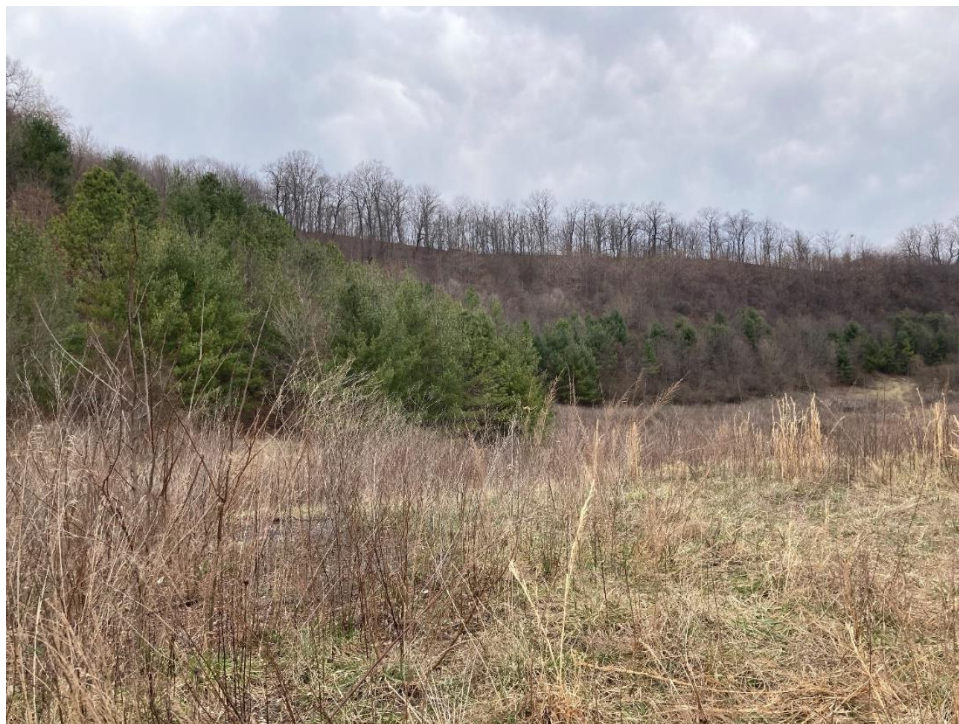
Photograph No. 2: View looking north where the site slopes up, likely indicating a mining bench. The clearing on the far right of the photo is the general location of Boring B-6.

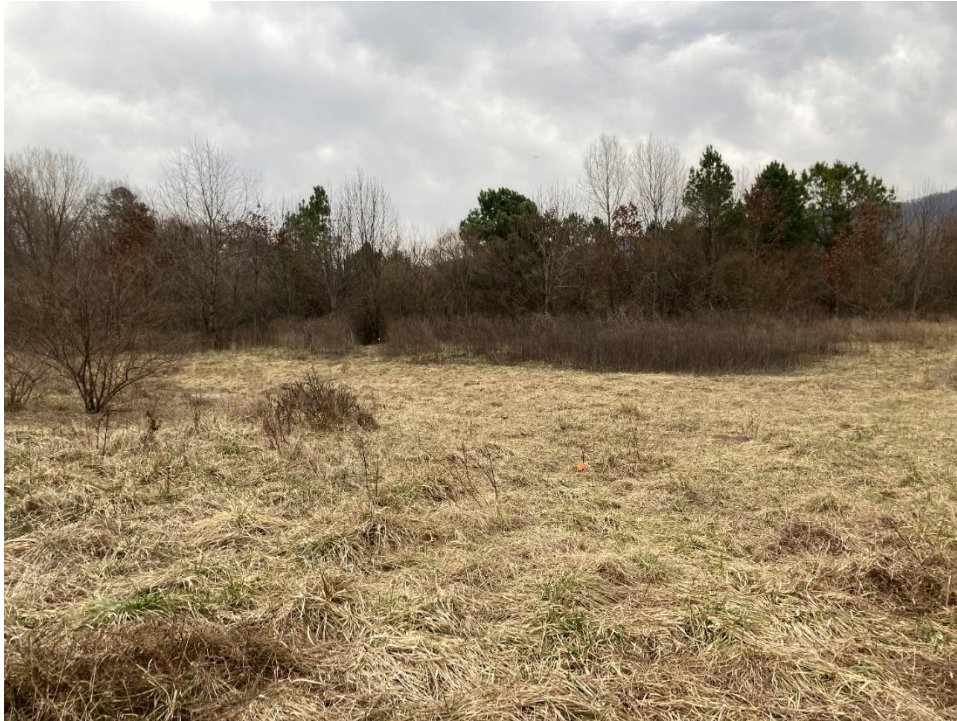
Photograph No. 3: View looking east on top of western bench with a small clearing at the crest of the bench. Pink flags indicate the location of geophysics line 2.

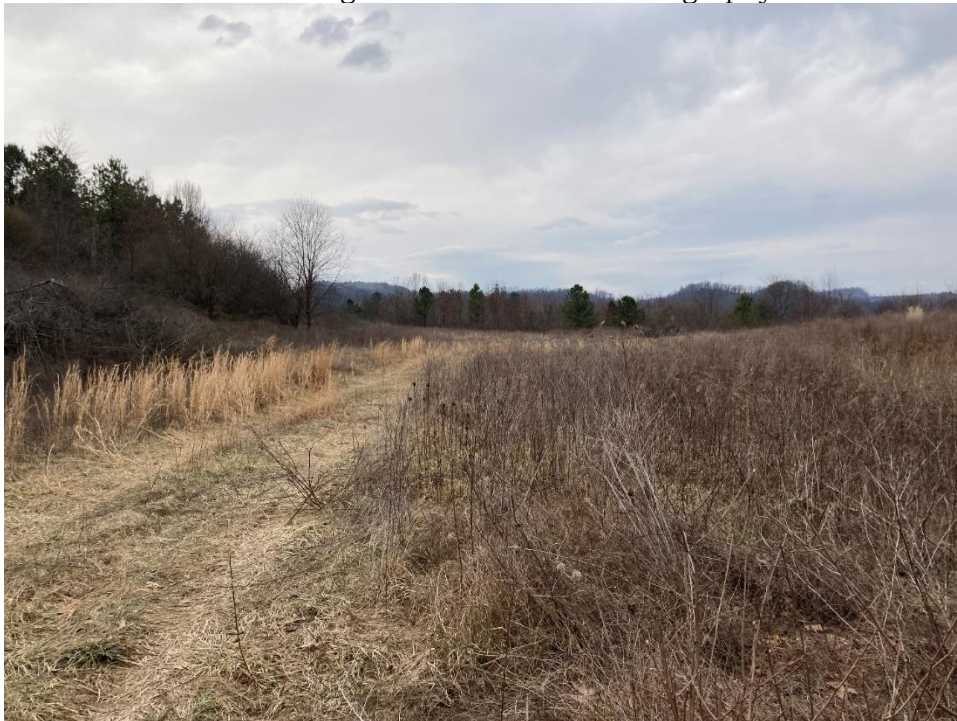
Photograph No. 4: View looking north on the lower eastern bench. To the west is the rise of the western bench.

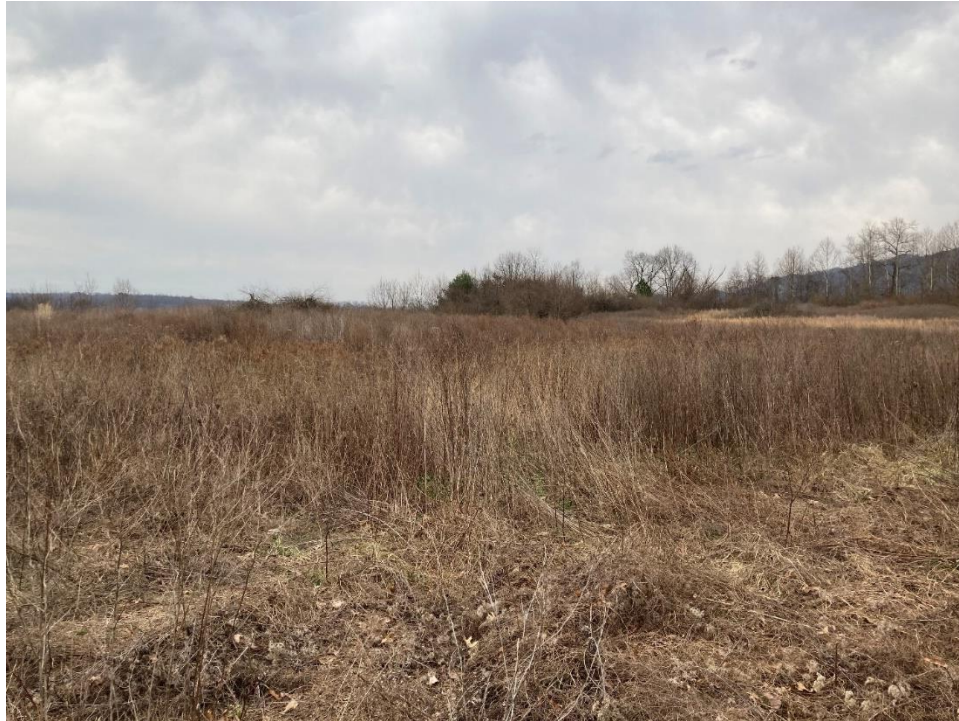
Photograph No. 5: View looking east on the eastern bench. Boring B-2 is located in the lighter colored grass on the right of the photo.

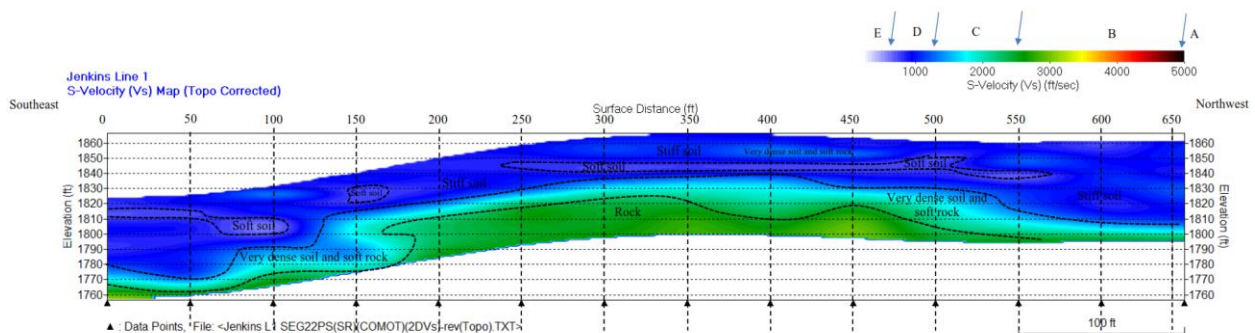
Figure 11: Results of MASW Survey along line 1.
 The green area is representative of suspected bedrock.

Comparing the results of the MASW testing and the soil boring refusal depths, the data generally agrees with the available mine mapping for the site, although the “bedrock” indicated in Line 2 is apparently a dense boulder fill within a natural valley with bedrock closer to 100 to 150 feet deep.
