MAINTENANCE CONDITION OF KENTUCKY HIGHWAYS

Statewide Maintenance Rating Program - FY 2011

**Division of Maintenance
Operations and Pavement Management Branch
March 2011**

2011 MAINTENANCE RATING PROGRAM REPORT

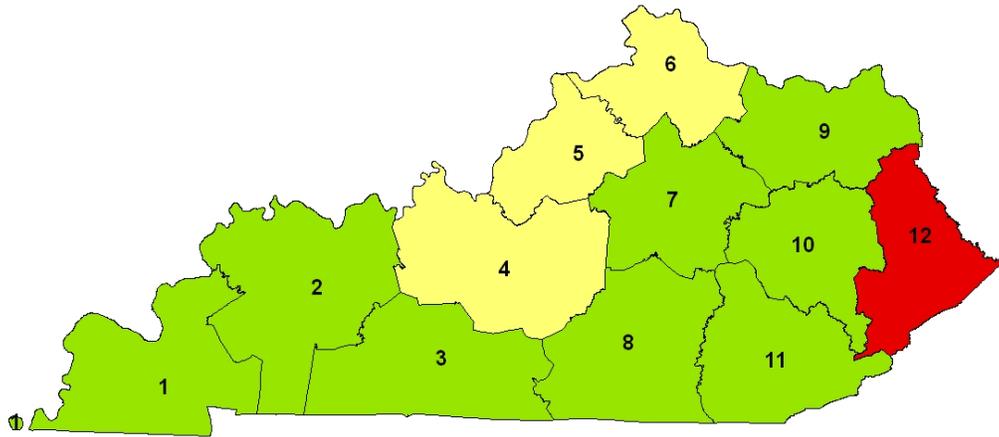
Figure 1: District Maintenance Levels of Service

The district levels of service determined from data collected during Fiscal Year 2011 are shown on Figure 1: District Maintenance Levels of Service. District eight was the highest overall performing district (86.4). District twelve received the lowest overall score of 68.8.

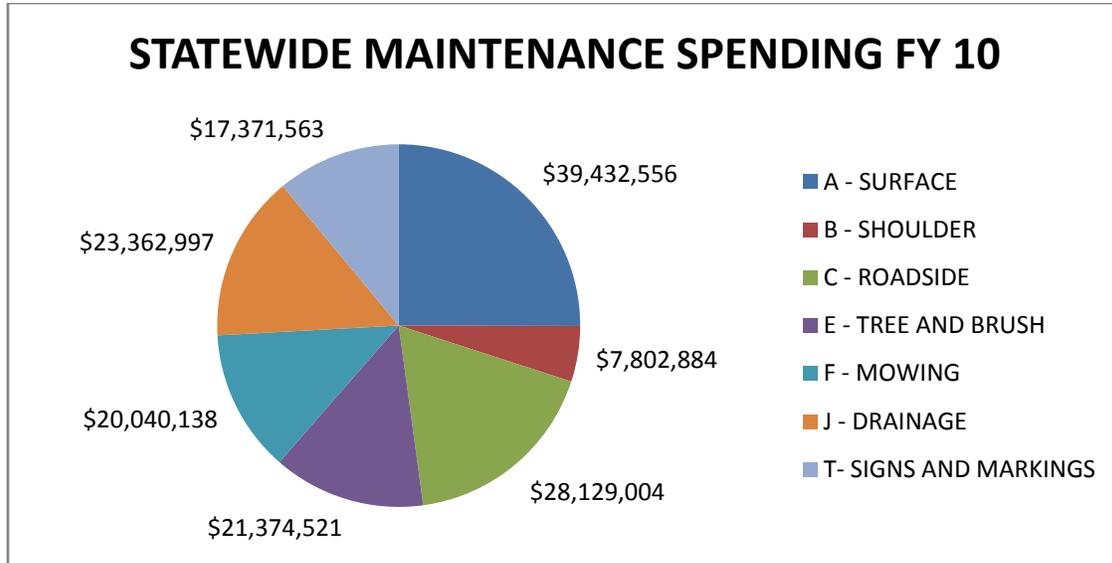
Figure 2: Maintenance Spending

The costs for routine maintenance, obtained through both EMARS and OMS, are shown in Figure 2: Maintenance Spending. Only activities that impact features inspected by the MRP were included in the summary. For a complete list of activities included refer to Appendix V.

Districts were allotted extra money for failing Maintenance Rating Program features with the FY '09 MRP Report scores. Districts were able to request reimbursement for up to \$100,000 per low scoring feature (in FY '10 budgets) in an effort to improve maintenance service provided. This money was tracked according to activity spending to ensure it was used to address issues noted in the report. Districts received a total allotment of \$3.06 million for FY '10 budgets. Table 2: Statewide Scores by Year compares the overall weighted scores from FY '09 (used to determine FY '10 allotments) to FY '11 scores (impacted by FY '10 budget). The level of service provided was similar across all roadway classification systems during this time.

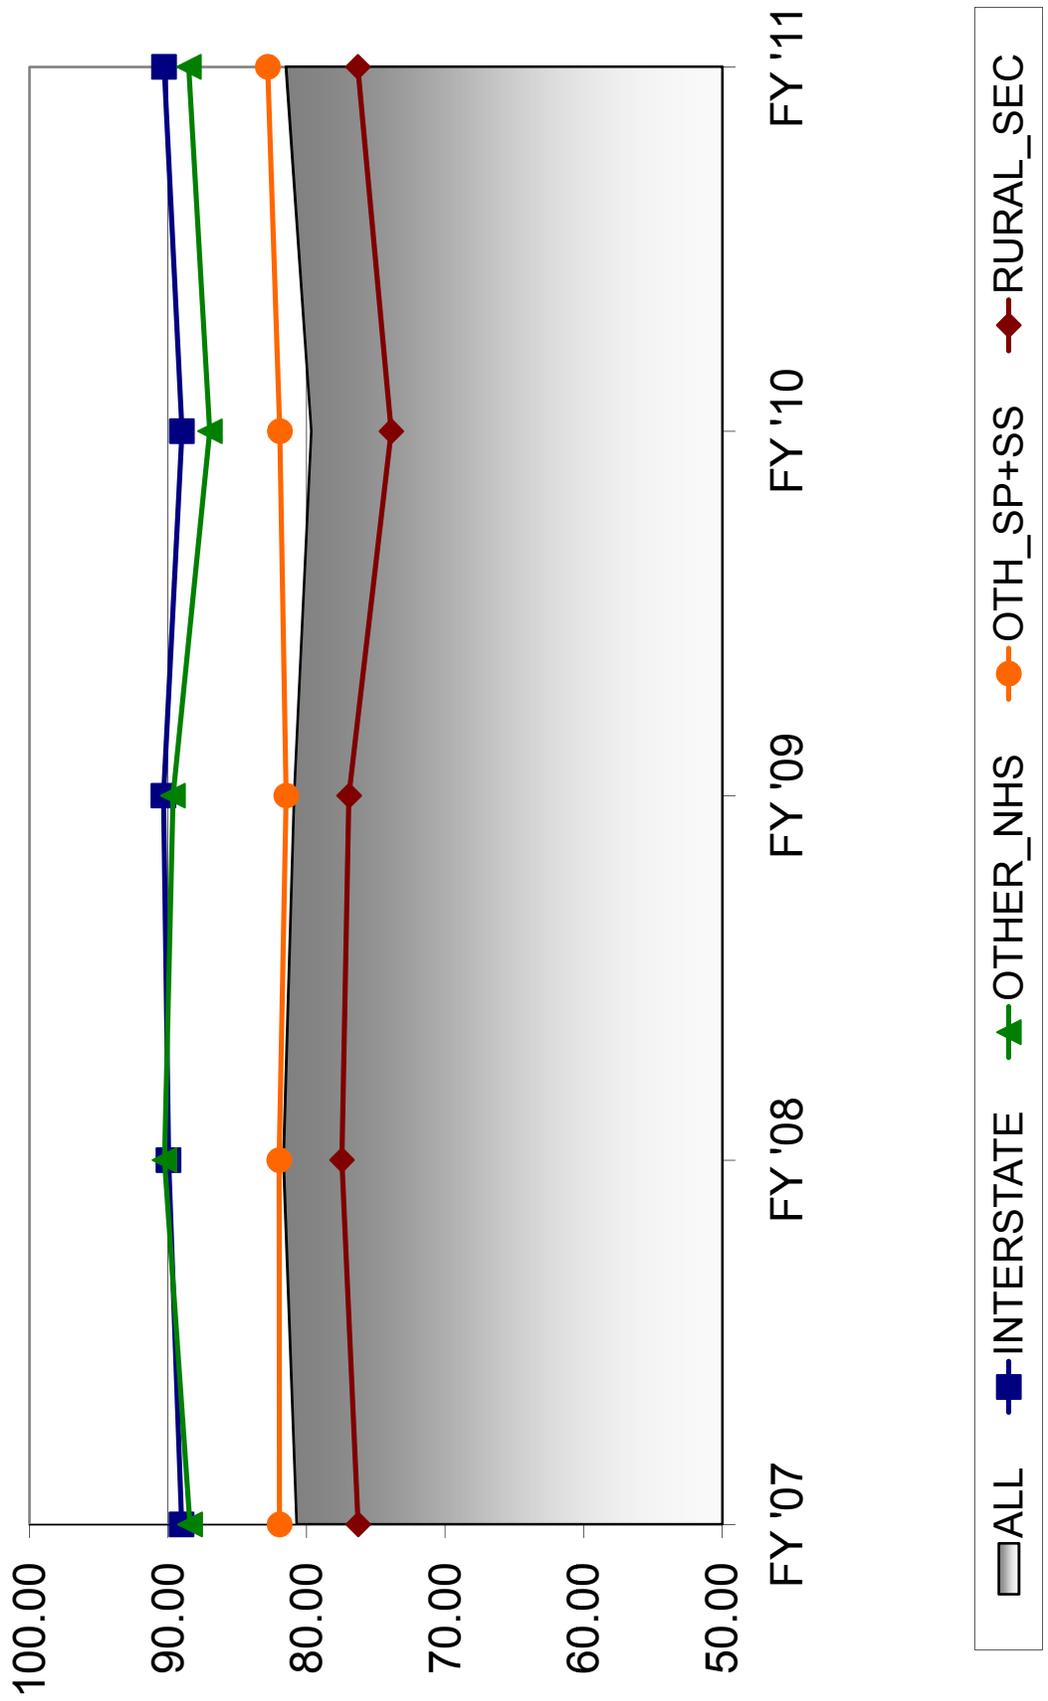
STATEWIDE MRP TOTALS

As in previous graphs, the four road types are represented by colored lines, while the overall weighted average is shown as a gray shaded area.
