FY 2022

Maintenance Conditions of Kentucky Highways

Division of Maintenance
Operations & Pavement Management Branch

2022 MAINTENANCE RATING PROGRAM REPORT

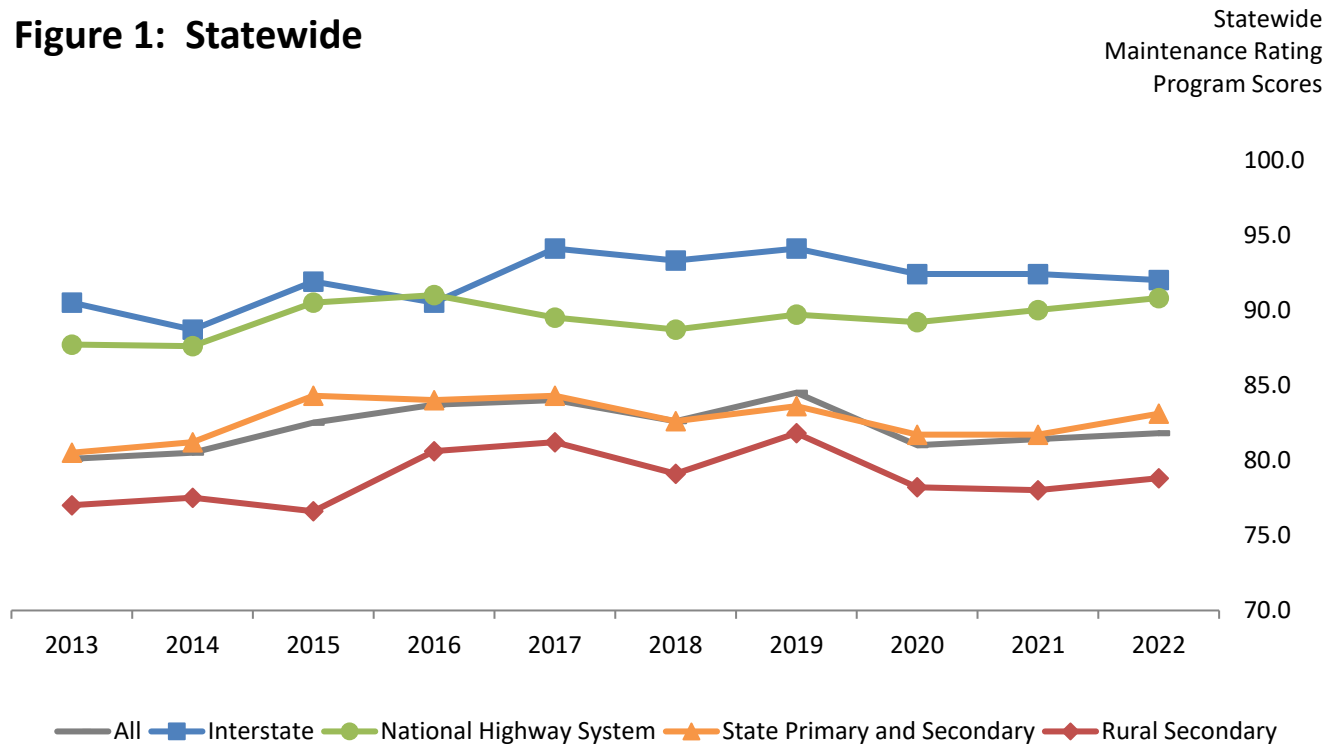
Figure 1: Statewide

FY 2020 KYTC MAINTENANCE STATEWIDE SCORES			
CLASSIFICATION	SCORE	GRADE	COMMENTS
Interstates	92.8	A	Slight Increase
National Highway System	91.9	A	Slight Increase
State Primary and Secondary	84.3	B	Slight Increase
Rural Secondary	81.4	B	Slight Increase
All Roads	84.0	B	Slight Increase
