# Bridge Inspection Report

056B00180N

12/11/2024

IDENTIFICATION			
Structure Num (8):	056B00180N		
NBI Number	056B00180N		
Structure Name:			
Location (9):	2.1 MI N OF I-264		
Carries (7):	I-65		
Type of Service (42A):	1 Highway		
Feature Crossed (6):	US 60A (EASTERN PKWY)		
Type of Service (42B):	1 Highway		
Placecode (4):	Not Applicable		
County (3):	Jefferson (056)		
State (1):	21 Kentucky		
Admin Area:	Inventory		
District:	District 5		
Latitude (16):	38° 12' 44"		
Longitude (17):	85° 45' 10"		
Owner (22):	State Highway Agency		
Maint. Resp. (21):	State Highway Agency		
Year Built (27):	1957	Border State (98A):	Not Applicable (P)
Year Recon (106):	1982	Border Number (99):	
		% Responsibility (98B):

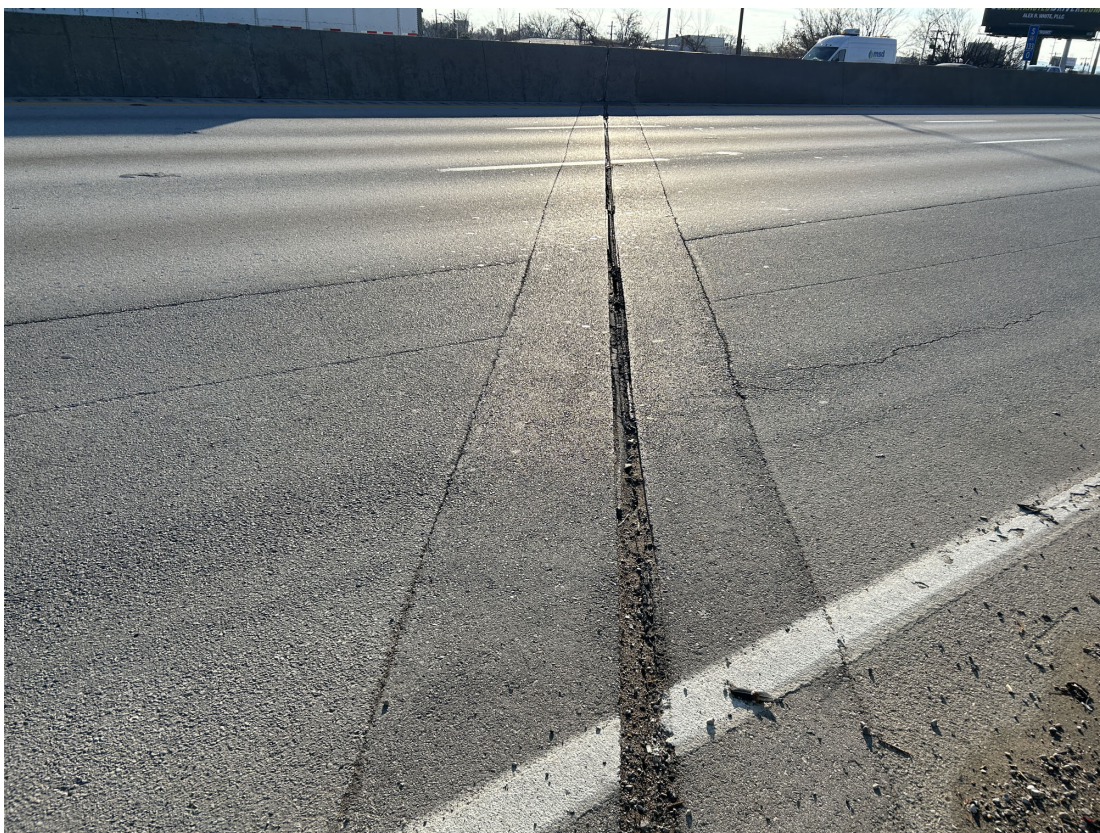
Asphalt plug joint over Abutment 1 SB.

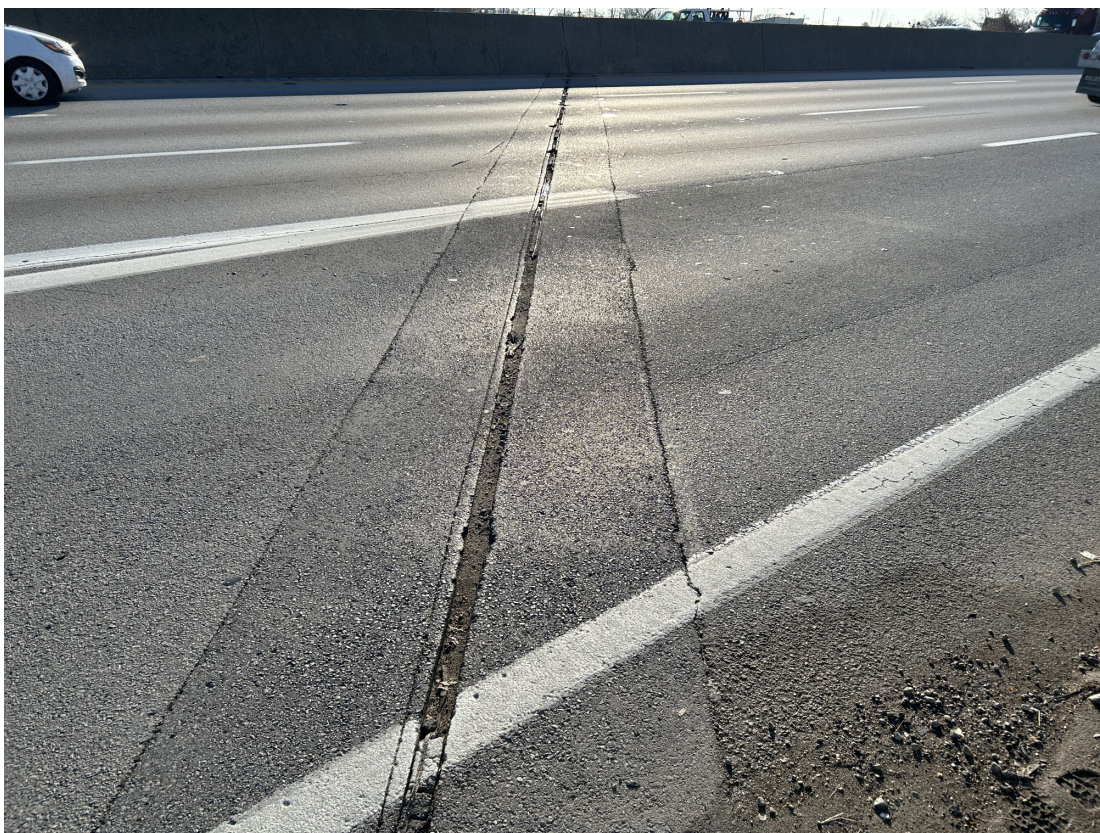
Asphalt plug joint over Pier 3.
