# Bridge Inspection Report

056B00191N

12/09/2024

Standard (24 months)

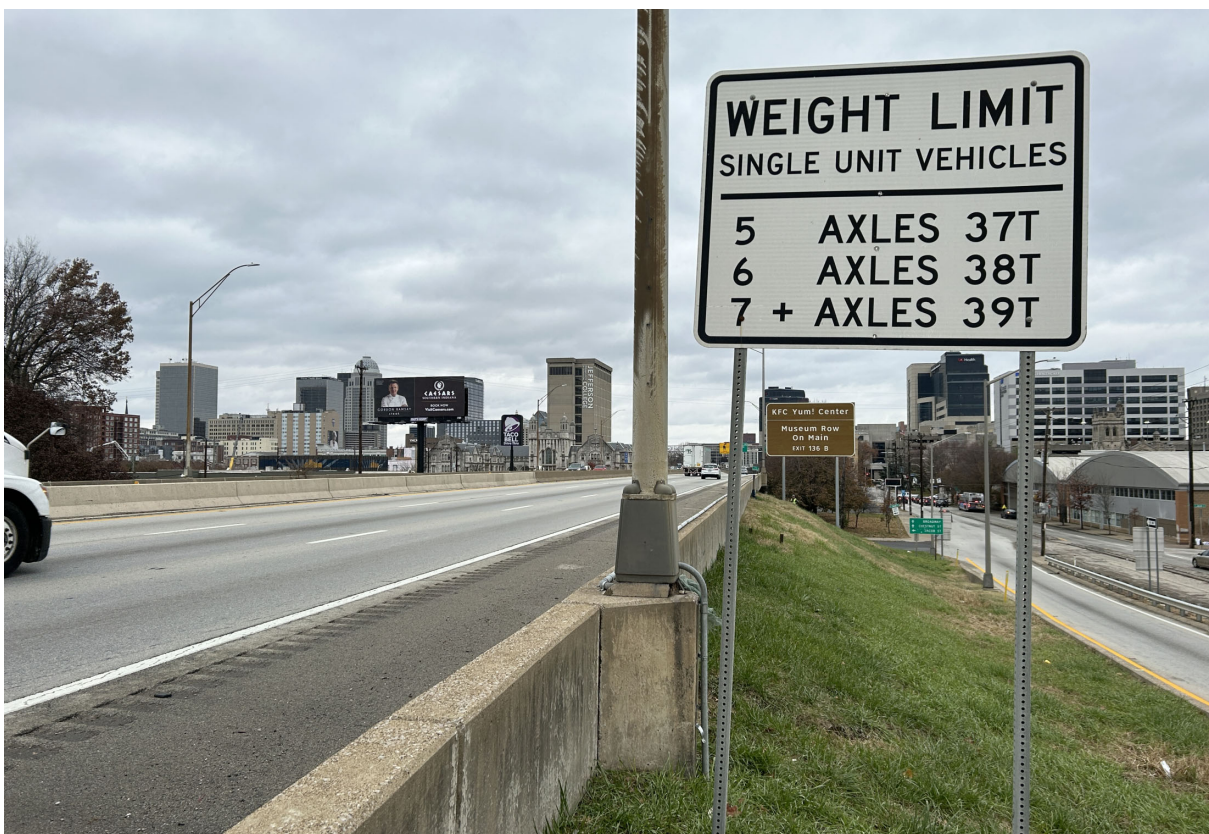
Looking north along I-65 NB with correct posting in place.

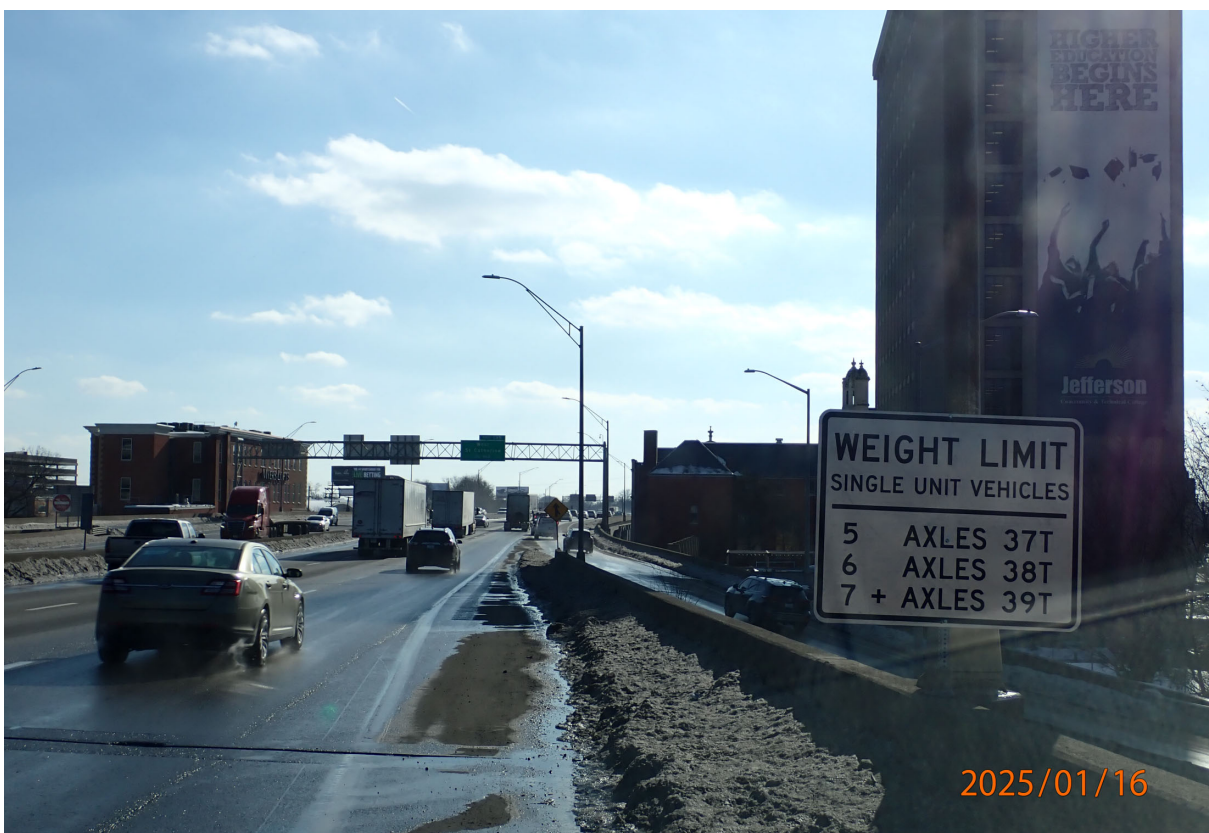
Looking south along I-65 SB with correct posting in place.

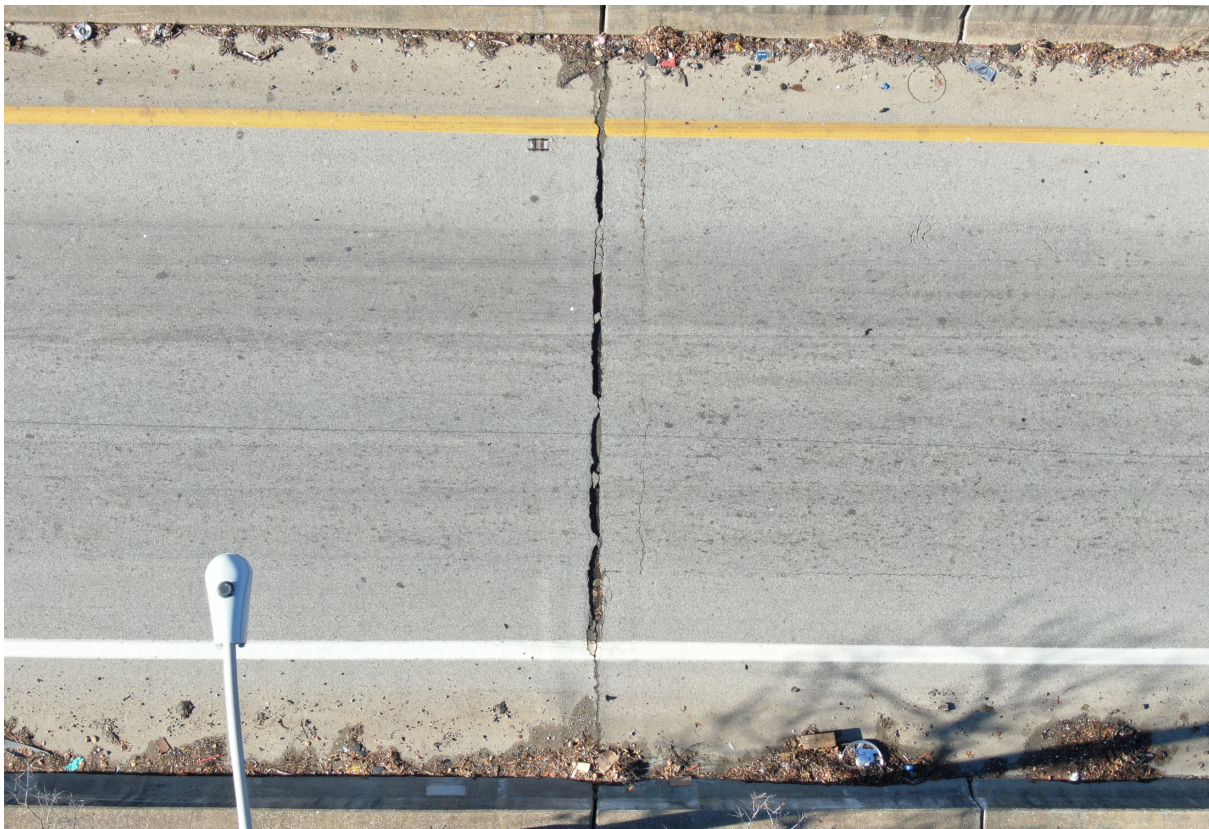
Joint over Abutment A.

Compression joint seals over Piers A-5, B-1, and B-2 as well as Abutments A and B were paved over in 2012, but asphalt has generally broken up and original joints are exposed. Visible portion of joint seals have partial to full depth tears and adhesion loss throughout, plus are filled with debris. Abutment B joint is the only joint still fully concealed by overlay, considered as CS4 since joint is full of asphalt which restricts movement.

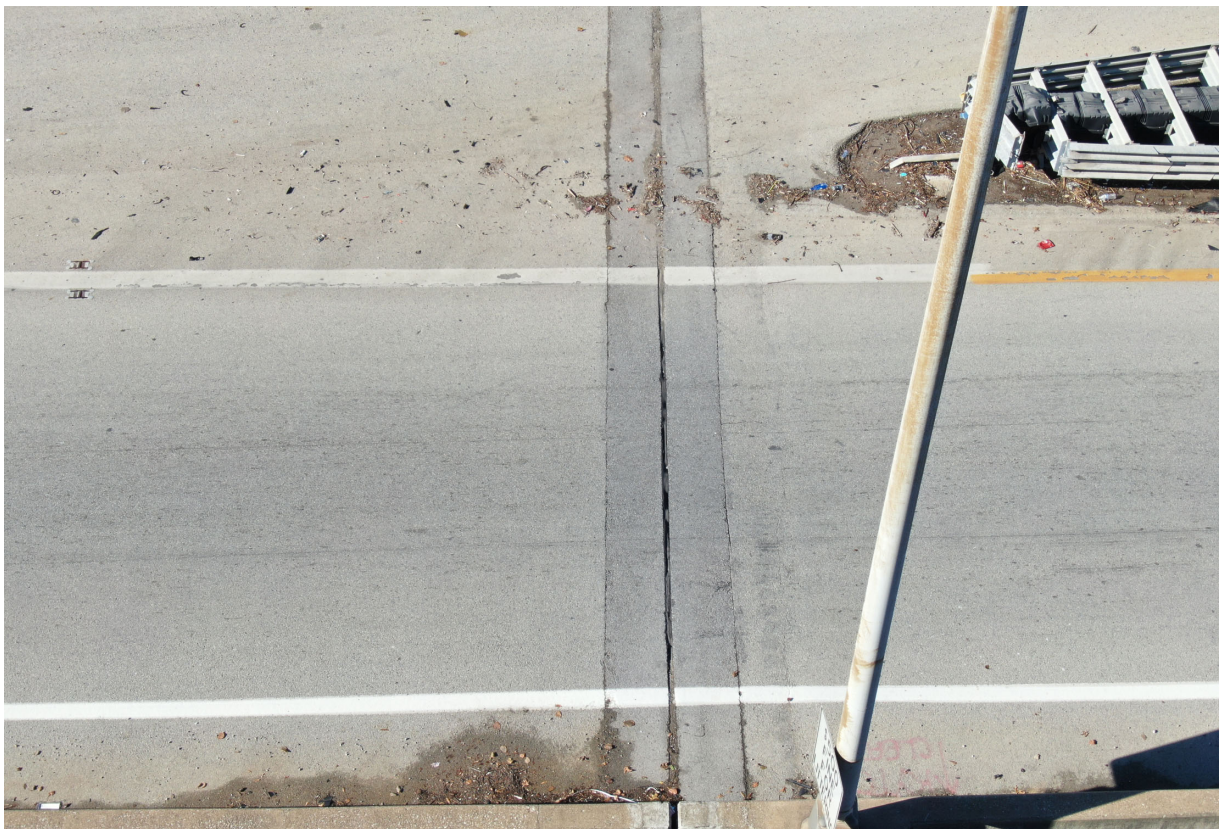
Joint over Pier A-1.

Asphalt plug joints were reconstructed in 2017 and are located along all mainline joints plus at Piers A-4 and A-1. Asphalt joints have deterioration throughout, with varying levels of adhesion loss, cracking, and spalling. Asphalt material has typically failed in all lanes and has limited effectiveness in the shoulders. Joint material is also spalling out over original armored edges at P118E, P103W at Abutment C in SB lanes.

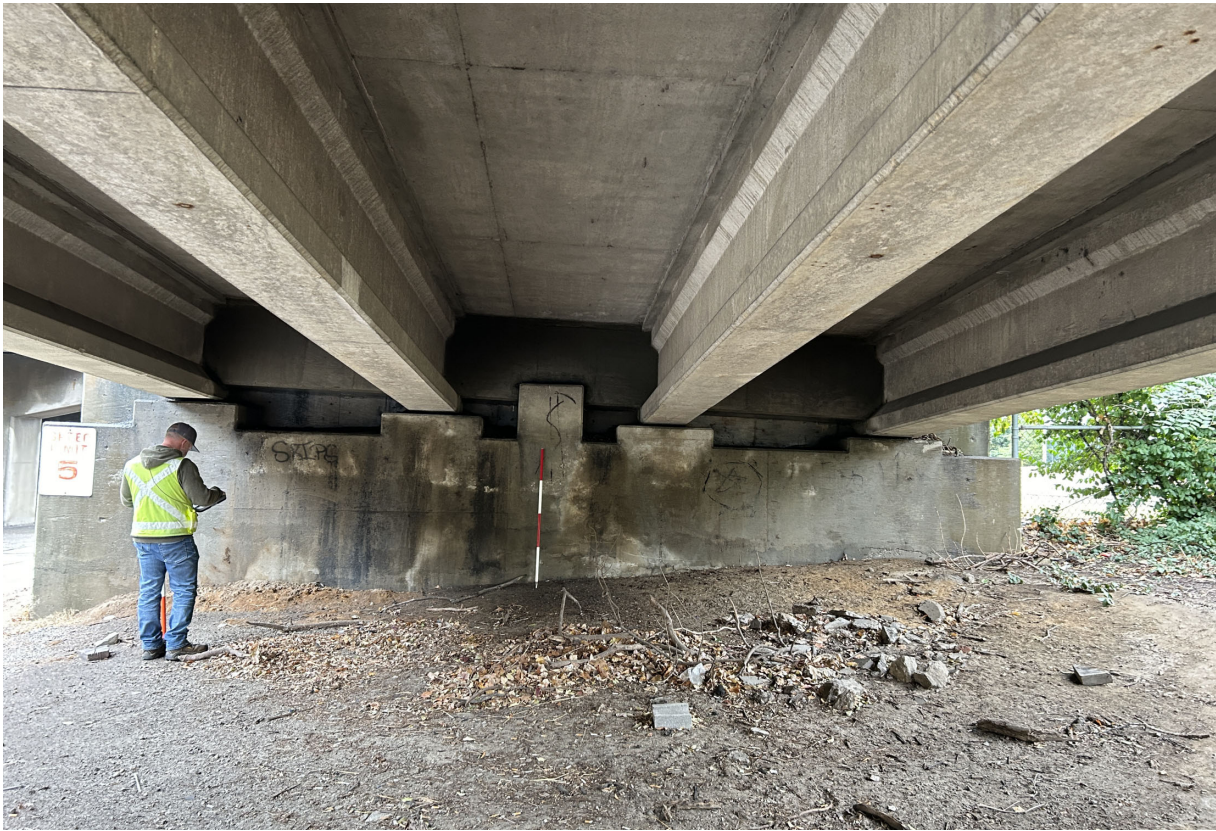
Ramp A: Abutment A

Abutment A has moderate vertical and diagonal cracks, some with efflorescence and/or rust staining at the west end. Abutment B has a few vertical cracks and small delaminations. Abutment C has moderate to wide horizontal cracking, delamination, unsound patches, and several spalls with exposed rebar.

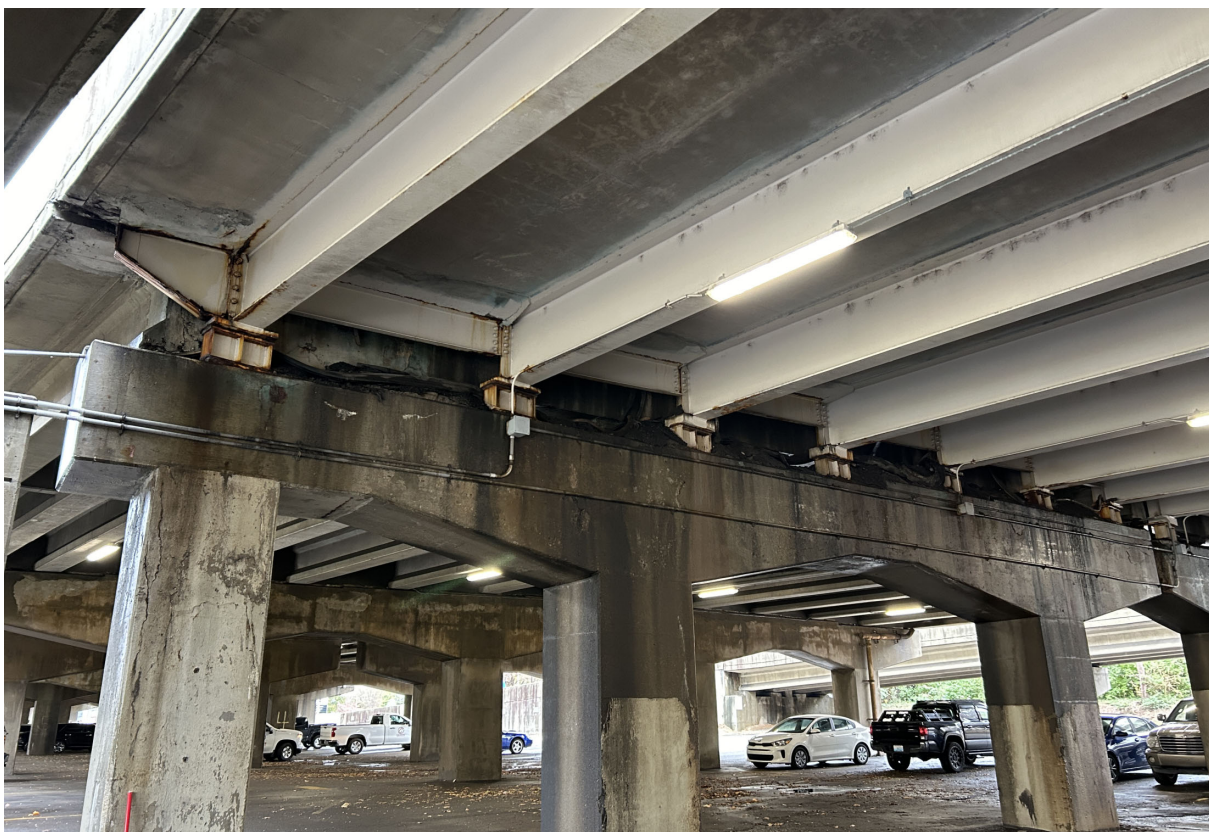
Pier 103W south face.

Pier caps below the joints typically have moderate to wide cracking with efflorescence and/or rust staining, delaminated areas, and large spalls with exposed rebar and section loss. Spalling and delaminations are also common in areas below the drainage system. Larger/more extensive areas of spalling with exposed rebar noted on caps for PA-5, PA-4, PA-1, PB-1, PB-2, P106W, 108E, P112W, P112E, P118W (full length), and P121W. Most predominate wide cracking noted on P103W, P106E, P111W, 115E and P121E.

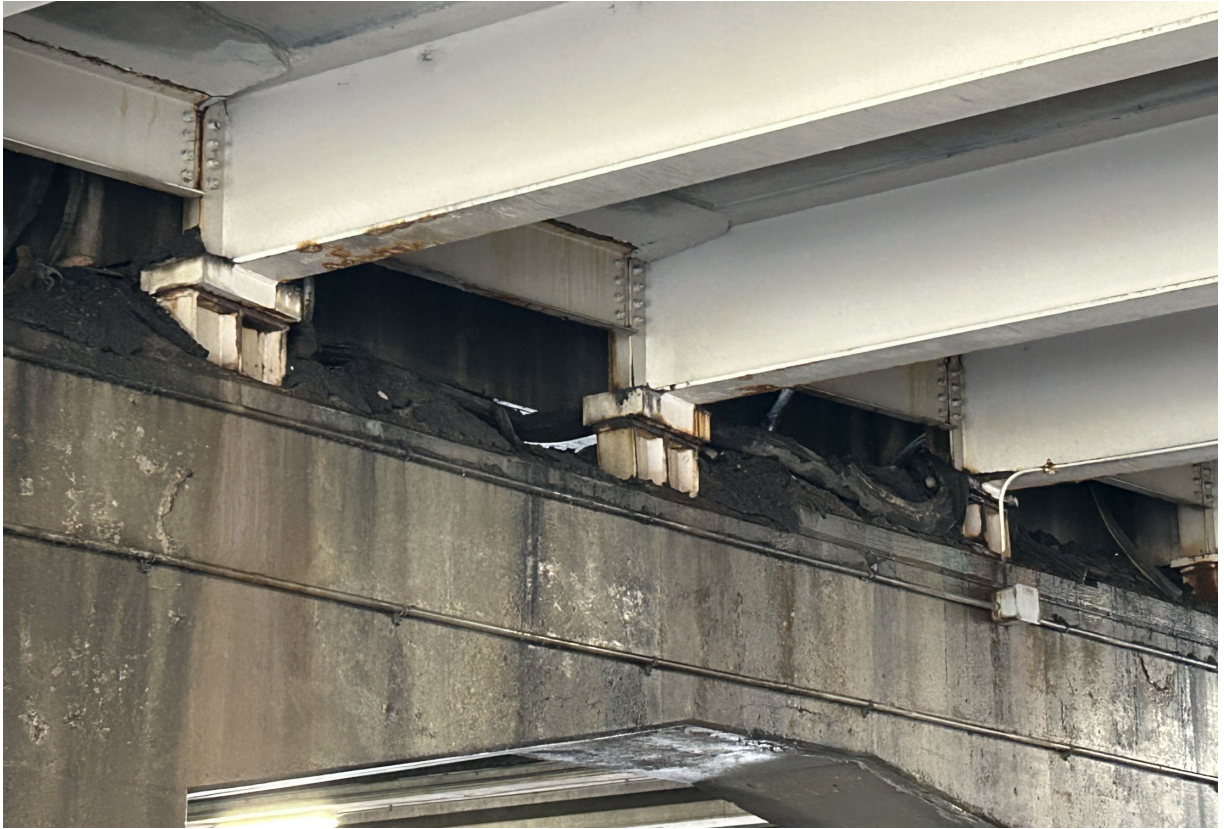
Several rocker bearings at Pier 103W and 103E are partially buried in asphalt.

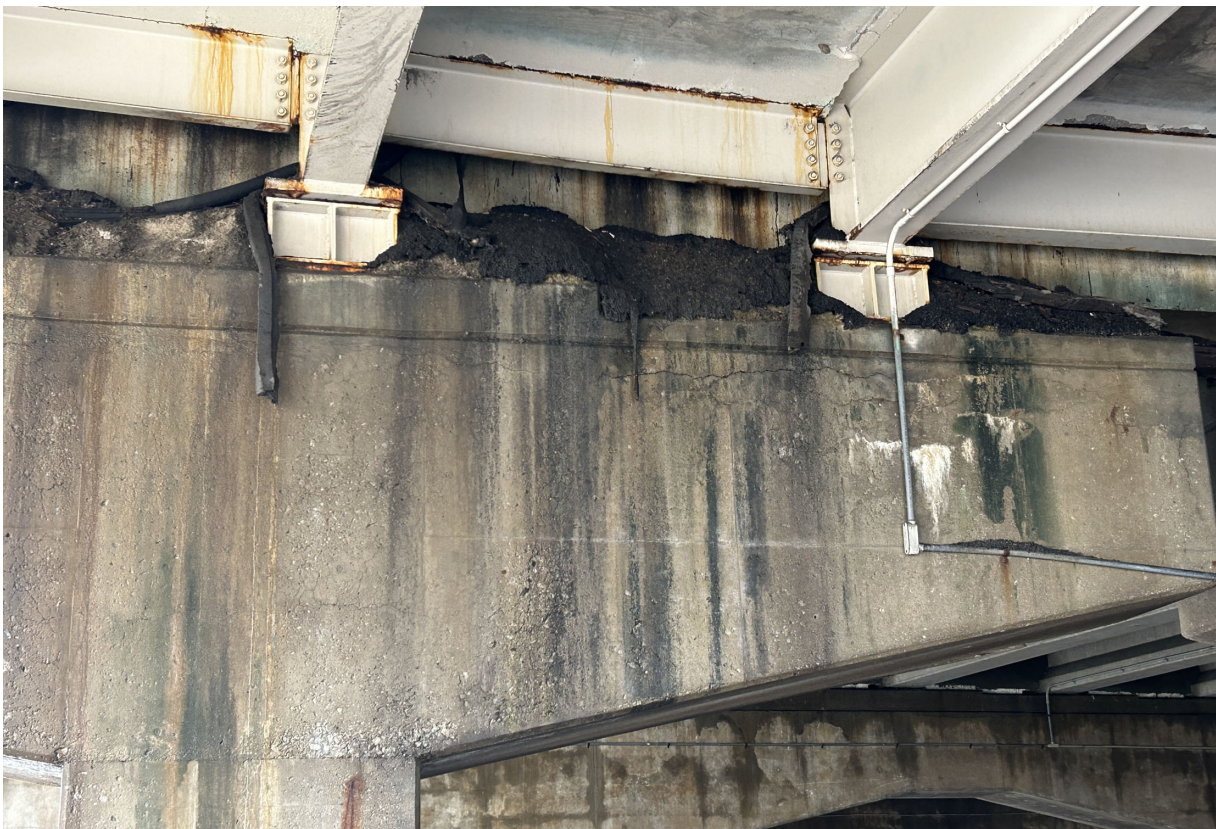
Several rocker bearings at Pier A-1 are partially buried in asphalt.

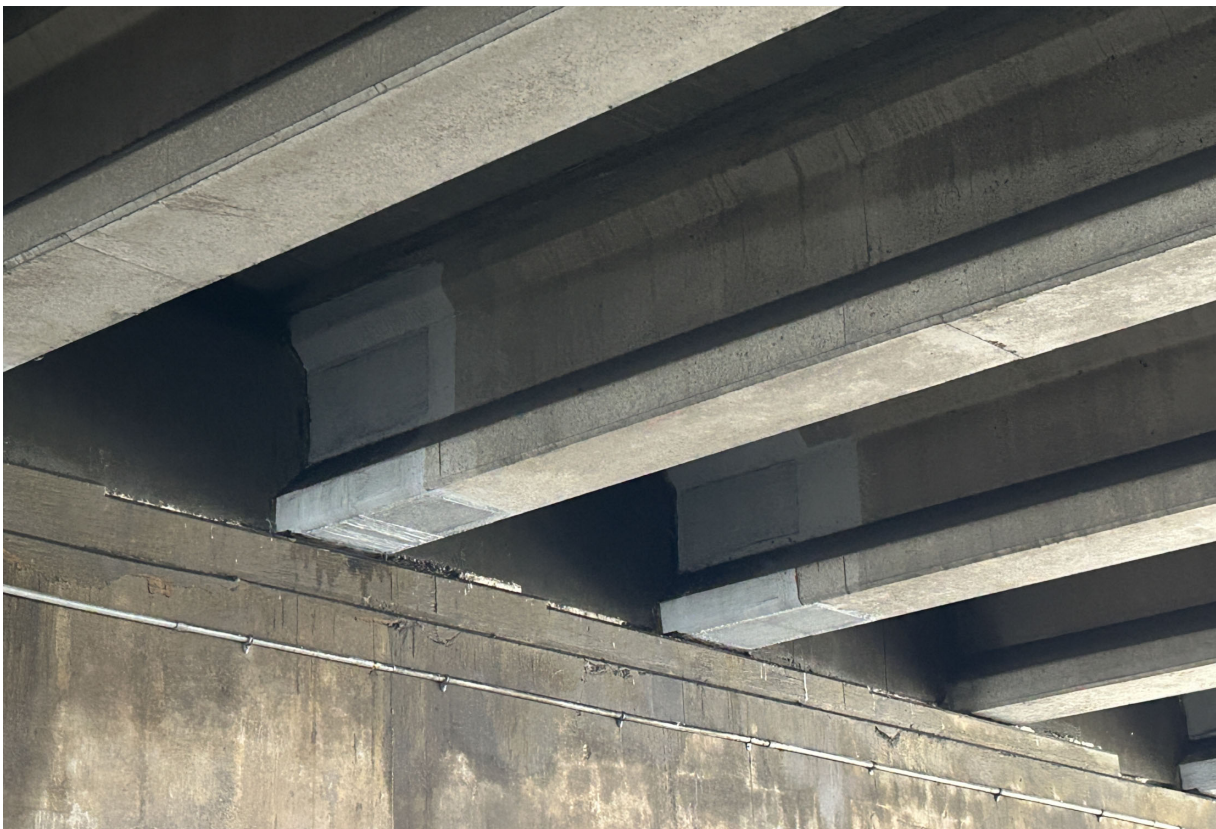
Several PCI beam ends in Spans 107 through 112 have sound CFRP patches, most in the SB portion. Span 107 at Pier 107W shown.

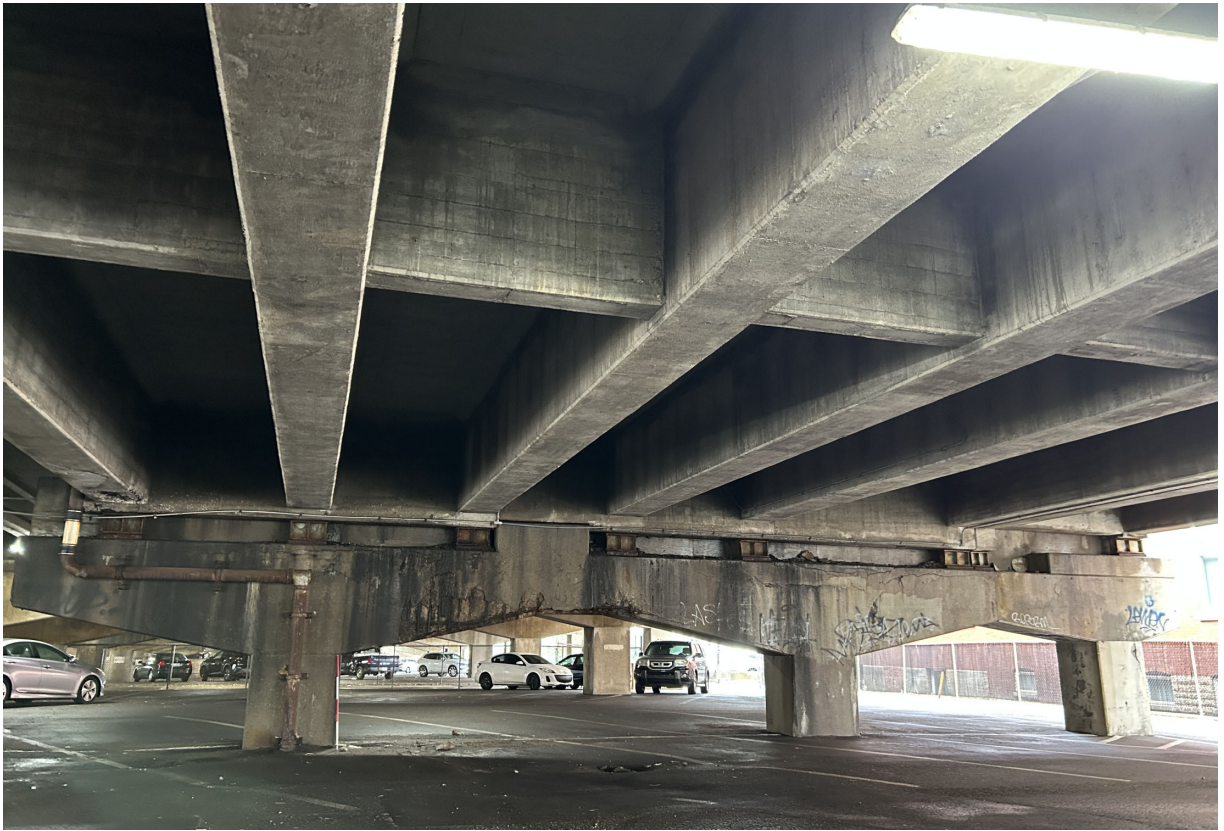
Pier 112E south face.

Some diaphragms have large spalls with exposed rebar, especially in the RCDG spans. North face of Pier A-5 shear key has spalling deeper than 1 inch. Diaphragms at Pier 112E have cracking with heavy efflorescence build-up along bottom face.

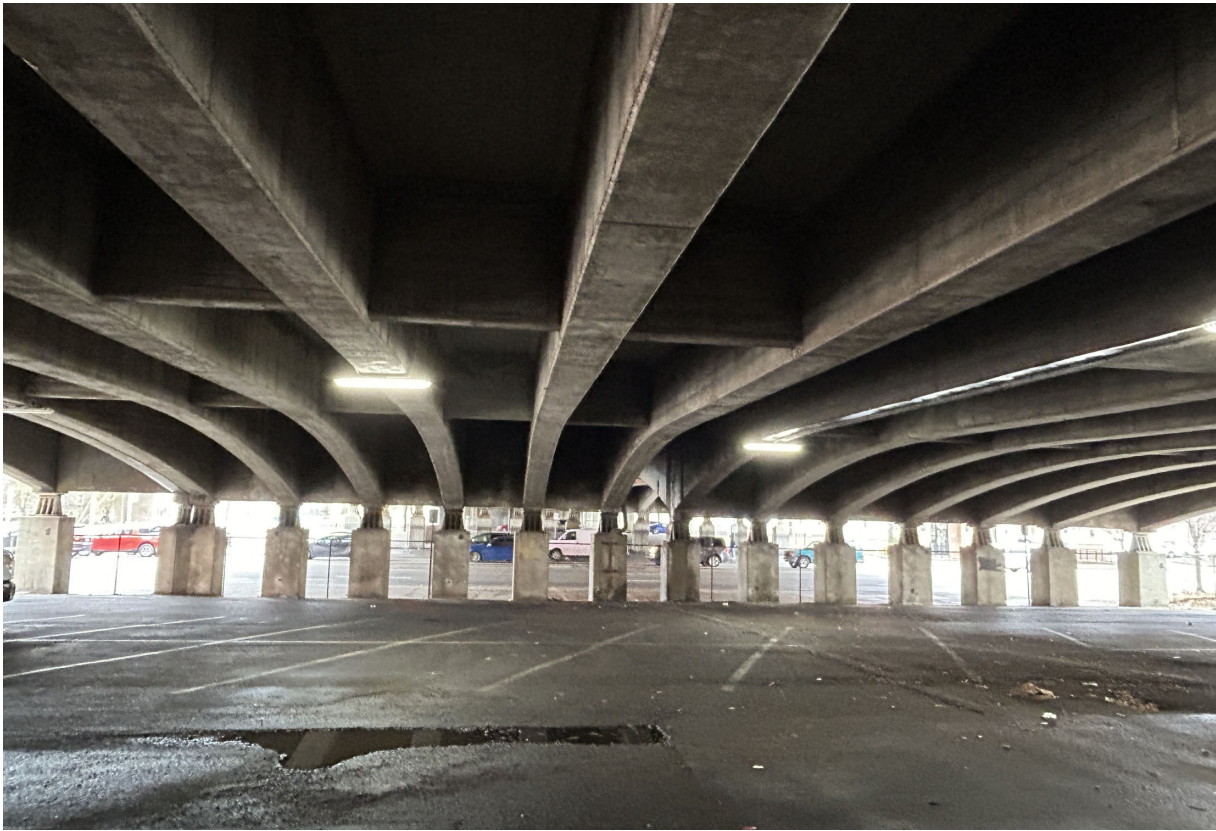
Pier 113 north face.

Fixed bearings generally have surface rust beginning to form, especially at Piers 113 and 123. Bearings in the ramps and at P104 hard to see from the ground.

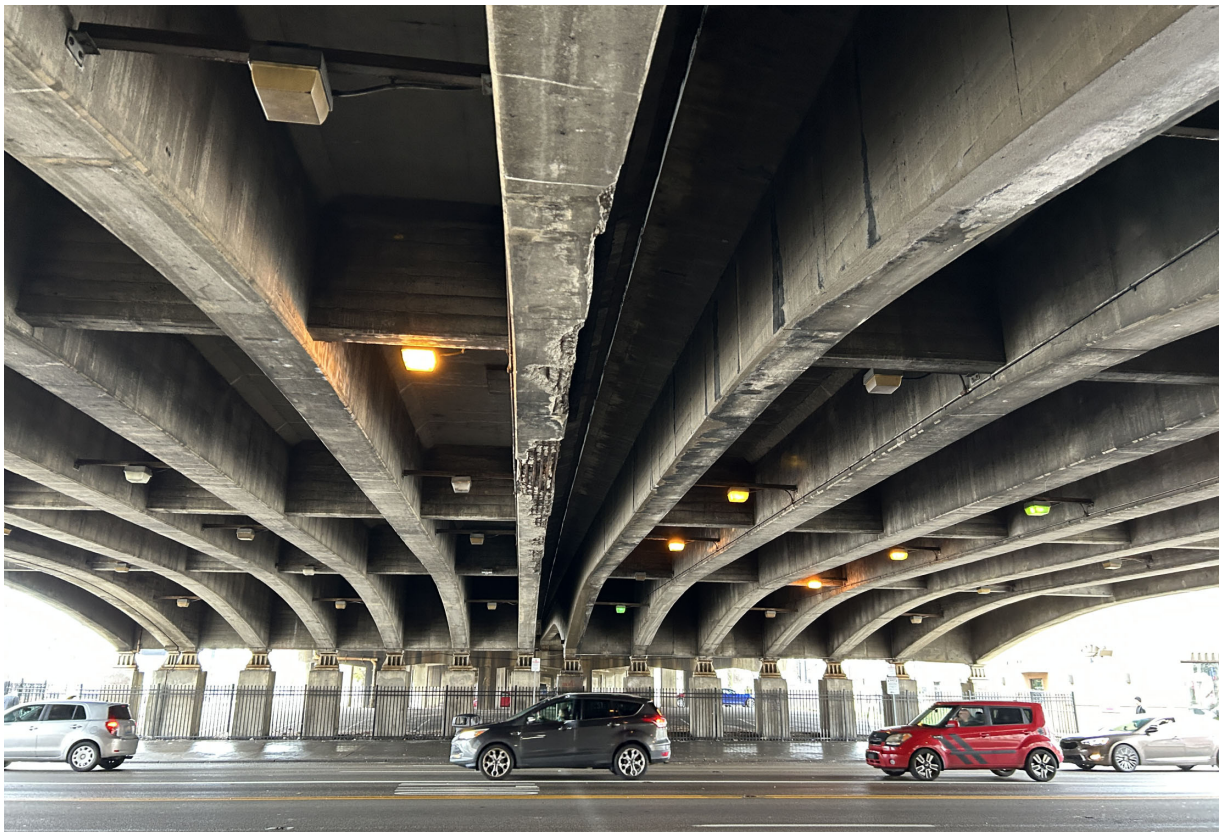
Pier 114 north face and Span 114.

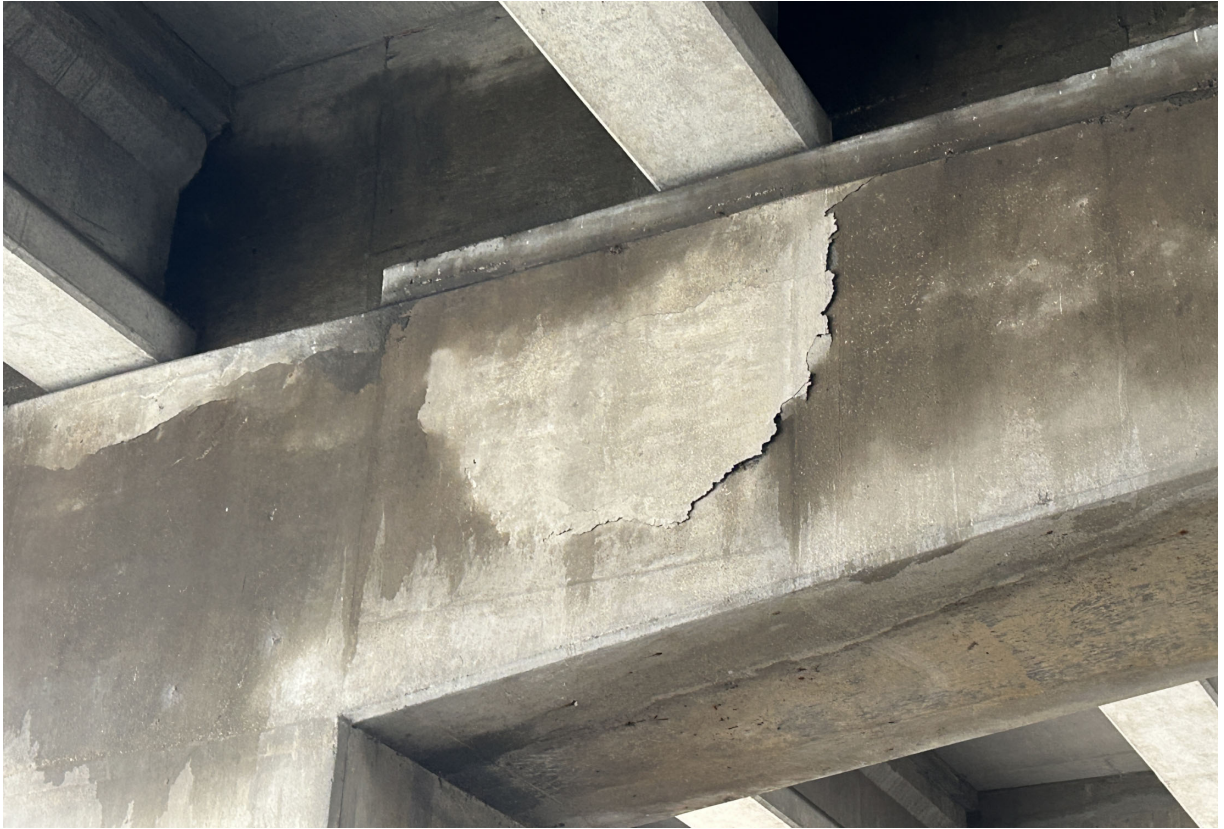
Pier 117E cap has a large delamination on the north face.

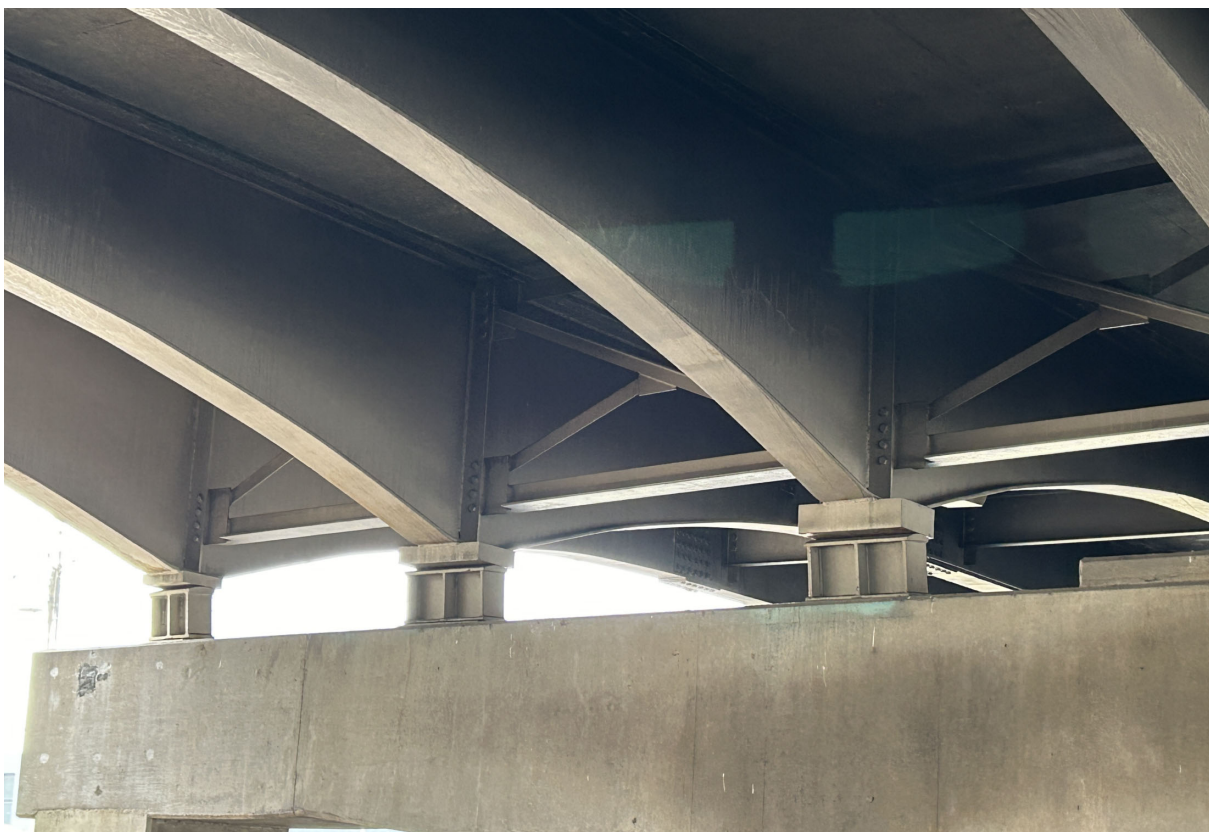
Typical Pier 122 bearings.

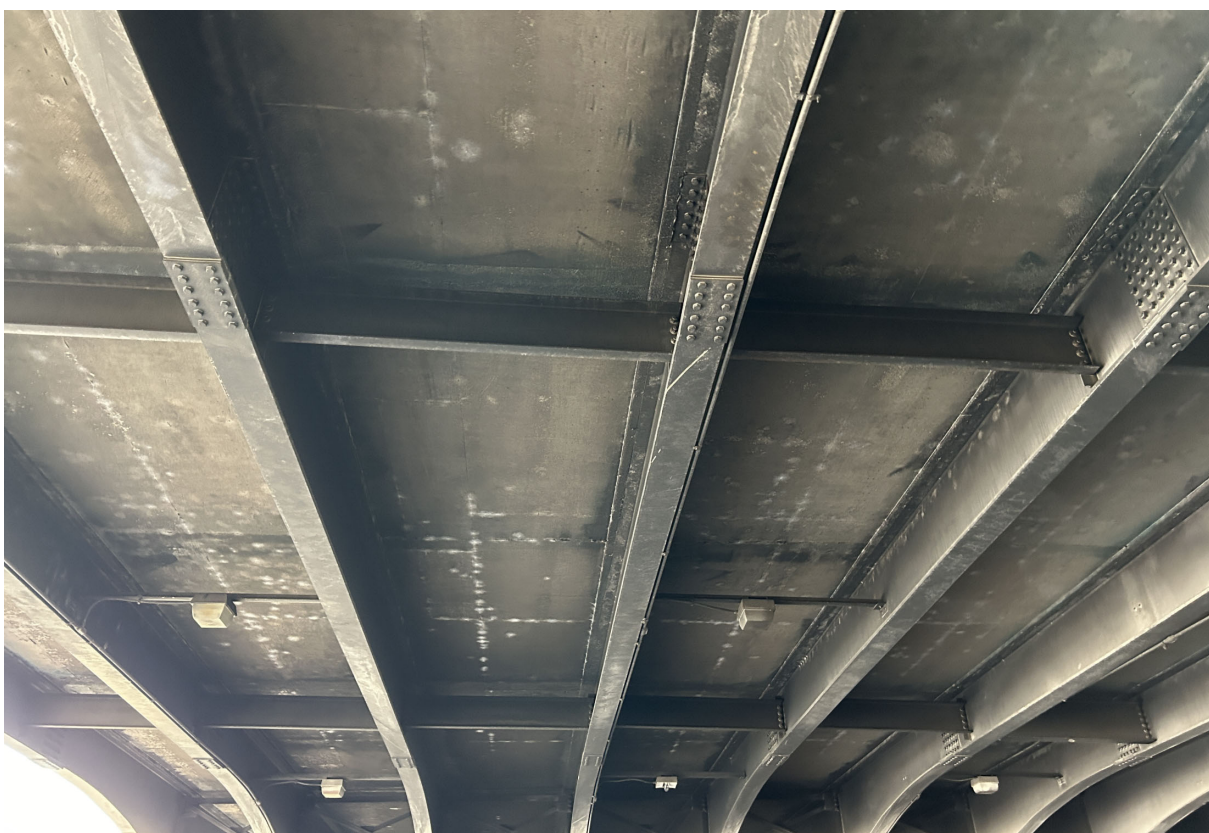
Span 123 is covered in soot from fires under the bridge.

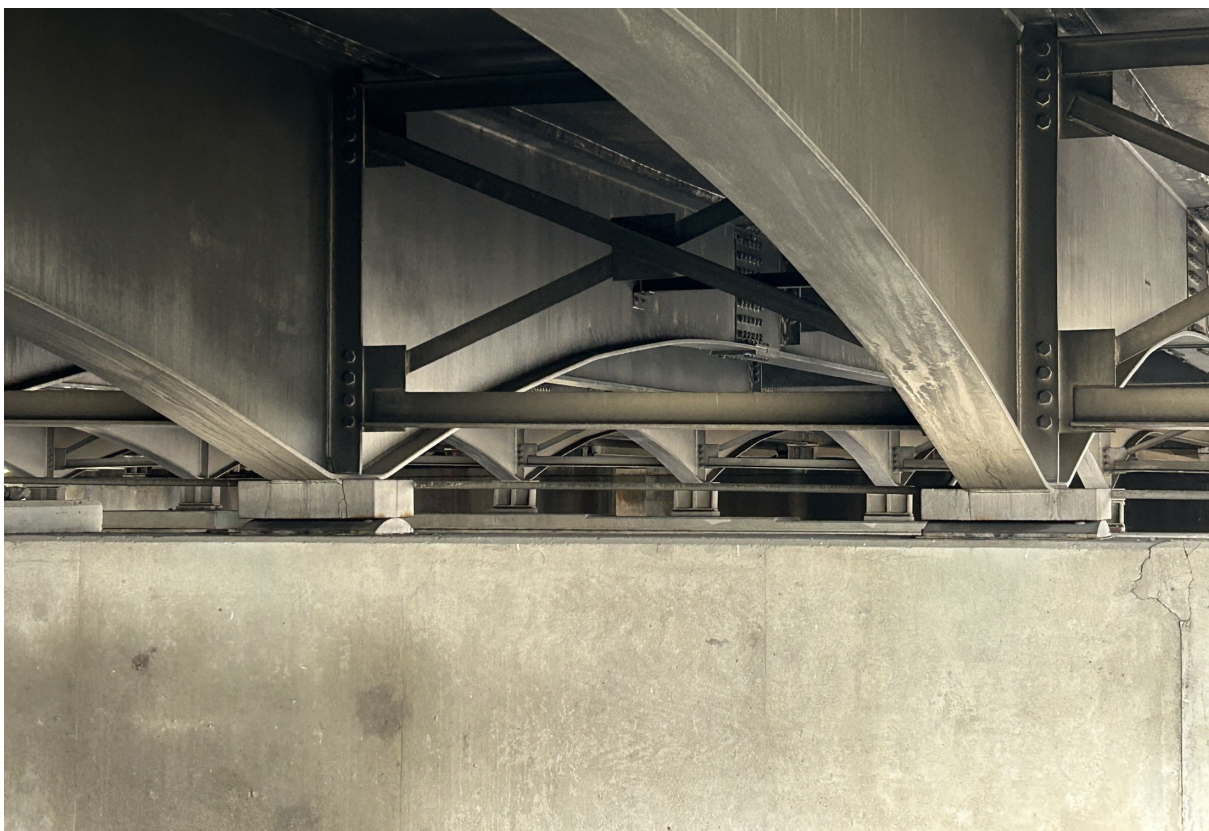
Typical Pier 123 bearings.

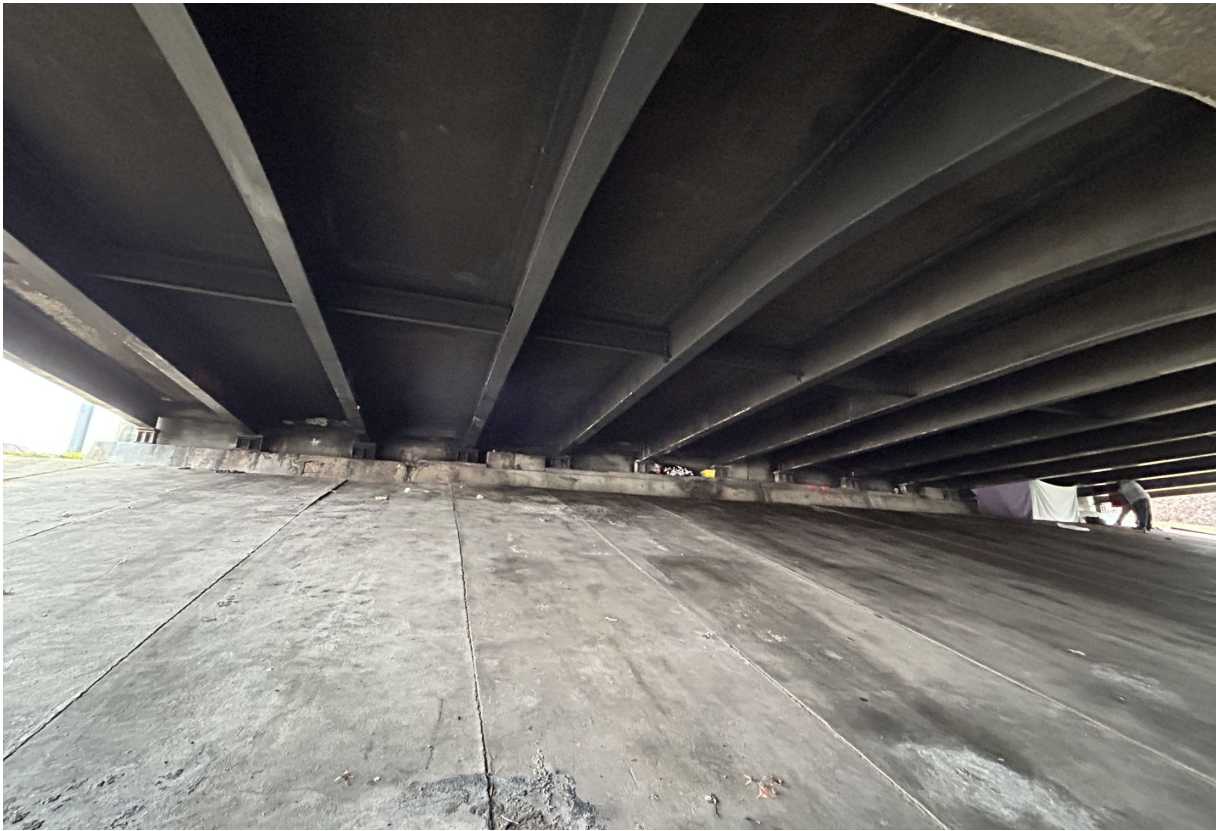
Concrete slope protection along Abutment C is being undermined, especially towards the west end, and is settling/cracking.
