Bridge Inspection Report

056B00193N

07/15/2024

Special-Other

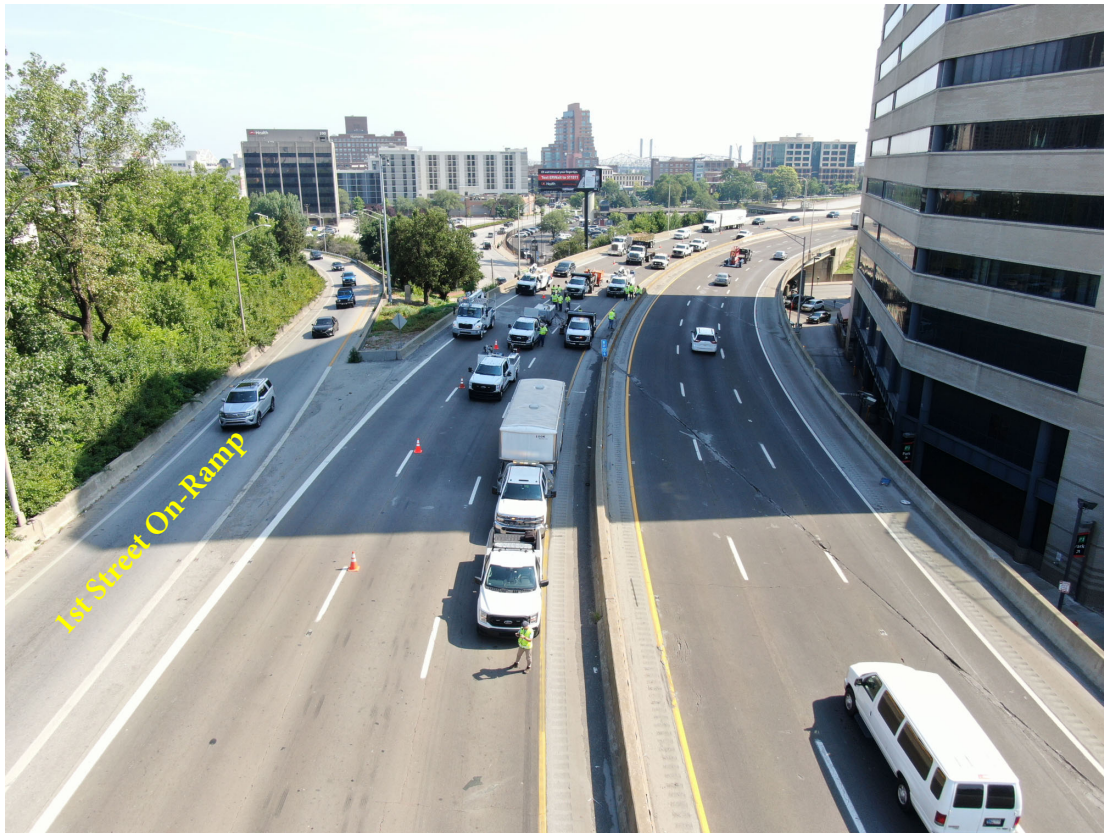
Looking north along I-65 towards Lincoln Bridge

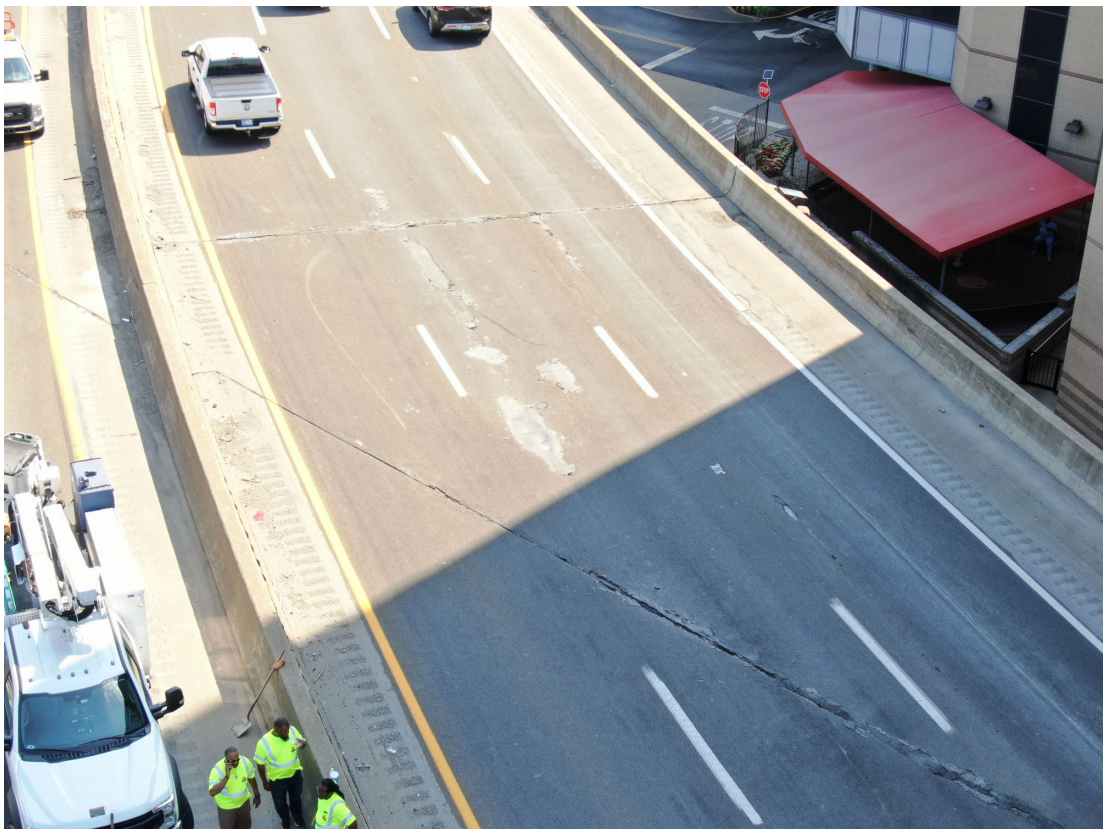
NB Lanes: Asphalt Patches in Span 2
(drone view)

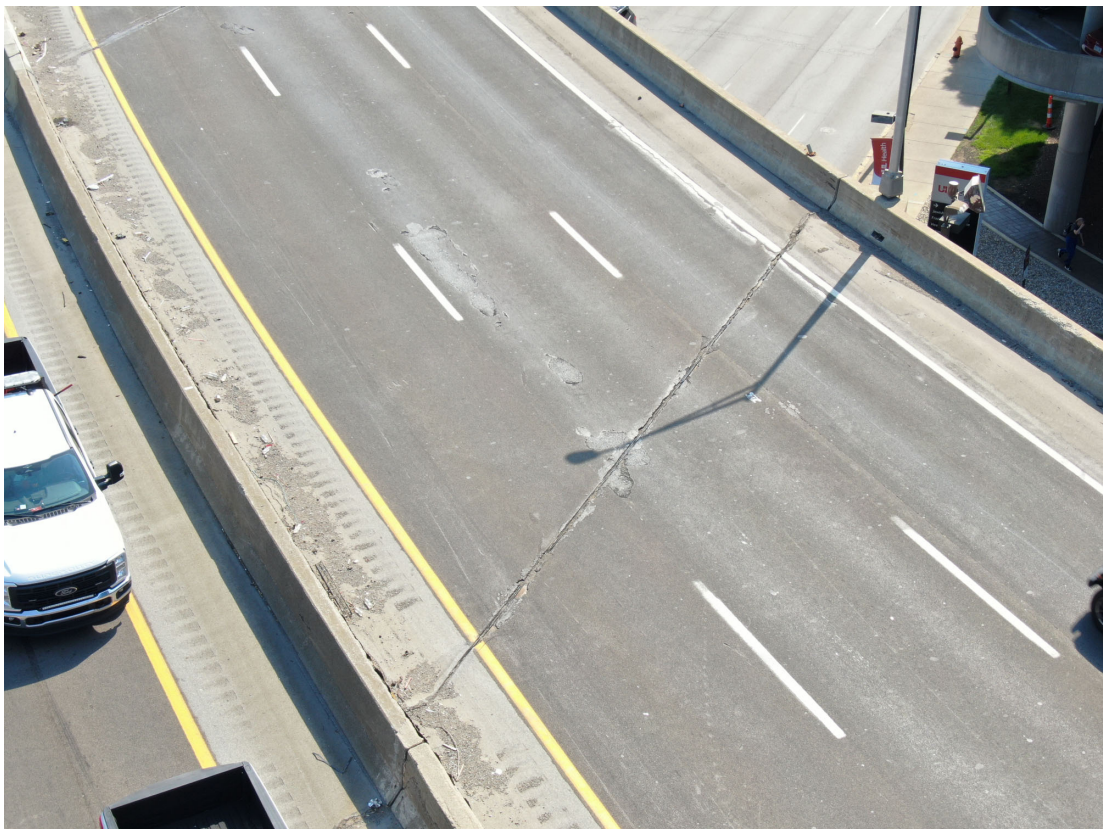
NB Lanes: Asphalt Patches in Span 6
(drone view)

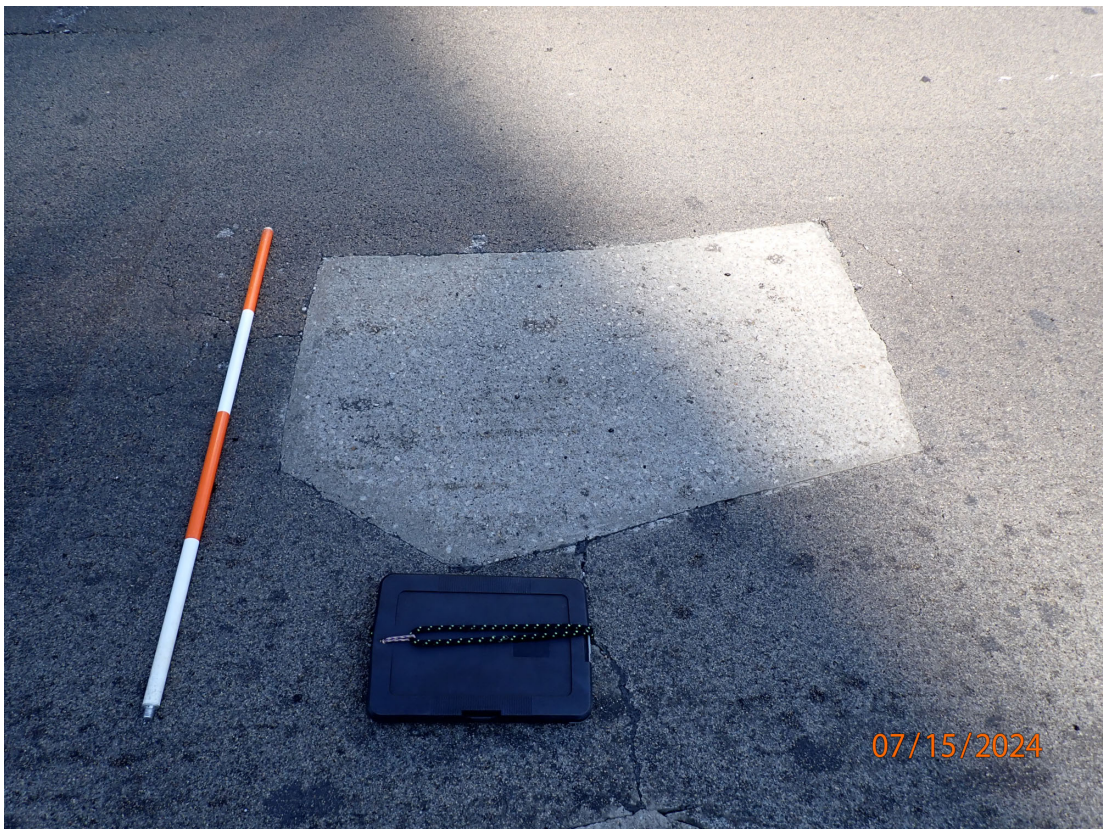
SB Lanes: Concrete Patch #2 = 4'L x 3'W = 12 SF

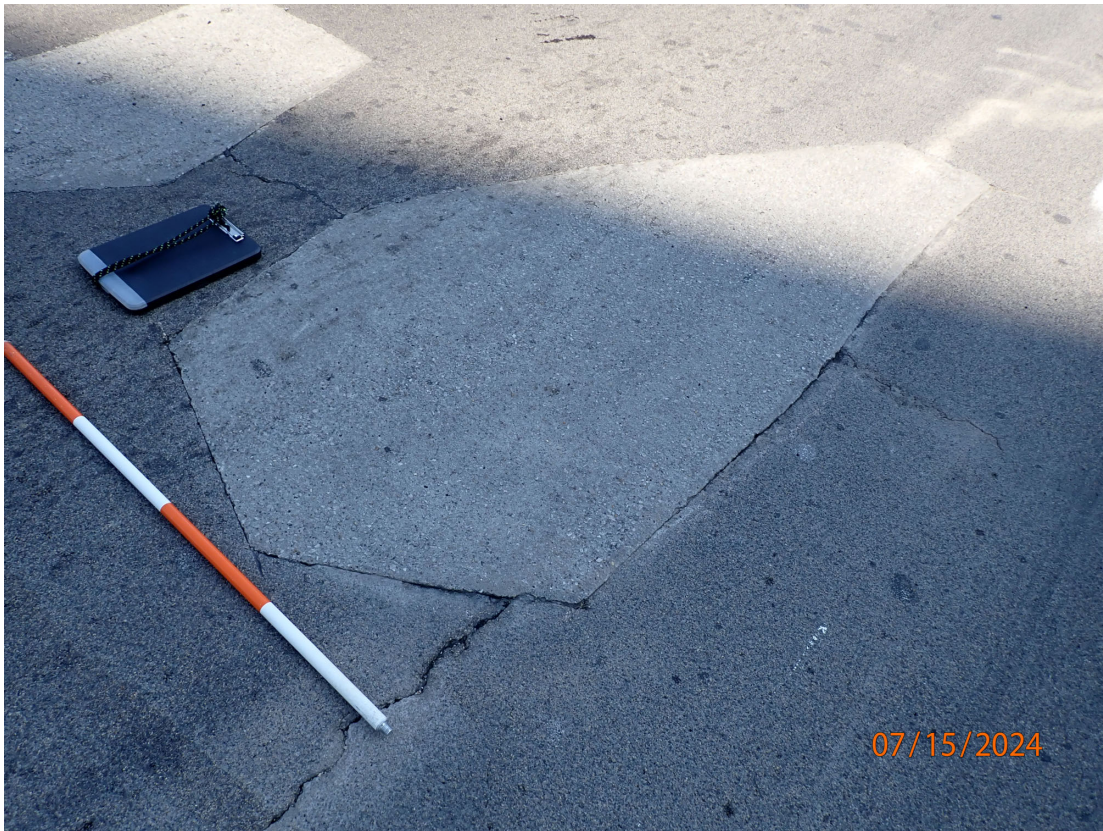
SB Lanes: Concrete Patch #3 = 8'L x 4'W = 32 SF

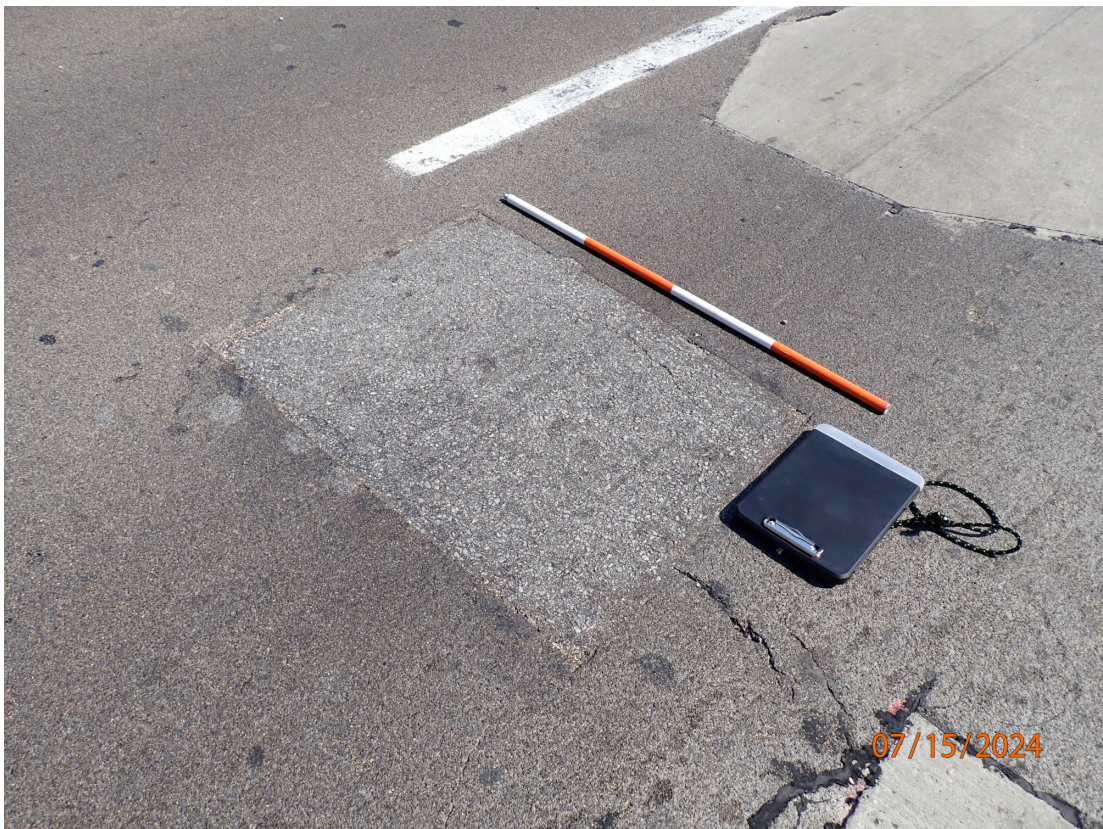
SB Lanes: Concrete Patch #5 = 3'L x 4'W = 12 SF

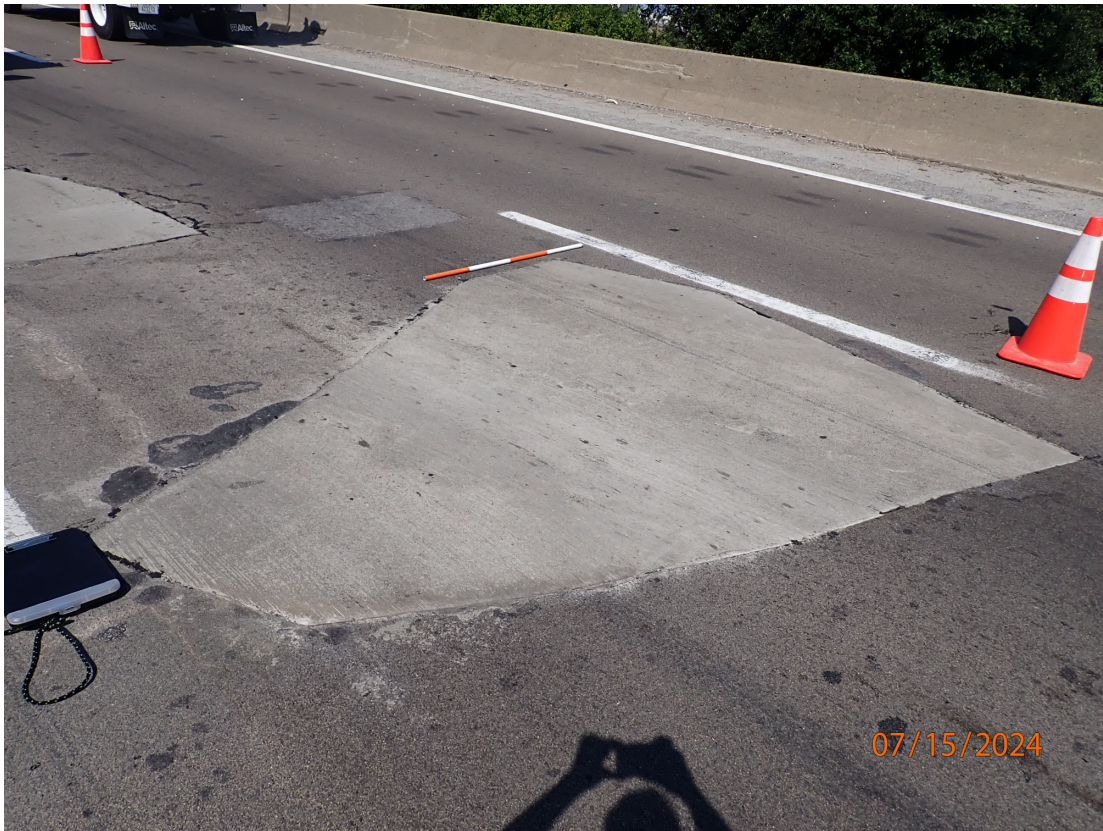
SB Lanes: Concrete Patch #6 = 9'L x 11'W = 99 SF

The top of the deck received a 1.5-inch Rosphalt overlay in 2006 followed by a high friction surface treatment in 2017. The top of the deck is not visible for inspection due to the overlay; however, while patching, the Bridge Crew observed that the deck is holding water. The northbound side is worse along the center lane where there are multiple ineffective asphalt patches in Spans 2 and 6. Likewise, the southbound side is worse along the center lane where there are six unsound concrete patches of different ages in Span 1. The total area of concrete deck patching is 224 SF with individual patch sizes ranging from 9 to 99 SF. On 05/22/2024, D5 was notified of a hole along the southbound center lane in Span 1-Bay 3. The 2 SF hole was surrounded by additional unsound concrete with exposed and broken rebar, which resulted in the 99 SF full-depth patch.

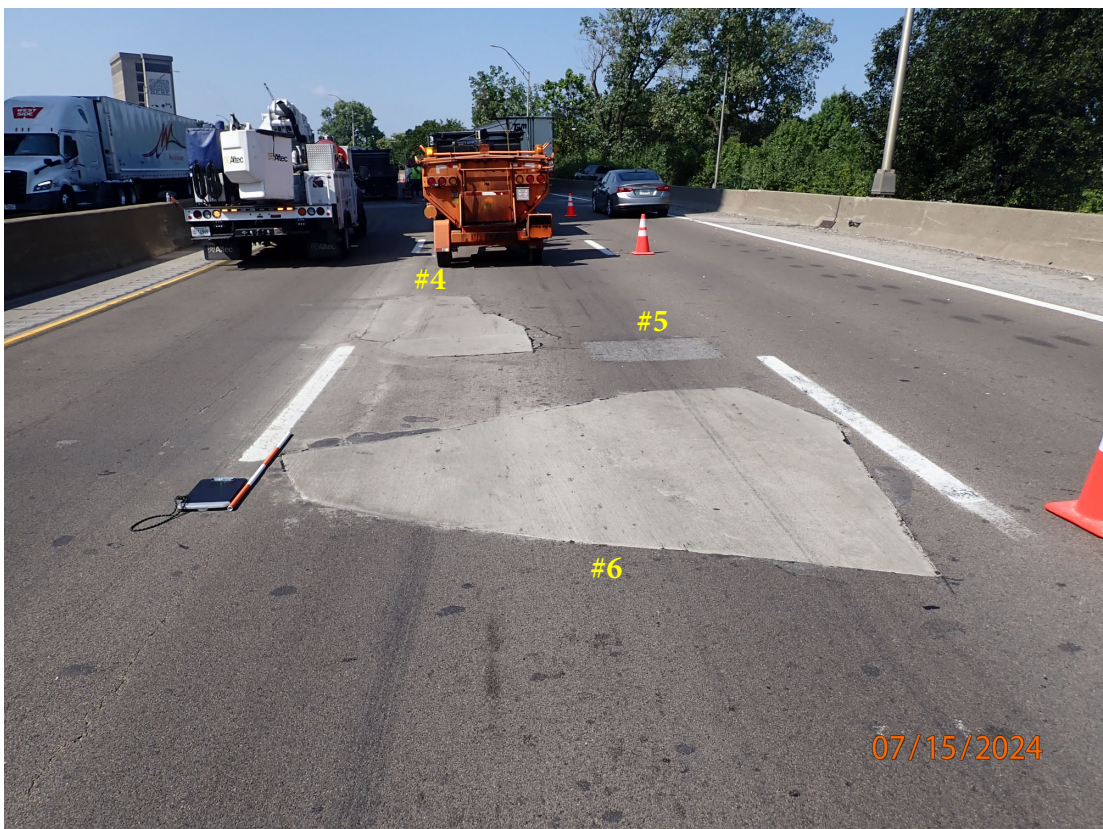
SB Lanes: Concrete Patches #4-6 in Span 1
(closer to P2 joint)

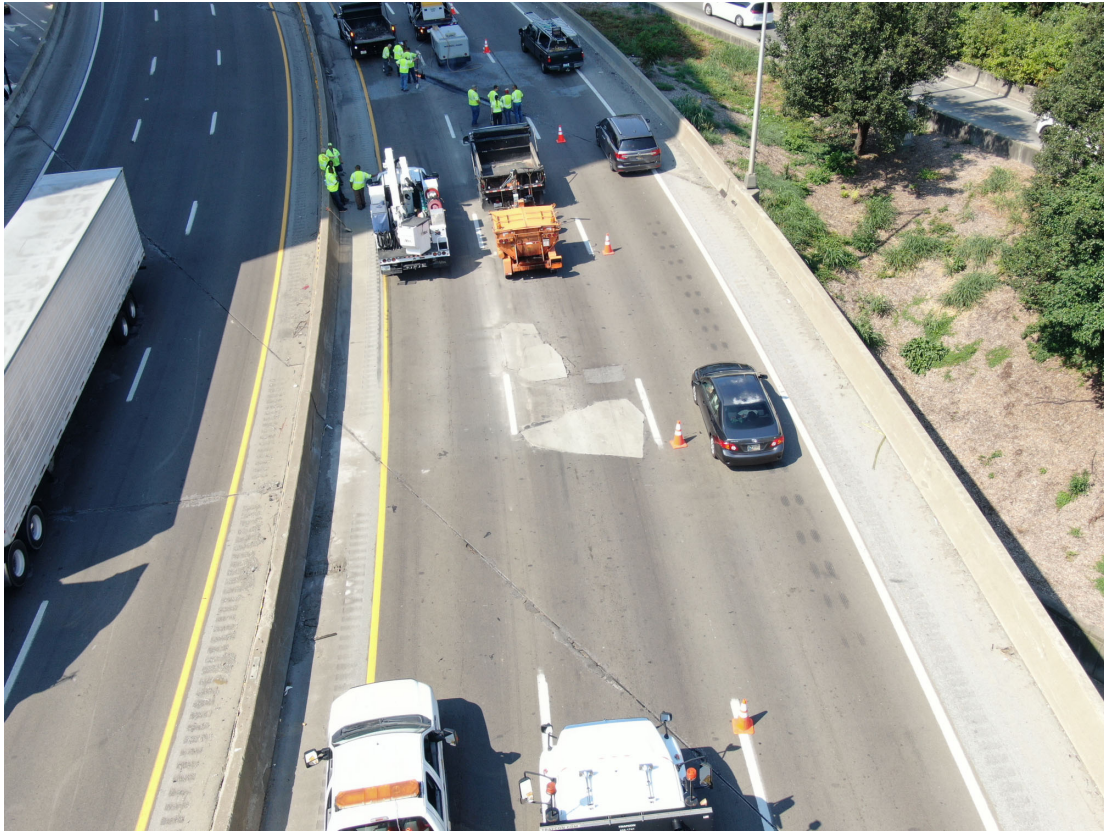
SB Lanes: Concrete Patches in Span 1
(drone view)

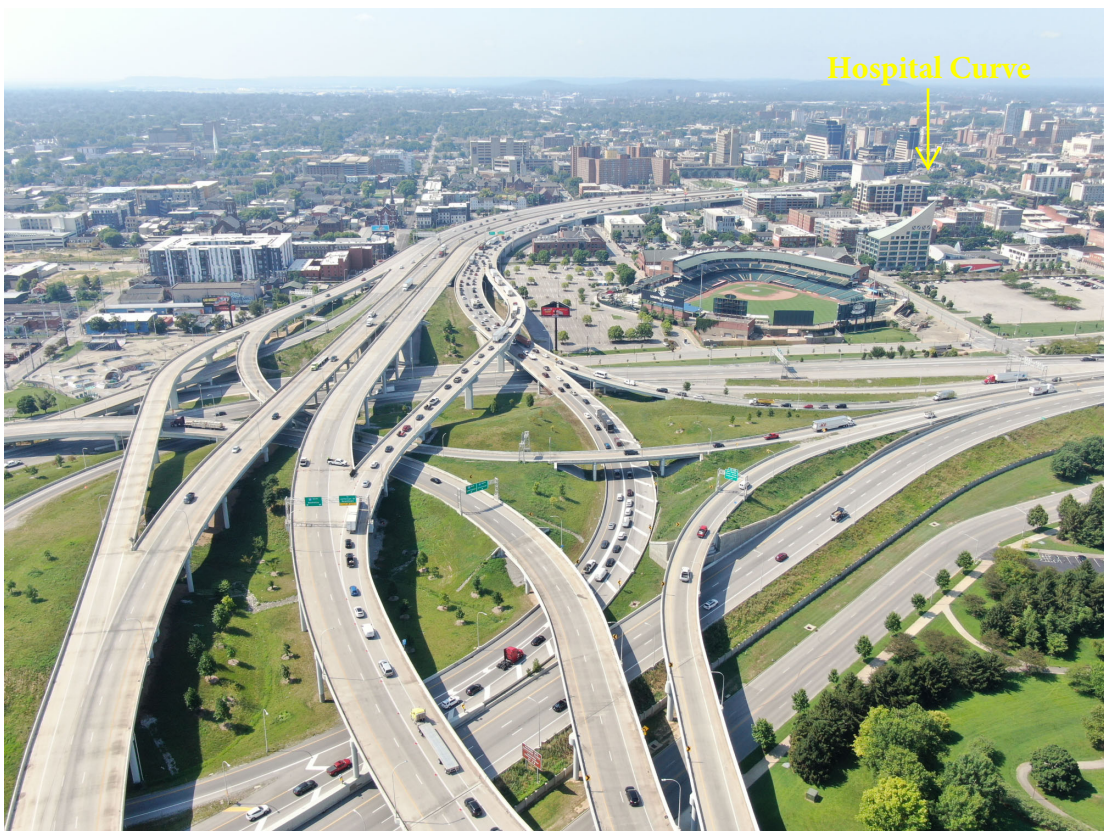
Looking south from Kennedy Bridge towards "Hospital Curve" showing 2+ mile traffic queue

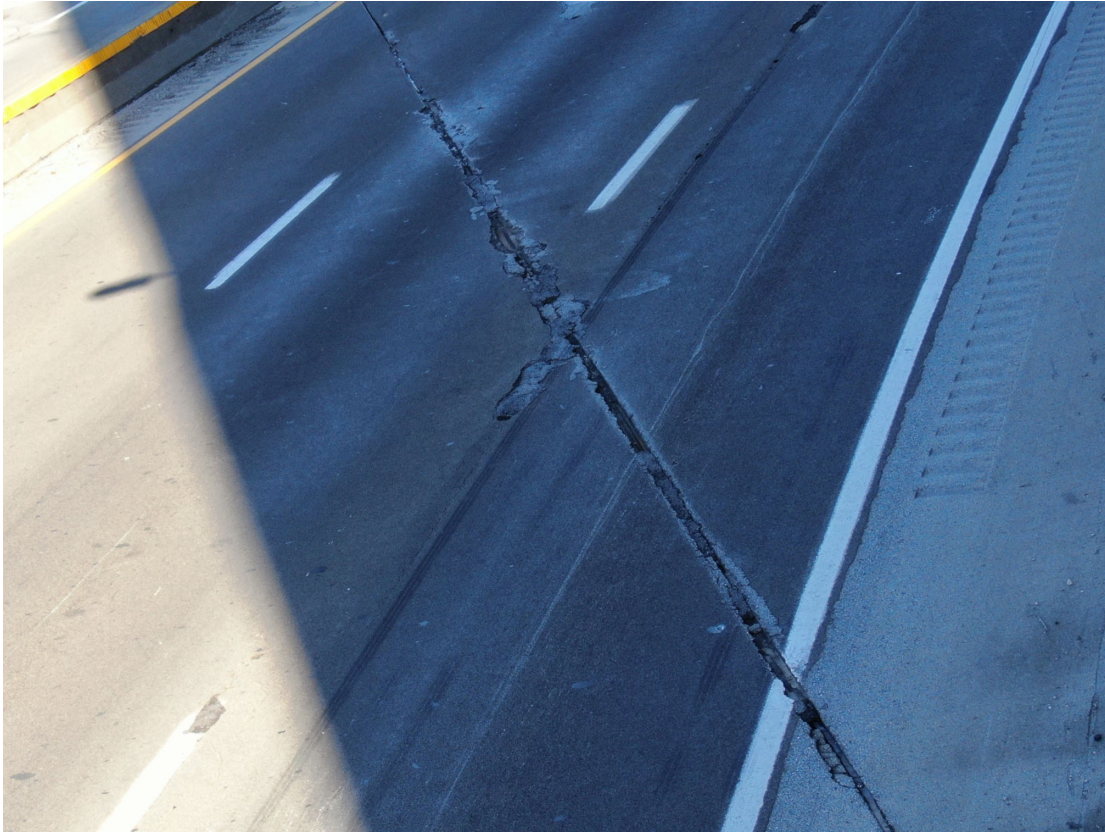
Close-up of joint over Pier 2 NB.

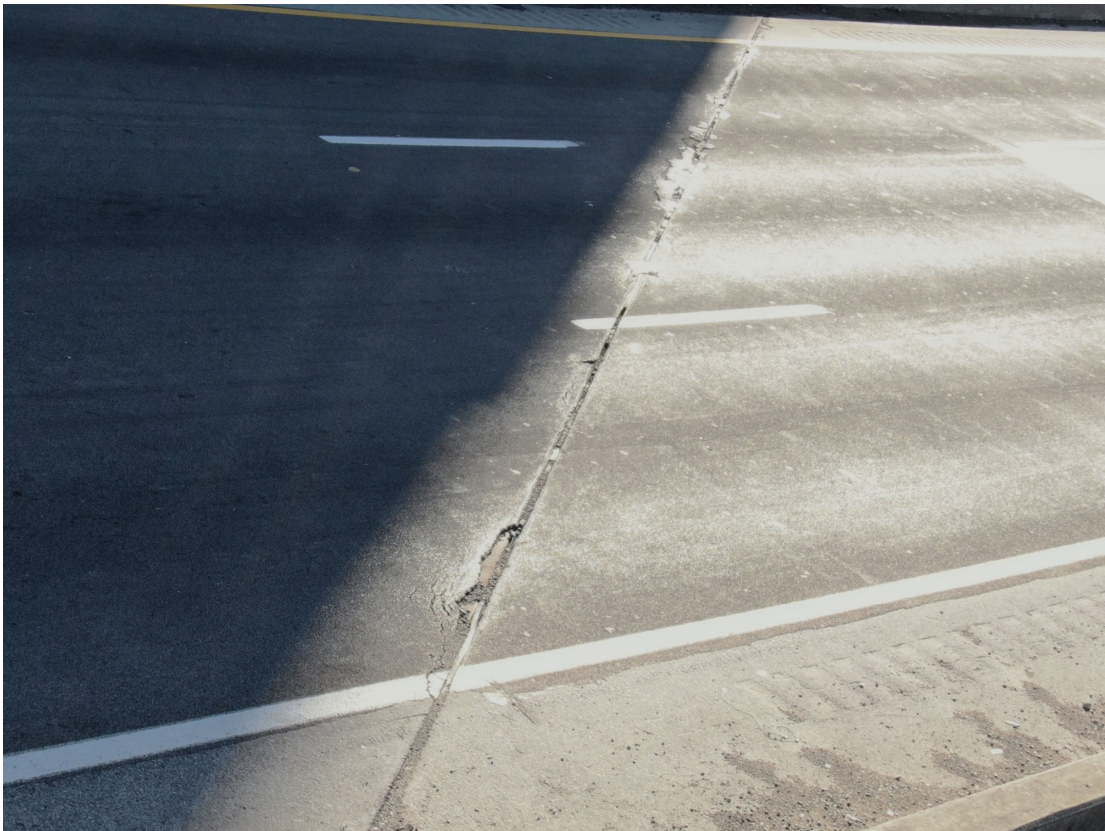
Close-up of joint over Pier 2 SB.

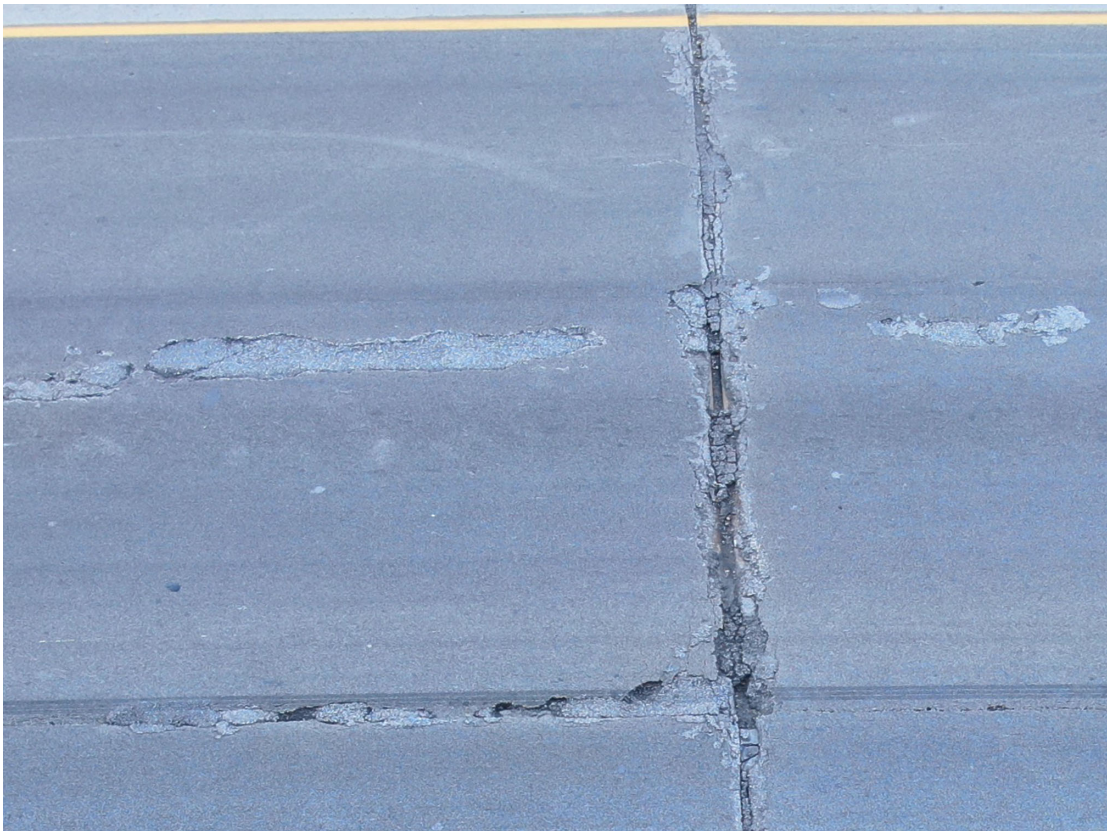
Close-up of Span 2 and the joint over Pier 3.

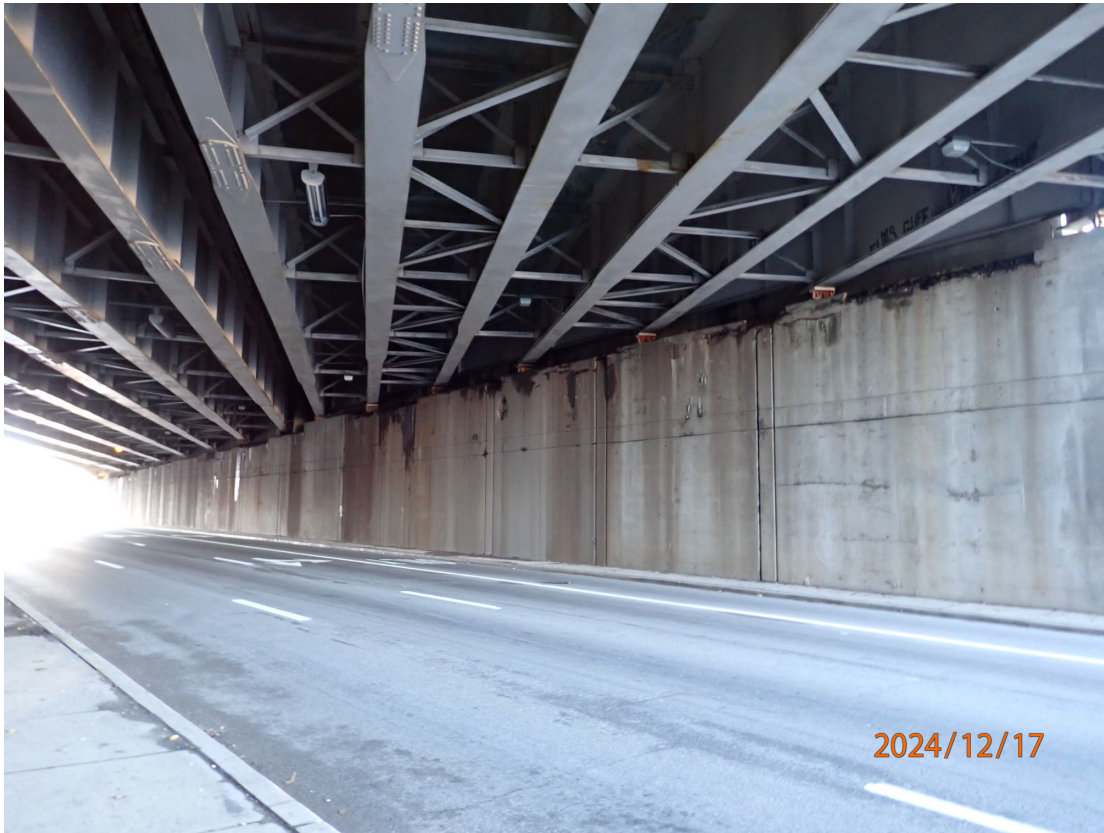
Quantity includes parallel wingwalls at the abutments up to the first joint. Abutment 1 has wide horizontal cracking with efflorescence, large delaminations, and spalling with exposed rebar along the top for roughly half the length. Abutment 6 has closely spaced diagonal cracking and spalling at each end of the backwall, and a large delamination above the sidewalk at the east end. Otherwise, abutments have moderate to wide vertical cracks and delaminations.

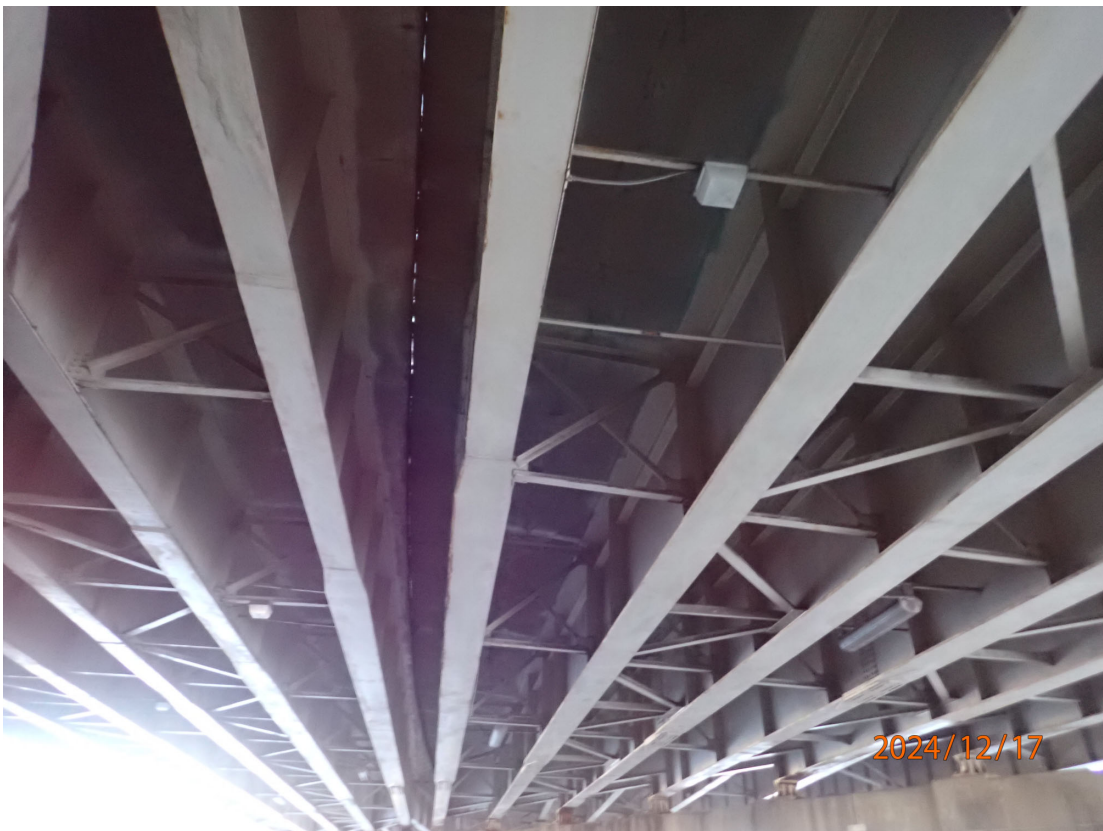
The bottom of the deck has intermittent transverse cracking with efflorescence, spalls with exposed rebar below the joints, and delaminations scattered throughout. In Span 1 SB, the bottom of the deck has areas of full-depth deterioration with leakage in Bays 3 and 4. There's also a spall with exposed rebar in Span 4 NB-Bay 14.

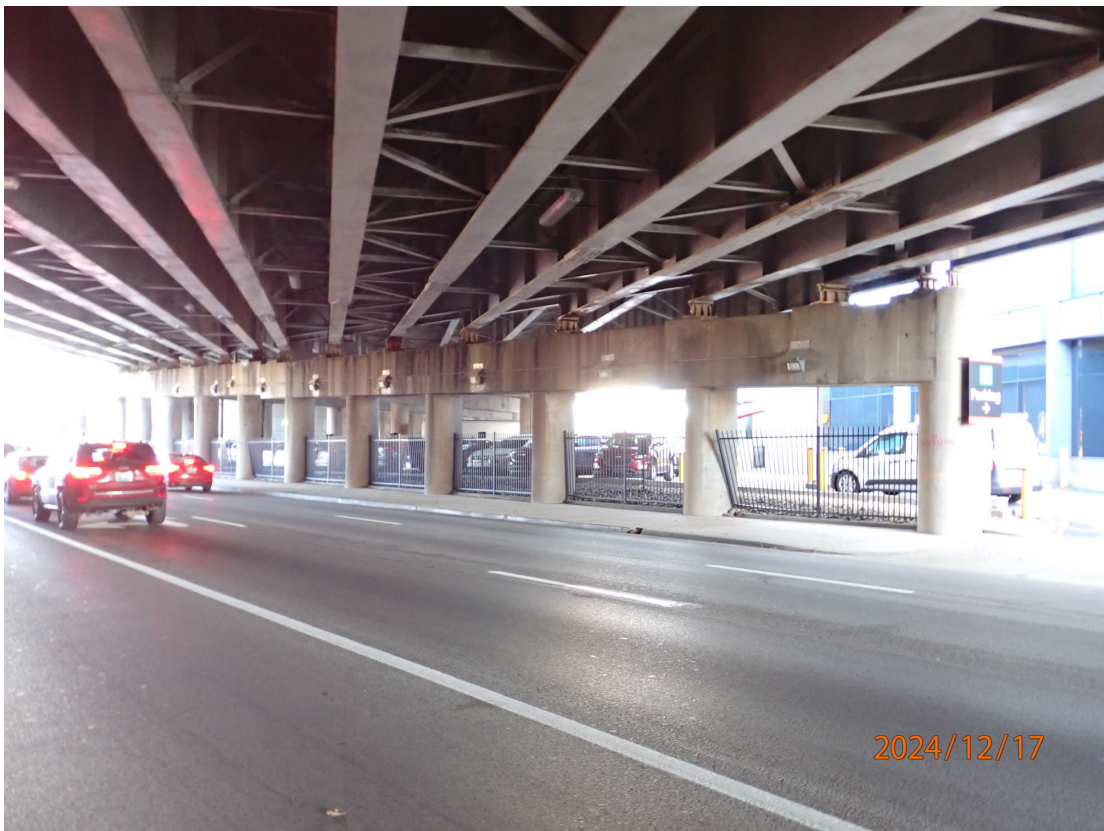
Pier 2 south face

Columns have moderate to wide vertical cracking, delaminated areas, and spalling with exposed rebar; deterioration is worst at Piers 2 and 5. At Pier 2, Column 5 has closely spaced wide cracking and a large spall with exposed rebar and section loss measuring 10 feet tall by 2 feet wide by 2.5 inches deep. Column 6 CFRP repair at Pier 5 is in good condition.

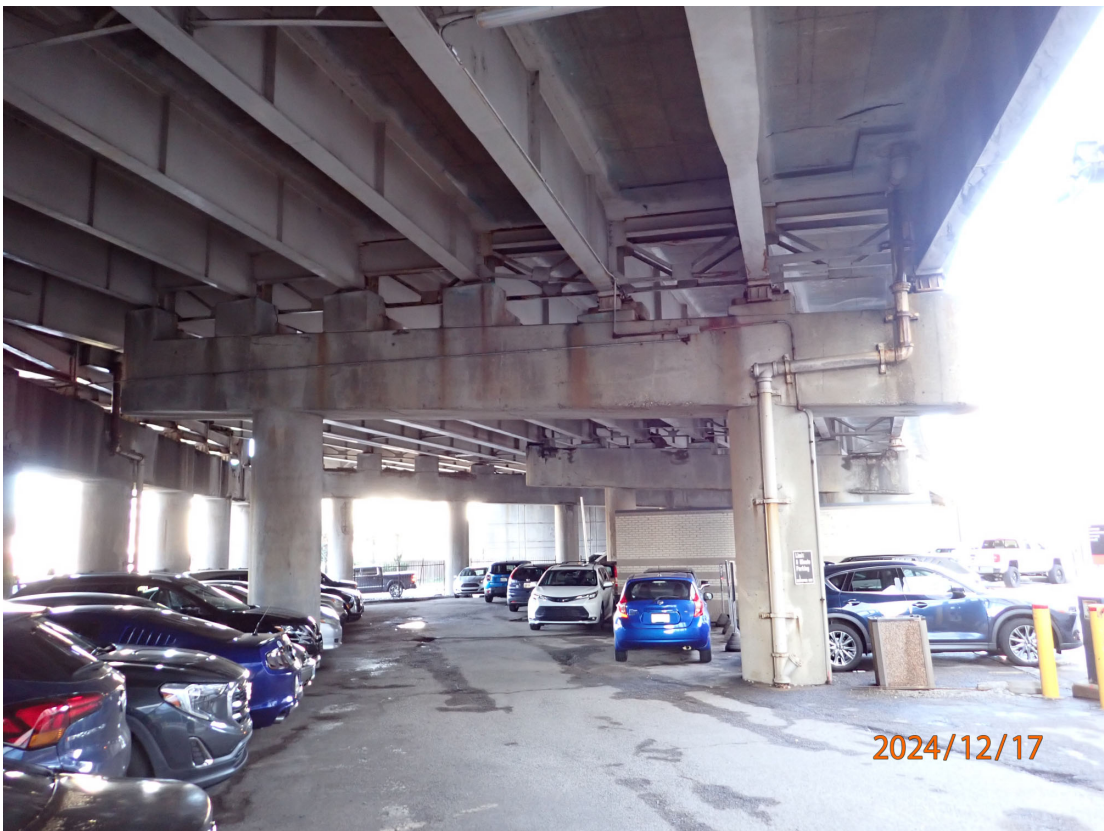
Pier 3 south face

Spalling on the bottom face of Pier. 3 cap at the east end

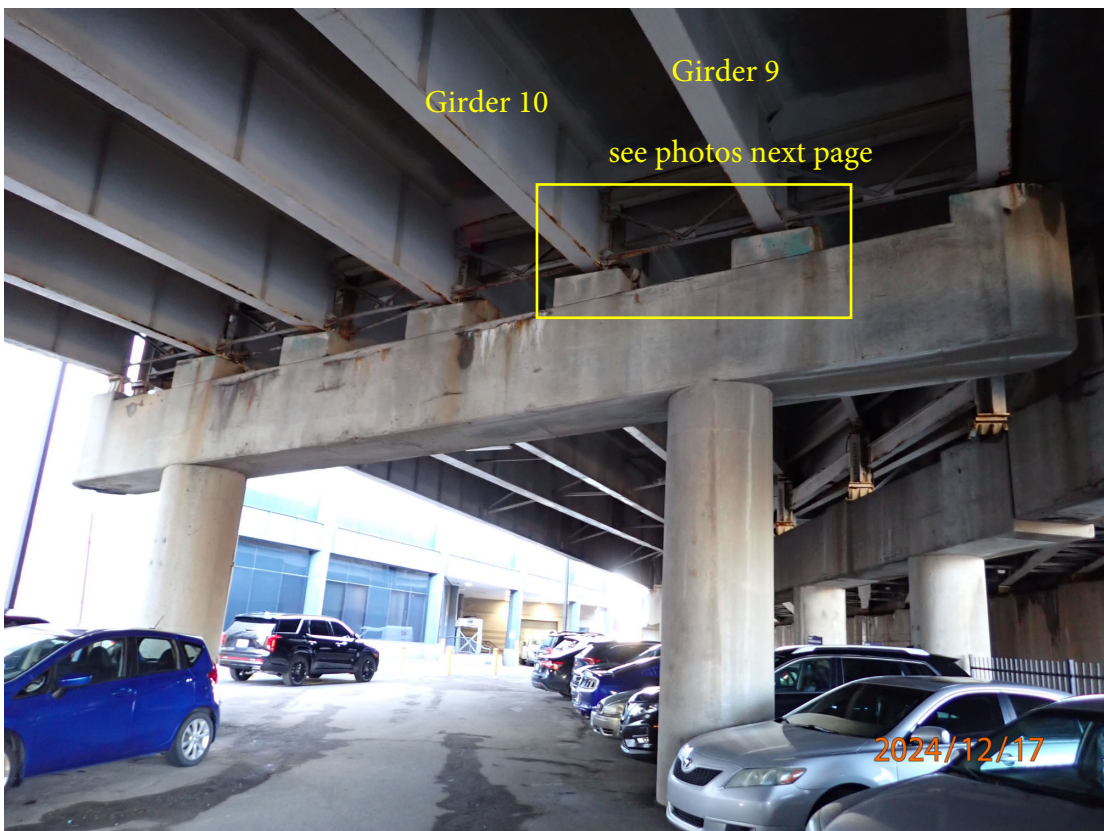
Pier 3 north face

North face of pier 3 cap has wide horizontal cracking under Bays 9-12, some with efflorescence and rust staining.

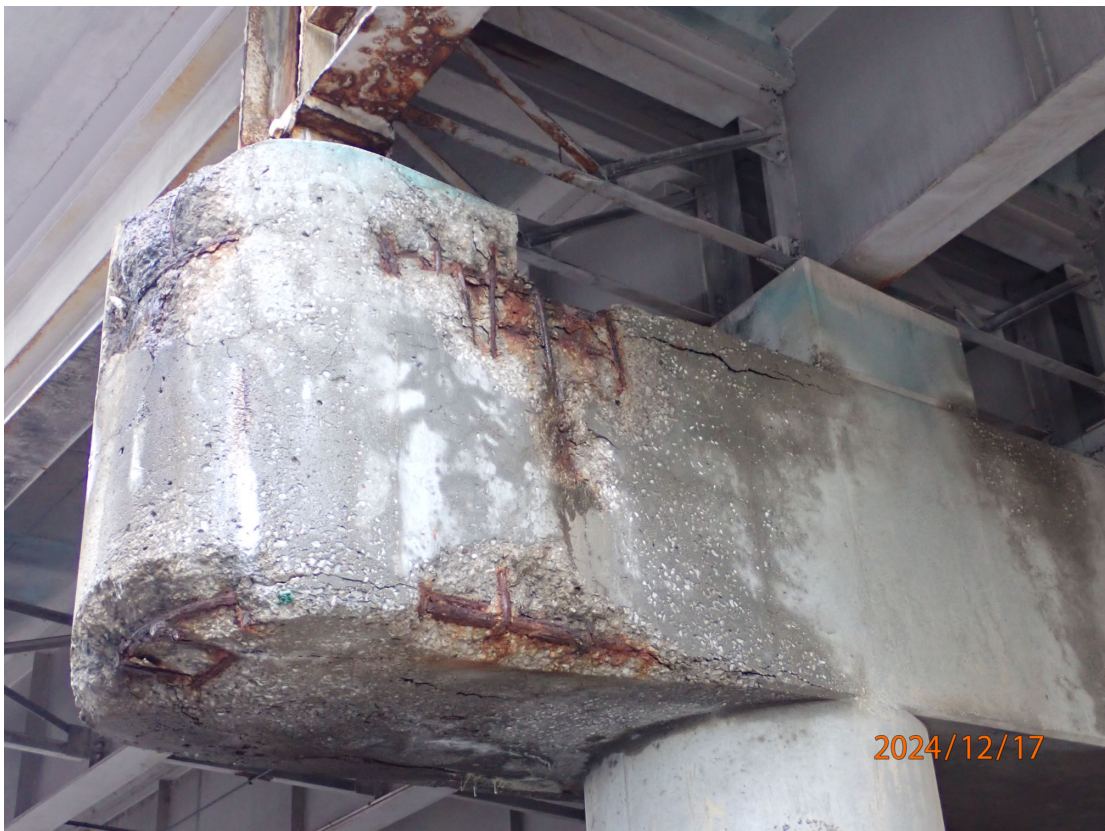
East end of the north face of Pier 4 cap.

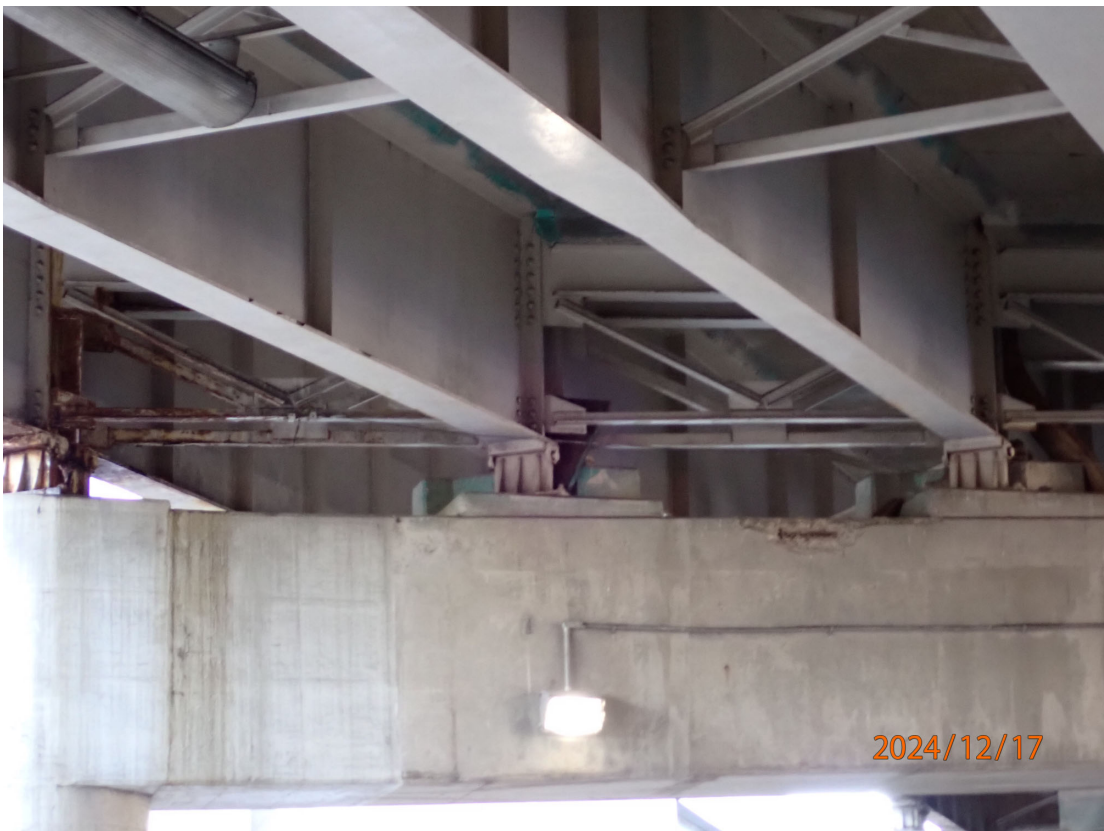
Pier 5 typical bearings
