KENTUCKY PUBLIC RIVERPORT CONSTRUCTION AND MAINTENANCE (KPRCM) APPLICATION

Barge Cell Revitalization – Phase II

Marine Solutions, Inc. (Marine Solutions) performed an inspection on the Paducah-McCracken County Riverport Authority Bulk Commodity Berth and General Cargo Berth from December 9 through December 13, 2024. The primary purpose of the inspection was to investigate the current condition of the mooring cells along the berthing line and provide a summary of recommended repairs to extend the service life of the facilities. The inspected structures included four mooring cells on the Bulk Commodity Berth (BCB) and five mooring cells on the General Cargo Berth (GCB). The inspection consisted of a below and above water examination of the cells, including the condition of the sheet piles, cell caps, and amount of aggregate fill material contained within the cell.

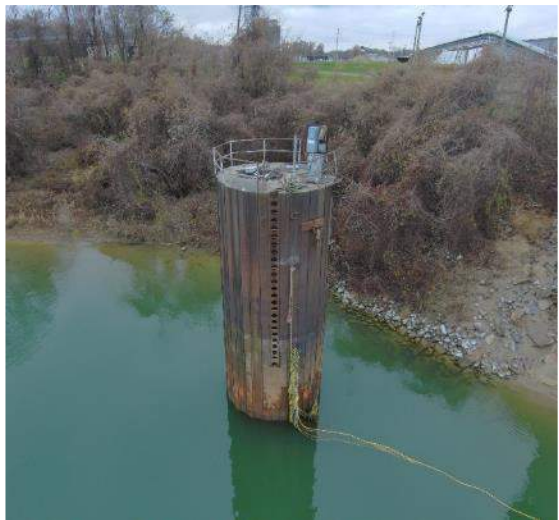
Structure: BCB 1

Team Leader: Joseph Guthrie			
Inspection Type: Baseline			
General Conditions			
Overall Rating: Poor			
Corrosion: Major			
Split Interlocks: Yes		Holes: Yes	
Loss of Ballast: Yes		Impact Damage: Yes	
Broken Moorings: No		Ladder Damage: Yes	
Waterway Information			
Water Surface Elevation:		301.9 feet NAVD88	
Normal Pool/Tide Range:		301.7 feet NAVD88	
Reference:		USGS Gauge 03611000

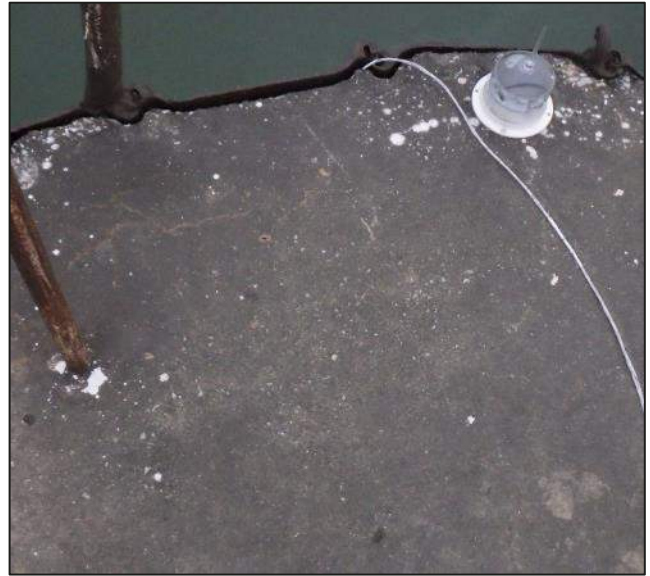
Photograph 6 View of the typical concrete condition.

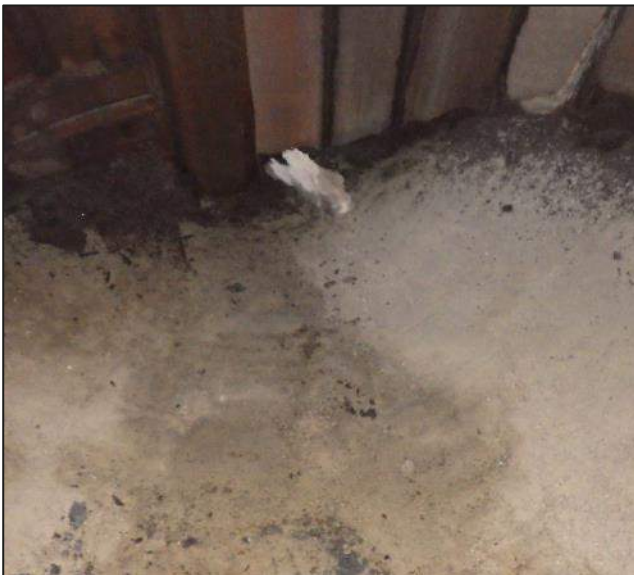
Photograph 7 View of the fill material inside the cell.

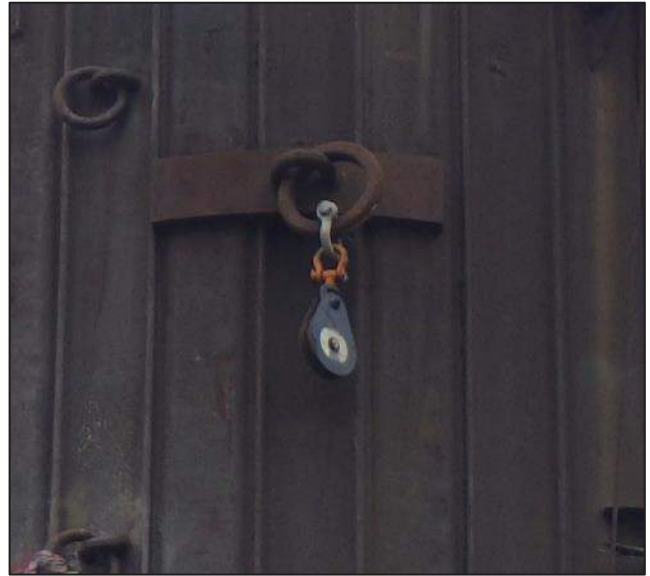
Photograph 10 View of additional mooring ring on Sheet 35.

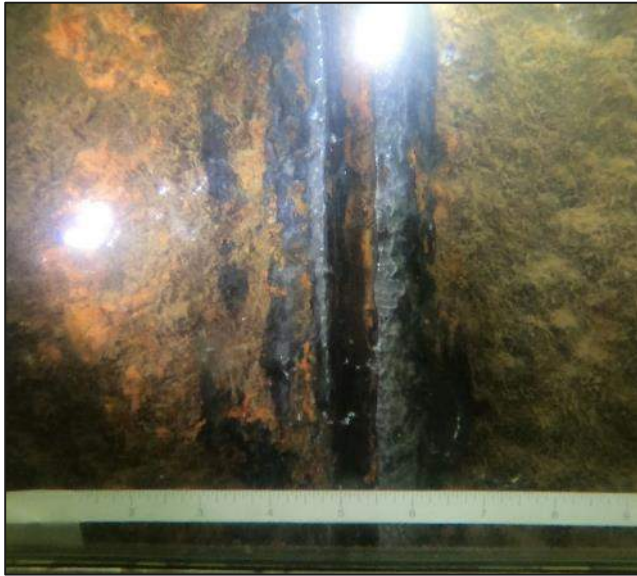
Photograph 13 Underwater view of split interlock between Sheet 1 and Sheet 2.

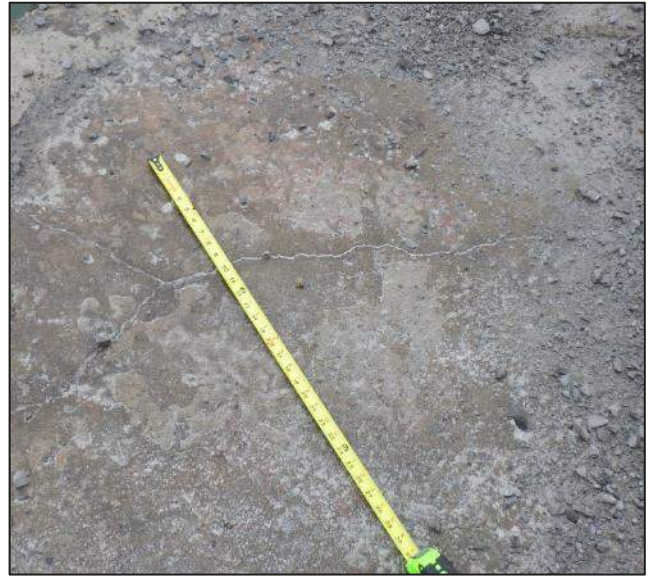
Photograph 6 View of typical concrete condition.

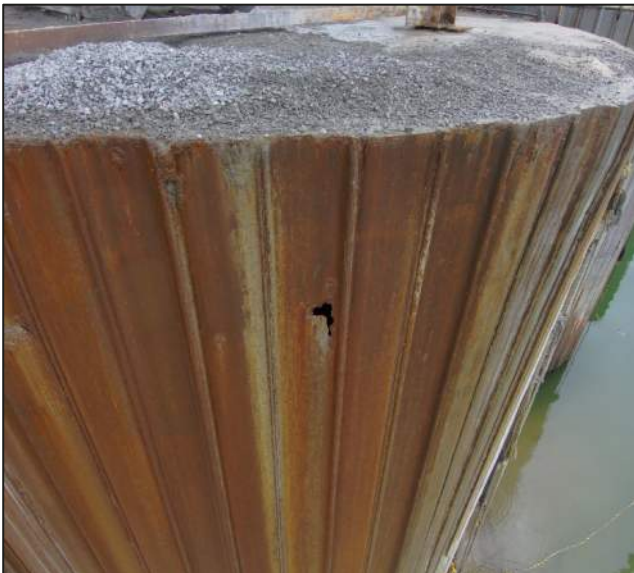
Photograph 11 View of hole on Sheet 7.

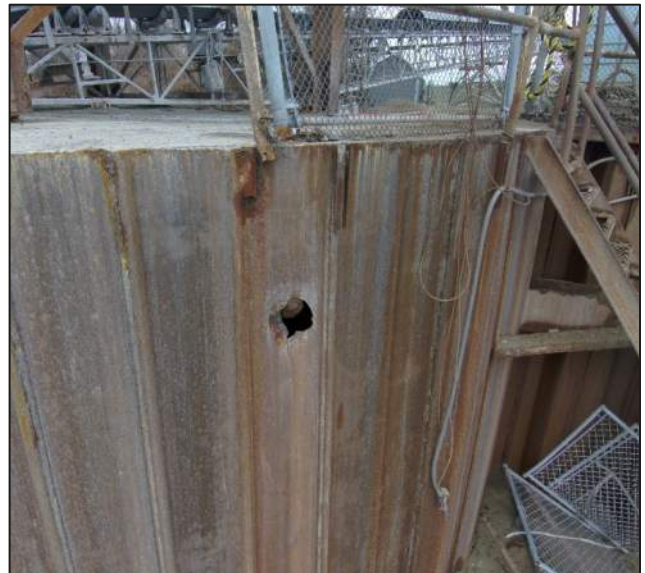
Photograph 12 View of hole on Sheet 62.

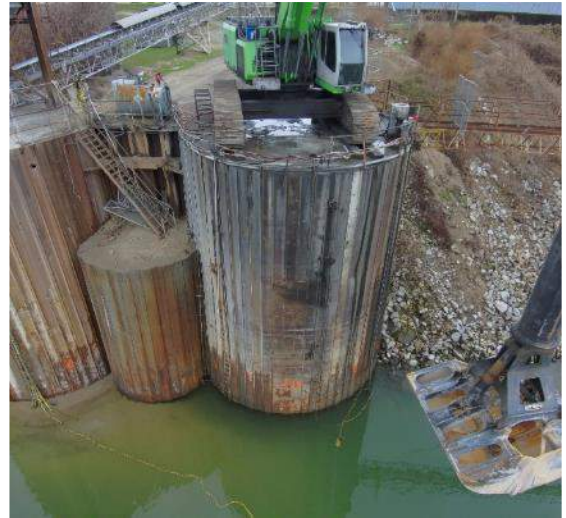
Structure: BCB 3

Team Leader: Joseph Guthrie	
Inspection Type: Baseline	
General Conditions	
Overall Rating: Poor	
Corrosion: Major	
Split Interlocks: Yes	Holes: No
Loss of Ballast: No	Impact Damage: Yes
Broken Moorings: No	Ladder Damage: Yes
Waterway Information	
Water Surface Elevation: 301.9 feet NAVD88	
Normal Pool/Tide Range: 301.7 feet NAVD88	
Reference: USGS Gauge 03611000

Average Sheet Pile Web Thickness Readings By Zone			Average Cell Band Thickness Readings By Location			
Original Thickness (in.): 0.375			Location	Original Thickness (in.)	Remaining Thickness (in.)	% Remaining
Zone	Remaining Thickness (in.)	% Remaining	Top of Cell	-	-	-
Top of Cell	0.346	92.3%	Above Water	-	-	-
Above Water	0.286	76.2%	Waterline	-	-	-
Waterline	0.324	86.4%	Mid-Depth	-	-	-
Mid-Depth	-	-	Mudline	-	-	-
Mudline	0.300	80.0%

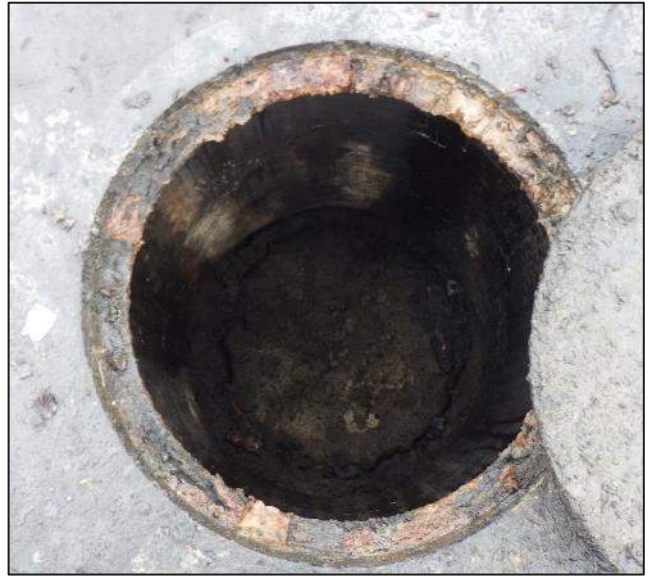
Photograph 6 View of open ballast height.

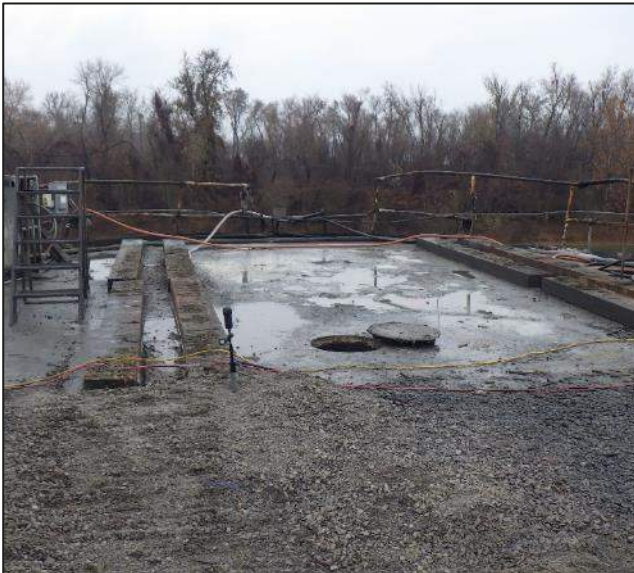
Photograph 7 View of typical condition of concrete cap.

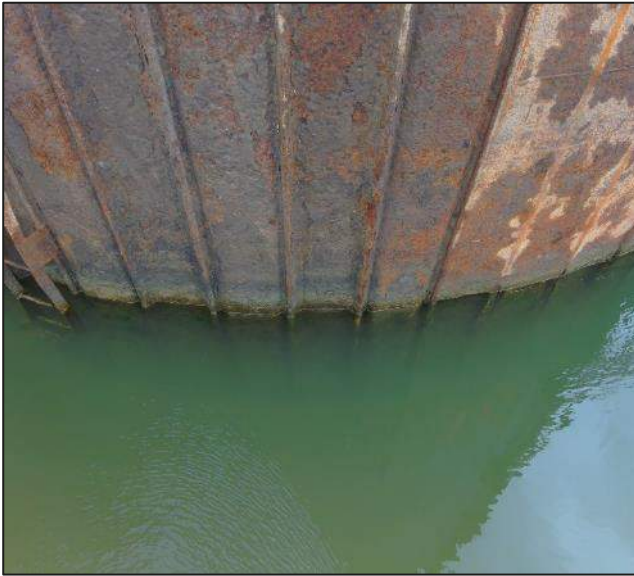
Photograph 13 View of typical waterline condition.

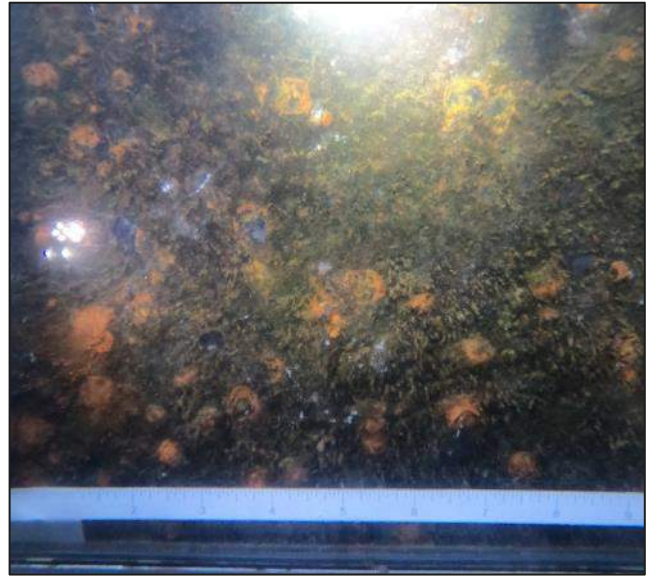
Photograph 14 Underwater view of typical sheet pile condition.

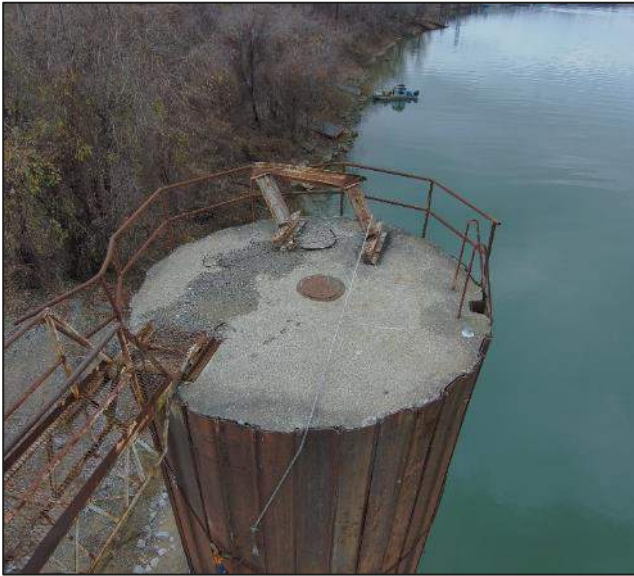
Photograph 5 View of BCB 4 concrete cap.

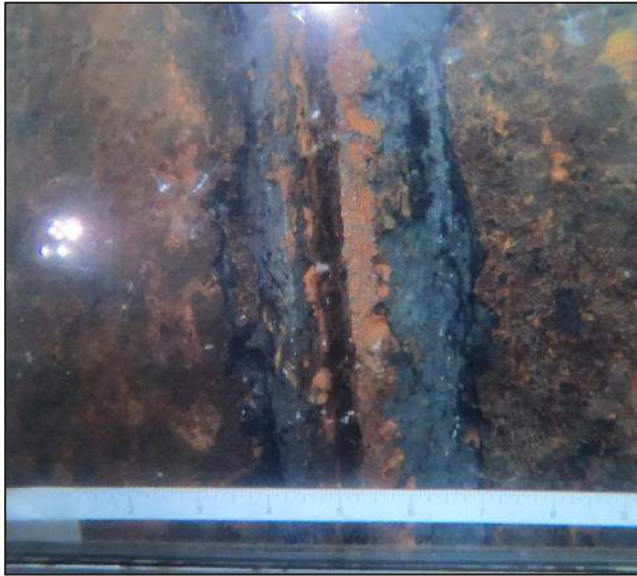
8. A split interlock was observed between Sheet 37 and Sheet 38 from approximately elevation 300.9 feet NAVD88 to approximately elevation 294.9 feet NAVD88 up to 1-1/2 inch wide with no exposed ballast.

Photograph 9 Underwater view of split interlock between Sheet 37 and Sheet 38.

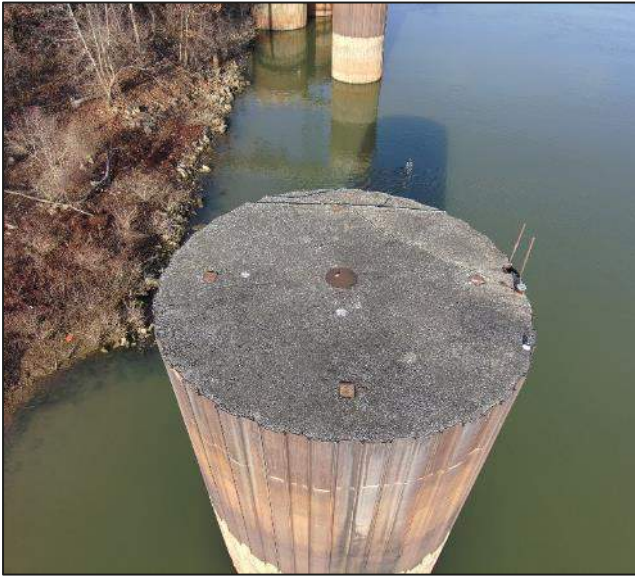
Photograph 5 View of CGB 1 concrete cap.

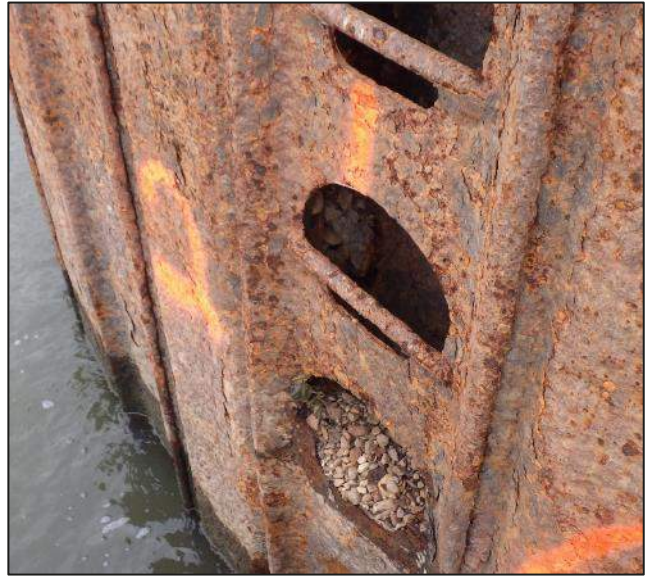
Photograph 6 View of split pan sheet with active loss of fill on Sheet 1.

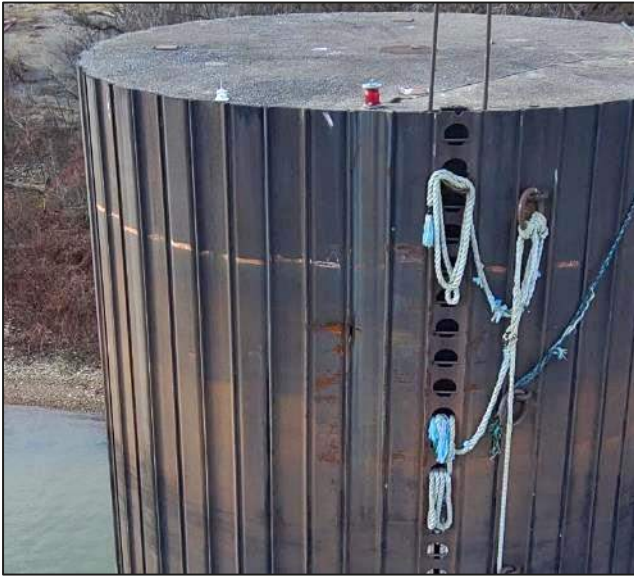
Photograph 9 View of interlock hole between Sheet 3 and Sheet 4.

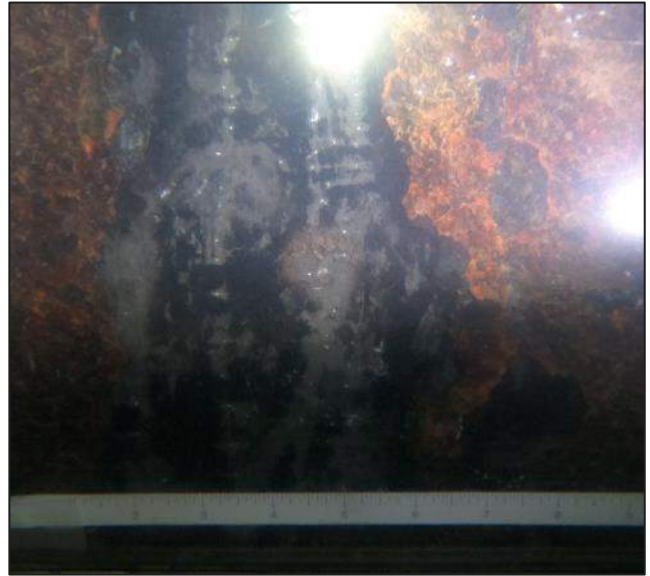
Photograph 10 Underwater view of typical sheet pile condition.

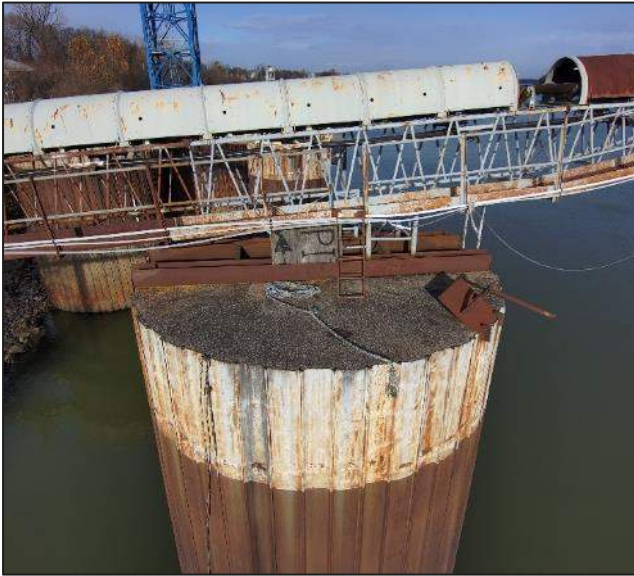
Photograph 5 View of CGB 2 concrete cap.

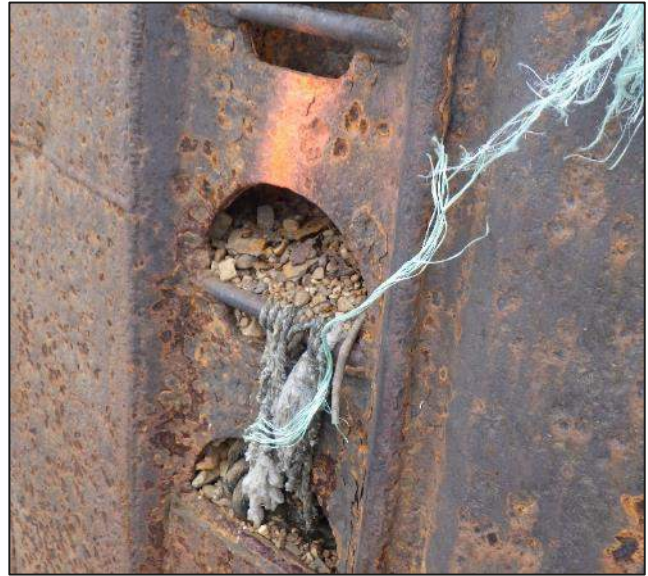
Photograph 6 View of pan sheet with active loss of fill.

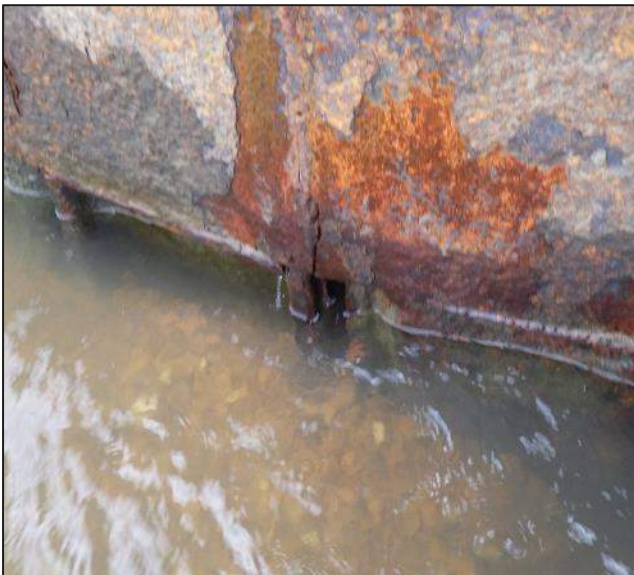
Photograph 7 View of split interlock between Sheet 2 and Sheet 3 showing exposed fill material.

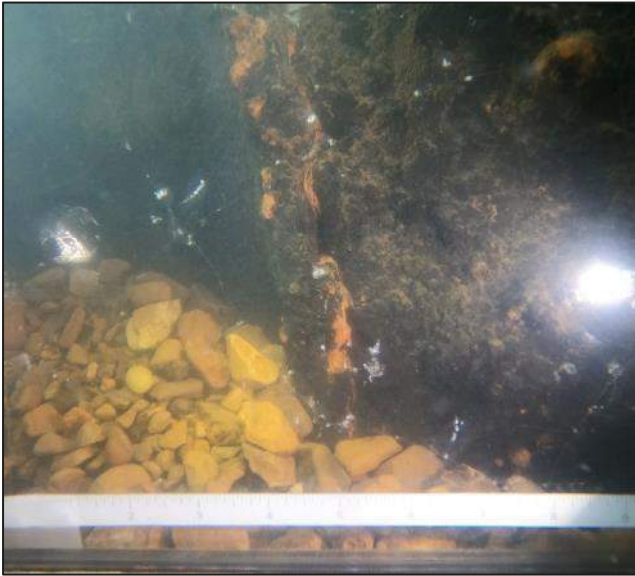
Photograph 13 Underwater view of split between Sheet 48 and Sheet 1

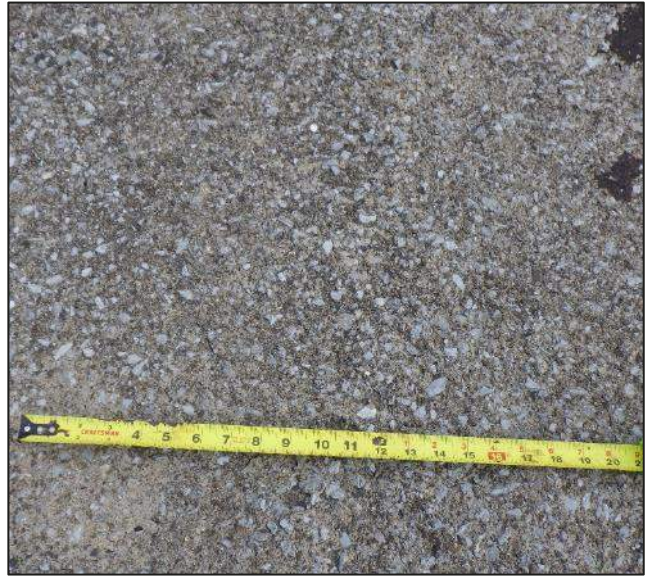
Photograph 6 View of the typical concrete condition.

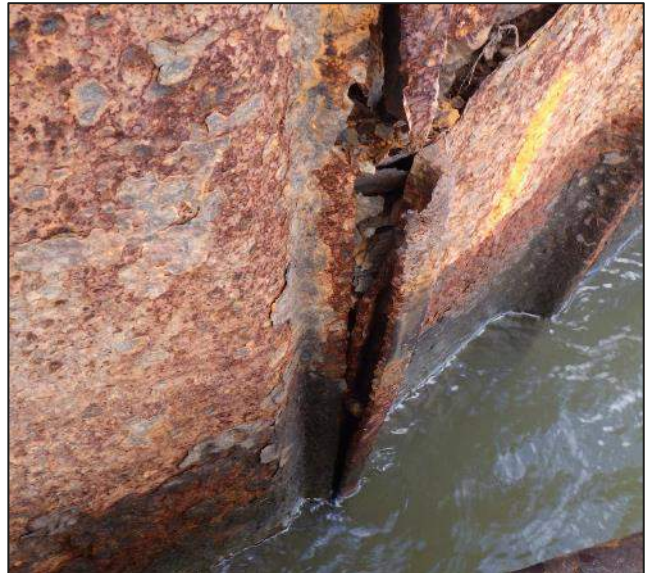
Photograph 8 View of split interlock between Sheet 1 and Sheet 2.

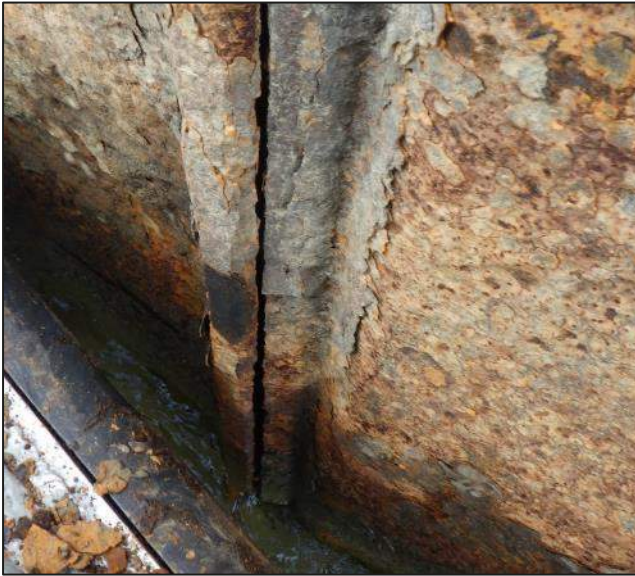
Photograph 9 View of split interlock between Sheet 2 and Sheet 3.

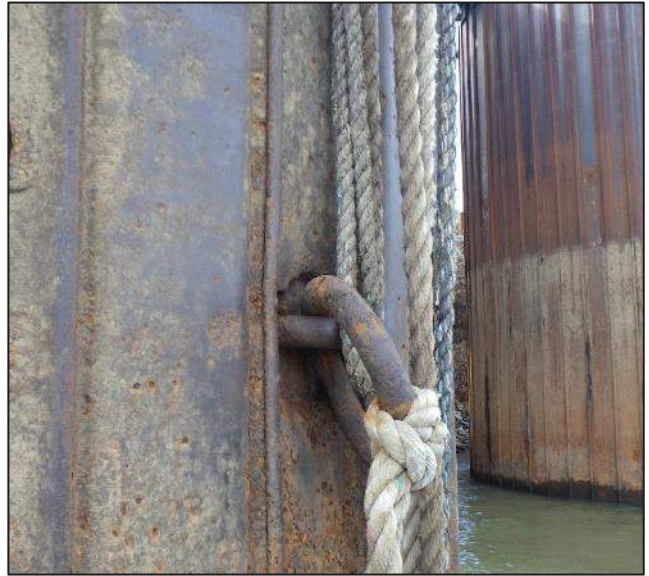
Photograph 10 View of impacted mooring ring on Sheet 37.

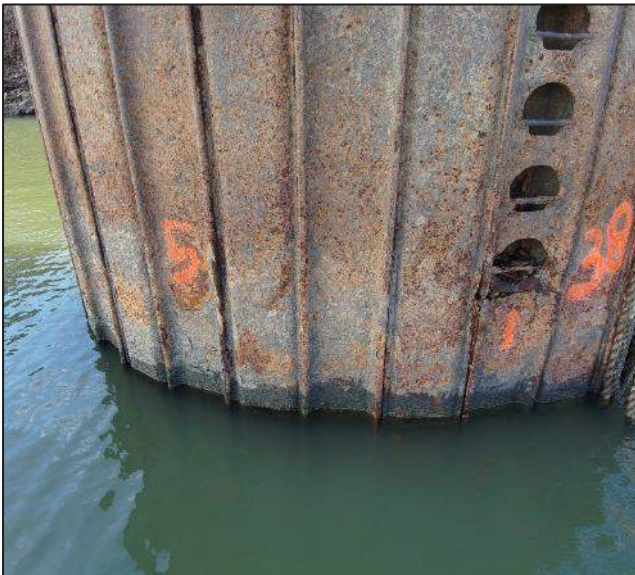
Photograph 11 View of the typical waterline condition.

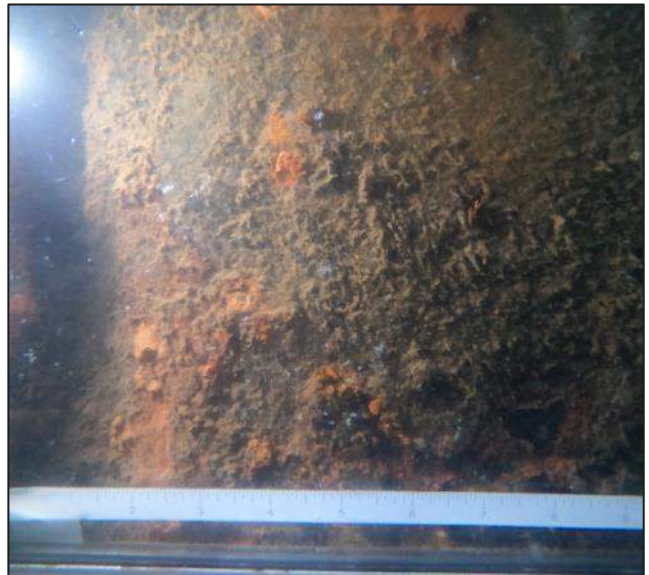
Photograph 12 Underwater view of typical condition of sheet piles.

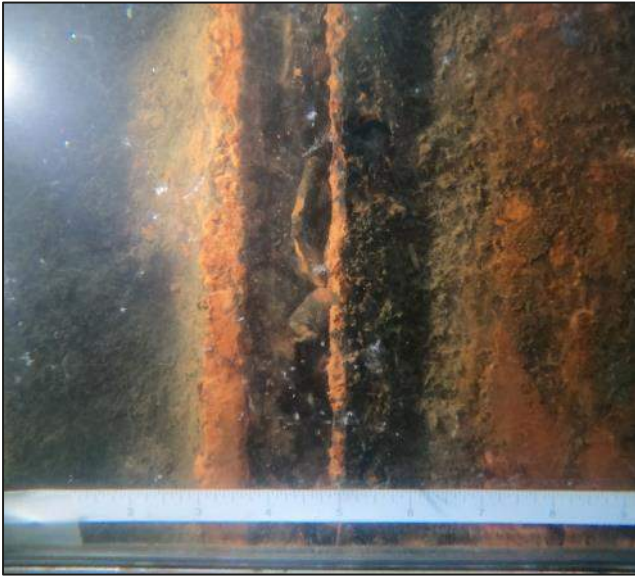
Photograph 13 Underwater view of split between Sheet 2 and Sheet 3

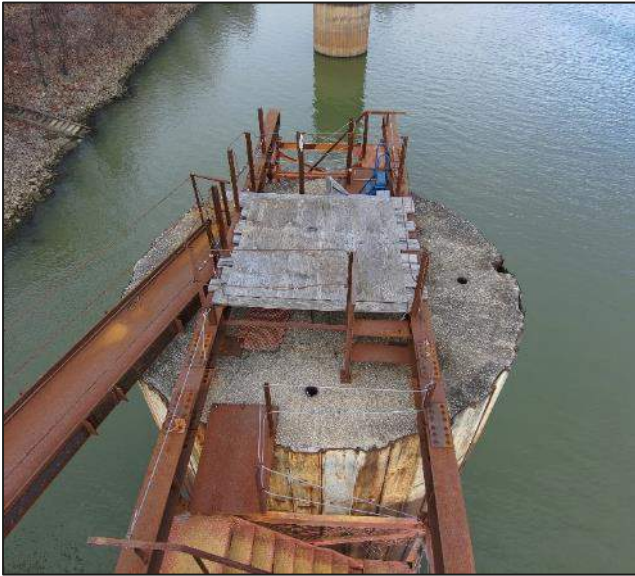
Photograph 5 View of CGB 5 concrete cap.

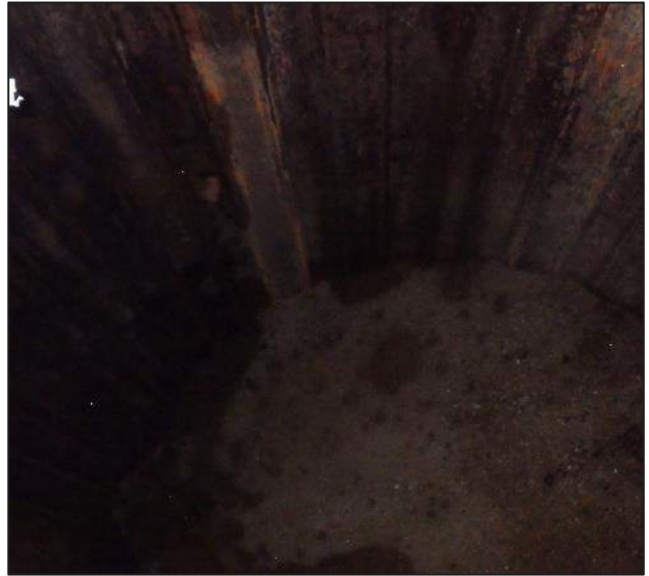
Photograph 6 View of ballast height inside cell.

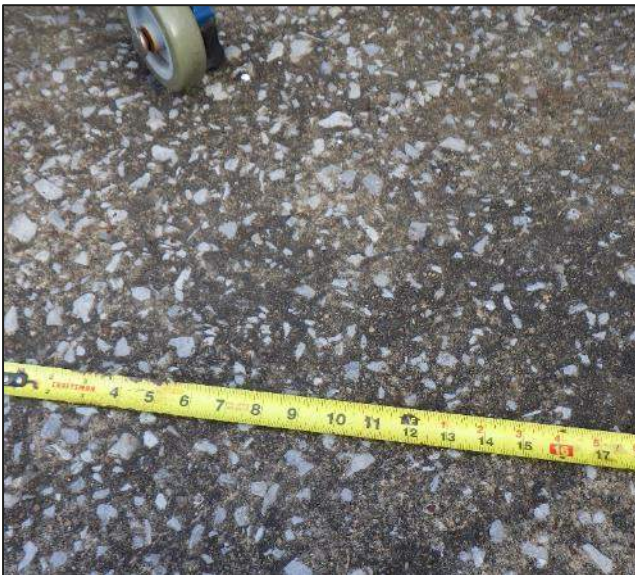
Photograph 7 View of the typical concrete condition.

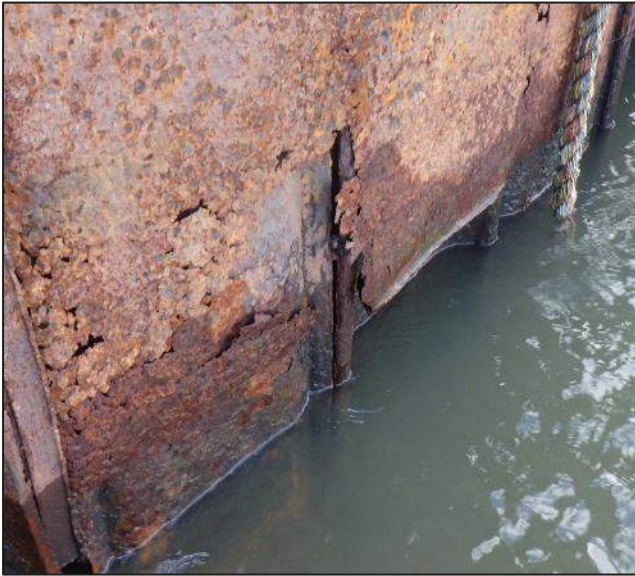
1. A split interlock was observed between Sheet 1 and Sheet 2 from approximately elevation 304.9 feet NAVD88 where the split extends underneath a patch plate to approximately elevation 298.9 feet NAVD88 up to 3 inches wide with exposed ballast, creating a pile of ballast on the channel bottom at the bottom of the split.

4. The patch plate is severely corroded and exhibits 100% loss of section between Sheet 1 and Sheet 2 from the waterline to approximately elevation 302.9 feet NAVD88.

Photograph 9 View of split interlock between Sheet 1 and Sheet 2.

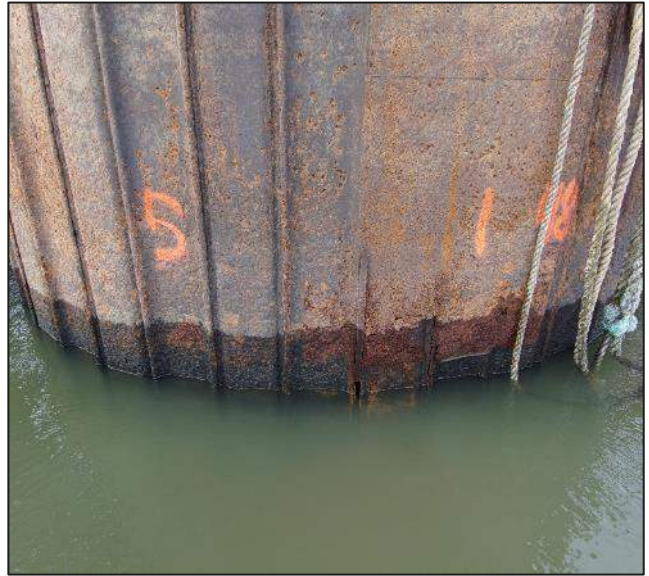
Photograph 10 View of the typical waterline condition.

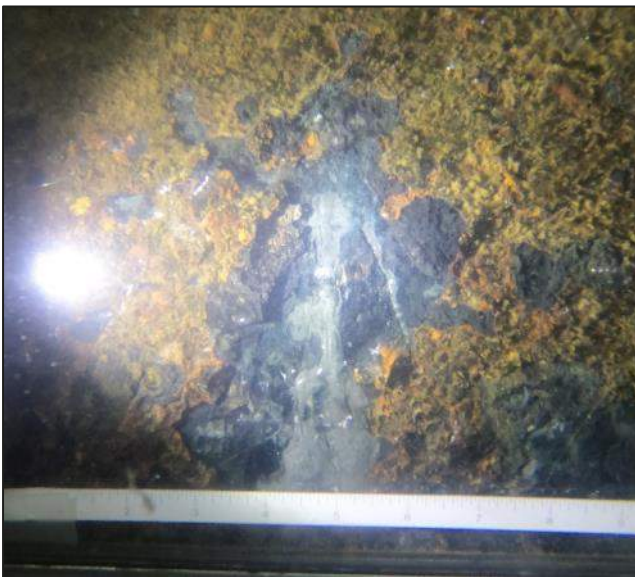
Photograph 11 Underwater view of typical sheet pile condition.

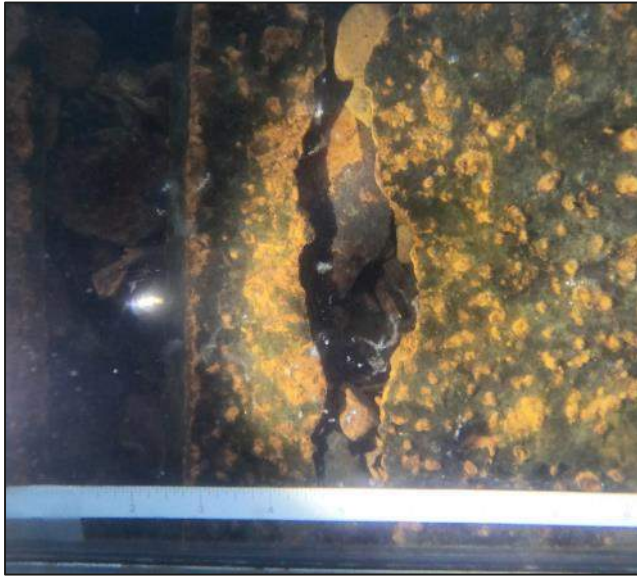
Photograph 13 Underwater view of split web on Sheet 2.

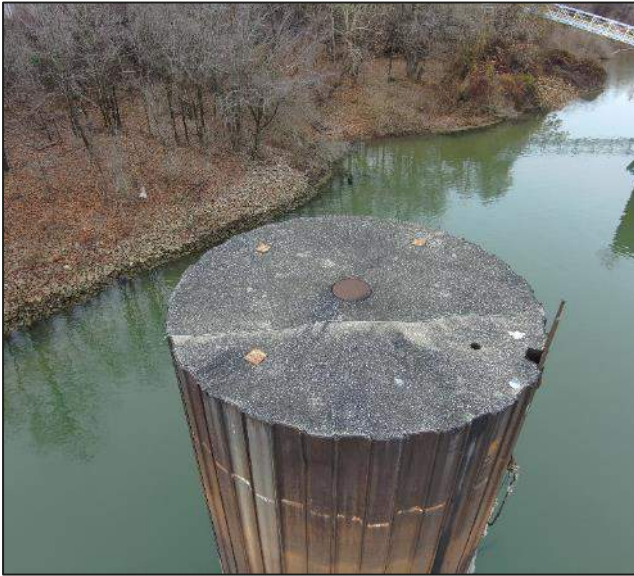
Photograph 5 View of CGB 6 concrete cap.

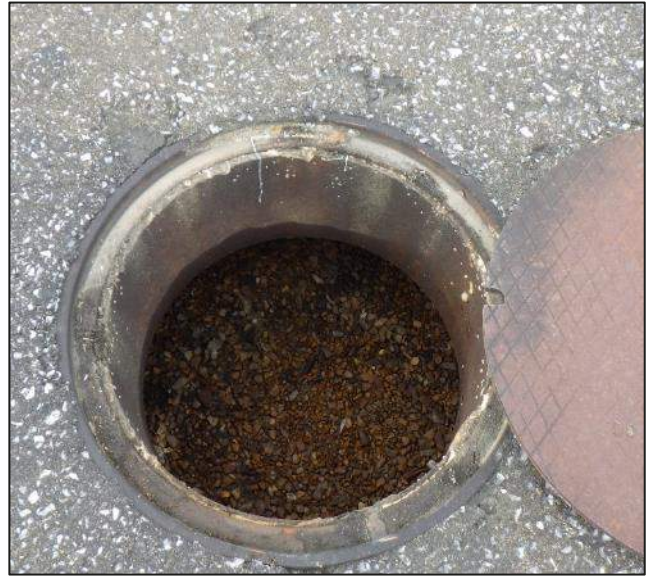
Photograph 6 View of the ballast height of the cell.

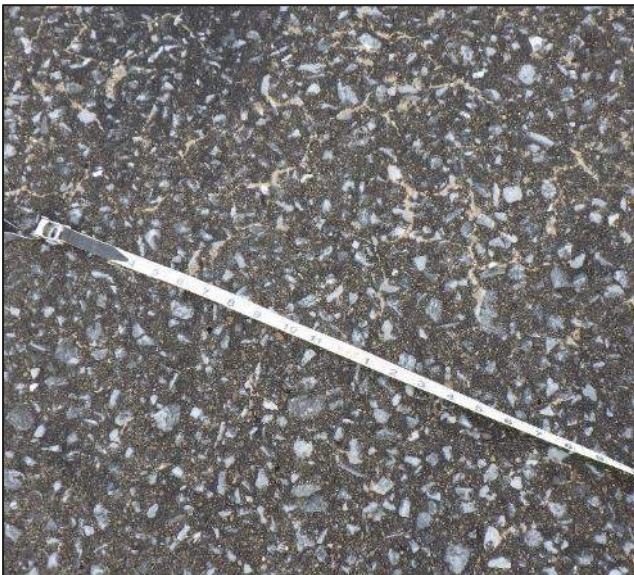
Photograph 7 View of the typical concrete condition.

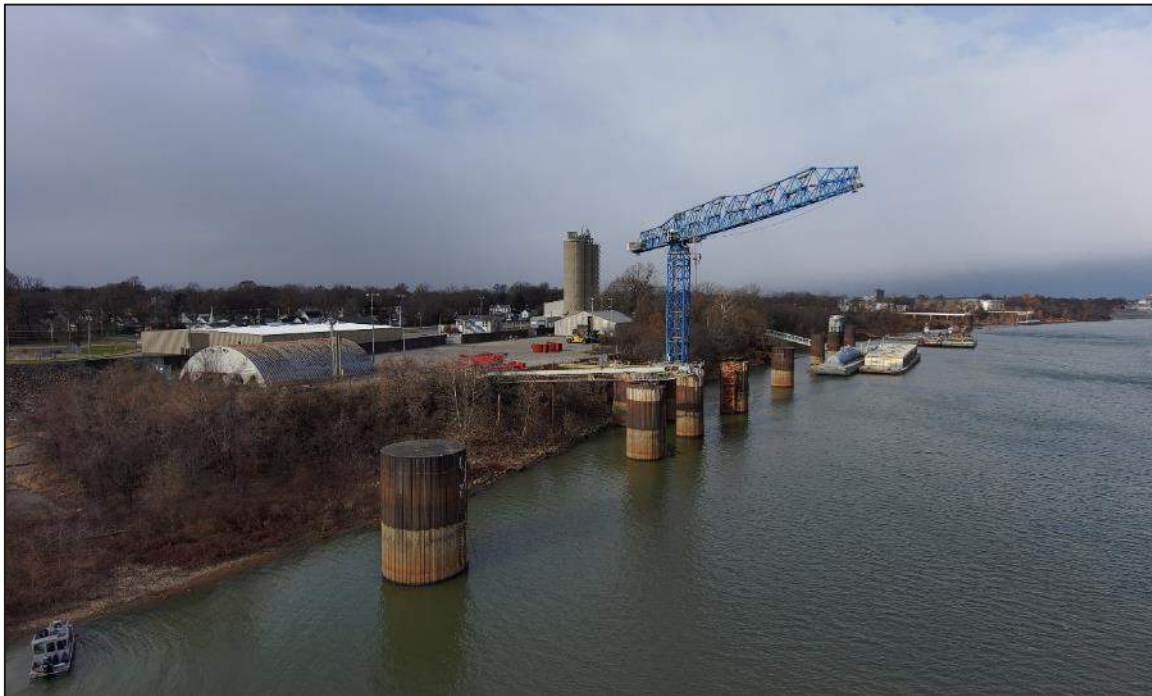
Photograph 1 Overview of the General Cargo Berth, looking northwest

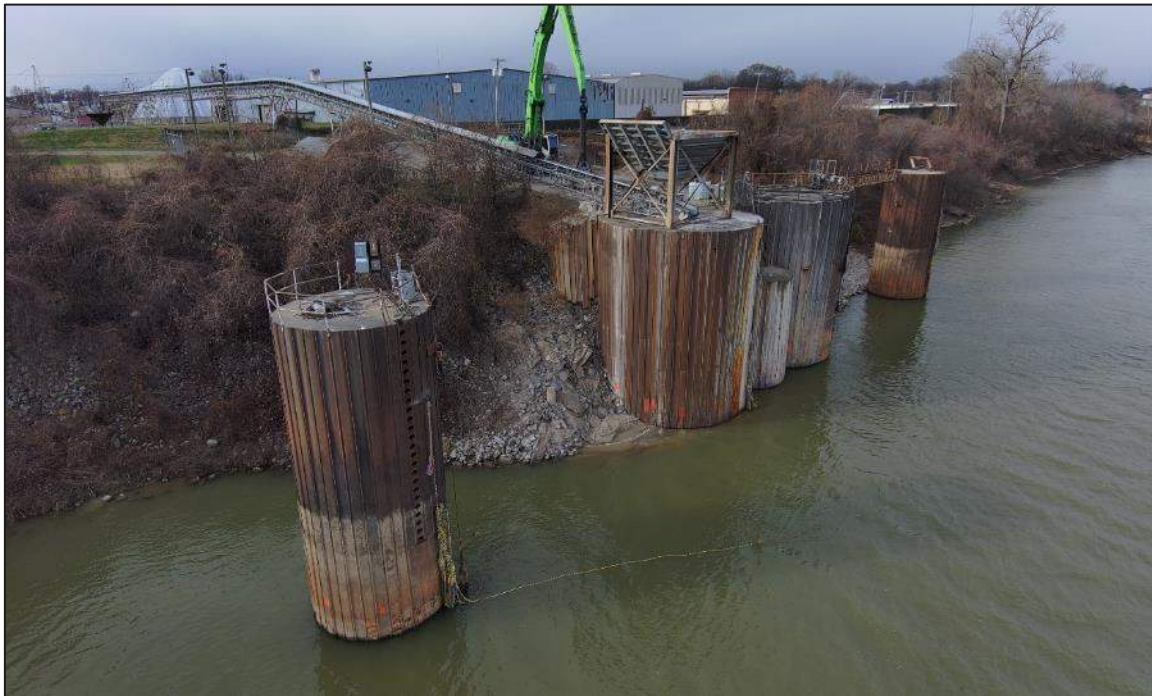
Photograph 3 Overview of the Bulk Commodity Berth, looking northwest

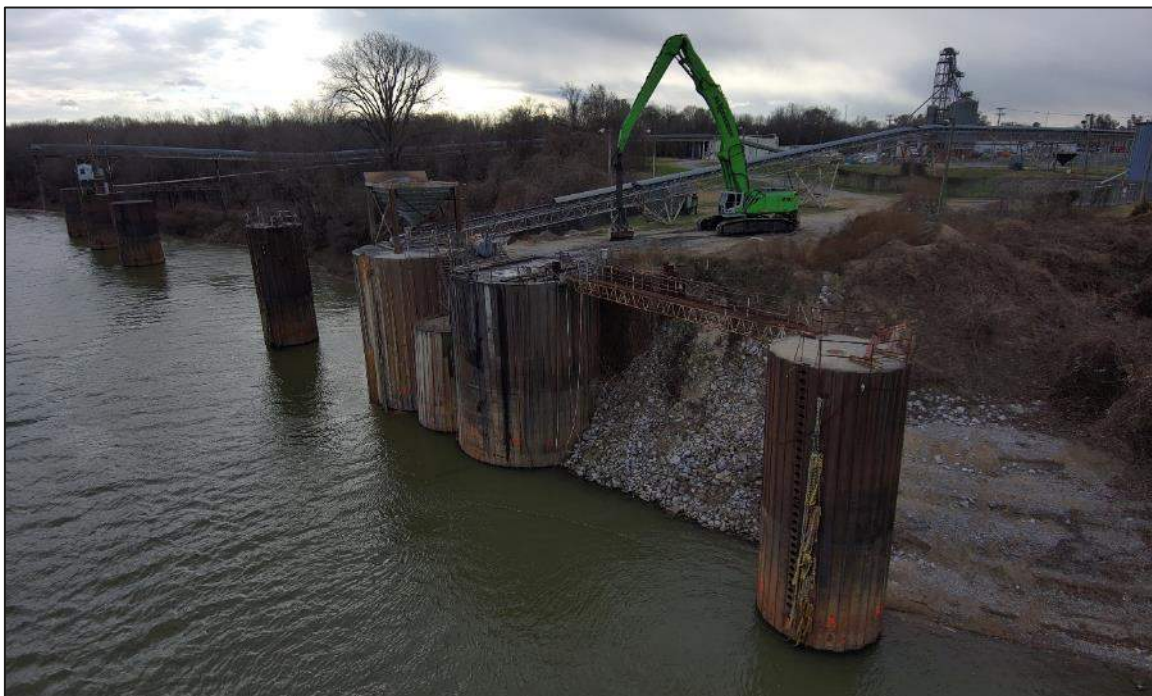
Photograph 4 Overview of the Bulk Commodity Berth, looking southwest
