November 11, 2020

RE: Cultural Historic Overview Survey for
the KY 52 Planning Study in
Boyle and Garrard Counties, Kentucky
(Item No. 7-104.00)
CRA Project No.: K20Q008
Contract Publication Series: 20-425

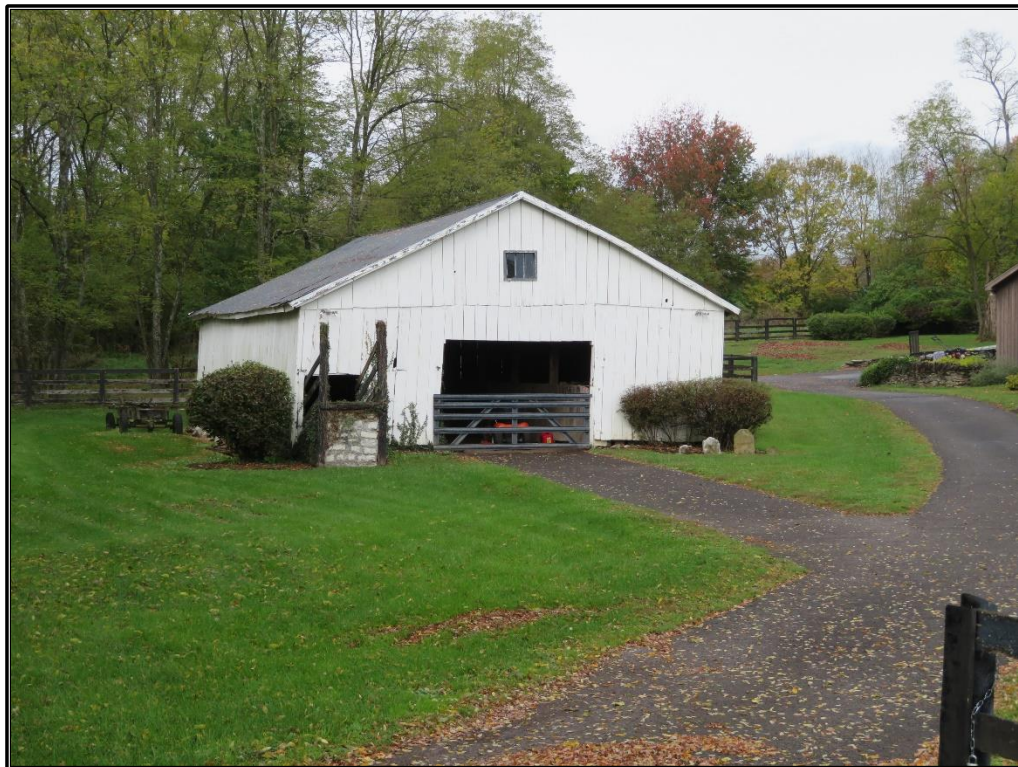
Figure 4. BO 311: Garage (Resource A), looking north-northwest.

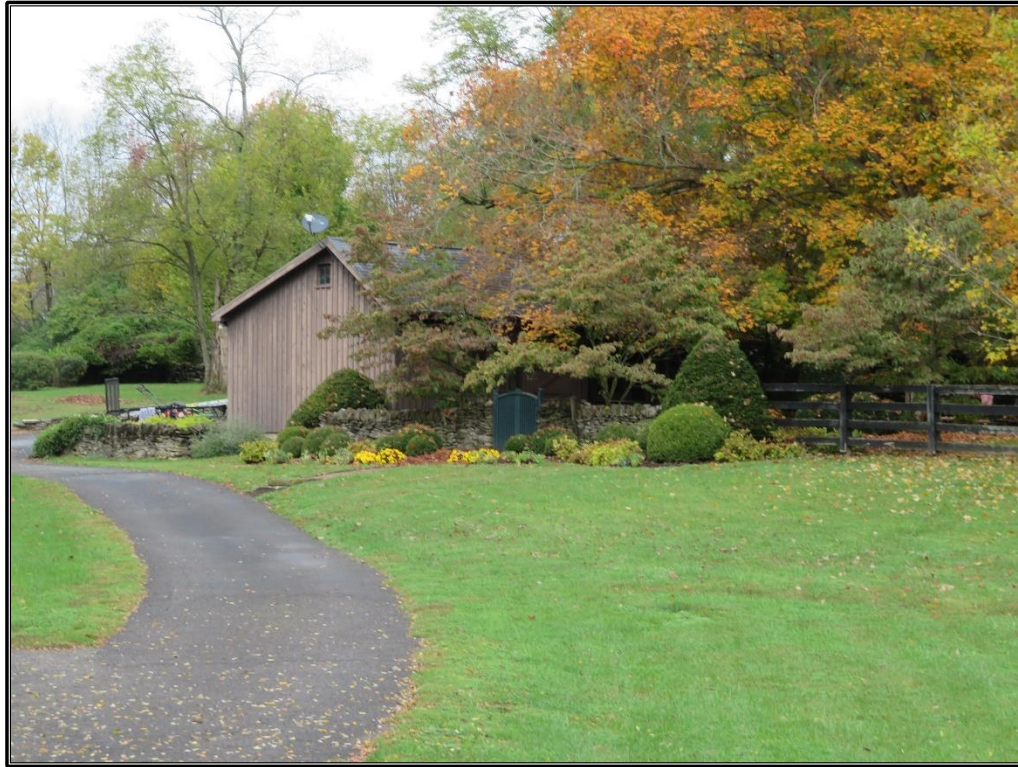
Figure 5. BO 311: Outbuilding (Resource B), looking west.

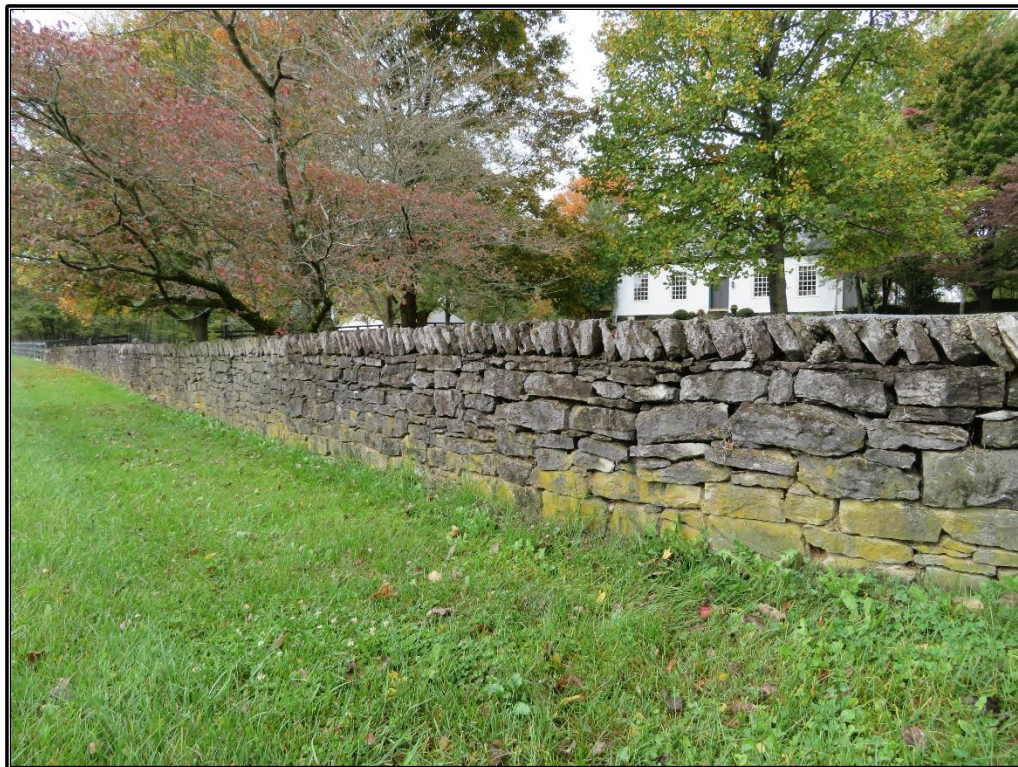
Figure 6. BO 311: Overview of stone wall (Resource C), looking west.

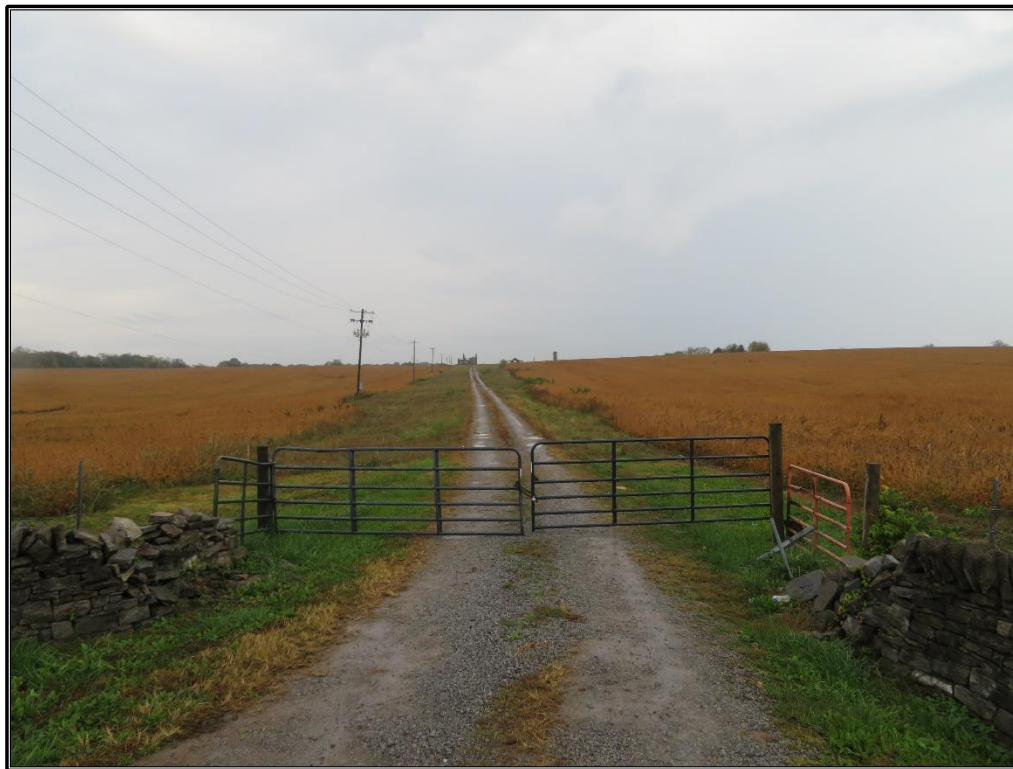
Figure 7. BO 367: Overview towards residence, looking north-northeast.

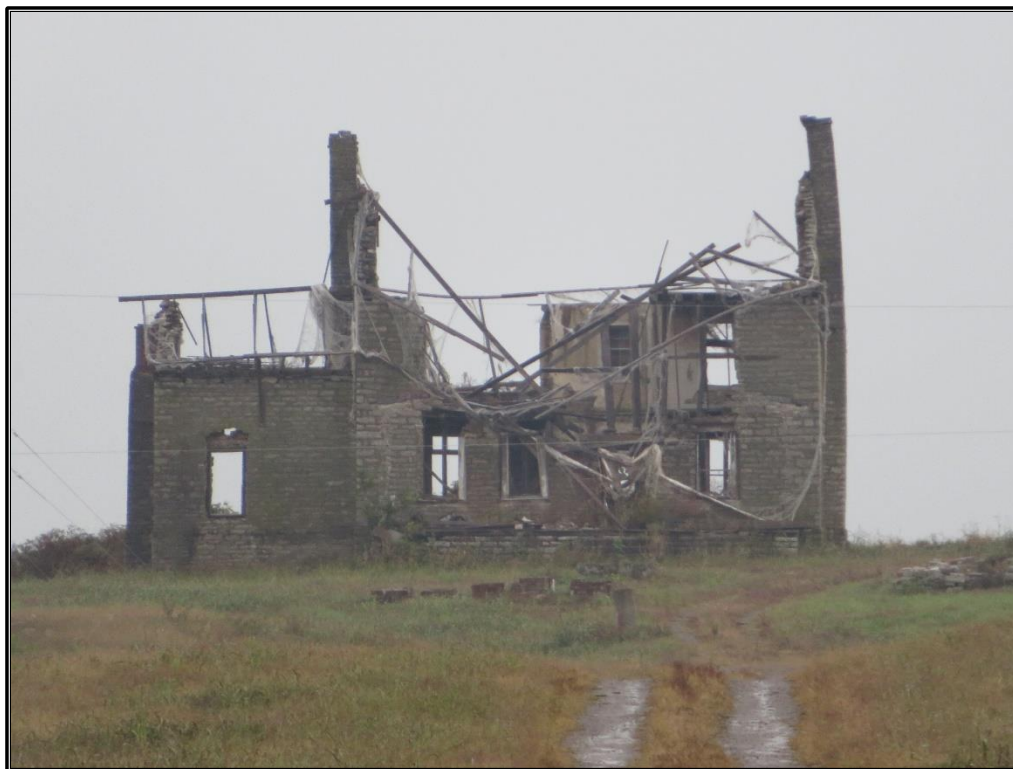
Figure 8. BO 367: View of partially collapsed residence, looking north-northeast.

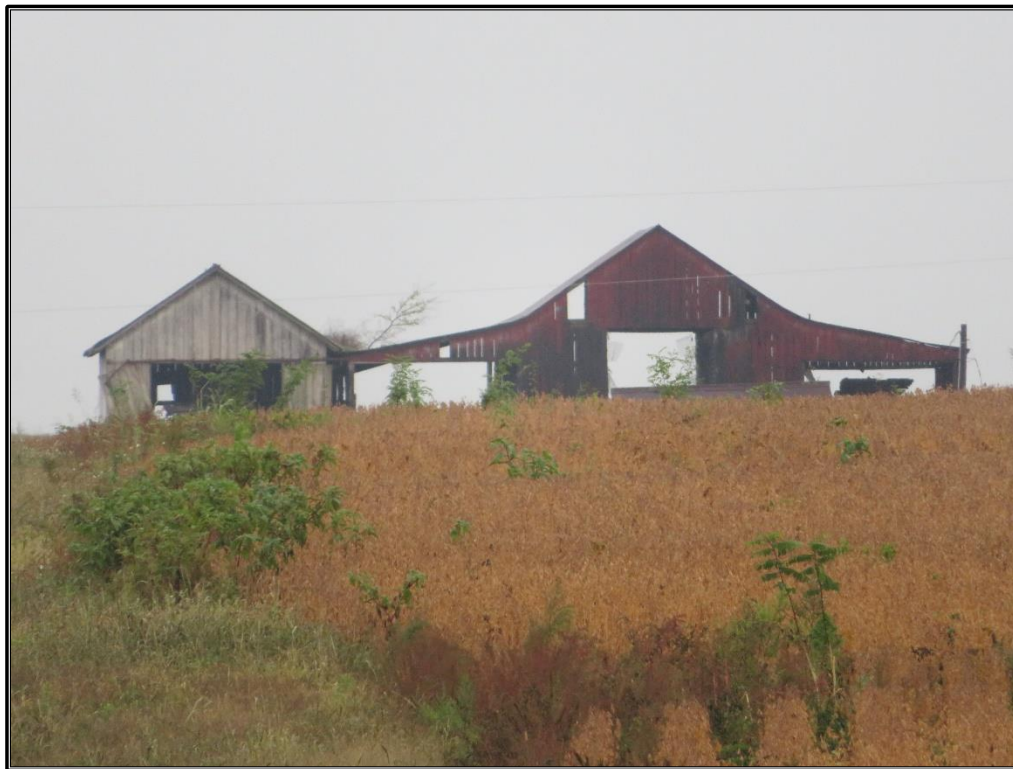
Figure 9. BO 367: Barns (Resource A and B), looking north-northeast.

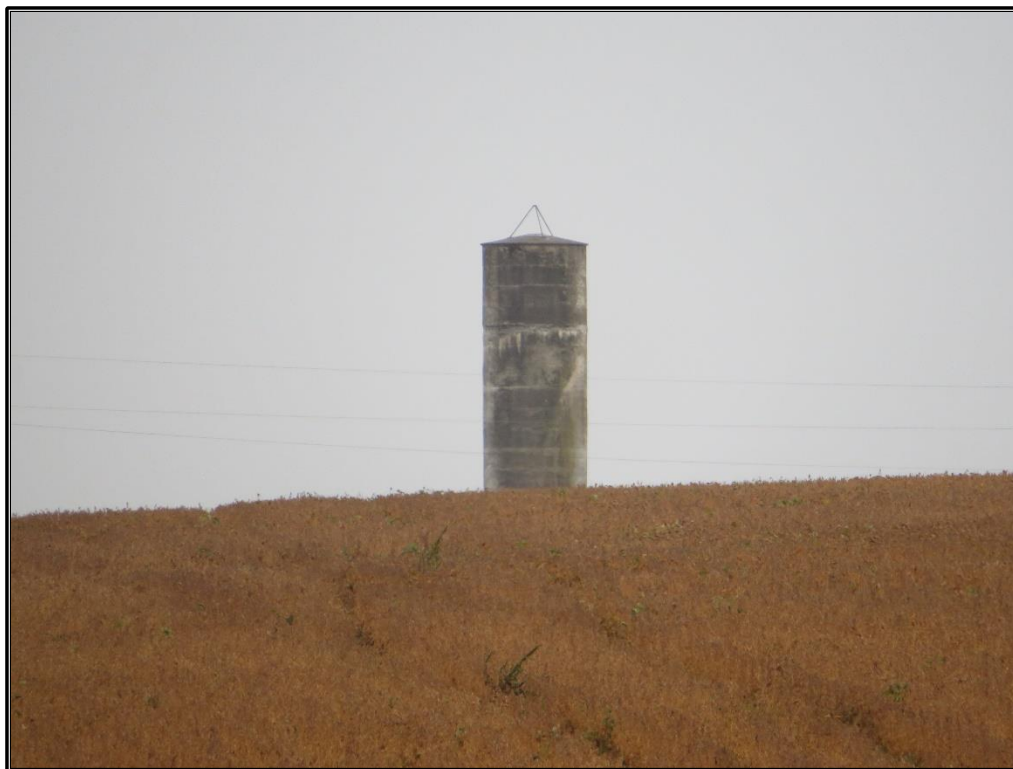
Figure 10. BO 367: Silo (Resource C), looking north-northeast.

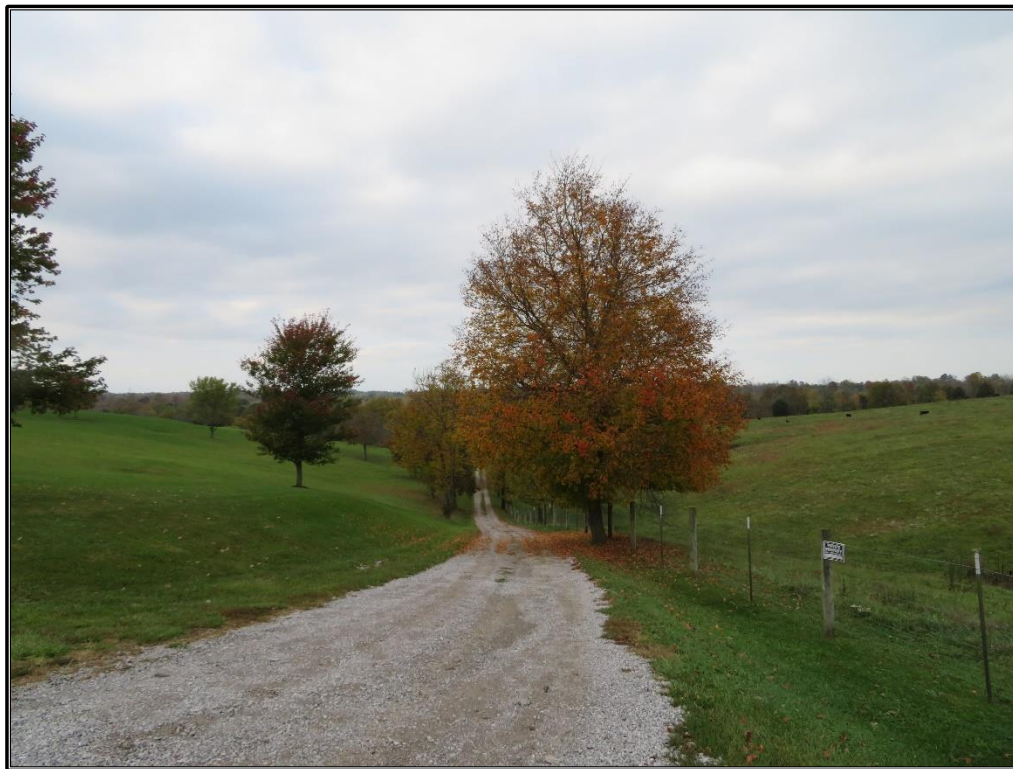
GD 65	Barlow House	Lancaster Road (KY 52)	Listed	Demolished; all structures non-extant	23
GD 66	Dunn-Watkins House	Lancaster Road (KY 52)	Listed	Undetermined; structures not visible from ROW	24-25
GD 67	Raz Dunn House	2461 Lancaster Road (KY 52)	Meets NRHP Criteria	Good; some replacement materials observed, but retains overall integrity	26-27
GD 417	Residence	1035 Lancaster Road (KY 52)	Meets NRHP Criteria	Good; retains integrity and historic materials and form	28

Figure 23. GD 65: Overview towards residence, looking north.

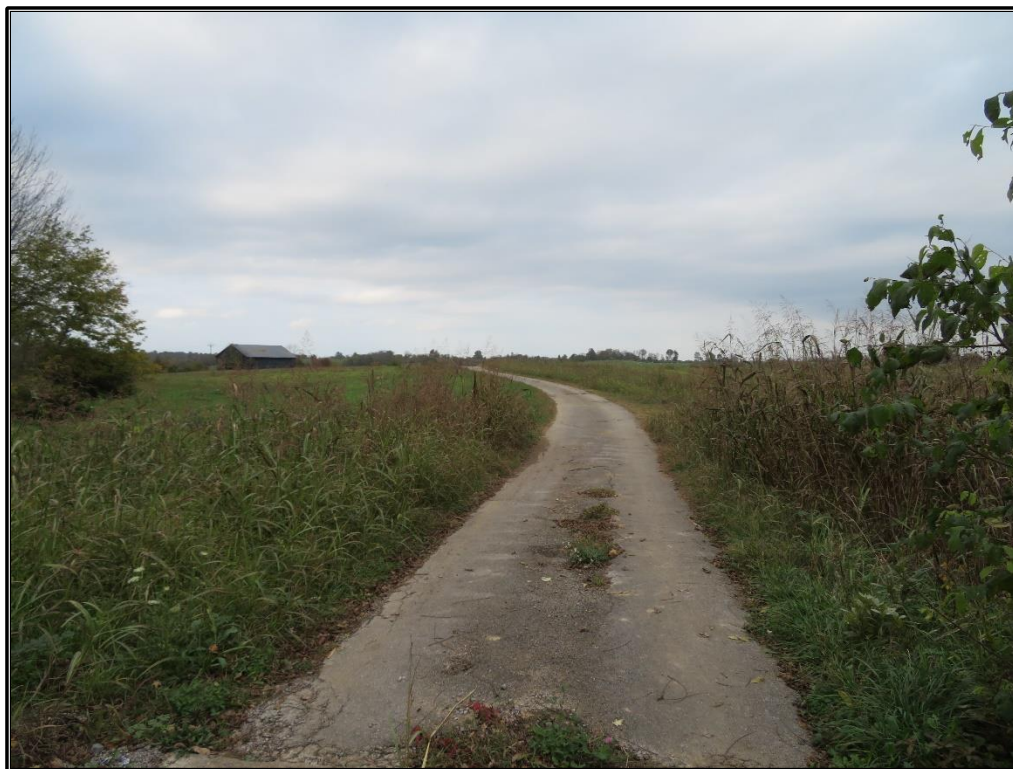
Figure 24. GD 66: Overview toward residence, looking north-northeast.

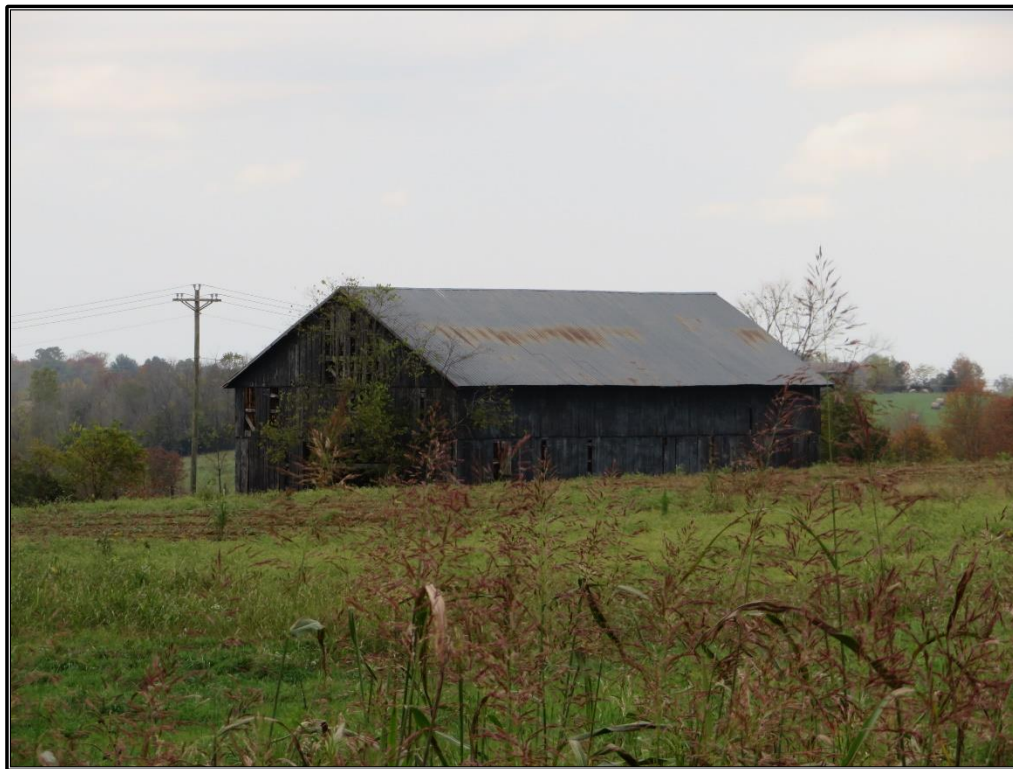
Figure 25. GD 66: Barn (Resource A), looking north.

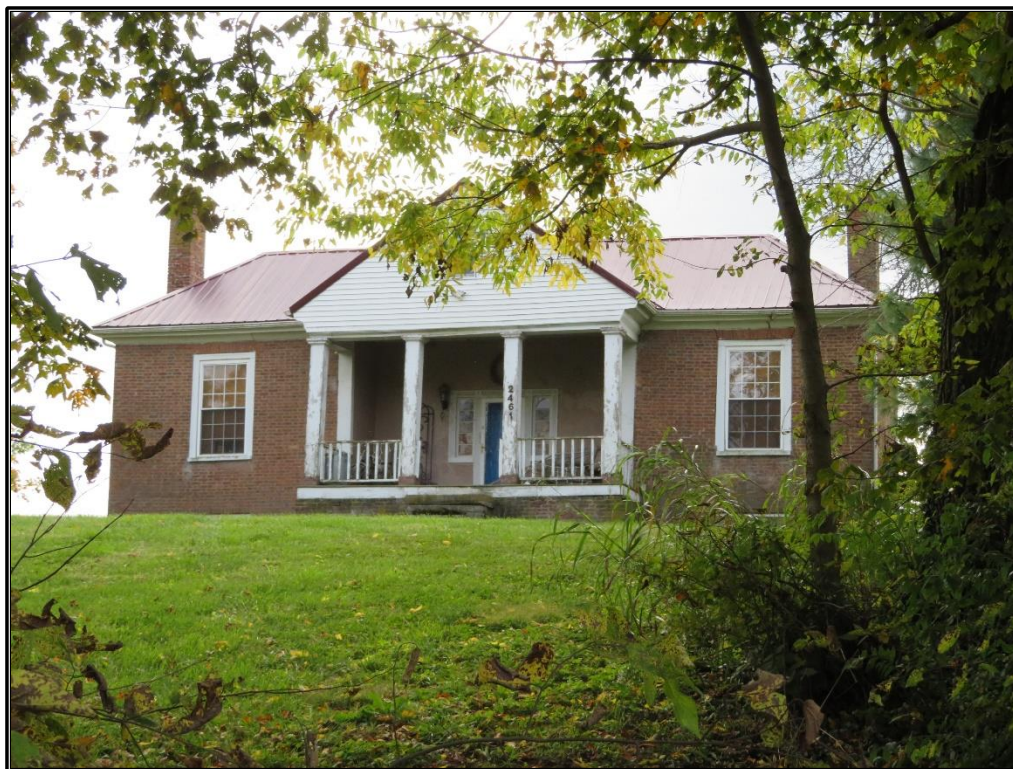
Figure 26. GD 67: Façade of residence, looking south-southwest.

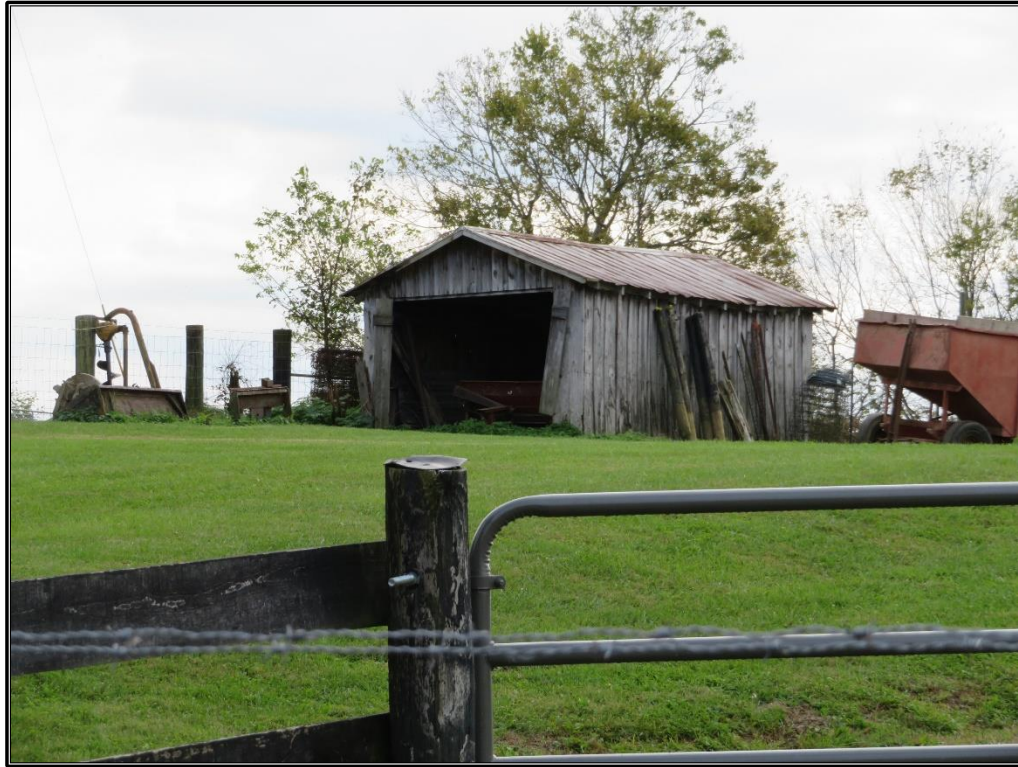
Figure 27. GD 67: Barn (Resource A), looking south-southwest.
