Inspection Report with SI&A Data

Structure Description: 766.08 Foot - 5 Span Prestressed concrete continuous Stringer/Multi-beam or Girder

7 Facility Carried: US-62

6A Feature Intersected: LAWRENCE CREEK

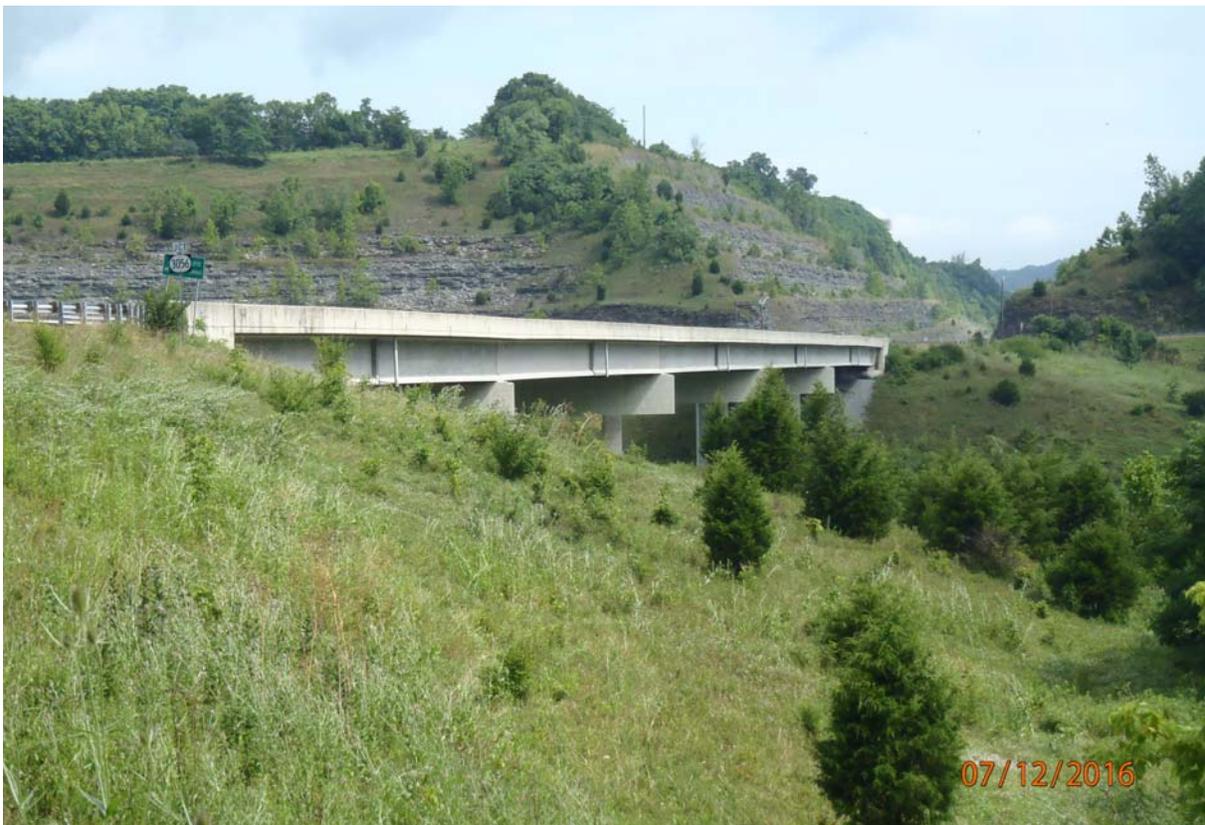
Elevation view looking from the upstream south embankment.

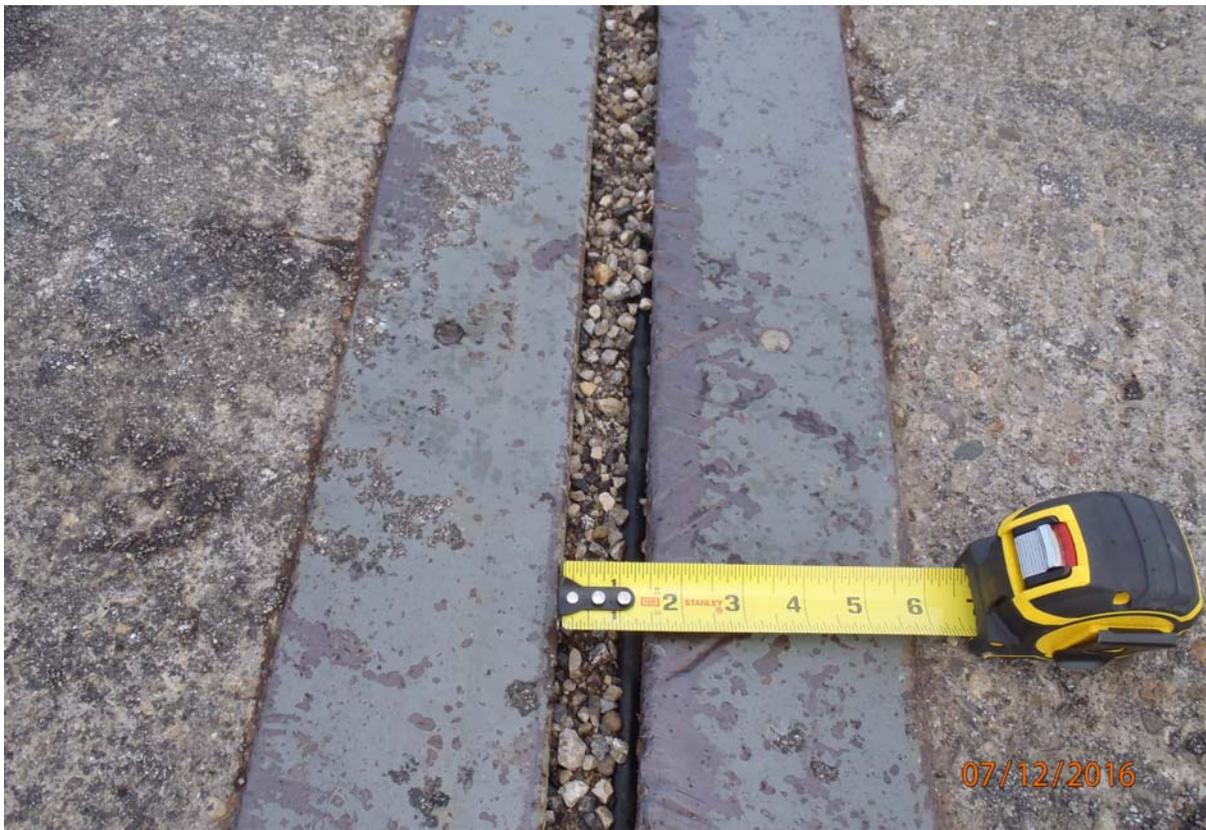
Close up view of the joint gap in the northbound lane at abutment 1.

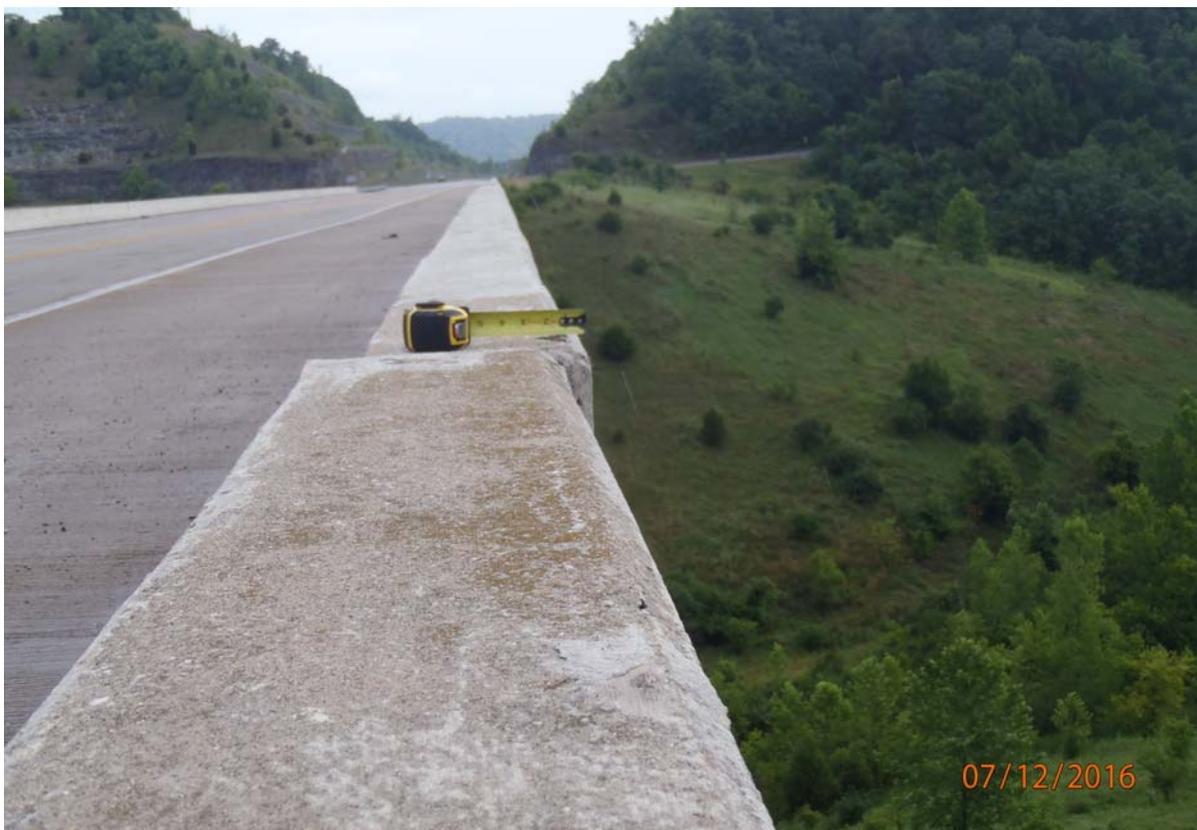
View of the horizontal offset between the upstream barrier wall at abutment 1. Note the entire superstructure appears to have moved towards the upstream at this location.

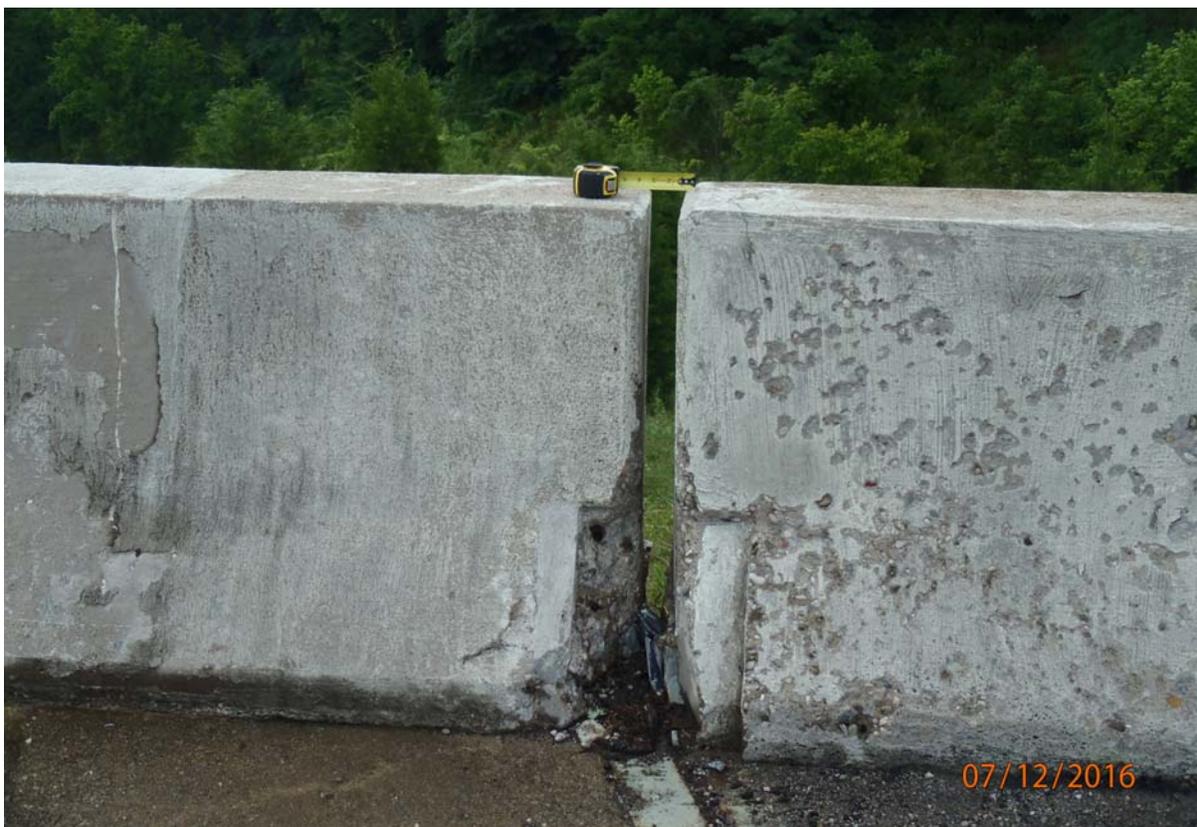
View of lateral offset between the upstream barrier wall at abutment 1. Note the barrier wall sliding plates have torn off due to the horizontal movement.

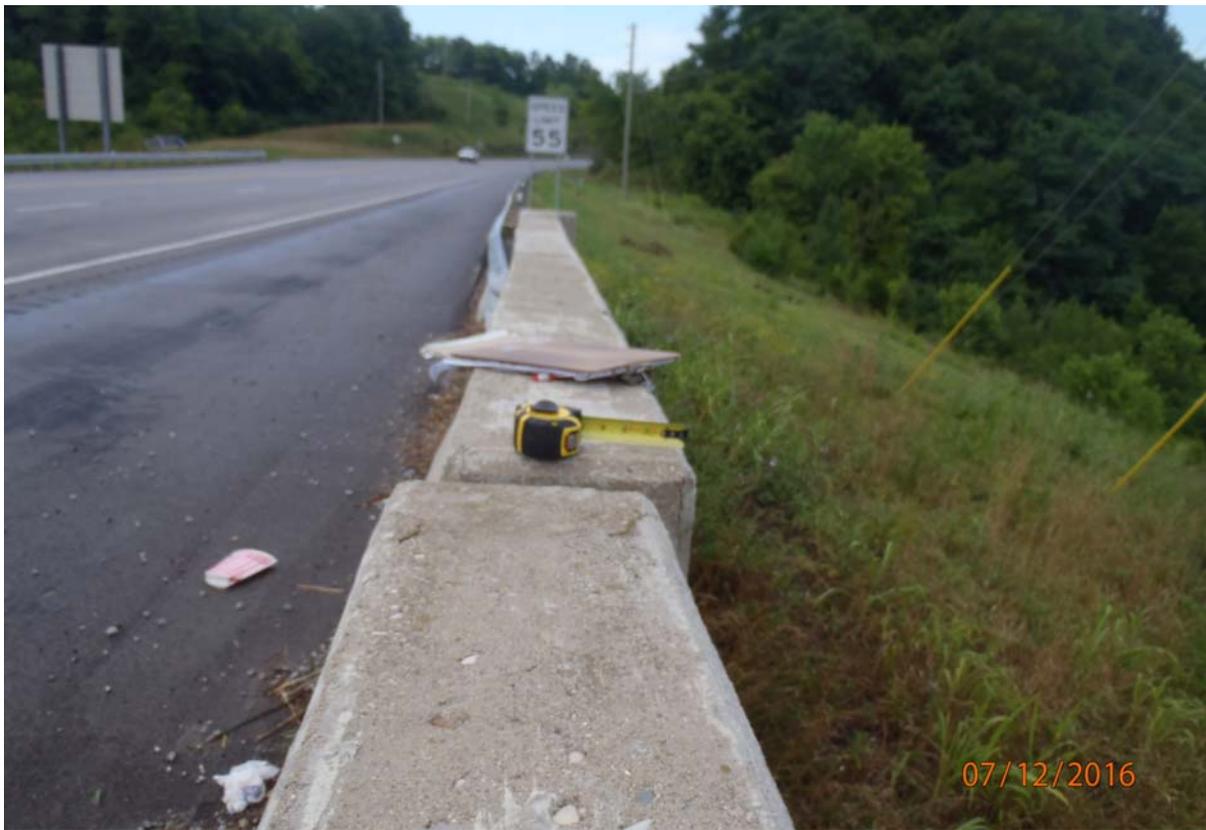
View of the horizontal offset between the downstream barrier wall at abutment 1. Note the entire superstructure appears to have moved towards the upstream.

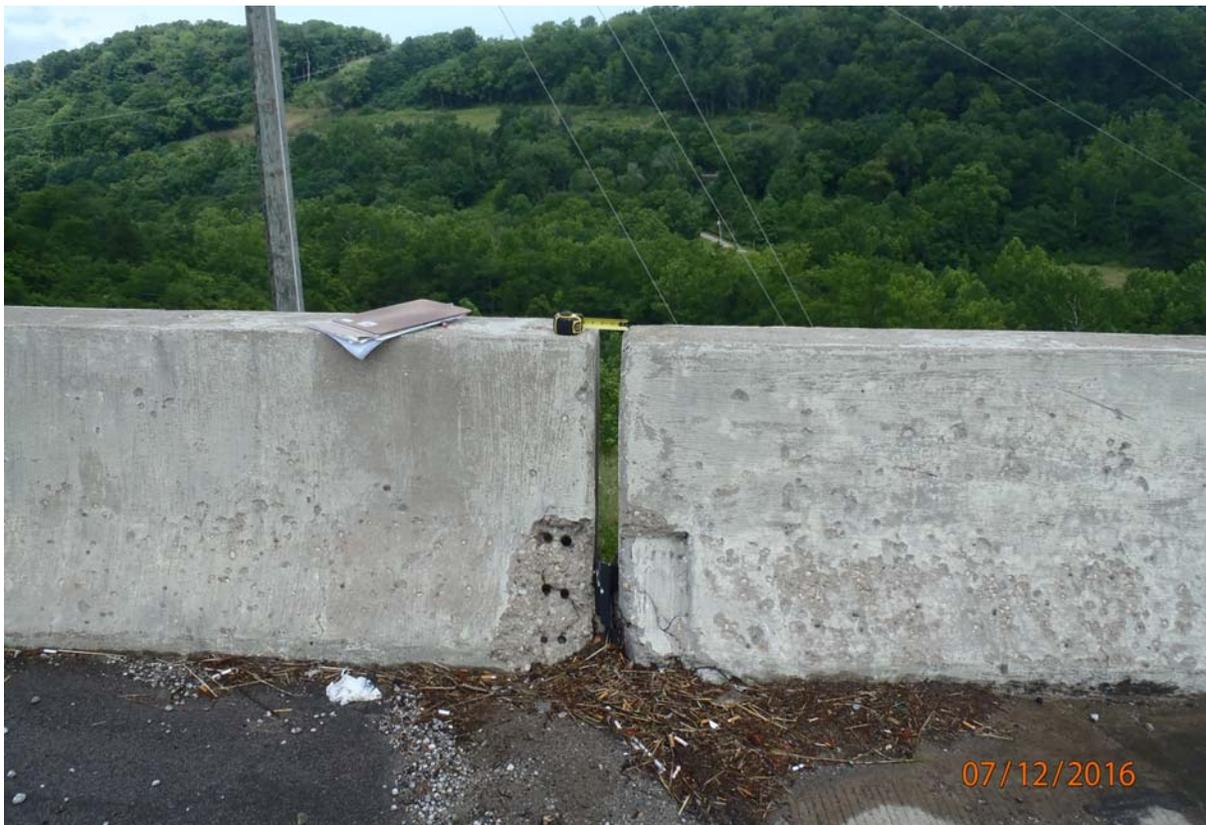
View of lateral offset between the downstream barrier wall at abutment 1. Note the barrier wall sliding plates have torn off due to the horizontal movement.

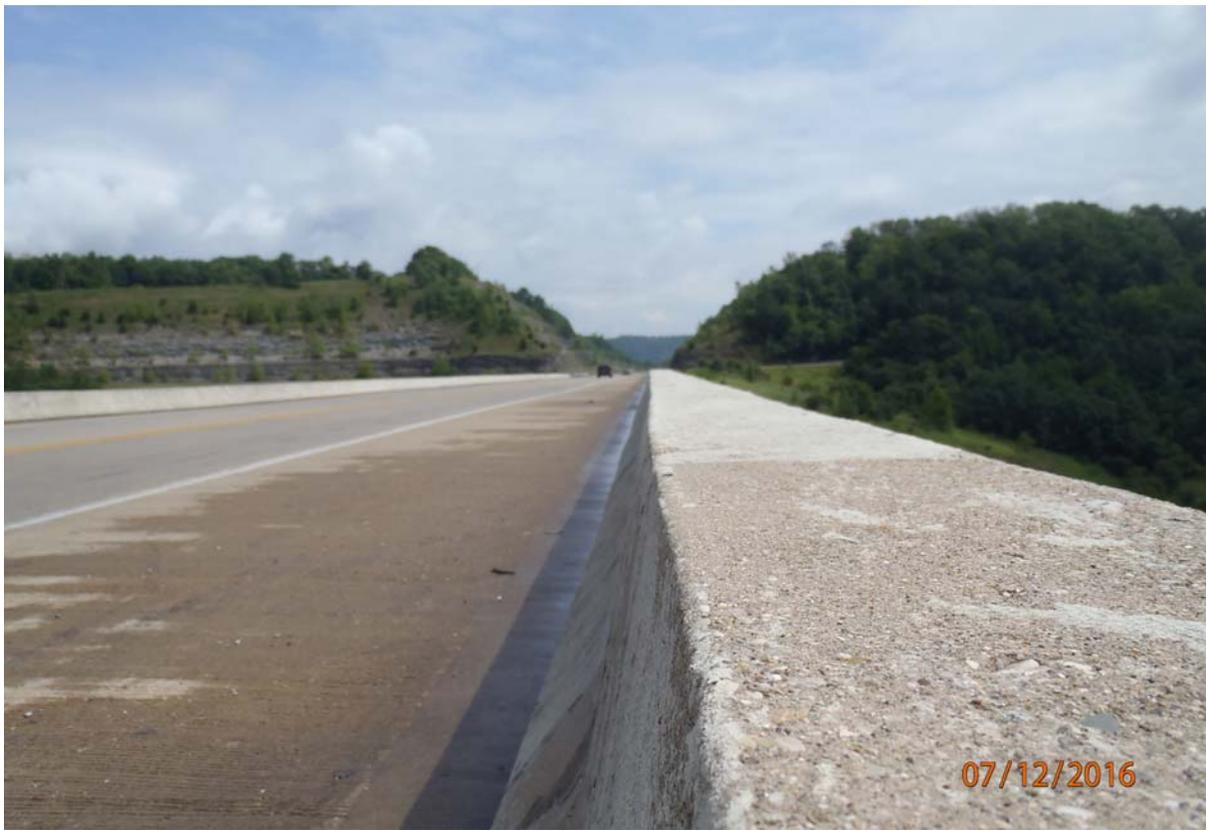
View sighted along the upstream barrier wall looking from abutment 1. Note the top of the wall appears to be wavy throughout, this is consistent with the driving surface; traffic appears to bounce while crossing the structure in both directions.

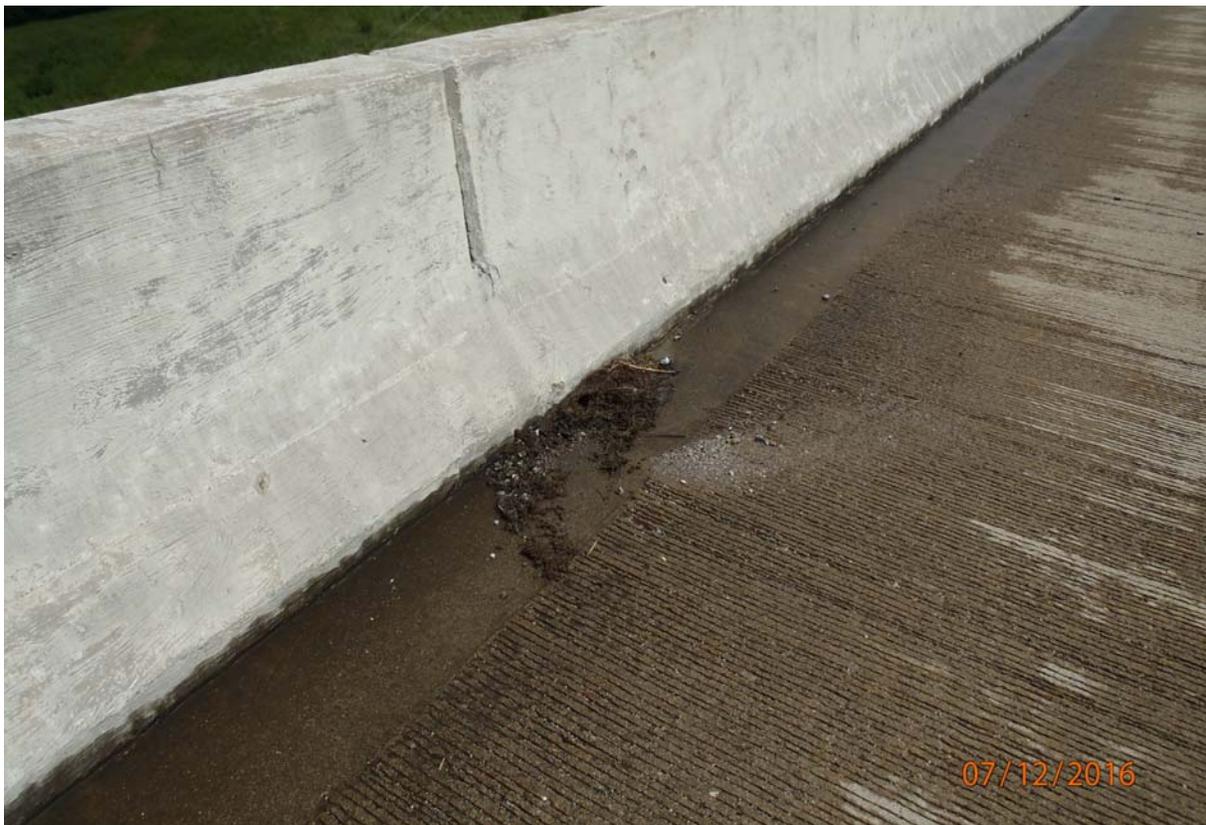
Some of the deck-drains are open, however a large number are 100% blocked with debris as shown above.

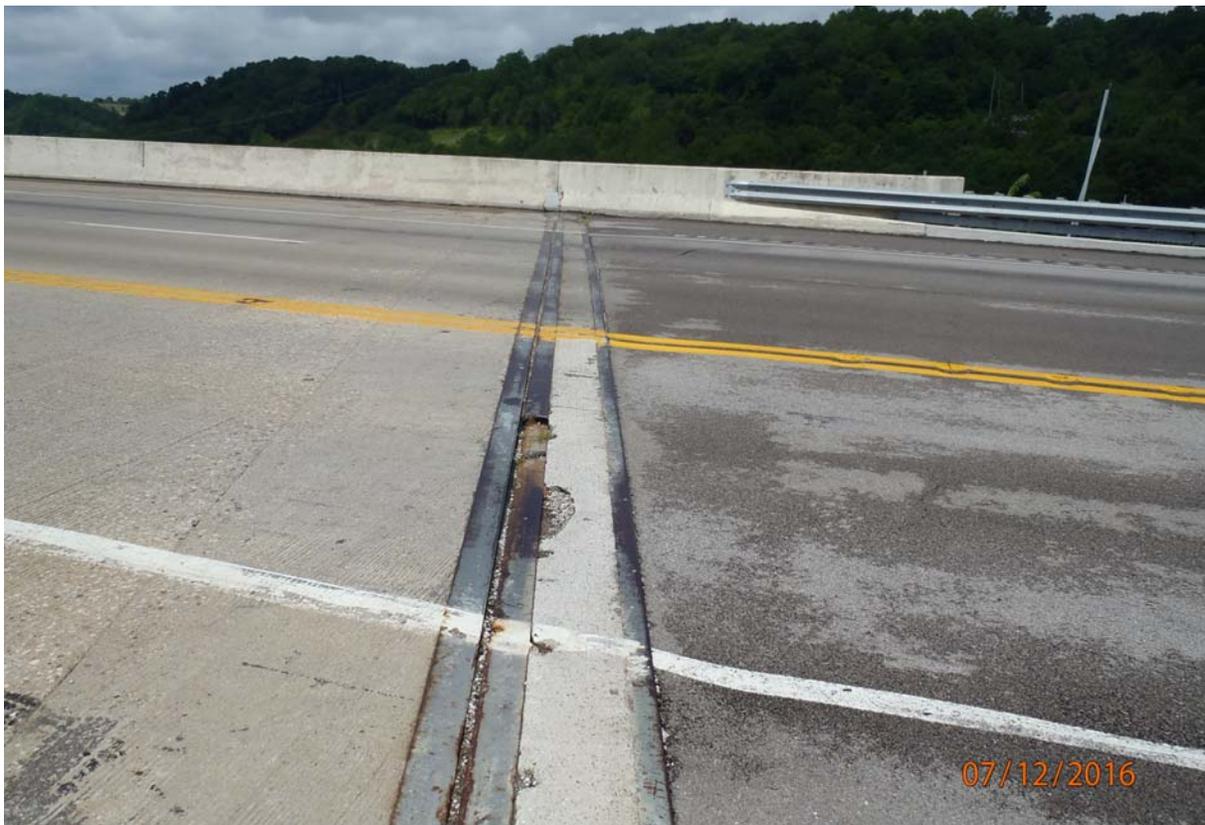
View of the north approach/transition.

Note the asphalt cracking present in the northbound lane and shoulder; an indication of continuing settlement.

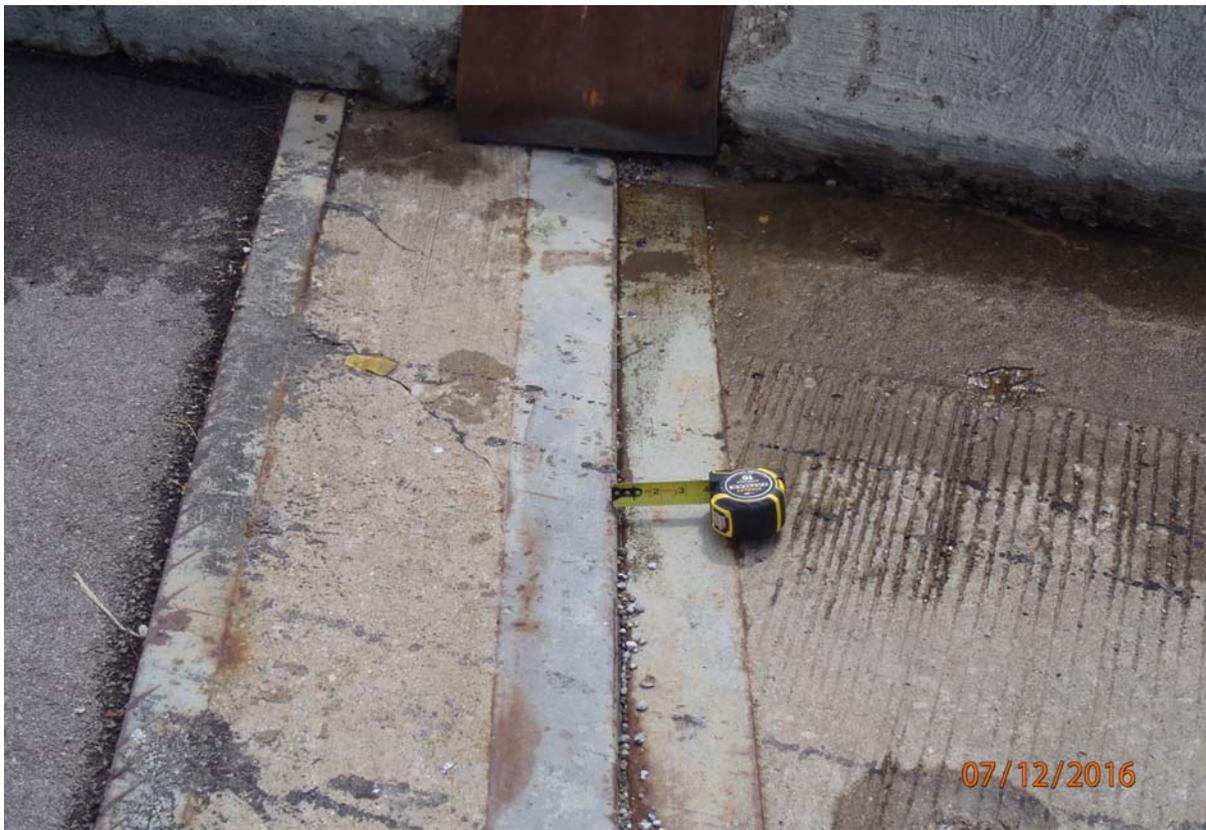
View looking down at the joint over abutment 6 near the upstream barrier wall.
Note the joint is completely closed at this location.

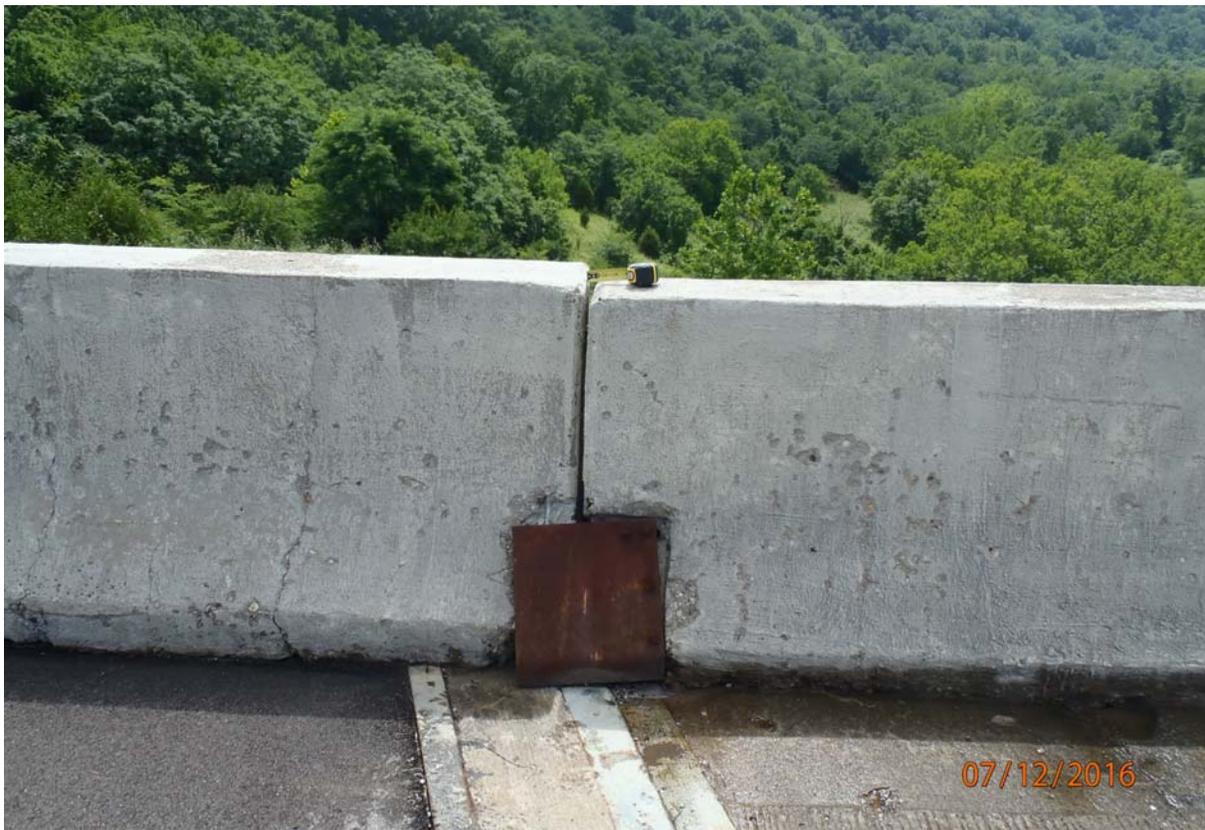
View of lateral offset between the upstream barrier wall at abutment 6.
Note the barrier wall sliding plate has mostly torn off due to the horizontal and lateral movement.

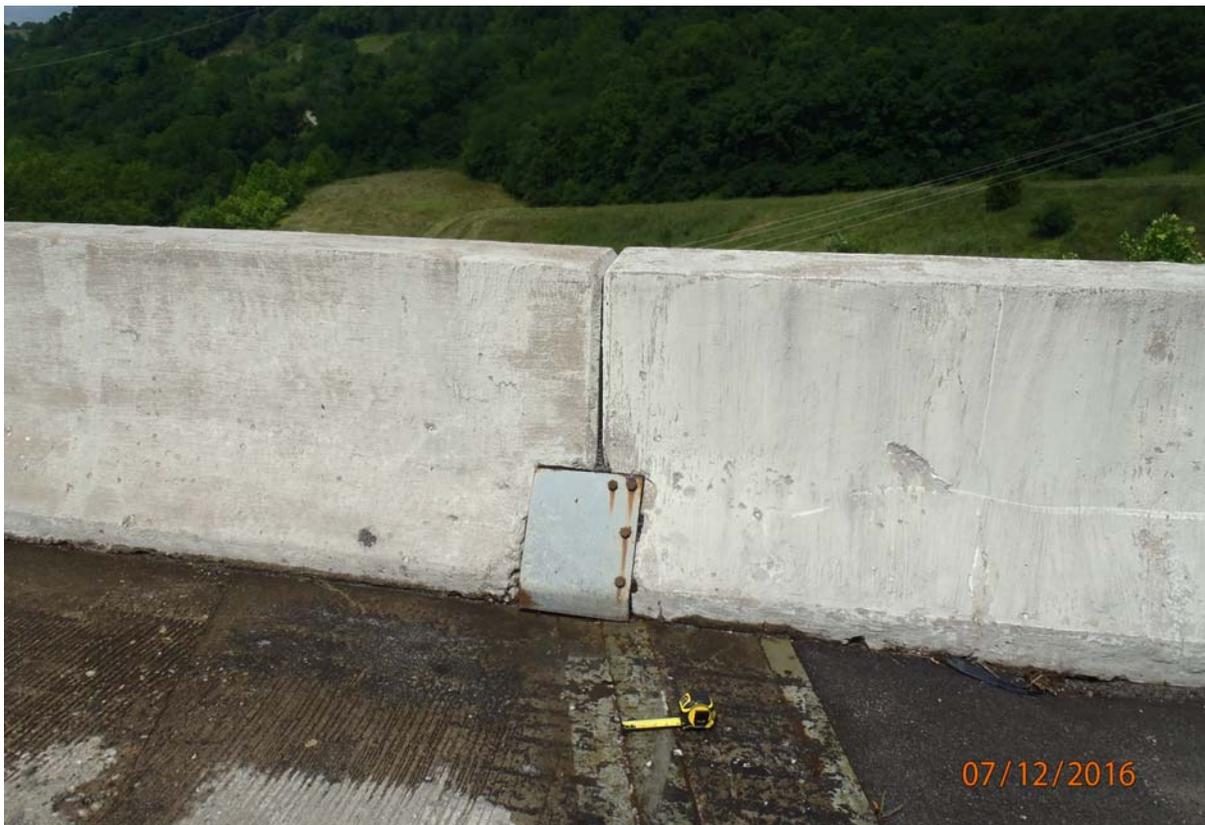
View of lateral offset between the downstream barrier wall at abutment 6.
Note the deck joint is completely closed at this location.

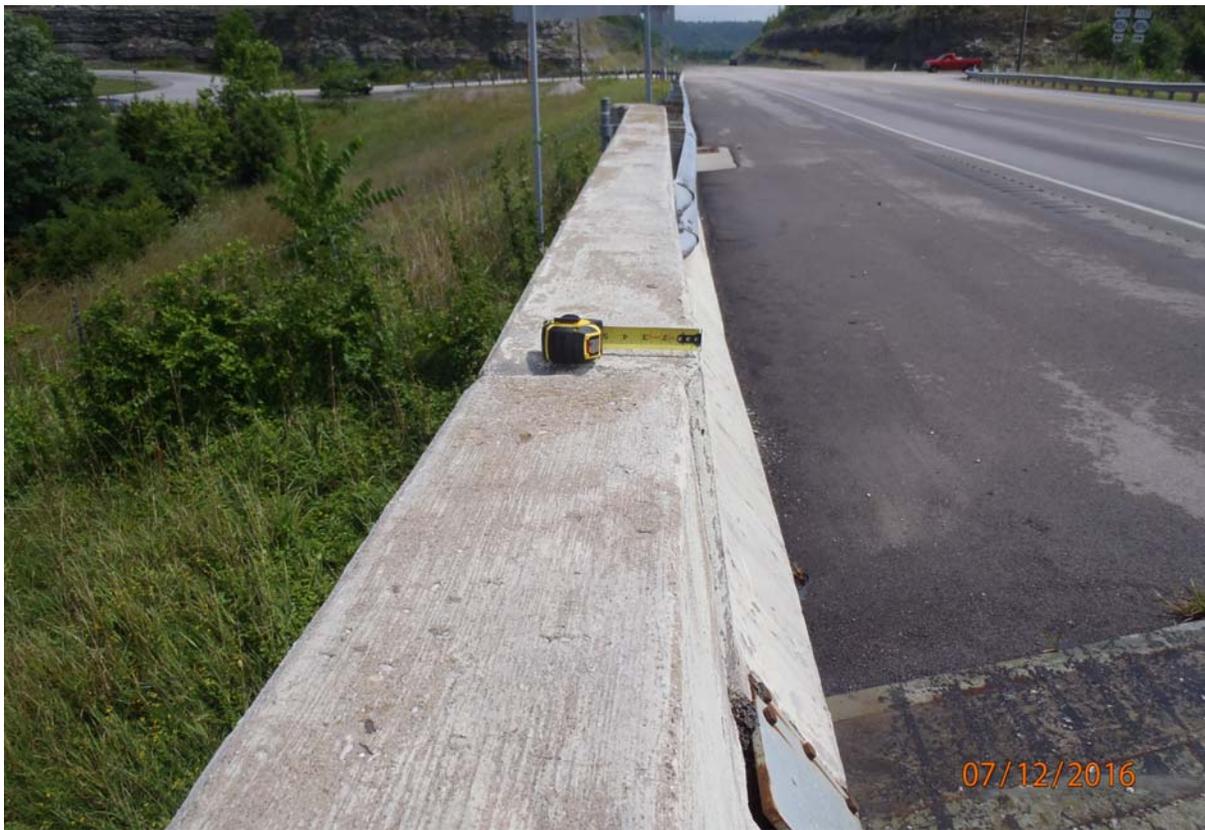
View of the horizontal offset between the downstream barrier wall at abutment 6. Note the entire superstructure appears to have moved towards the downstream at this location.

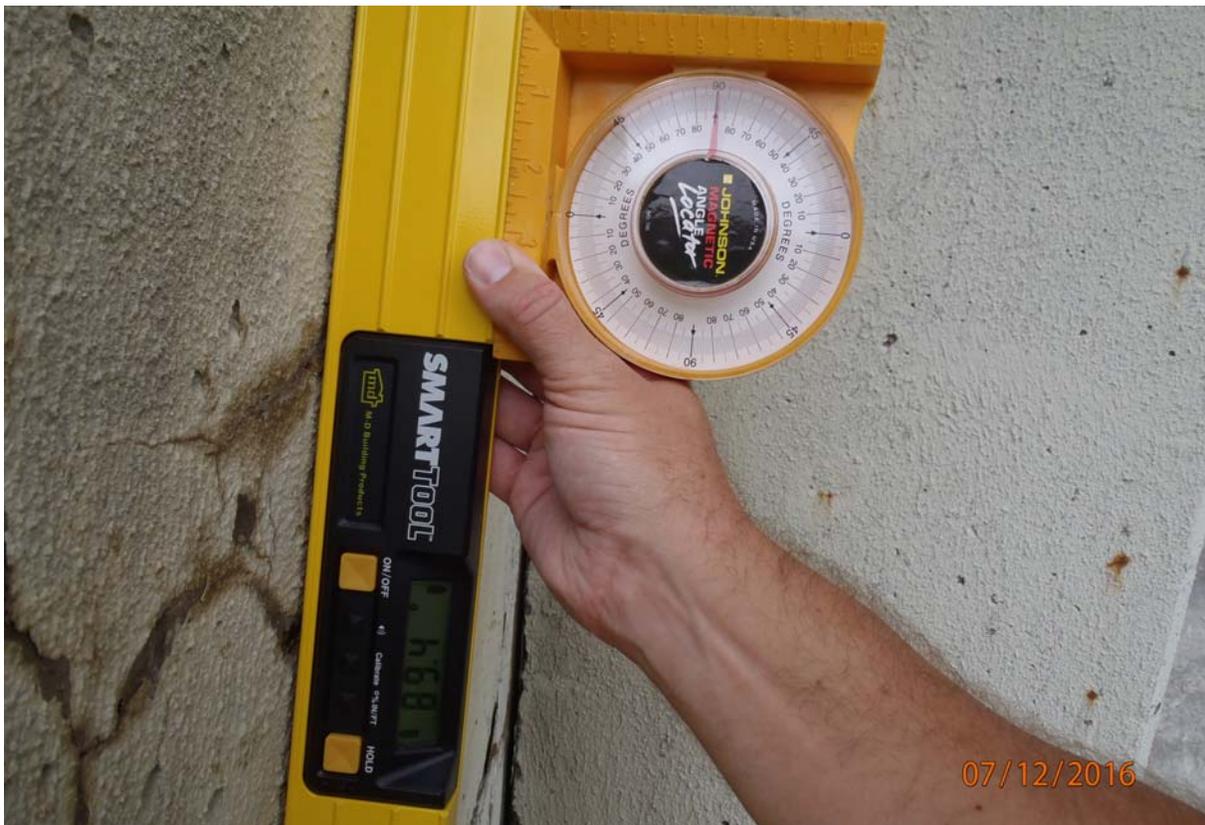
View of the level reading taken at the above location.

Note when the smart level was flipped the reading did not change; this smart level is assigned to B. Jones and the calibration might vary slightly.

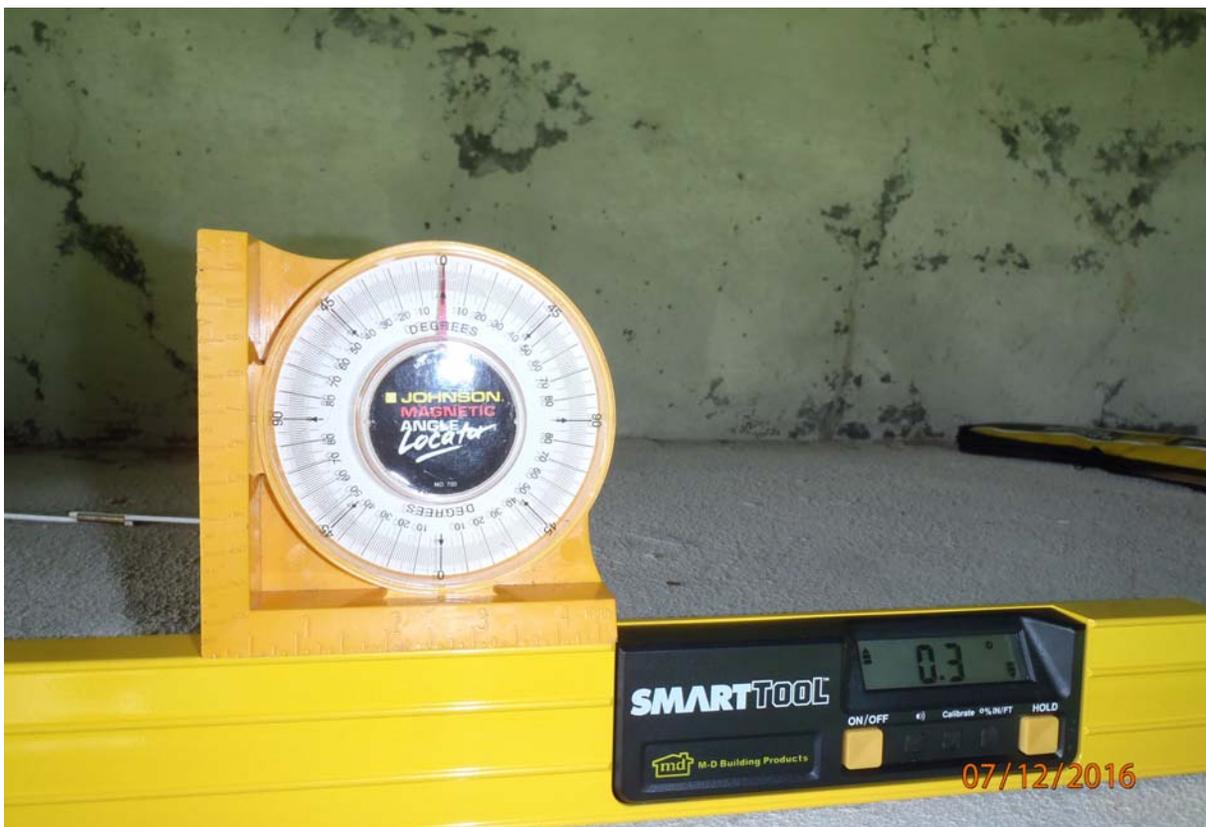
Close-up the above noted smart level reading taken between beams 5 and 6 at abutment 6.

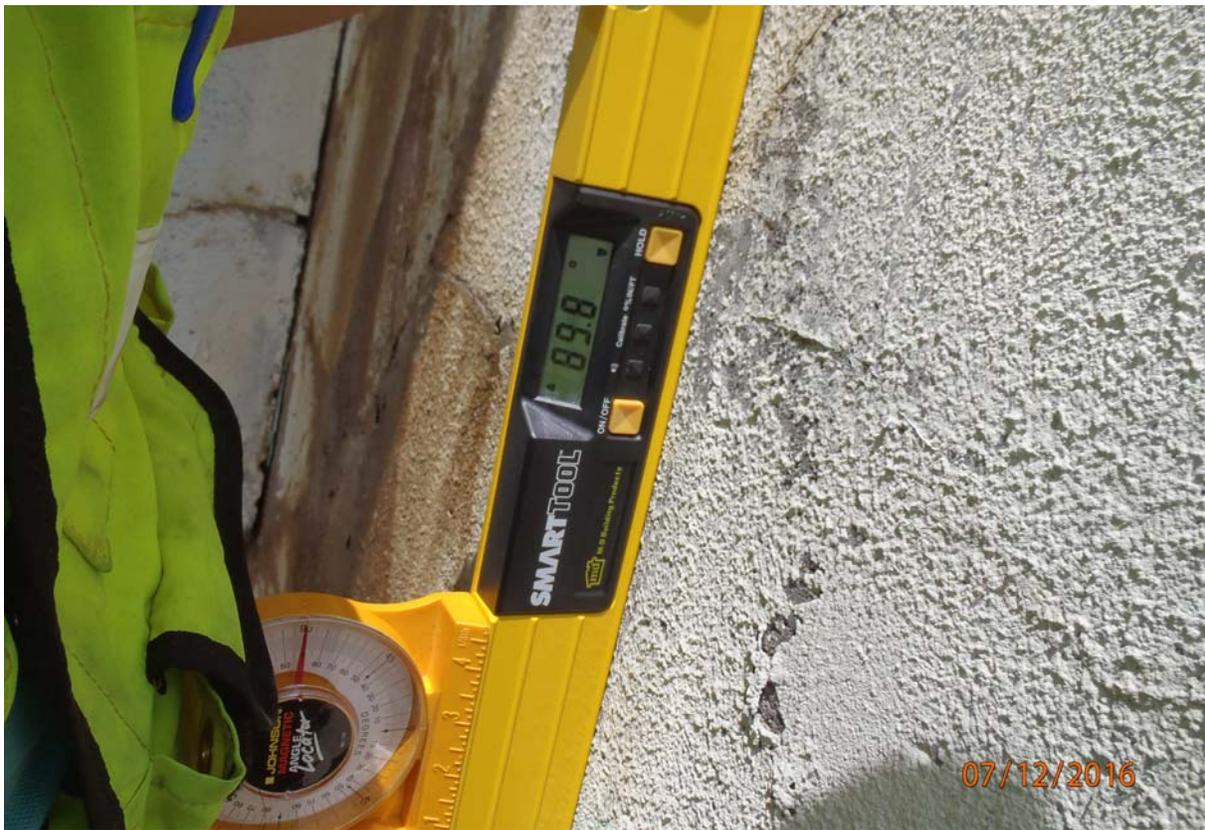
View of the level reading taken at the above location (bottom photo page 29). Note when the smart level was flipped the reading did change by 0.01 degrees (89.7 degrees); this smart level is assigned to B. Jones and the calibration might vary slightly.

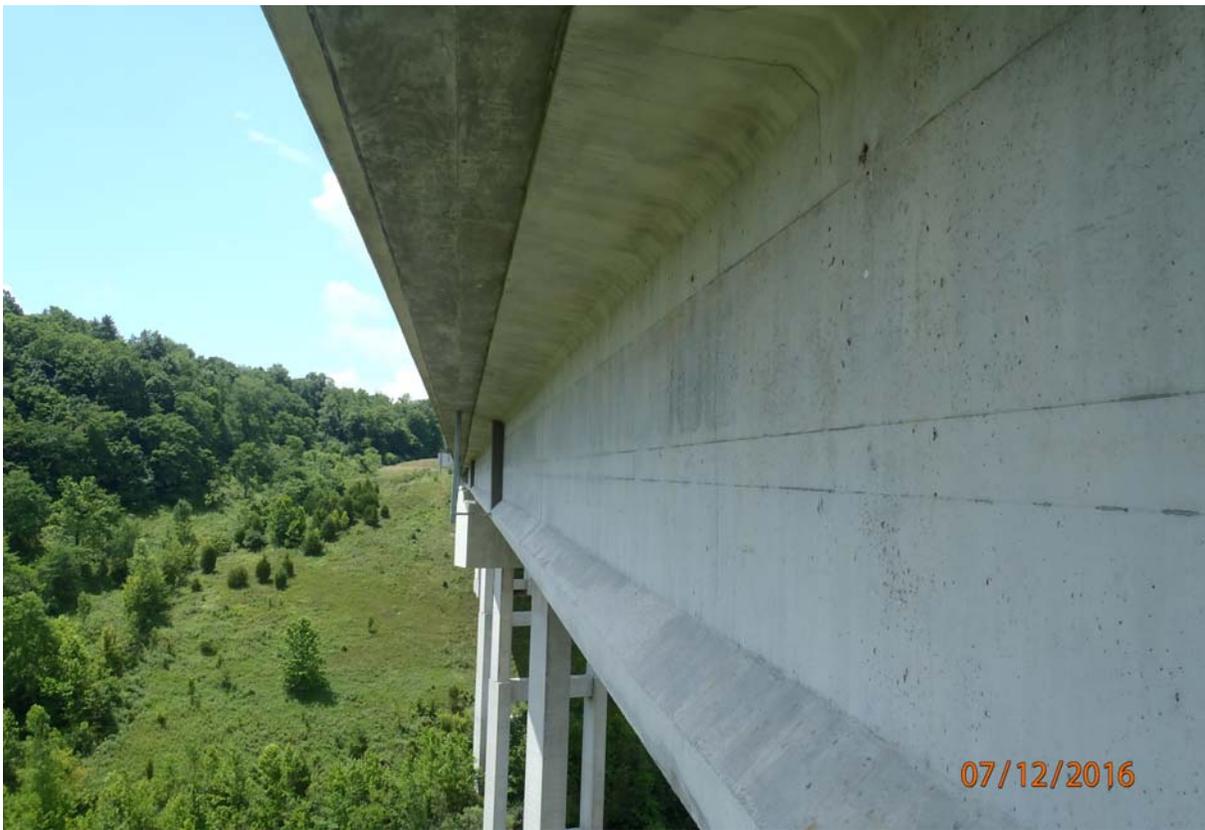
View sighted along the upstream face of beam 1.

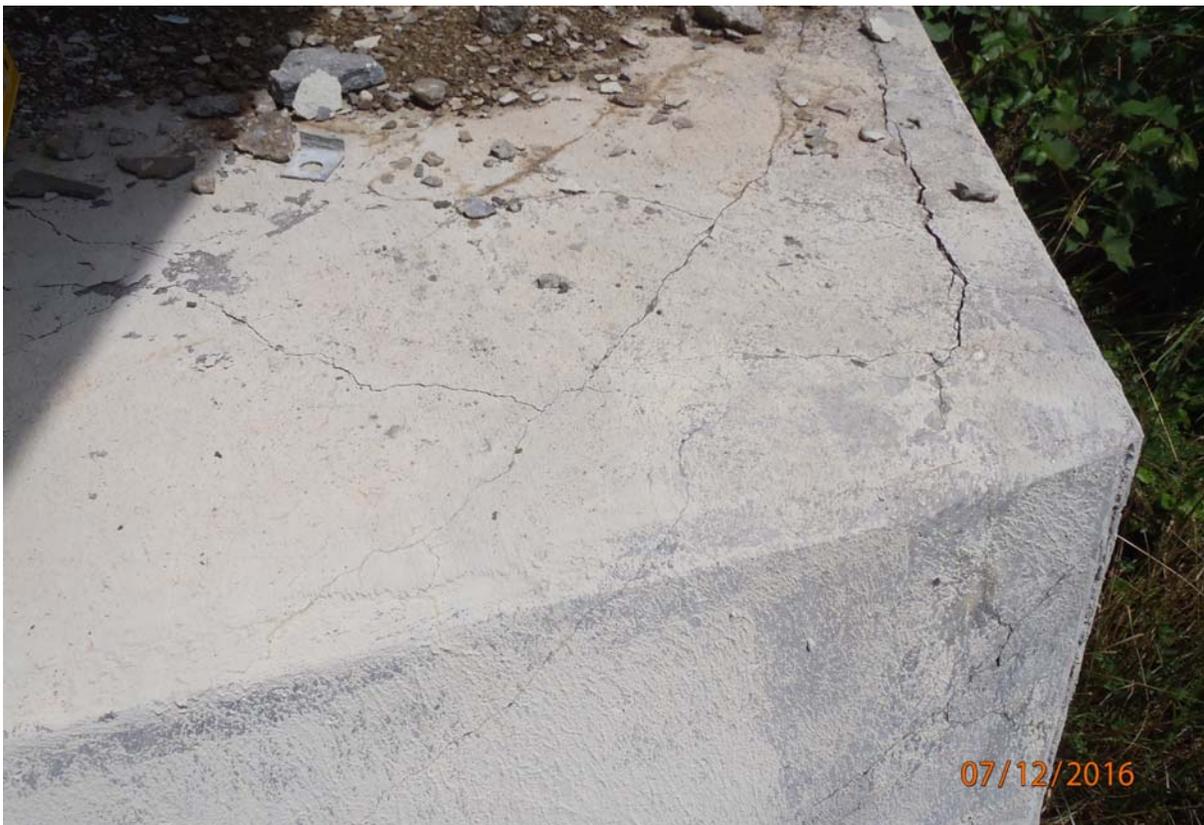
View of cracking present on the abutment seat upstream of beam 1.
Note the cracking widths are up to 1/4" wide.

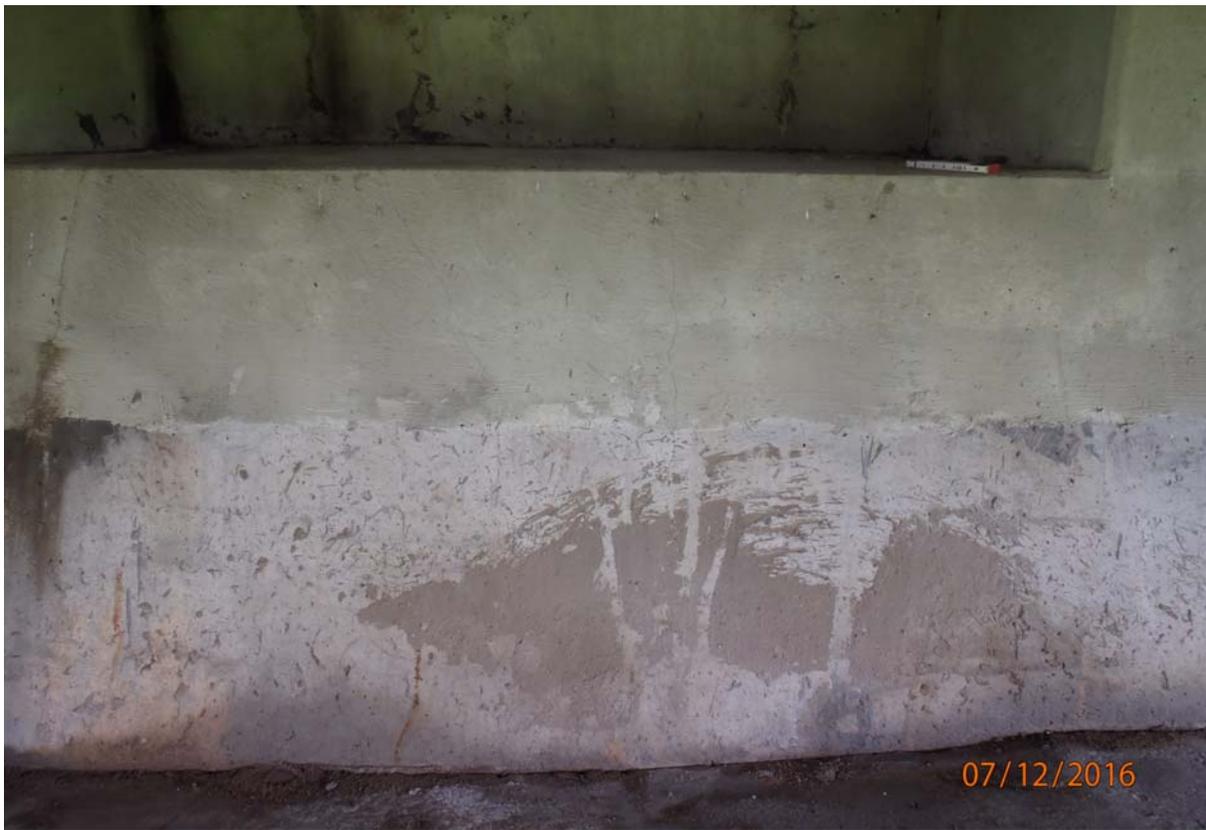
View of cracking in the face of abutment 6 between beams 3 and 4.

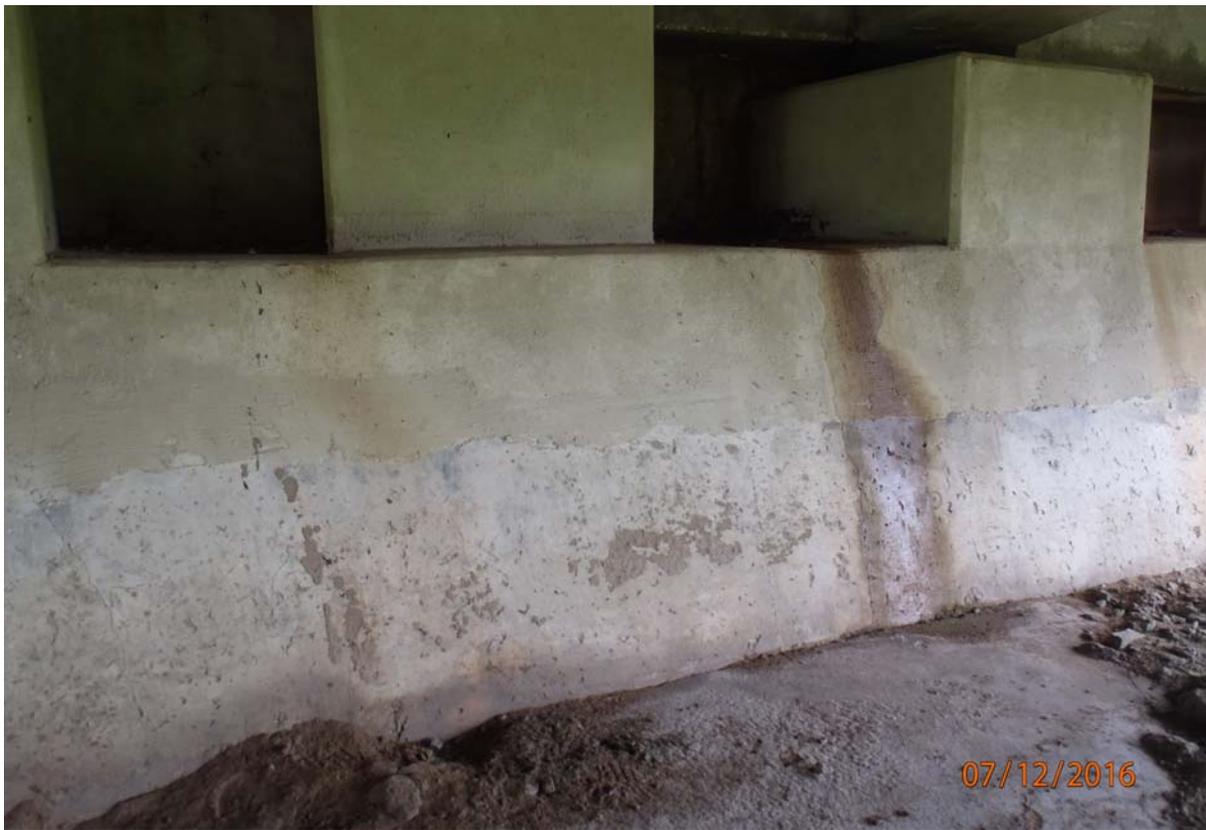
View of cracking in the face of abutment 6 under beam 3.

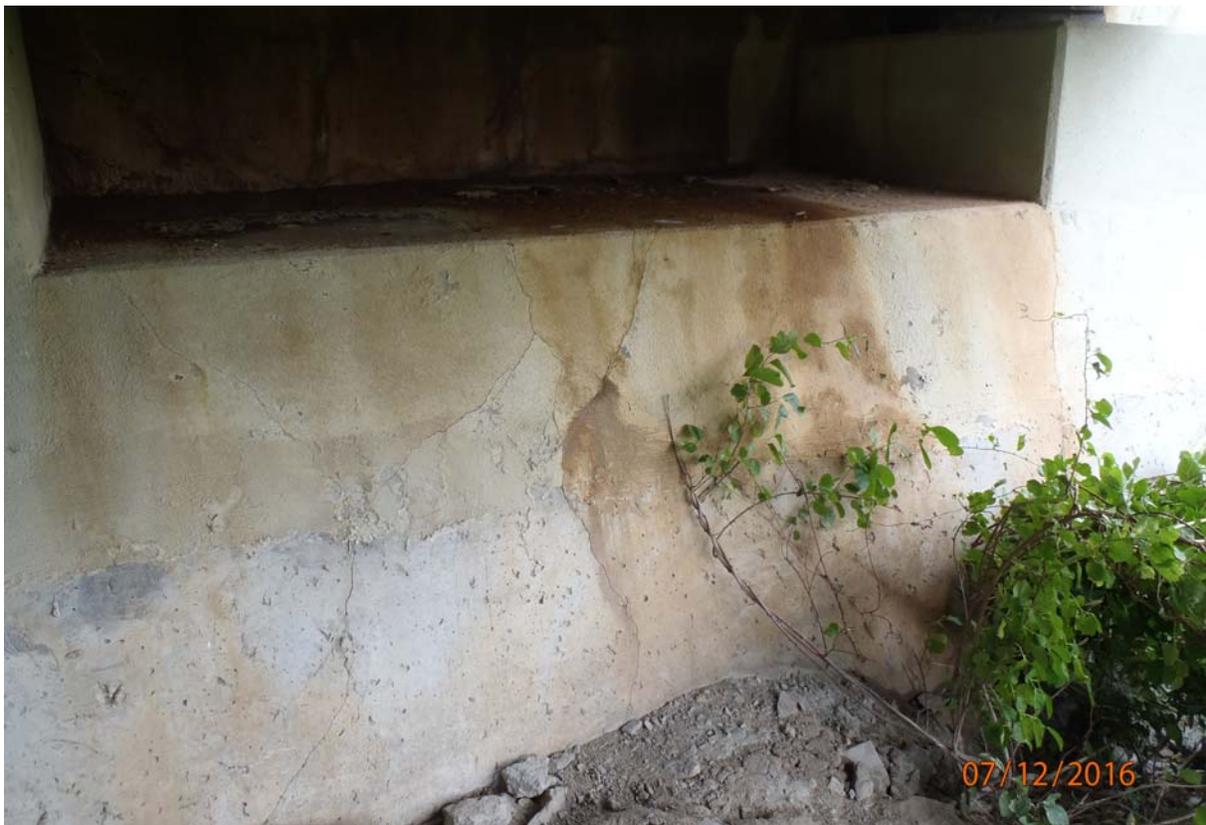
View of cracking in the face of abutment between beams 2 and 3.

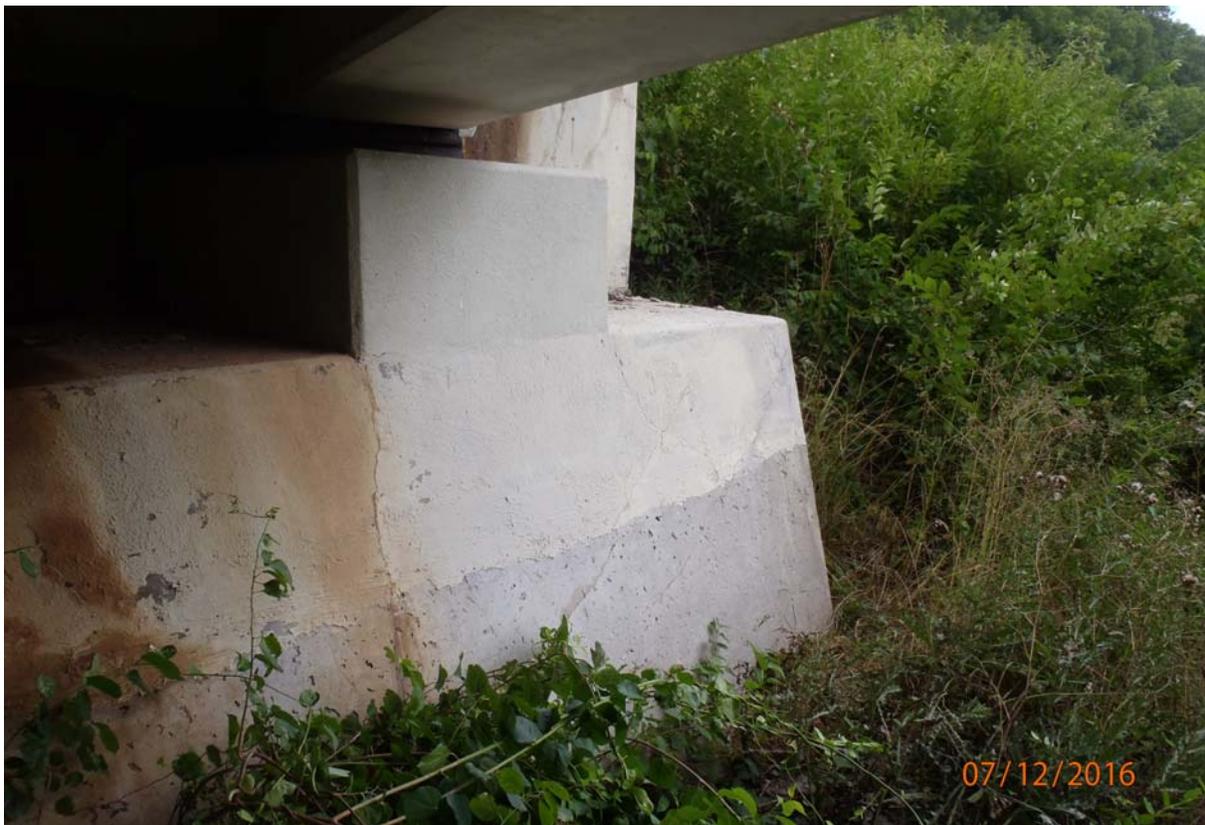
View of cracking and heavy staining in the back-wall of abutment 6 between beams 1 and 2.
