Inspection Report with SI&A Data

Structure Description: 766.08 Foot - 5 Span Prestressed concrete continuous Stringer/Multi-beam or Girder

7 Facility Carried: US-62

6A Feature Intersected: LAWRENCE CREEK

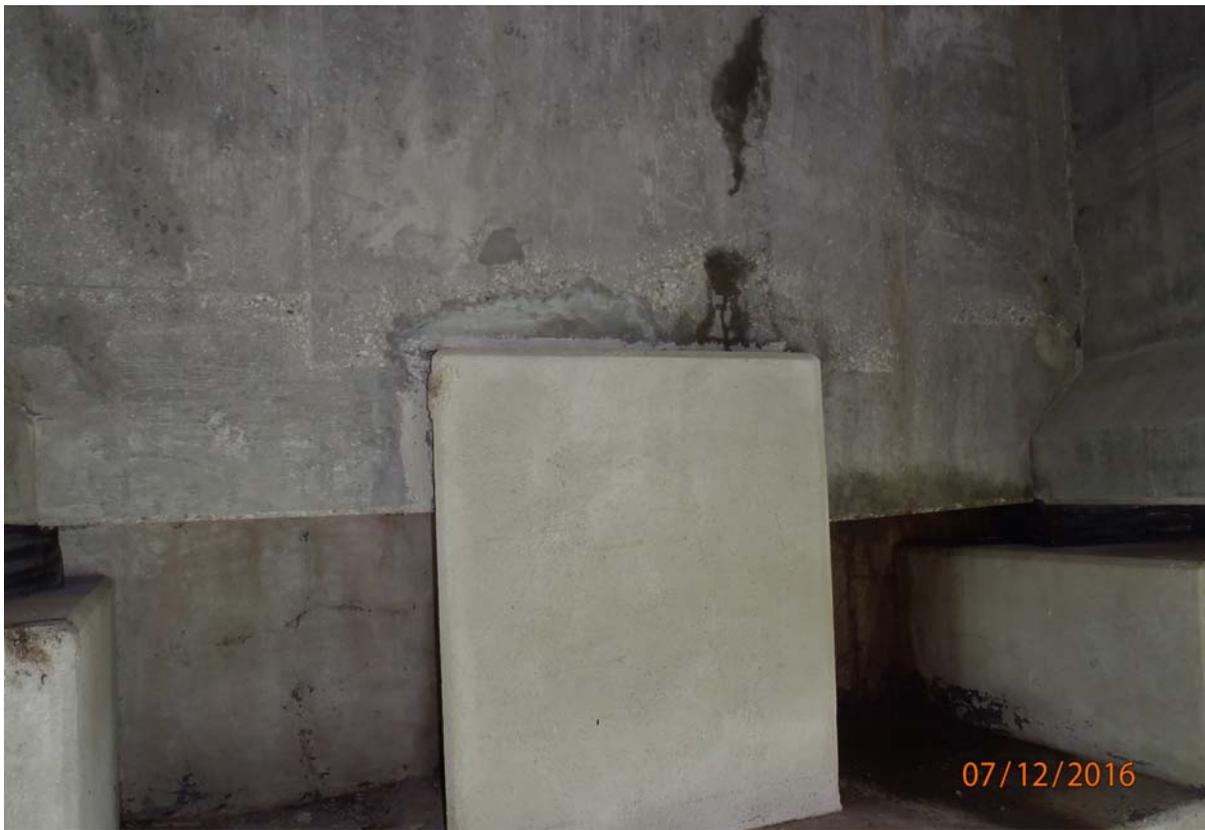
View of the shear key and diaphragm between beams 4 and 5 at abutment 6.
Note the gap/movement of the superstructure towards the downstream.

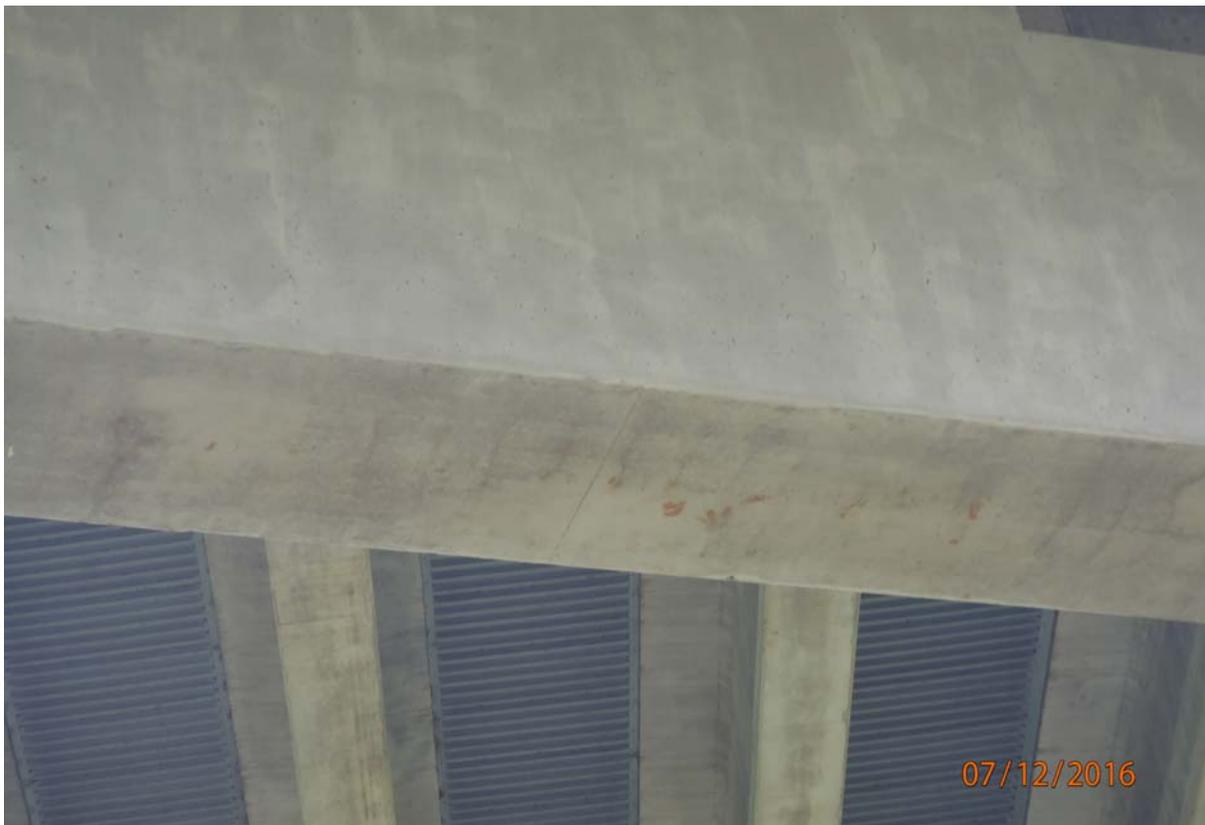
View of the underside of the pier cap of pier 5.
Note the transverse rust staining most likely from inadequate cover over the stirrup/shear reinforcing on cap underside.

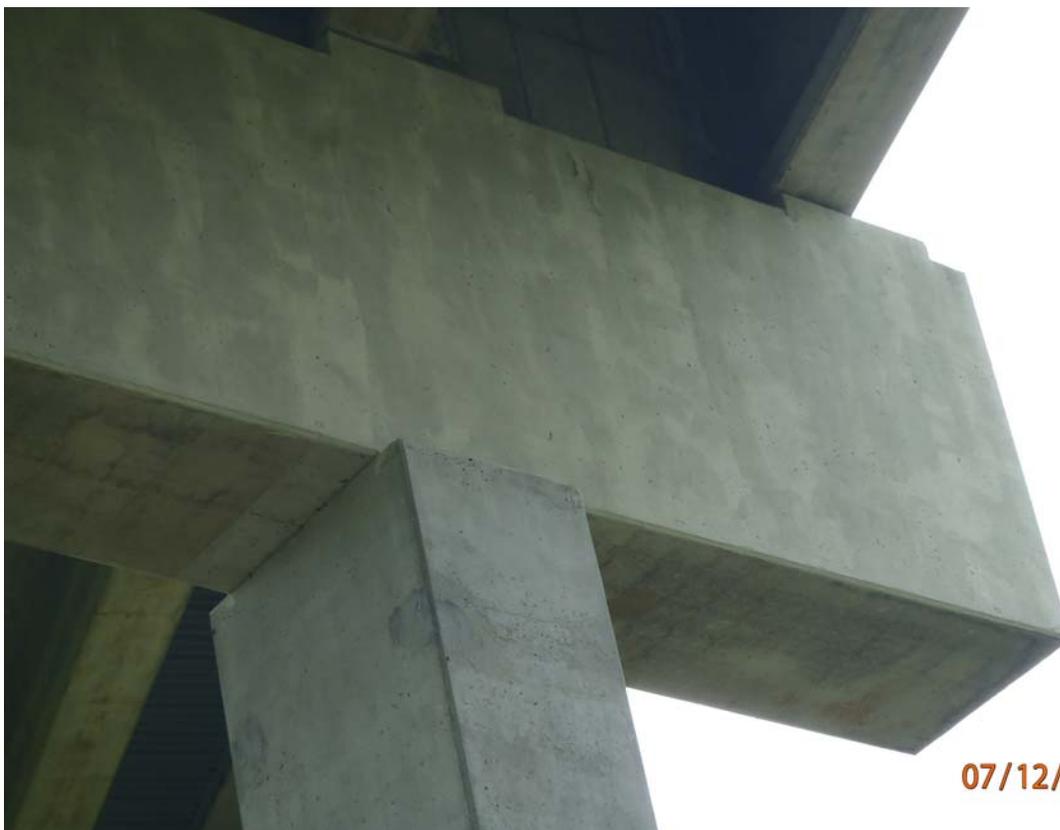
View of the underside of the pier cap of pier 5.
Note the transverse rust staining most likely from inadequate cover over the stirrup/shear reinforcing on cap underside.

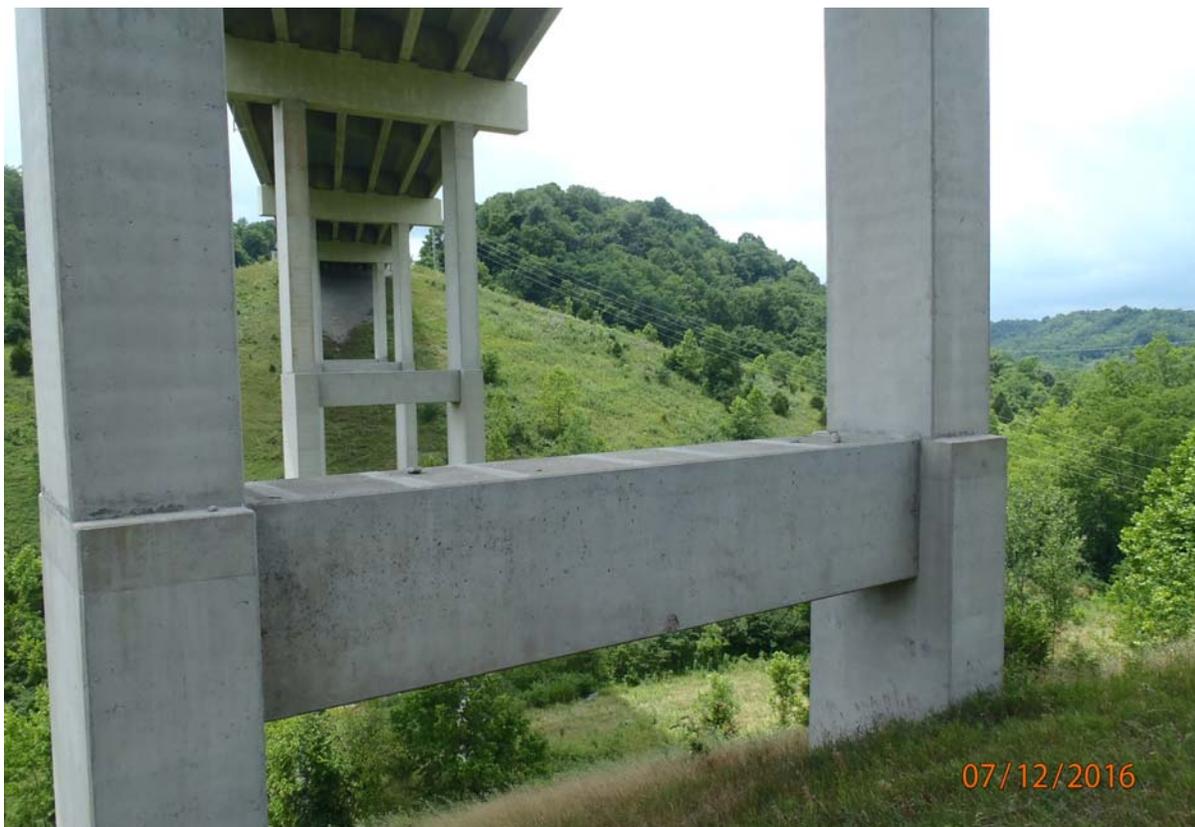
View of the underside of the pier cap of pier 5.
Note the transverse rust staining most likely from inadequate cover over the stirrup/shear reinforcing on cap underside.

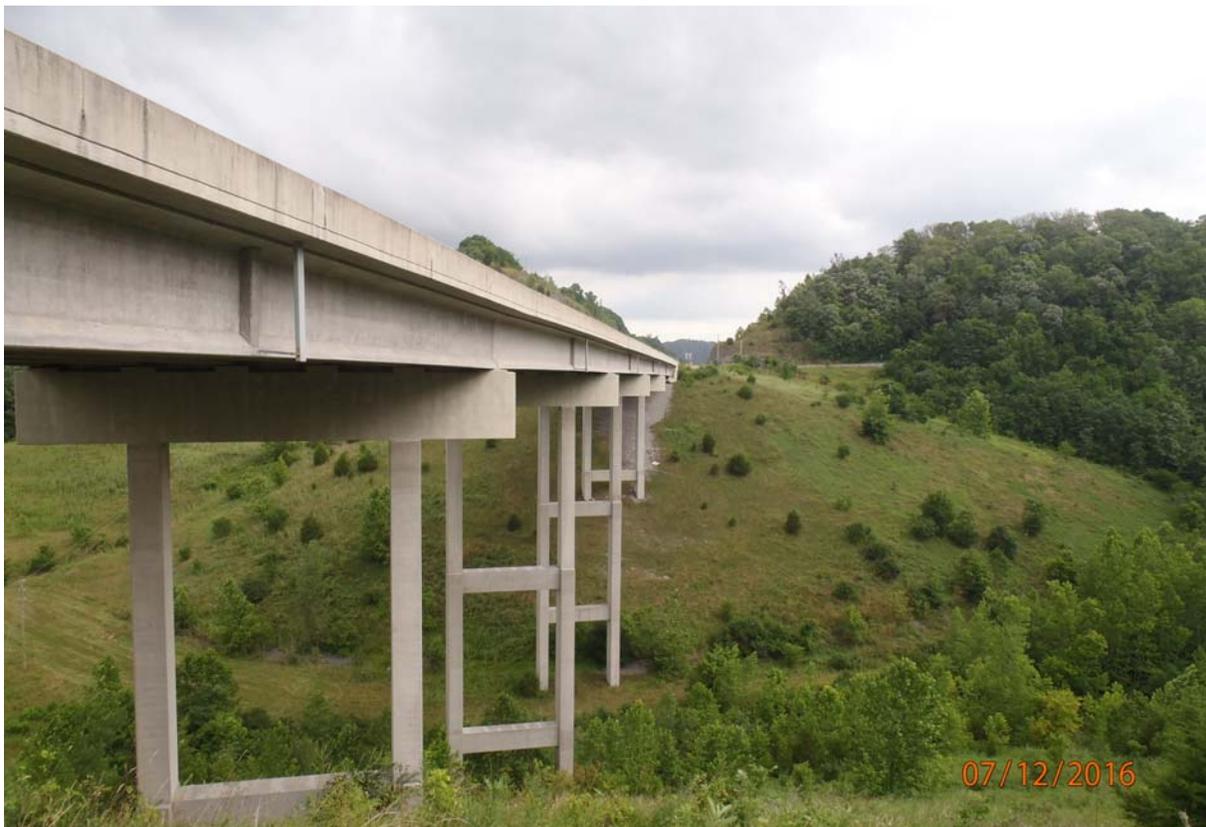
View along the upstream face of beam 6 looking from abutment 1.
Note the waviness of the superstructure.

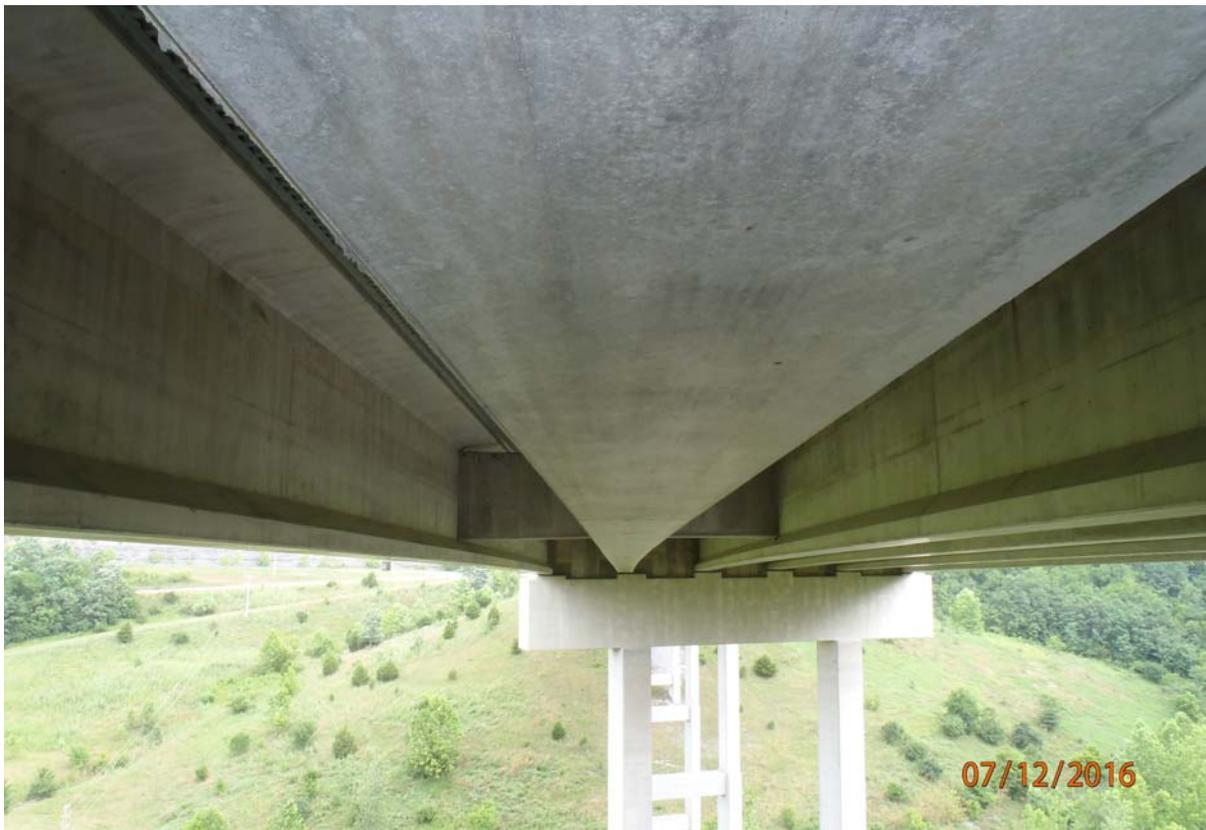
View sighted along the underside of beam 6 in span 1.
Note it appears the beam is sweep towards the upstream.

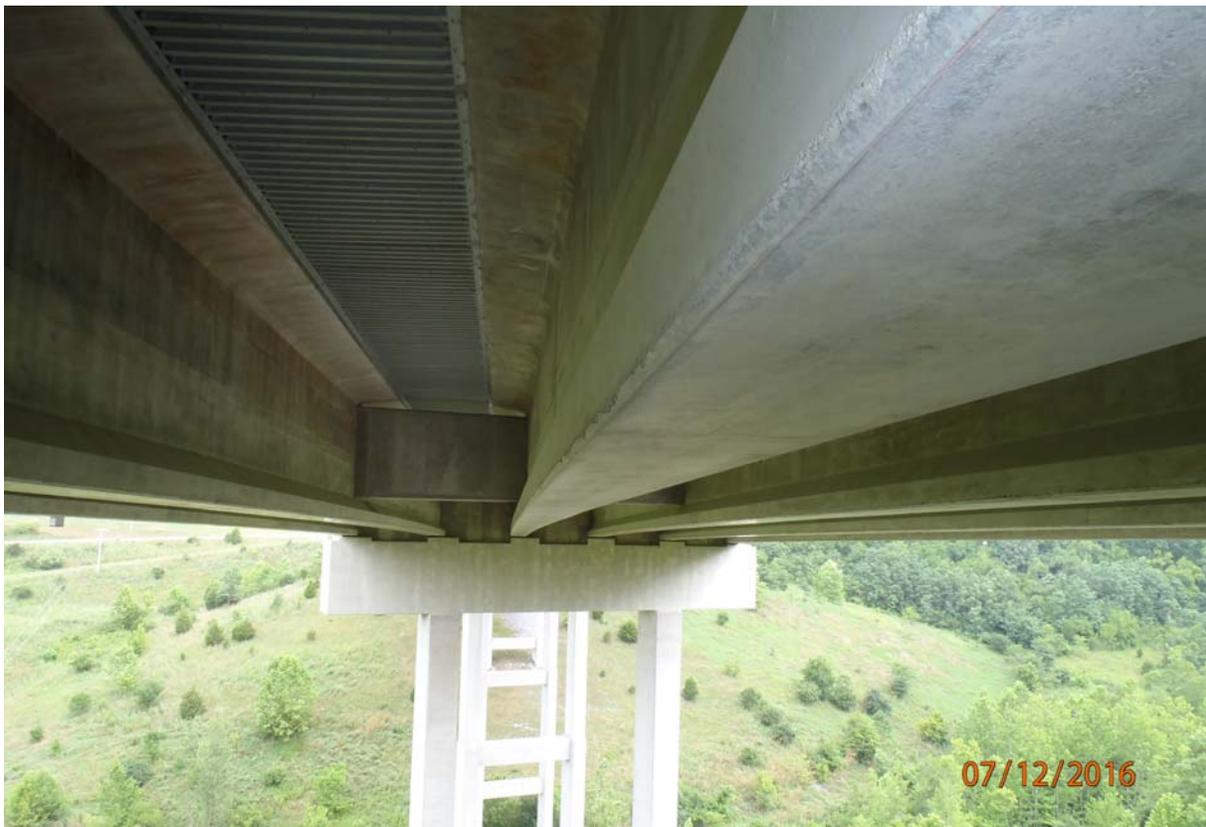
View sighted along the underside of beam 5 in span 1.
Note it appears the beam is sweep towards the downstream.

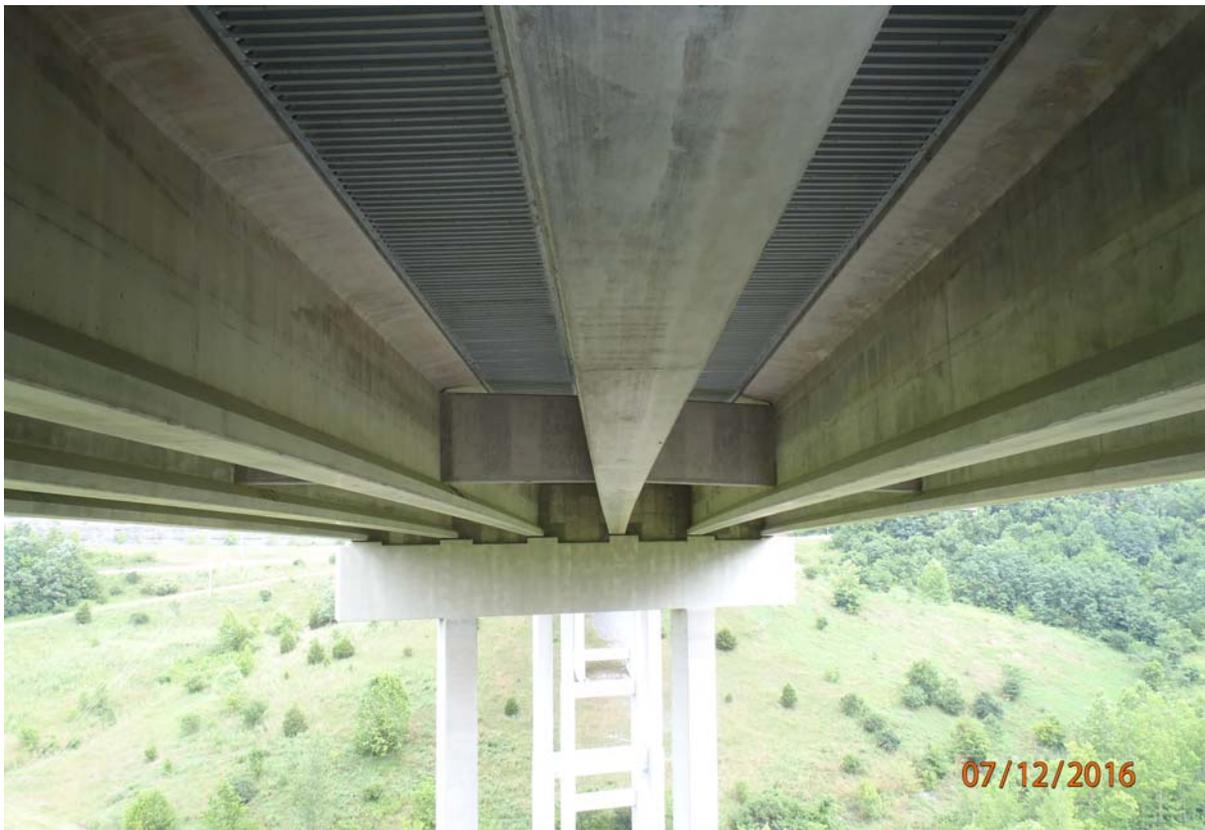
View sighted along the underside of beam 4 in span 1.
Note it appears the beam is sweep towards the downstream.

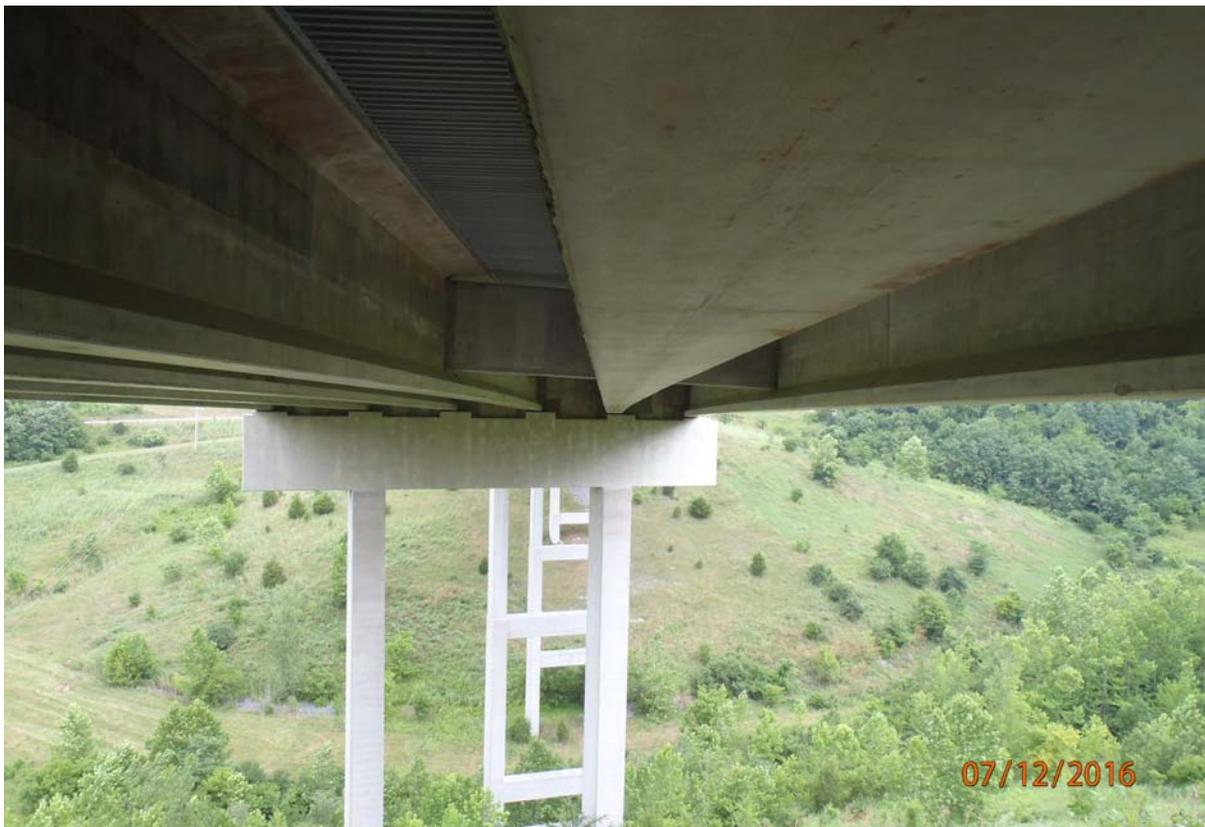
View sighted along the underside of beam 3 in span 1.
Note it appears the beam is sweep towards the downstream.

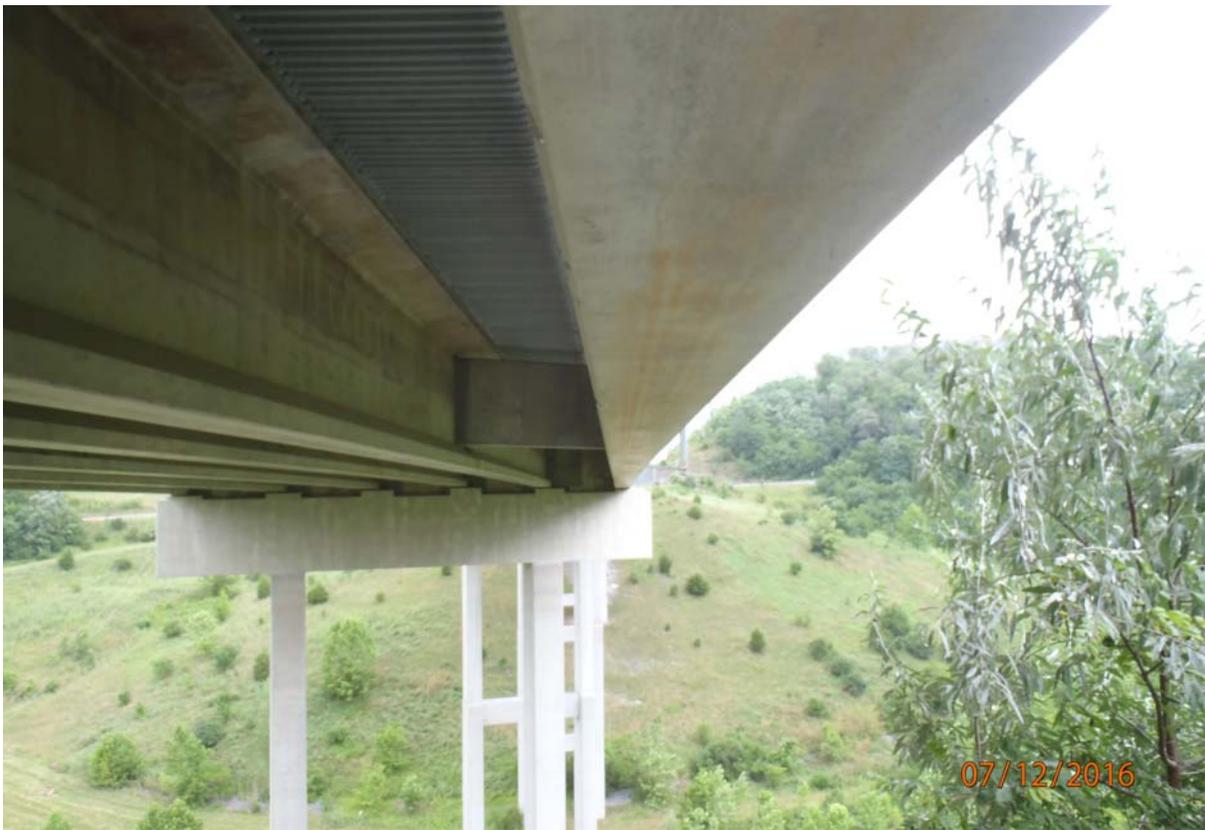
View sighted along the underside of beam 2 in span 1.
Note it appears the beam is sweep towards the downstream.

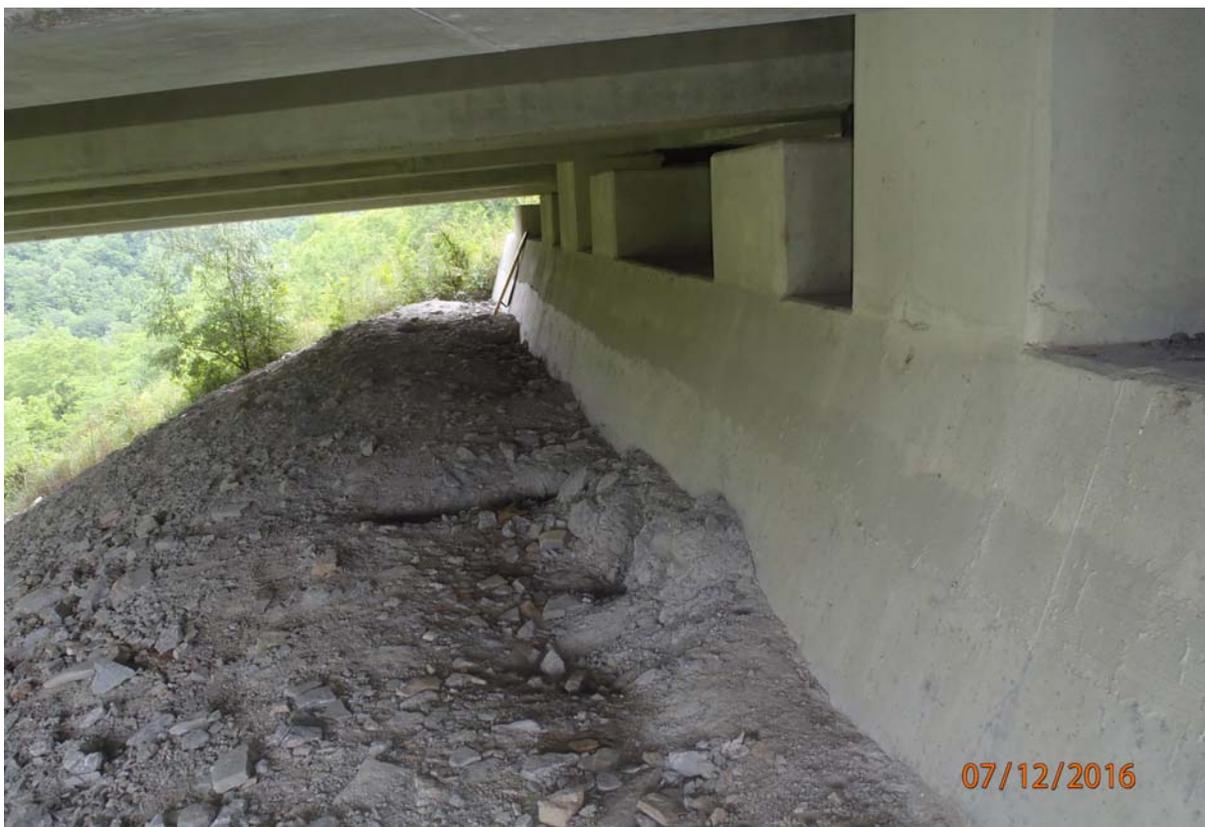
View of erosion and voided area/undermining of the downstream side of the pile cap of abutment 1 at/near beam 1. No piles are exposed or could be detected.

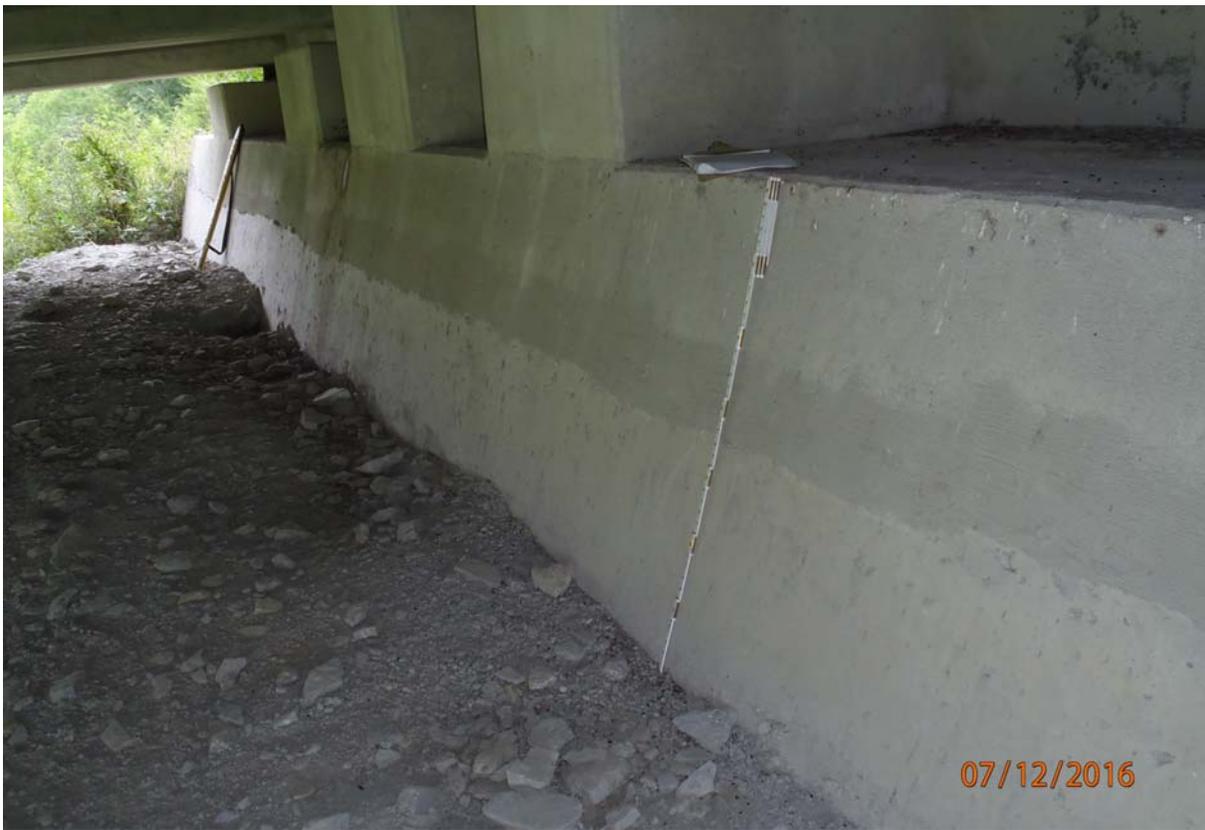
View along the face of abutment 1.
Note the evidence of settlement and potential drag-down.

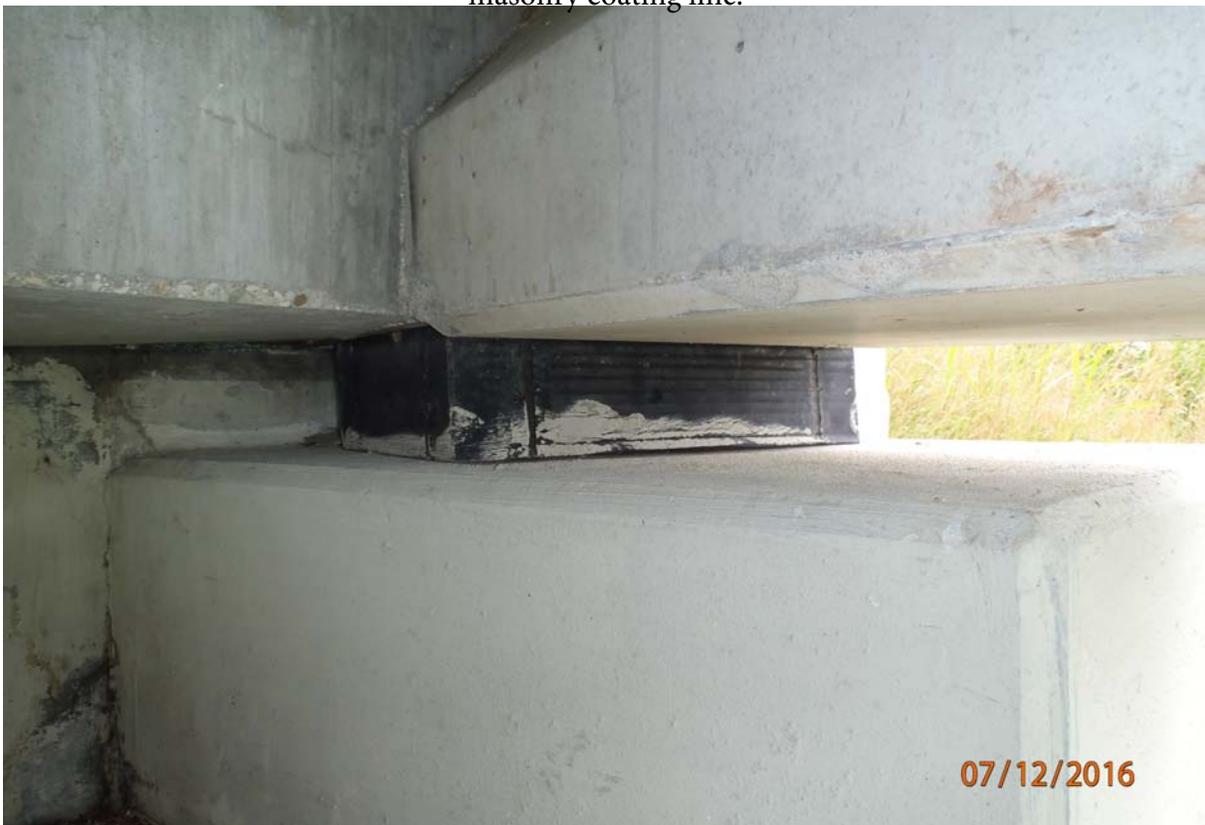
View along abutment 1.

Note the approximate 1'-10" difference between the soil and original masonry coating line from construction along the abutment face; from previous records (1997) the fill was actually to/near the masonry coating line.

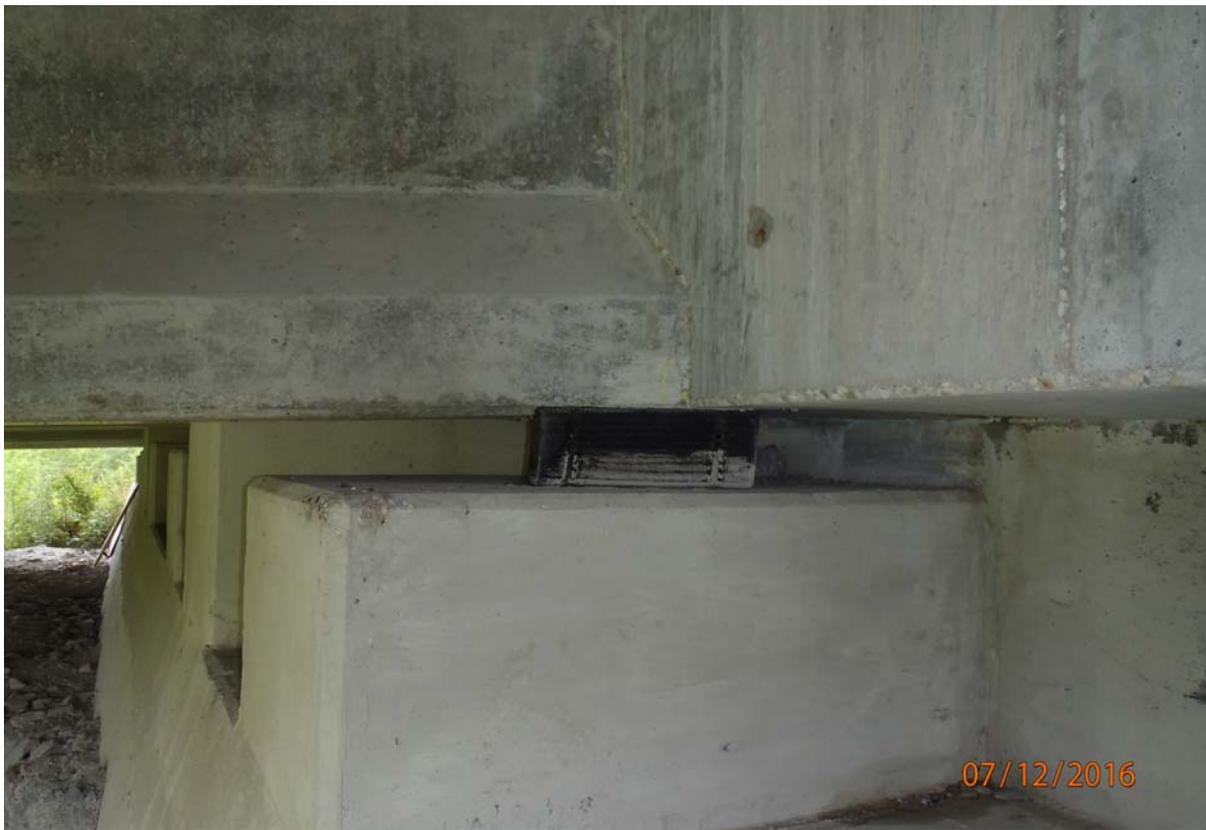
View of the bearing under beam 6 at abutment 1.
Note the bearing pad has moved from its original position.

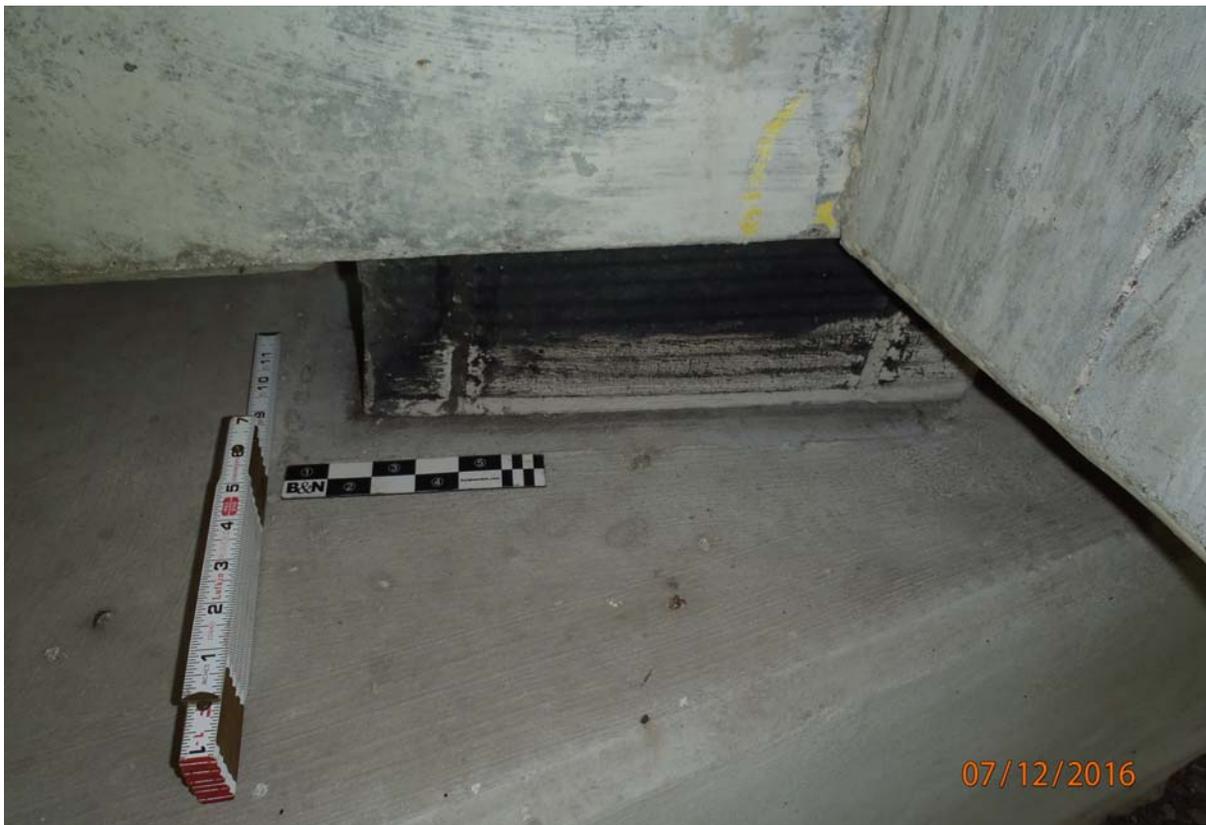
View of the bearing under beam 5 at abutment 1.
Note the bearing pad has moved from its original position.

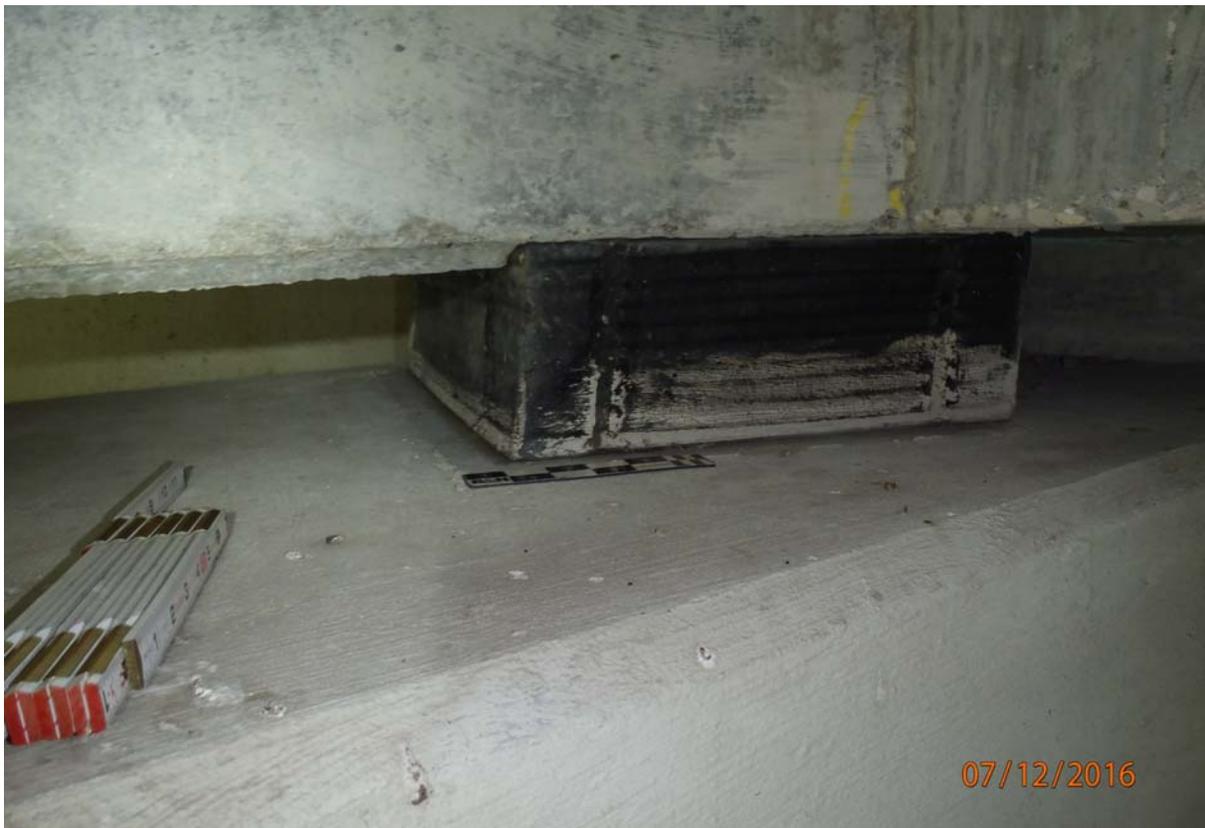
View of the bearing under beam 5 at abutment 1.
Note the bearing pad has moved from its original position.

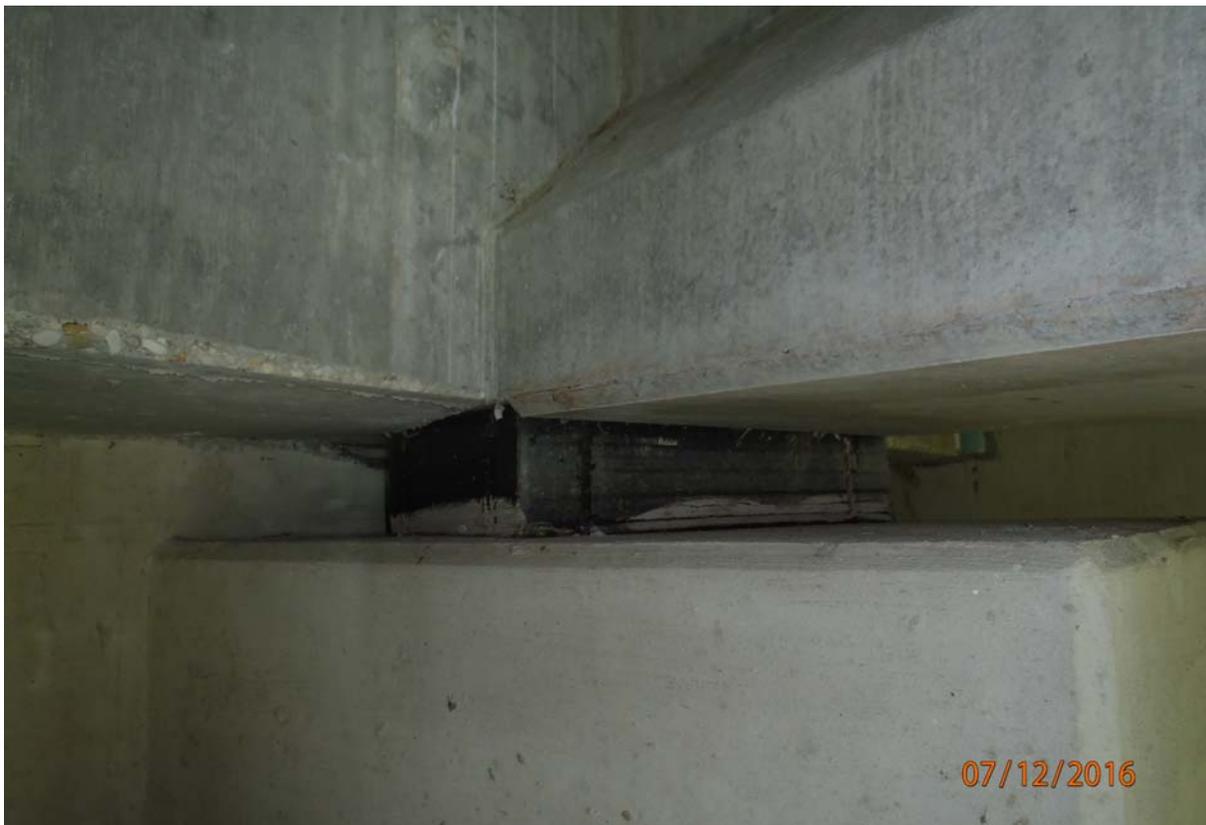
View of the horizontal gap between the diaphragm and shear block between beams 4 and 5 at abutment 1; indicating the superstructure has moved towards the upstream at this location.

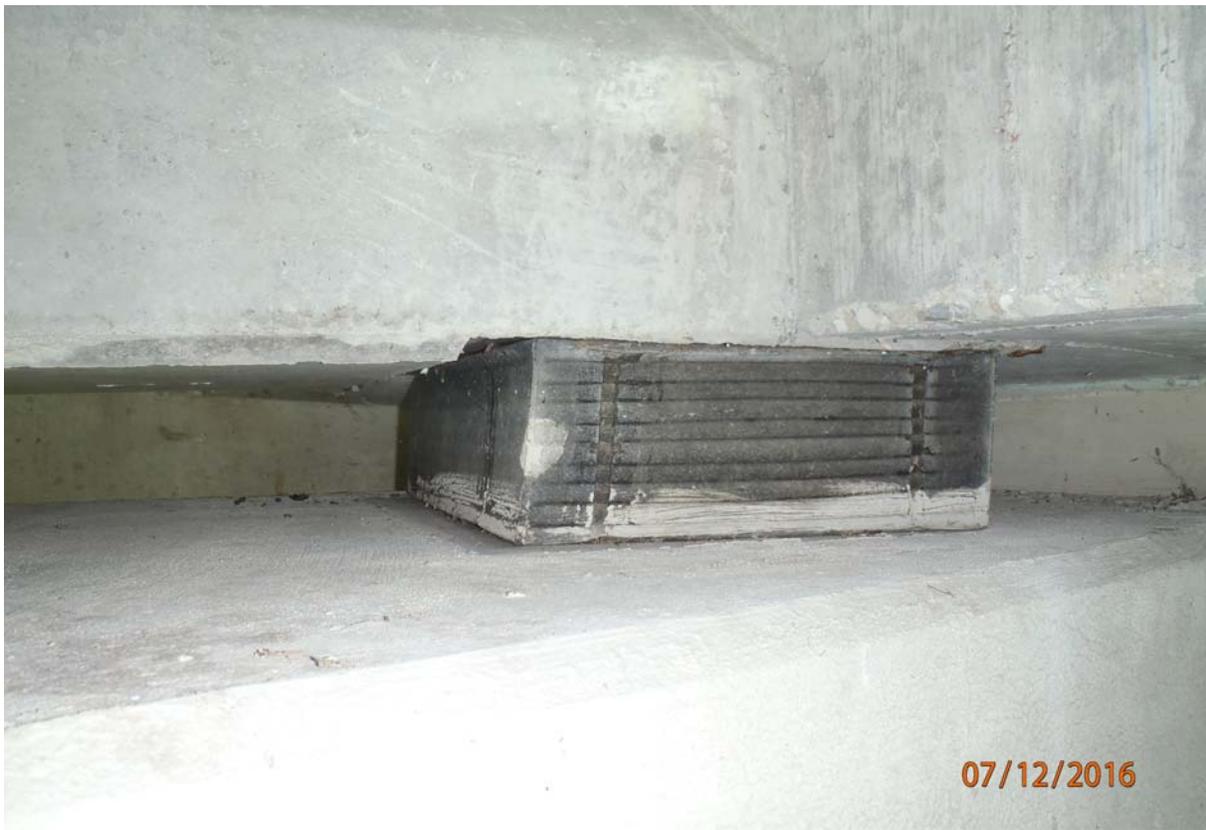
View of the bearing under beam 4 at abutment 1.
Note the bearing pad has moved from its original position.

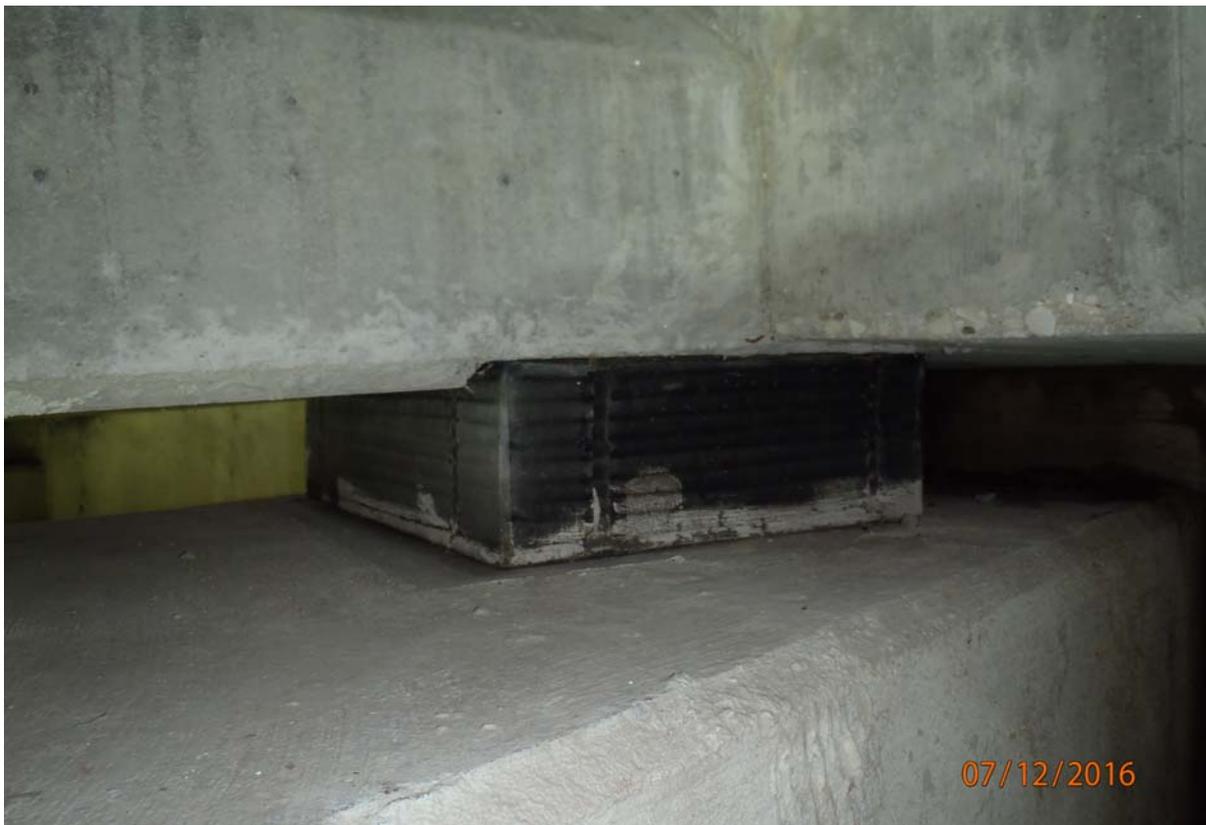
View of the bearing under beam 2 at abutment 1.
Note the bearing pad has moved from its original position.

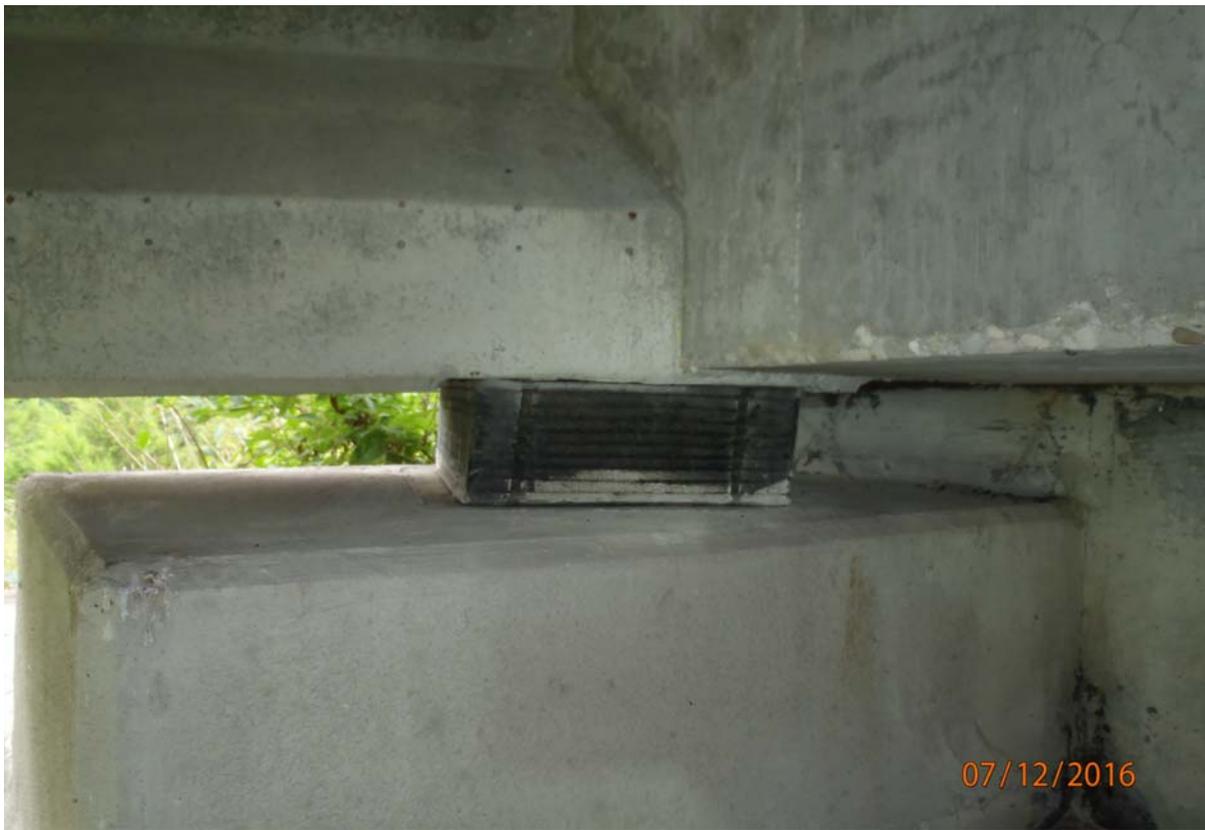
View of the bearing under beam 1 at abutment 1.
Note the bearing pad has moved from its original position.

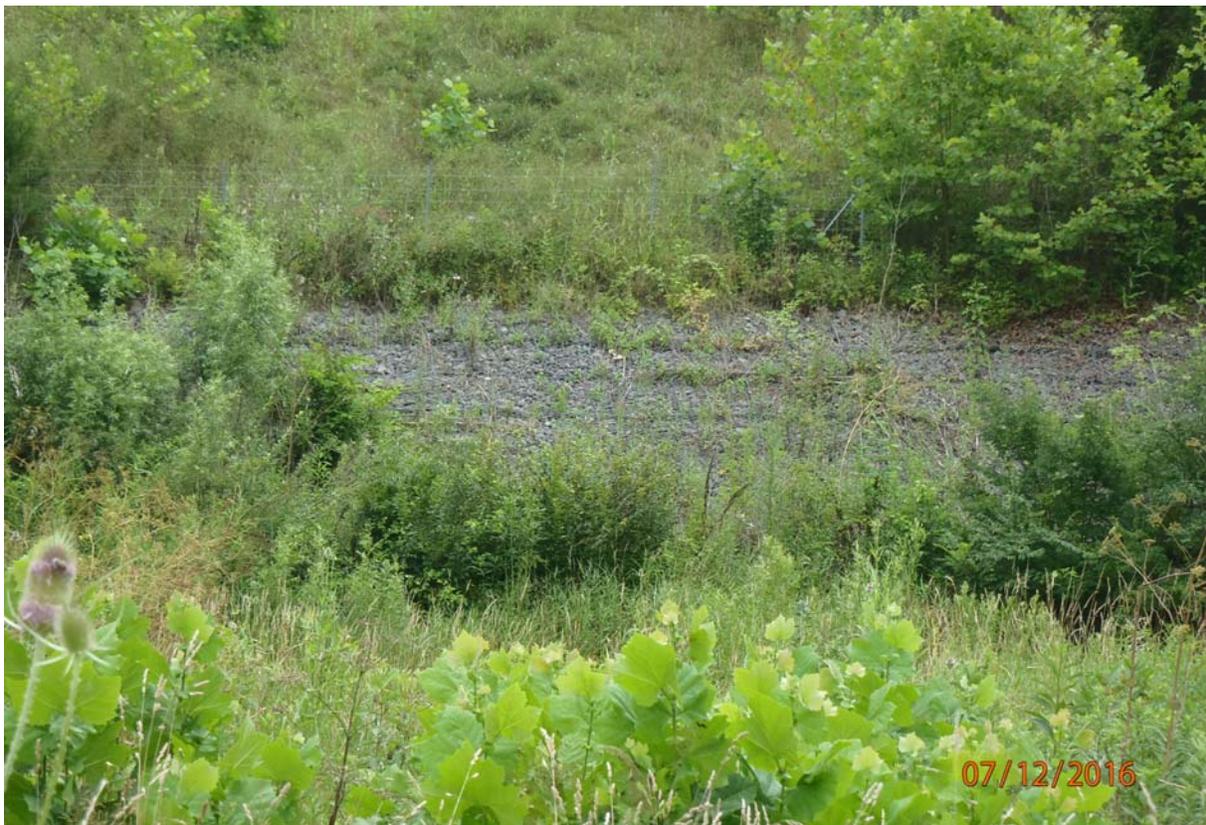
View of the fill/embankment on the downstream side of abutment 6. Note the gabion baskets at the base of the fill.
